Confidential Inspection Report

LOCATED AT:
3227 Weldon Avenue
Los Angeles, California 90065

INSPECTED ON:
Wednesday, July 3, 2019

Inspector, Tom de Spain
Advanced Building Inspections
26500 Agoura Road, Ste 102-567
Calabasas, CA 91302
Office 818.883.9810

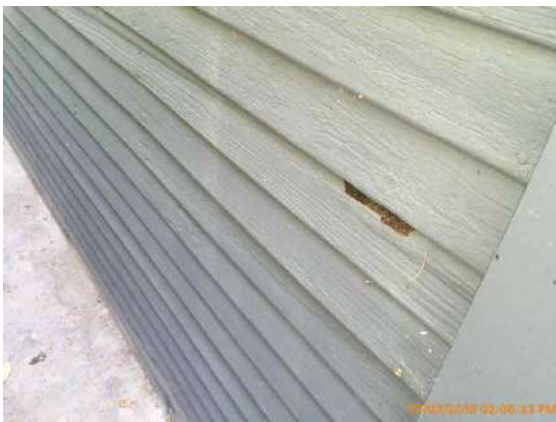
FE 39: There is evidence commonly associated with wood-destroying pest and/or organism activity. We recommend consultation with a licensed pest control operator.

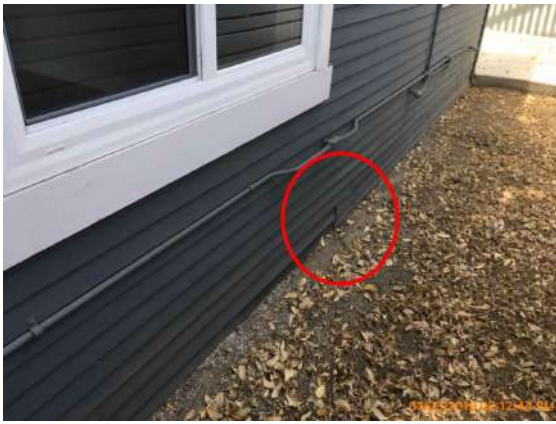
CORR 54: There are unsealed joints in the siding that may allow water penetration. We recommend the joints be caulked and sealed to prevent leakage and damage.

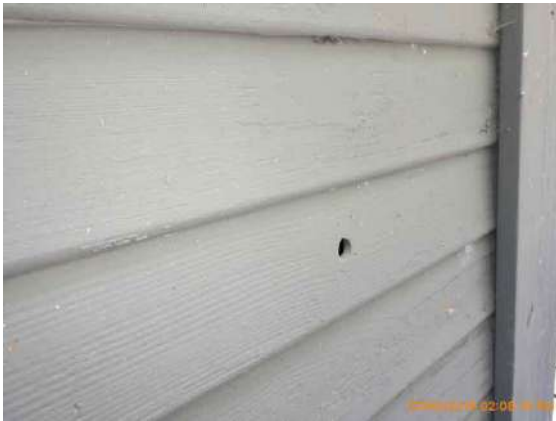
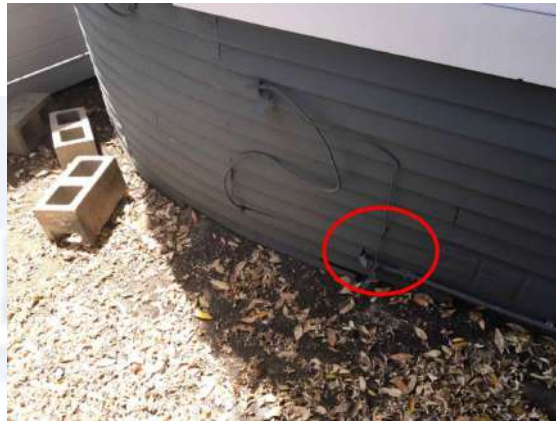
CORR 55: Gaps in the siding were observed at one or more of the pipe and/or vent penetrations. We recommend all such gaps be sealed or plugged in the course of routine property maintenance.

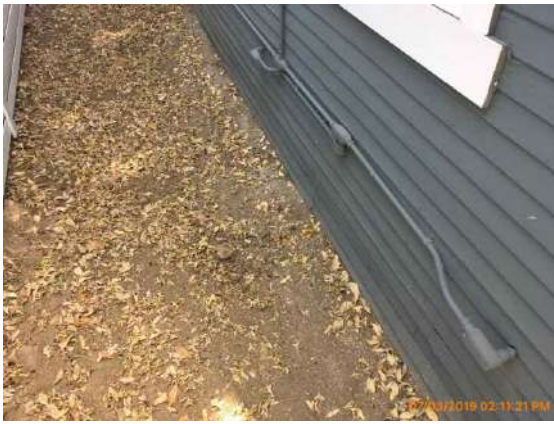
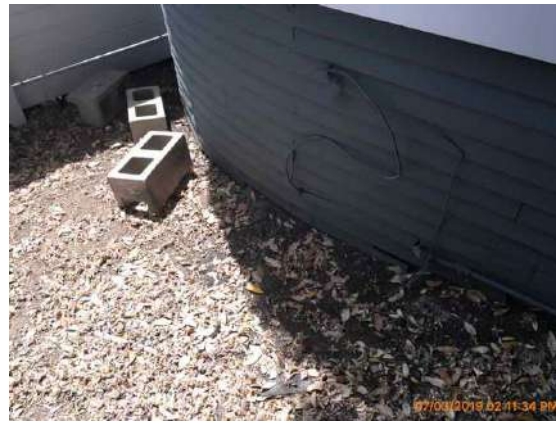
CORR 56: Portions of the siding are in contact with and/or embedded in concrete. This is not an accepted practice, but modification would be difficult. As preventive maintenance, we recommend the area be flooded with a wood preservative from time to time.

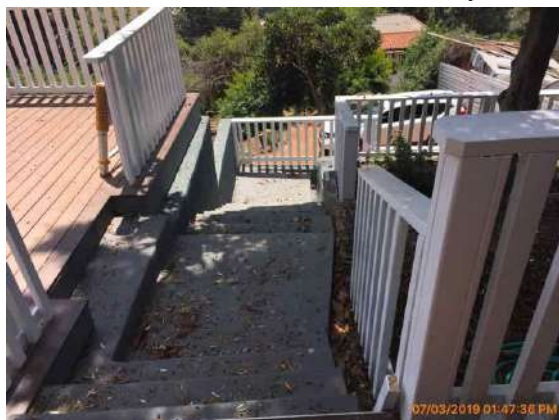
SFTY CORR 72: The steps at the front are nonconforming. Standards require all steps to be almost identical in 'rise' and 'run' for safety. Ideally, the stairs should be rebuilt. If not, we recommend caution in the use of this stairway.

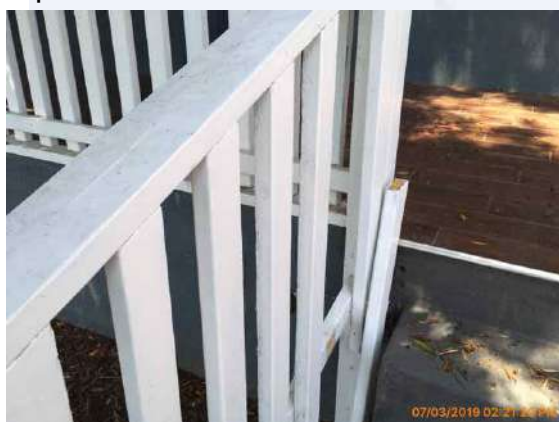
CORR 74: The railings at the front step are damaged. We recommend they be repaired or replaced.

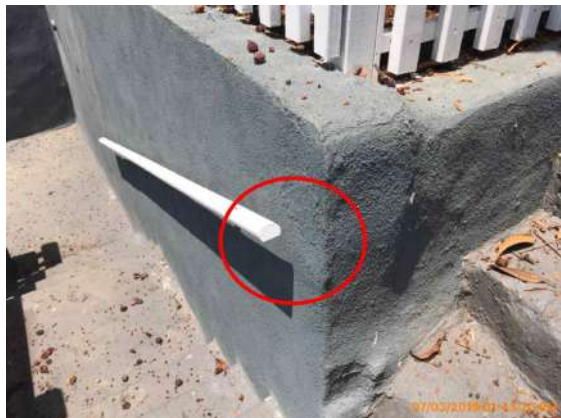
75: The handrail(s) for the stairway did not have newel-posts or "return" to the wall. The newel posts and wall returns serve two purposes; the first is to indicate to the visually impaired that they have reached the end (top or bottom) of the steps/stairwell. The second is to prevent clothing, garments or bags from getting hung up on the open-ended handrails.

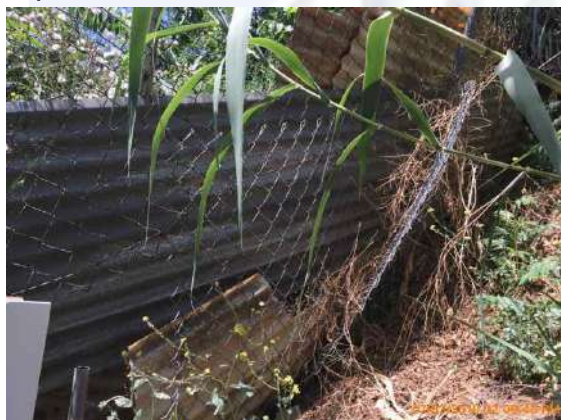
CORR 77: There is major damage to the fencing. We recommend the fencing be repaired and/or replaced.

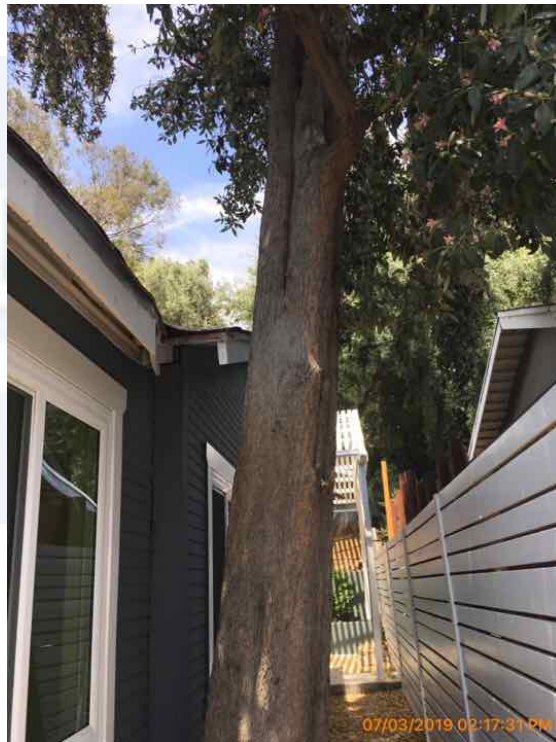
84: Trees were planted too close to the structure. This condition limits the inspection and is conducive to moisture intrusion/deterioration and provides ready access to rodents and insects.

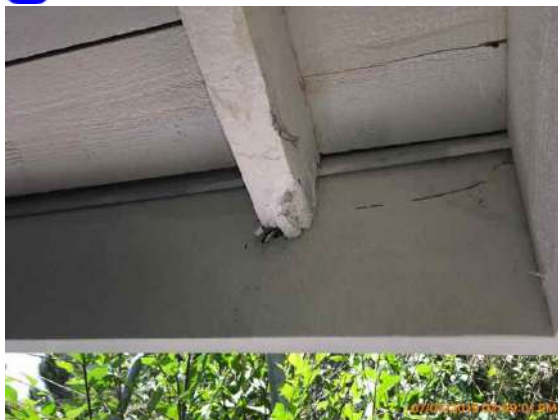
CORR 89: EAVES: Rafter tails are deteriorated. We recommend repair or replacement.

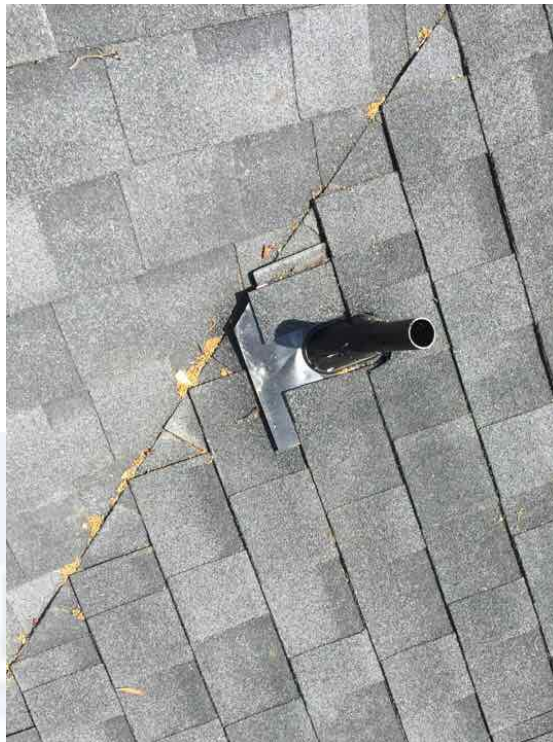
FE 147: A number of the vent flashings were over exposed at the lower edges. More of the flashings should be covered to prevent moisture intrusion and damage to the building components. We recommend further evaluation and repair.

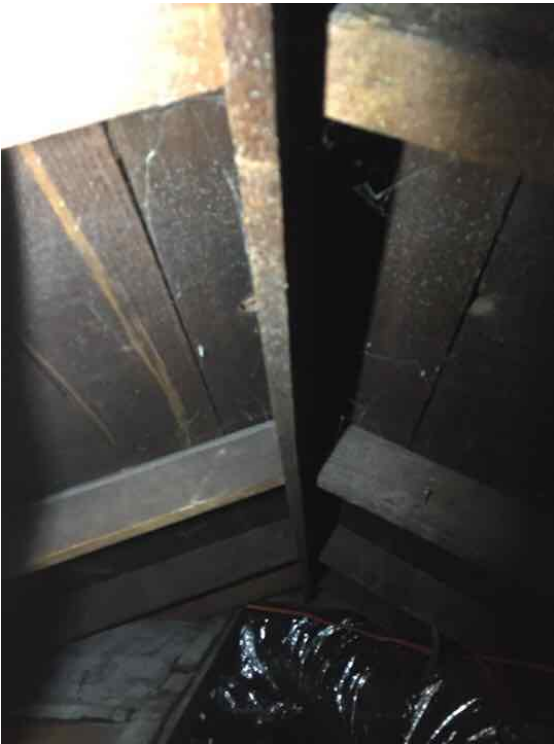
FE 163: The roof framing ridge-beam was narrower than the face of the rafters fastened to it. This condition does not provide adequate support for the lower edge of the roof rafters thereby reducing their load carrying capabilities.

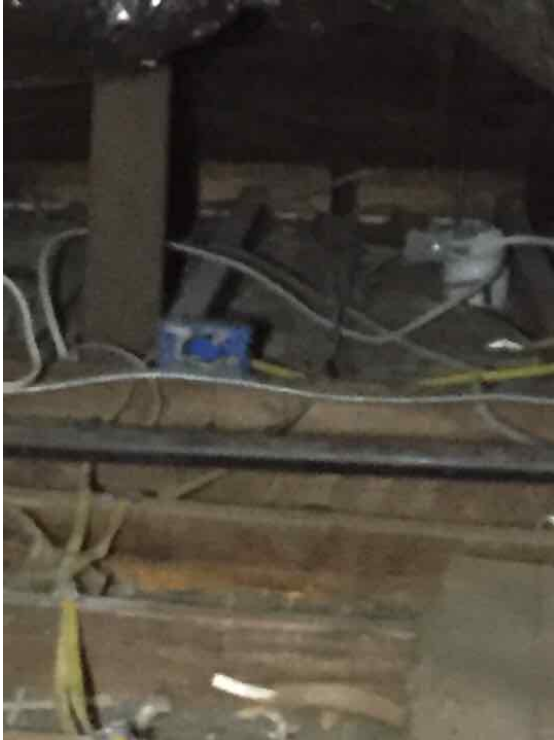
UPGR **166:** There was no insulation in the attic. This condition is not energy-efficient and the building may experience excessive heat-gain in the summer and heat-loss in the winter. We recommend adding insulation in the attic.

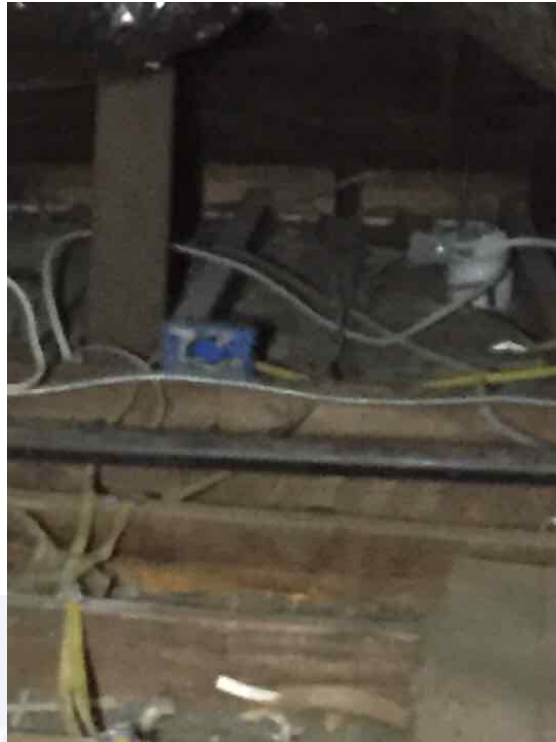
168: Missing electrical cover plates.

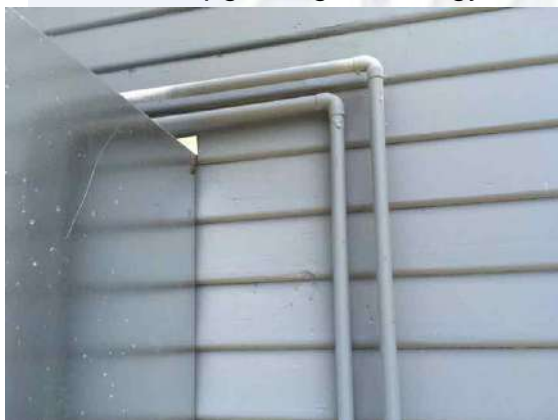
UPGR 225: The exterior & interior plumbing lines are not insulated as per current code. We recommend upgrading for energy savings.

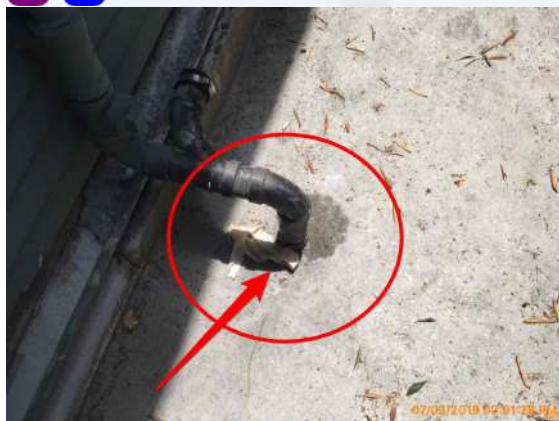
FE **CORR** **234:** The kitchen drain line is leaking at the exterior. We recommend that it be repaired.

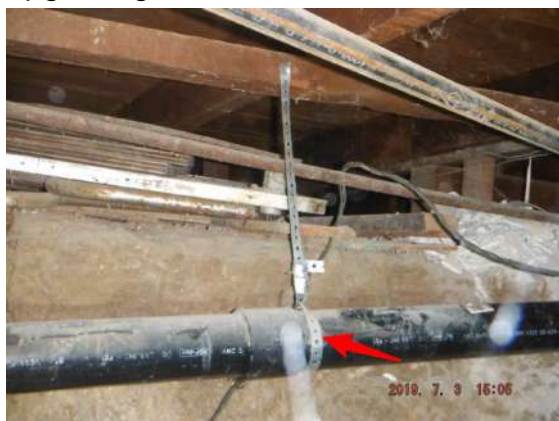
CORR **235:** Improper hangers/strapping is used for the ABS/PVC drain piping. We recommend upgrading.

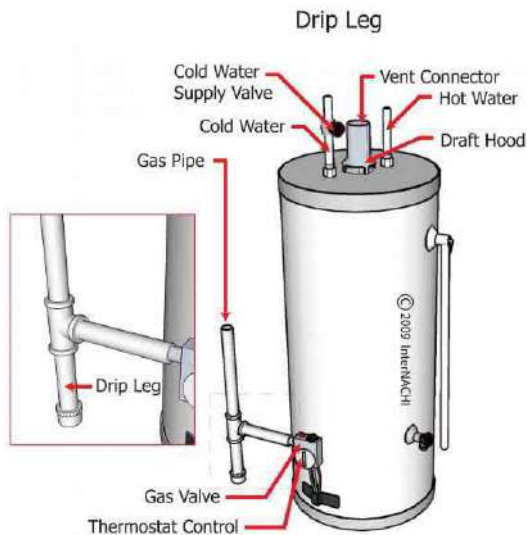
UPGR **263: GAS SHUT OFF VALVE:** The fuel piping does not include a 'T' extension to collect condensation and debris, as is considered good practice. In the course of future upgrading or repair, a 'drip leg' should be added to the gas piping just ahead of the connector.

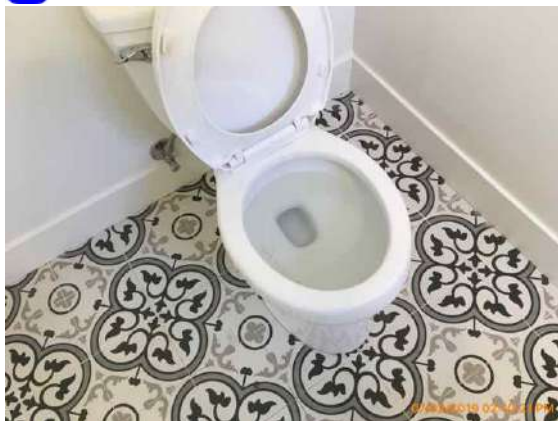
CORR 358: The toilet doesn't flush properly. We recommend repair.

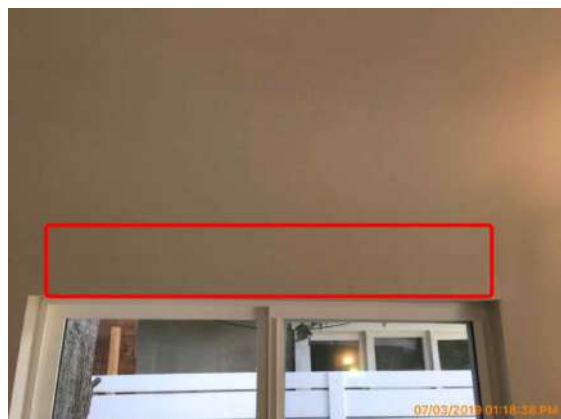
FE **CORR** **459:** Moisture was detected on the wall. The source of moisture should be identified and corrected.
