Affordable Inspection Services, Inc.

Mold Investigation Findings:

Initial Inspection

1532 9th Street Unit 7
Santa Monica, CA

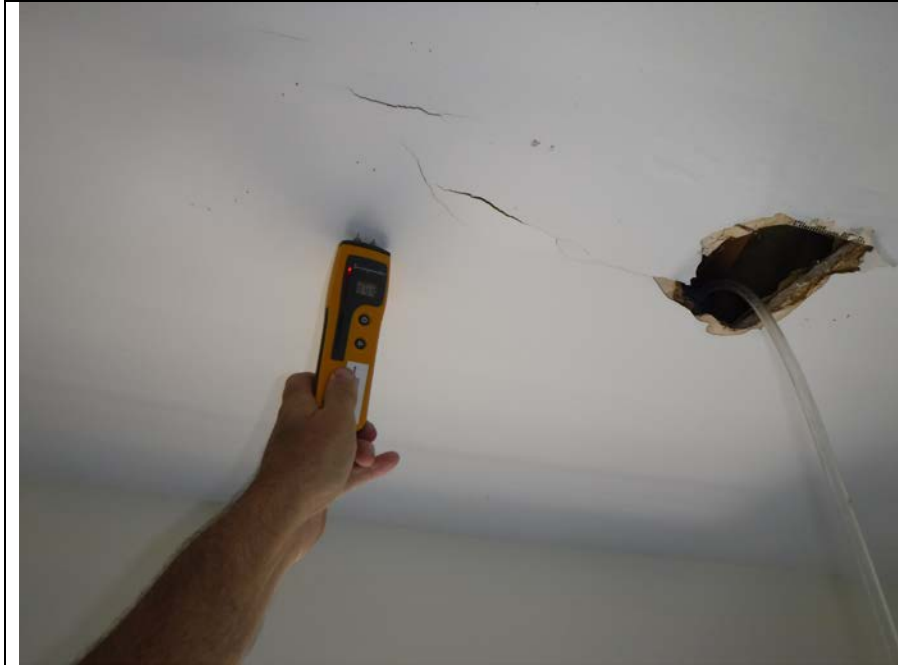
INSPECTION RESULTS			
Bedroom 1			
	Inspected for:	Observation	Findings
1.	Visible mold or suspected mold.	Visible mold was observed on the ceiling in this room.	Unacceptable

2.	Water Damaged / Stained building materials.	Water damaged or stained building materials was observed on the ceiling in this room.	Unacceptable
3.	Elevated moisture readings.	Elevated moisture readings (100%) were recorded on the ceiling material in this room.	Unacceptable

4.	Mold Growth: Molds seen with underlying mycelial and / or sporulating structures – Swab #2 – BR 1 Ceiling.	Mold growth (<i>Stachybotrys</i> and <i>Monodictys</i> species) was observed.	Unacceptable

Location of air and swab samples with elevated mold spores and moisture readings on the ceiling in BR 1.

Areas identified in this report as containing elevated mold should be immediately repaired following the below guidelines. Initial areas which should be remediated following these guidelines shall include:

- Entire bedroom ceiling.
