## **Diana Andreassen**

4064 Huerfano Ave #251  
San Diego, California 92117

Chris Dembroski NACHI10071406  
Smart Home Inspection  
(619) 846-5737  
chris@smarhomeinspection.net  
5582 Forbes Ave  
San Diego, CA  
92120  
[www.smarhomeinspection.com](http://www.smarhomeinspection.com)

Friday  
April 12, 2024

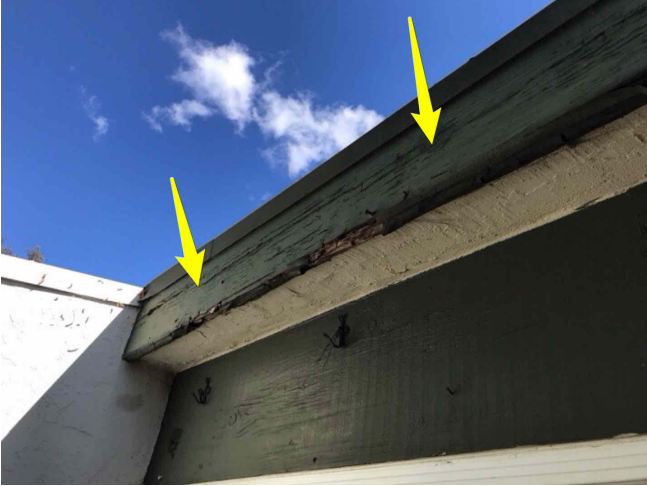
**R 19:** Sections of the fascia at the patio are deteriorated. We recommend they be repaired or replaced.

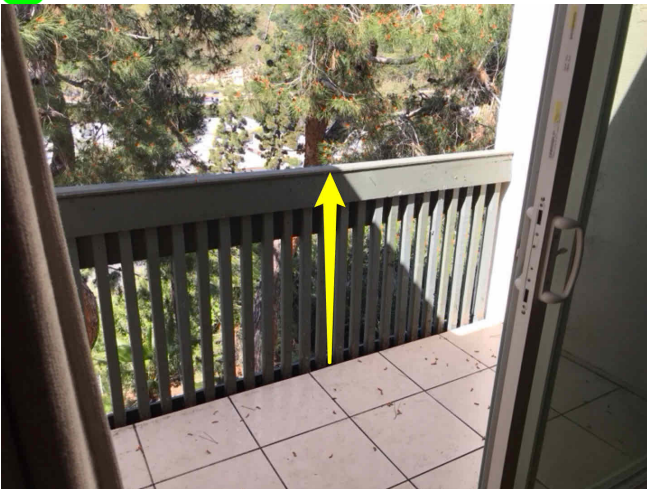
**S 24:** The railings and/or guardrails do not comply with current industry standards. We suggest modification for safety.

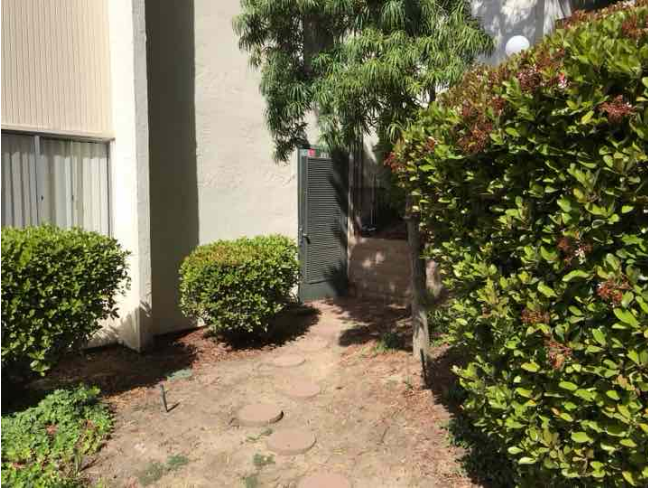
**39:** The main disconnect is located in a locked HOA cabinet and could not be inspected.

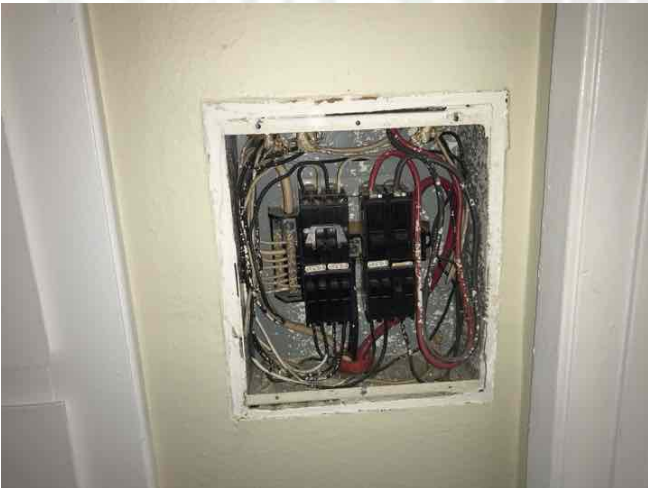
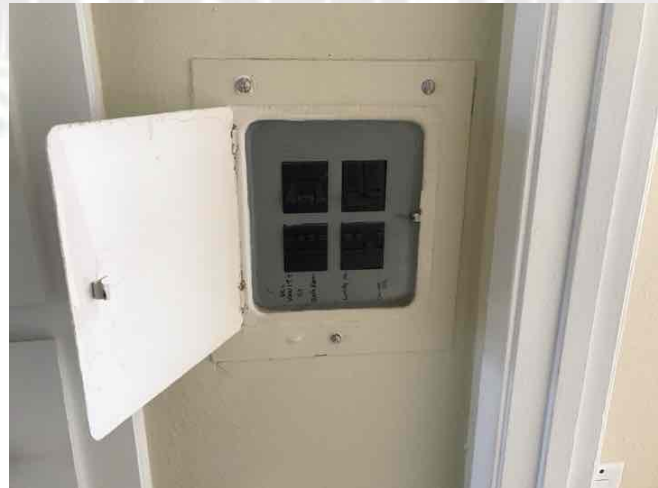
**42:** The main electric panel is located hallway

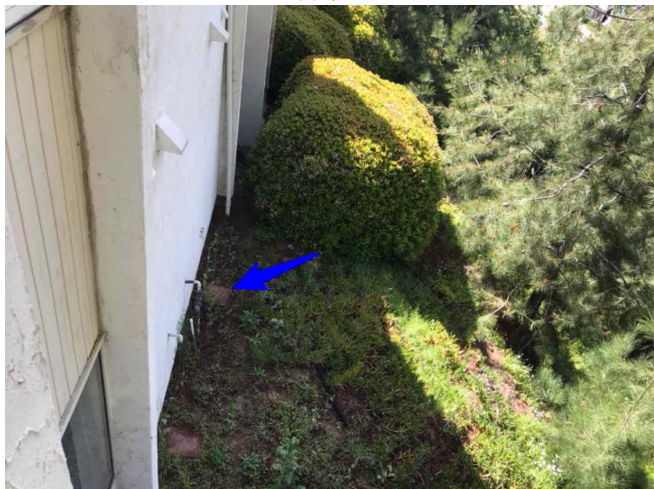
- 68: The domestic water supply main shut-off valve is outside at the rear of the building.

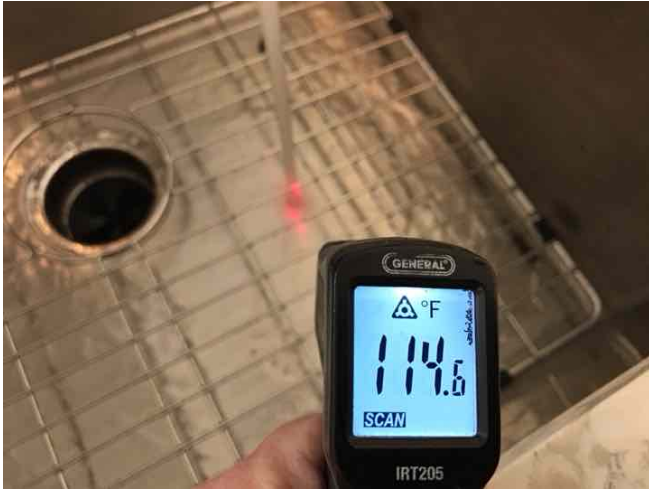
**77:** The water temperature measured 114 degrees which is an acceptable safe temperature. Any Temperature over 126 degrees is a potential scalding hazard.

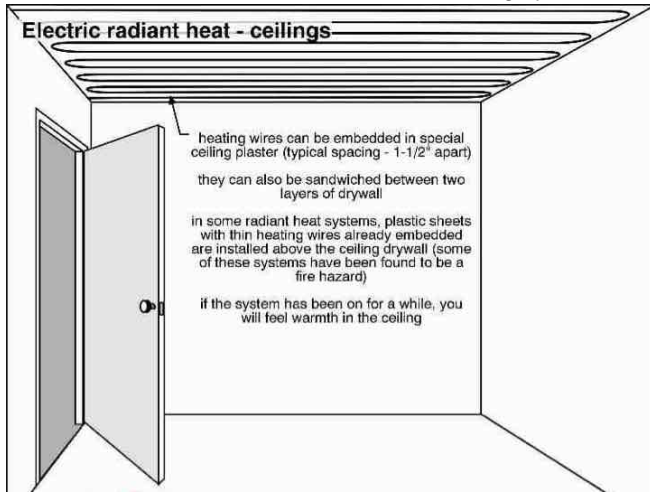
**81:** Electric ceiling heat also known as spot heaters are made up of thermostats and electric coils that are placed into the plaster or drywall of the ceiling. These types of systems are no longer installed due to their inherent safety issues. It is advised that a safer and more efficient heating system be installed.

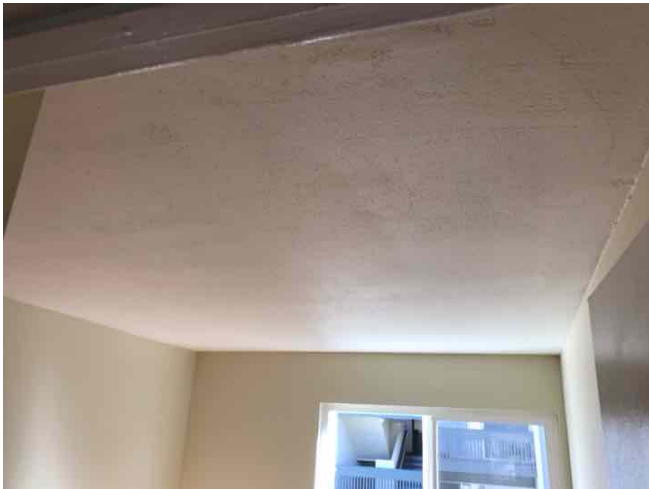
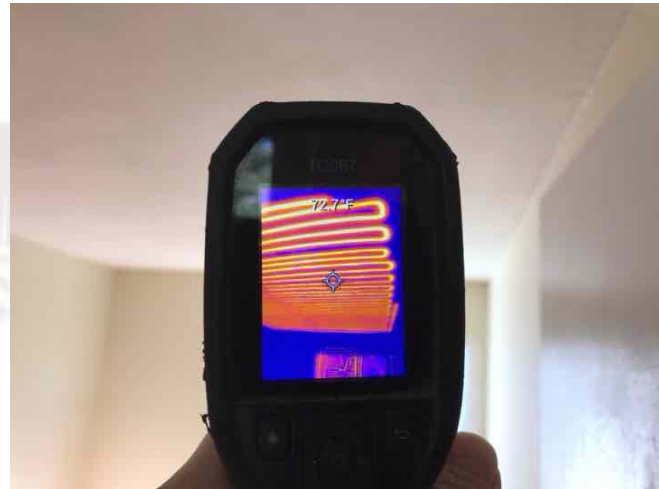
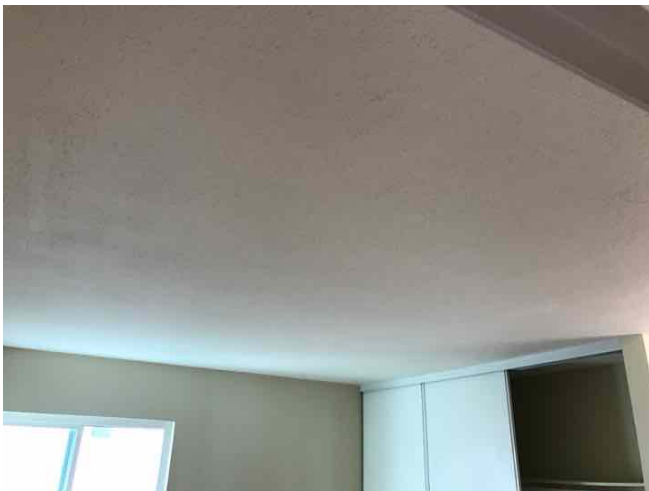
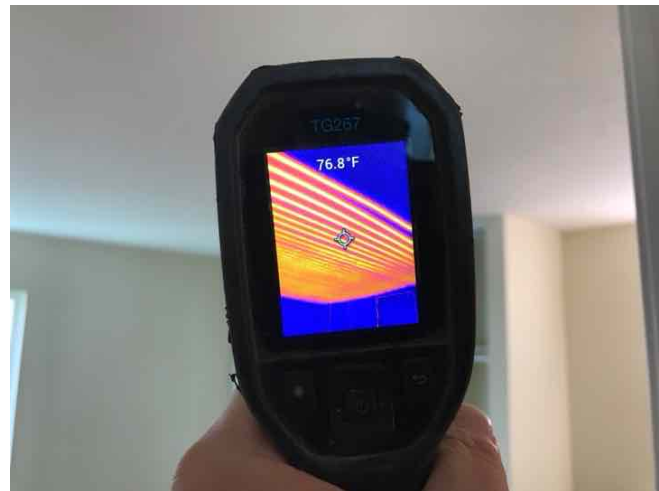
**82:** The ceiling heat system located bedrooms responded to normal user controls at the time of inspection.

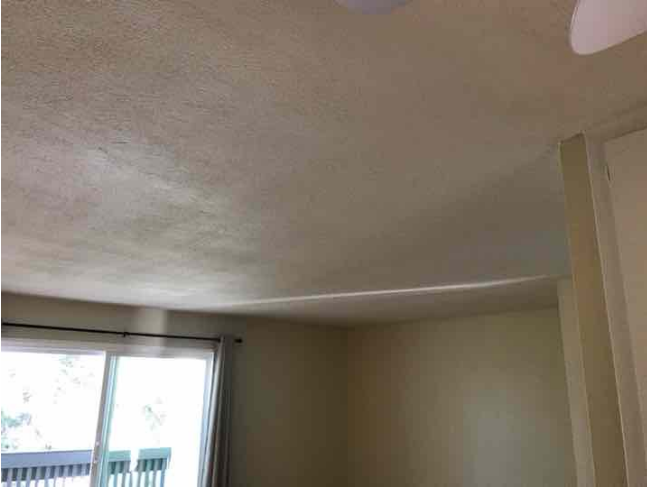
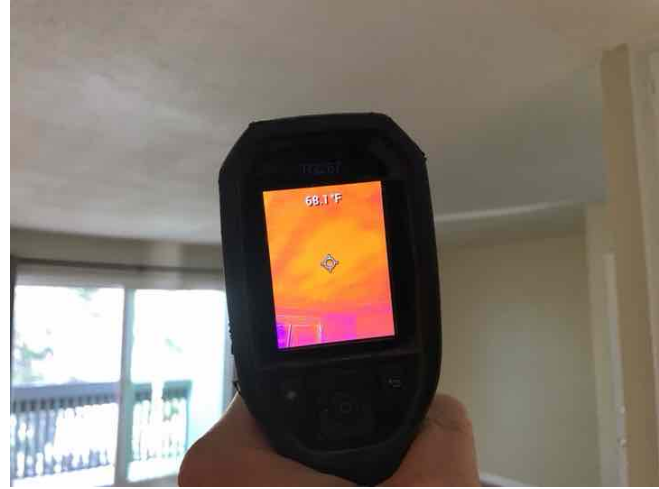
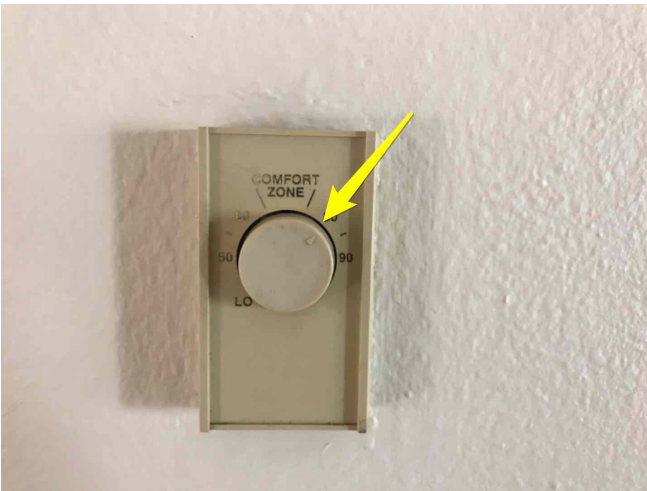
**R 83:** The ceiling heat system located living room did not respond to normal user controls at the time of inspection and needs to be further evaluated by an appropriate qualified professional.

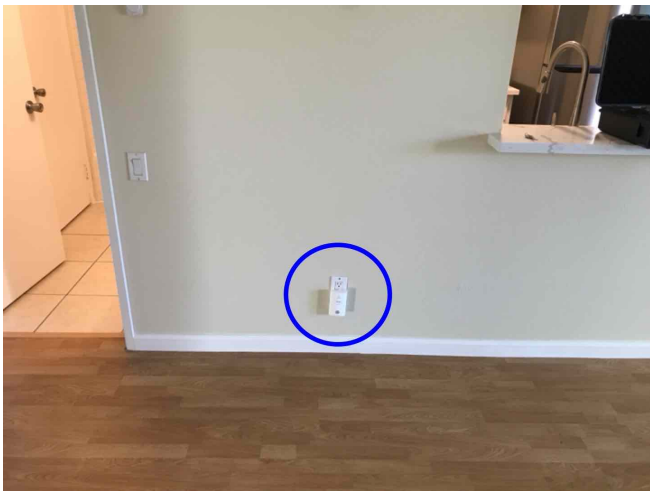
**105:** There is a carbon monoxide detector installed in the hallway of the home.

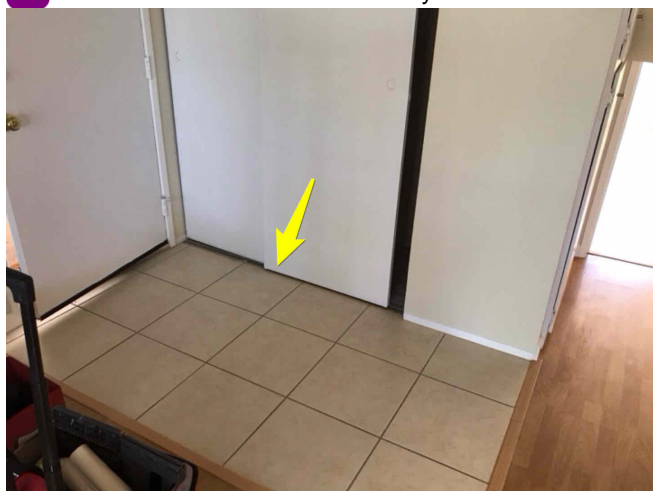
**M** 113: The closet doors at the entry are off the bottom track and need service.

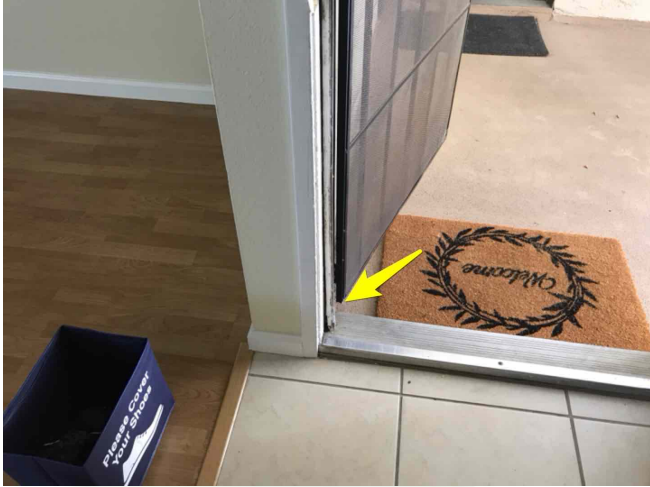
**M** 123: The door has damaged or missing weather stripping and needs to be repaired or replaced.

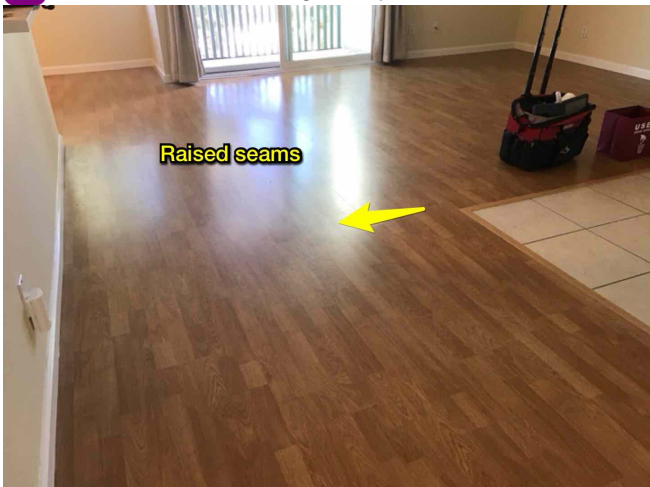
**M** 126: The wood flooring is only in fair condition. The floor may need minor repairs or sanding, refinishing or replacement.

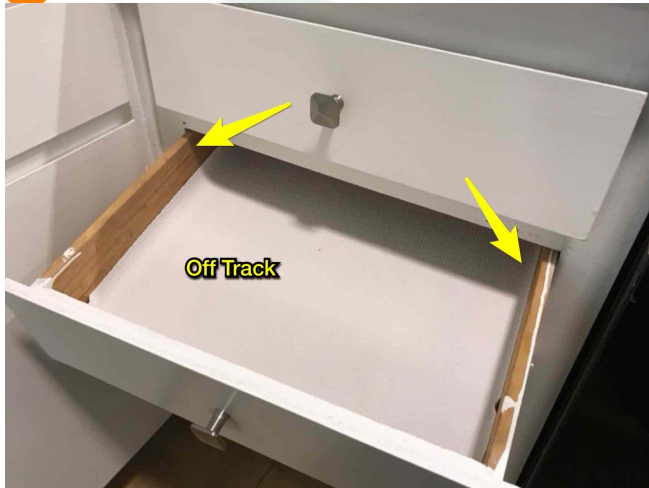
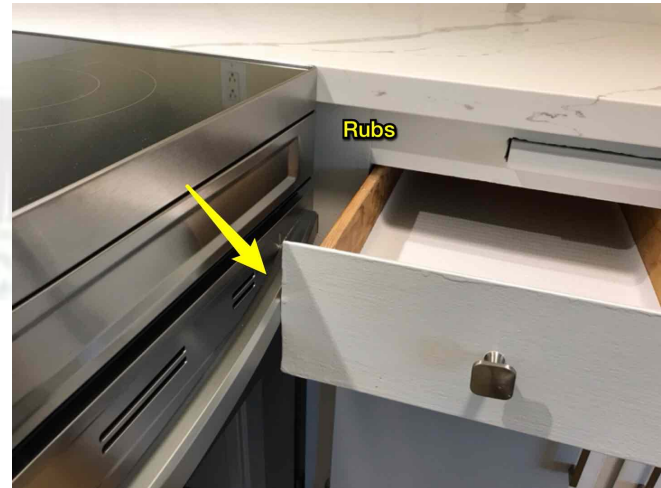
**R** 150: One or more of the kitchen drawers is damaged and needs service.

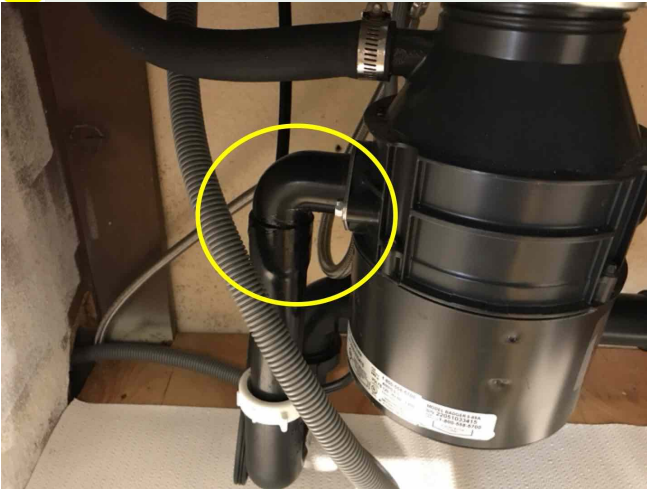
**W 163:** The drain trap has been installed in a substandard manner. We recommend it be repaired or replaced.

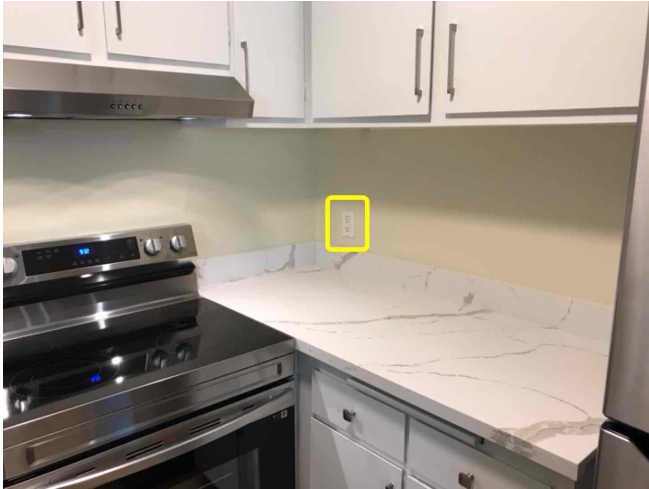
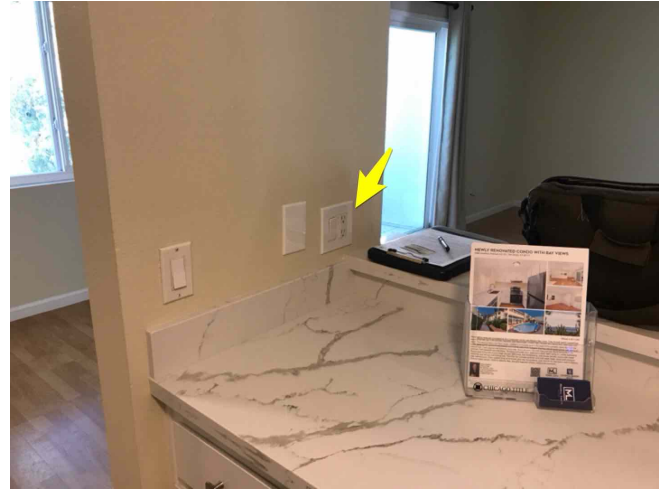
**U 169:** GFCI protection was not found at all countertop receptacles even though this was not mandatory at the time of construction. We recommend upgrading in compliance with current standards.

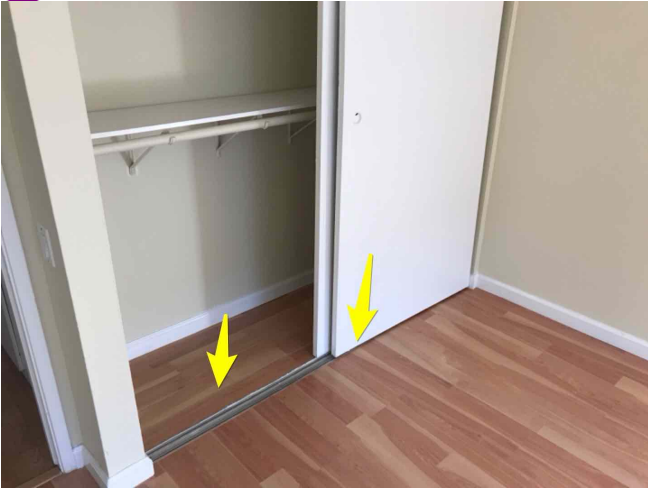
**M** 176: The closet doors are off the bottom track and need service.

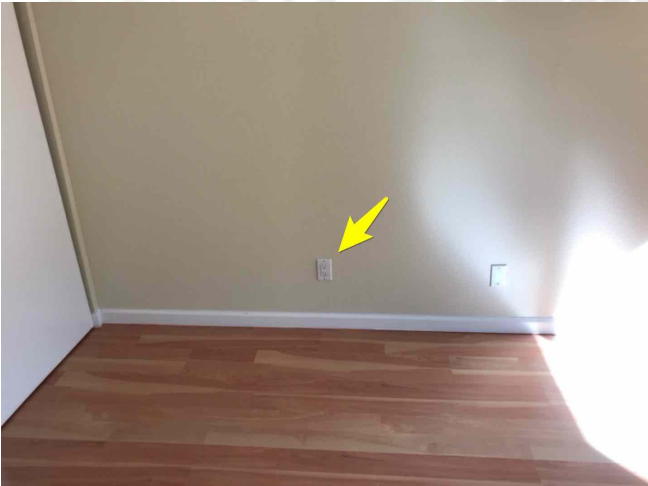
**S** 179: There is an ungrounded three prong receptacle at the bedroom. We recommend it be properly grounded or restored to its original two prong configuration.

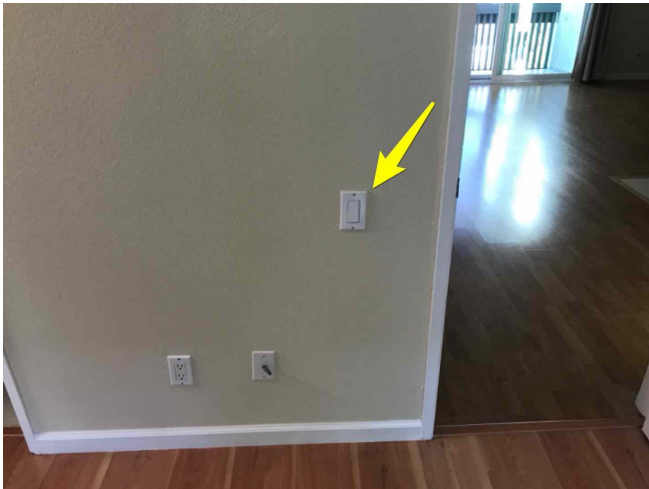
**U 188:** There is no switched light or receptacle in this area. We recommend a switch be installed, in accordance with present standards.

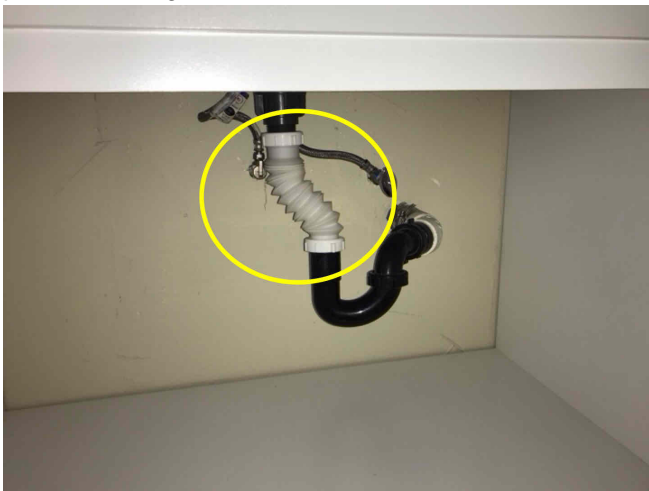
**U** 199: The sink drain line is corrugated plastic, it is advised that the drain line be replaced with a smooth type drain line to prevent blockage.

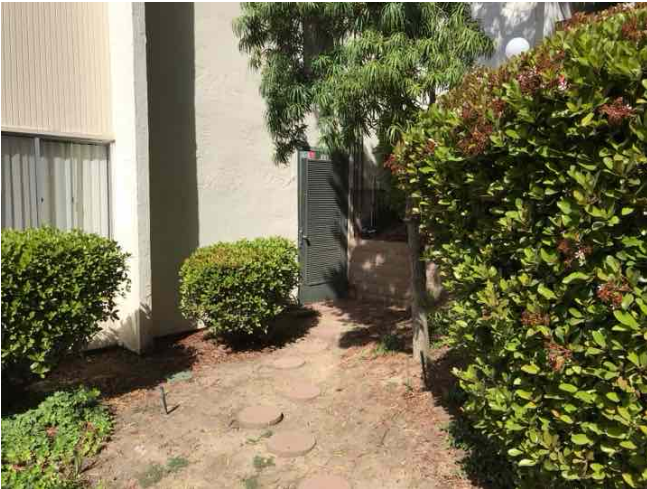
**2:** The main disconnect is located in a locked HOA cabinet and could not be inspected.

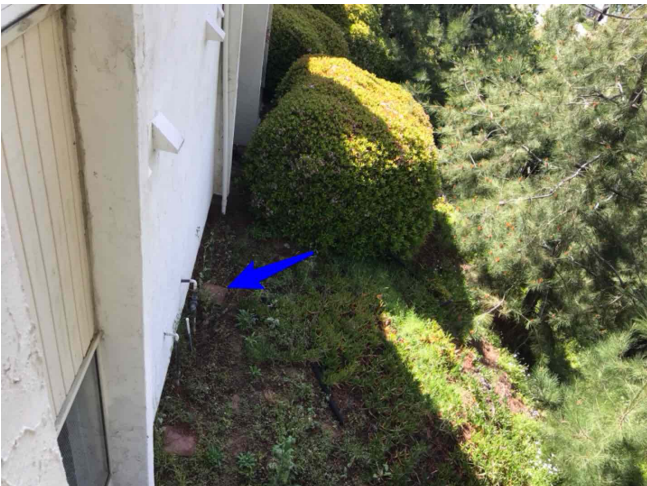
**3:** The domestic water supply main shut-off valve is outside at the rear of the building.
