Property Inspection Report

Client(s): Patricia Shah
Property address: 726 Pier Ave

Santa Monica CA 90405-4579

Inspection date: Saturday, September 16, 2023

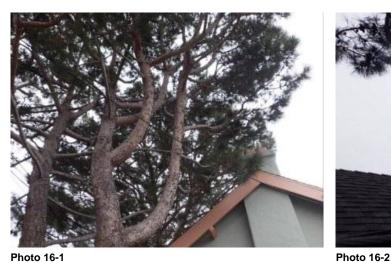
Photo 16-1

16) <a> Trees are overhanging roof and are within 10 feet of roof vertically. This is a conducive condition for wood destroying insects and organisms since organic debris such as leaves or needles are more likely to accumulate on the roof surface. Accumulated debris may cause water to enter gaps in the roof surface and leak into attic and/or interior spaces. Trees should be pruned so they are at least 10 feet above roof, or don't overhang the roof.
