**Exclusive Property Inspection Report Prepared For
Gus Guerrero**

Property Address: 5701 E. Walton St. Long Beach CA.

Inspection Date: 11/8/2024

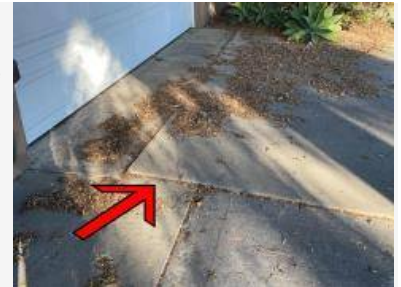
- Uneven surface joints are visible. The condition poses a trip hazard. We recommend correction using appropriate methods by a qualified state licensed concrete contractor.

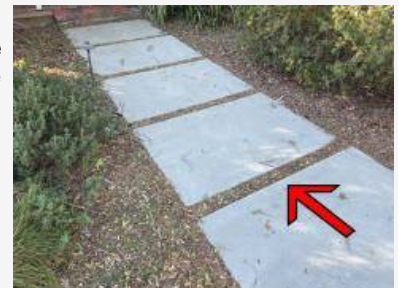
- Gaps are visible between the segments of concrete which is causing the surface to be uneven at the main entry walkway. The condition poses a trip hazard. We recommend correction using appropriate methods by a qualified state licensed concrete contractor.

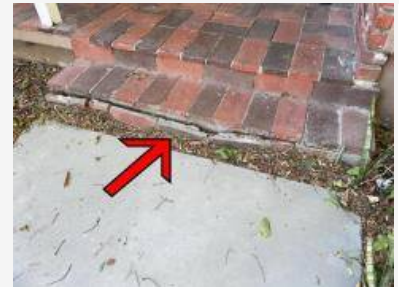
- Detached bricks are visible from the bottom step riser. The condition poses a trip hazard. We recommend correction using appropriate methods by a qualified state licensed masonry contractor.

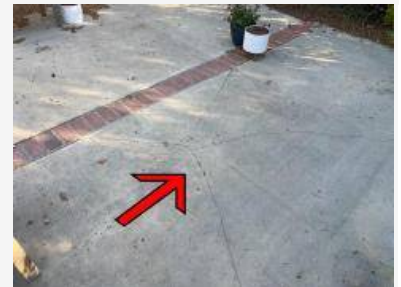
- Significant crack damage is visible at multiple locations. Determining the cause is beyond the scope of this inspection. We recommend further evaluation / correction using appropriate methods by a qualified state licensed concrete contractor.

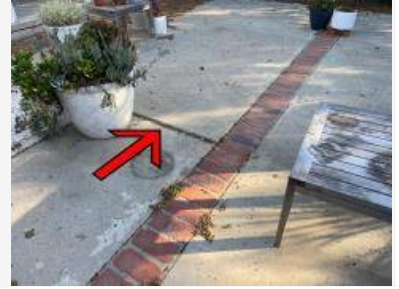
- Uneven surface joints are visible at multiple locations. The condition poses a trip hazard. We recommend correction using appropriate methods by a qualified state licensed concrete contractor.

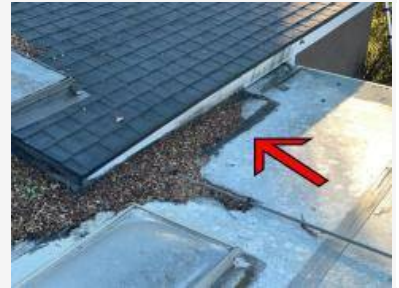
- Mastic patching is visible to the roof which is likely an attempt to repair leakage. We recommend further evaluation / correction using appropriate methods by a qualified state licensed roofing contractor.

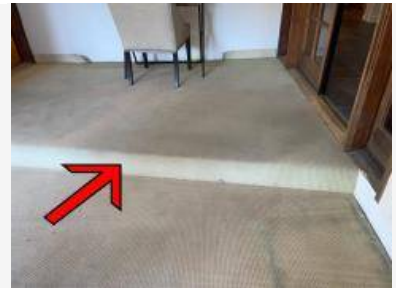
- The height of the step riser is greater than 7-3/4". The condition poses a trip hazard. We recommend correction using appropriate methods by a qualified state licensed concrete contractor.

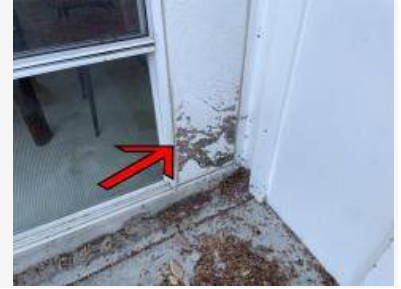
- Moisture related damage is visible to the exterior wall cladding. We recommend correcting the cause of the damage and repairing the cladding using appropriate methods. We also recommend further evaluation by a qualified state licensed Structural Pest Control Operator to determine if any wood decay and / or pest related damage exists.

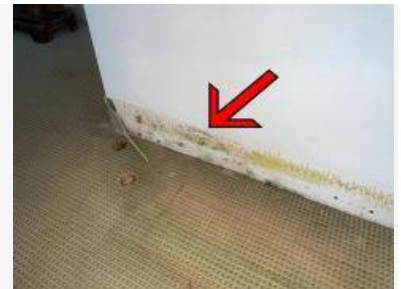
- An undetermined black substance is visible on the base of the wall claddings. Determining the presence of any type of mold / microbial growth is beyond the scope of this inspection. We recommend further evaluation by a qualified specialist to determine if such conditions exist.

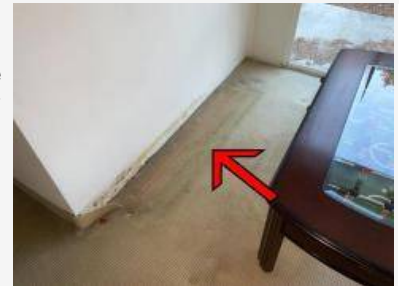
- Moisture related stains are visible to the carpet at multiple location. The condition likely indicates a history of moisture intrusion from the exterior. Replacement of the carpet with an appropriate flooring material is likely needed. We recommend further evaluation / correction using appropriate methods by a qualified state licensed flooring contractor.

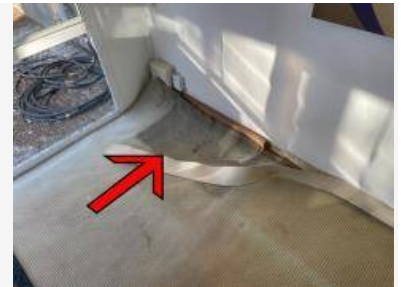
- Carpet is installed over the foundation access openings. The condition poses a trip & fall hazard. We recommend correction using appropriate methods.

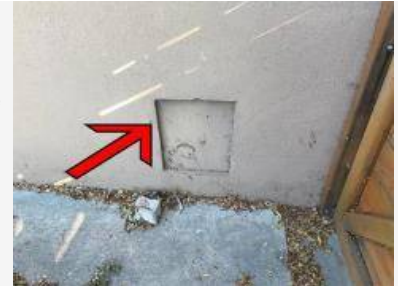
- An opening is cut out of the stucco and covered with a wood panel at the garage exterior wall. The condition is conducive to moisture intrusion and subsequent damage. We recommend correction using appropriate methods by a qualified state licensed lathing & plastering contractor.

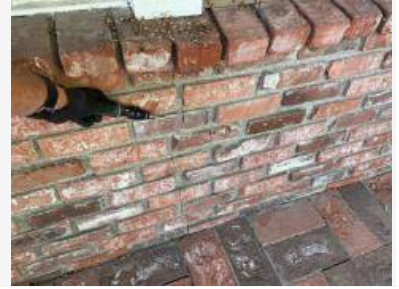
- Vertical crack damage is visible to bricks at the front exterior wall. The cause is not determined. We recommend further evaluation / correction using appropriate methods by a qualified state licensed masonry contractor.

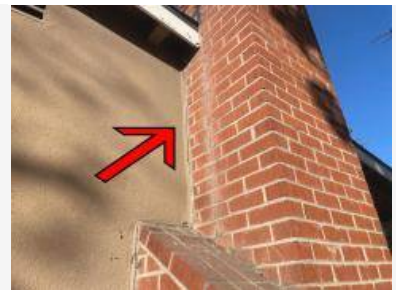
- Deteriorated caulking is visible at the chimney flashing. The condition is conducive to moisture intrusion and subsequent damage. We recommend correction using appropriate methods.

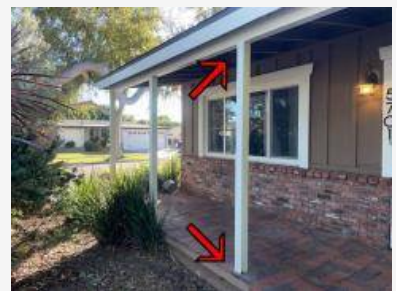
- Connection hardware is absent from the support posts at the front of the building which is not unusual for the age of the building. Installation of appropriate connection hardware should be considered for safety enhancement to minimize potential separation of the support posts during an earthquake.

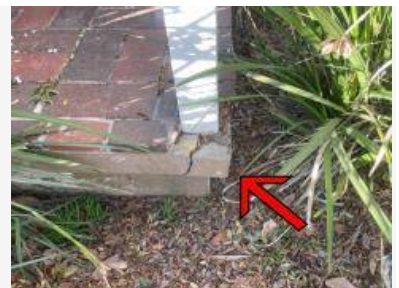
- Crack damage is visible to the concrete porch surface below the left side post. The condition makes the post unstable. We recommend correction using appropriate methods by a qualified state licensed concrete contractor.

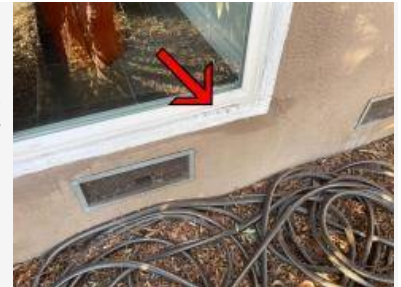
- Moisture related damage is visible to the wood at multiple window locations. We recommend correcting the cause of the damage and repairing the wood using appropriate methods. We also recommend further evaluation by a qualified state licensed Structural Pest Control Operator to determine if any wood decay and / or pest related damage exists.

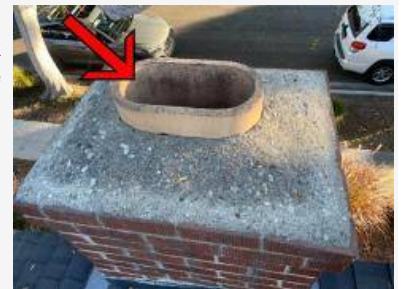
- A spark arrestor / rain cap assembly is absent. Installation of an appropriate spark arrestor / rain cap assembly is recommended to prevent sparks from exiting the flue and to prevent moisture intrusion into the flue.

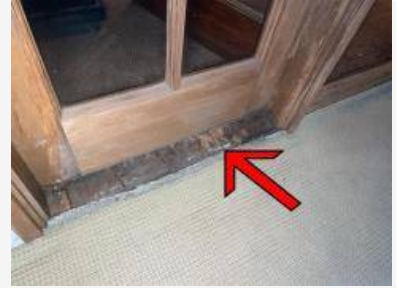
- Damage is visible to the wood framing at multiple locations. The damage may be pest related. We recommend further evaluation by a qualified state licensed Structural Pest Control Operator.

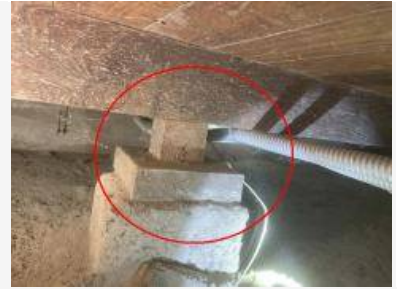
- Connection hardware is not provided at the piers, posts, girders, etc. which is not uncommon for the age of the building. Installation of appropriate connection hardware should be considered for safety enhancement to help minimize the potential for separation of the posts during an earthquake.

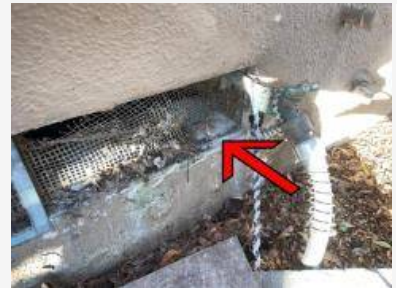
- Damaged screens are visible at multiple vent openings. The condition is conducive to animal / insect / vermin intrusion into the building. Replacement of the damaged screens with an appropriate screen material is recommended.

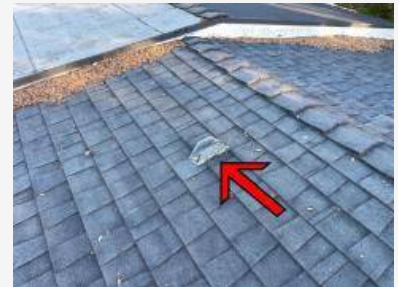
- A satellite dish mount is bolted through the roof material. The condition is conducive to roof leakage and subsequent damage. We recommend correction using appropriate methods by a qualified state licensed roofing contractor.

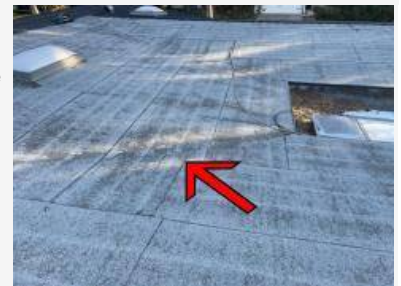
- The material is at the end of its service life due to significant granule loss which exposes the fiberglass mat. Replacement of the roof material is likely needed. We recommend further evaluation / correction using appropriate methods by a qualified state licensed roofing contractor.

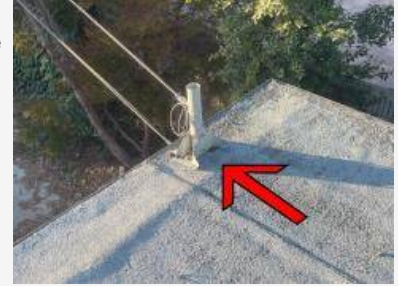
- A satellite dish mount is bolted through the roof material. The condition is conducive to roof leakage and subsequent damage. We recommend correction using appropriate methods by a qualified state licensed roofing contractor.

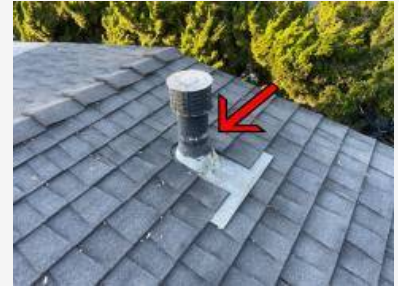
- A storm collar is absent where the water heater vent pipe transitions through the flashing. The condition is conducive to moisture intrusion and subsequent damage. We recommend correction using appropriate methods by a qualified state licensed roofing contractor.

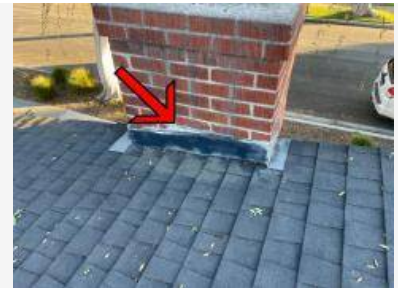
- Chimney flashing is improperly installed as it is face mounted with mastic seal instead of using reglet flashing. The condition is conducive to moisture intrusion and subsequent damage. We recommend correction using appropriate methods by a qualified state licensed roofing contractor.

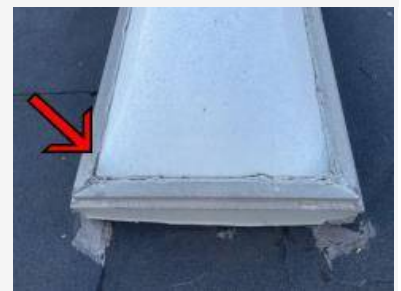
- Deteriorated sealant is visible at the dome to frame interface. The condition is conducive to moisture intrusion and subsequent damage. We recommend correction using appropriate methods by a qualified state licensed roofing contractor.

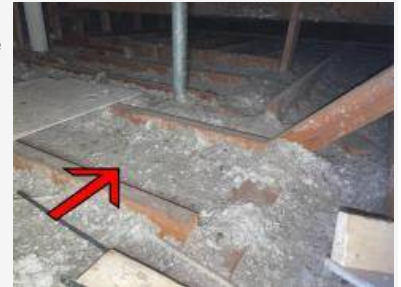
- The thickness of the existing insulation is poor by today's construction standards. The condition is conducive to thermal loss from the interior living space. Installation of additional insulation should be considered.

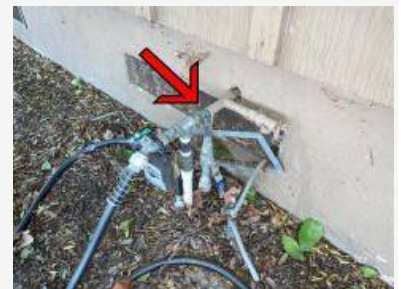
- A pressure regulator is not installed on the main line. Installation of an appropriate pressure regulator by a qualified state licensed plumbing contractor should be considered to prevent any adverse overpressure conditions.

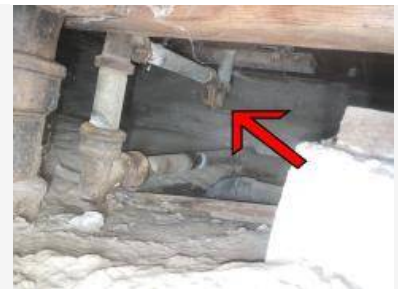
- Leakage is visible from piping at the foundation sub area. We recommend correction using appropriate methods by a qualified state licensed plumbing contractor.

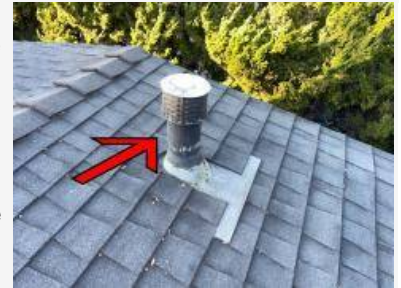
- The vent pipe was not replaced when this water heater was installed. Please be aware that the transite pipe may contain asbestos. In certain conditions, asbestos is known to be a health hazard to people. Any replacement and disposal should be performed by a qualified specialist using appropriate methods as asbestos is known to be a health hazard to people. To determine if asbestos is present, we recommend retaining a Cal/OSHA-Certified Asbestos Consultant. Only a Cal/OSHA-Certified Asbestos Consultant (CAC) can provide asbestos consulting (as defined by the Business and Professions Code, 7180-7189.7, and triggered by the same size and concentration triggers as for registered contractors). These services include building inspection, abatement project design, contract administration, supervision of site surveillance technicians, sample collection, preparation of asbestos management plans, and clearance air monitoring.

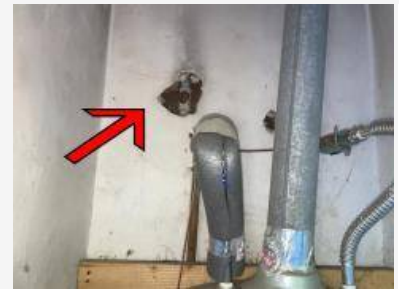
- Wall cladding is broken out at multiple locations within the closet. We recommend correction using appropriate methods.

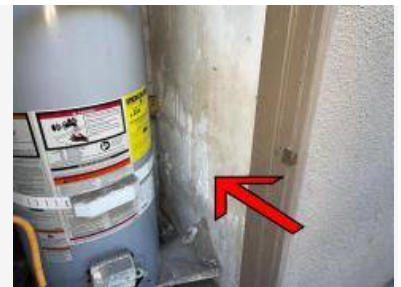
- Moisture related damage is visible to the wall cladding within the closet. Determining if any active leakage exists is beyond the scope of this inspection. We recommend correction using appropriate methods.

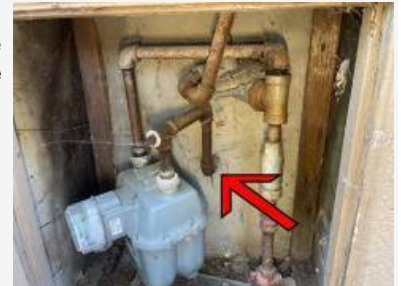
- Corrosion related deterioration is visible on piping at property owners side of the meter. Corrosion is conducive to pipe failure and subsequent gas leakage. We recommend further evaluation / correction using appropriate methods by a qualified state licensed plumbing contractor.

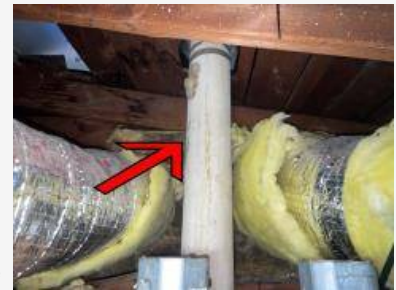
- Please be aware that the existing transite pipe may contain asbestos. Any replacement and disposal should be performed by a qualified specialist using appropriate methods as asbestos is known to be a health hazard to people. To determine if asbestos is present, we recommend retaining a Cal/OSHA-Certified Asbestos Consultant. Only a Cal/OSHA-Certified Asbestos Consultant (CAC) can provide asbestos consulting (as defined by the Business and Professions Code, 7180-7189.7, and triggered by the same size and concentration triggers as for registered contractors). These services include building inspection, abatement project design, contract administration, supervision of site surveillance technicians, sample collection, preparation of asbestos management plans, and clearance air monitoring.

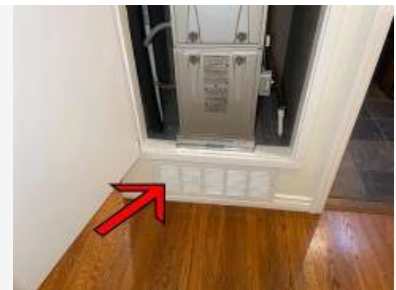
- The return air plenum is located below the closet door which is not acceptable by today's construction standards. Hazardous products of combustion air can be drawn from within the closet and into the air distribution system as a result, therefore a carbon monoxide poisoning hazard exists. We recommend correction using appropriate methods by a qualified state licensed Warm-Air Heating, Ventilating and Air-Conditioning contractor.

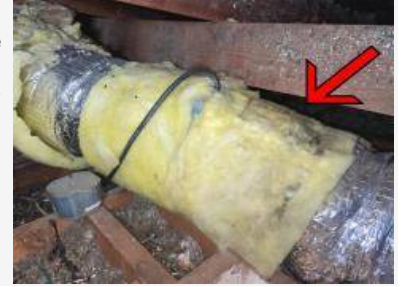
- Vermin droppings are visible on the duct insulation at multiple locations. The condition poses an adverse health hazard to people from contamination. Replacement of any contaminated ducting by a qualified state licensed Warm-Air Heating, Ventilating and Air-Conditioning contractor is recommended. Determining active vermin infestation is beyond the scope of this inspection. We recommend further evaluation by a qualified state licensed Pest Control Operator.

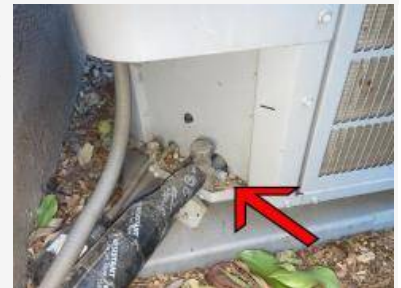
- Locking-type tamper-resistant caps are absent from the refrigerant circuit access ports. We recommend correction using appropriate methods by a qualified state licensed Warm-Air Heating, Ventilating and Air-Conditioning contractor to prevent unauthorized access resulting in injury.

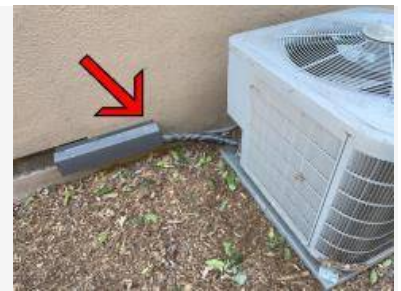
- The opening where the line set transitions into the exterior wall chase lacks a sealing method to prevent insect / vermin intrusion into the building. We recommend correction using appropriate methods.

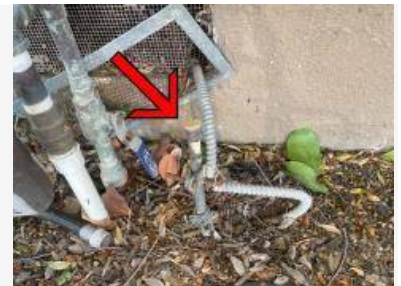
- The mushroomed head on the ground rod could indicate the rod has been cut, therefore the rod may not be of sufficient length to function as intended. The condition poses a potential electrical shock hazard. Further evaluation by a qualified state licensed electrical contractor is recommended.

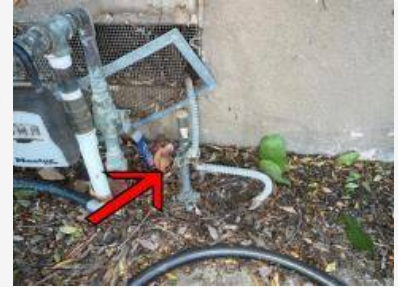
- The grounding electrode conductor termination clamp is loose on the ground rod, therefore may not function as intended. The condition poses an electrical shock hazard. We recommend correction using appropriate methods by a qualified state licensed electrical contractor.

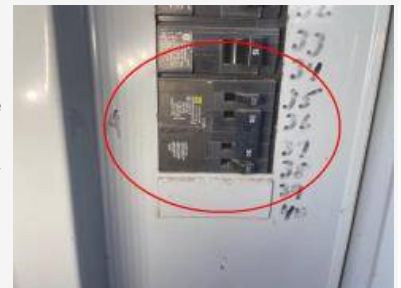
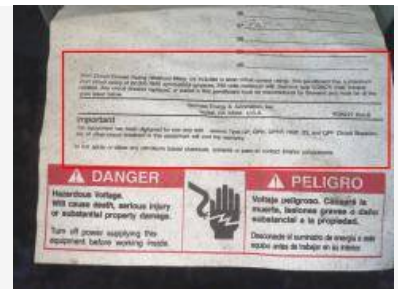
- There are circuit breakers that are not listed for use in the panel per the listing attached to the panel. Incompatible breakers do not offer safe overcurrent protection, therefore an electrical shock and risk of fire hazard exists. Determining the compatibility of the circuit breakers beyond what is listed on the panel is beyond the scope of this inspection. We recommend correction using appropriate methods by a qualified state licensed electrical contractor.
