**HomeGuard**  
**Incorporated**

# HOME INSPECTION REPORT

1115 Savoy Street, San Diego

681861

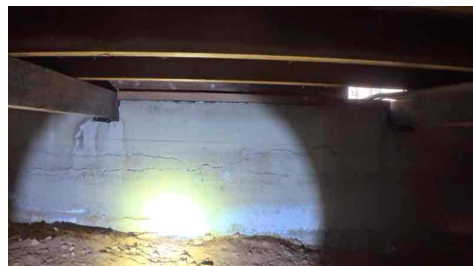
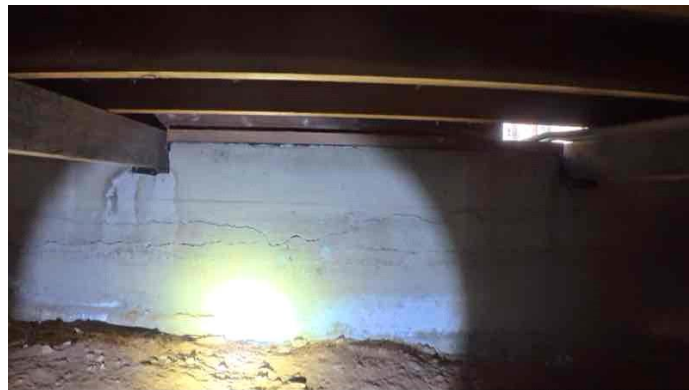
Photo 40

1. A horizontal crack was observed in the foundation wall at the right and left sides of the structure. Horizontal cracks may result from various factors, including foundation wall movement or stress. In some cases, they can also be caused by the expansion of reinforcing steel due to moisture intrusion, particularly when near the edge of the formwork used during construction. This condition may indicate a potential defect or developing concern. A thorough evaluation is beyond the scope of this visual inspection. We recommend further assessment by a licensed foundation contractor to determine the cause and whether any repairs are warranted.

- ! 1. A horizontal crack was observed in the foundation wall at the right and left sides of the structure. Horizontal cracks may result from various factors, including foundation wall movement or stress. In some cases, they can also be caused by the expansion of reinforcing steel due to moisture intrusion, particularly when near the edge of the formwork used during construction. This condition may indicate a potential defect or developing concern. A thorough evaluation is beyond the scope of this visual inspection. We recommend further assessment by a licensed foundation contractor to determine the cause and whether any repairs are warranted.  
(See Photo 40)

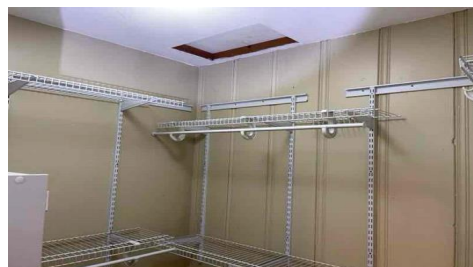
Photo 30

2. Clothes racks were blocking the attic access opening, therefore, the attic space was not inspected. With access and an opportunity for a complete inspection, conditions in need of attention may be discovered. The personal belongings should be removed so the attic may be inspected.

- ! 2. Clothes racks were blocking the attic access opening, therefore, the attic space was not inspected. With access and an opportunity for a complete inspection, conditions in need of attention may be discovered. The personal belongings should be removed so the attic may be inspected.  
(See Photo 30)

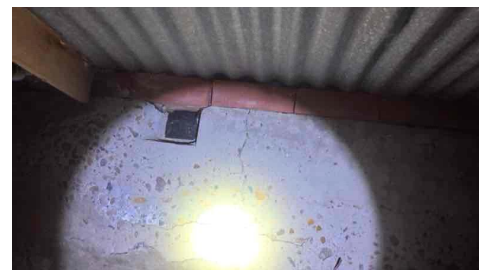
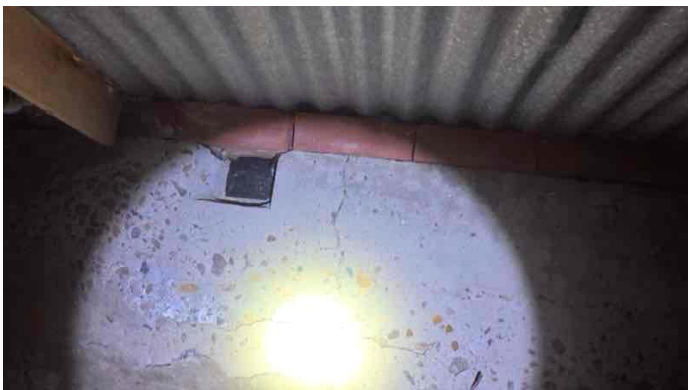
Photo 37

3. Vertical cracking was observed in the foundation walls of the structure indicating movement and/or settlement of the structure may have occurred. The rate of movement cannot be predicted during a one-time inspection. A thorough evaluation of this condition is beyond our qualifications. For additional information we recommend contacting a licensed foundation contractor for further evaluation.

- ! 3. Vertical cracking was observed in the foundation walls of the structure indicating movement and/or settlement of the structure may have occurred. The rate of movement cannot be predicted during a one-time inspection. A thorough evaluation of this condition is beyond our qualifications. For additional information we recommend contacting a licensed foundation contractor for further evaluation.  
(See Photo 37)

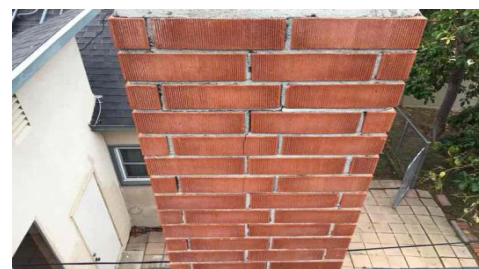
Photo 03

4. There is a large crack at the back of the chimney. This condition may indicate movement of the chimney. It is impossible to determine the rate of movement during a one time visit to the property. We recommend the advice of a licensed masonry contractor.

- ! 1. There is a large crack at the back of the chimney. This condition may indicate movement of the chimney. It is impossible to determine the rate of movement during a one time visit to the property. We recommend the advice of a licensed masonry contractor.  
(See Photo 3)

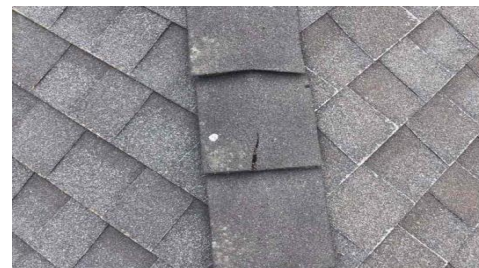
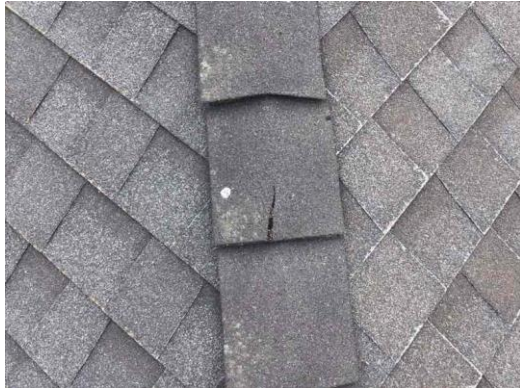
Photo 01

5. Repairs to the roof covering are recommended. Damaged, loose or missing roofing material at the roof should be repaired or replaced. All roof penetrations should be examined and sealed as necessary. For further evaluation of the condition of the roof we recommend you consult a licensed roofing contractor.

- ! 2. Repairs to the roof covering are recommended. Damaged, loose or missing roofing material at the roof should be repaired or replaced. All roof penetrations should be examined and sealed as necessary. For further evaluation of the condition of the roof we recommend you consult a licensed roofing contractor.  
(See Photo 1) (See Photo 2)

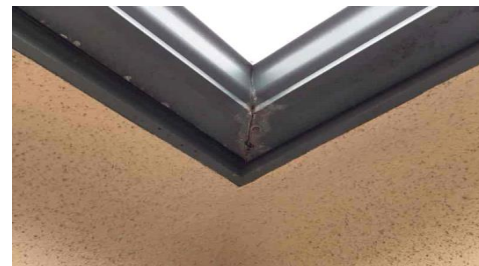
Photo 08

6. Leaks were noted in the downspouts and/or gutters at various locations. During wet weather conditions these areas are more obvious and during dry weather conditions they are noted from the stains at the areas where the leaks have occurred. We recommend all leaks be repaired.

- ! 3. Leaks were noted in the downspouts and/or gutters at various locations. During wet weather conditions these areas are more obvious and during dry weather conditions they are noted from the stains at the areas where the leaks have occurred. We recommend all leaks be repaired.  
(See Illustration 2D) (See Photo 8)

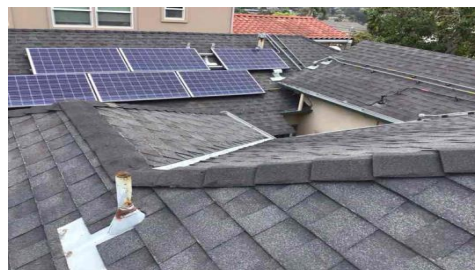
Photo 06

7. All deteriorated, damaged or rusted out roof plumbing or appliance vent caps should be replaced.

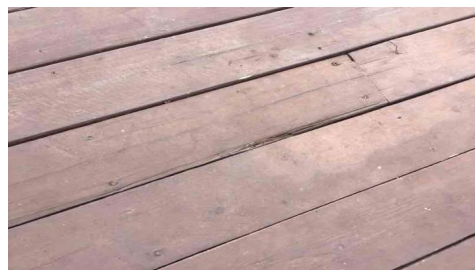
Photo 11

8. Water damage was noted at the rear deck(s). We recommend the services of a licensed general contractor and/or structural pest control company.

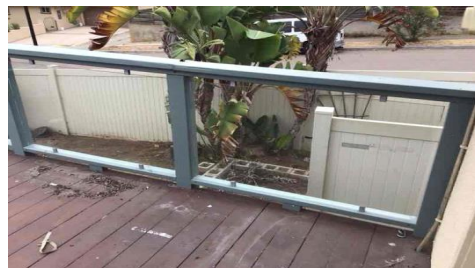
Photo 13

9. The railing is loose at the deck. It is recommended that this be repaired for improved safety.

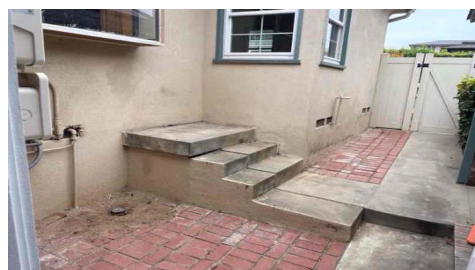
Photo 29

10. For safety purposes, railing(s) should be provided at the exterior.

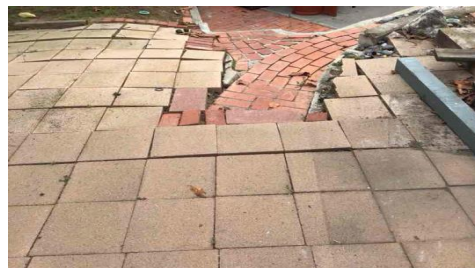
Photo 09

11. The cracked, heaved, or uneven walkway sections at the various locations pose a potential trip hazard. We recommend corrective action to improve safety and reduce the risk of injury. A qualified contractor should assess the affected areas and perform necessary repairs to ensure a level walking surface.

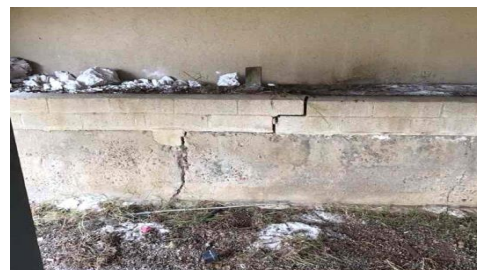
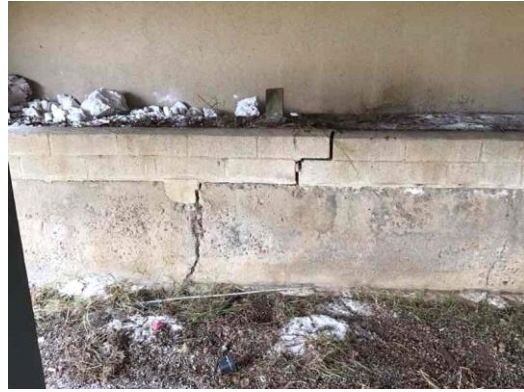
Photo 16

12. The retaining wall at the rear shows evidence of significant movement and/or cracks. It is not within the scope of our expertise to determine when rebuilding will become necessary. Further evaluation of this condition by the appropriate tradesperson is recommended.

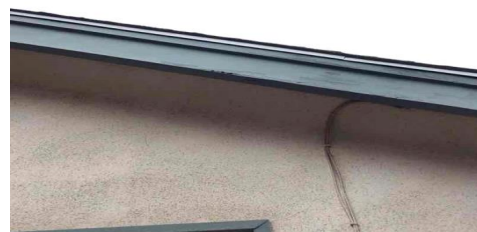
Photo 10

13. Water damage was observed to the fascia at the rear. We recommend the services of a licensed general contractor and/or structural pest control company.

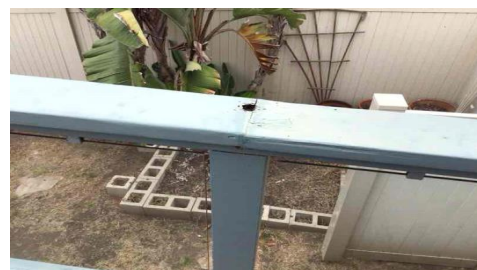
Photo 12

14. The railing at the deck is water damaged. We recommend the services of a licensed general contractor and/or structural pest control company.

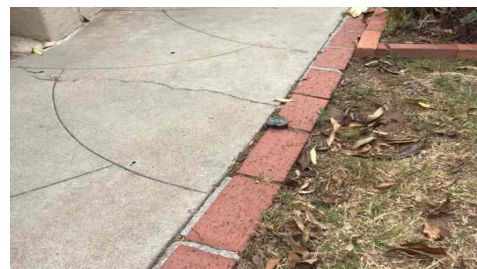
Photo 17

15. The sprinkler valve at the front section of the walkway presents a trip hazard. This condition should be altered for improved safety.

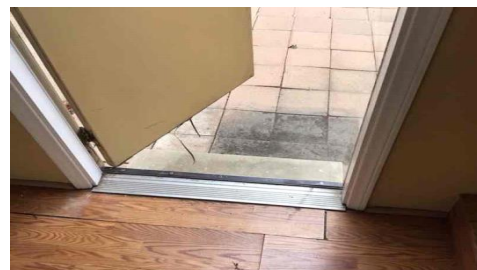
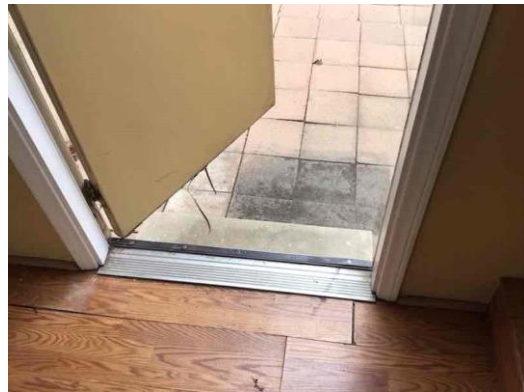
Photo 28

16. The door at the left side hallway swings out over a step. This can be a potential hazard. We recommend that a 3'x3' landing be installed where the door swings out.

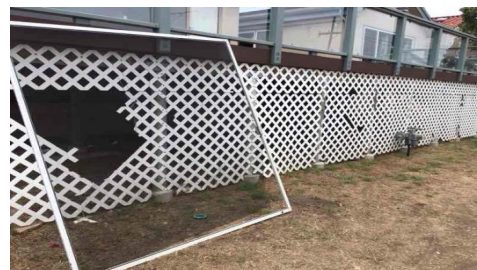
Photo 14

17. The lattice is damaged at the deck. We recommend repairing this for cosmetic purposes.

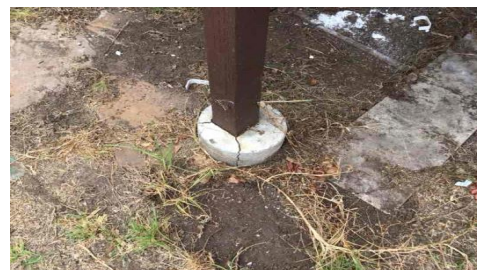
Photo 15

18. The concrete footings at the deck are damaged in various areas. We recommend repairing or replacing the damaged footings.

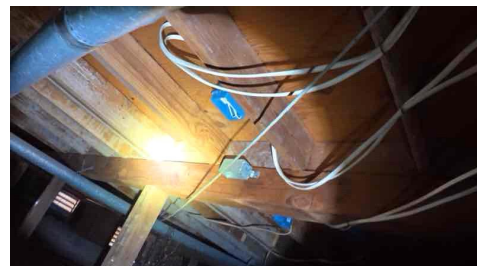
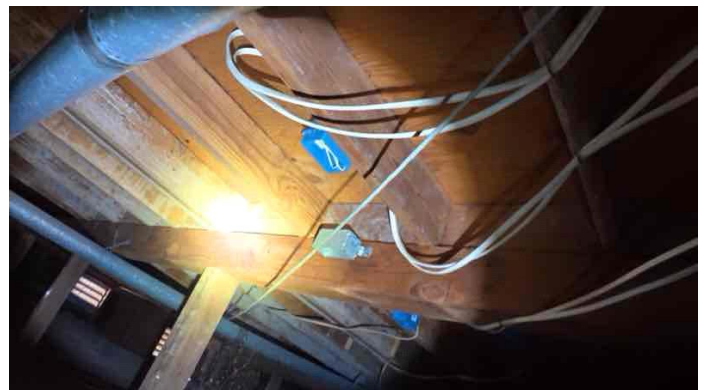
Photo 38

19. Exposed electric connections or open junction boxes at the subarea should be corrected. All electric connections should be made inside approved junction boxes fitted with proper cover plates.

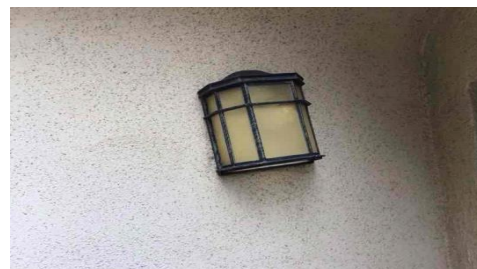
Photo 07

20. The loose light fixture at the exterior should be repaired or replaced.

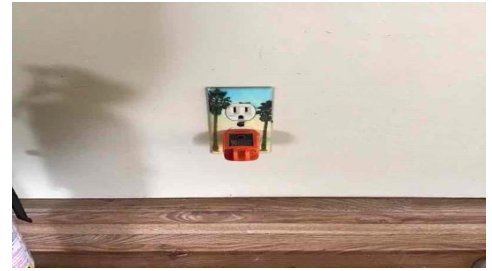
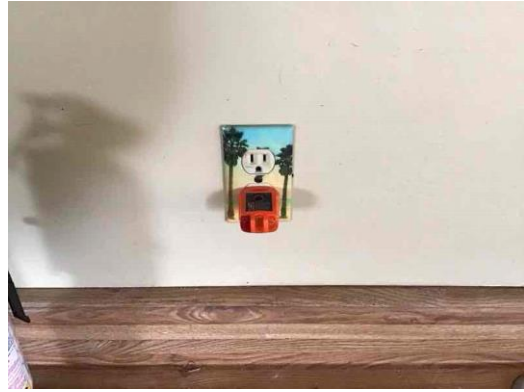
Photo 32

21. One or more outlets at the garage were inoperative at the time of our inspection. Possibly due to turned off switches which were not located during our inspection. These outlets and circuits should be investigated and corrected as necessary. Based upon our inspection of a representative number of outlets, we recommend testing of every outlet at a later date. Repairs or rewiring are recommended at all deficient locations.

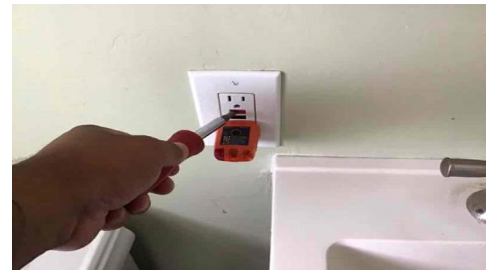
Photo 23

22. A ground fault circuit interrupter (GFCI) outlet at the middle hall bathroom and the left side hall bathroom did not function or did not trip when tested with an outside source and/or the test button. This outlet and circuit should be investigated and repaired.

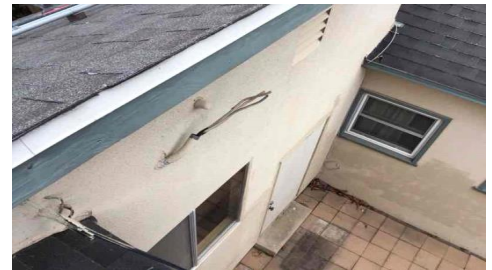
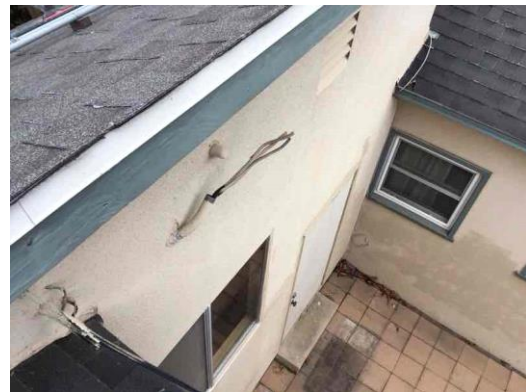
Photo 04

23. Abandoned wiring was noted in the rear. We recommend the wiring be disconnected at its source or terminated in an approved manner in a covered junction box.

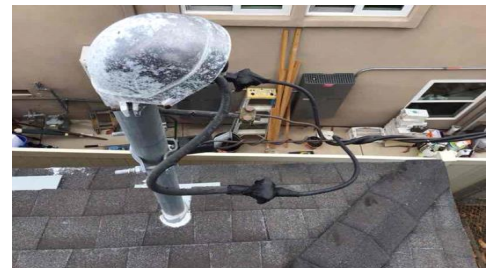
Photo 05

24. The service entrance wires have exposed metal visible at the mast splice connection. These should be repaired or replaced. Contact your local utility service provider.

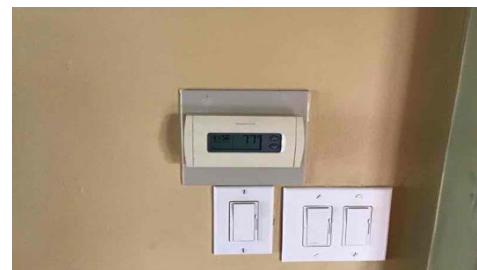
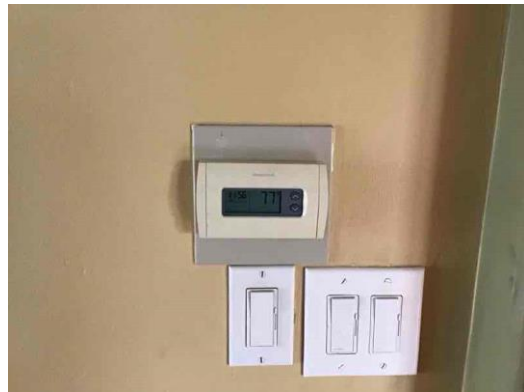
Photo 20

25. The heater thermostats were inoperable at the time of our inspection, and therefore the heater was not tested. We recommend the thermostat be repaired or replaced and proper operation of the heater verified by appropriate trades.

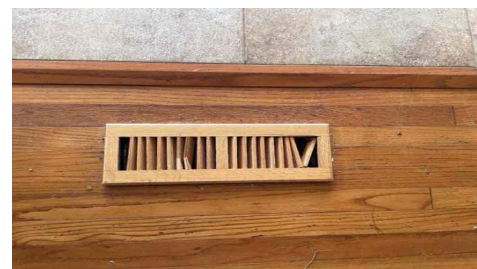
Photo 19

26. There is a damaged or disconnected heater duct registers in the living room. We recommend all damaged ducts and registers be repaired or replaced.

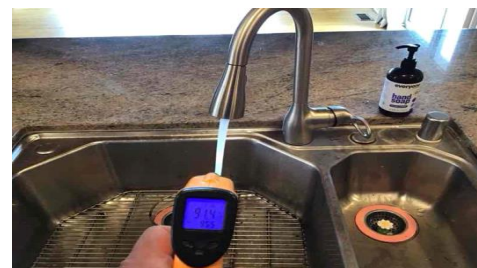
Photo 21

27. The kitchen sink faucet hot and cold water controls are reversed. Reversed hot and cold water can result in hot water burns. We recommend that this condition be corrected.

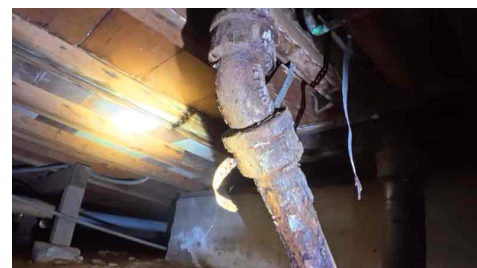
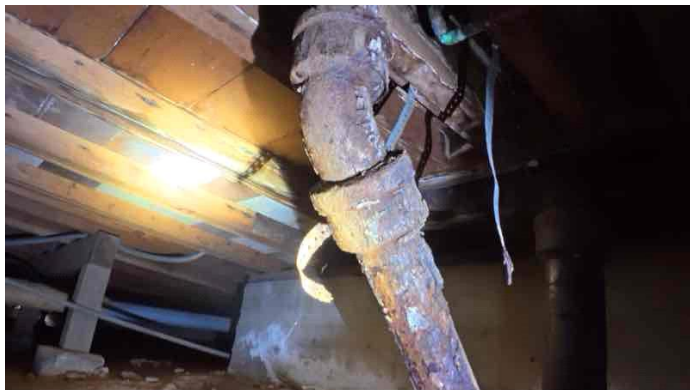
Photo 39

28. The drain is leaking into the crawl space under the hall bathroom. We recommend all leaks be repaired.

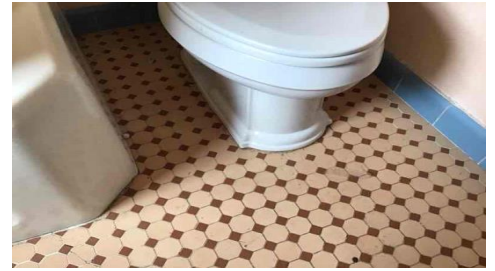
Photo 25

29. The toilet at the hall bathroom is loose and should be properly re-secured, tightened and caulked.

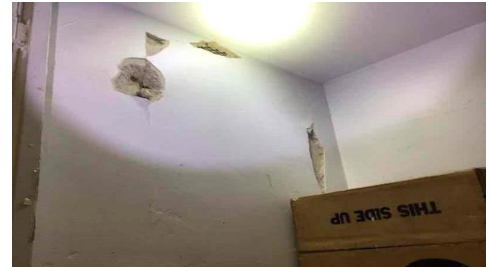
Photo 22

30. The walls at the guest bedroom closet and garage are damaged. We recommend it be repaired.

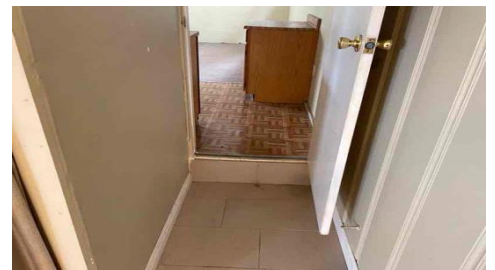
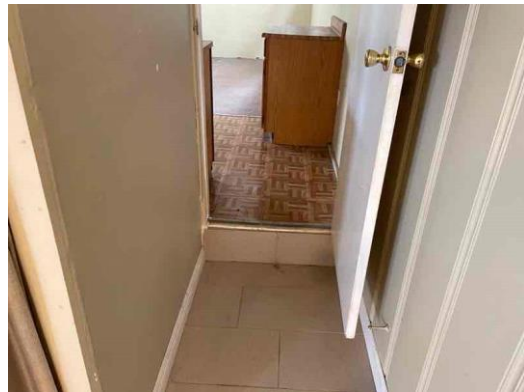
Photo 36

31. The door swings out over a step at the garage door. This can be a potential hazard. We recommend that either the door be made to swing inward or that a 3'x3' landing be installed where the door swings out. The door may also be modified to swing in the other direction where there is no step.

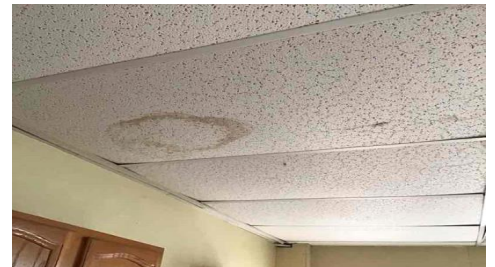
Photo 31

32. The ceiling at the garage shows evidence of water stains. It is recommended that the source of these stains be identified and corrected and the surface be refinished.

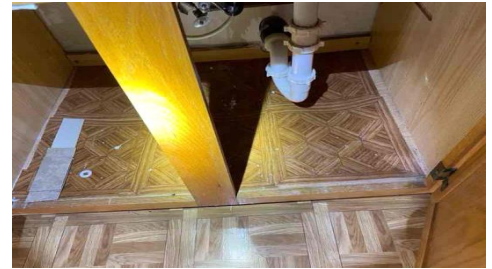
Photo 34

33. The base and/or side of the garage kitchen cabinet sink shelf is deteriorated. We recommend the advice and services of a licensed pest control operator for investigation and possible repair of this condition.  
([See Photo 34](#))

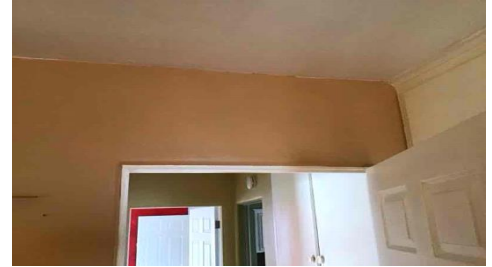
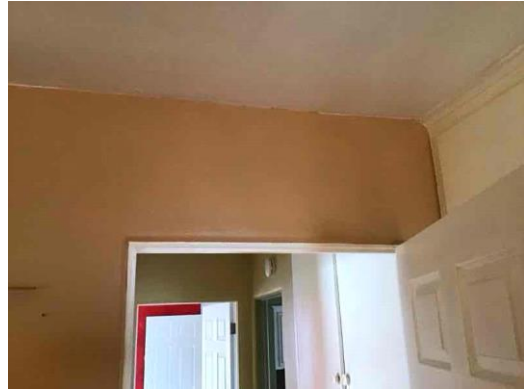
Photo 24

34. This home does not have enough smoke detectors installed. The installation of smoke detectors should be placed on each floor in non-sleeping areas. In addition, one smoke alarm must be installed in each room where sleeping occurs and one smoke alarm should be located in each hallway that leads directly to sleeping rooms.  
([See Photo 24](#))

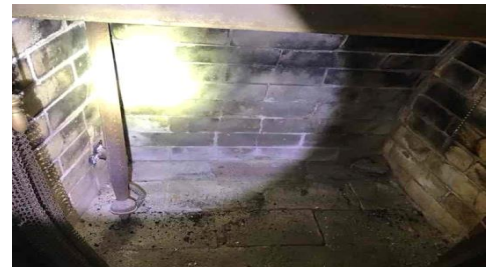
Photo 18

35. The interior of the fireplace firebox should be repaired where the bricks or mortar are heavily eroded, loose, or cracked. We recommend the advice and servicing of a licensed masonry contractor or fireplace specialist.  
([See Photo 18](#))

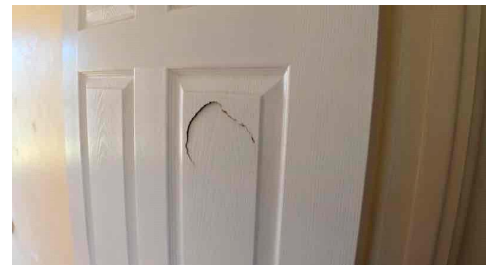
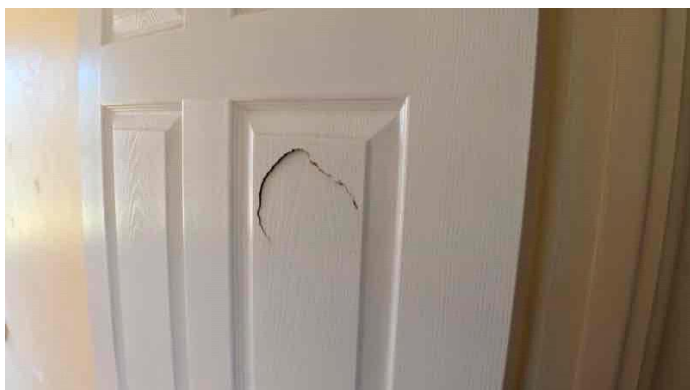
Photo 41

36. Damaged, splitting or cracking was noted at the guest bedroom door. We recommend it be repaired or replaced for cosmetic consideration and ease of use.  
([See Photo 41](#))

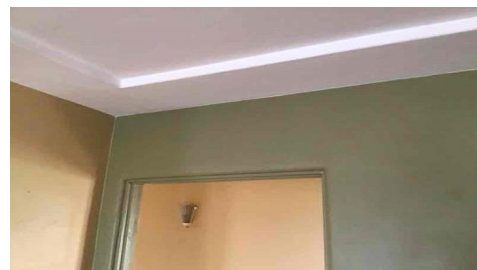
Photo 26

37. California law requires that all homes have a State Fire Marshall approved Carbon Monoxide Detector be installed outside of the sleeping areas in the hallway and on each level of the home including basements. At the time of this inspection a Carbon Monoxide Detector could not be located. We recommend consulting with the owner to see if a Carbon Monoxide Detector exists and if not they should be installed in all required locations.

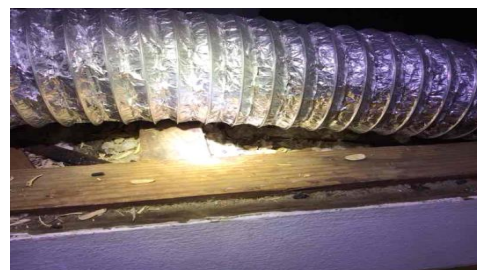
Photo 27

38. Evidence of vermin activity was observed within the structure. It is likely this evidence will extend into inaccessible areas. The owner is advised to contact the appropriate trade for further evaluation and remedial measures if necessary.

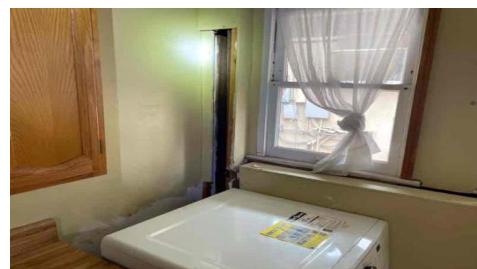
Photo 33

39. Holes in the garage drywall should be repaired as necessary.
