# Roof Inspection

Roof Type: **High Profile Laminated Asphalt Composition Shingle Roof**      Approx. Age: 20 years  
 Layers: One layer  
 Approx. Slope(s): 4:12

Property Address: **6712 Birch Court, Dublin, CA, 94568**

Inspection Date: 6/12/2024

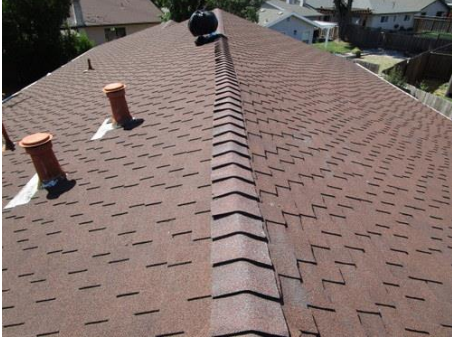
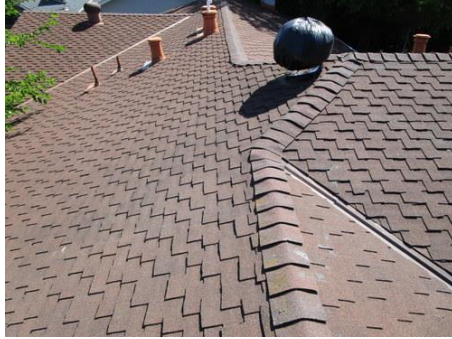
ITEM 1

- 1. Overviews of the current conditions of the roof and its related components.** The two rotor vents on the right side of the house have been wrapped in a plastic bag and therefore are not part of the roof inspection.

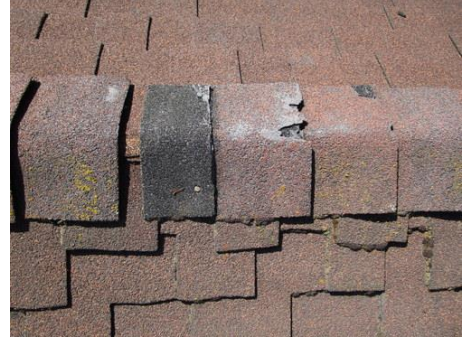
ITEM 2

- There are approximately 15 partially displaced or damaged ridge shingles due to periods of high wind and/or tree branch damage that should be repaired or replaced.  
Recommendation: Repair or replace all damaged ridge shingles.

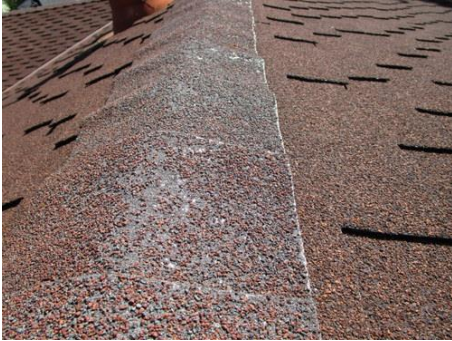
ITEM 3

- There are several ridge shingles at the main ridge where the southern exposure of the shingles have lost a moderate amount of their granular surfacing due to the age of the shingles and should be repaired. The granule displacement can reveal the underlying components of the shingle such as the fiberglass scrim.  
Recommendation: Repair these shingles.

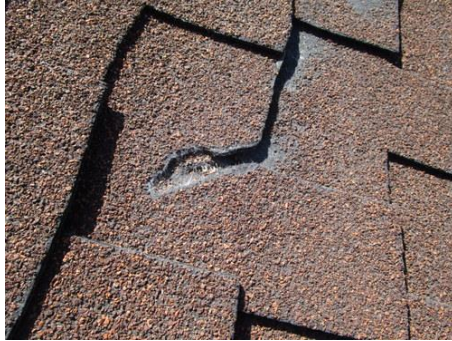
ITEM 4

- There are approximately 10 field shingles that have abrasion or other damage.  
Recommendation: Repair or replace these shingles.
- Plumbing vent pipe flashing at the left is severely deflected off the roof.  
Recommendation: Secure this flashing in place.

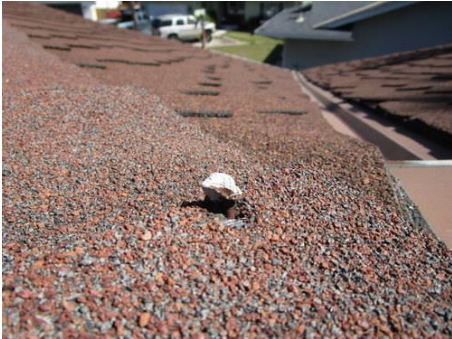
ITEM 6

- There are exposed nails at all hip and ridge locations that have deteriorated sealant. Some of the nails are backing out and rusted.  
Recommendation: Reset and seal all exposed nails.

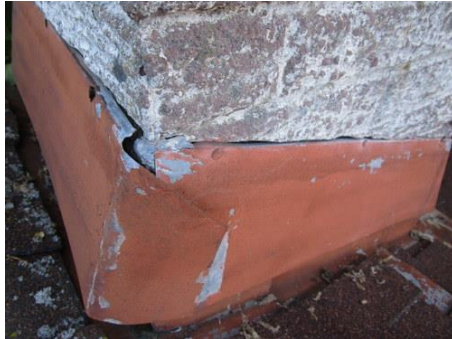
ITEM 7

- The counter flashing at the chimney is partially detached and has deteriorated sealant.  
Recommendation: Reset and seal the chimney flashing.
- A valley nail on the left side of the garage has backed out of the roof and created a hole in the overlying shingle that may allow water to seep under the valley flashing.  
Recommendation: Repair the popping nail.
