Kevin Kelpin  
7177 Sunny Place  
Yucca Valley, CA 92284

Andrew Alder-Larue  
76 Calle Manzanita  
Rancho Mirage, CA 92270

Inspection type: Follow-Up Inspection

**Note: Inspected items in this report are based off of the initial Inspection Report Summary only (2/7/2024). This report states whether or not a correction has been made, or not made. All other items from the initial report were not re-inspected. Sewer lateral inspection was not re-inspected.**

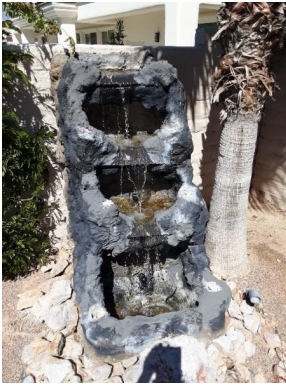
**CORRECTION MADE**

The water feature was tested and operational at time of inspection.

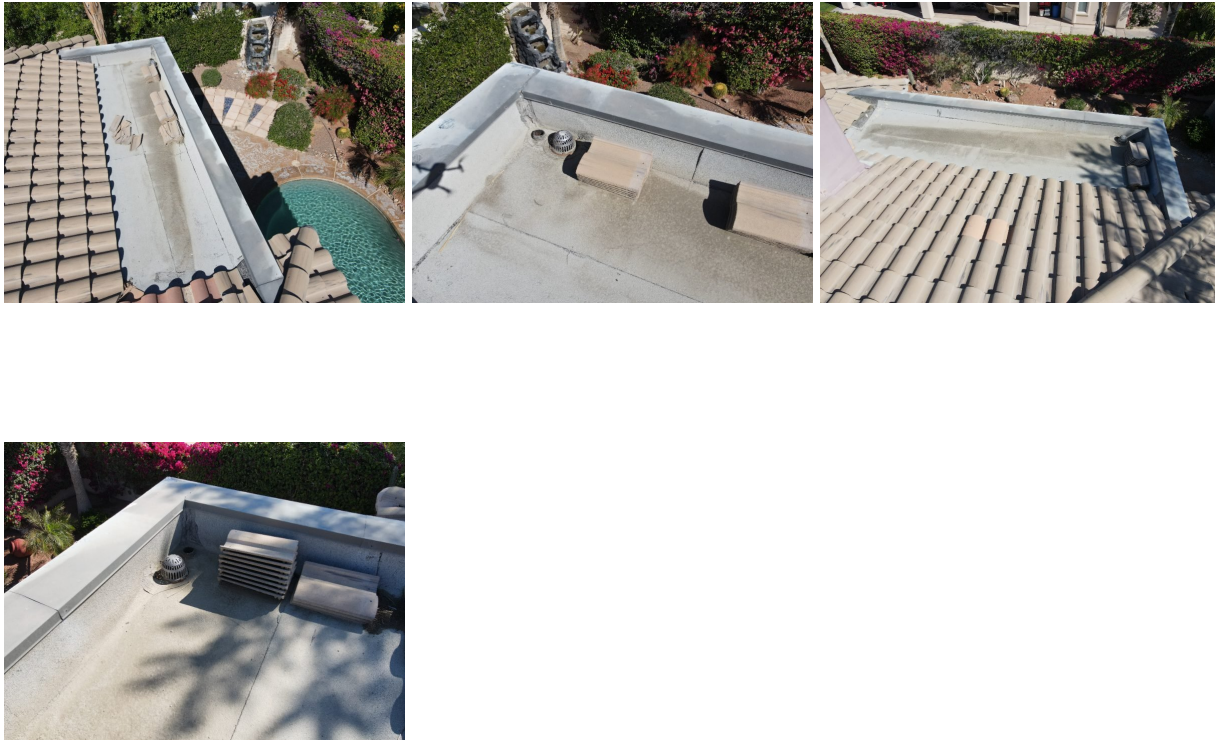
**CORRECTION MADE**

No visible defects noted.

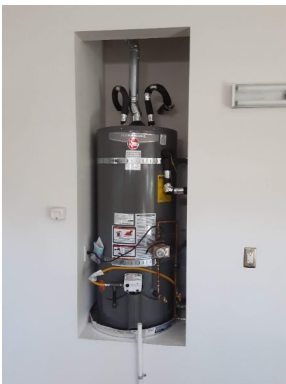
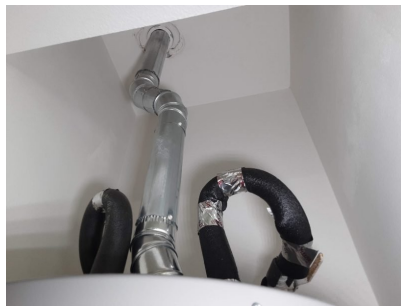
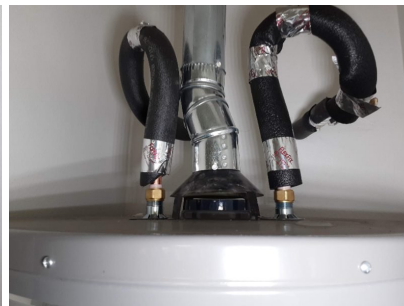
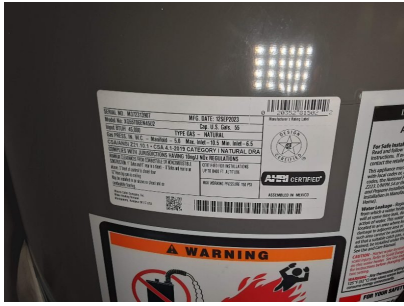
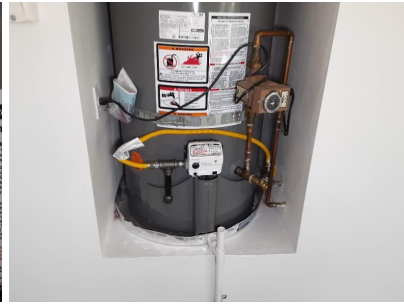
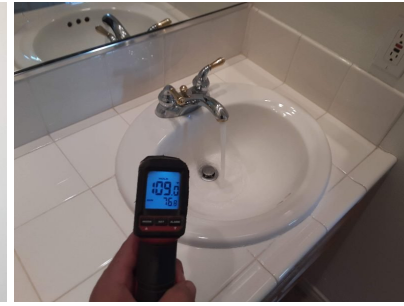
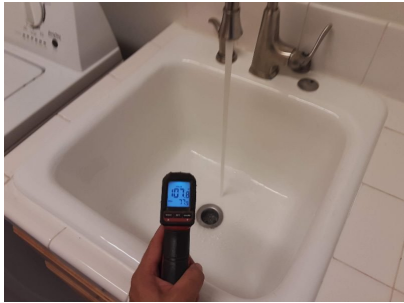
**CORRECTION MADE**

The water heater was manufactured in 2023. The unit was producing hot water at time of inspection. No gas leaks detected. No visible defects noted.

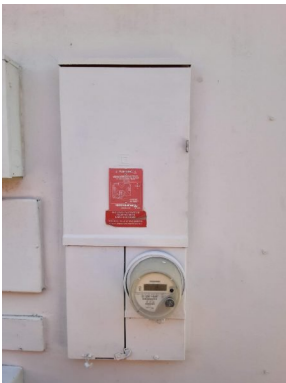
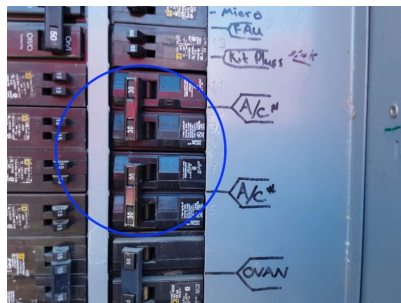
**CORRECTION MADE**

The circuit breakers for the A/C units were replaced with the proper amperage (30amp).

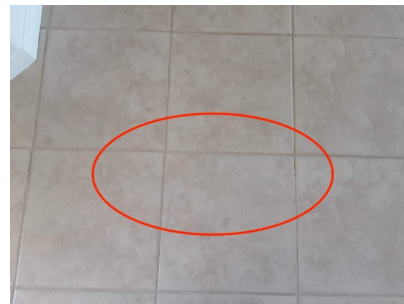
Corrections were made at several of the damaged tiles noted in the summary. **There were cracked tiles still present near the front entry.** Recommend contacting a licensed flooring contractor for replacement.

Cracked Tiles

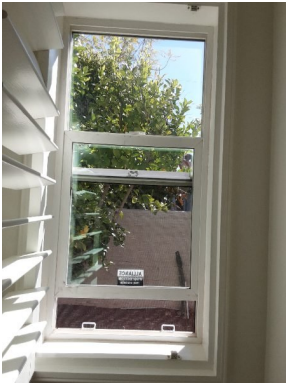
Correction Made

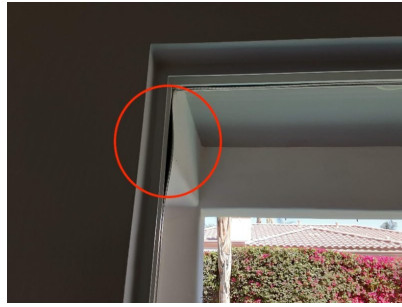
The double-hung window in the primary bathroom was repaired. **The defective inner seals at the living room and dining room windows were not repaired.**Note: There is no evidence that these defects were affecting the function of the windows at time of inspection.

Defective Inner Seal

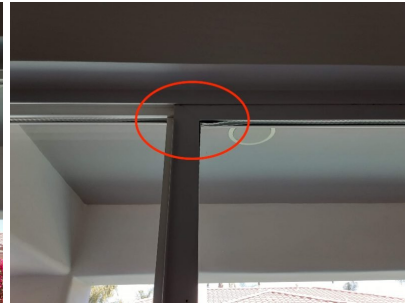
Defective Inner Seal

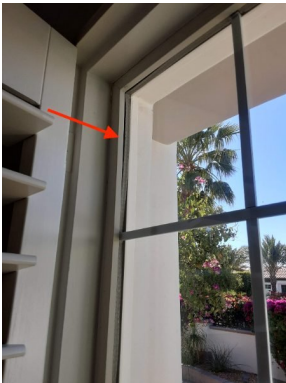
Defective Inner Seal

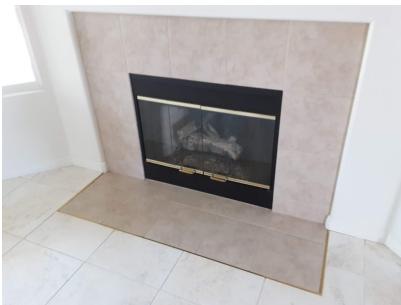
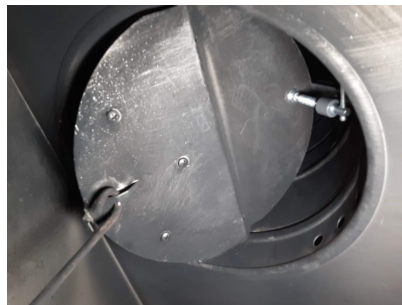
**CORRECTION MADE**

The fireplace and flue were cleaned. Damper clip was installed.

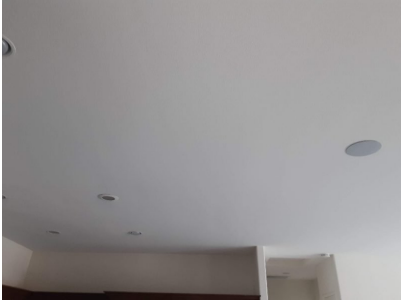
**Comments:**  
**CORRECTION MADE**

The ceiling in the living room and kitchen area was repaired and repainted.

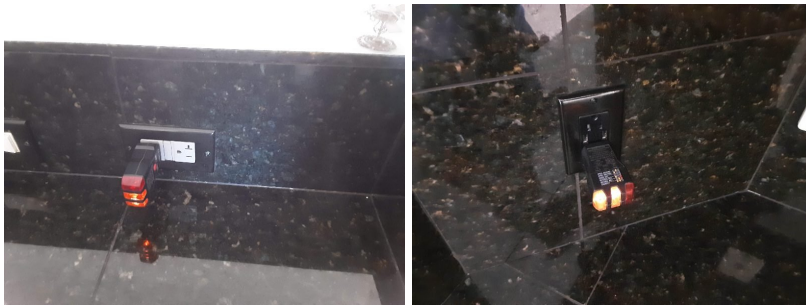
**CORRECTION MADE**

The outlets in the kitchen were repaired and replaced with GFCI protection.

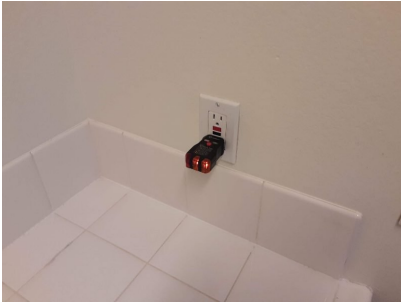
**CORRECTION MADE**

The outlet next to the laundry sink was replaced with a GFCI protected outlet.

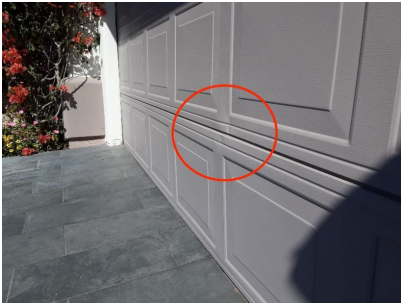
**CORRECTION NOT MADE**

Damage to the bottom panels of the main garage door was not repaired. Recommend contacting a licensed garage door professional for repairs.
