**TITLE 25 HEALTH & SAFETY INSPECTION**

# INSPECTION REPORT

## 5540 W. 5th st, #69

| INSPECTOR | INSPECTION DATE | REPORT ID | STATUS |
|---|---|---|---|
| Clinton Dotson | 23 Jul 2026 | INS-07232026-2 | FINAL |

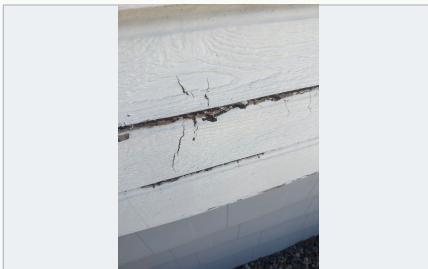
#### FINDING 1

**Issues found:** Wood rot / water intrusion

This is on the side of the cabana.

**Action** Wood rot or moisture damage observed in siding or trim. Indicates ongoing or past water intrusion.

- Citation: Title 25 CCR §1606(g).

- Corrective action: Remove rotted material, identify and correct moisture source, replace with treated lumber, prime and paint.

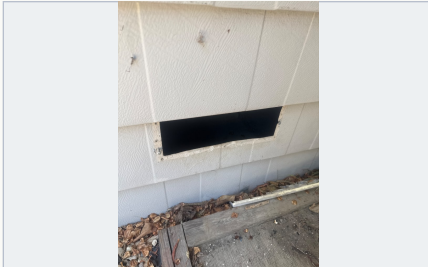
### FINDING 2

**Action** [Custom] Inspector-specified corrective action  
Missing skirting vent screen.

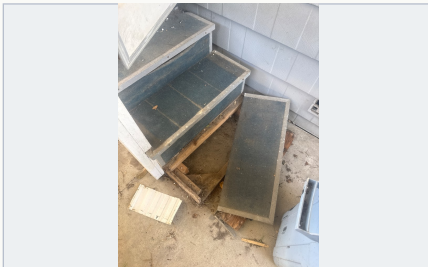
### FINDING 3

Trades and razors and bottom step at back door or non-compliant and unsafe.

**Action** Stair tread or landing platform shows damage, rot, or instability creating trip/fall hazard.  
• Citation: Title 25 CCR §1606(k).  
• Corrective action: Replace damaged components, ensure stable structure.

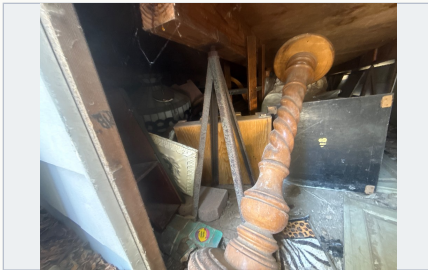
**FINDING 4****Visible rubbish, debris, or sources of infestation****· CORRECTED 24 AUG****Issues found:** Debris and infestation source

This is under the cabana.

**Citation** Debris and infestation source**Action** Accumulated rubbish, debris, or stored items creating harborage for pests/rodents.

- Citation: Title 25 CCR §1606 — sources of infestation prohibited.
- Corrective action: Remove debris, address infestation source, professional pest control treatment if active infestation.

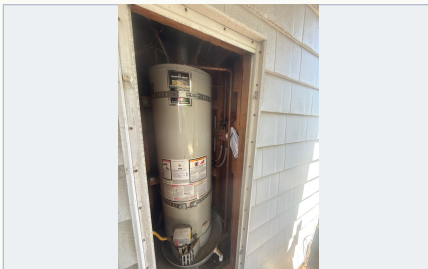
**FINDING 5****Water heater T&P relief valve: Present, functional****· CORRECTED 24 AUG****Issues found:** Missing or improper T&P discharge

T&amp;P discharge does not terminate on the exterior side of the skirting.

**Citation** Missing or improper T&P discharge**Action** Corrective action required by appropriately licensed contractor.**PHOTO EVIDENCE**

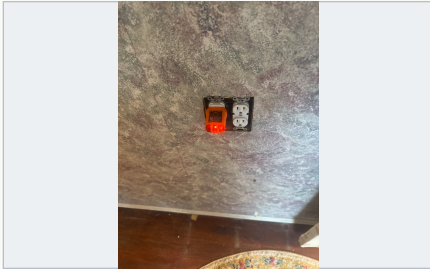
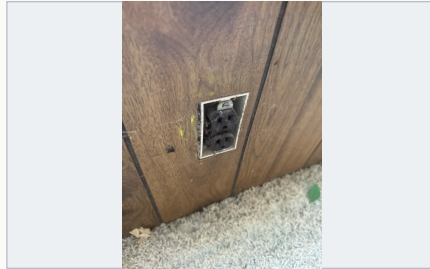
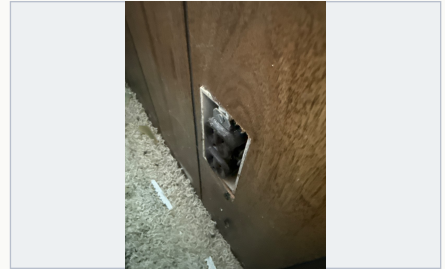
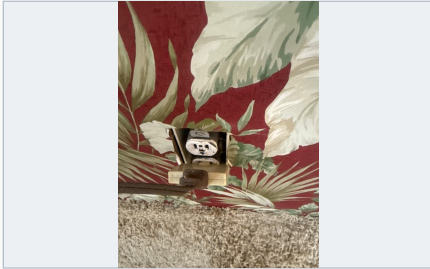
FINDING 6

**Action** [Custom] Inspector-specified corrective action  
Missing cover plates at electric electrical outlets throughout the home.

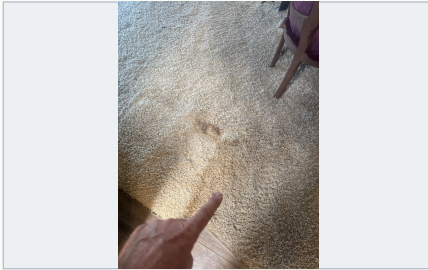
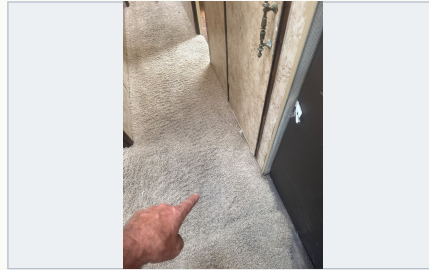
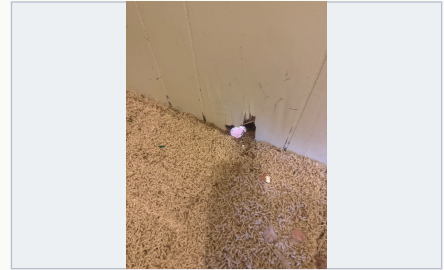
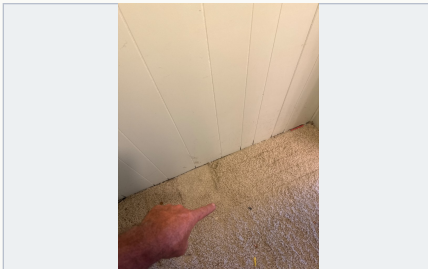
FINDING 7

Damage subfloor and hole in the base of the wall at the floor in the closet of the primary bedroom.

Floor structure shows sag, soft spots, or visible damage indicating sub-floor failure.

- Citation: Title 25 CCR §1606(b).

Walls or ceilings show damage, holes, or detachment.

- Corrective action: Identify cause (rot, joist failure, moisture); repair sub-floor and structural support. Engineer evaluation if widespread.

- Corrective action: Patch or replace damaged sections, prime and paint.

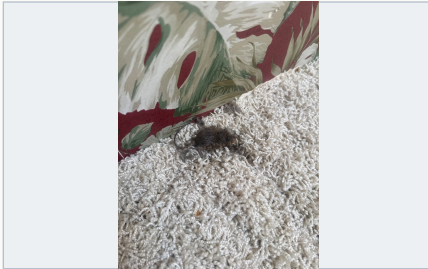
**FINDING 8**

Dead mice found in home.

**Action** Evidence of insect, rodent, or vermin infestation observed (droppings, nesting, damage, live activity).

- Citation: Title 25 CCR §1606(a).

- Corrective action: Professional pest control treatment, seal entry points, remove harborage, replace damaged materials.

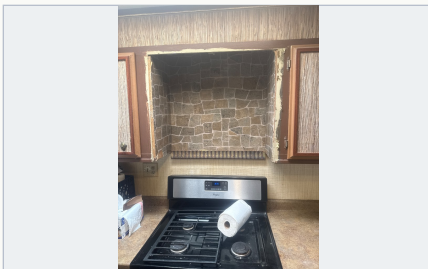
FINDING 9

No exhaust ventilation hood or mechanical exhaust system is installed above the gas range/cooking appliance. The kitchen lacks any means of exhausting cooking vapors, grease, heat, or combustion byproducts to the exterior of the home.

A mechanical exhaust system or ducted range hood shall be provided above the cooking appliance, capable of exhausting a minimum of 100 CFM to the exterior of the home. Recirculating (ductless) filter units do not satisfy this requirement.

Classification: FAIL – Health & Safety

Install an approved ducted range hood or mechanical exhaust fan above the cooking appliance, vented directly to the exterior of the home, meeting the minimum 100 CFM exhaust requirement. Work shall be completed and re-inspected prior to close of inspection.

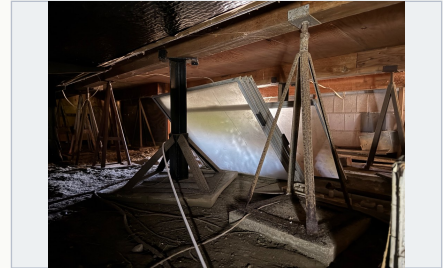
IMG\_1501

**Action** [Custom] Inspector-specified corrective action  
16 of the support peers have rusted to the point where they're no longer serviceable and deteriorated no longer transferring the load to the footing.

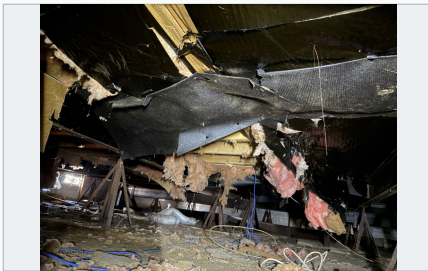
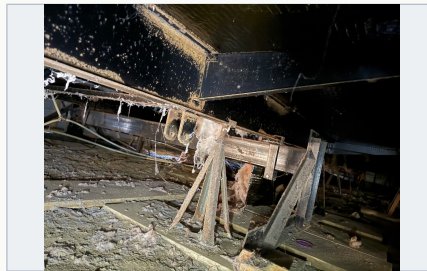
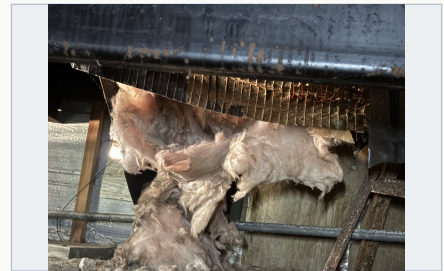
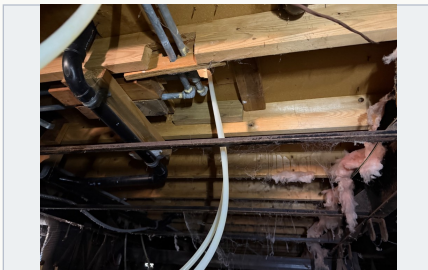
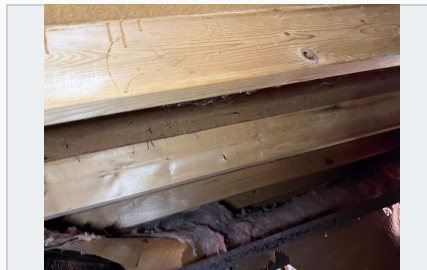
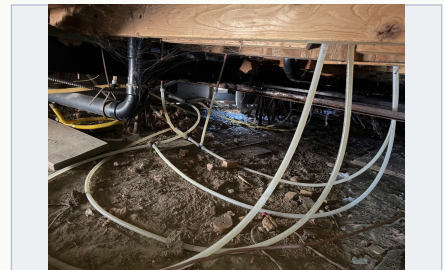
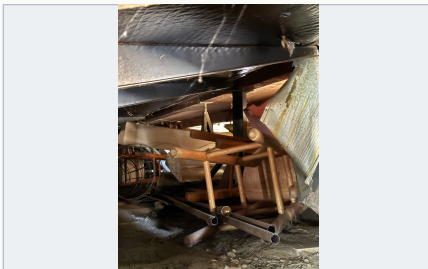
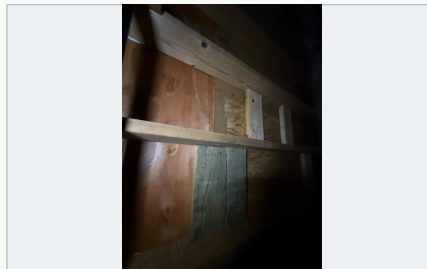
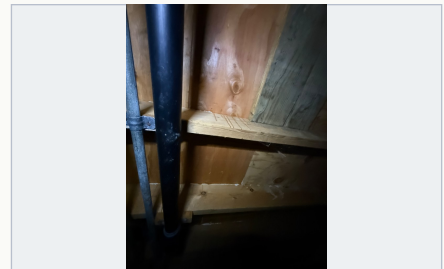
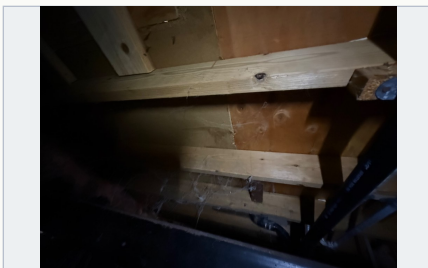
### FINDING 11

**Action** Floor insulation in crawl space is damaged or missing. This creates risk of moisture intrusion, energy loss, and potential pest infestation.

- Citation: This constitutes a structural and sanitation hazard under Title 25 CCR § 1606 and the general endangerment / nuisance standard.

- Corrective action: Install new insulation and vapor barrier to manufacturer specifications. Ensure proper coverage, secure attachment, and ventilation to prevent condensation.

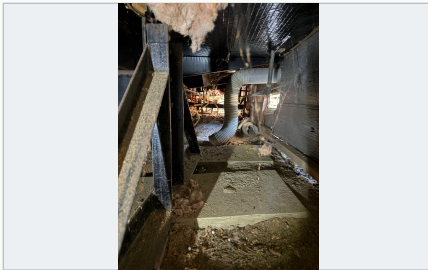
IMG\_1498

Dryer duct discharging under home. Extend dryer vent to discharge to the exterior side of the skirting..

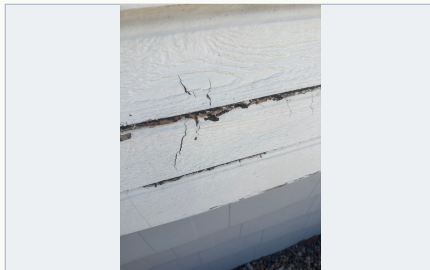
### FINDING 1

**Issues found:** Wood rot / water intrusion

This is on the side of the cabana.

**Action** Wood rot or moisture damage observed in siding or trim. Indicates ongoing or past water intrusion.

- Citation: Title 25 CCR §1606(g).
- Corrective action: Remove rotted material, identify and correct moisture source, replace with treated lumber, prime and paint.

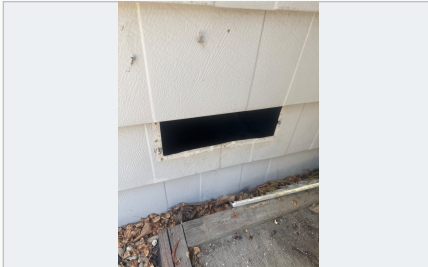
### FINDING 2

**Action** [Custom] Inspector-specified corrective action  
Missing skirting vent screen.

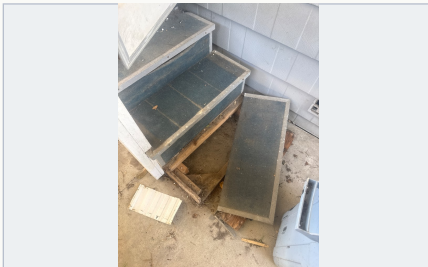
### FINDING 3

Trades and razors and bottom step at back door or non-compliant and unsafe.

**Action** Stair tread or landing platform shows damage, rot, or instability creating trip/fall hazard.  
• Citation: Title 25 CCR §1606(k).  
• Corrective action: Replace damaged components, ensure stable structure.

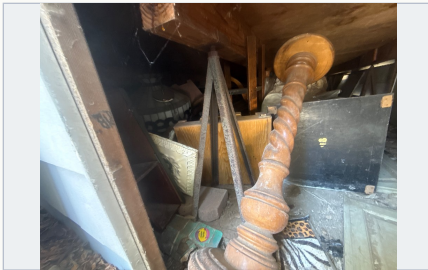
**FINDING 4**

**Issues found:** Debris and infestation source

- Citation: Title 25 CCR §1606 — sources of infestation prohibited.
- Corrective action: Remove debris, address infestation source, professional pest control treatment if active infestation.

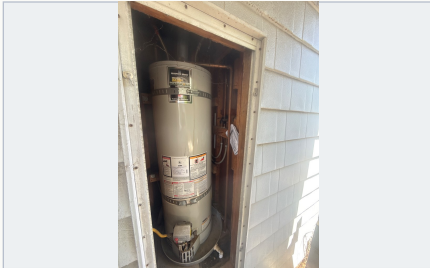
**Issues found:** Missing or improper T&P discharge

**Action** Corrective action required by appropriately licensed contractor.

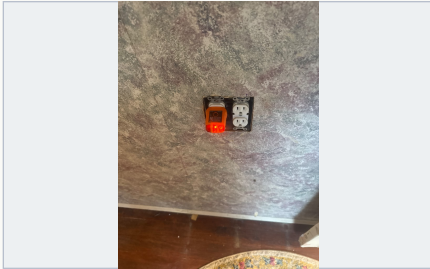
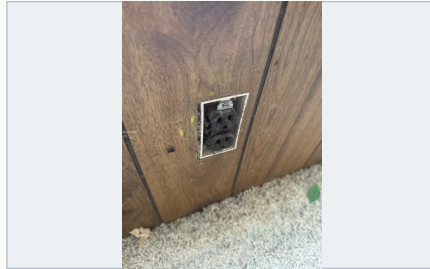
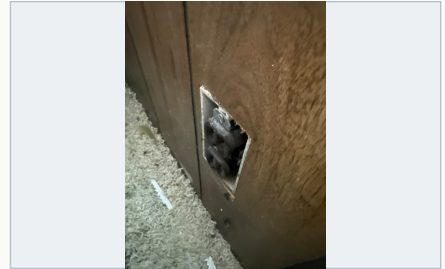
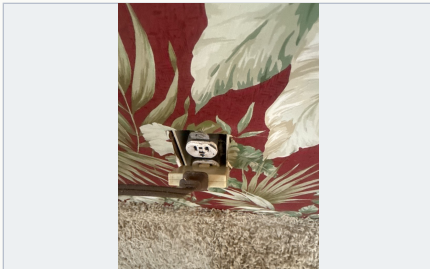
Action [Custom] Inspector-specified corrective action  
Missing cover plates at electric electrical outlets throughout the home.

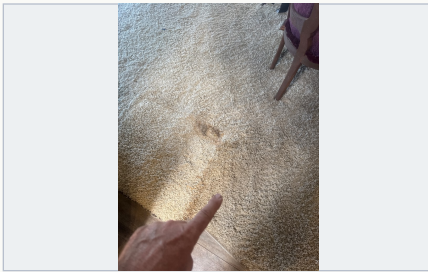
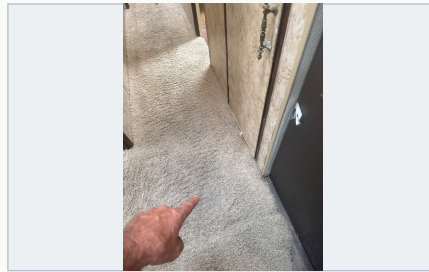
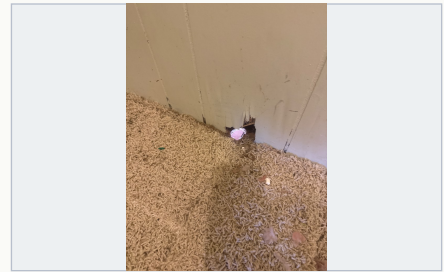
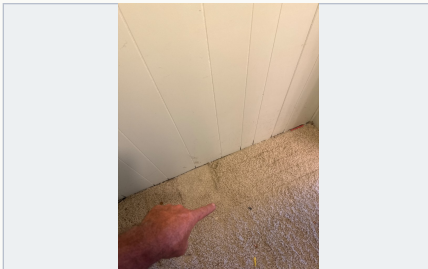
Damage subfloor and hole in the base of the wall at the floor in the closet of the primary bedroom.

Floor structure shows sag, soft spots, or visible damage indicating sub-floor failure.

Walls or ceilings show damage, holes, or detachment.

- Corrective action: Identify cause (rot, joist failure, moisture); repair sub-floor and structural support. Engineer evaluation if widespread.

- Corrective action: Patch or replace damaged sections, prime and paint.

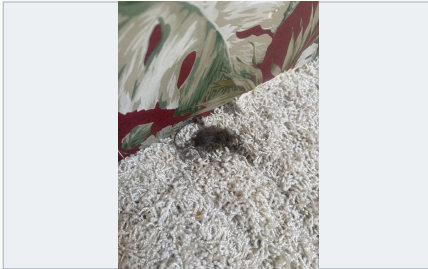
Dead mice found in home.

**Action** Evidence of insect, rodent, or vermin infestation observed (droppings, nesting, damage, live activity).

- Corrective action: Professional pest control treatment, seal entry points, remove harborage, replace damaged materials.

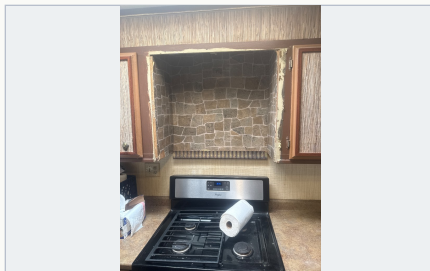
**Action** [Custom] Inspector-specified corrective action  
DEFICIENCY – KITCHEN EXHAUST VENTILATION

Classification: FAIL – Health & Safety

Install an approved ducted range hood or mechanical exhaust fan above the cooking appliance, vented directly to the exterior of the home, meeting the minimum 100 CFM exhaust requirement. Work shall be completed and re-inspected prior to close of inspection.

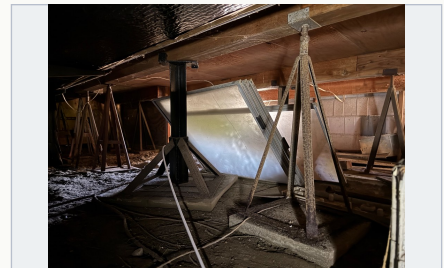
IMG\_1501

**Citation** Other — custom corrective action**Action** [Custom] Inspector-specified corrective action  
16 of the support peers have rusted to the point where they're no longer serviceable and deteriorated no longer transferring the load to the footing.

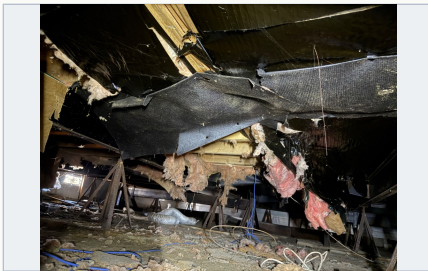
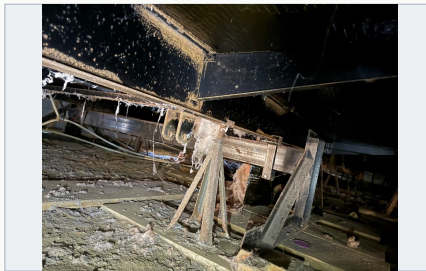
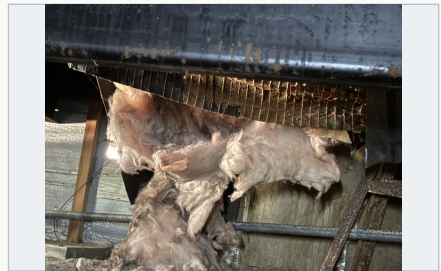
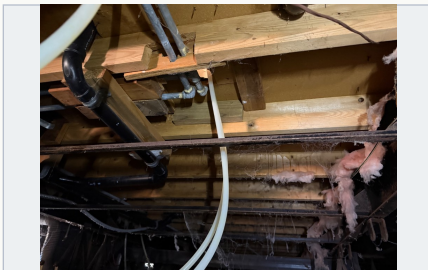
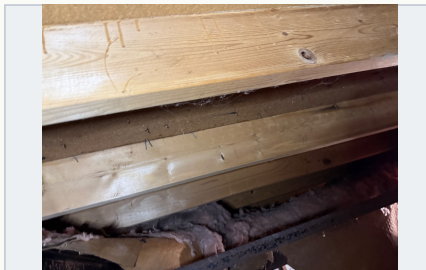
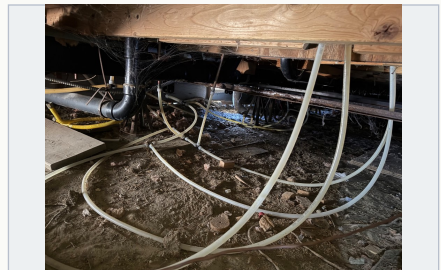
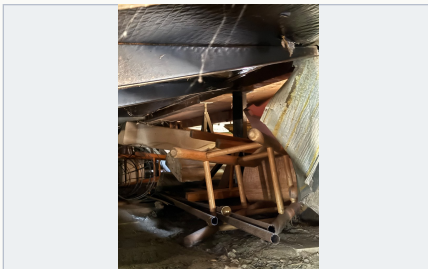
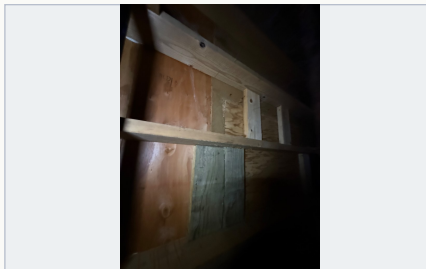
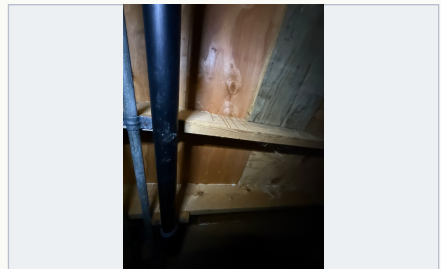
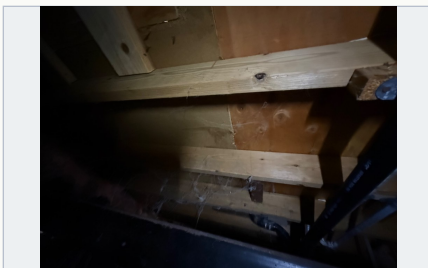
**FINDING 11****Insulation / vapor barrier: Intact****' CORRECTED 13 SEP****Issues found:** Damaged and missing floor insulation

**Citation** Damaged and missing floor insulation**Action** Floor insulation in crawl space is damaged or missing. This creates risk of moisture intrusion, energy loss, and potential pest infestation.

- Citation: This constitutes a structural and sanitation hazard under Title 25 CCR § 1606 and the general endangerment / nuisance standard.

- Corrective action: Install new insulation and vapor barrier to manufacturer specifications. Ensure proper coverage, secure attachment, and ventilation to prevent condensation.

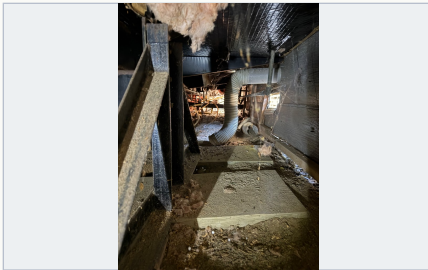
IMG\_1498

Issues found: Inspector to specify

**Action** Inspector to describe specific crawl-space hazard in field notes.  
• Citation: Title 25 CCR §1606.  
• Corrective action: To be determined based on specific defect.
