# Inspection Report

**Property Address:**  
2301 Plumb St  
San Diego California 92106

**Nation Wide Inspections**

<b>Date:</b> 2/4/2025	<b>Time:</b> 08:44 AM	<b>Report ID:</b> J020425A
<b>Property:</b> 2301 Plumb St San Diego California 92106	<b>Customer:</b> Lynn Grimm	<b>Real Estate Professional:</b>

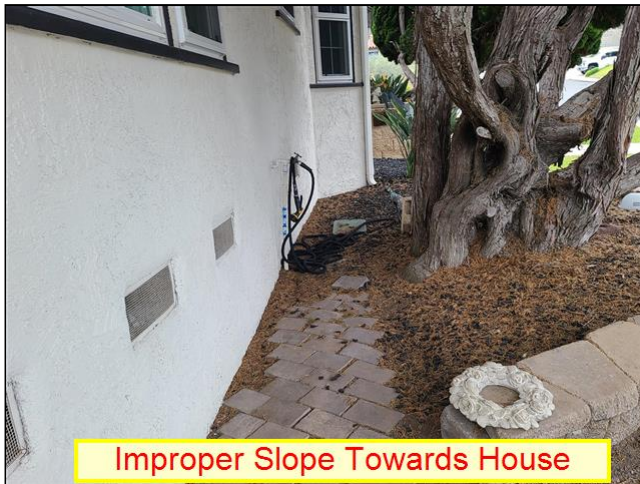
**Improper Slope Towards House.** The hardscape at the front of the property allows water to run towards the house. It is recommended that surface drains be or other means be provided to keep water away from the house and foundation.

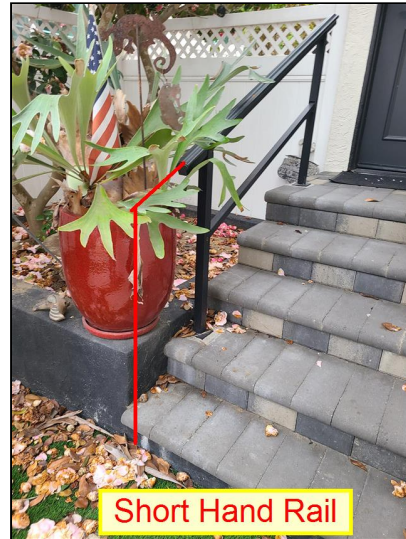
🏠 (1) **Short Hand Rail.** The hand rails at the stairs does not fully extend to the bottom of the stairs. **Hand rails should extend the full length of the stairs.** It is recommended that alterations be made to allow for a hand rail to extend the full length of the stairs.

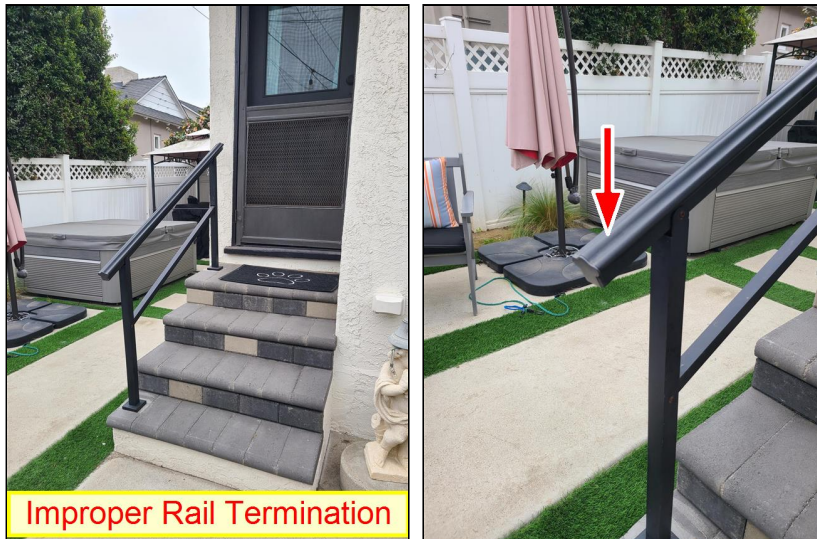
(2) **Improper Rail Termination.** The ends of the hand rails, at the stairs, did not return to the wall or post. This can allow for loose clothing to catch on the end of the rail, increasing the risk of injury. Ends of hand rails should return to the wall or post. **This is a newer requirement that may not have been in effect when these rails were installed.** It is recommended that this be changed to meet today's standards.

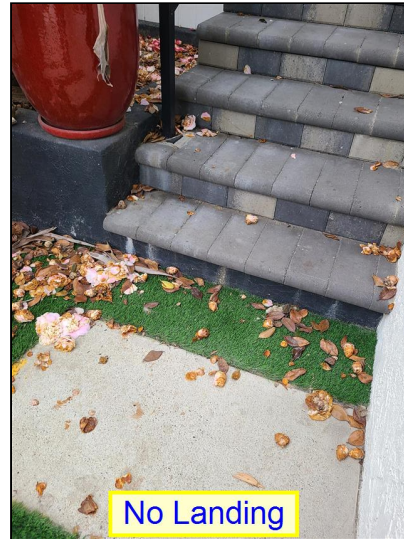
(3) **No Landing.** There was not a landing provided at the bottom of the stairs. **Landings should be a minimum of 36 inches.** This is noted for your information and should be corrected.

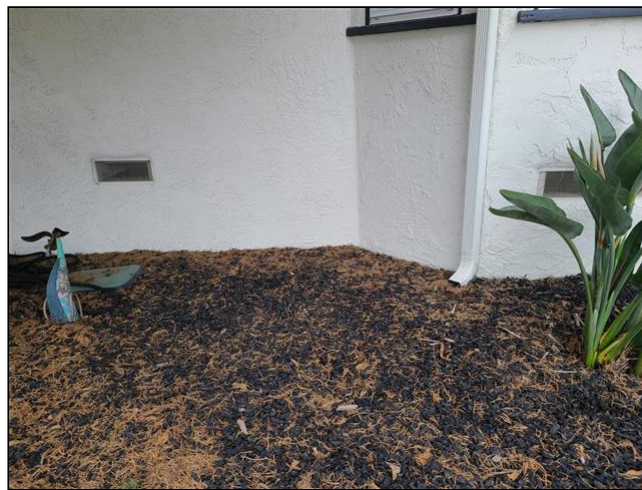
📍 (1) **Poor Drainage.** There are areas around the house where the drainage is poor or there was no directional slope away from the house. There were no visible surface drains noted at these locations. It is important that all water shed away from the house and foundation. Ideally there should be a minimum slope of 6 inches within the first 10 feet of the house. It is recommended that swales, french drains or other means of drainage be provided to keep water away from house and foundation.

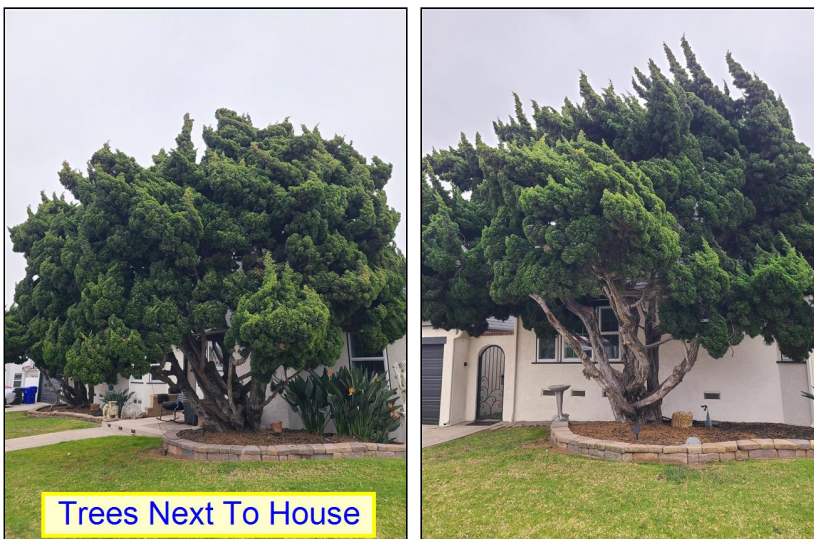
(2) **Trees Next To House.** It was noted that there was a large tree in close proximity to the house. Some trees can have evasive root structure which can potentially cause damage to house foundations, plumbing and irrigation systems. Others can come into contact with the home and roof causing exterior damage to these areas. **It is recommended that you consult an arborist or other plant specialist about this tree and the potential problems that might be associated with it.**

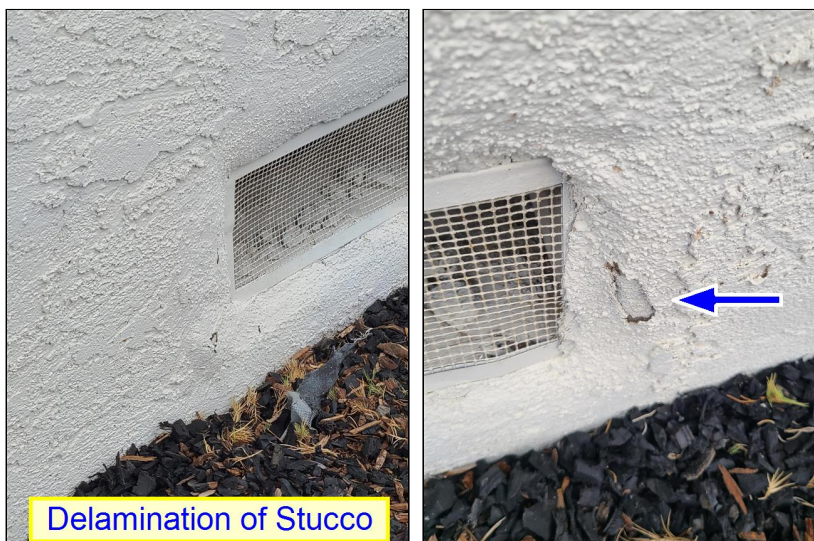
🏠 (2) **Delamination of Stucco.** There was some delamination of stucco noted at the exterior of the house. The stucco is beginning to delaminate at the exterior of the home. **This is common in older homes that are not provided with weep screed flashings at the stucco.** Although there are many causes of delamination, most often, it is due to excess moisture wicking into the stucco, and causing it to fail. **This is a cosmetic fix but, but efforts should be made to keep the area around your foundation dry.**

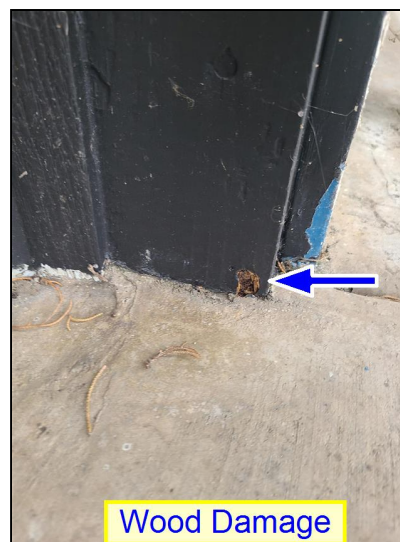
(3) **Wood Damage.** There was some wood damage noted at some of the trim work at the garage door. **It is recommended that you read your termite report thoroughly and that any damaged wood be repaired or replaced by a licensed contractor.**

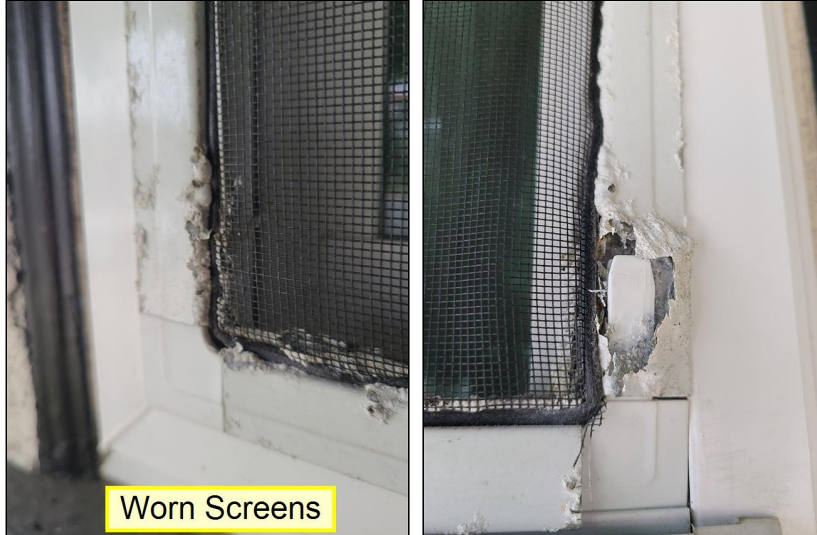
**NOTE: Worn Screens.** There were some window screens and frames that were worn and beginning to deteriorate. This is noted for your information and can be repaired as needed at your convenience.

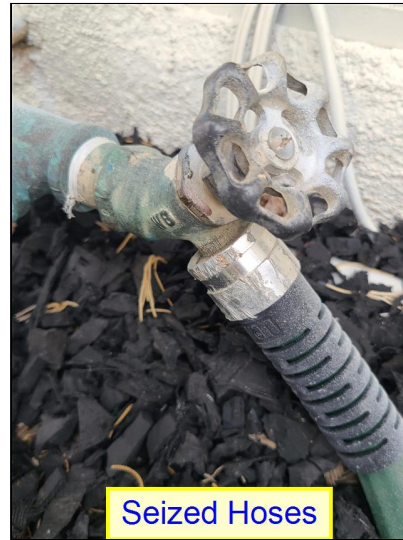
📌 (1) **Seized Hose on Faucet.** There were a few faucets that had hoses attached to the spigots. The hoses were currently seized to the faucet handle and was not able to be removed. **It is recommended that the hose be removed and plumbers (Teflon) tape applied at this location.**

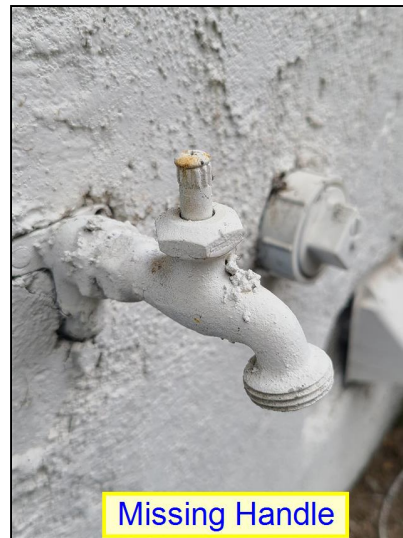
(3) **Missing Handle.** There was a missing handle for one of the hose bibs at the rear of the property. **This fixture was not tested for proper working order. It is recommended that this handle be replaced to ensure proper working order.**

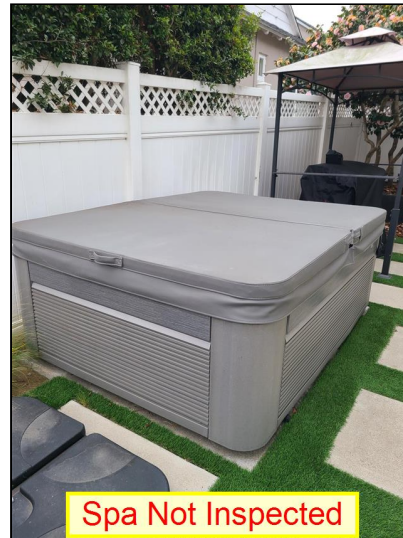
(2) **NOTE: Spa Not Inspected.** The spa was not part of this inspection and was not inspected. This includes safety hazards in and around the spa area, condition of spa and related equipment (including: verification of safety equipment, proper bonding, grounding and GFCI protection of equipment as well as working order of the pumps and heaters). It is recommended that the spa and all of the equipment be properly inspected by a qualified specialist.

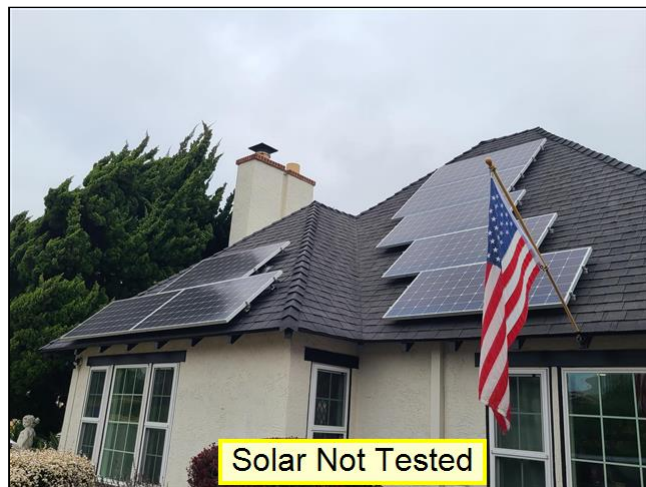
(2) **NOTE: Solar Not Tested.** This house is equipped with a solar voltaic system electrical system as well as being powered from the grid. **The working order of the solar system is not part of the inspection and was not tested for proper function.** This includes the function of the panel arrays and inverters. For further inspection of this system it is recommended that you contact a licensed electrician who is familiar with the working operation and installation of solar systems.

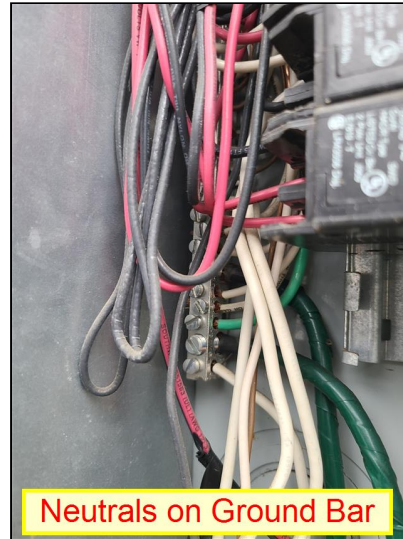
(3) **Neutrals on Grounding Bar.** The sub-panel currently has the neutral wires (White Wires) bonded to the grounding bar. In sub-panels, the neutral (white) wires should be "floating" (not touching the panel, the grounding wires ((bare copper or green)), or any other metal part of the panel) . In this application the neutral wires have been attached to the grounding bar . **Bonding of these conductors is improper and hazardous .** It is highly recommended that this be repaired by a licensed electrician.

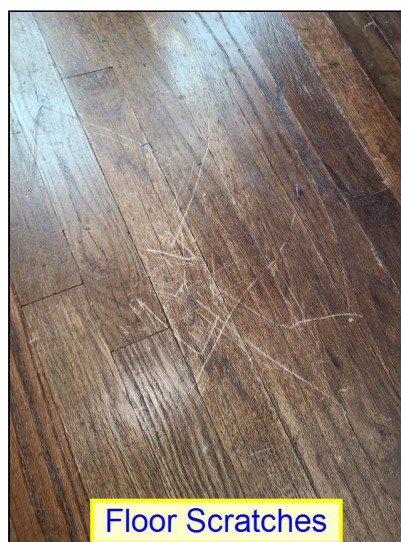
🏠 (4) **Floor Dings/ Scratches.** There was damage to the wood type floors of this house. These would include areas having small scratches and dings associated with flooring materials of this nature. **This is noted for your information.**

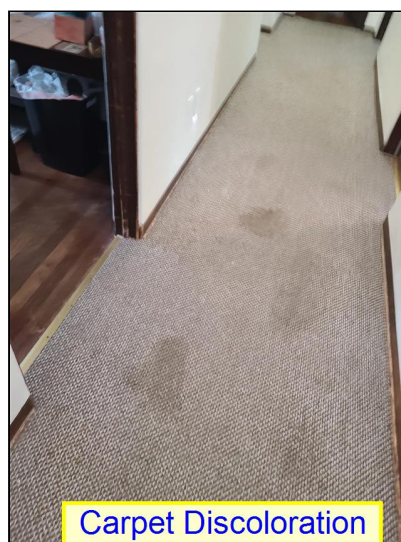
🏠 (5) **Carpet Discoloration.** There is carpet discoloration or stains throughout the rooms of this unit . It could not be determined if these areas of discoloration or stains can be removed. **It is recommended that a professional carpet cleaning company be called out to further evaluate these areas.**

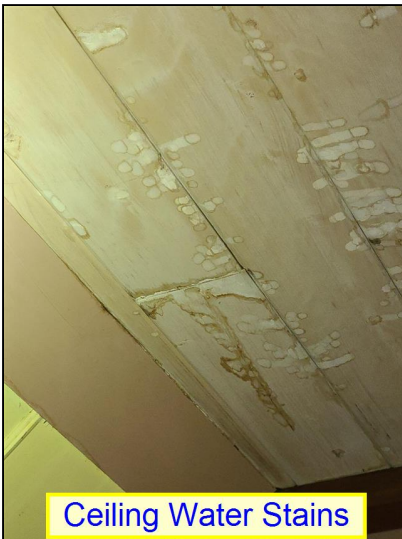
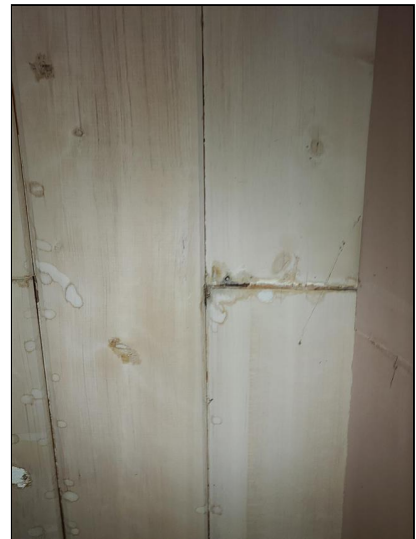
(2) **Ceiling Water Stains.** There was some water staining noted on the ceilings of the upstairs loft area. It appears that there have been a roof leaks at these locations at one time. **It could not be determined if these leaks have been properly repaired.** It is recommended that you ask the current owner about these stains and that a roofing contractor be hired to further evaluate these areas if needed.

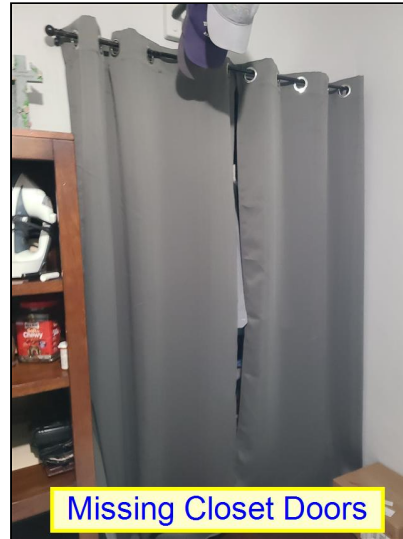
**Missing Closet Doors.** The closet doors in bedroom #2 were not present at the time of the inspection. This is noted for your information and it is recommended that these doors and tracks be installed at your convenience.

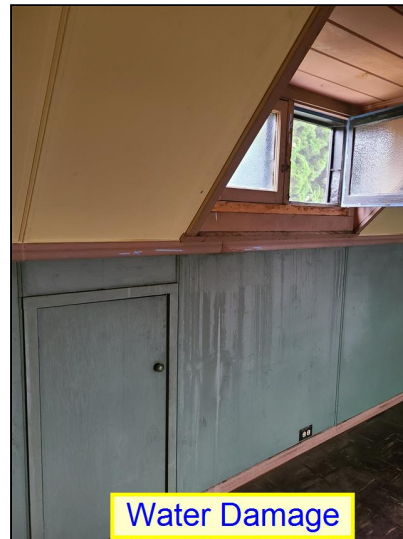
(2) **Water Damage Noted Under Window.** There was some water marks and wood damage noted at the underside of the loft windows. This was located in the upstairs loft area. **It was not able to be determined if these water mark was caused by a faulty window system, or the window having being left open during a rain.** This is noted for your information and should be further evaluated for potential problems.

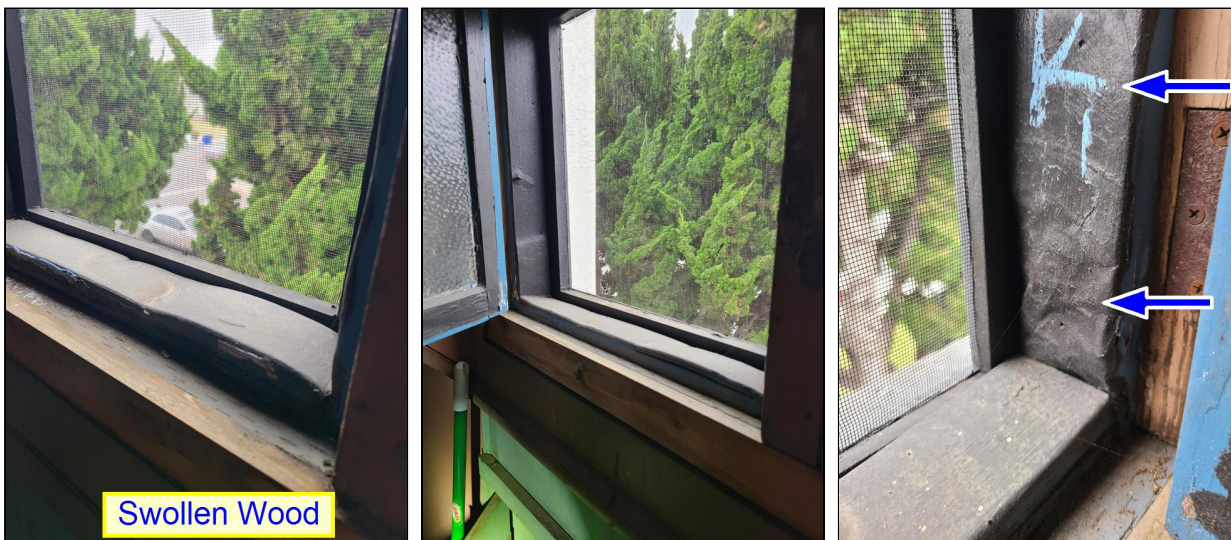
(2) **Wood Damage.** There were a few windows that had wood damage. There was some wood at the frames that was soft and deteriorated. It appears that the interior trim has gotten wet and has swollen. **It is recommended that these areas be further evaluated and repaired as needed by a licensed contractor.**

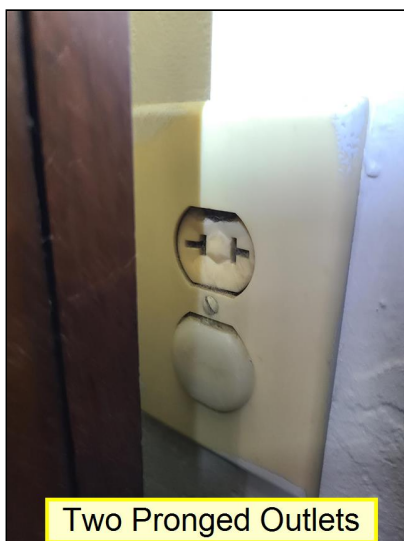
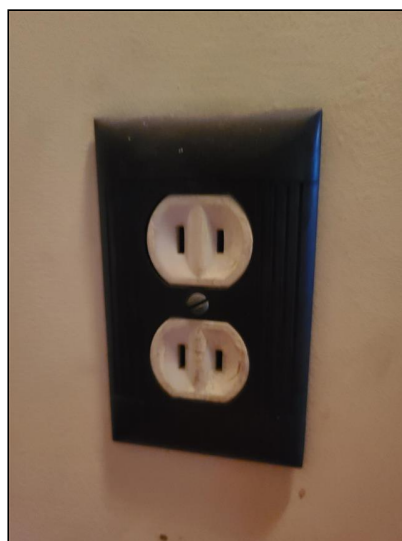
(2) **NOTE: Ungrounded Grounding.** Due to the year in which this house was built; there is no grounding for some of the electrical System. The original style of two pronged outlets have remained for your knowledge and reminder. These outlets can not be properly changed to the three pronged outlets unless the outlets have been properly grounded or are protected by a GFCI outlet or protected circuit, and a sticker has been added to the cover plate identifying that there is "No Equipment Ground". This is noted for your information. **It is important to know and understand that the two pronged outlets have not been upgraded and are NOT GROUNDED.**

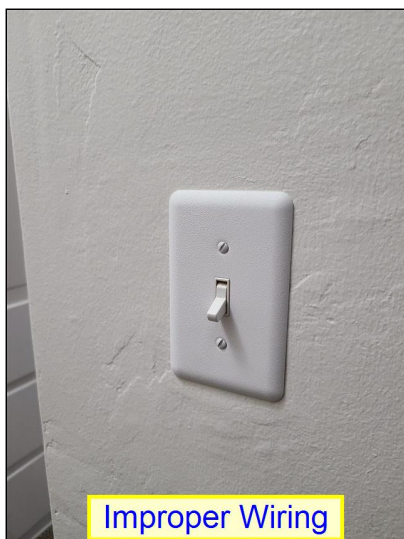
(4) **Improper Wiring of Switch.** The three-way switch provided for the hallway was incorrectly wired, and did not properly function. Currently one of the switches may not work if not in the correct configuration . It is recommended that this switch be properly wired by a licensed electrician.

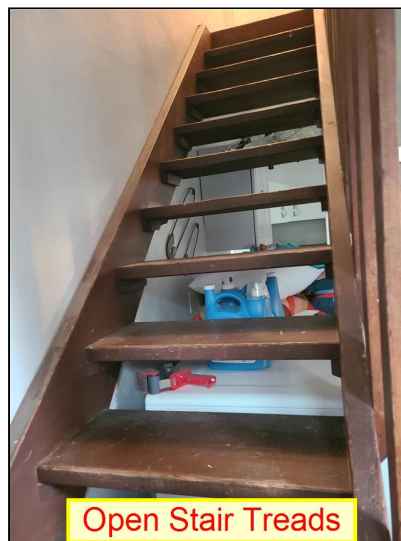
(2) **Open Stair Treads.** The stairway was not provided with backings at the treads. This increases the risks of objects and children being injured or falling. Although these stairs may have been built to standards at the time of construction, it is recommended that they be upgraded to today's standards. This is noted for your information and safety.

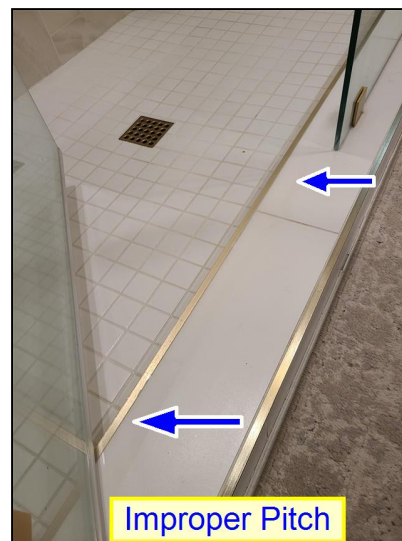
**(2) Improper Pitch.** The pitch at the shower dam was not sufficient. This can cause water to exit the shower enclosure. **This is noted for your information and safety and efforts should be made to keep this area dry.**

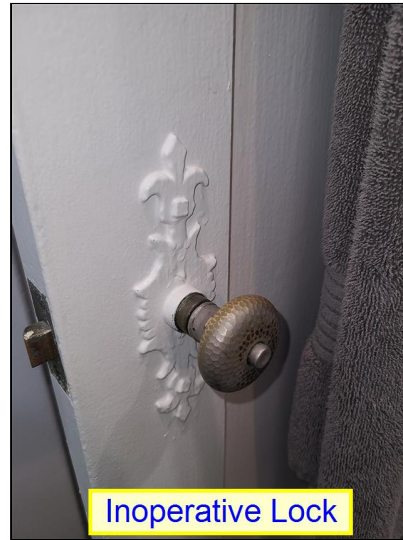
**Inoperative Lock.** The lock for the door at this bathroom did not function at time of inspection. For privacy purposes it is recommended that a locking device be provided on these doors.

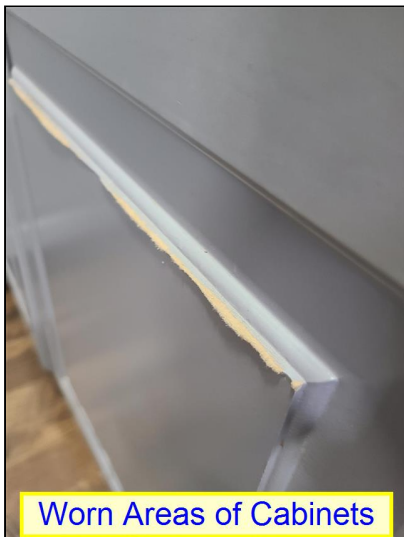
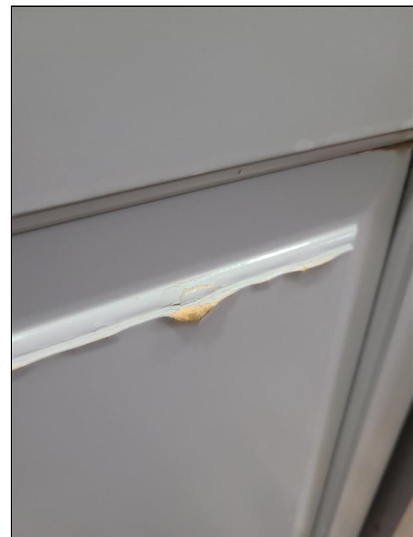
(1) **Worn Areas of Cabinets.** It was noted that a few areas of the kitchen cabinets show some wear at heavily used areas of the cabinet doors. **This is noted for your information.**

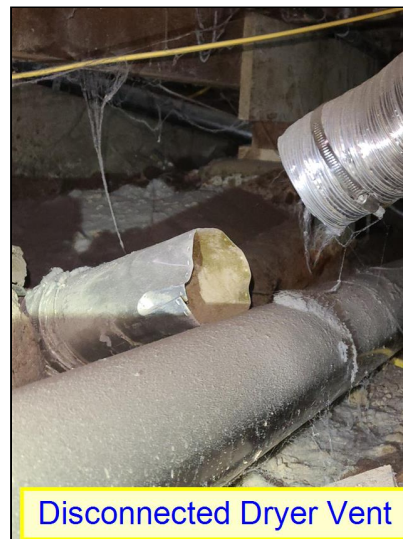
(3) **Disconnected Vent.** The laundry vent line was disconnected at the underside of the house. Currently the lint and moisture is not properly exiting and is venting to the underside of the house. **This can allow for moisture related issues.** It is recommended that this the vent reconnected and the length shortened to allow for proper venting of air.

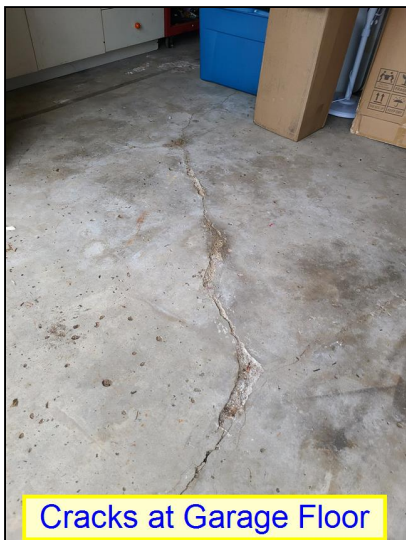
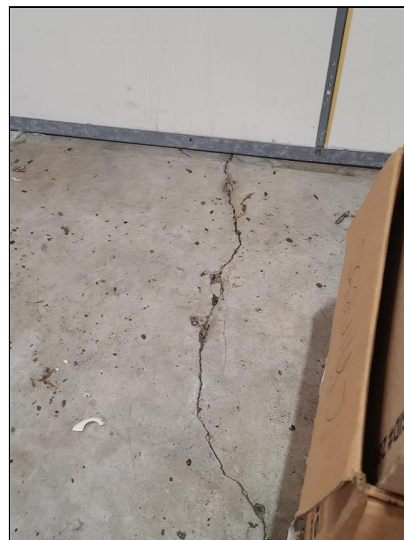
(2) **Cracks at Garage Floor.** There were several cracks at the garage floor . This is noted for your information and does not appear to be structural in nature.

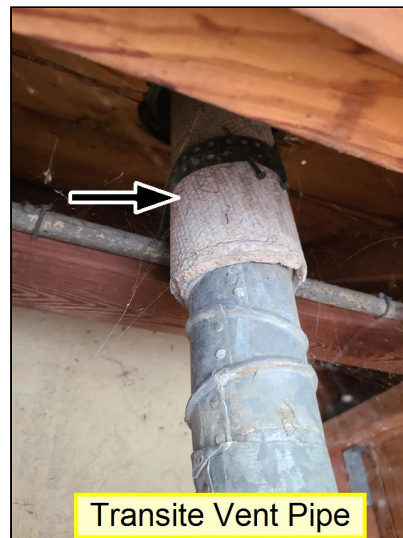
(2) **NOTE: Transite Vent Pipe.** It was noted that the water heater provided for this home appears to have a Transite vent pipe. Transite has a high probability of containing asbestos, a material that if damaged or disturbed can cause serious health risks. For more information about this material please read the provided links found in **Section 1.13.** of this report.

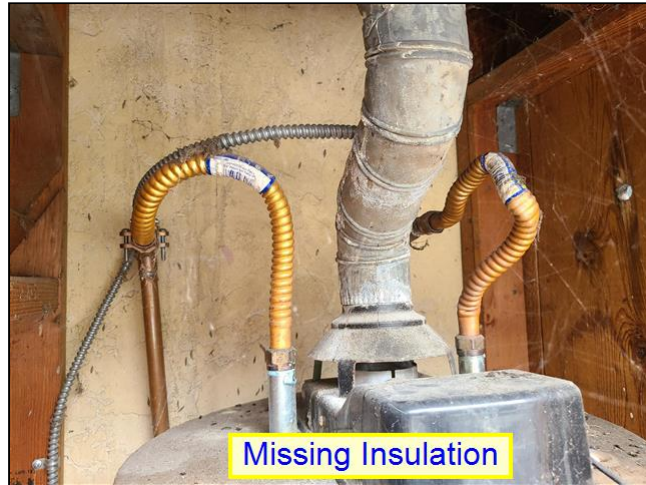
🏠 (3) **Missing Insulation.** The water supply lines were not insulated. **The first 5 feet of hot and cold water pipes are required to be insulated if they are exposed in unconditioned space . It is recommended that these lines be properly insulated.**

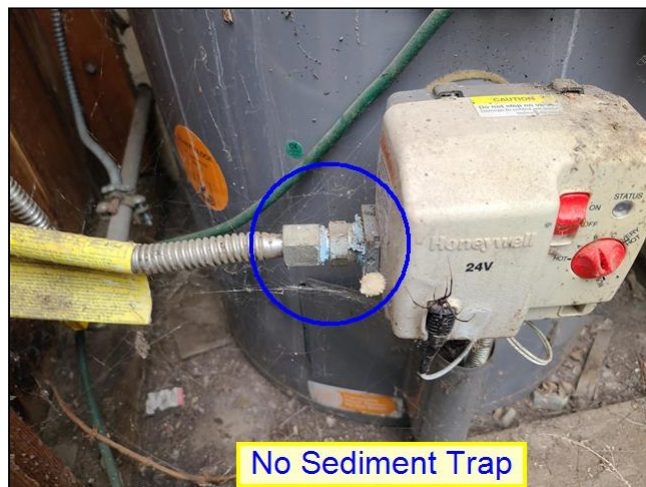
(4) **No Sediment Trap.** There was currently no sediment trap on the gas line leading into the hot water heater. It is recommended by the manufacturer that a sediment trap be installed at this heater. **It is recommended that a trap be installed by a licensed plumber.**

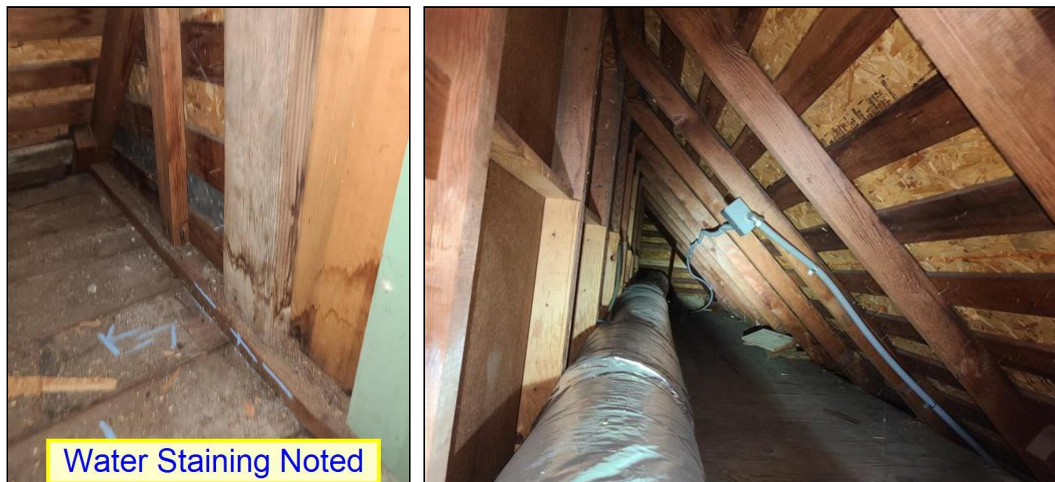
evidence of roof or material damage at these locations. This is noted for your information and can be further evaluated if so desired.

Water Staining Noted

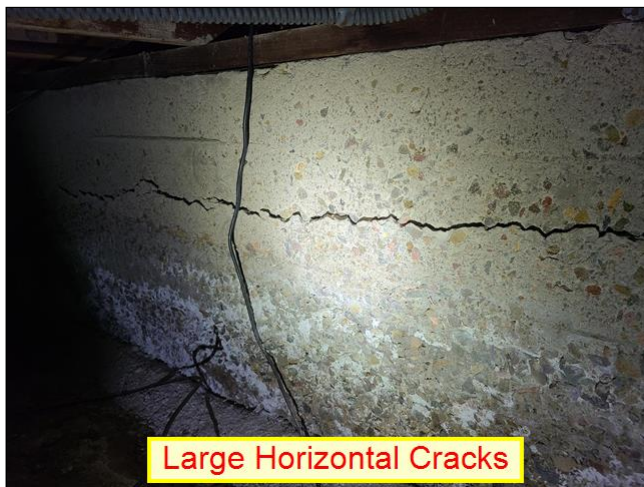
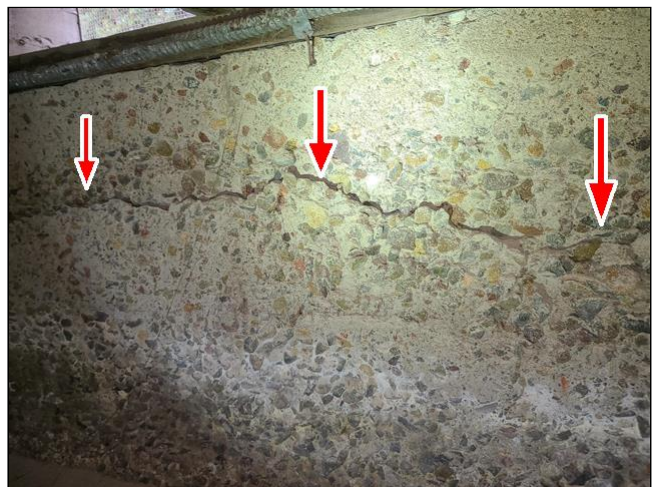
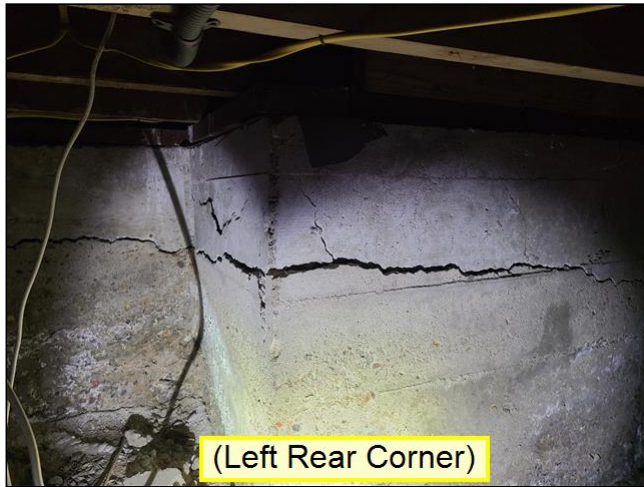
(Left Rear Corner)

(2) **Large Horizontal Cracks.** There were areas at the underside of the house that have large horizontal cracks. These cracks were noted across the rear and left side of the property. These cracks had areas that were very deep, and some appear to penetrate through the entire wall. **These are considered structural deficiencies needing further evaluation and repair.** It is recommended that these locations be further evaluated by a structural engineer and or foundation specialist.

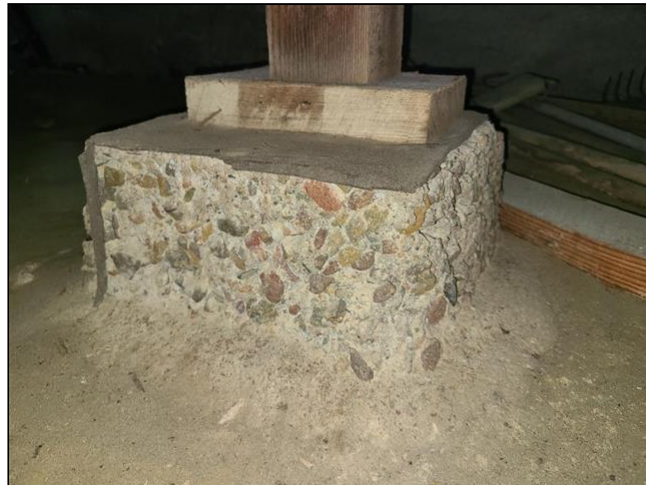
Deterioration of Piers
