# Inspection Report

**Property Address:**  
4768-72 Coronado Ave  
San Diego CA 92107

**Foresight Building Inspection**

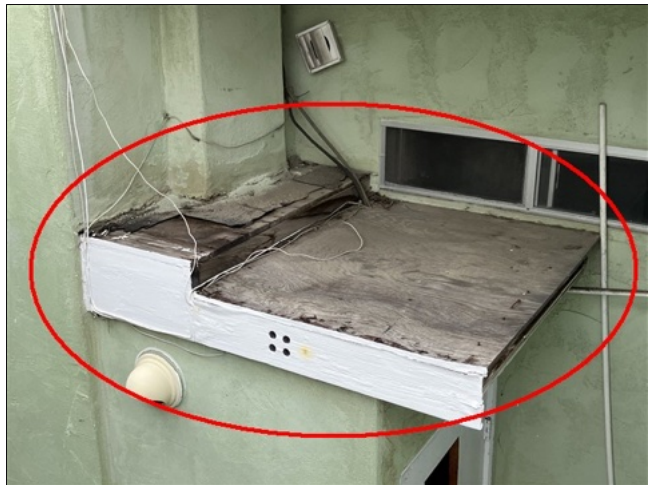
Visible defects were observed at areas of the roof covering . It is recommended to contact a licensed roofer for a complete evaluation of all roof defects and repair/replace as needed.

1.0 Item 1(Picture) water heater utility room roof: substandard installation or building material was observed / recommend further evaluation

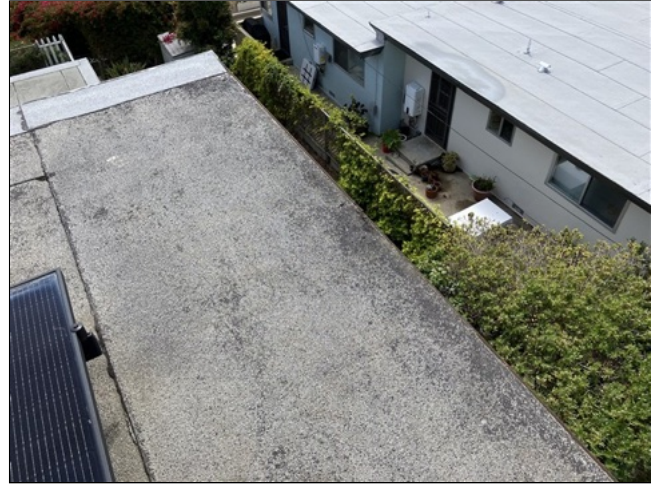
1.0 Item 9(Picture) roll roofing deterioration visible / recommend further evaluation and correction as needed

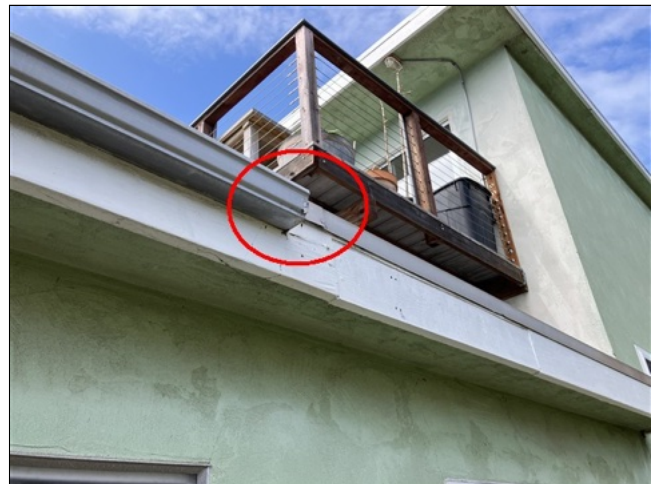
Defects or deficiencies were observed at one or more areas of the downspout components. It is recommended to have the system evaluated by a rain gutter specialist and repaired/replace as needed.

1.1 Item 2(Picture) missing gutter components

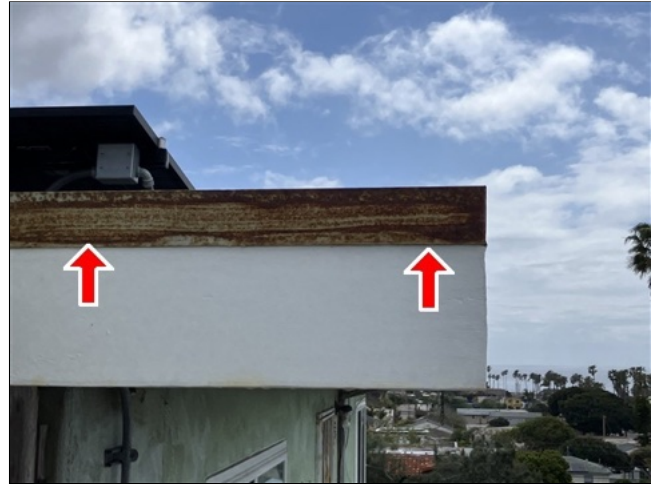
(2) The flashings at the chimney, vent penetrations, or transitions were missing, deteriorated, or had other observable defect. It is recommended to have all flashings systems evaluated by a licensed roofer and repaired/replaced as needed.

1.2 Item 3(Picture) oxidized flashings observed

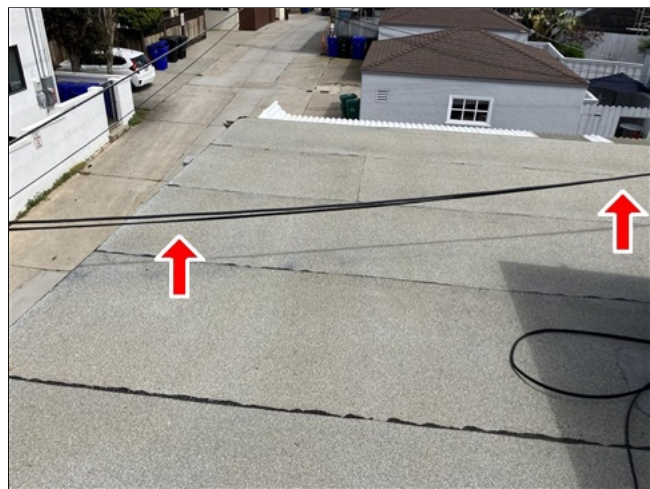
The cable service drop line runs above the roof was observed to pose a tripping hazard. Rerouting the cable service line is recommended.

1.7 Item 1(Picture) tripping hazard

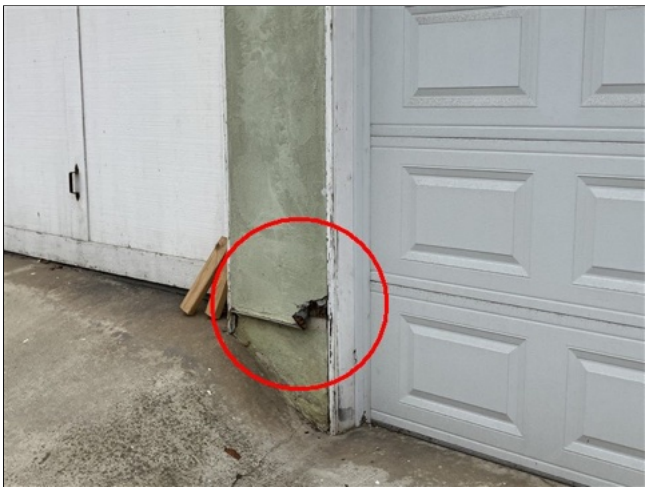
(1) There were damages, deterioration, or other visible defects observed at areas of the exterior wall cladding system or components. It is recommended to have this evaluated by an appropriate licensed contractor or tradesman and repaired/ replaced as needed.

2.0 Item 1(Picture) stucco damage/defect visible // maintenance/repairs needed

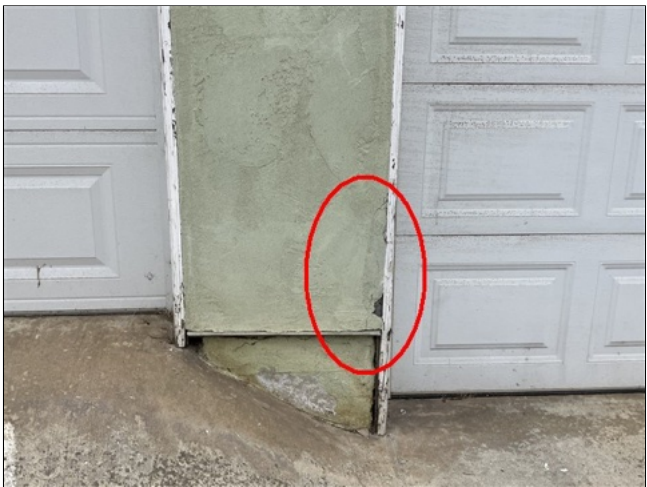
2.0 Item 2(Picture) stucco damage/defect visible // maintenance/repairs needed

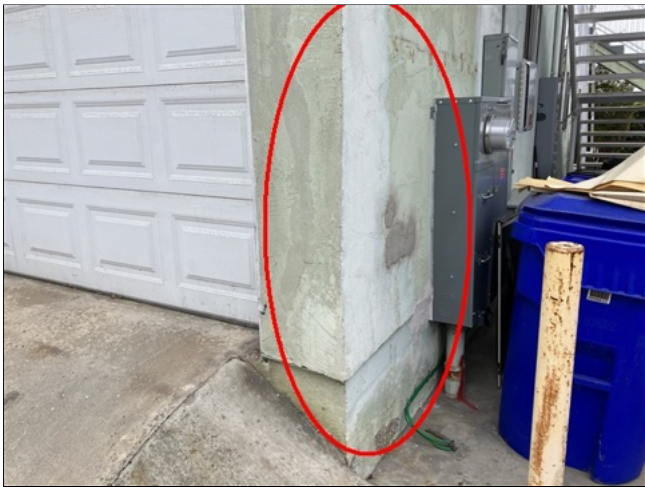
2.0 Item 3(Picture) stucco surface and paint maintenance/repairs needed

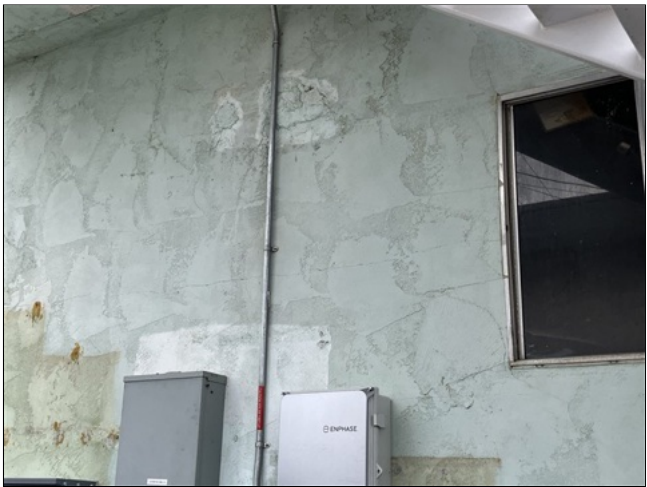
2.0 Item 4(Picture) stucco surface and paint maintenance/repairs needed

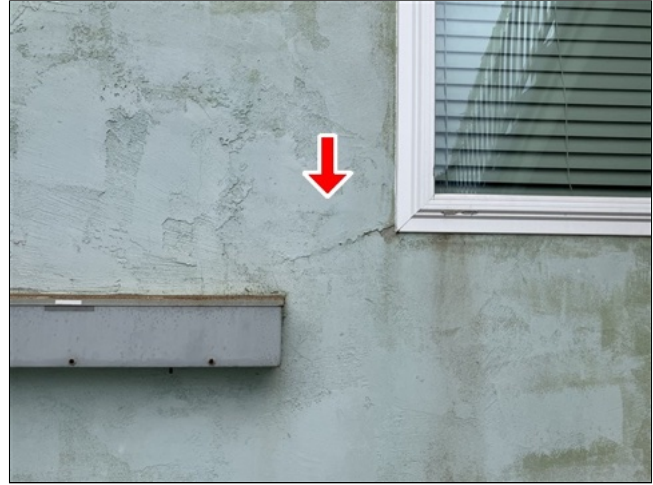
2.0 Item 6(Picture) cracks visible at stucco

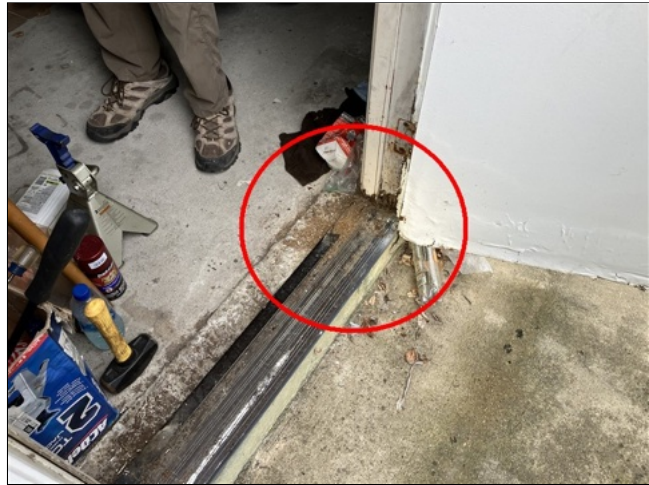
Possible WDO (wood destroying organisms) evidence or damage was observed at areas of the exterior door systems. It is recommended to have a licensed pest control company evaluate all WDO related defects and remediate as needed.

2.1 Item 2(Picture) garage occupant door: possible WDO evidence or damage observed

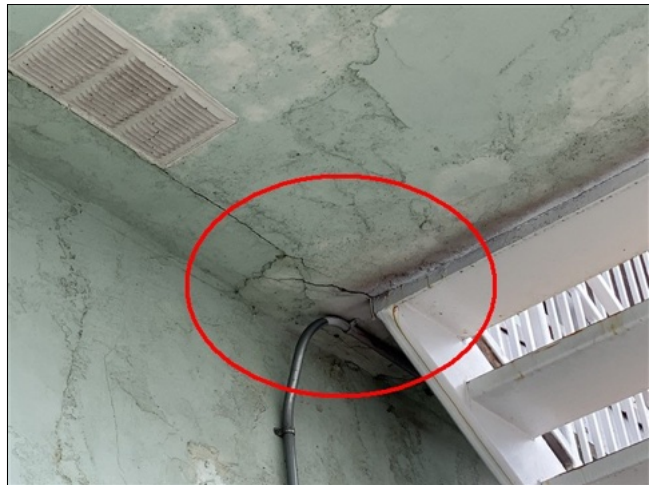
2.3 Item 2(Picture) stucco cracks visible near stair attached to the deck / recommend further evaluation and correction as needed

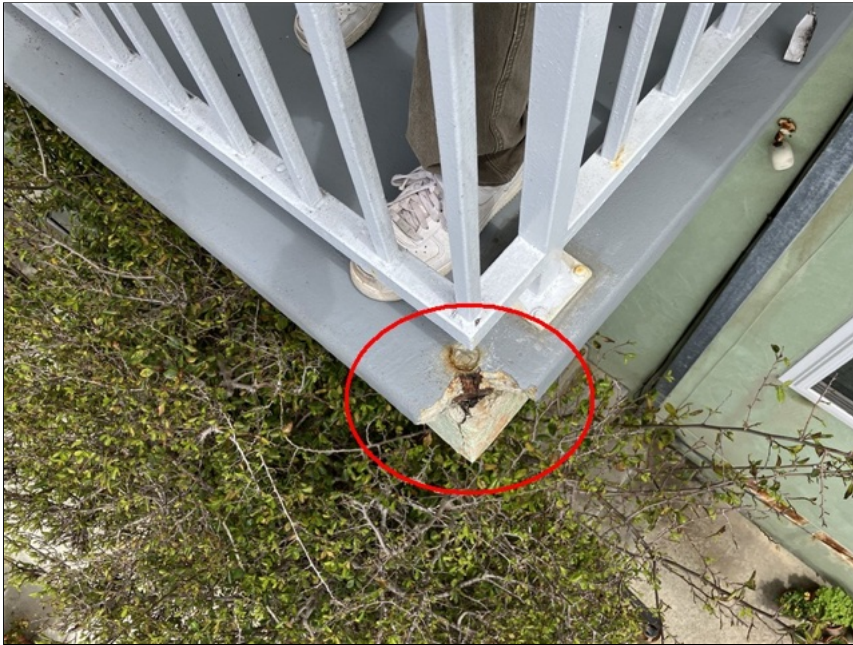
2.3 Item 4(Picture) concrete spalling visible / recommend further evaluation and correction as needed

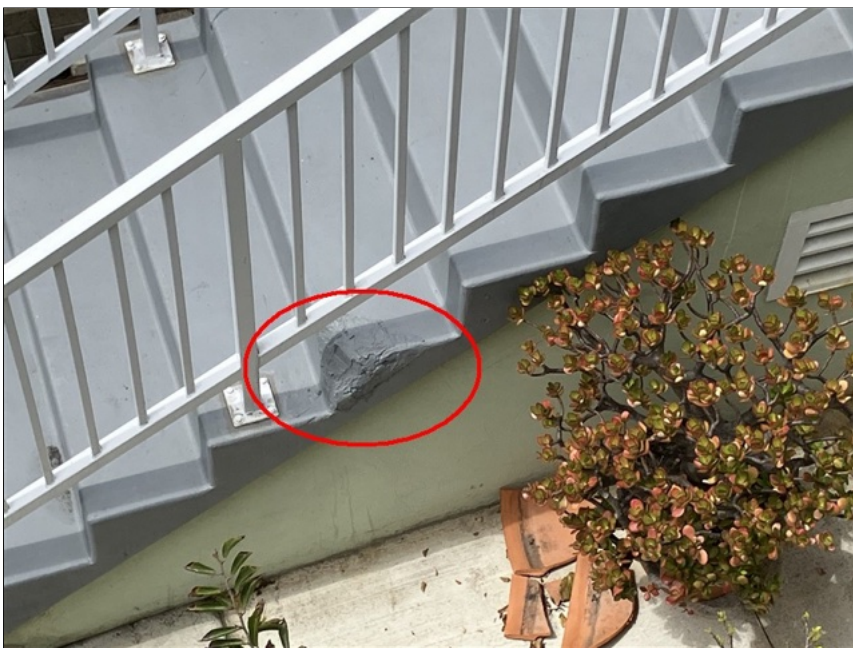
2.3 Item 5(Picture) possible evidence of repairs observed / recommend further evaluation of repair

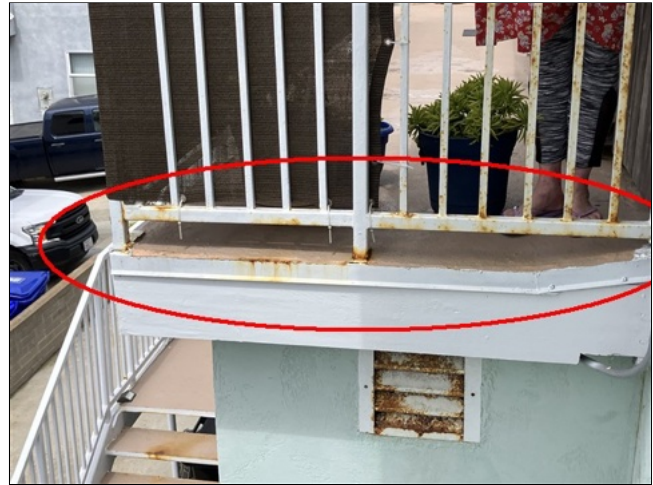
2.3 Item 7(Picture) oxidation visible at deck railing system and deck flashing

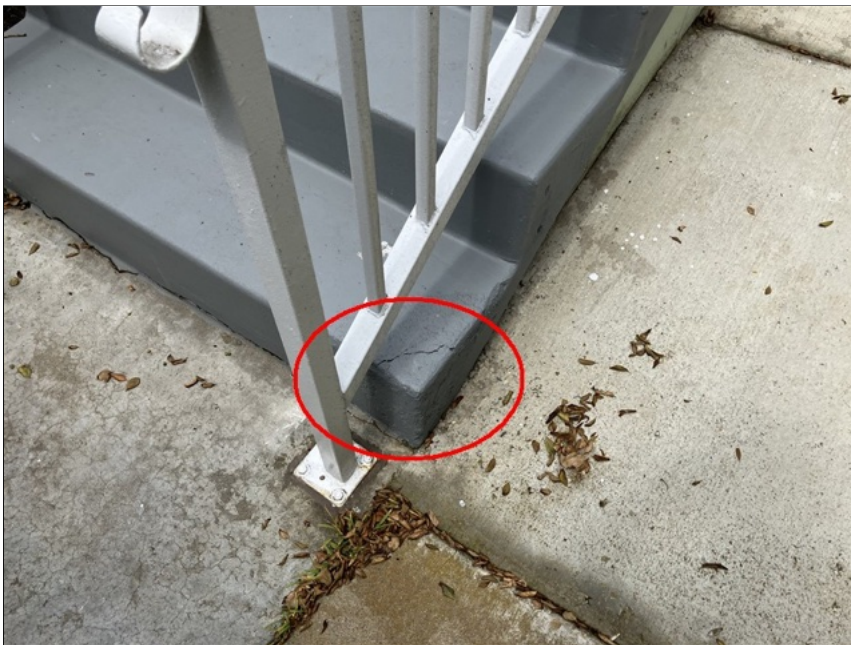
2.3 Item 8(Picture) cracks visible at concrete stairs

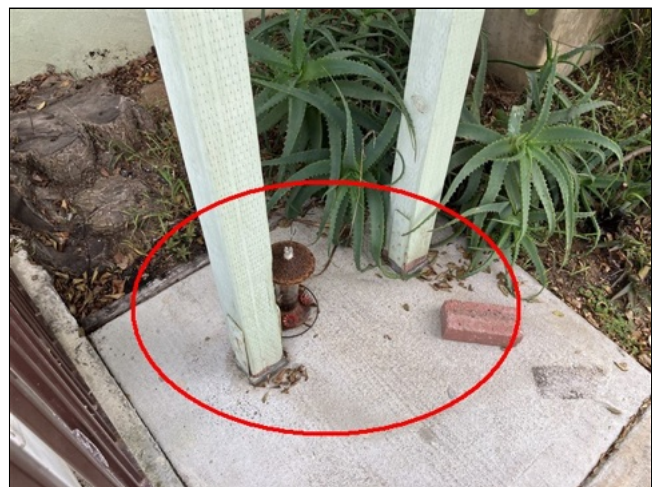
2.3 Item 10(Picture) substandard deck stair support installation observed

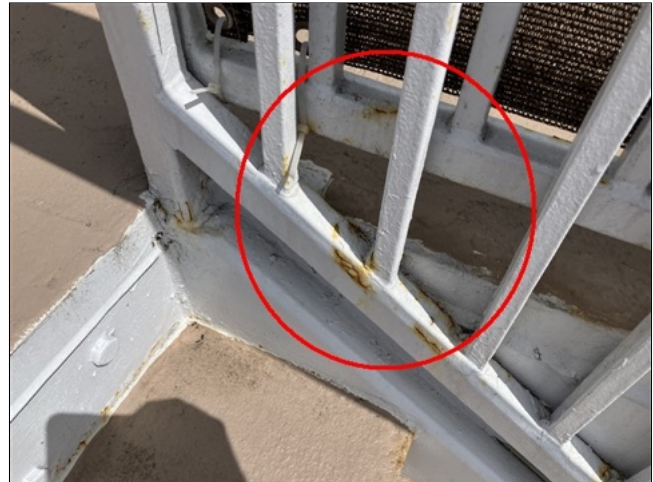
2.3 Item 14(Picture) oxidation visible at railing

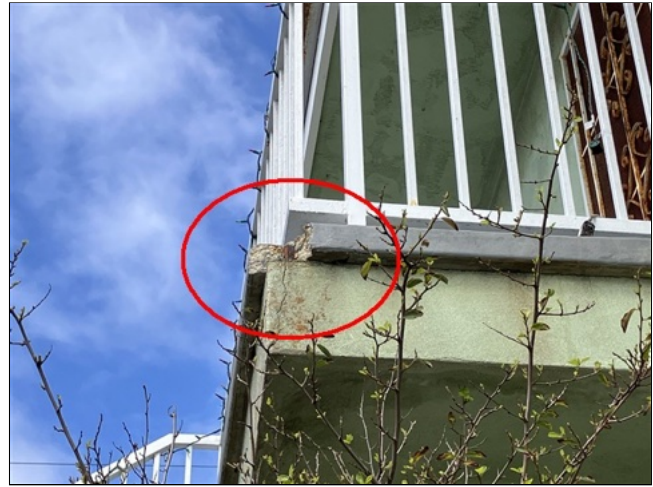
2.3 Item 17(Picture) concrete deck: spalling observed

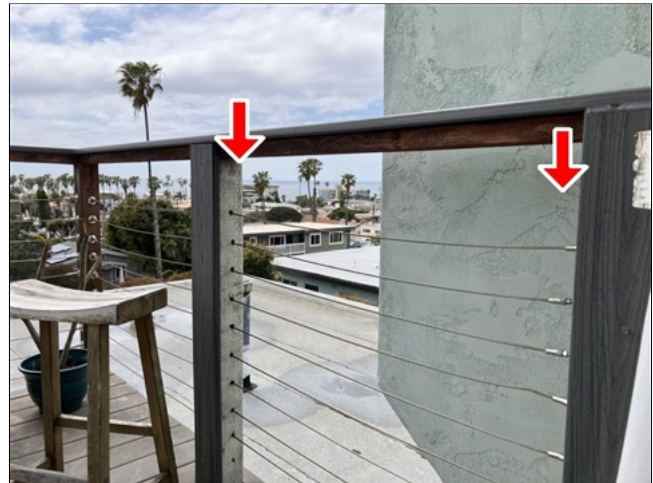
(2) Areas of the stair or guard railing systems were damaged, deteriorated, or had other observable defect. Because a defective or inadequate railing system can create a safety fall hazard, it is recommended to have a qualified contractor evaluate the exterior railing systems and repair/replace as needed.

2.3 Item 19(Picture) unit 4772: missing cable railing / loose cable railings

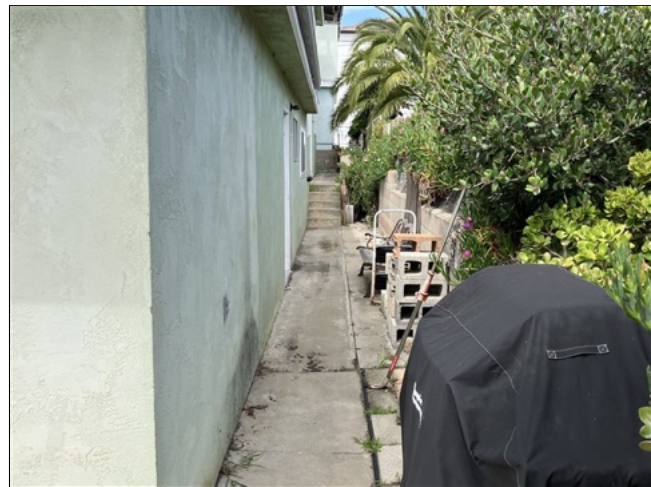
(1) Insufficient slope or potentially poor drainage was observed at areas of the driveway, walkways, or landscaping which can increase moisture related damages and defects to the structure. Drainage or landscaping corrections and improvements are recommended. It is recommended to contact a licensed landscaping contractor for evaluation and correction as needed.

2.4 Item 4(Picture) grading or drainage improvements/ corrections are recommended to achieve positive slope away from the property

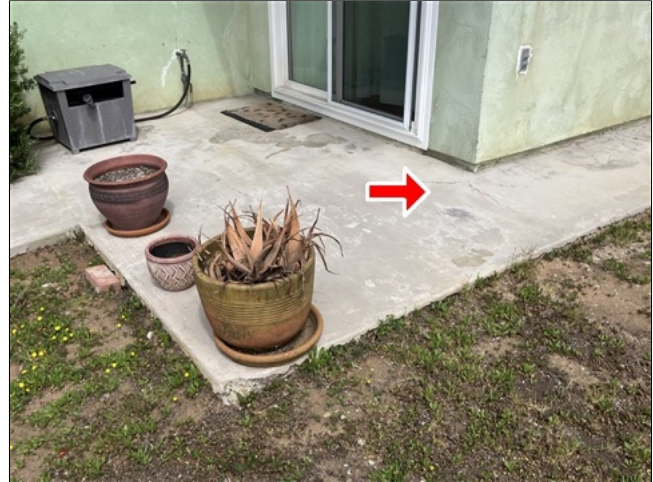
(2) Cracking, damage, or other visible defect was observed at areas of the exterior hardscape (driveway, walkway, stairs, patio, etc.). It is recommended to have these evaluated by a licensed contractor and repaired/replaced as needed.

2.4 Item 6(Picture) cracks visible at concrete patio

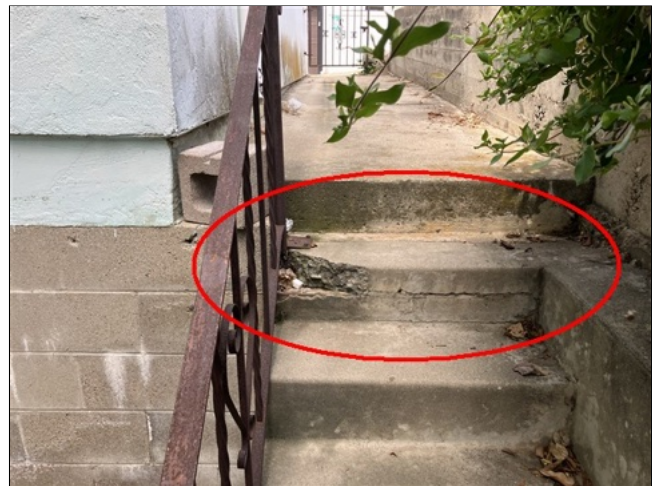
2.4 Item 8(Picture) concrete spalling at stairs observed

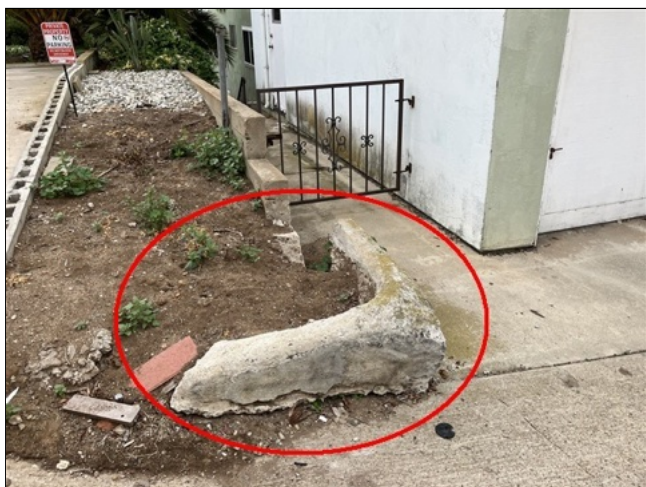
(1) Note: While fences, gates, or dividing walls are not inspected as part of the scope of the inspection, one or more defects were observed at the fence or gate system that should be evaluated by a qualified tradesman and repaired/replaced as needed.

2.6 Item 1(Picture) concrete wall maintenance / repairs / or replacement needed

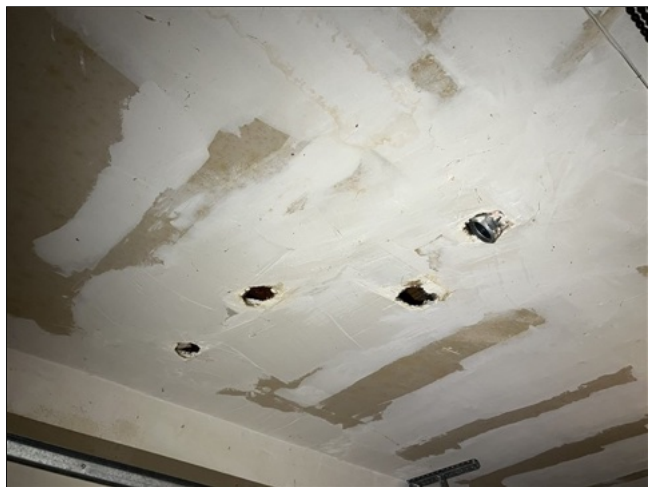
(1) There were holes, damages, or other breaches observed in the garage firewall separation (the wall and/or ceiling that separates the garage from the living areas). All penetrations (damages, holes, attic access, etc.) in the garage firewall should be evaluated and corrected as needed.

3.1 Item 1(Picture) unit 4770 garage ceiling: penetrations observed in garage firewalls

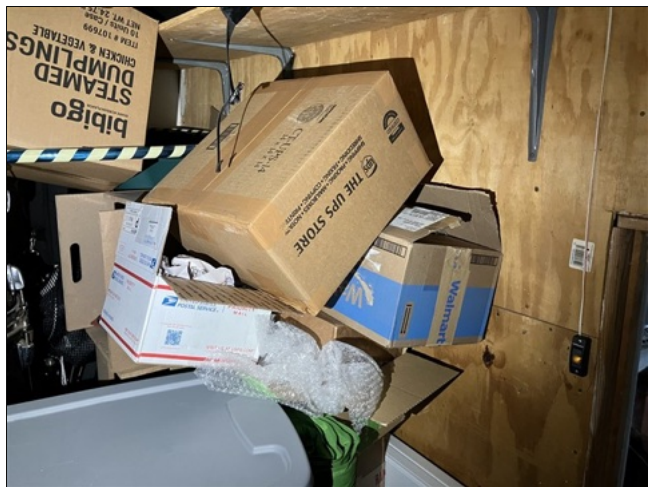
Areas of the garage walls, ceilings, and doors that would be part of modern garage firewall system did not appear to be adequately constructed to current firewall standards. While this may not have been required at the time of construction, walls and ceilings separating the garage from living space are considered a firewall and should be covered with an appropriate material, typically a sheetrock (drywall) of a certain thickness or rating depending upon location. It is recommended to have a licensed contractor evaluate the garage firewall systems and upgrade as needed.

3.1 Item 2(Picture) unit 4770 garage: firewall upgrades recommended

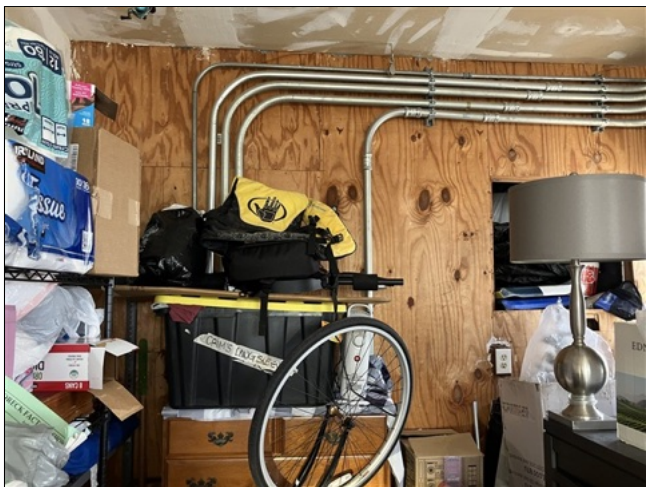
3.1 Item 3(Picture) unit 4772 garage: firewall upgrades recommended

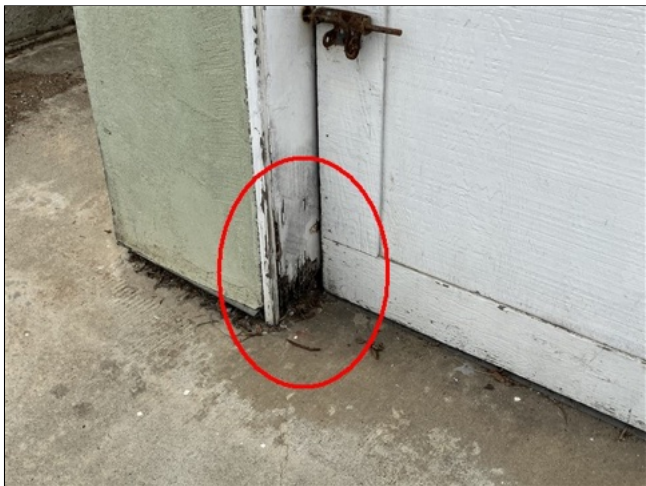
3.4 Item 2(Picture) possible WDO evidence or damage observed at garage door jamb

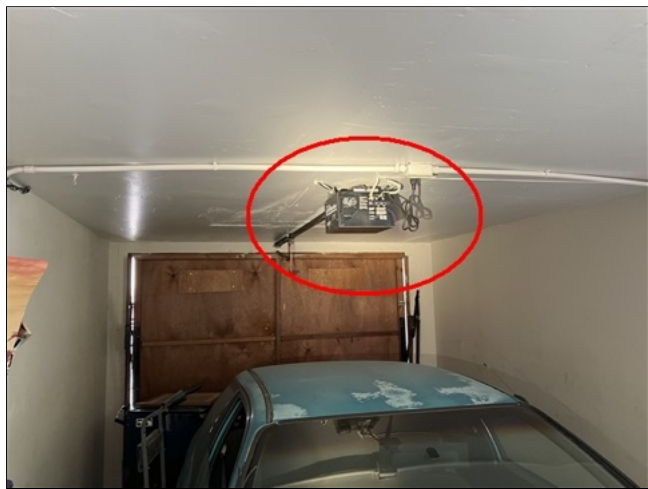
One or more of the garage door opener systems or components did not operate properly when tested or had other visible defect. It is recommended to have the garage door operator evaluated and by a qualified person and repaired/ replaced as needed.

3.5 Item 1(Picture) garage door operator did not operate properly when tested

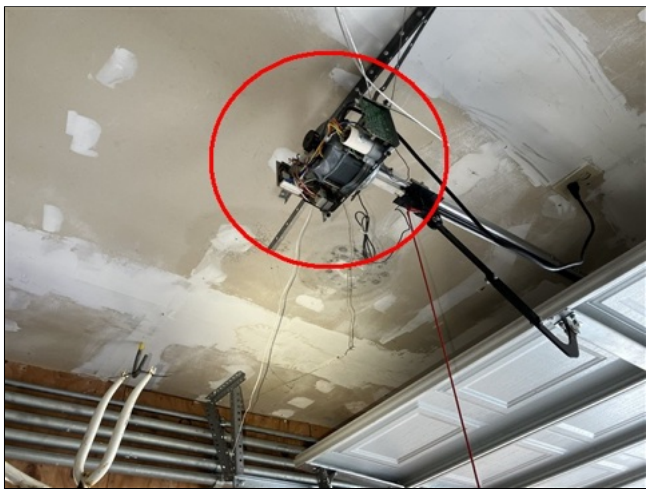
3.5 Item 2(Picture) unit 4772 (alley side): garage door opener cover was missing

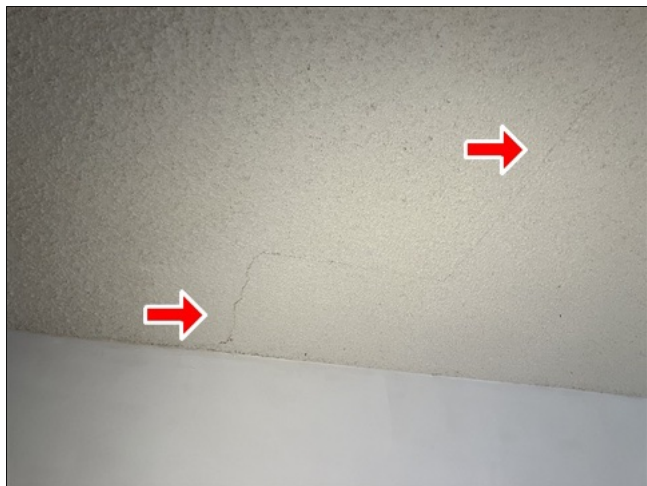
(1) Disclaimer: Cracks in the ceiling and/or walls may be a result from possible settling, movement, or defect that has occurred. This inspection is not meant to be a structural evaluation but an observation of visible physical defects. Only further evaluation and investigation from a qualified person can determine if non-visible defects are present and corrections as needed.

4.0 Item 1(Picture) unit 4768: cracks in ceiling observed

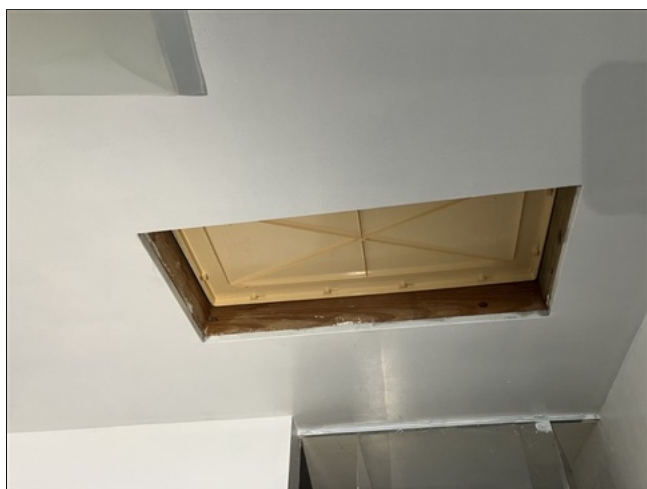
(2) Damages, missing drywall, or other defects to the walls or ceilings were observed. It is recommended to have these walls and ceilings evaluated by a qualified tradesman and repaired/replaced as needed.

4.0 Item 2(Picture) unit 4770 bathroom: unfinished ceiling / possible abandoned skylight

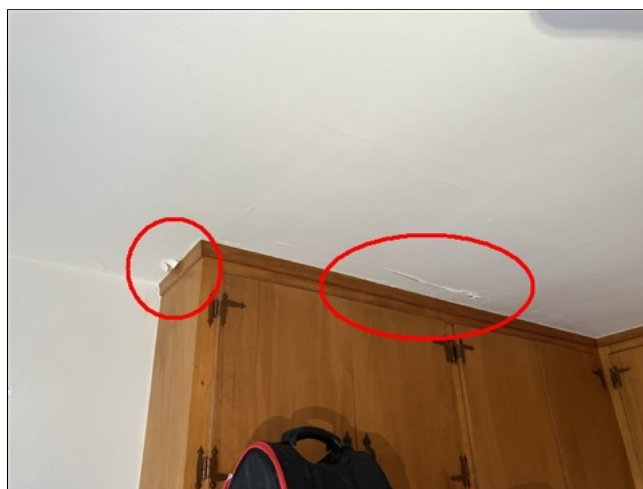
4.0 Item 3(Picture) unit 4772: ceiling paint defects observed

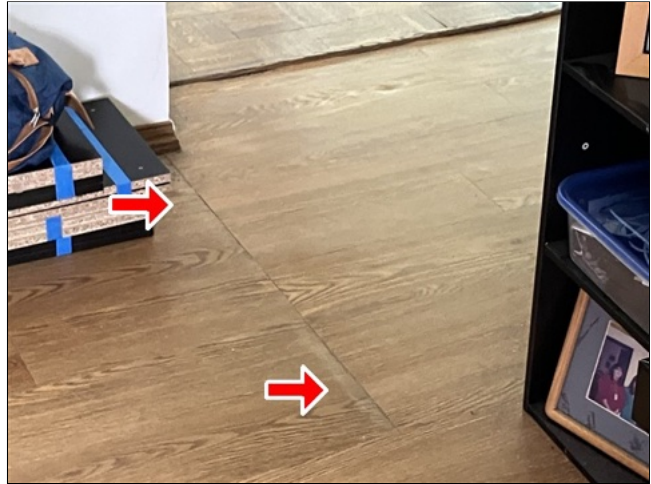
4.1 Item 2(Picture) unit 4768: possible evidence of repairs observed / recommend further evaluation of repair

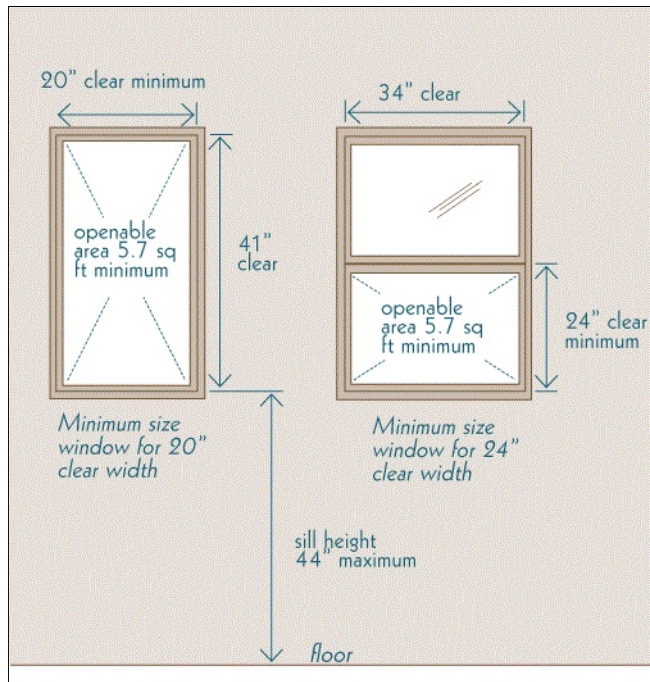
4.5 Item 1(Picture)

When the second exit in a bedroom is a window, specific size requirements have been established for egress. A window sill height may not exceed 44 inches from the floor and the openable portion of the window must exceed 5.7 sq/ft (5.0 sq/ft if on the ground level) and comply with height/width distance minimums. While these requirements may not have been required at the time of construction, as a safety upgrade, it is recommended to have this evaluated by a licensed contractor and upgrade as needed.

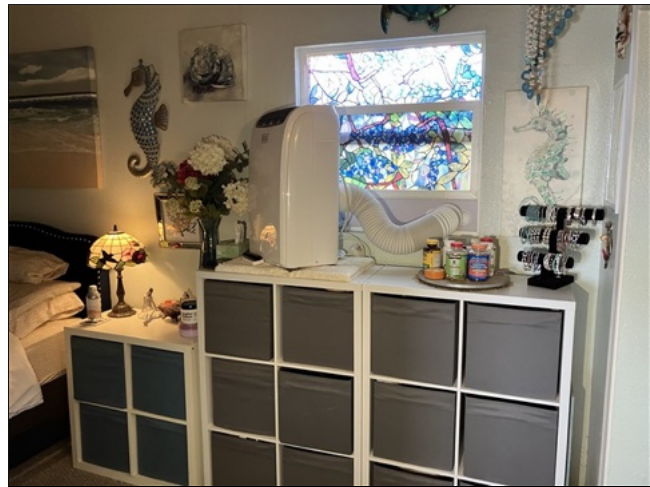
4.5 Item 3(Picture) unit 4772 (alley side): bedroom window egress upgrades recommended

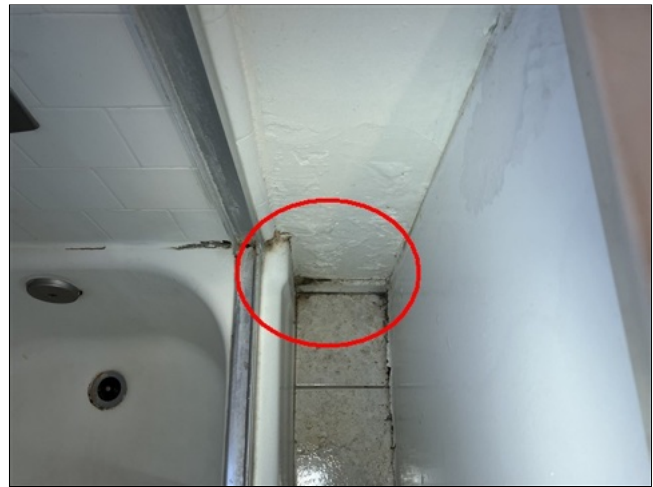
4.6 Item 3(Picture) unit 4772: moisture stains or damage visible

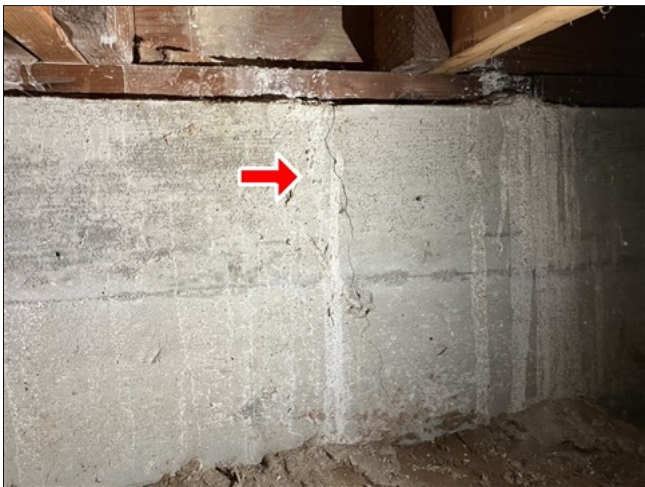
5.0 Item 1(Picture) crack visible at foundation stem wall

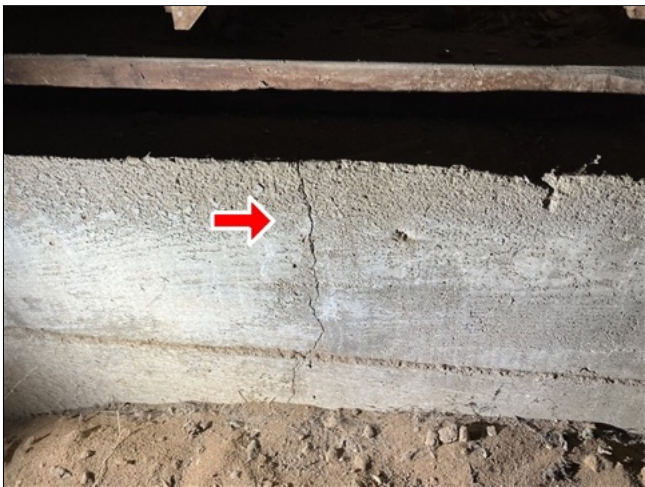
5.0 Item 2(Picture) crack visible at foundation stem wall

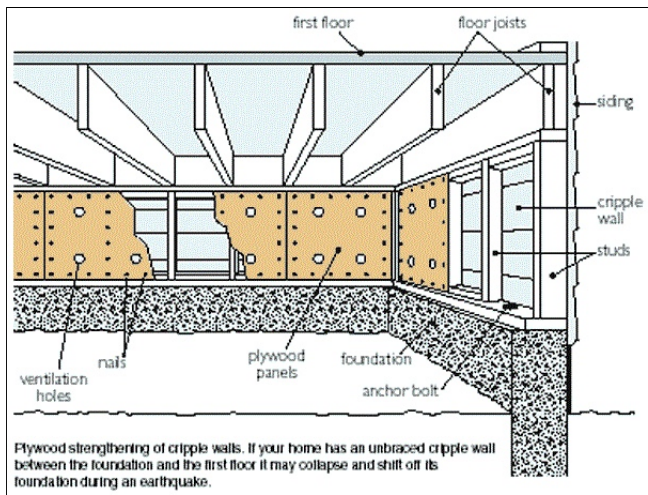
5.3 Item 1(Picture)

resulting from seismic activity. It is recommended to have this evaluated by a licensed contractor and upgraded as needed.

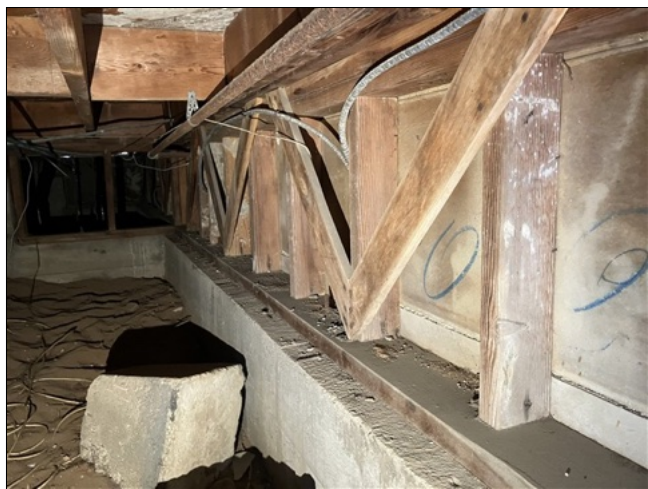
5.3 Item 2(Picture) cripple wall bracing upgrades recommended

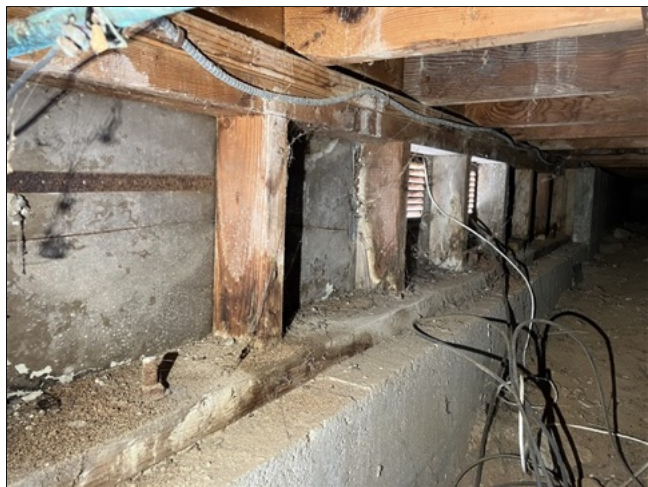
5.3 Item 3(Picture) cripple wall bracing upgrades recommended

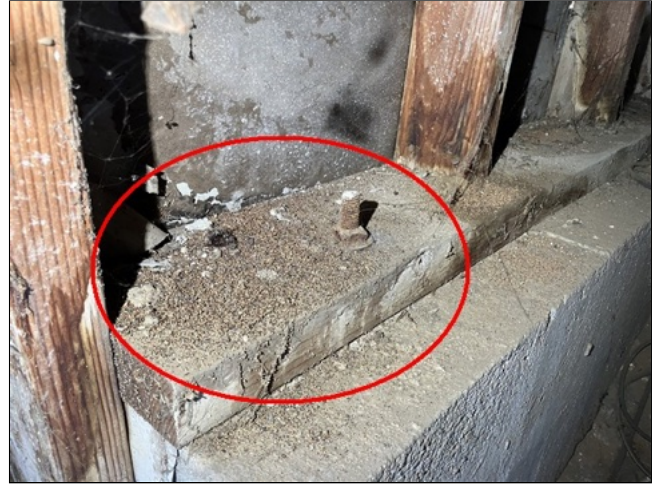
5.3 Item 5(Picture) subfloor area: possible WDO evidence or damage observed

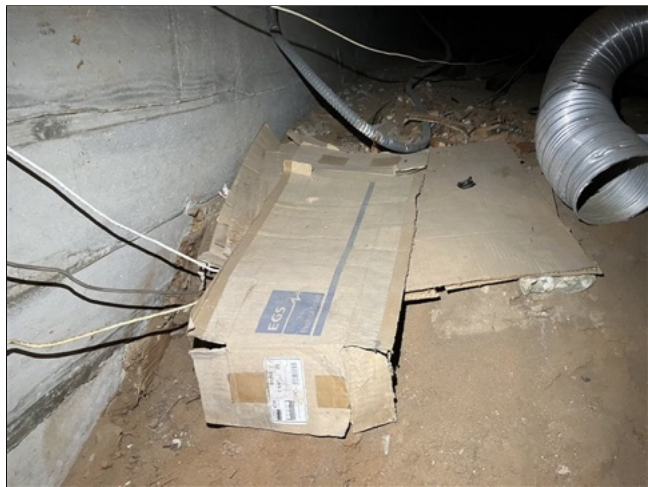
(3) There was debris (wood, cardboard, abandoned materials, etc.) observed in the attic or subfloor area. It is recommended to have all debris removed.

5.7 Item 4(Picture) subfloor area: debris removal needed

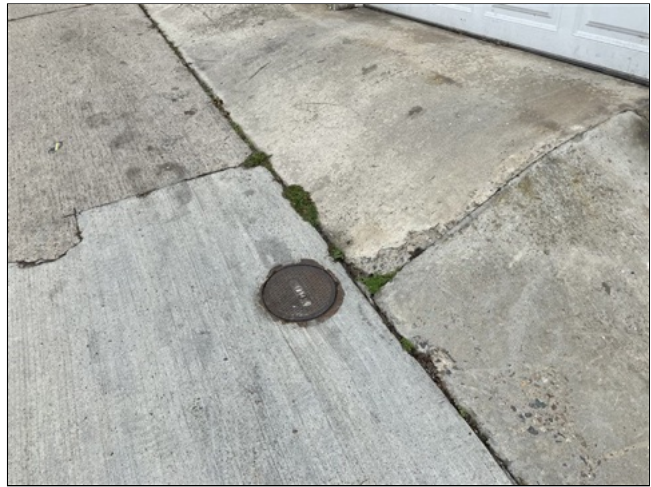
6.3 Item 2(Picture) sewer camera inspection recommended

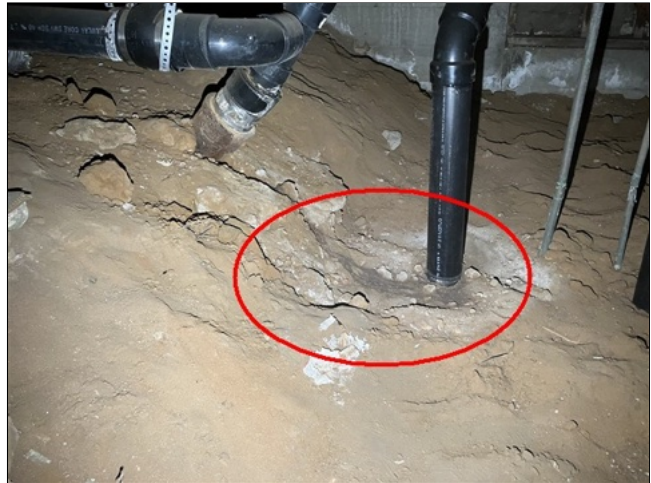
6.3 Item 4(Picture) evidence of past leakage observed / no visible leaking observed / recommend sewer camera inspection

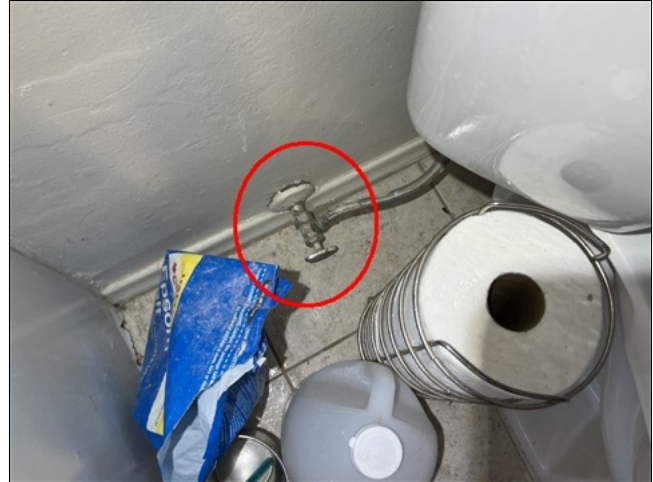
6.4 Item 2(Picture) unit 4772: aged water supply valves/hoses observed

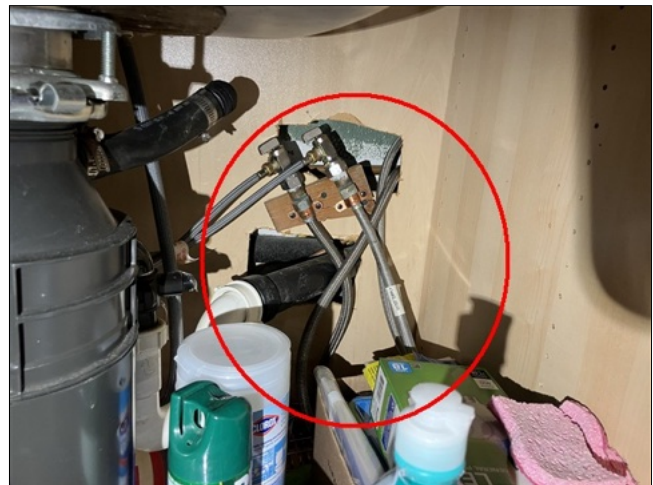
6.4 Item 4(Picture) unit 4772 (alley side): double-hoses observed

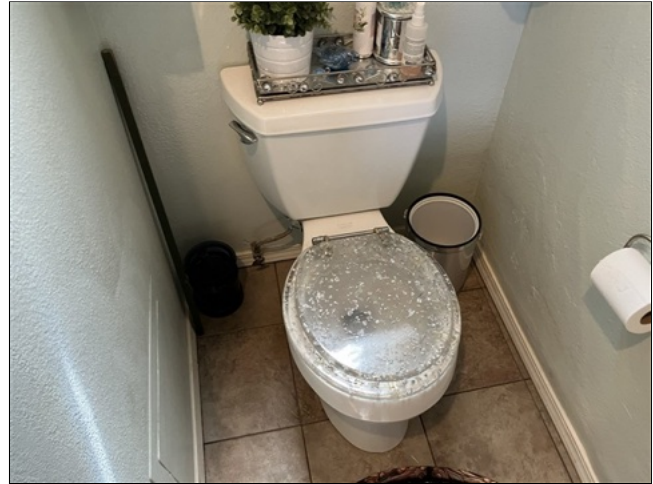
6.5 Item 2(Picture) unit 4772 (alley side): loose toilet

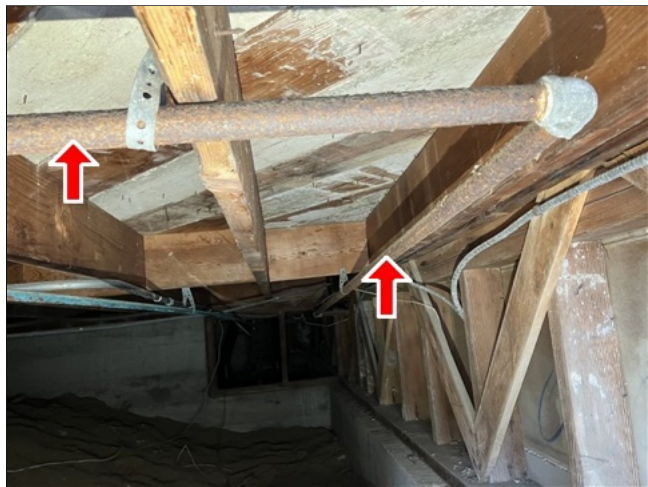
The gas distribution piping appeared aged and may be near to exceeding its expected serviceable life. It is recommended to contact a licensed plumber to determine remaining life expectancy and replacement as needed.

6.6 Item 1(Picture) subfloor area: oxidation visible at gas supply

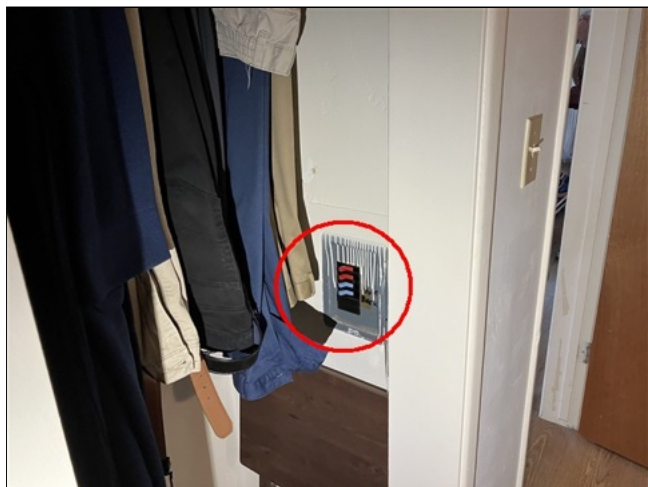
The location of one or more of the electrical distribution panels did not comply with modern panel location standards. Panels are no longer permitted to be installed in bathrooms and clothes closets. Height limitations and other location restrictions have also been modified over the years to improve safety and accessibility. Because these changes may not have been required at the time of construction, it is recommended to have a licensed electrician evaluate and upgrade as needed.

7.2 Item 1(Picture) unit 4768: electrical panel location upgrade recommended

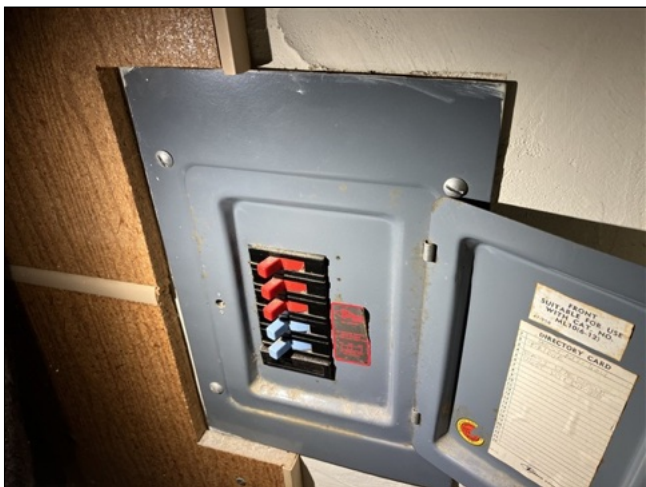
7.2 Item 2(Picture) unit 4770: electrical panel location upgrade recommended

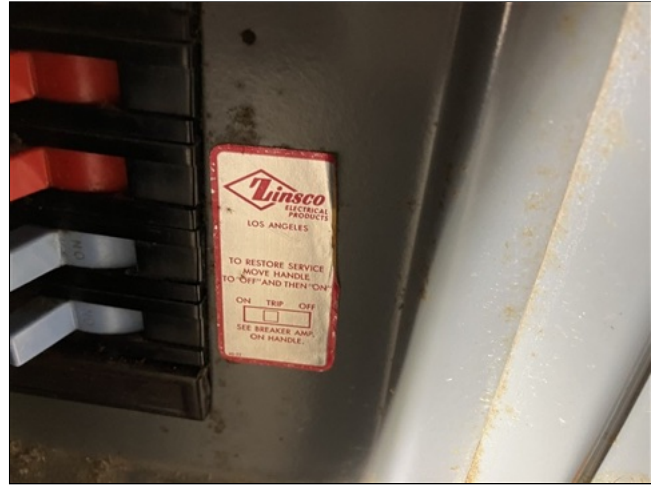
7.3 Item 2(Picture) unit 4770: a Zinsco panel performance and safety inspection by a qualified person is recommended

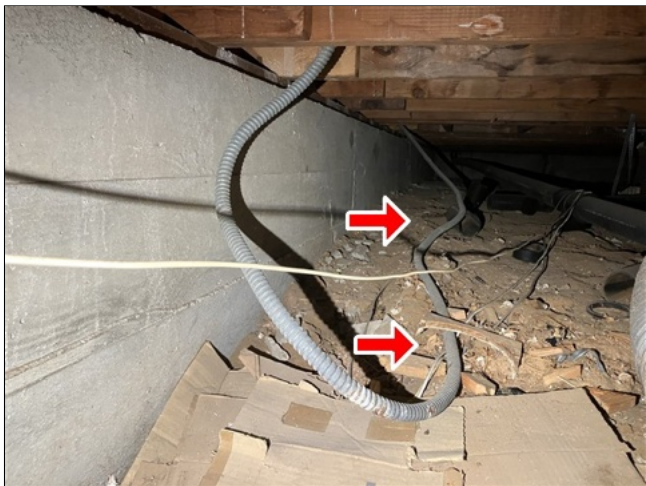
7.4 Item 2(Picture) subfloor area: conduit should be secured to the framing and off of the ground

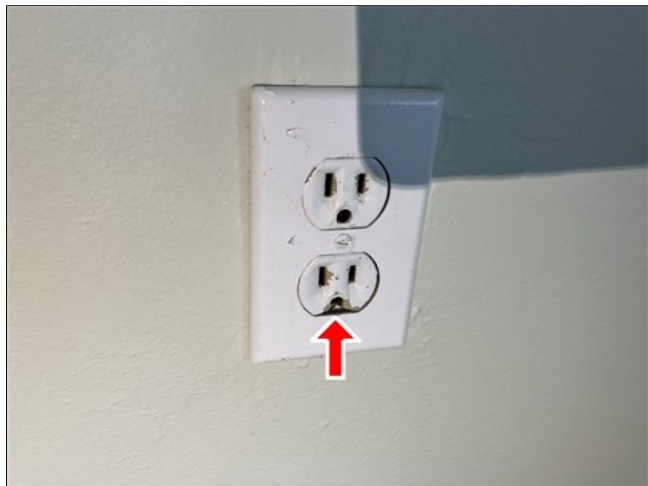
Defects were observed at one or more of the outlets, switches, or fixtures. All electrical system and component defects should be considered safety hazards. It is recommended to have a licensed electrician evaluate all outlets, switches, and fixtures and repair/replace as needed.

7.5 Item 1(Picture) unit 4768: damage outlet observed

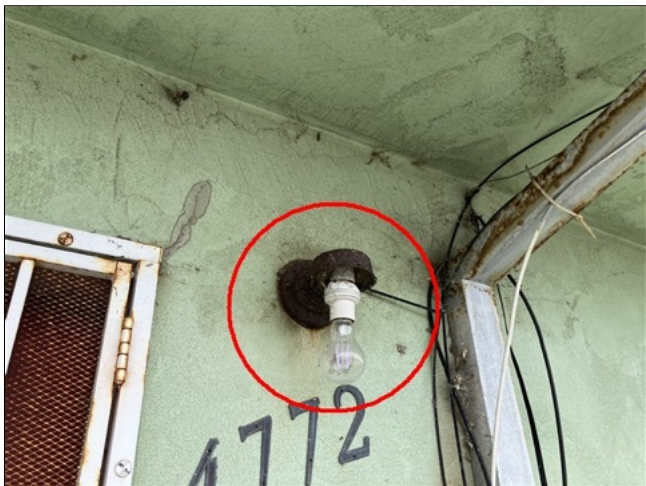
7.5 Item 2(Picture) unit 4772: aged fixture / missing cover

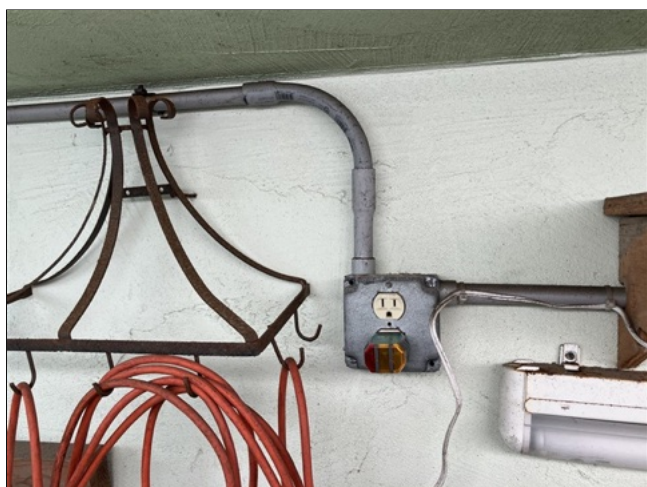
7.5 Item 5(Picture) second floor unit exterior patio: no power observed at outlet

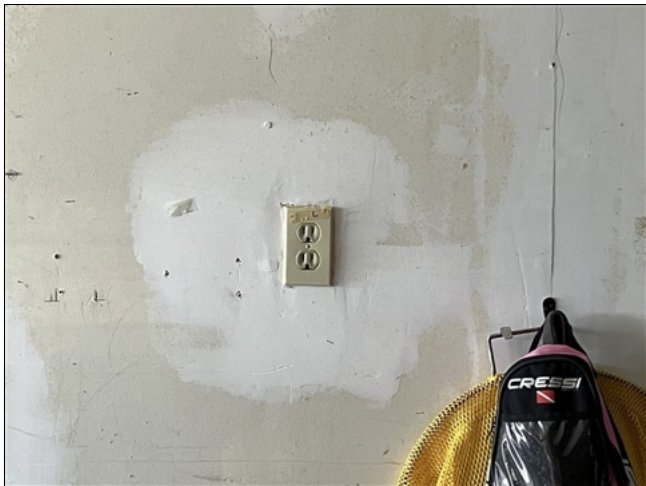
7.6 Item 2(Picture) unit 4770 garage: recommend evaluation and upgrade of any non-GFCI outlets

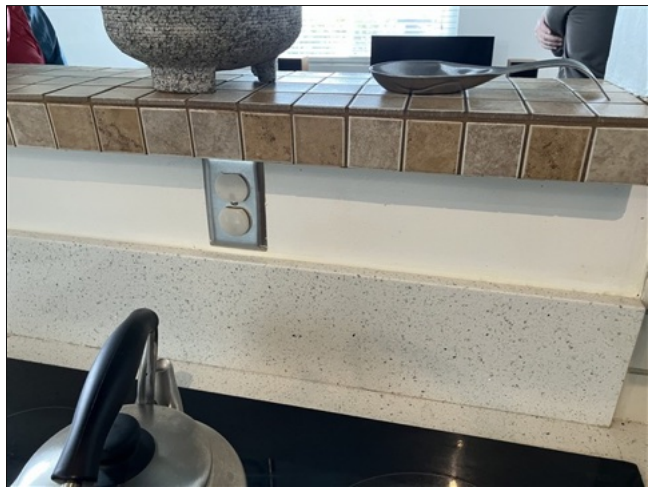
7.6 Item 3(Picture) unit 4770: recommend evaluation and upgrade of any non-GFCI outlets

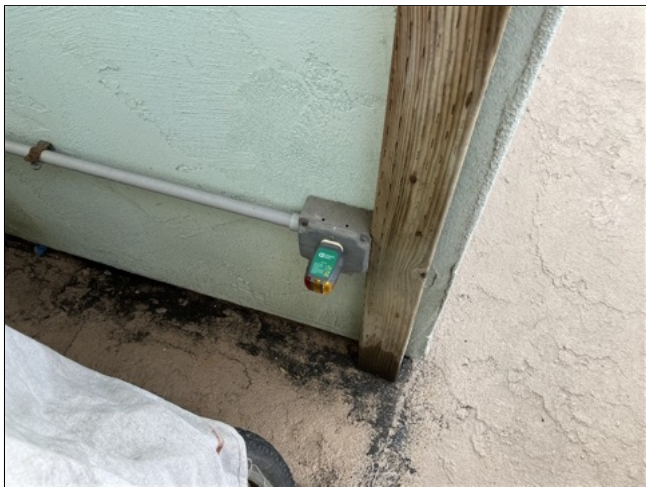
7.6 Item 4(Picture) exterior patio: recommend evaluation and upgrade of any non-GFCI outlets
