# Inspection Report

**Property Address:**  
4768-72 Coronado Ave  
San Diego CA 92107

**Foresight Building Inspection**

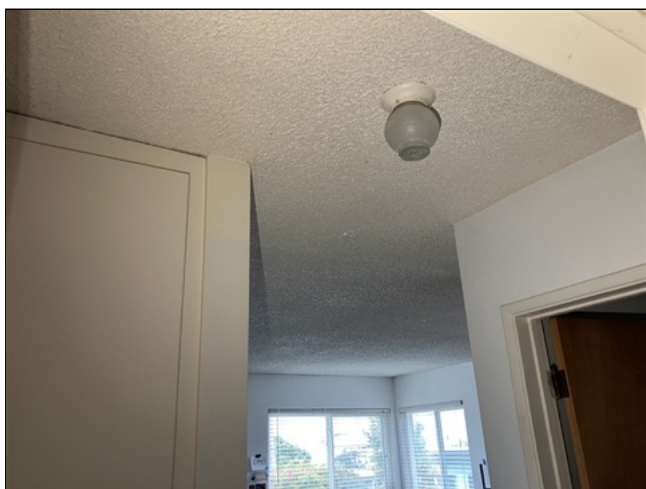
7.7 Item 1(Picture) unit 4768 hallway: missing smoke and CO detector

If there is no visible installation date or the age cannot be verified, it is recommended to install a new detector with a visible date to facilitate future replacement. It is recommended to test detectors according to the manufacturers specifications. Consult with the local fire department for tips and other useful information on smoke alarm installation and maintenance.

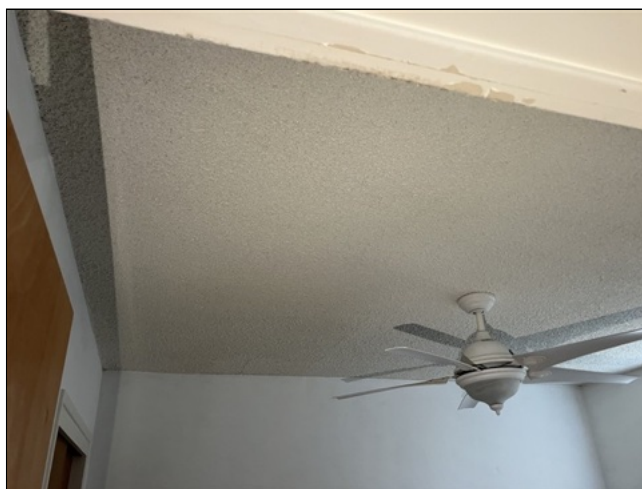
7.7 Item 2(Picture) unit 4768 bedrooms: missing smoke detectors

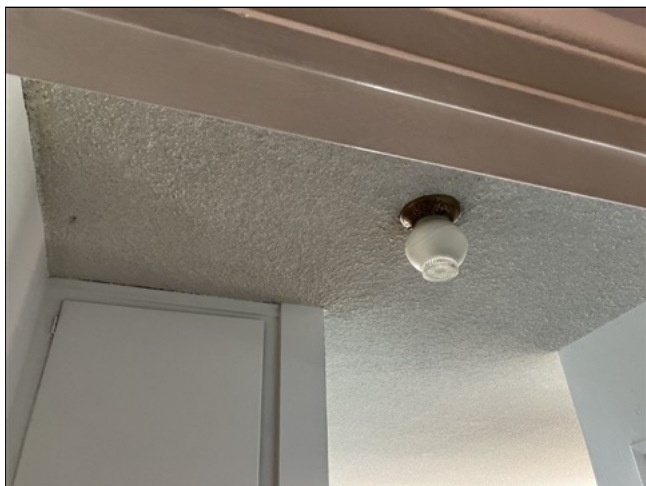
7.7 Item 3(Picture) unit 4768 hallway: missing smoke and CO detector

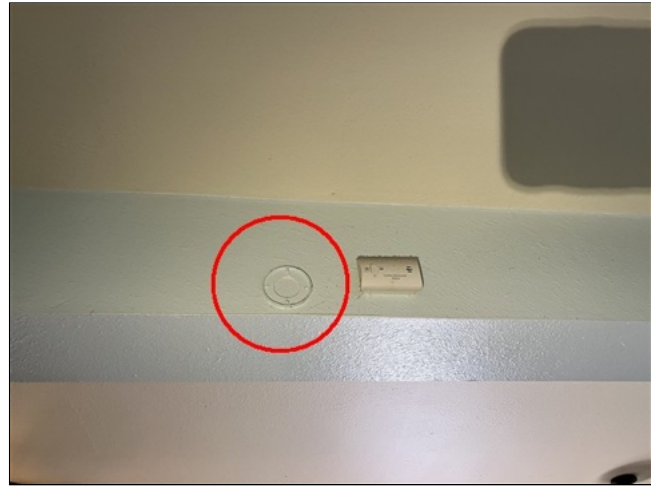
7.7 Item 6(Picture) unit 4772 (alley side): missing hallway smoke detector

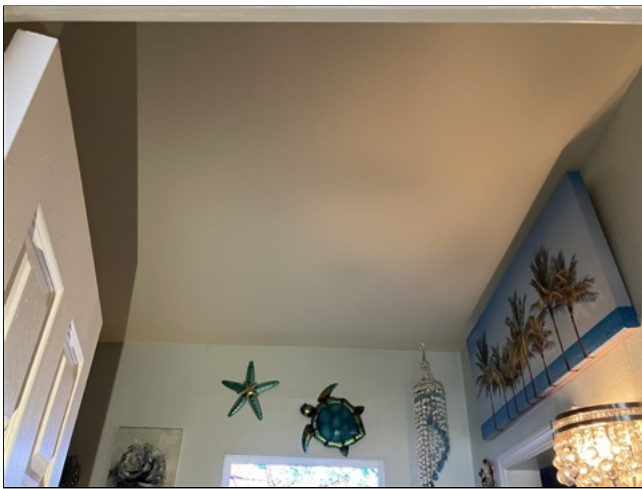
7.7 Item 7(Picture) unit 4772 (alley side): missing bedroom smoke detector

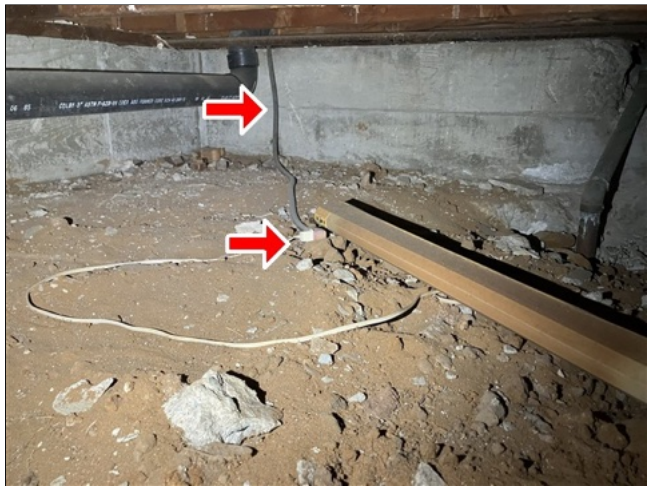
(2) There was an unidentifiable system or component observed. It is recommended to have this evaluated by a licensed electrician or other appropriate tradesman for identification and inspection.

7.8 Item 4(Picture) subfloor area: unidentified extension cord observed / recommend further evaluation

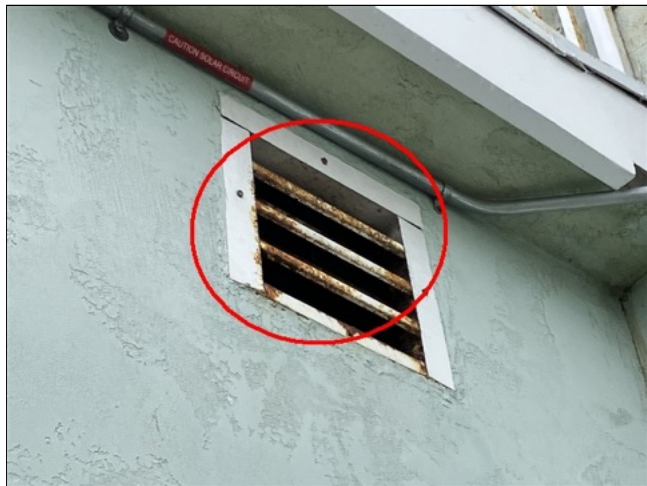
**Comments:** Repair or Replace  
(1) One or more of the crawlspace, attic, or garage vent screens were missing, deteriorated, or had other observable defect. Vent screens help control pest intrusion. It is recommended to have all damaged or missing vents evaluated and repaired/replaced as needed.

9.2 Item 1(Picture) deterioration/oxidation visible at vent screens

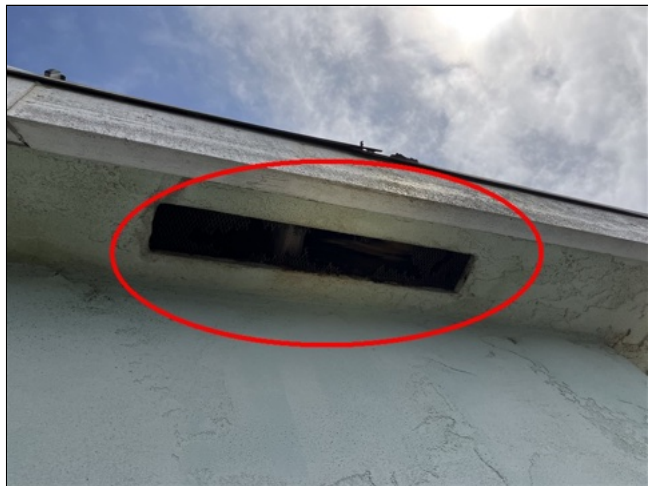
9.2 Item 2(Picture) deterioration/oxidation visible at vent screens

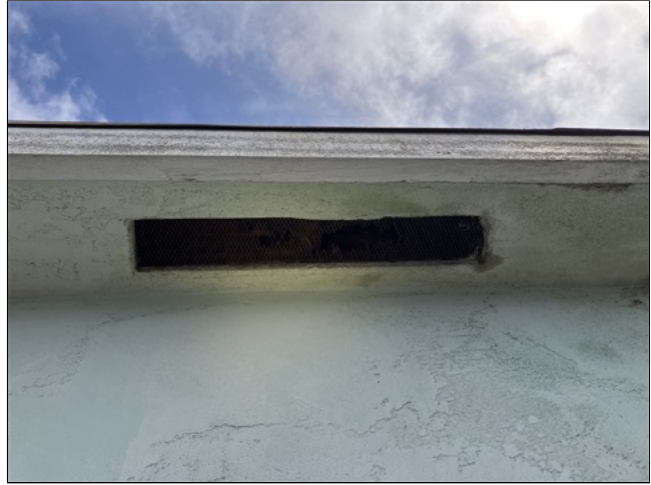
9.2 Item 4(Picture) deterioration/oxidation visible at vent screens

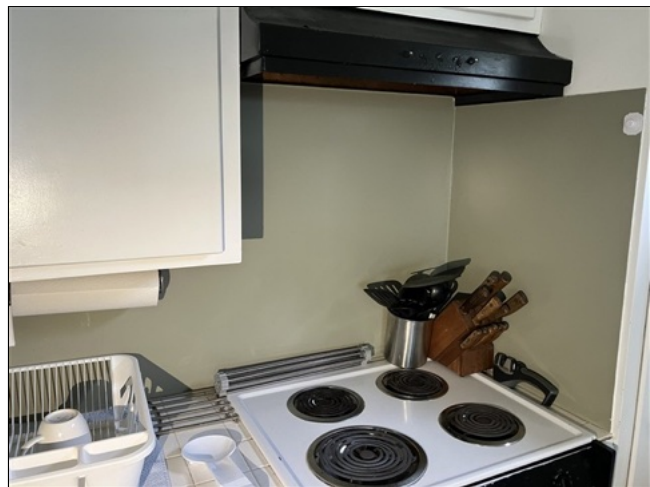
(2) A non-combustible material is needed behind and on the sides of the range oven or stove-top. This can be stainless steel, tile, stone, or other suitable non-combustible material. It is recommended to have this evaluated and corrected as needed.

10.1 Item 2(Picture) unit 4768: non-combustible backsplash needed
