**Orange Coast Property Services****South Coast Property Services****(949) 454-7900 -- (760) 585-2355**

| Doc #: | 202505-12064 | Inspector: | Christiano Goulart |
| Date: | 5/27/2025 | | |
| Address: | 24848 Starlight Mountain Rd<br>Ramona CA 92065 | | |

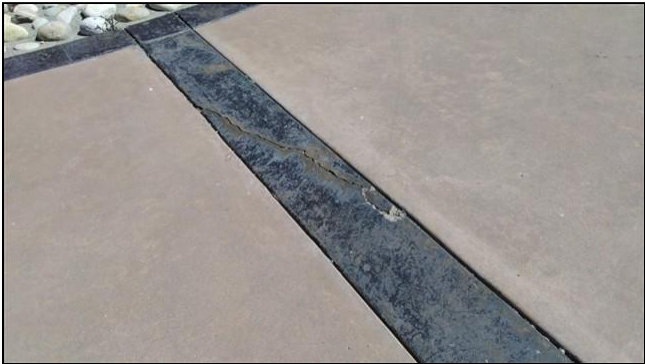
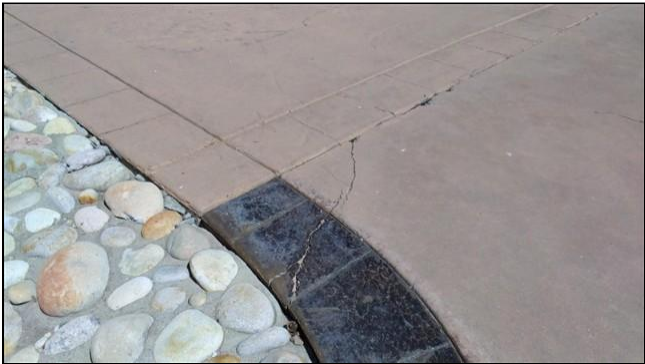
| Step # | Component | Comment |
|---|---|---|
| 1.0 | Driveway | <b>Condition:. Chipped concrete noted.</b> |

**Expansive and common cracks noted.**

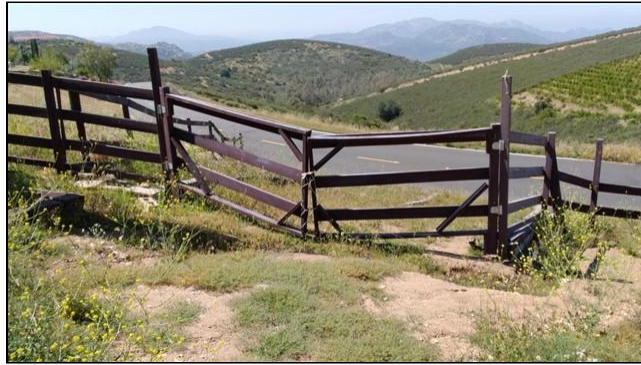
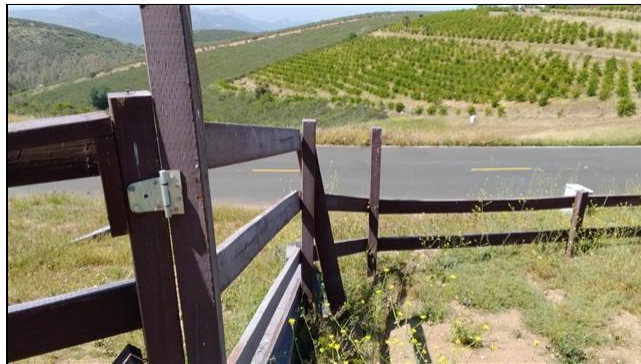
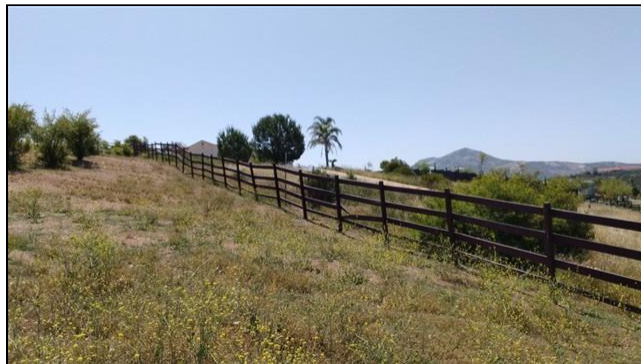
**Condition:. Right side gate is damaged.****Damaged wood sections noted.**

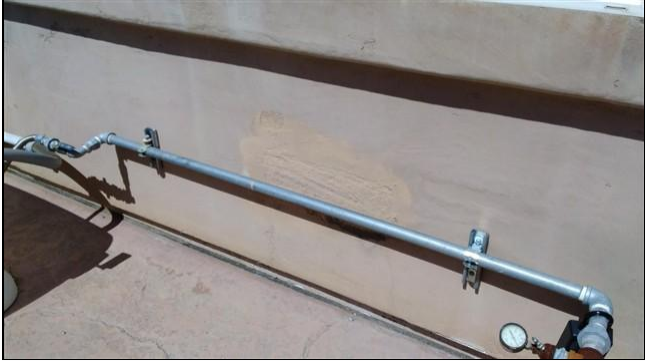
- 1.3 Siding **Condition:.. Common cracks noted.**
- Evidence of patching noted, unable to determine the effectiveness of this repair.**
- Holes noted.**

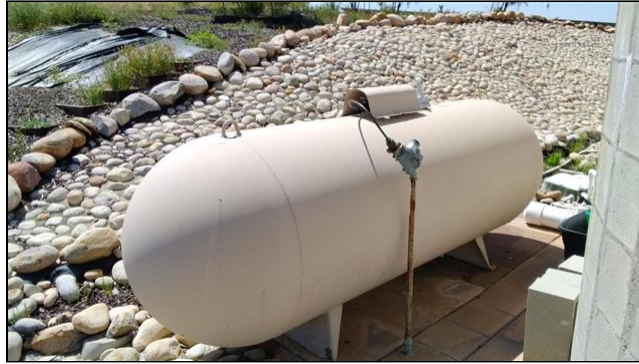
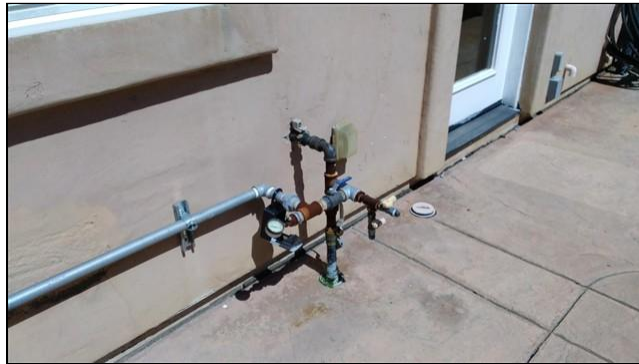
- 1.12 Gas Meter **Condition:.. House is on a propane tank, tank was not inspected as it is beyond the scope of this inspection.**

**Shut-off valve is located right side.**

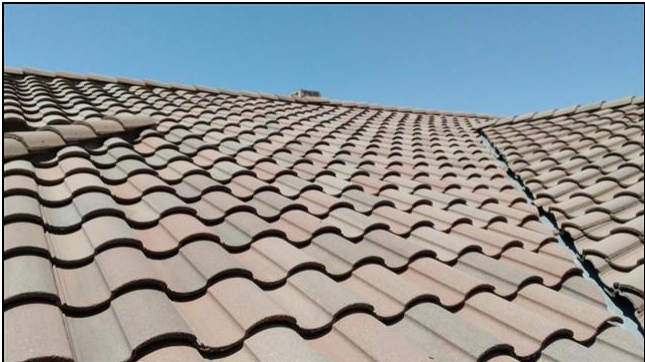
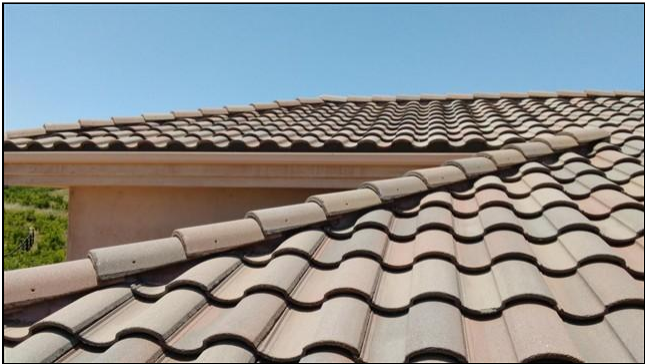
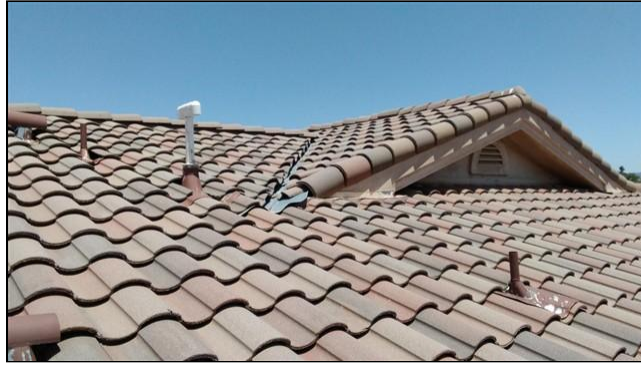
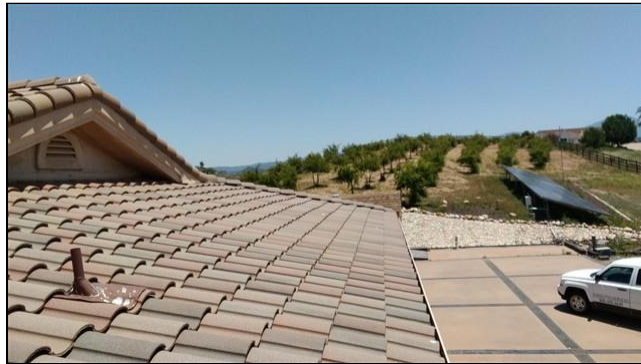
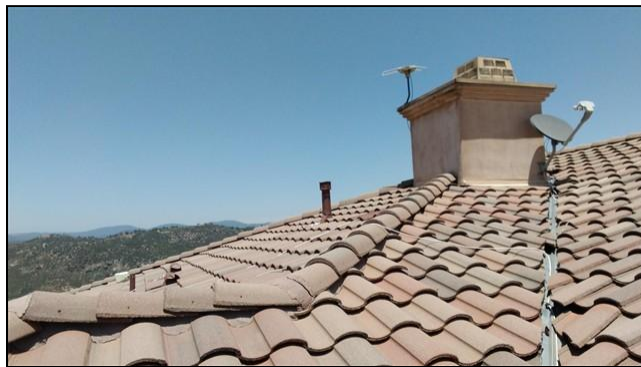
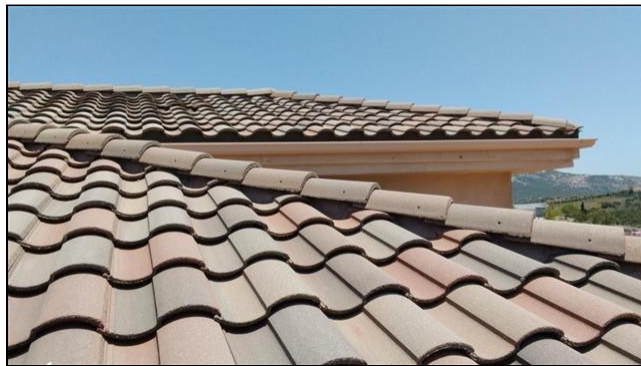
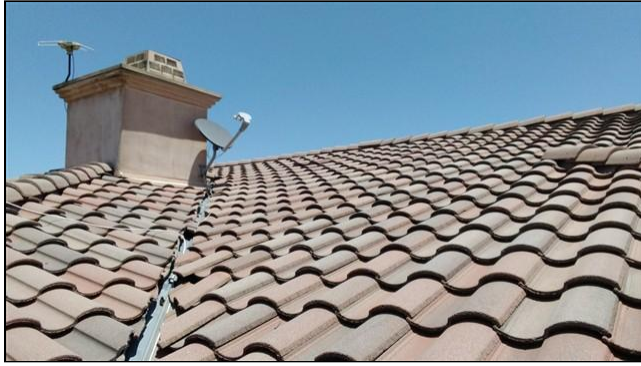
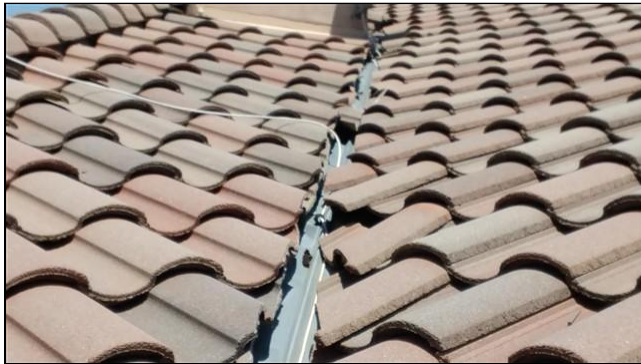
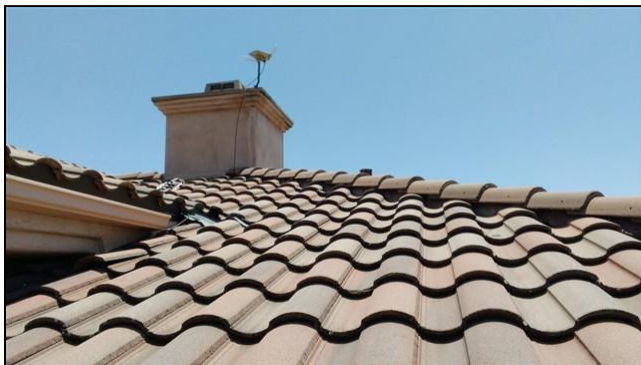
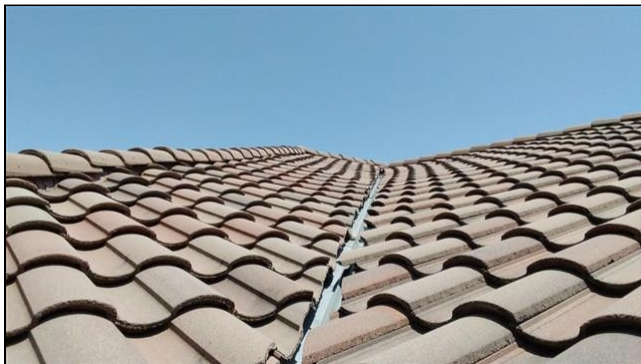
| Step # | Component | Comment |
|---|---|---|
| 2.1 | Condition | <p><b>Condition. Roof shows normal wear for its age and type. Displaced/slipped tiles noted. We suggest that the maintenance efforts be made in the few areas where roofing materials are damaged or missing. Suggest consulting a licensed roofer for further review.</b></p> <p><b>Roof was visually inspected from accessible points on the interior and/or exterior. If a roof is too high, is too steep, is wet, is part of an association or is composed of materials which can be damaged if walked upon, the roof is not mounted by inspector. Therefore, client is advised that this is a limited review.</b></p> |

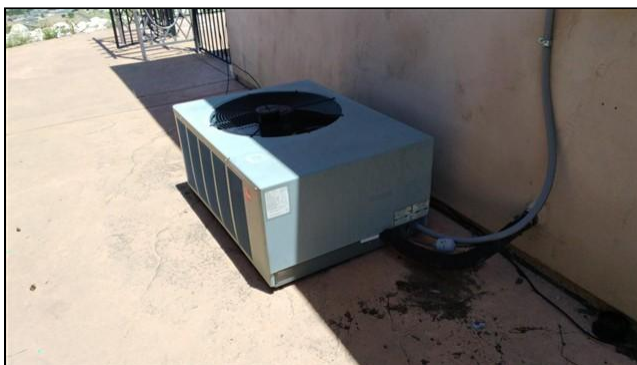
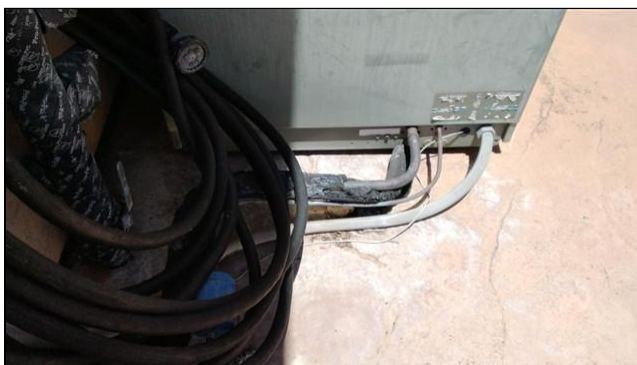
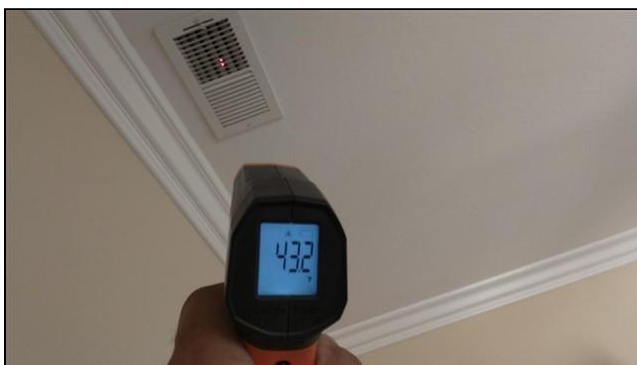
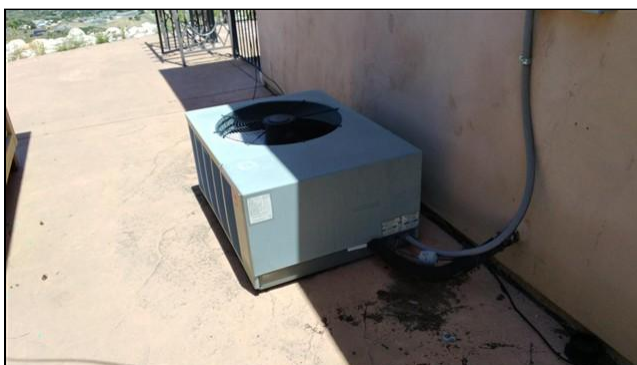
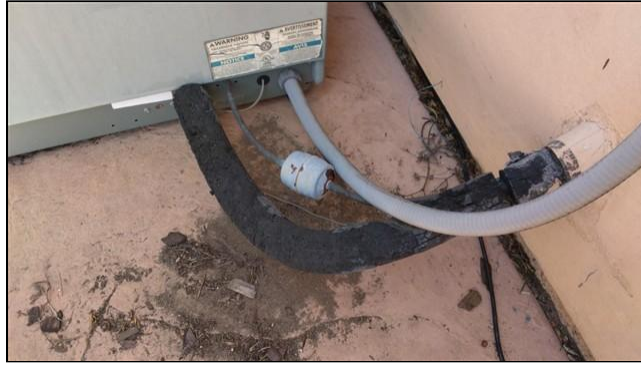
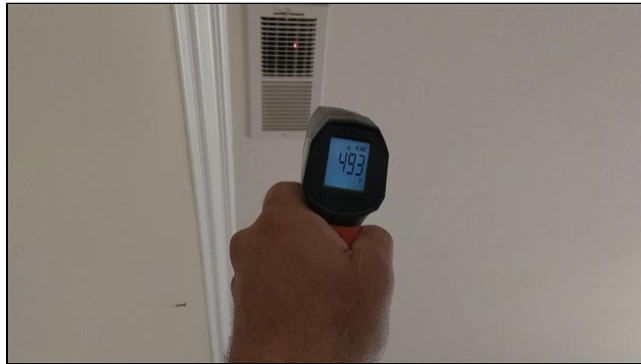
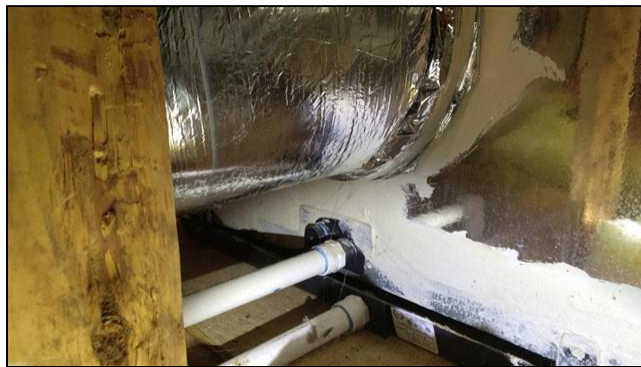
**Condition: Compressor is not sitting on a proper pad.****Deteriorated insulation noted on the refrigerant line at the compressor.****No secondary condensation drain line noted, suggest further review with a licensed HVAC contractor.**

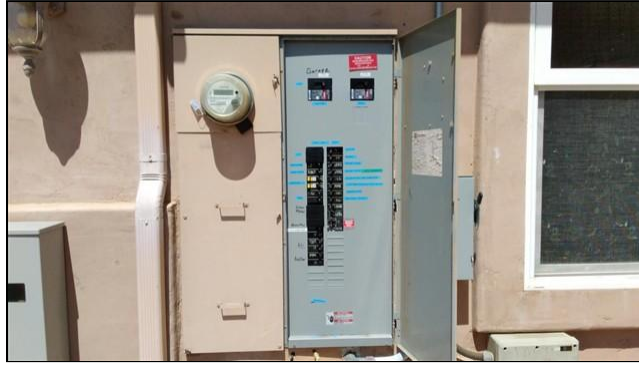
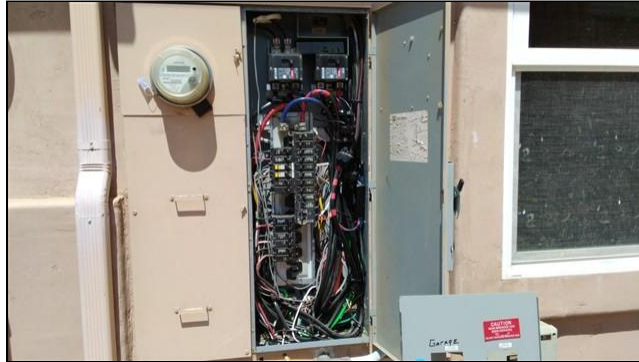
**Condition:.** Buzzing breaker noted at the main panel as a safety hazard, suggest further review with a licensed electrician.

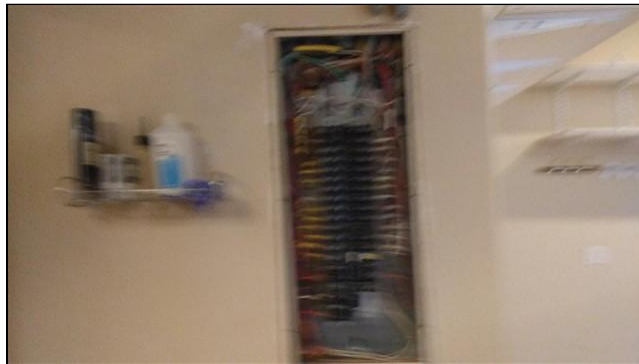
**Condition:.** Tripped breaker noted at the sub panel, suggest further review with a licensed electrician.

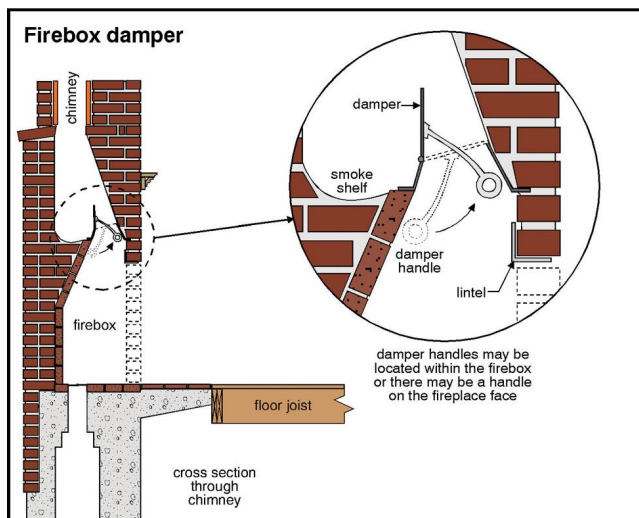
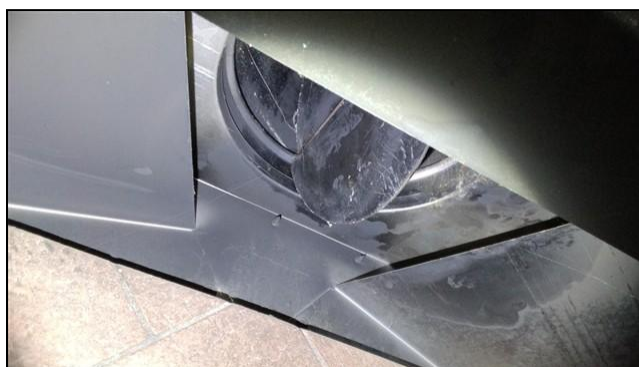
**Condition:.** Gas logs noted in the fireplace and damper is not permanently blocked in the open position. This is a possible safety hazard if gas logs are used. Moveable dampers in gas log fireplaces are hazardous due to the gases emitted after the gas is turned off. The logs can emit gas long after the fire is turned off.

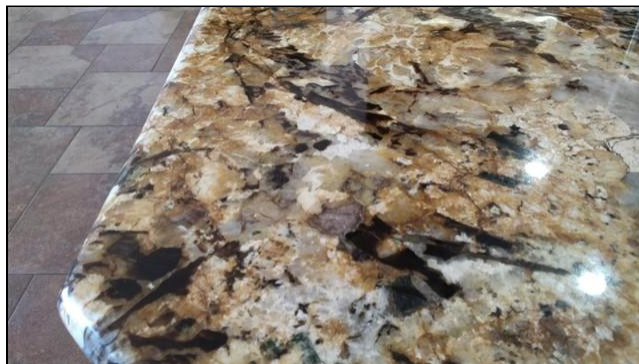
| Step # | Component | Comment |
|---|---|---|
| 13.7 | Countertops | Condition:. Chipped granite observed. |

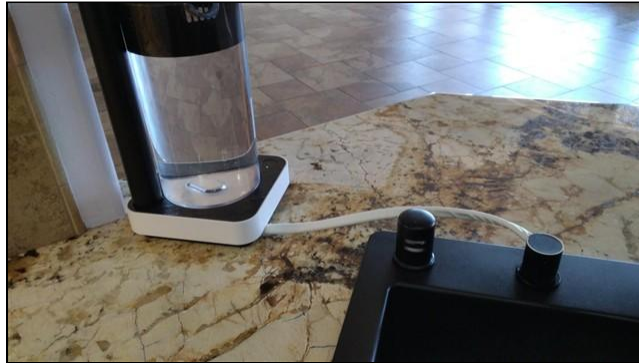
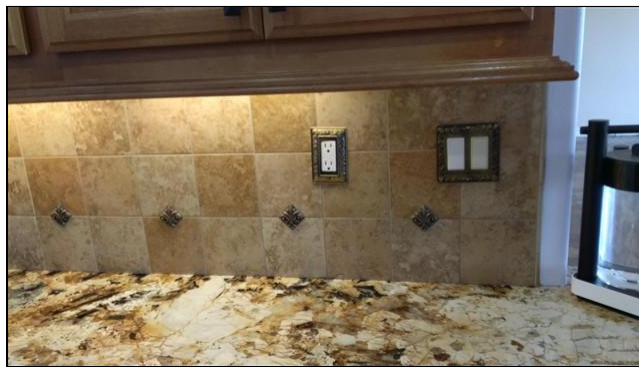
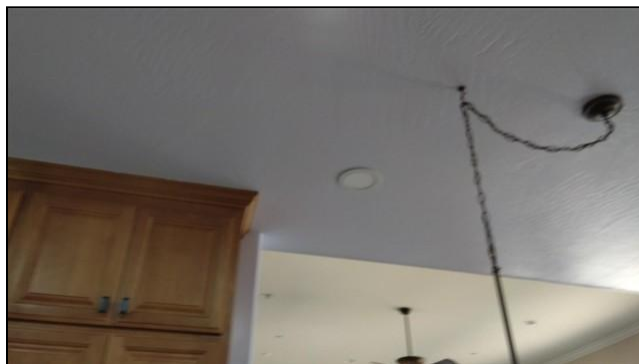
**Condition:.** Exposed romex wiring noted. This may be a safety concern if used where it could be subject to physical damage. Suggest consulting a licensed electrician for further review.

Some outlets are not GFCI protected, noted as a possible safety hazard, suggest further review with a licensed electrician.

One inoperable light noted.

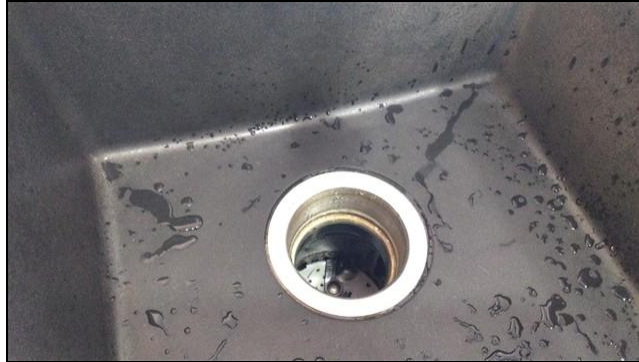
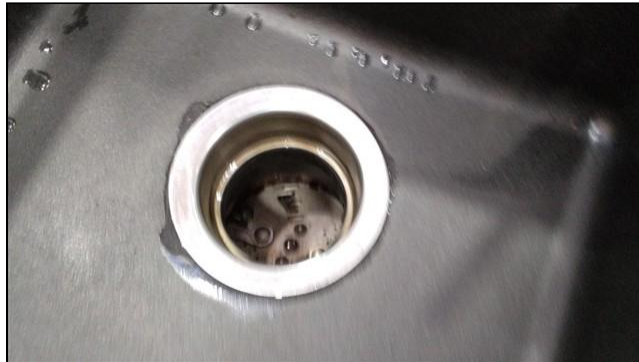
**Two units noted.**

**Drain guards are not present.**

**Units are inoperable, suggest further review with a licensed plumber.**

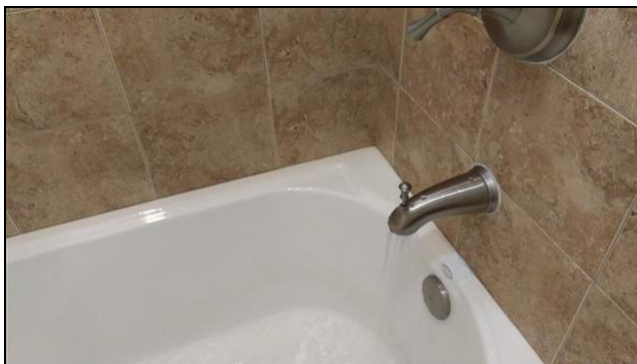
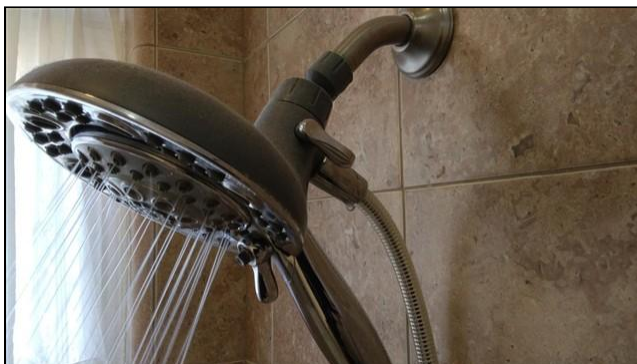
**Condition: Showerhead leaks when in use.****Diverter valve allows water through the tub spout and showerhead at the same time.****Drain slowly.**

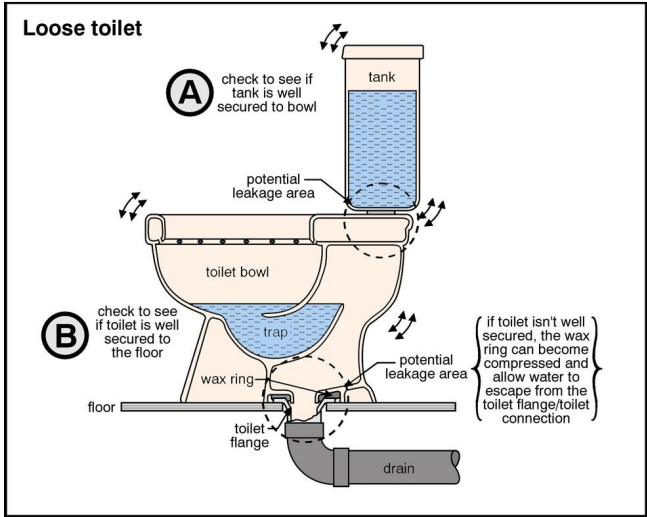
TOILET ANCHOR BOLTS

**Condition:.** The toilet bowl is loose at floor anchor bolts. The wax ring inside the unit must have a snug, secure fit in order to keep from leaking. We suggest properly resealing and re-securing the unit to prevent water leakage and damage.

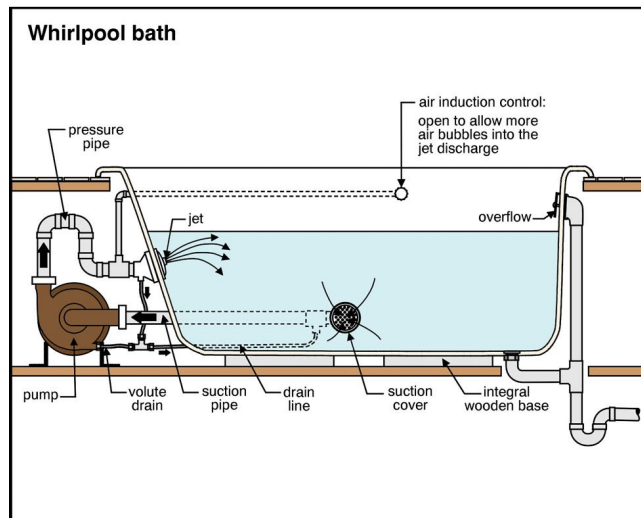
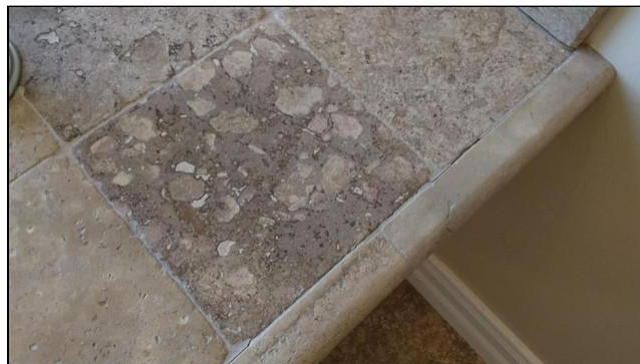
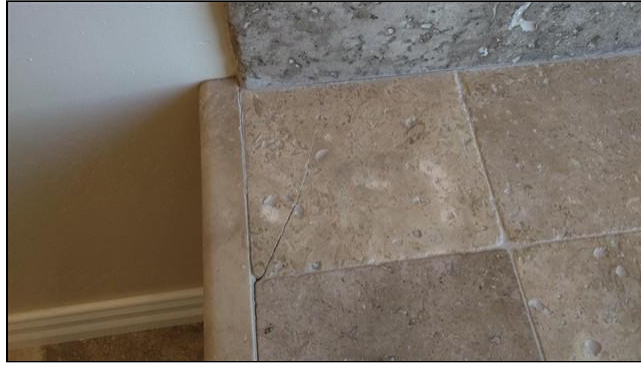
**HYDRO-TUB**

| 15.9.B | Tub | <b>Condition:.. Cracked grout noted at the joints.</b> |

**Cracked tile noted.**

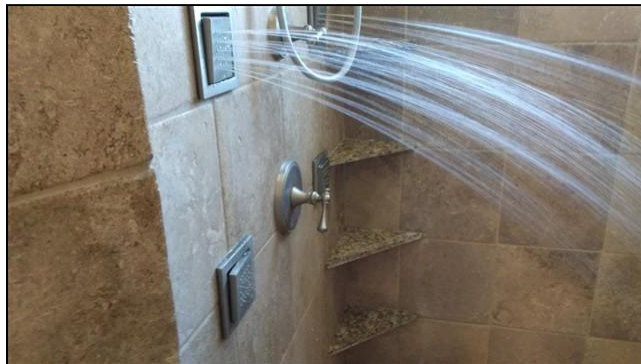
15.14.B Shower Faucet **Condition:. Sprayer is inoperable.**

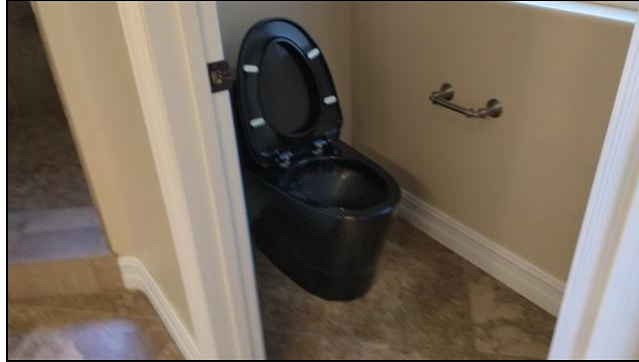
**Condition:.** The toilet bowl is loose at floor anchor bolts. The wax ring inside the unit must have a snug, secure fit in order to keep from leaking. We suggest properly resealing and re-securing the unit to prevent water leakage and damage.

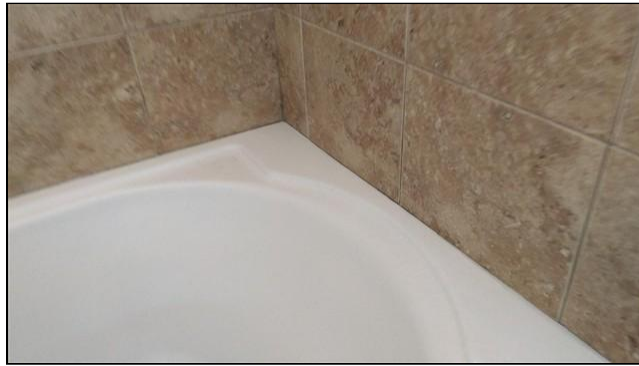
**Condition:.. Cracked grout noted at the joints.**

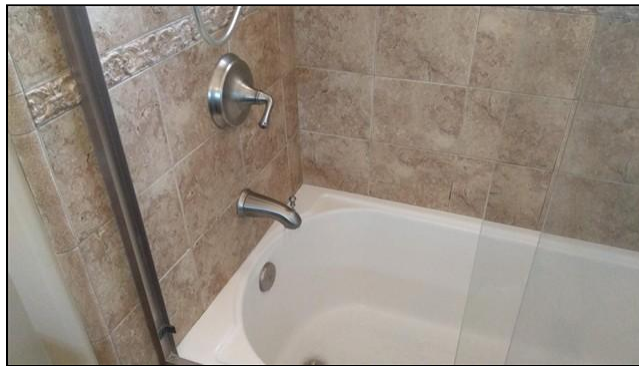
**Condition:.. Diverter valve allows water through the tub spout and showerhead at the same time.**

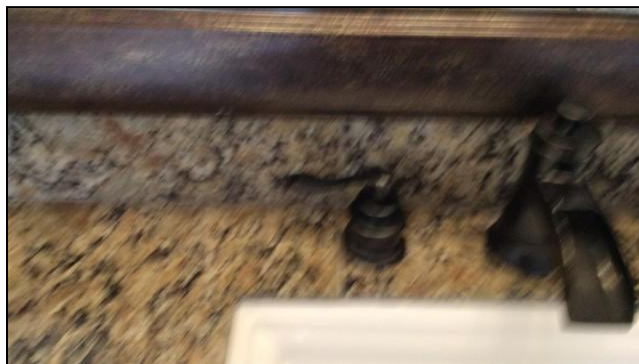
**Condition:.. Handle rubs in the backsplash.**

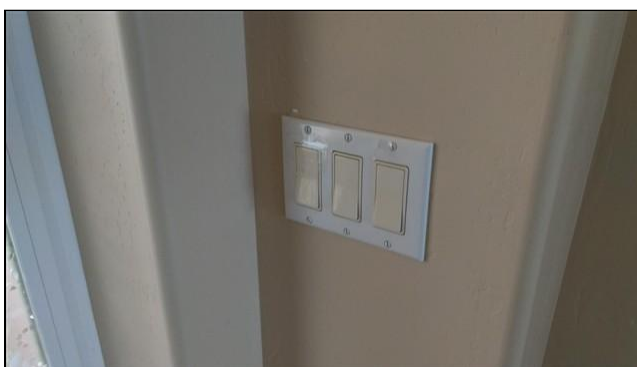
| Step # | Component | Comment |
|---|---|---|
| 16.6 | Electrical | Condition:. Switch is taped, unable to test. |
