# **SewerLine Check Professionals, LLC**

## **Sewer Line Inspection Report**

5182 Vista Miguel Dr. La Canada-Flintridge, CA

DATE OF INSPECTION: January 24, 2023.  
TIME OF INSPECTION: 9:00 AM.  
CLIENT NAME: Kay Witticker.  
ADDRESS: 5182 Vista Miguel Dr. La Canada-Flintridge, CA.  
INSPECTOR: Edward Fayton - Senior Inspector/Technical Supervisor.

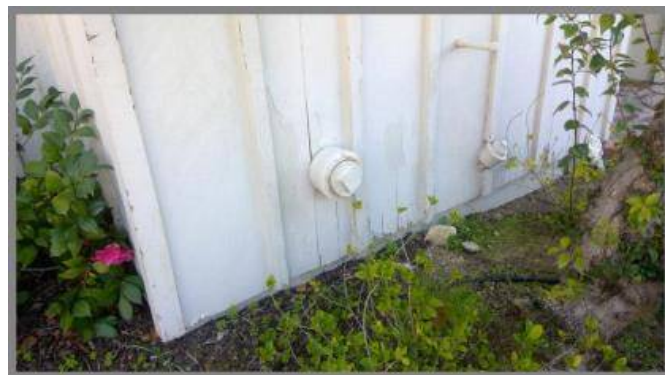
**ACCESS LOCATION:** The main sewer line was accessed through this building drain cleanout found at the front of the house to the left of the front door.

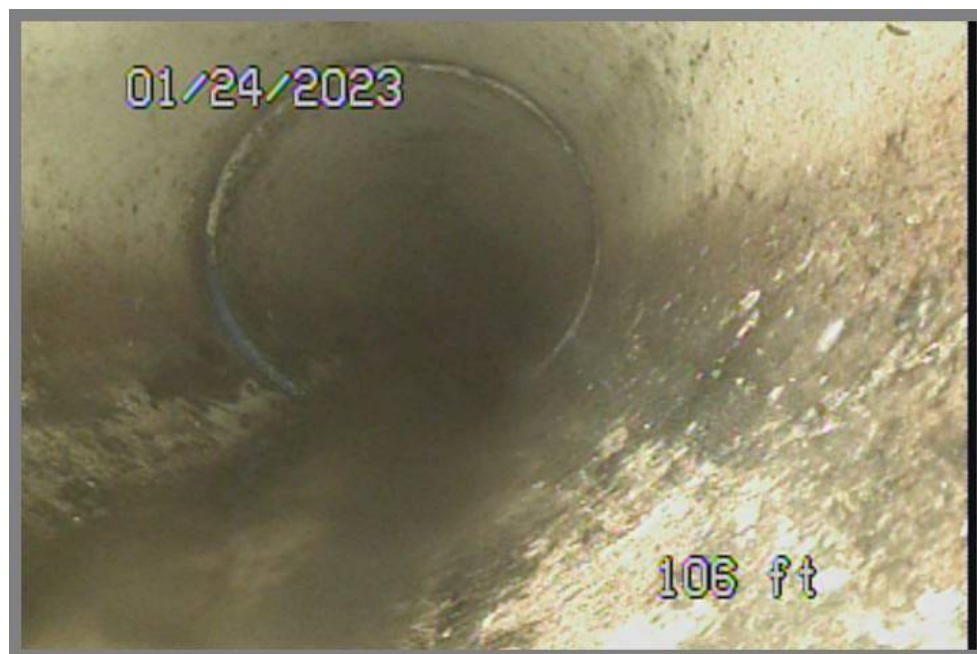
**FINDINGS:** **Generally Acceptable**, this plastic pipe main sewer line is draining serviceably at this time.

The main sewer line exits the middle front of the house and off the middle front of the property on its way to the clay pipe city sewer under the street.

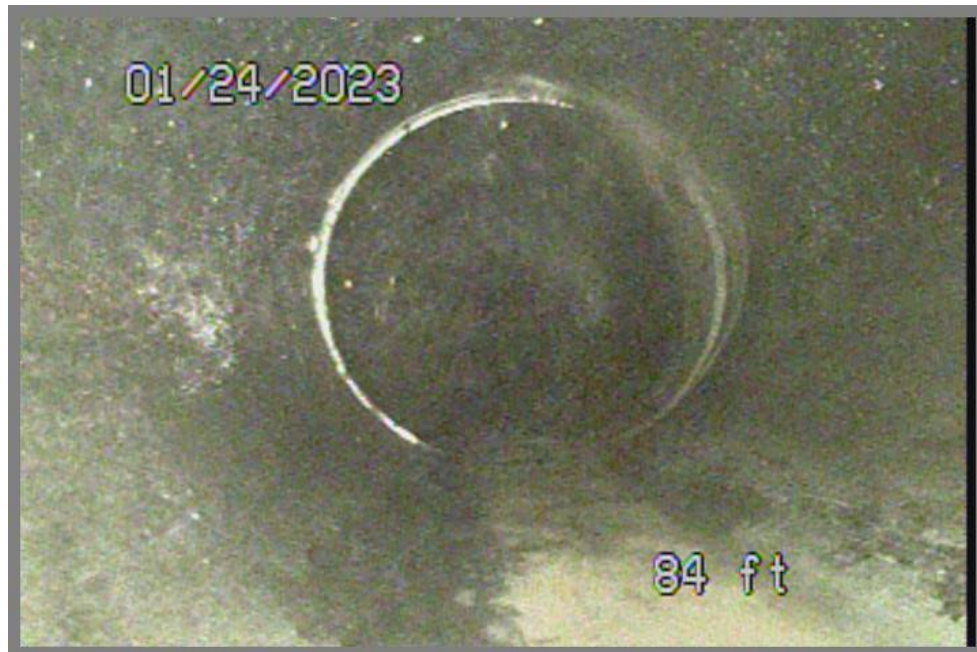
A section of this plastic system has a typical low spots that is causing some sewer water to pool in the pipe.

This bowing of the pipe is common in a plastic system and generally does not require repair as water will find its own level in the pipe and then drain off.

No regular maintenance is necessary on the main sewer line at this time however it is advised to have the main sewer line video examined every 3 to 5 years or after any significant seismic activity as conditions could change over time.
