Summary of Inspector's Major Findings

LOCATED AT:
22587 Waterbury St
Woodland Hills, CA 91364

INSPECTED ON:
Wednesday, October 15, 2025

Inspector, Seth Keena Certified CREIA Inspector #165987
FIT Property inspectors
818-224-8869

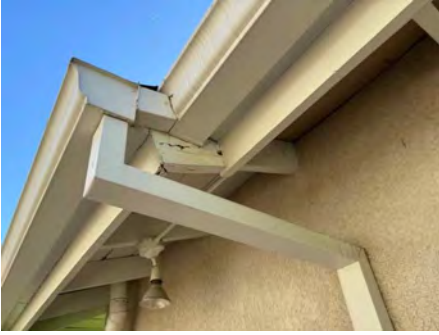
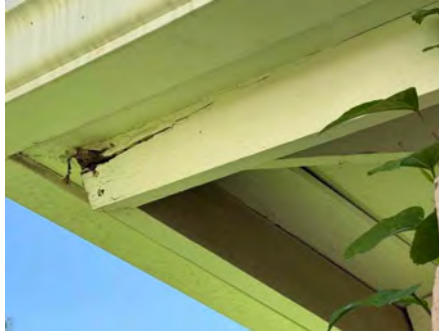
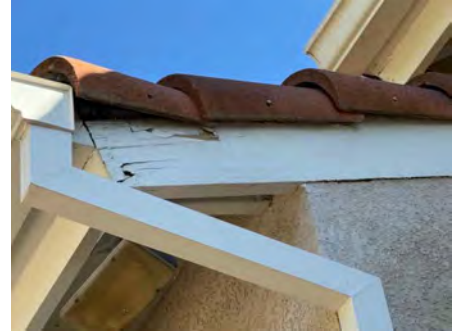
CR FE s-43: There was moisture/termite type of damage on the fascia. We recommend further evaluation and corrections by a specialist in the appropriate trade.

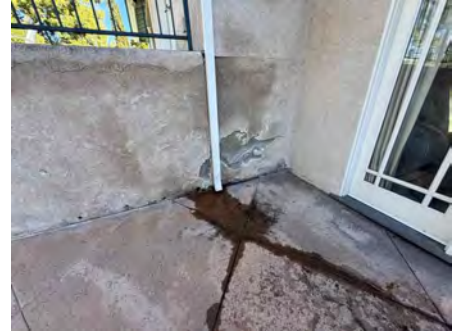
CR FE s-49: The retaining wall running front to back in the backyard, separating the two levels is cracked and water damaged. The drainage has also failed. Further evaluation and corrections by a specialist in the appropriate trade is recommended.

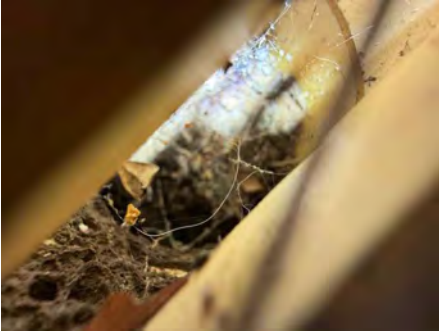
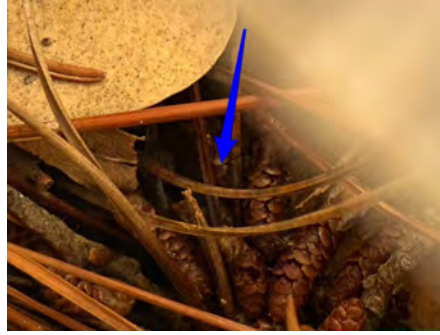
CR s-55: One or more of the surface water drainage lines had water, dirt, debris, etc. in the plumbing. Recommend the drainage line(s) be hydro-jetted by a specialist in the appropriate trade.

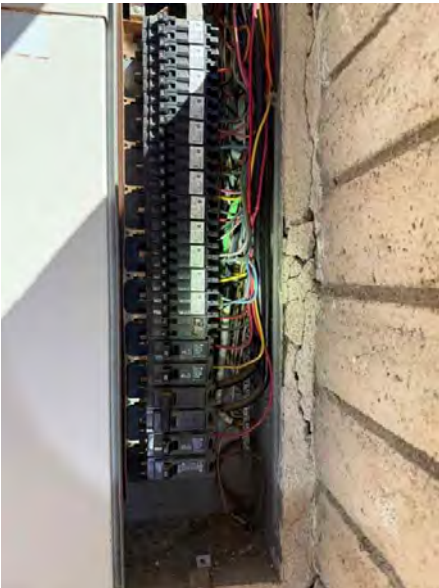
s-91: The main service panel is in serviceable condition with the exceptions listed.

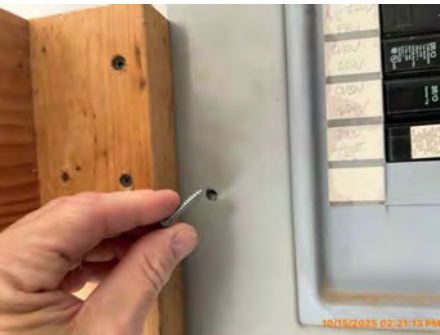
SC CR s-98: The pointed screws installed in the electrical subpanel should be replaced with blunt end screws to minimize the chance of piercing a wire. We recommend this be corrected by a specialist in the appropriate trade.

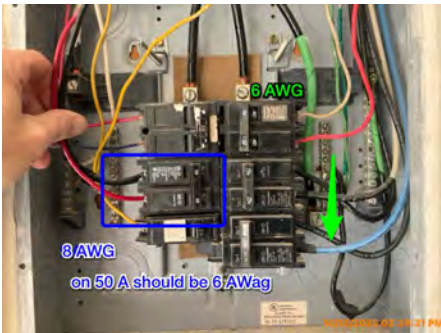
SC CR s-99: We found over-fusing in the subpanel, meaning breakers or fuses that are too large for their connected wires. This is a safety concern. We recommend this be corrected by a specialist in the appropriate trade.

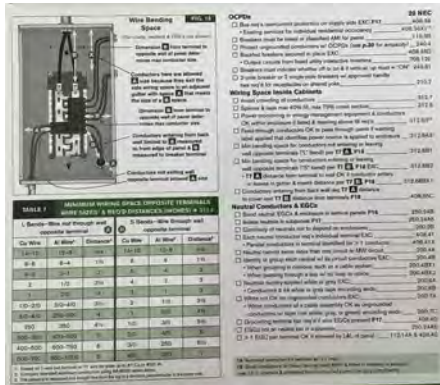
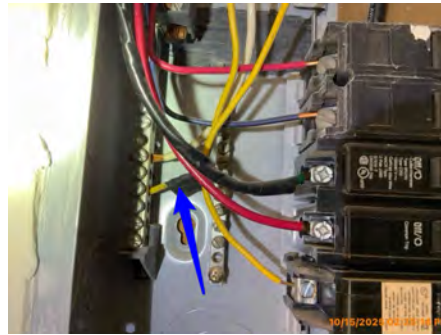
SC CR s-100: There was a conductor being used that was not the correct color for the application it was being used for. We recommend this be corrected by a specialist in the appropriate trade.

Should be white

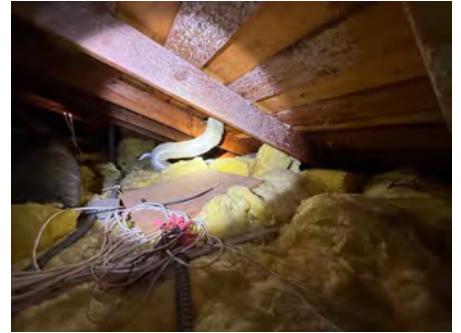
SC CR s-106: Running splices, which are improper connections outside of a junction box, are used in several areas. All splices should be made with approved connectors inside a junction box to prevent accidental contact or mechanical damage. It is recommend this be corrected by a specialist in the appropriate trade.

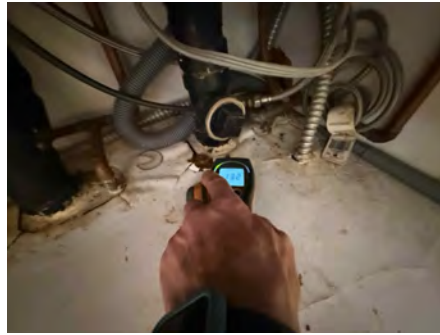
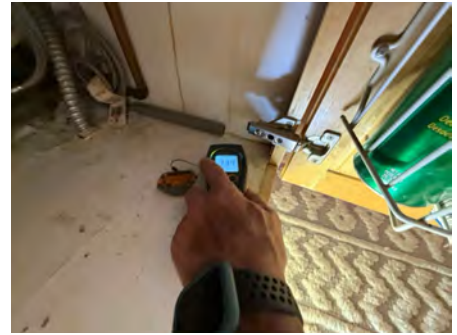
CR FE s-141: There was water stains and/or damage underneath the cabinets. These appear to be older. No active leak was observed during the inspection.

P-trap could leak again any anytime

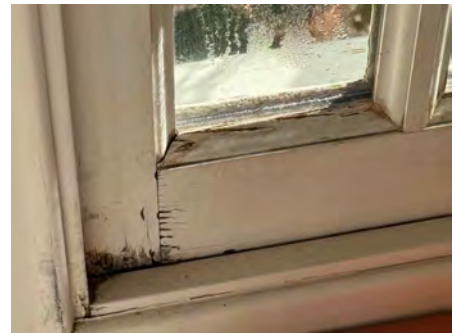
CR s-145: There is condensation, damage from condensation or others signs the hermetic seal(s) (thermal seals) has failed in one or more multi-pane windows in this area. We recommend this be corrected by a specialist in the appropriate trade.

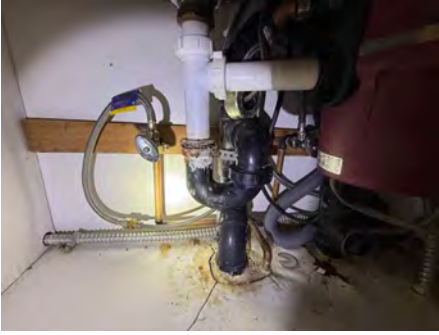
CR s-156: The drain trap is damaged and has leaked. Recommend this be corrected by a specialist in the appropriate trade.

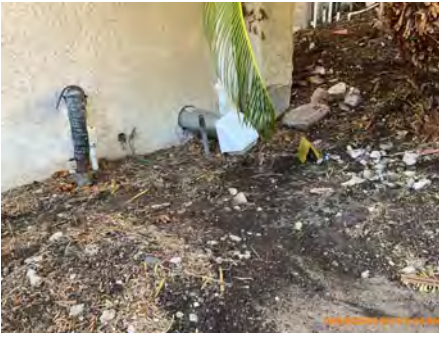
SC CR s-182: The dryer vent is installed in a substandard manner. It extends past the exterior wall and is terminated at soil level which blocks the termination. We recommend correcting the condition noted.

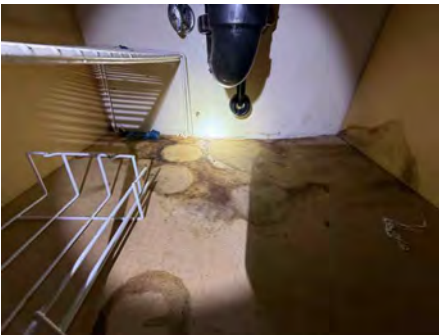
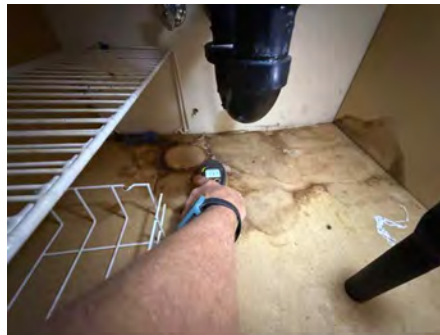
CR FE s-184: There was an organic like substance observed in this area. To determine what the possible organic substance it is would require lab testing. We recommend further evaluation and corrections by a specialist in the appropriate trade.

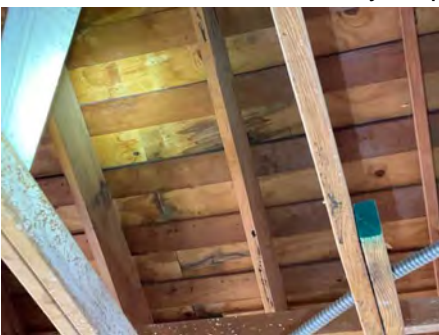
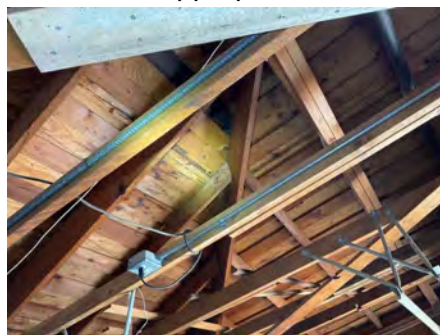
CR FE s-188: The wood sheathing in the garage appears newer but shows signs of water staining and/or water damage. This sheathing likely was installed during the most recent roof replacement, and the observed staining is consistent with potential water intrusion from the roof system. We recommend further evaluation and corrections by a specialist in the appropriate trade.

Water stains on newer sheathing

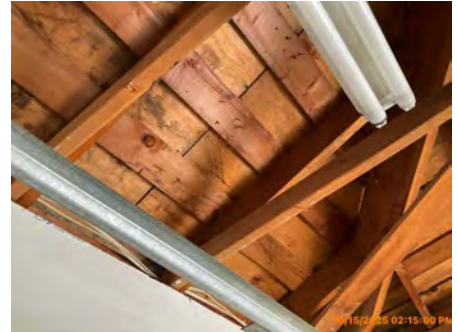
CR FE s-189: There was water stains and/or water damage observed at the ceiling. We recommend finding the source of the water and correcting the condition noted. We recommend further evaluation and corrections by a specialist in the appropriate trade.

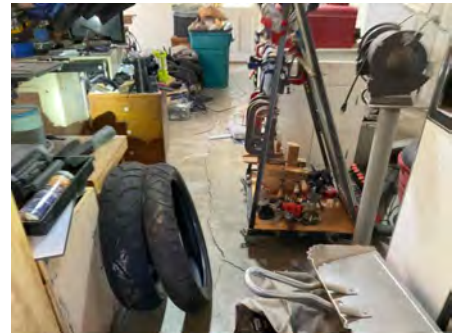
CR s-190: The concrete slab in the garage was Damaged and cracked with the cracks having variances in heights that . Further evaluation and corrections by a specialist in the appropriate trade is recommended.

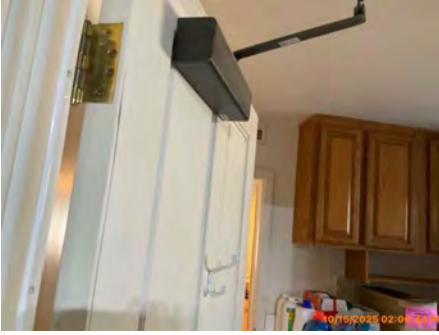
FE s-198: New standards call for the fire door to have a tag that verifies it's fire rating. We were unable to verify if the door is fire rated.

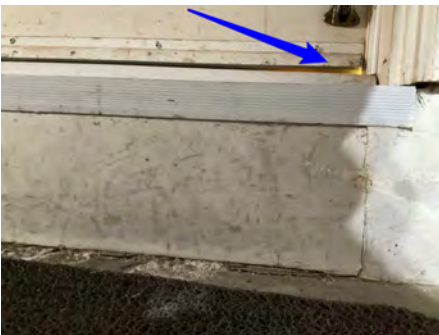
SC CR s-199: There was a gap at the bottom and/or side of the fire door. All four sides of the fire door should be sealed to keep out any potential flames, smoke or fumes. We recommend correcting the condition noted.

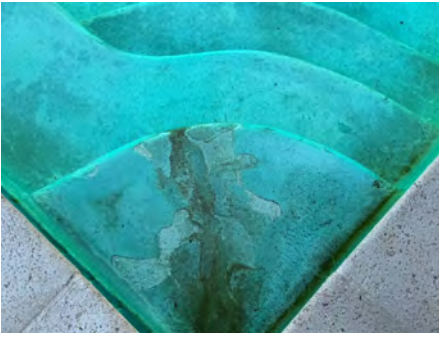
CR s-217: The vessel finish has major damage throughout. We recommend this be corrected by a specialist in the appropriate trade.

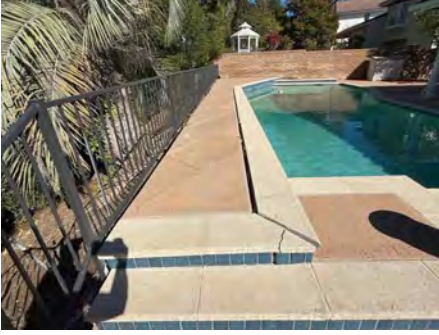
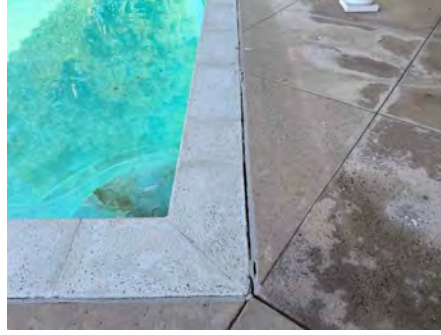
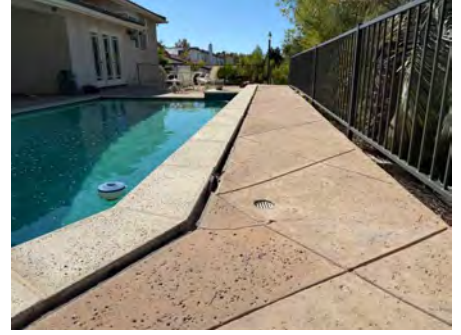
CR FE s-220: The flatwork is more evidence that there has been more than usual movement of the pool vessel. Further evaluation and corrections by a specialist in the appropriate trade is recommended.

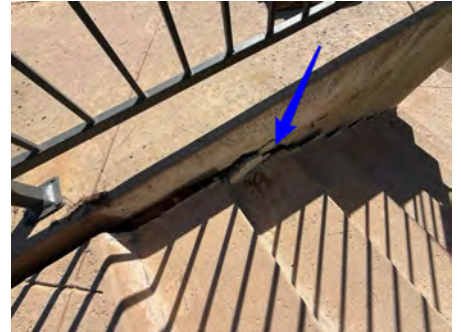
CR s-222: The pool flat work/decking and stairway and the pool has been cracked. We recommend the further evaluation and corrections by a specialist in the appropriate trade.

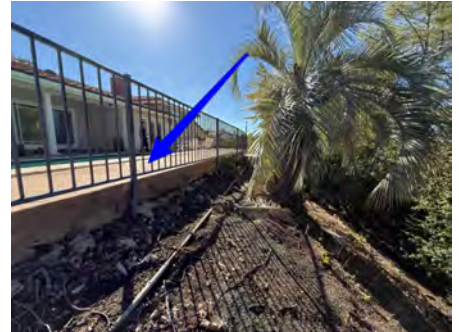
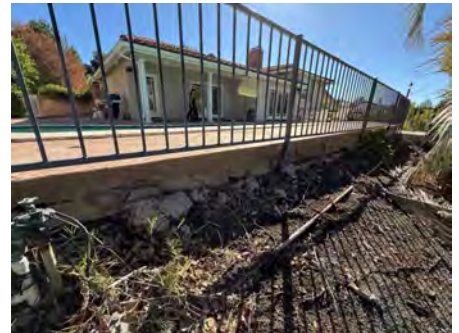
CR FE s-223: The back side of the pool deck has pulled away from the coping/bonding beam of the pool. This has opened up a several inch wide void. Further evaluation and corrections by a specialist in the appropriate trade is recommended..

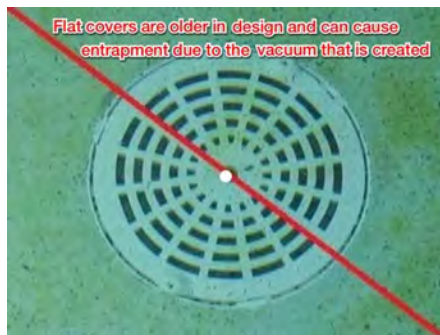
Anti-vortex is a safer option

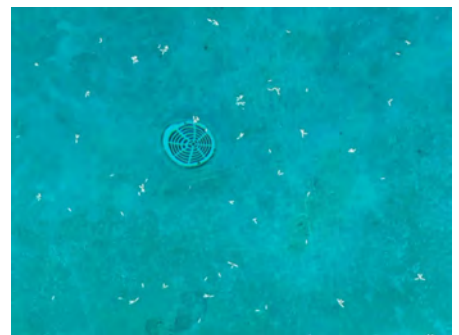
Flat covers are older in design and can cause entrapment due to the vacuum that is created

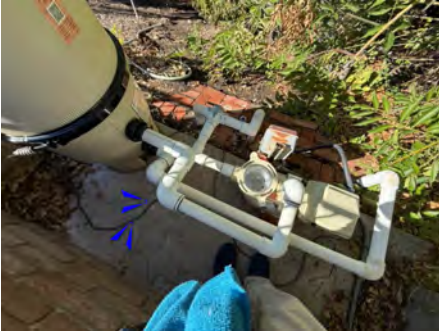
CR s-227: It is recommended that plastic pool equipment plumbing be painted to avoid UV damage due to sun exposure. It is recommended this be corrected by a specialist in the appropriate trade.

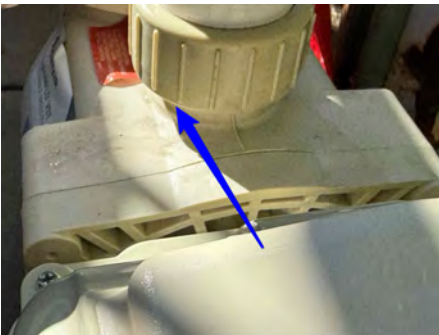
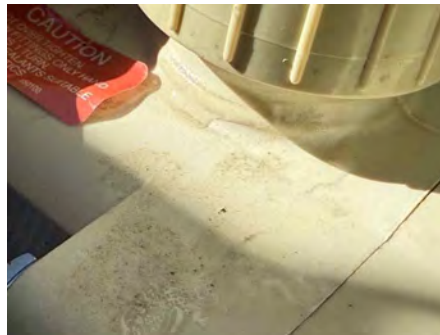
CR s-228: There was a leak or leaks observed in the plumbing where it connects to the top of the pump. We recommend this be corrected by a specialist in the appropriate trade.

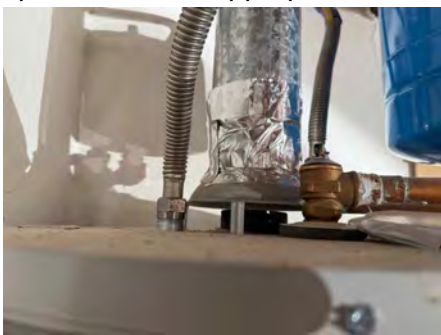
SC CR s-256: The water heater flue is not fastened properly. We recommend this be corrected by a specialist in the appropriate trade.

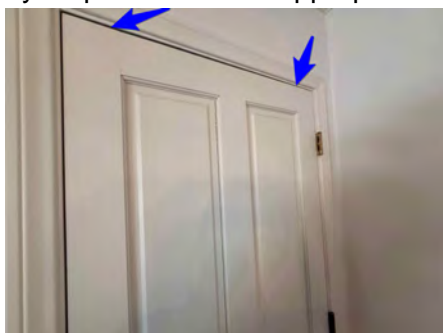
CR **FE** **s-287:** There is a door or doors in this room that are;is/are not square in the door frame. Based off of this and other conditions observed, it is our opinion that this was caused by building settlement. All structures settle and most settlement happens in the first couple years, We recommend this be corrected by a specialist in the appropriate trade.

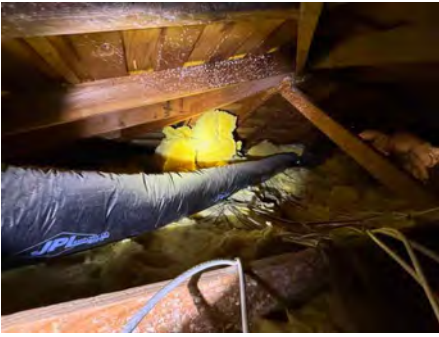
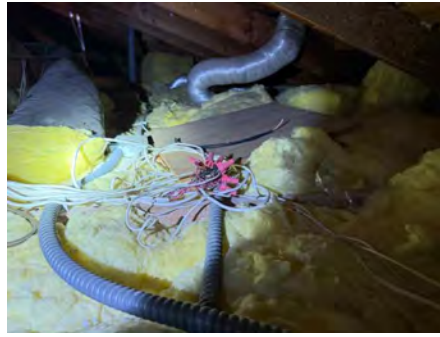
CR s-345: Some of the ducting has been crushed or compressed. It is recommend this be corrected by a specialist in the appropriate trade.

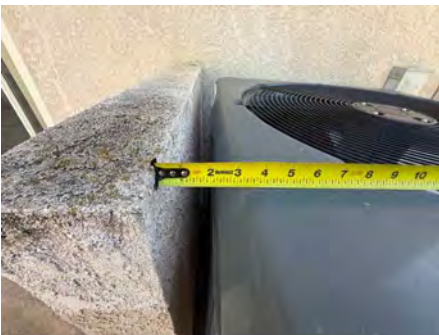
CR s-359: Most manufacturers call for at least 6 inches of clearance all side of all condensing units. This is to ensure the unit has plenty of ventilation so it will function properly. It is recommend this be corrected by a specialist in the appropriate trade.

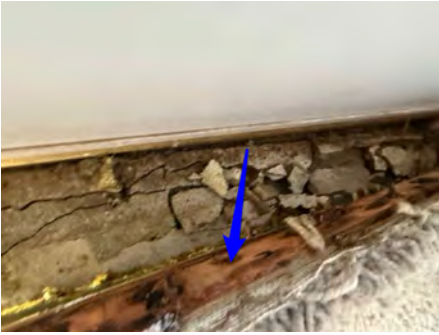
CR FE s-371: There is water intrusion coming from the door(s) in this area. We recommend further evaluation and corrections by a specialist in the appropriate trade.

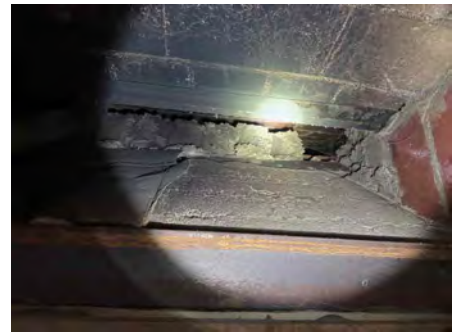
SC CR FE s-376: There were one or more cracks and voids observed in the firebox and/or firebox throat. We recommend further evaluation and corrections by a specialist in the appropriate trade.

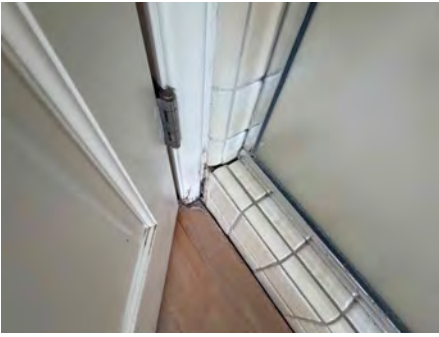
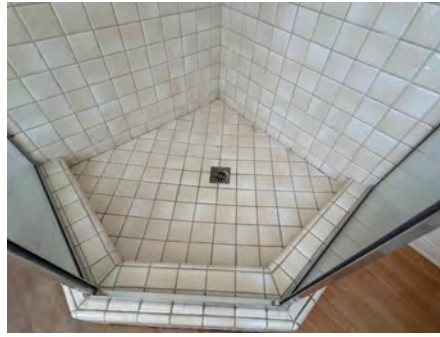
CR s-386: The shower pan and/or dam is cracked. This condition is conducive to moisture intrusion, damage and deterioration. We recommend this be corrected by a specialist in the appropriate trade.

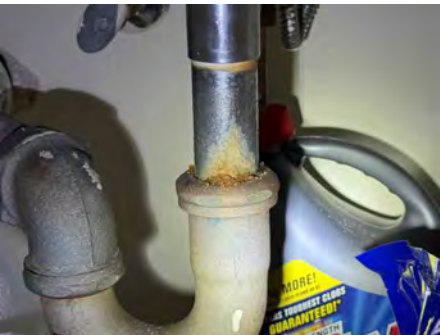
RU s-422: There is corrosion at the drain traps. We recommend this be corrected by a specialist in the appropriate trade.

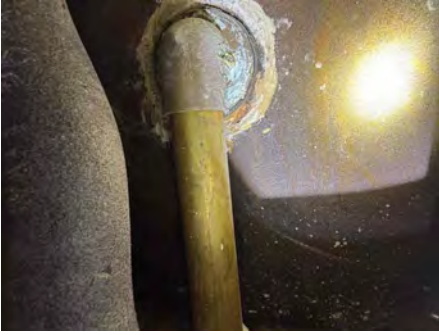
CR s-425: The bathtub overflow gasket is deteriorated. This condition is conducive to moisture intrusion, damage and deterioration. We recommend this be corrected by a specialist in the appropriate trade.
