Alex Fulford
402 Porter St.
Fallbrook, CA 92028
253-880-4569 sdfulfordcontractor@gmail.com

Type of Roof: Composition Shingles
Color: Slate
Year Home Built (Per Zillow): 1986

Roof Inspection Report

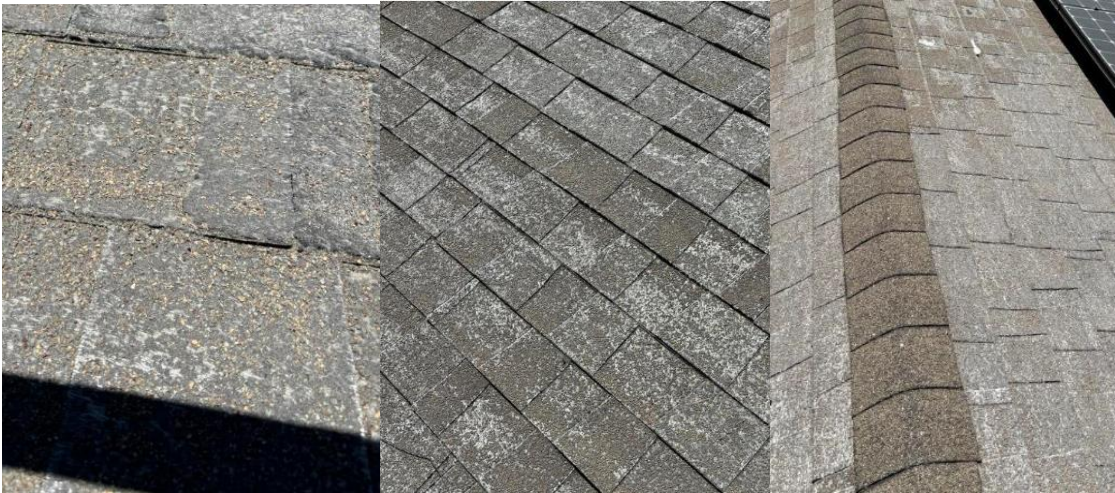
- **Extreme loss of granules**
- **Missing drip edge metal as required by building codes**
- **Chimney not flashed properly should have "Z" bar installed**
- **Pipe flashings need to be resealed**
- **Exposed fasteners need to be sealed**

Examples of granular loss

- Replace the entire shingle roof. **Estimated budget = \$21,600.00** for similar grade roofing material.
NOTE: Budget based on removal of up to 2 layer of existing shingles. Additional layers = \$8/SF
NOTE: Budget excludes wood repairs, permit fees, upgrades such as attic vents, etc.
NOTE: Estimated replacement cost includes inspection fee credit
- Refer to licensed pest control/termite contractor to inspect wood and repair prior to roofing repairs.
- Have attic inspected by licensed pest control contractor or general home inspector.
NOTE: This inspection EXCLUDES inspection of attic or interior unless otherwise noted.
- Have solar system inspected by solar contractor.

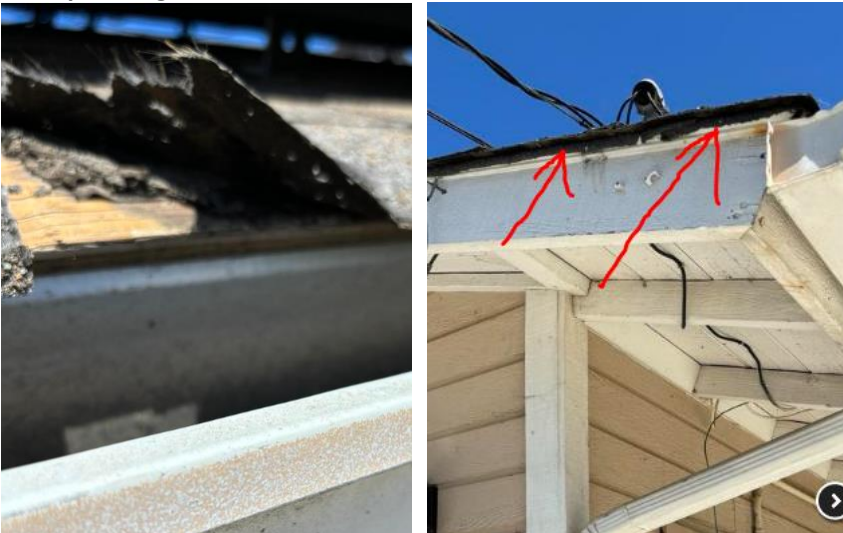
Examples of missing edge metal

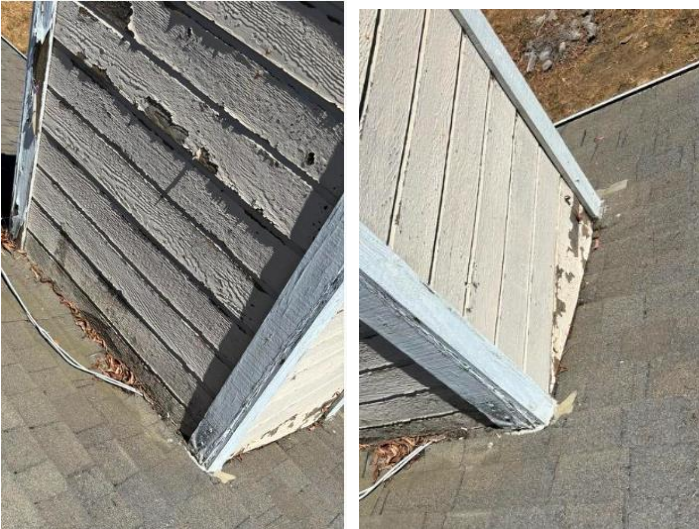
Examples of improper flashing at chimney

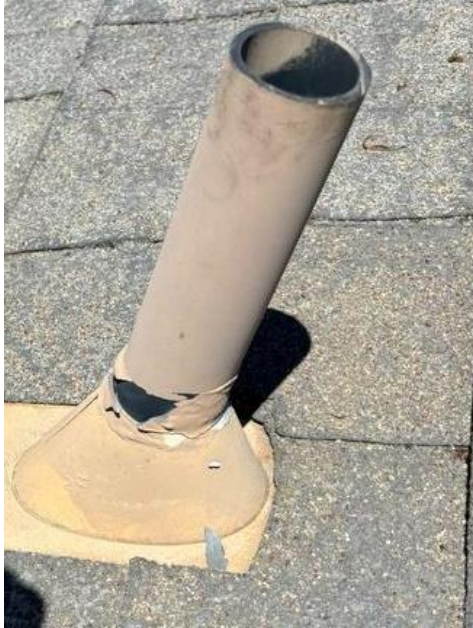
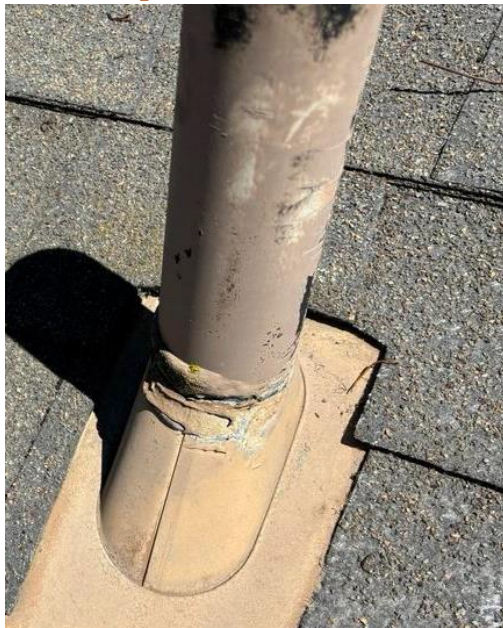
Examples of pipes need sealing

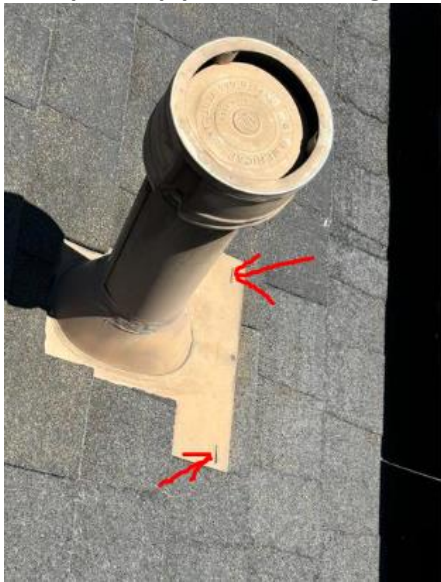
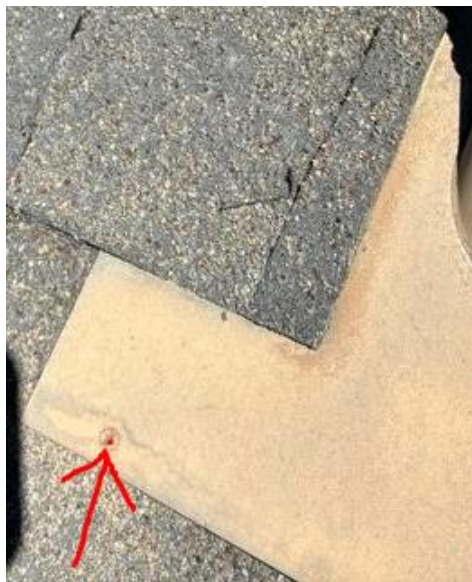
Examples of exposed fasteners
