Al Silva Jr.  
Mr. Home Inspector  
San Diego County

# Inspection Report

**Property Address:**  
2908 Aber St  
San Diego CA 92117

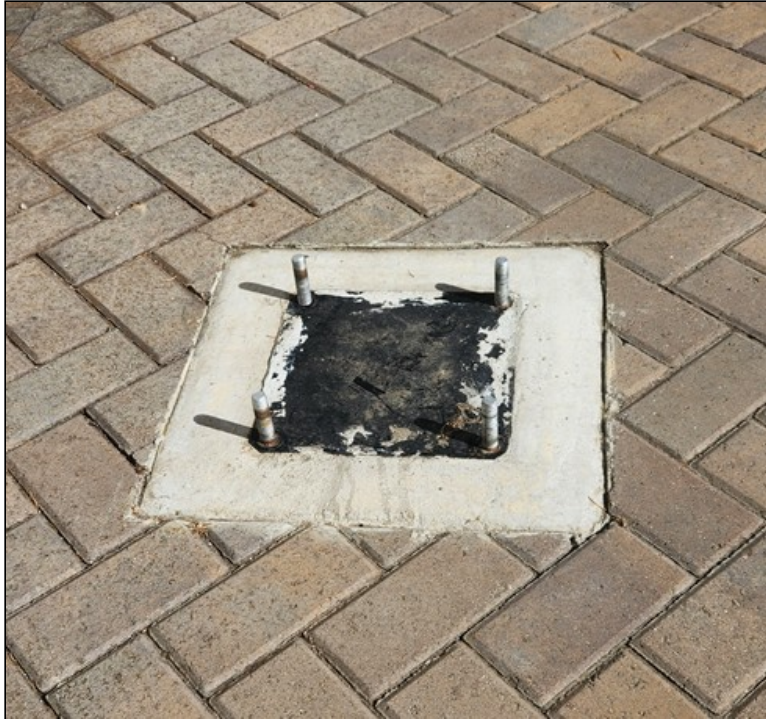
1.1 Item 1(Picture)

**Metal Rod:** There is a threaded metal rod coming out of the concrete at the front patio. This is a trip hazard. **Recommend a qualified professional cut off rod at cement.**

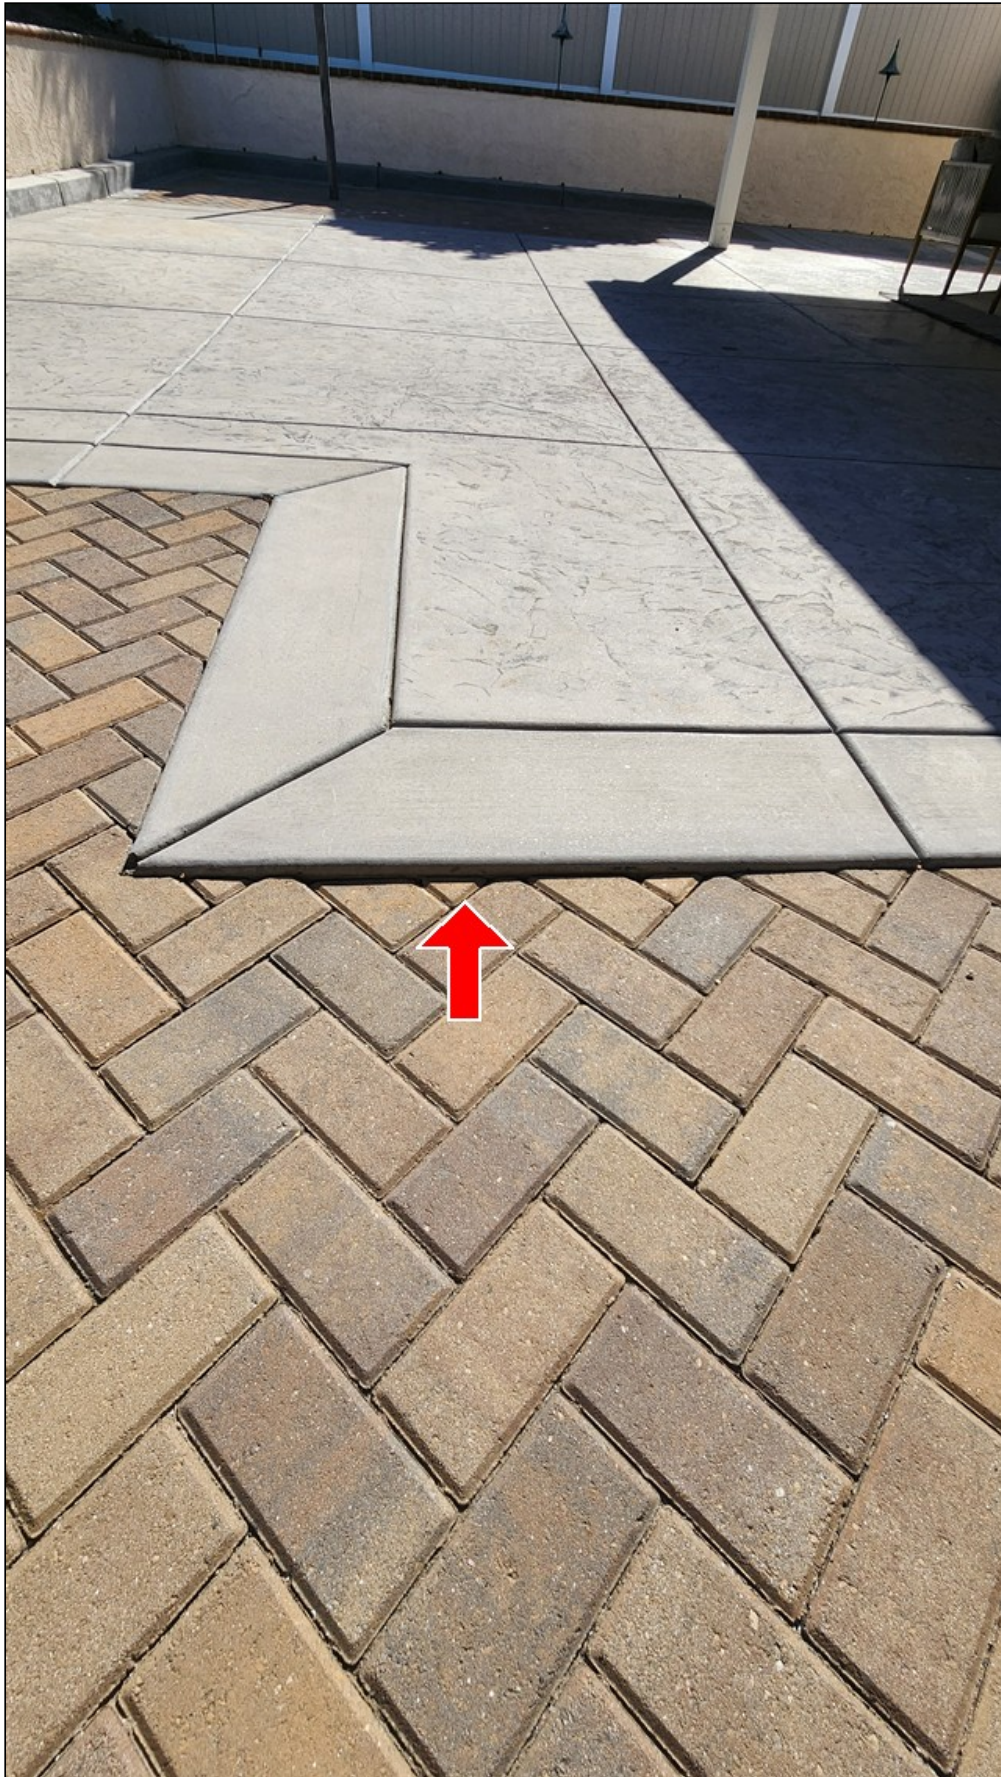
1.1 Item 2(Picture)

**Unlevel Surfaces- Trip Hazards:** There were areas at the rear of the home which had unlevel and raised surfaces noted. These areas may pose a trip hazard when they are over 3/8" high. **It is recommended that adjustments be made to create a smooth walking surface at these locations.**

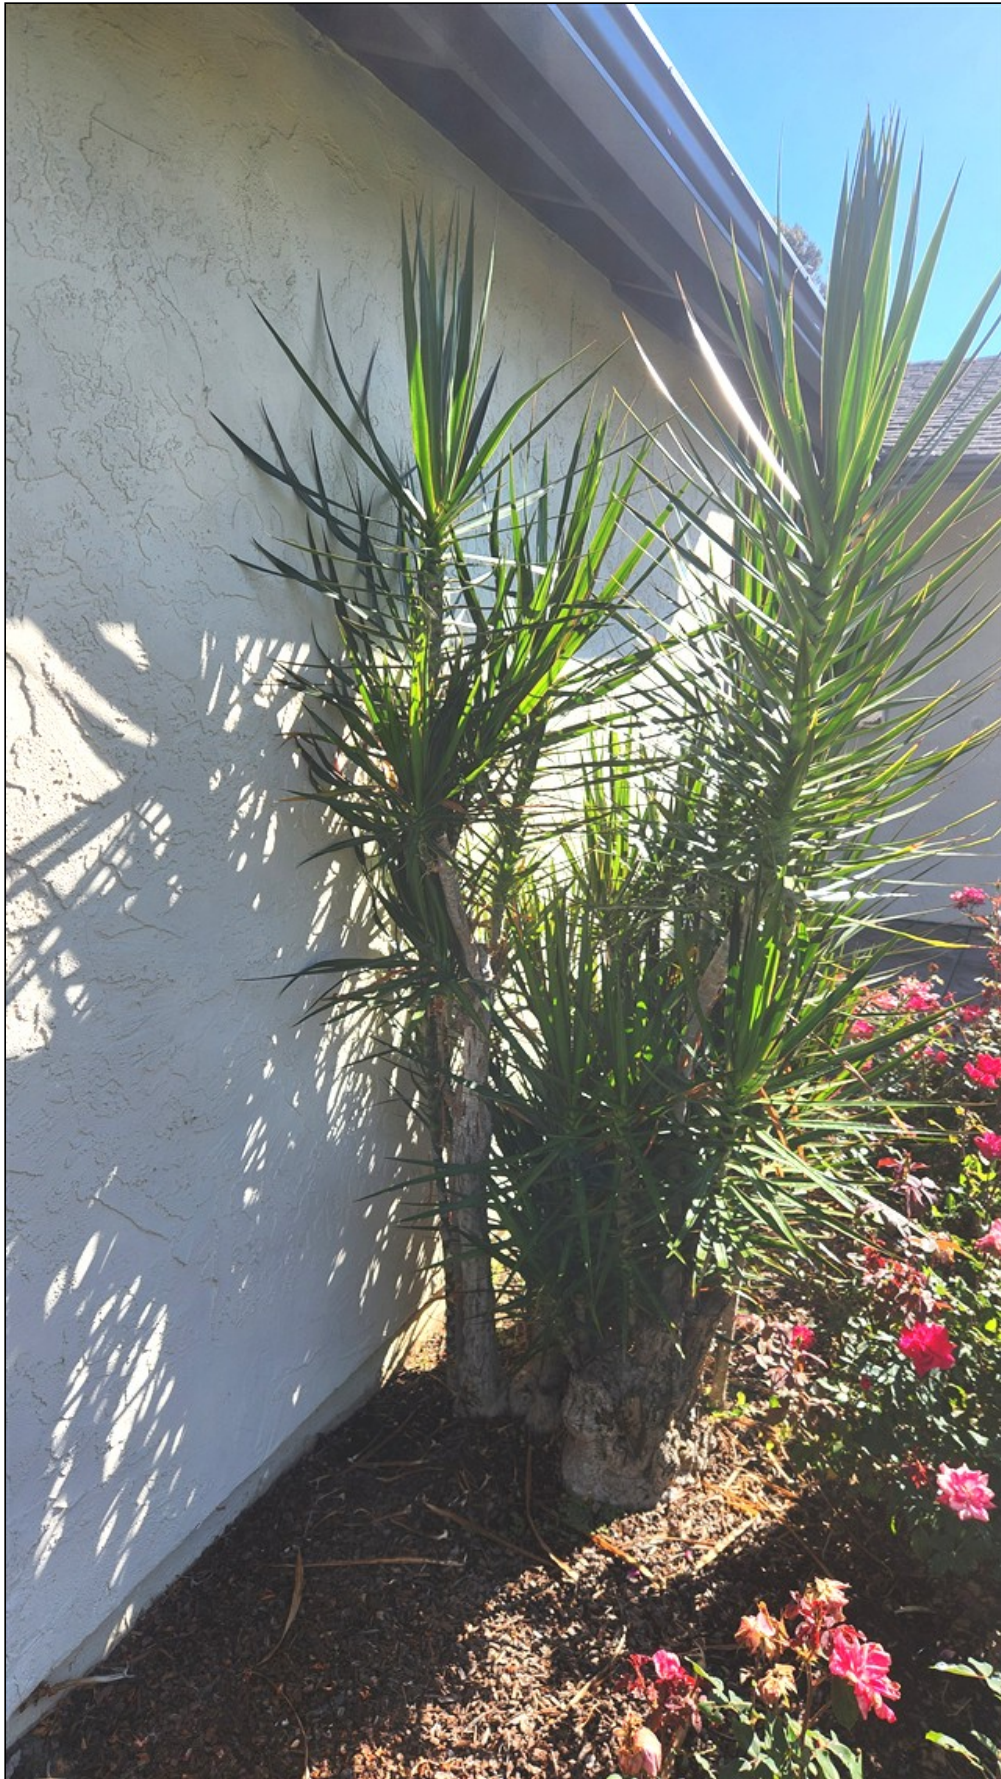
1.2 Item 1(Picture)

(1) [Trees Next To House](#). It was noted that there was a tree in close proximity to the front of the house. Some trees can have evasive root structure which can potentially cause damage to house foundations, plumbing and irrigation systems. **It is recommended that you consult an arborist or other plant specialist about this tree and the potential problems that might be associated with it.**

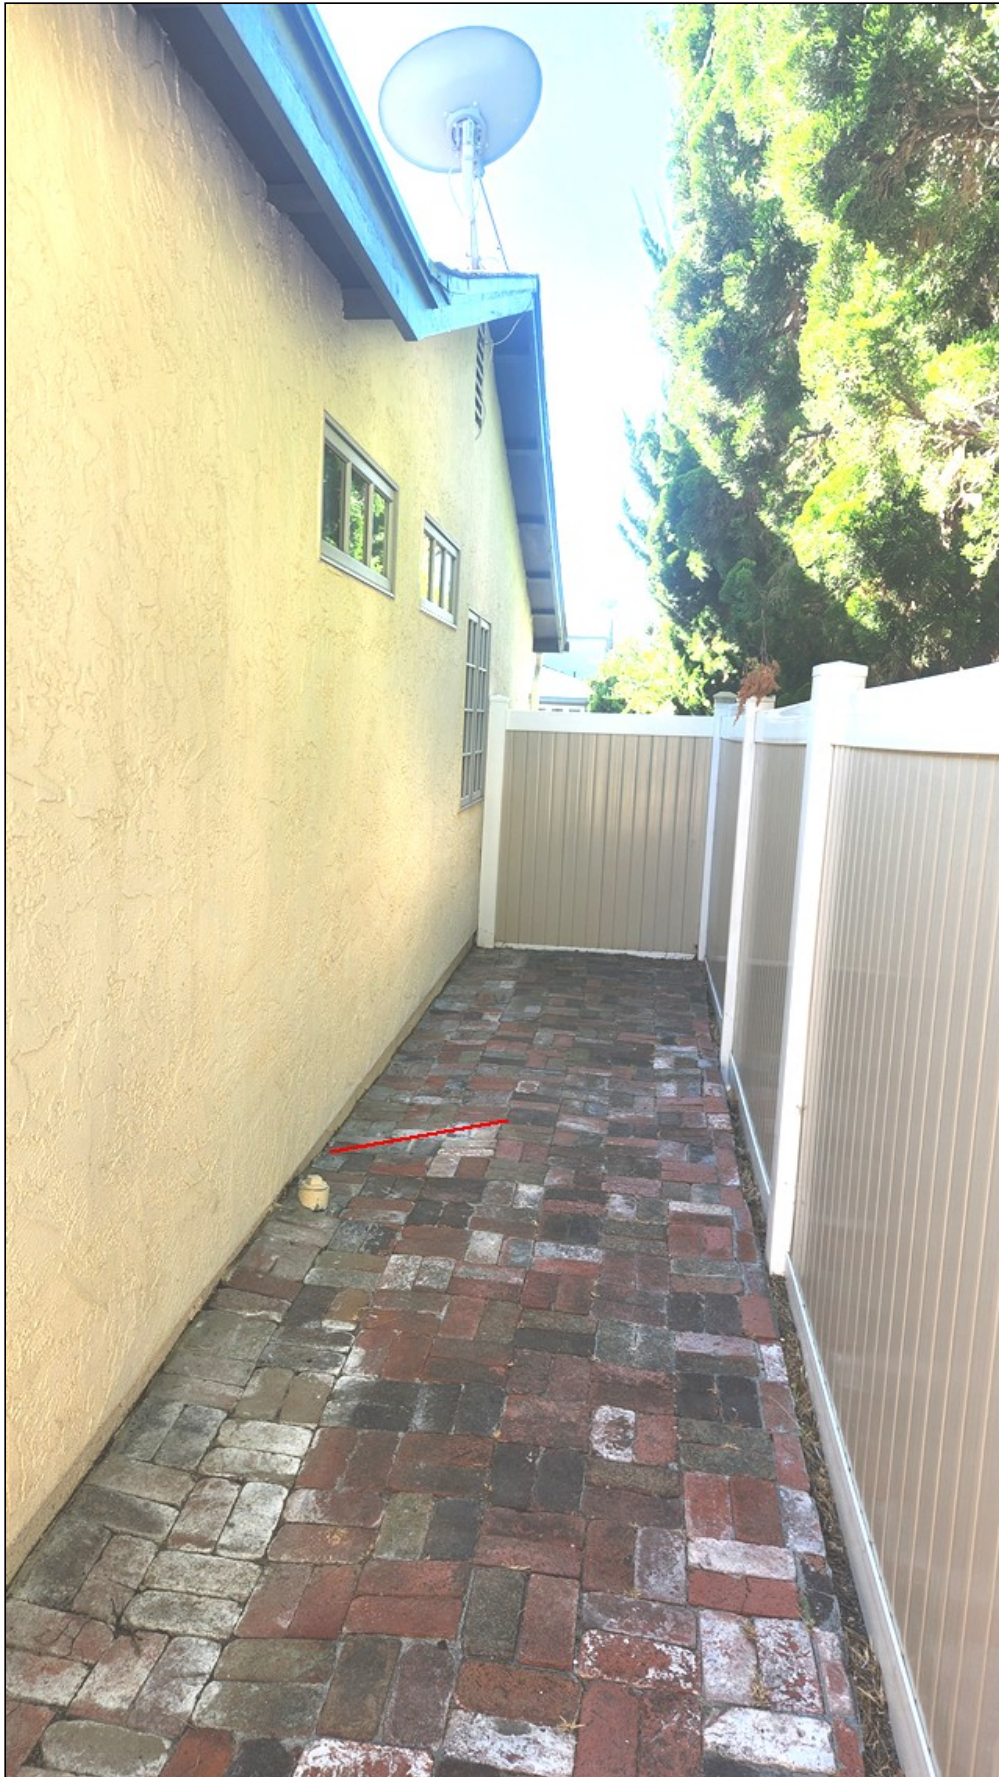
1.2 Item 2(Picture)

(4) [Improper Slope](#). There are areas at the left side of the home where the bricks slope toward the

house or does not appear to have a proper directional slope . There were no visible surface drains noted at these locations. Ideally there should be a minimum slope of 6 inches within the first 10 ft of the house. It is recommended that a swale, french drain or other means of drainage be provided to keep water away from house and foundation.

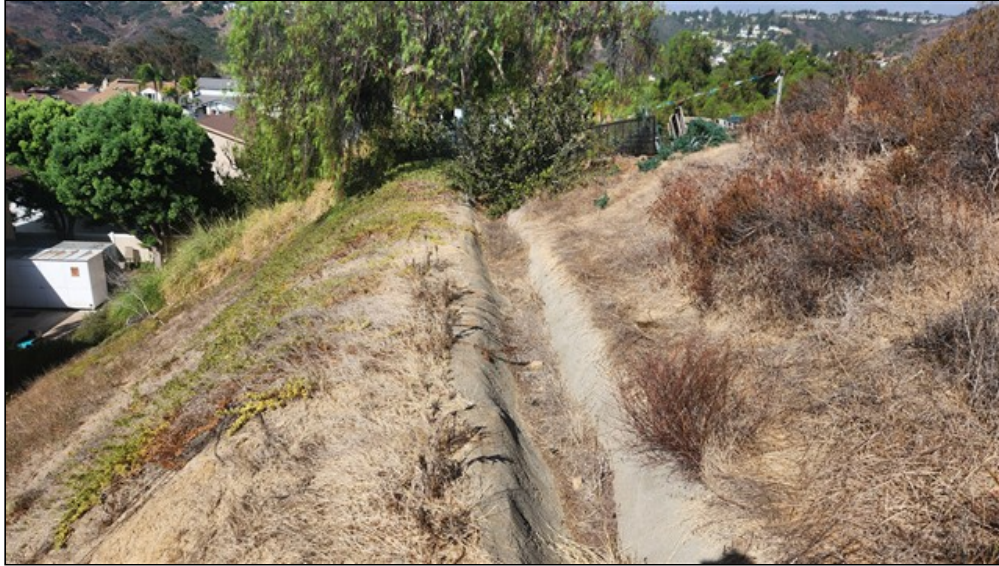
1.2 Item 3(Picture)

(5) **Blocked Drain:** There is a large cement swale drain that runs across the rear of the property. The

drain is blocked with debris & will not drain properly. We could not determine wear the drain exited the property. **These drains need to be cleared & tested for proper drainage. Check to see if this is an easement that is maintained by the city.**

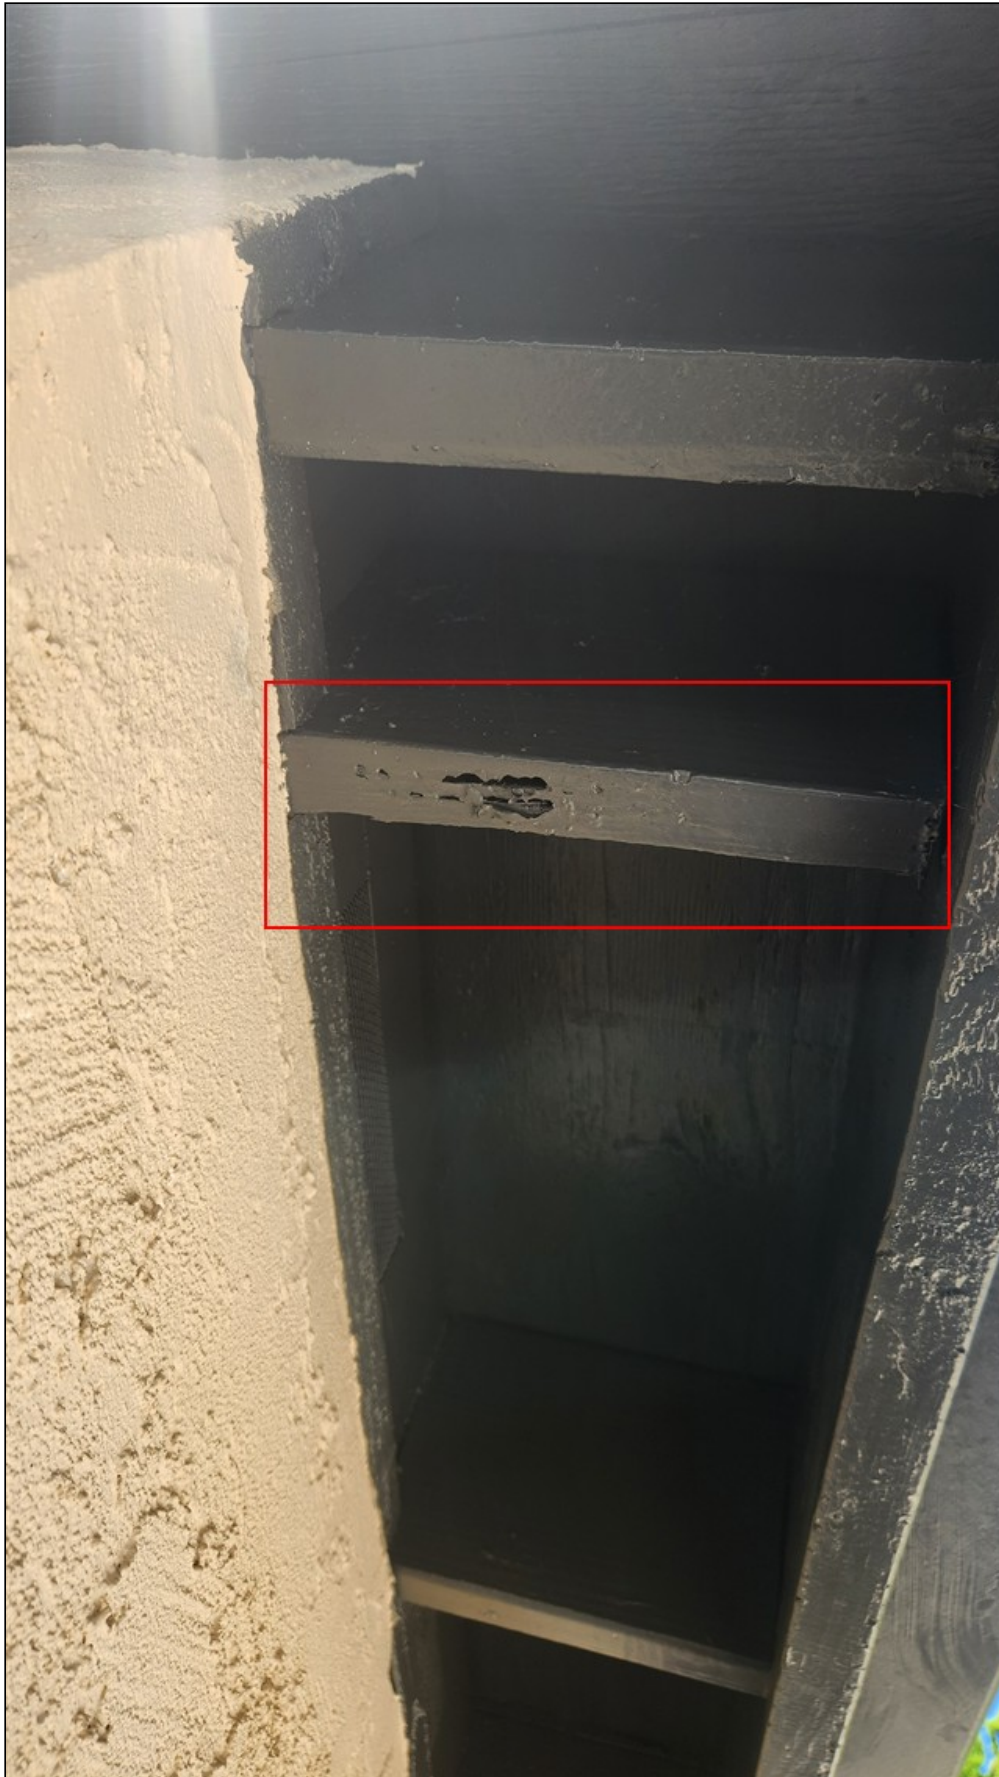
1.7 Item 1(Picture)

**Tail Damage.** There is some wood damage at the rafter tails at the rear patio. Damaged wood should be repaired or replaced. **It is recommended that you read your termite report thoroughly and that damaged wood be repaired or replaced.**

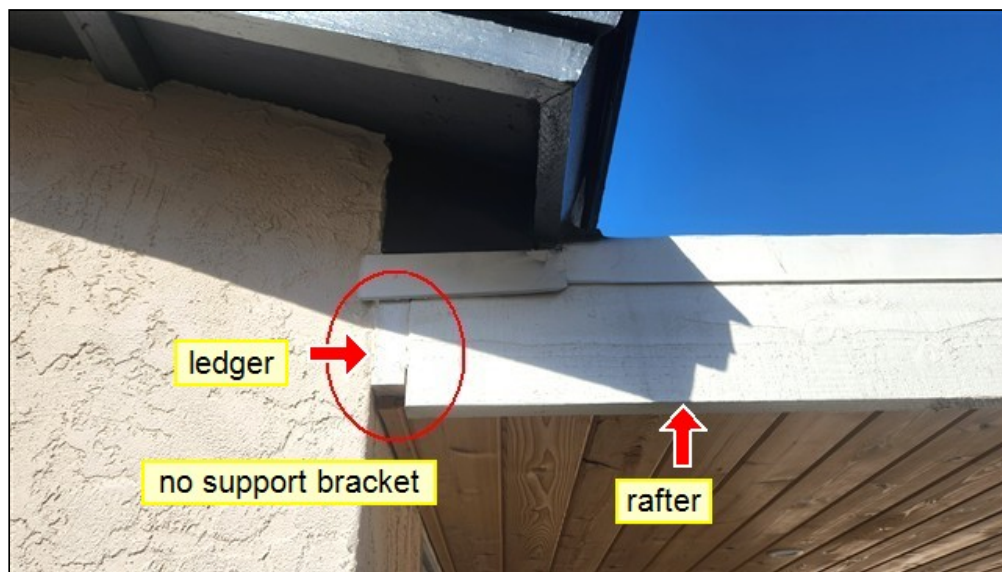
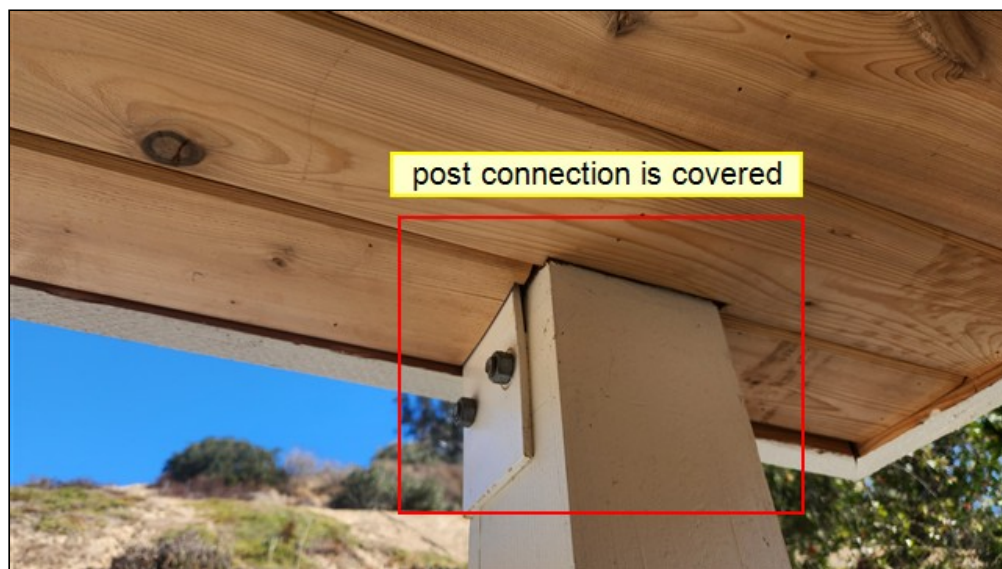
(1) **Can't Verify Support- Ledger Board.** The patio cover is supported by the use of a ledger board. Ledger boards should be fastened into place by the use of staggered bolts, with washers, anchored into the framing members of the building. Often times these are improperly supported with nails. **Currently the ledger board was covered and the support was not able to be verified. It is recommended that this be further evaluated for safety and corrected if needed by a licensed contractor.**

**Can't Verify Attachment-** Currently the support at the patio cover were not visible and were not able to be verified. The ceiling is covered with wood planking which blocks our inspection of all connection points. It is recommended that this be further evaluated for safety corrected if needed by a licensed contractor.

**Support Bracing:** There were no metal supports or brackets found at the connection point of rafter to ledger board. (only 1 beam is visible). All support connections require a bracket to prevent any movement. This is not up to today's standards & should be evaluated by a licensed contractor.

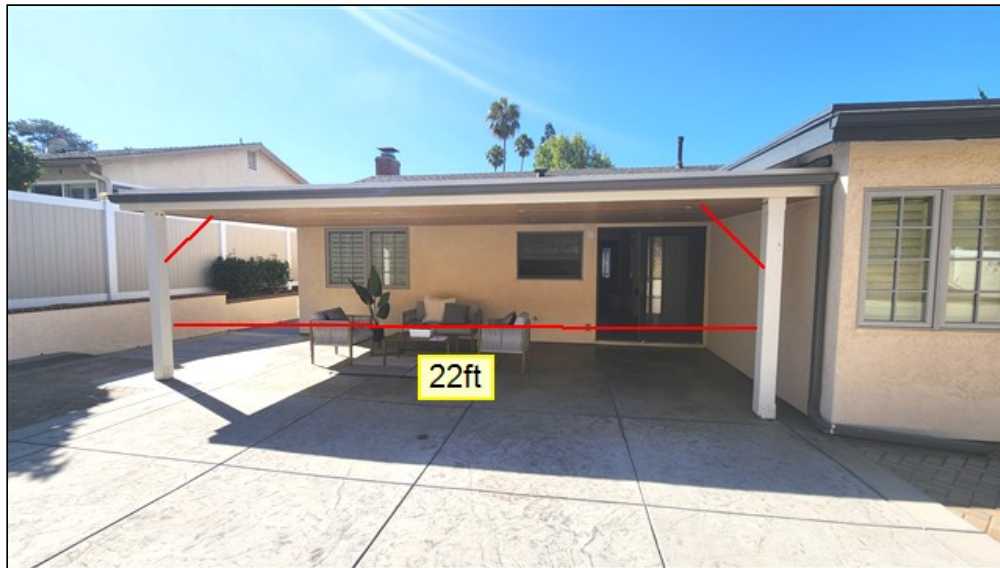
1.8 Item 3(Picture)

**Post Spacing:** The posts at the rear patio cover are over 22ft apart. For a 6x6 wood post supporting a standard residential patio cover in San Diego, the maximum recommended post spacing (on center) is 8 to 12 feet, depending heavily on your roof load, beam size, and rafter span. **It is recommended that these posts be further evaluated by a licensed contractor to determine if any upgrades are required..**

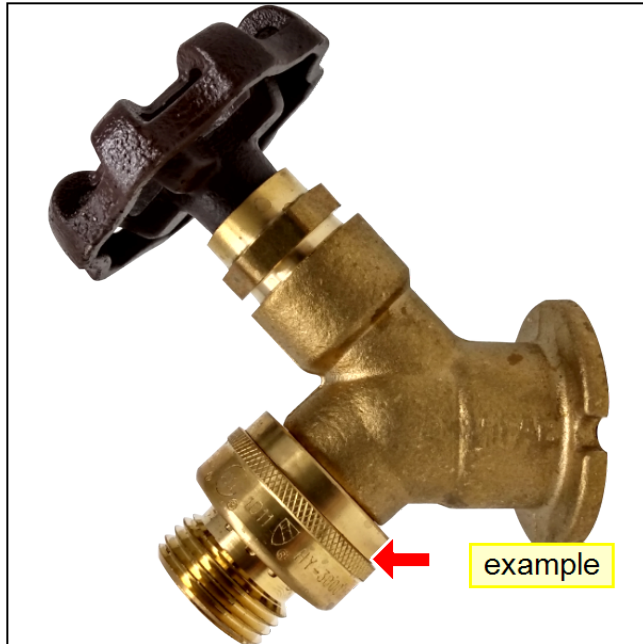
1.10 Item 1(Picture)

**No Vacuum Breakers.** The exterior hose bibs were not provided with vacuum breakers. **Although this was not a requirement for when this house was constructed, it is recommended that vacuum breakers be installed at all exterior hose bibs.** These are designed to prevent contamination should there be a pressure drop in the city's system. Vacuum breakers will prevent water from being siphoned backwards potentially contaminating the public drinking water. **Recommend installation of these devices.**

**Leaky Faucet Handle.** The hose bib at the rear of the home leaks at the handle when turned on. **This is noted for your information and can be replaced or repaired at your convenience if so desired. This could be covered by the HOA.**

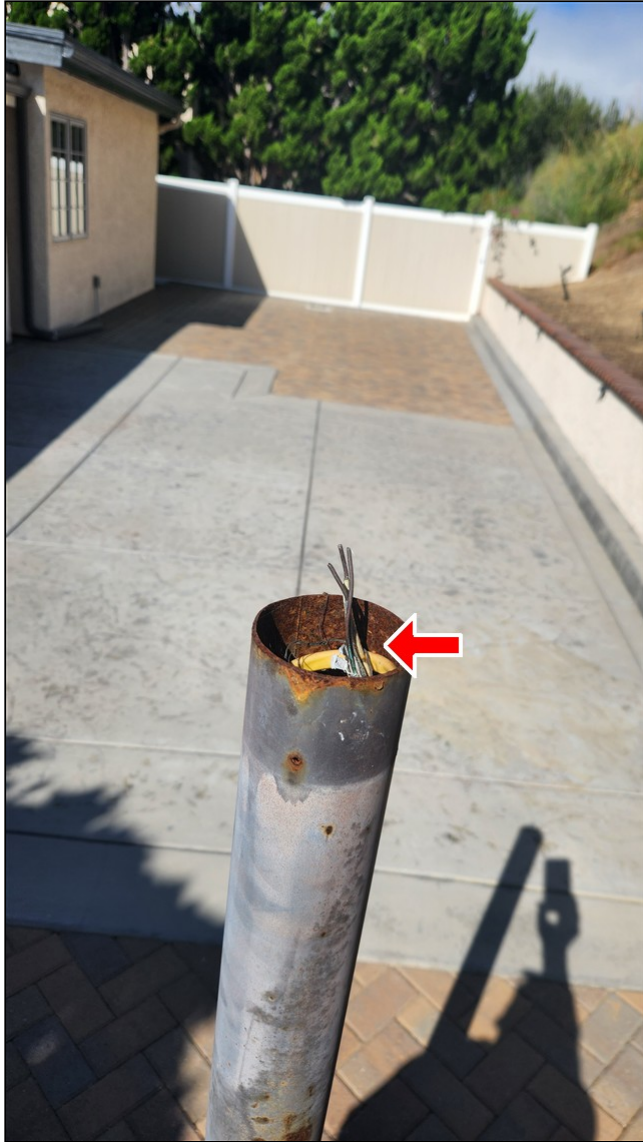
1.11 Item 1(Picture)

- 🏠 (3) **No GFCI Protection**. The outlets at the exterior of the home are currently not all GFCI protected. GFCI's are a safety device built into an outlet to "trip" the circuit if it detects that electricity is unbalanced, or if it detects improper connections of the neutral. **Although this was not a requirement at the time in which this house was constructed, it is recommended that these outlets be GFCI protected.** It is recommended that ALL exterior outlets be on a working GFCI circuit using a WR (weather resistant) & TR (tamper proof) type plug.

- 🏠 (4) **Loose Outlet(s)**. There is a loose plug at the wall connection at the rear patio outlet. Loose outlets can pull the wires from the back of the receptacle causing the wires to arch or cause electric shock & allow moisture into the wall. For safety reasons it is recommended that these outlets be properly secured & sealed to the wall by a qualified professional.

- 🏠 (5) **Exposed Wires**. There were some exposed wires noted at the lamp post on the patio. Due to the extreme hazard of exposed wires, it is recommended that the wires be properly capped and contained within a box, removed or a proper light installed. It is recommended that these wires be either removed or properly contained within a box by a licensed electrician.

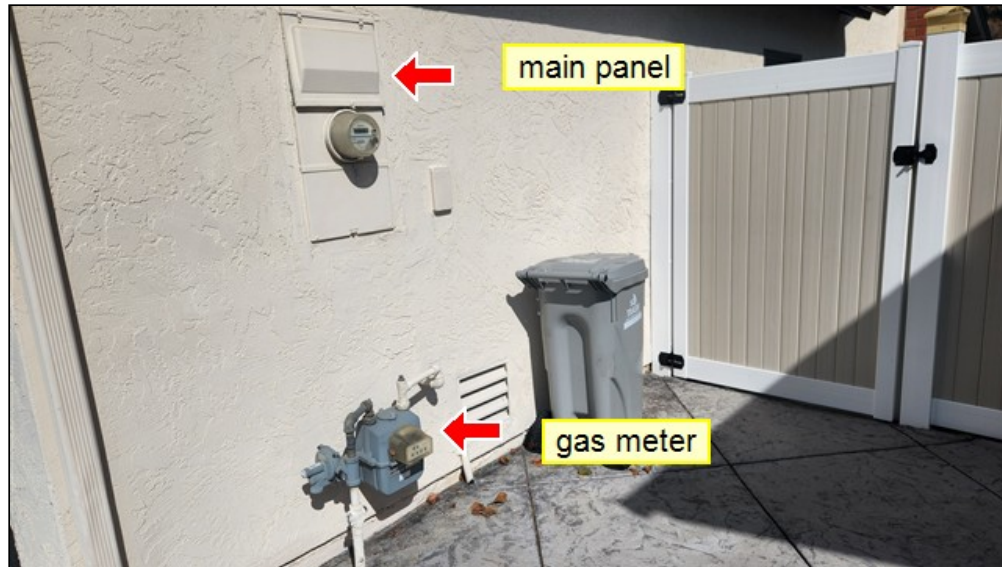
2.1 Item 1(Picture)

**NOTE: Close to Gas Meter.** The electrical panel was located above the gas meter and located less than 3 feet away. **Although this was permitted at the time of construction, some panel upgrades may require the panel to be relocated.** This is noted for your information.

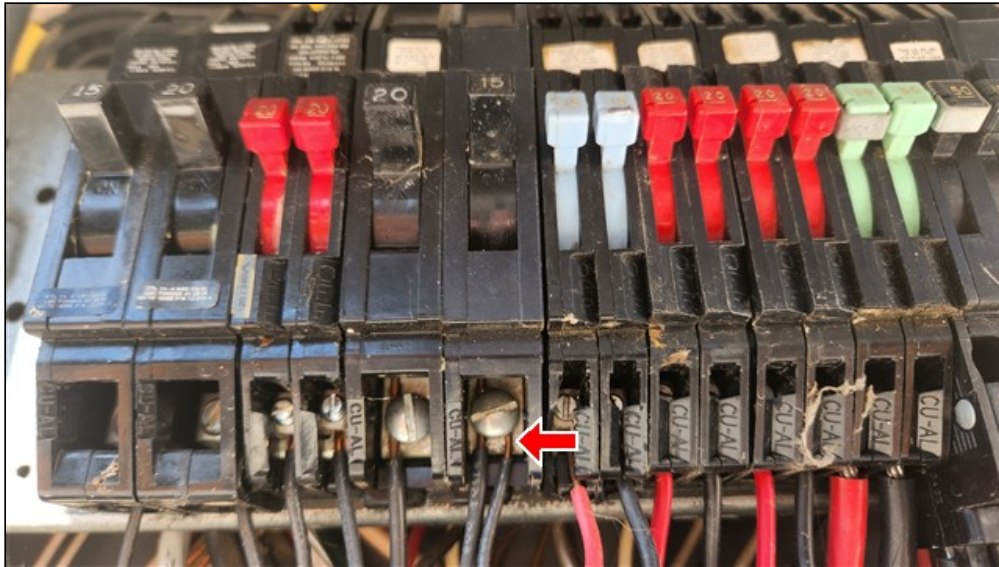
2.3 Item 1(Picture)

**Double Tapping of Breaker.** The main panel has a breaker that is double tapped. Double tapping is when two wires enter a single breaker. This typically occurs when the panel is too small for the current amount of breakers provided, or an additional breaker was just not added. **Recommend further evaluation and repair by a licensed electrician.**

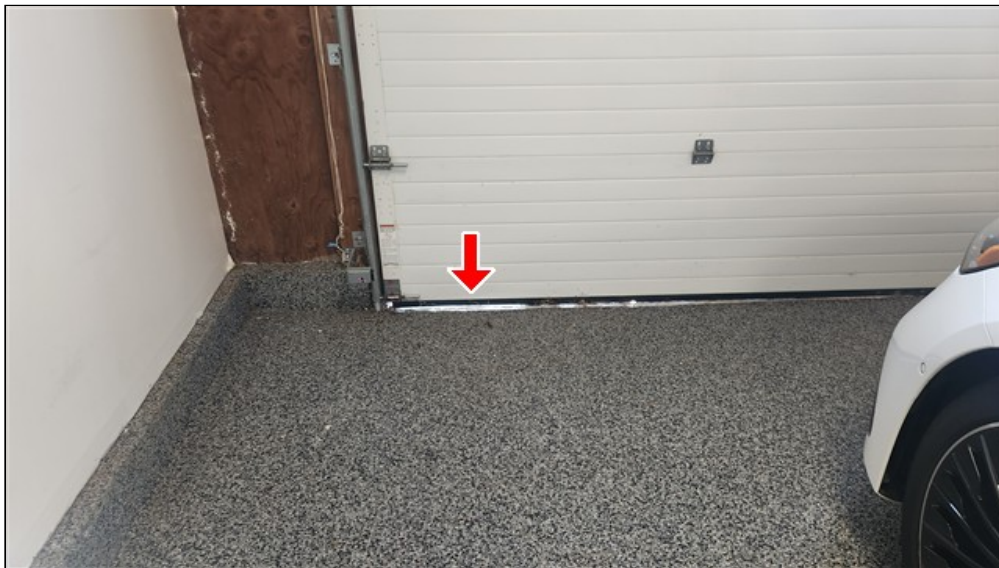
3.0 Item 1(Picture)

**Gap at Door.** The garage door had a gap at the base of the door. This can allow for rodents and other things to enter the garage from the underside of the door. **It is recommended that a weather strip or similar repair be conducted to the base of this door.**

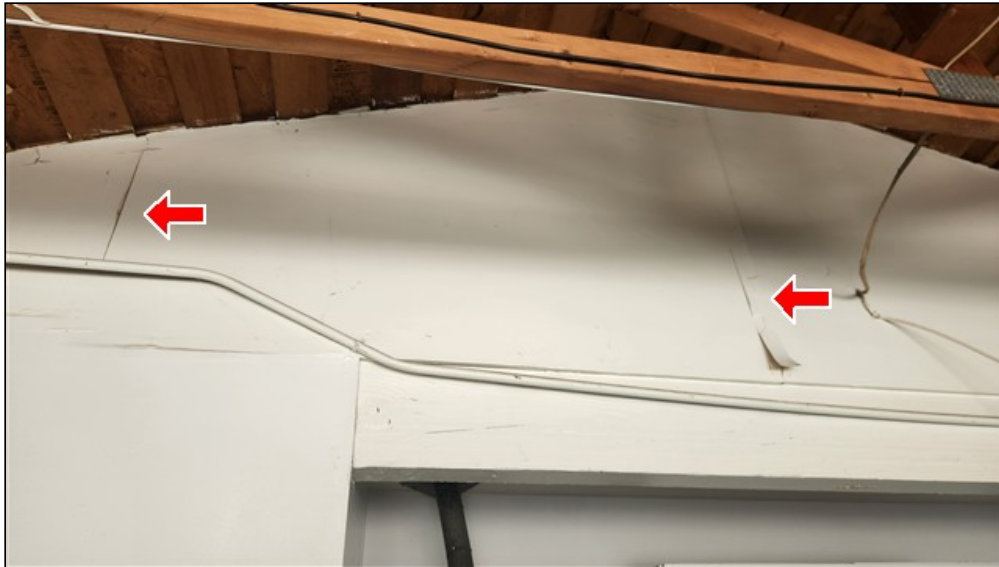
3.1 Item 1(Picture)

**Drywall Not Taped/ Finished.** The Garage wall which connects to the house is a fire rated assembly. Any penetrations to this wall must have proper protection to guard against the spread of fire and spread of carbon monoxide. **Currently there were areas where the drywall was not taped or finished & the tape is coming off.** **Recommend that this wall be properly repaired by a licensed contractor.**

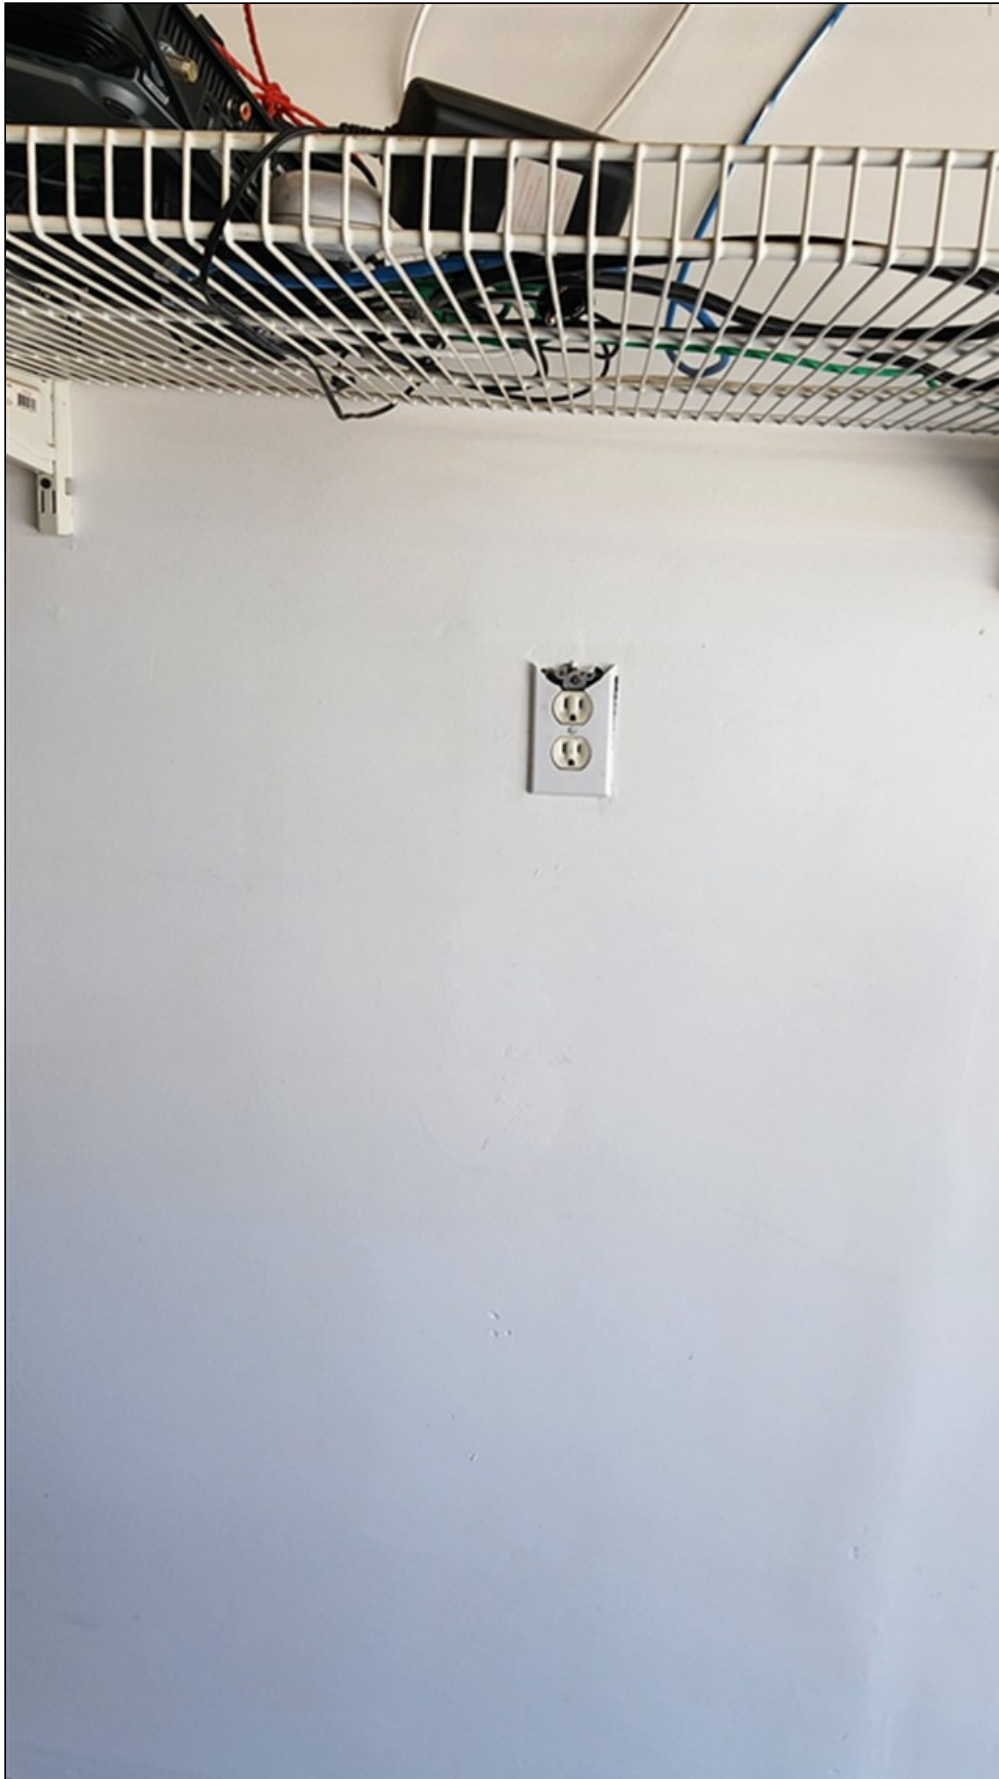
3.6 Item 1(Picture)

(2) **Missing Covers/damaged.** There are some outlets/ switches in the garage that are missing covers or damaged. Missing faceplates expose electrical parts of receptacle outlets, and switches creating a potential shock hazard. **For safety reasons all outlets and switches should have secure covers to reduce the chance of electric shock.**

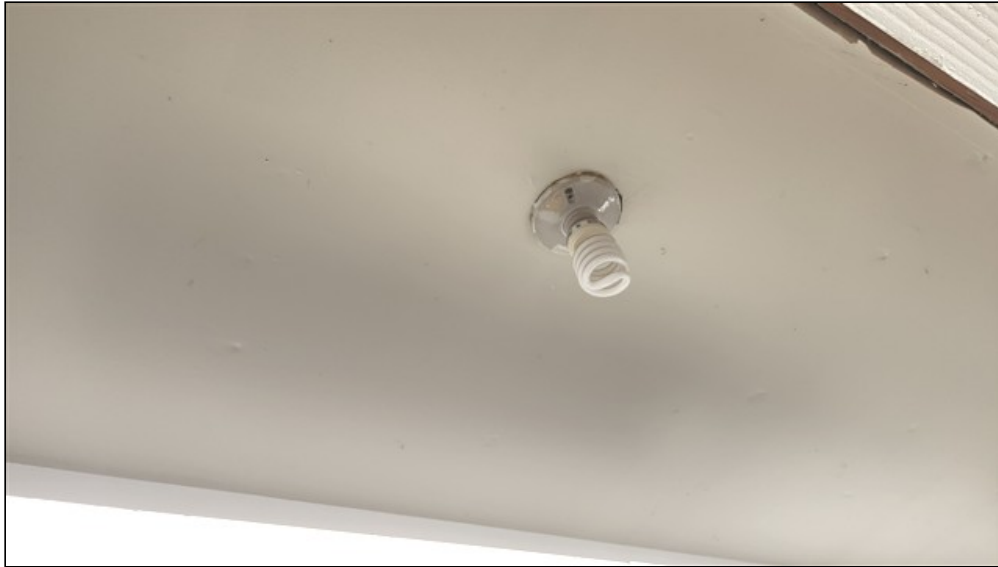
3.6 Item 2(Picture)

(3) [Missing Light Cover](#). The ceiling light was not provided with a globe or cover. This is needed to

protect the bulb & fixture from damaged. It is recommended that the fixture have a cover provided.

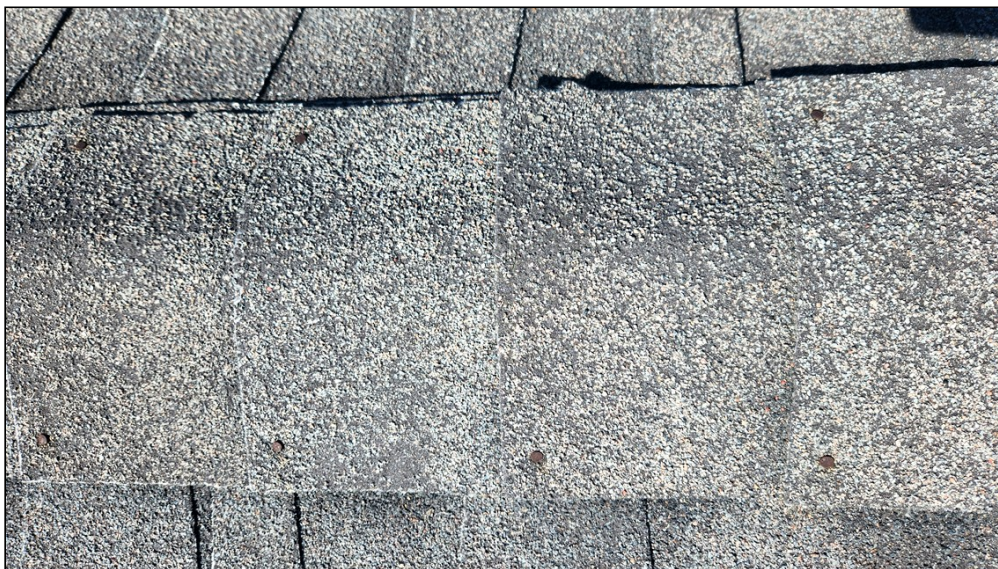
4.1 Item 1(Picture)

(3) **Exposed Nails.** The ridge shingles have exposed fasteners. Roofing materials should not have exposed nails or staples; these fasteners should be covered by roofing material to decrease the chance of leaks. Although it could not verify if current fastener holes leak water during times of rain, it is recommend that exposed nails and or staples be covered by an overlapping roofing material by licensed contractor or roofer.

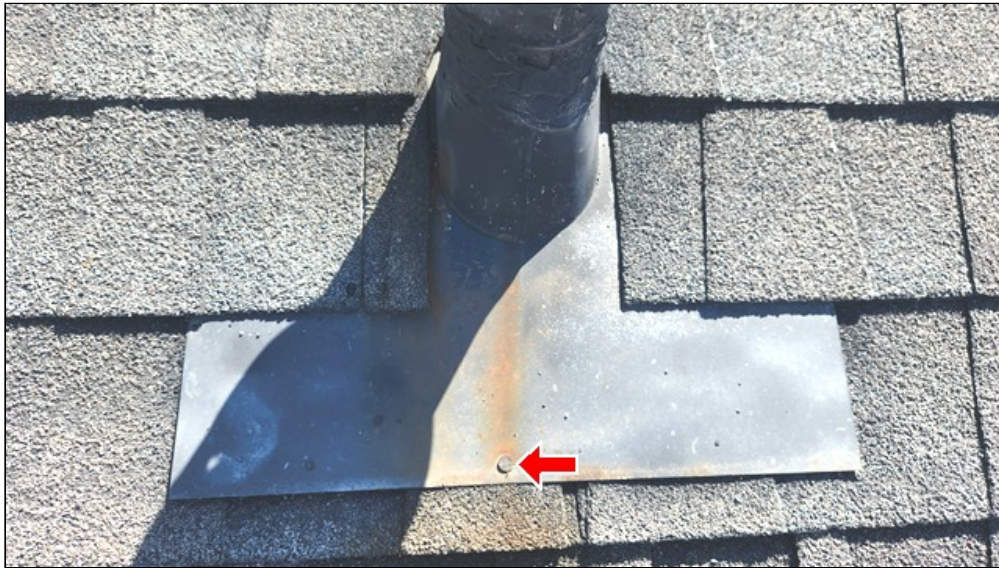
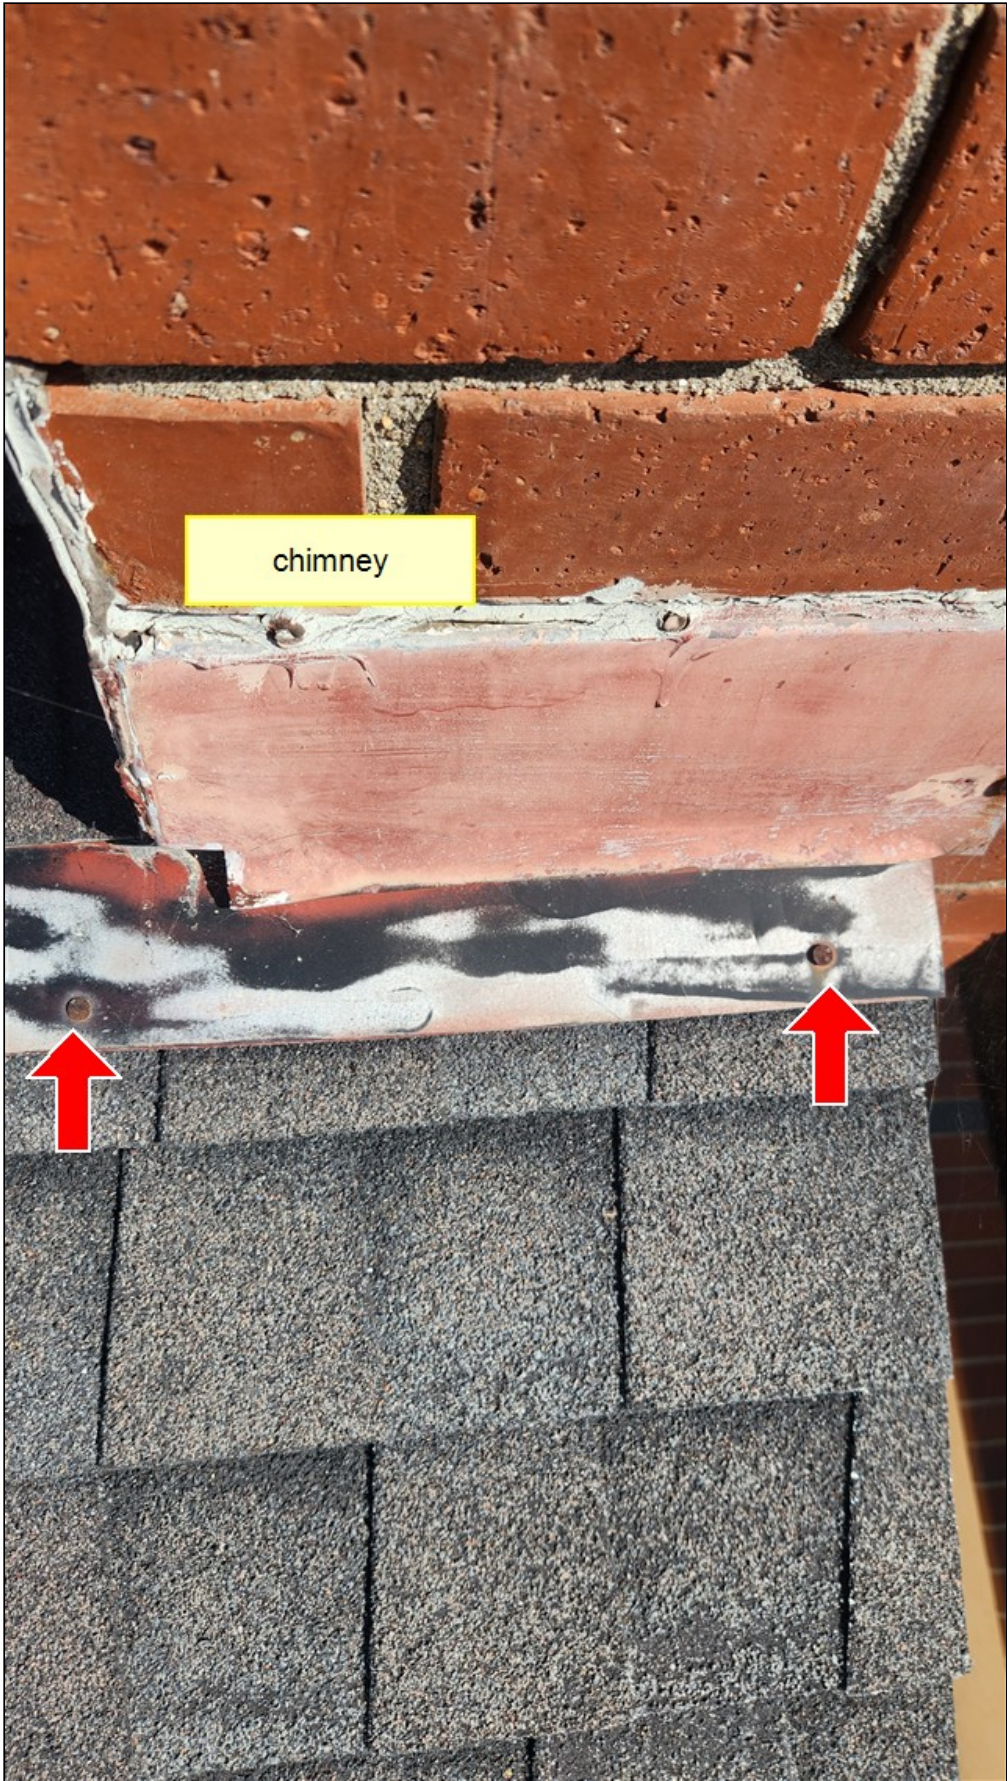
**Exposed Nails at Flashings.** The roof flashings have exposed nails at the vents . Roofing materials should not have exposed nails; these nails should be covered by roofing material or sealed to decrease the chance of leaks. **Although it could not be verified if current nail holes leak water during times of rain, it is recommend that exposed nails be removed and patched or have a waterproofing material applied over each nail.**

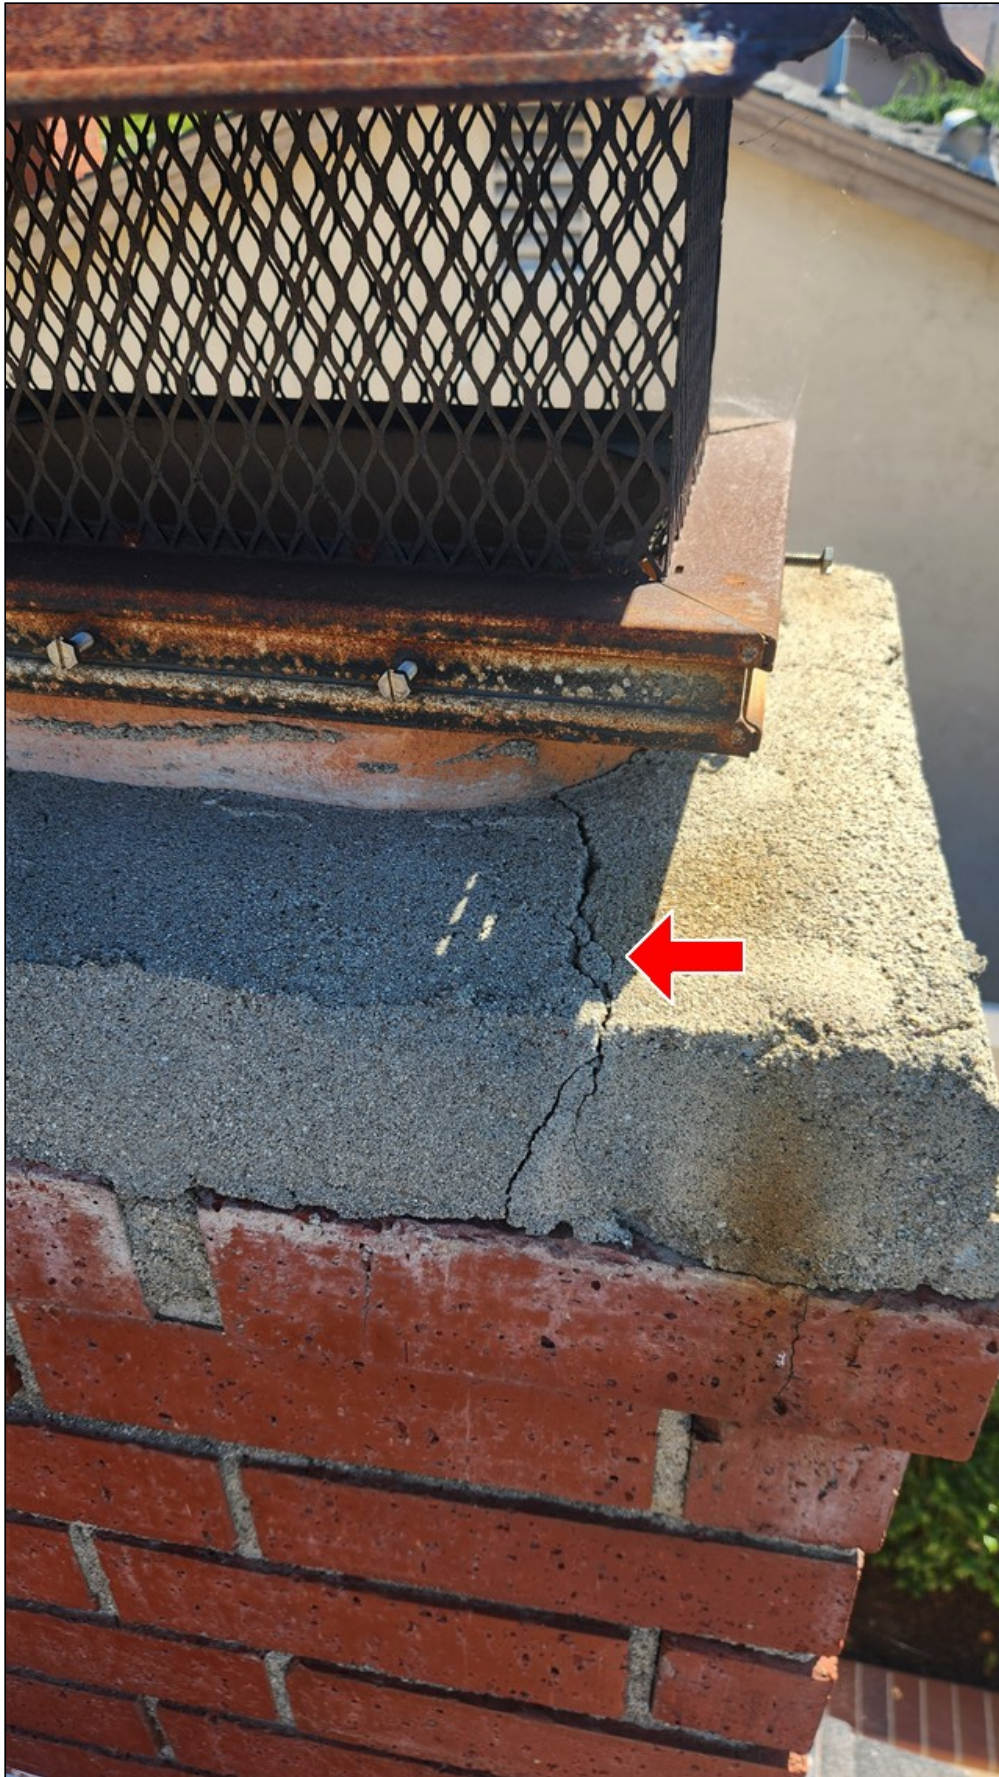
4.4 Item 1(Picture)

(2) [Seal Chimney Cap](#). There were some cracks at the chimney cap. Damaged mortar can allow for leaks into the chimney liner. *It is recommended that the chimney be further evaluated and repaired as needed by a licensed contractor.*
