Al Silva Jr.  
Mr. Home Inspector  
San Diego County

# Inspection Report

**Property Address:**  
2908 Aber St  
San Diego CA 92117

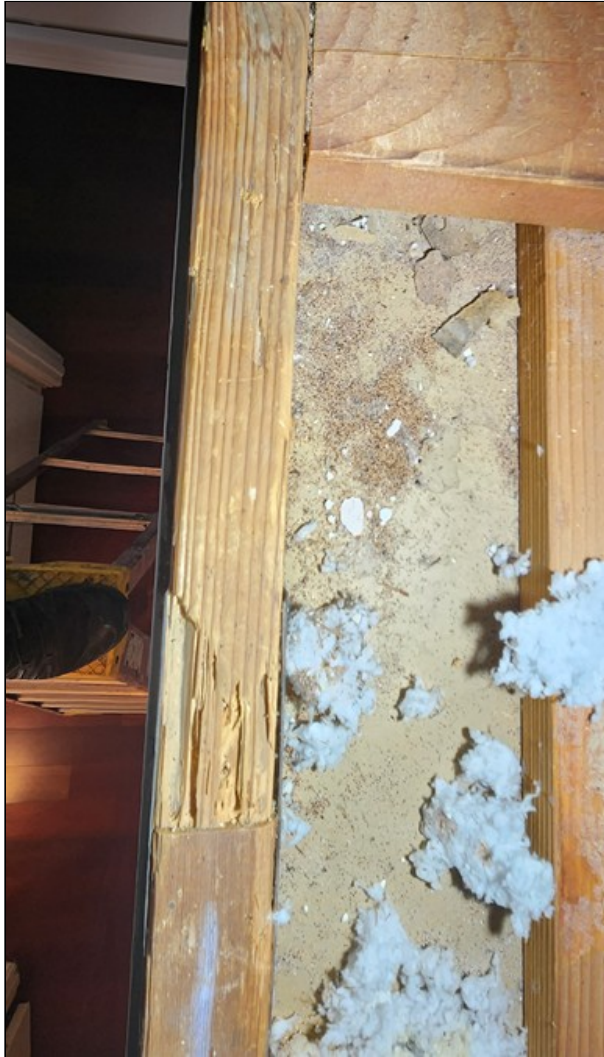
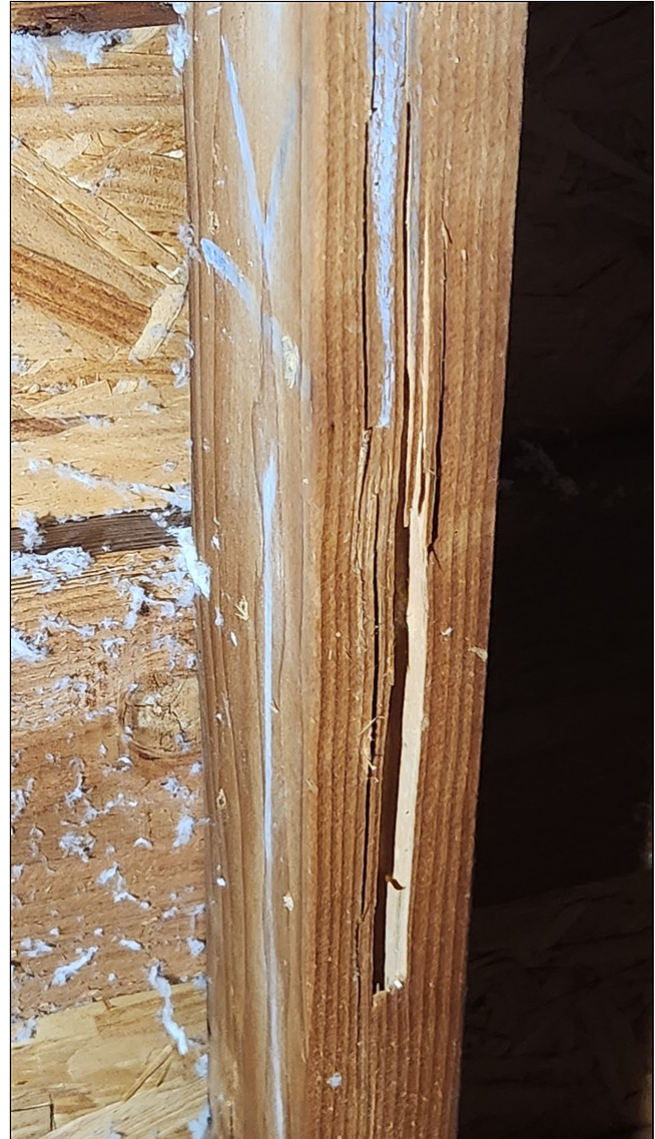
(2) **Insects:** There are signs of wood destroying insects on the floor in the attic. **Recommend reviewing termite inspection report for more information.**

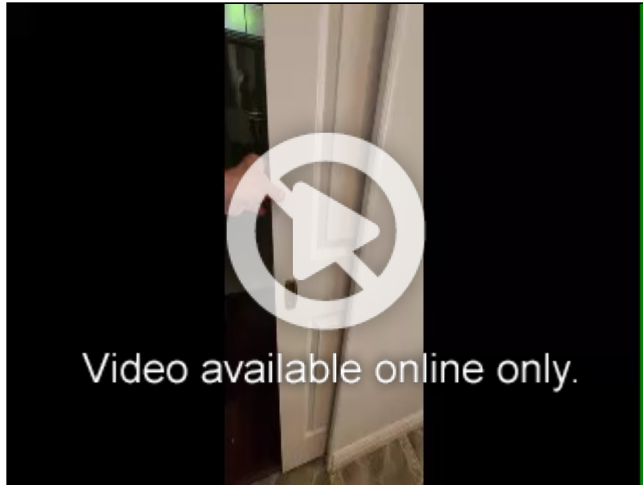
6.3 Item 1(Video)

**Inoperative Pocket Door.** The pocket door at the dining room did not work at the time of the inspection. The door did not properly closet completely. **It is recommended that this be further evaluated and repaired as needed.**

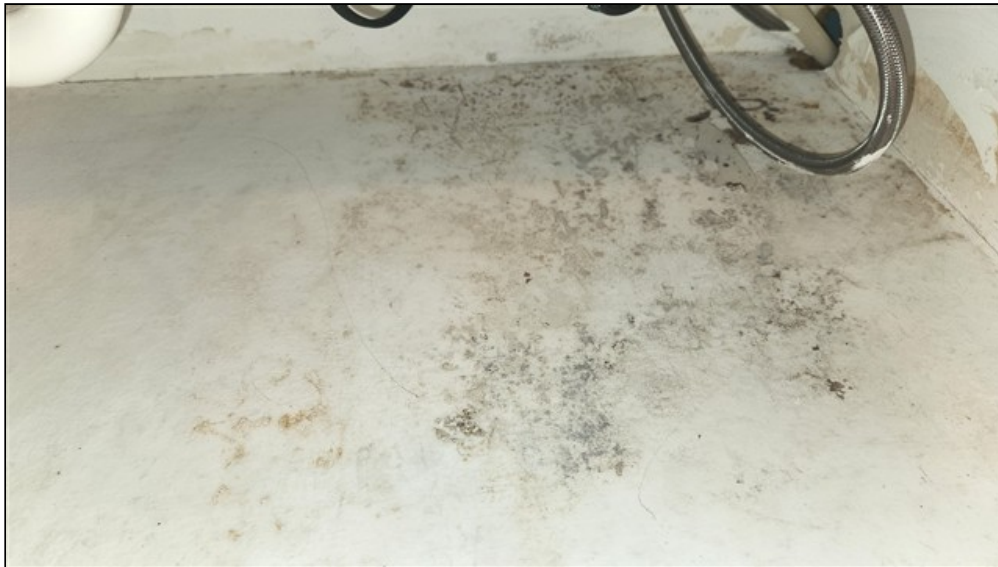
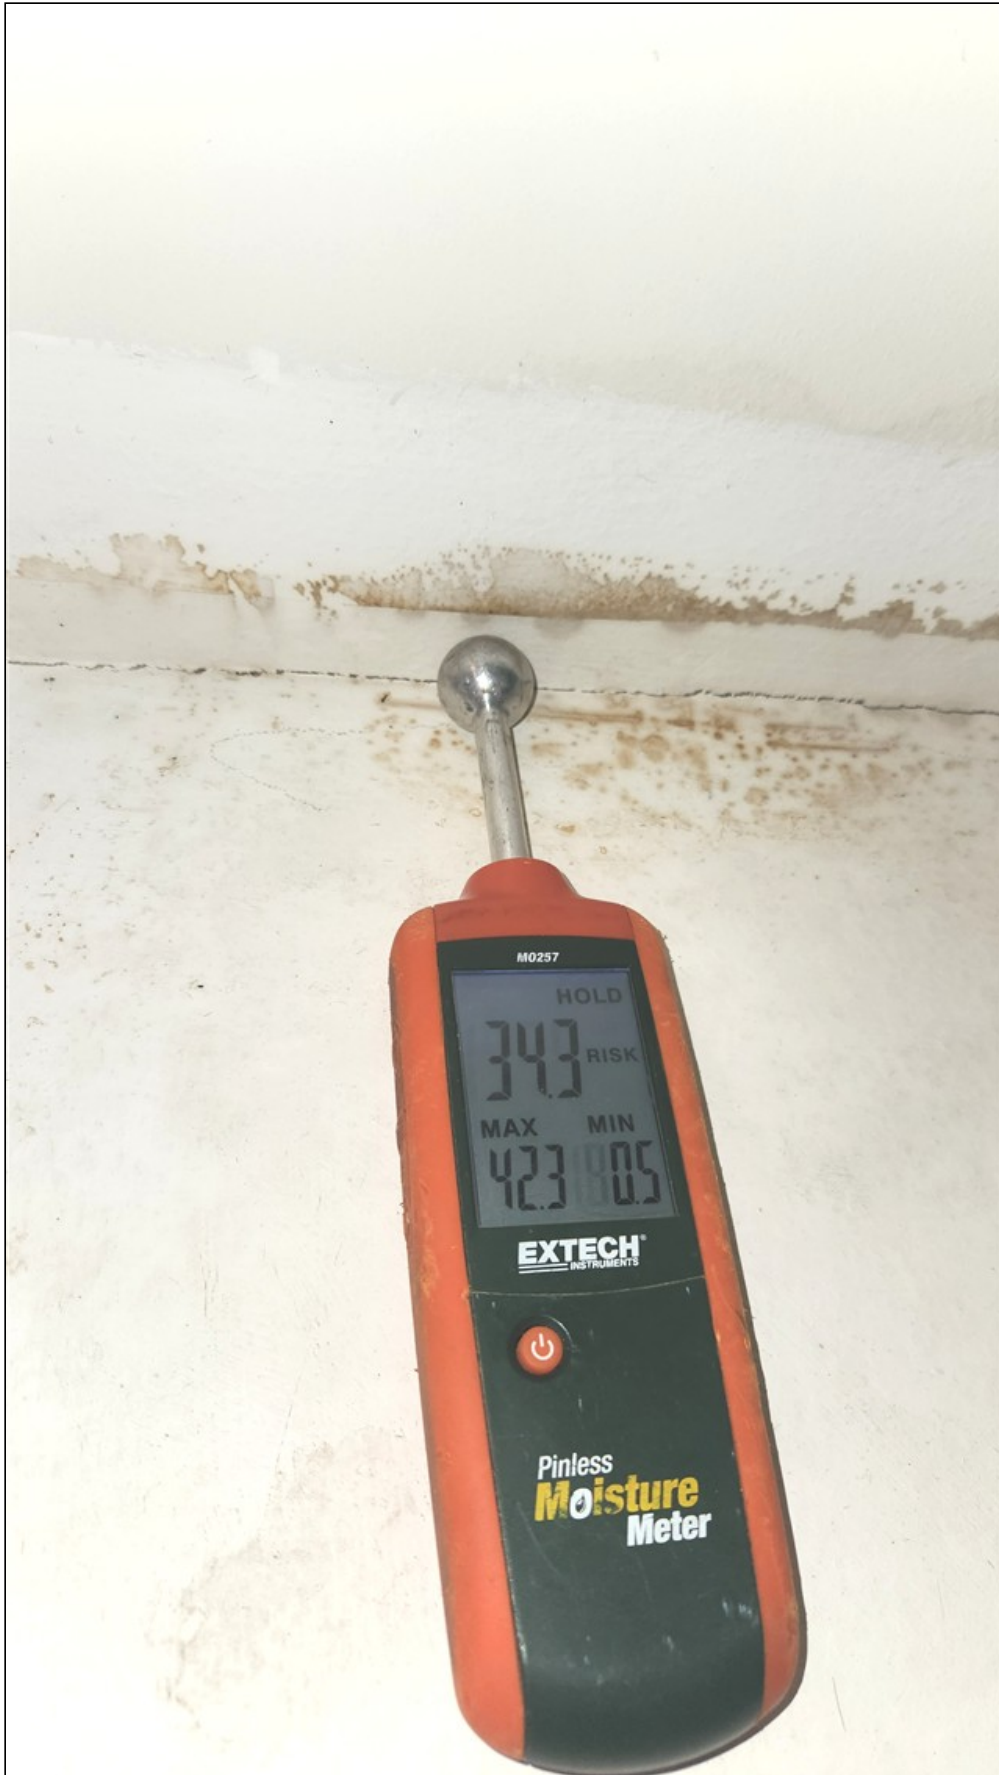
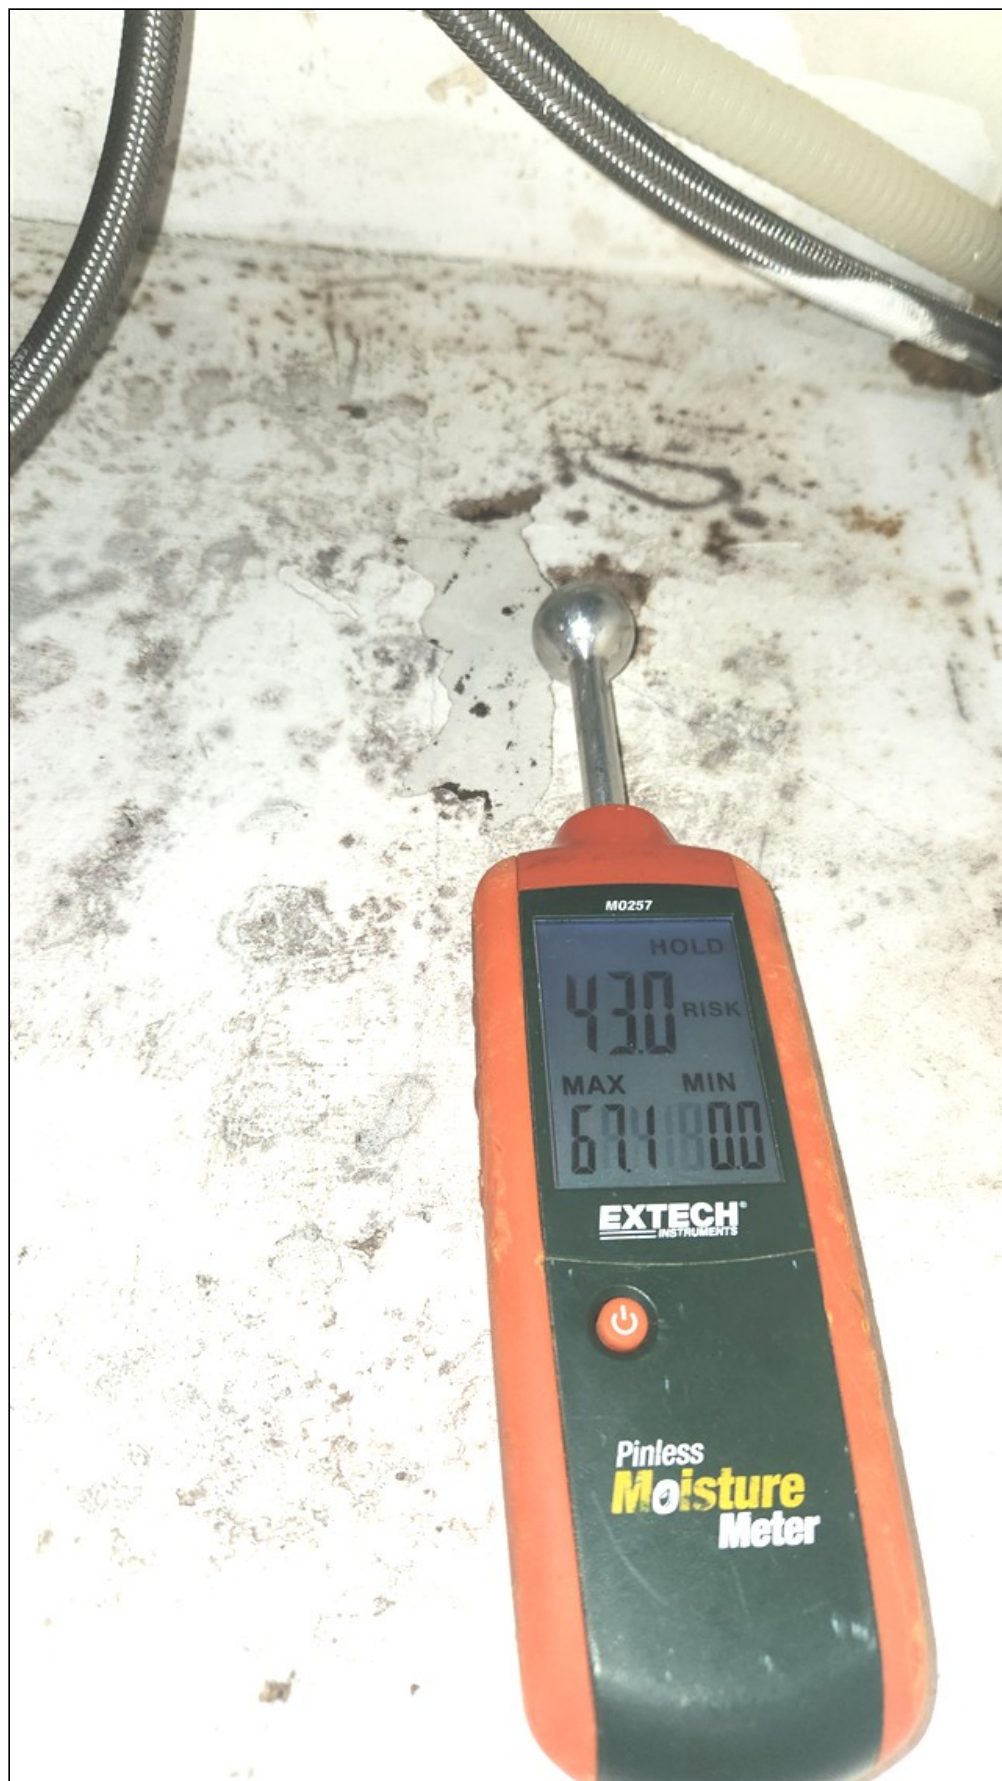
**Cabinet Damage.** It appears that there has been a leak at the sink base cabinet and the cabinet floor has some moderate damage. The cabinet flooring under the sink is made of particle board. Once this material has had water damage it loses its strength, warps and begins to crumble. **The cabinetry test for high moisture reading and there was currently growth noted at this location.** It is recommended that all water damaged materials be replaced by a licensed contractor to decrease the possibility of further damage and growth.

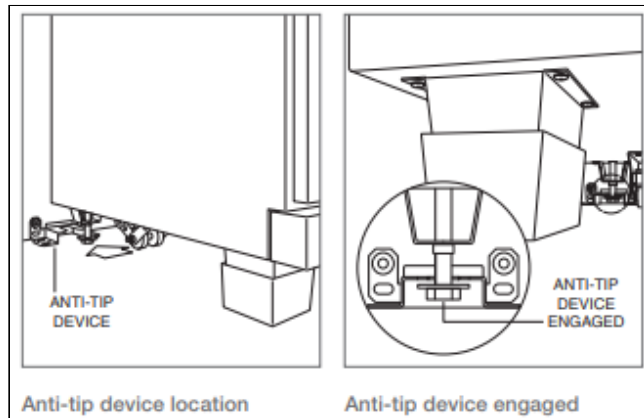
7.7 Item 1(Picture)

**No Safety Strap on Oven.** Ovens come with a child safety strap (Anti-tip strap) to prevent the oven from tipping and falling if children use the oven door as a step. **It is recommended, especially if children are present, that this oven be equipped with a safety strap.**

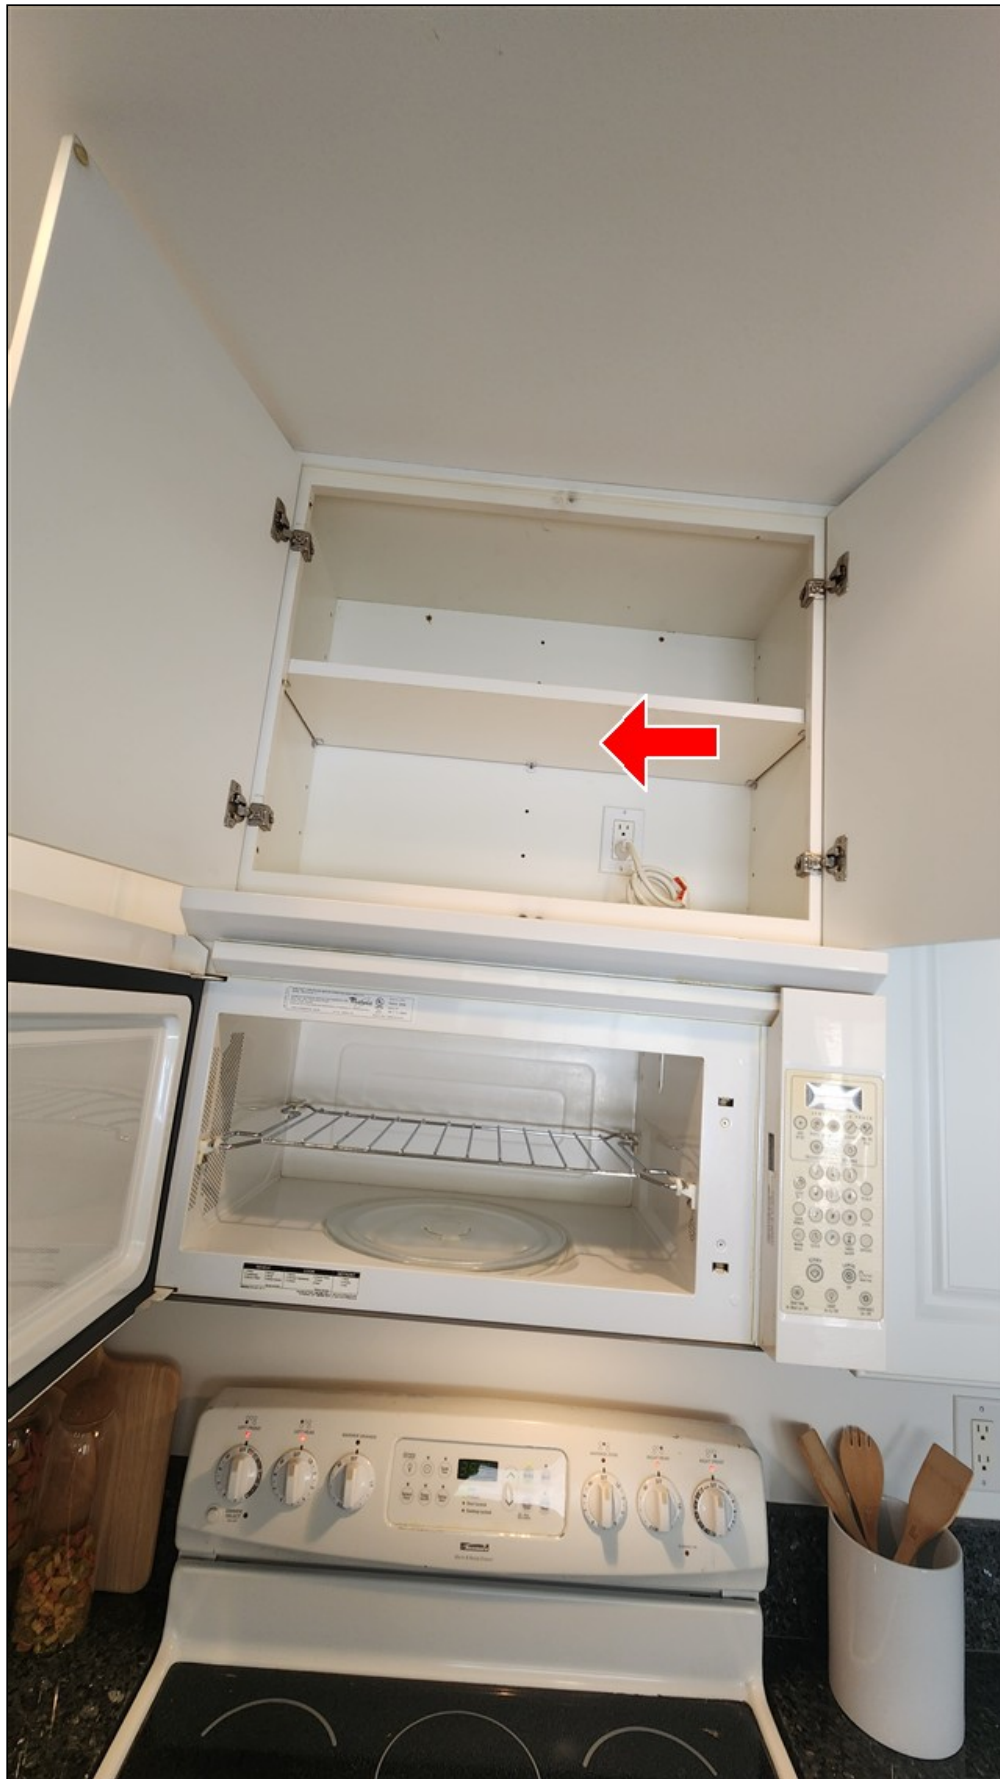
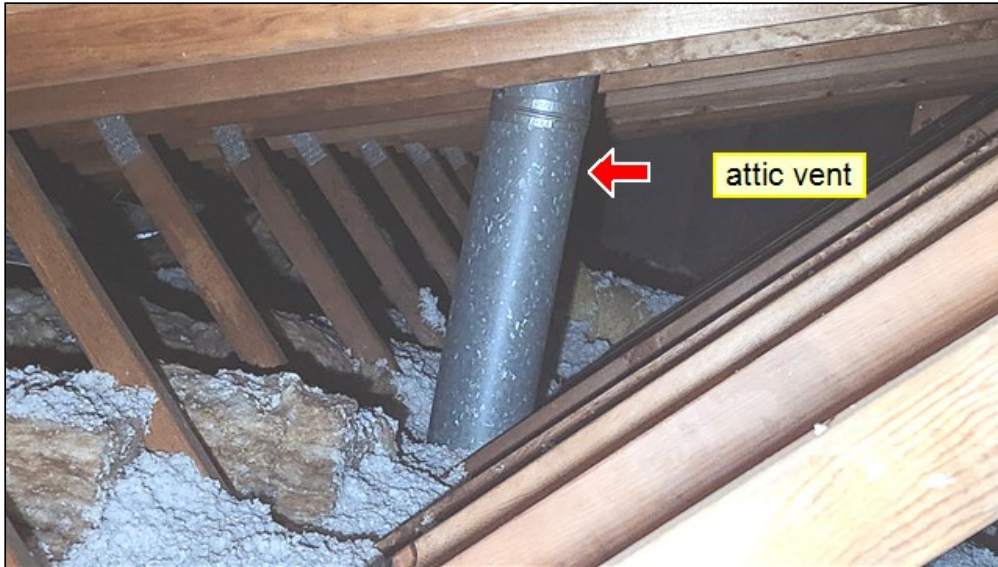
**Not Vented to Exterior.** The kitchen was remodeled and the microwave was not vented to the exterior. The old vent is still installed in the attic to the roof. **For today's standards, most jurisdictions now require venting to terminate to the exterior of the home.** **It is recommended that the vent be properly attached to the microwave by a qualified professional.**

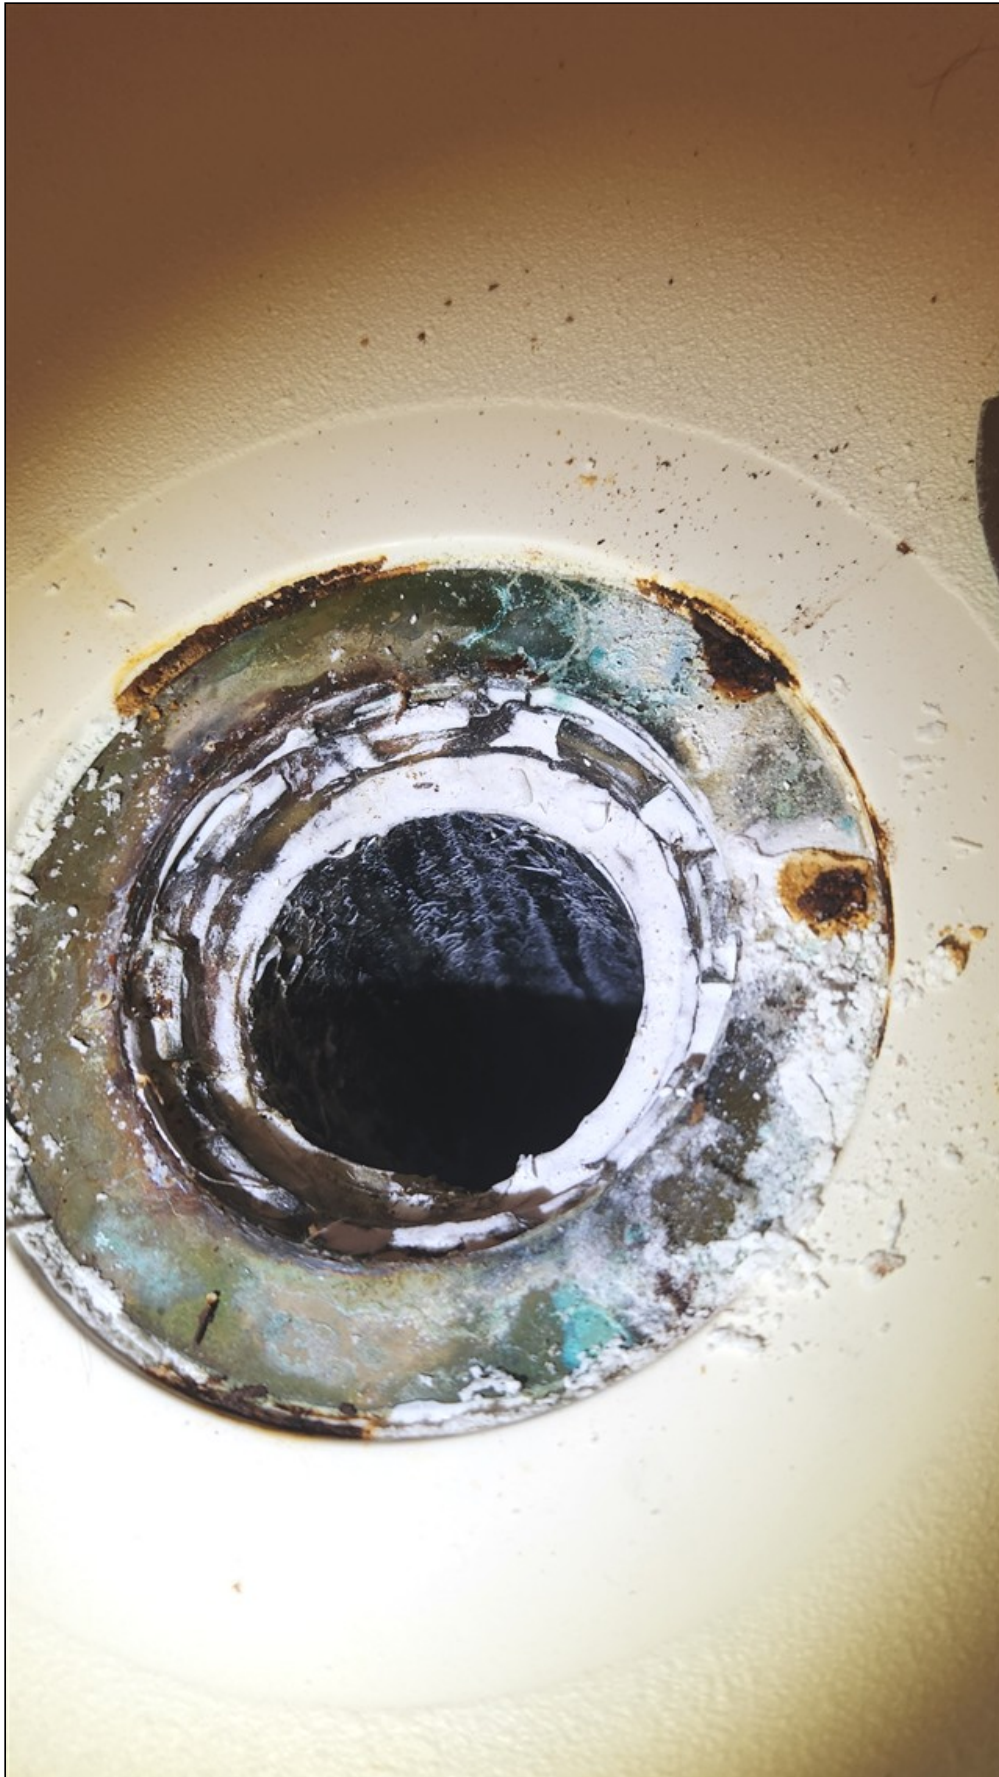
8.6.B Item 1(Picture)

(1) **Drain Weep Holes:** There were no weep holes found at the top of the drain pipe in the shower. Blocked weep holes in the drain flange can allow for water to pool and exit the shower pan enclosure from the underside of the unit. This can cause damage to the exterior walls and floors within the bathroom. It is recommended that this be further evaluated by a tile/bathroom specialist and repaired as needed.

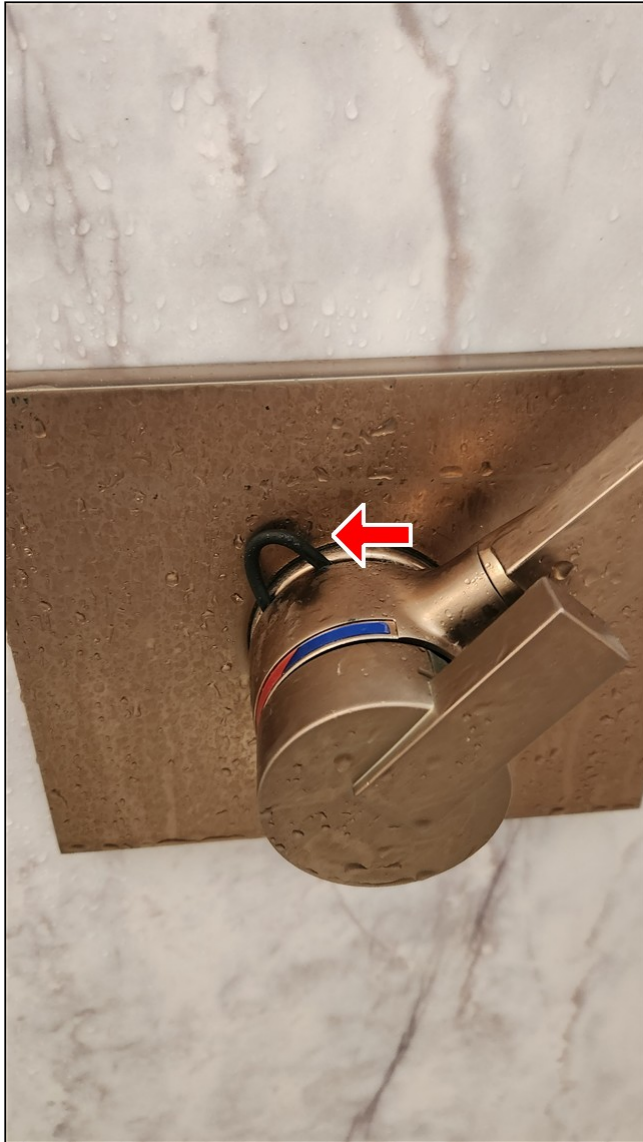
8.6.B Item 2(Picture)

(3) [Fixture Cover](#): The shower fixture has an exposed rubber seal at the cover. This can allow water to

enter into the wall area. Recommend a qualified professional repair or replace as needed.

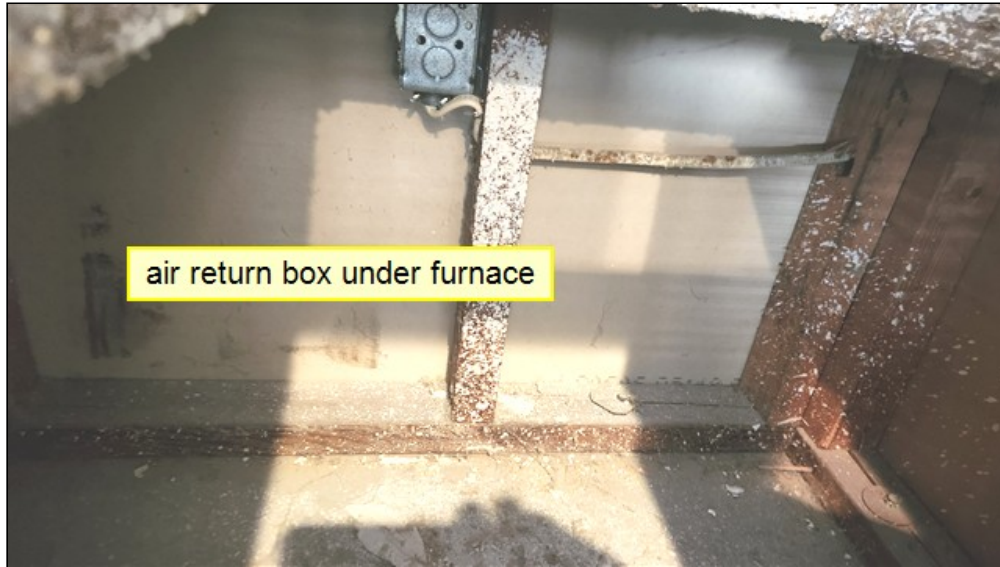
9.4 Item 1(Picture)

(1) **Supply Air Box:** When installing a new HVAC system it is recommended that the supply air box be sealed to prevent any cross contamination between intake & exhaust air. Also this will keep any foreign matter like insulation from being distributed into the living area. **Recommend a licensed HVAC company inspect & advise on any needed upgrades**

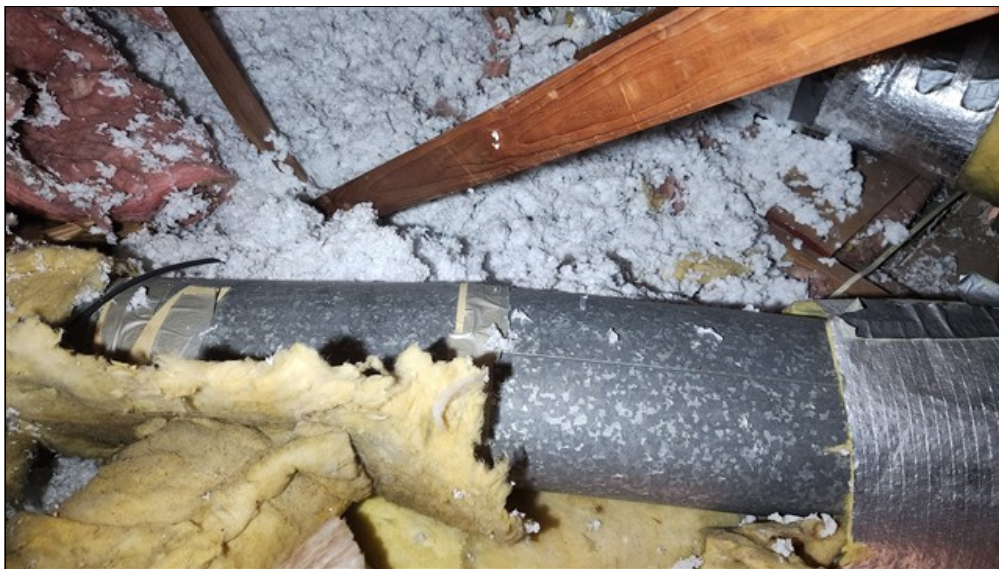
9.4 Item 2(Picture)

(3) **Damaged Insulated.** Some sections of the HVAC ducts have damaged, insulation that is pulling from the duct. The ducting was not all insulated. This can affect the efficiency of your HVAC system. **It is recommended that these areas have insulation provided to decrease heat/ cooling loss and increase energy savings.**

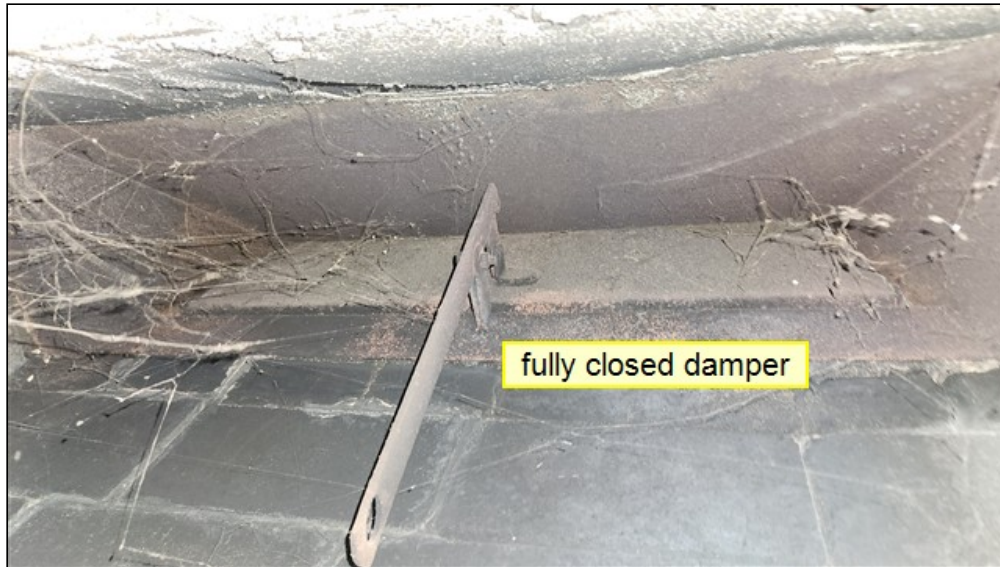
9.7 Item 1(Picture)

(2) **No Damper Lock.** The chimney damper for gas fireplaces, should be locked in the "open" position. This is to ensure that gas can properly vent if there is a leak, or the gas was accidentally left on. **It is**

recommended that a flue clamp be installed at this damper.

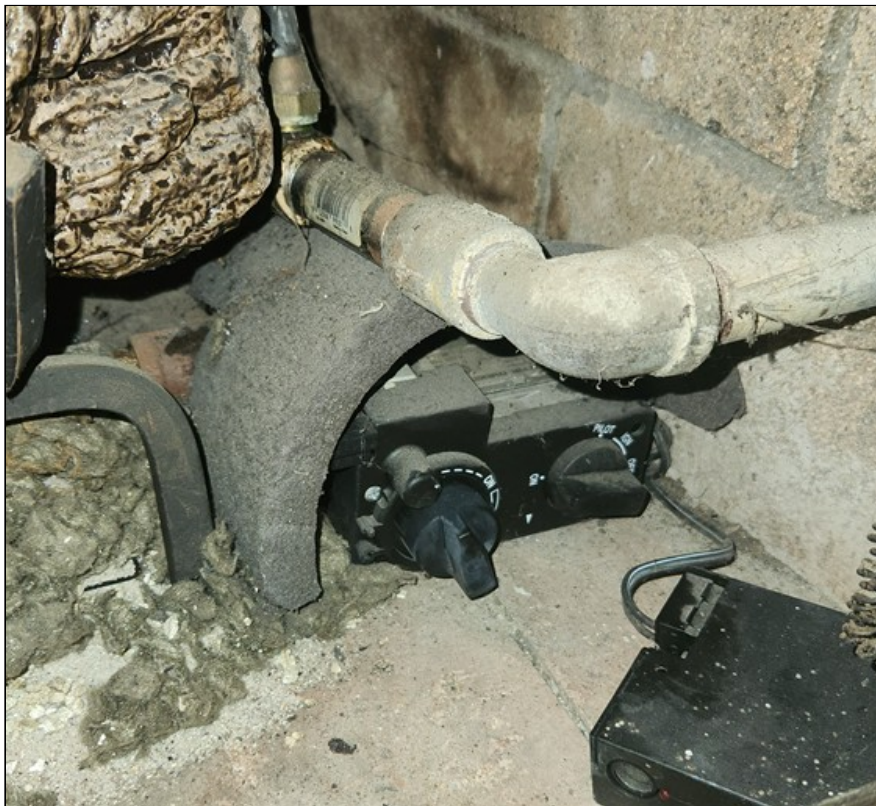
9.7 Item 2(Picture)

(3) **Ignitor system:** There is an ignitor system installed inside the fire box. The gas was on at the shutoff but the polite was not on. For safety reasons we do not light polite lights. The system was turned on but did not work. **Recommend the fireplace be fully inspected buy a professional before using.**

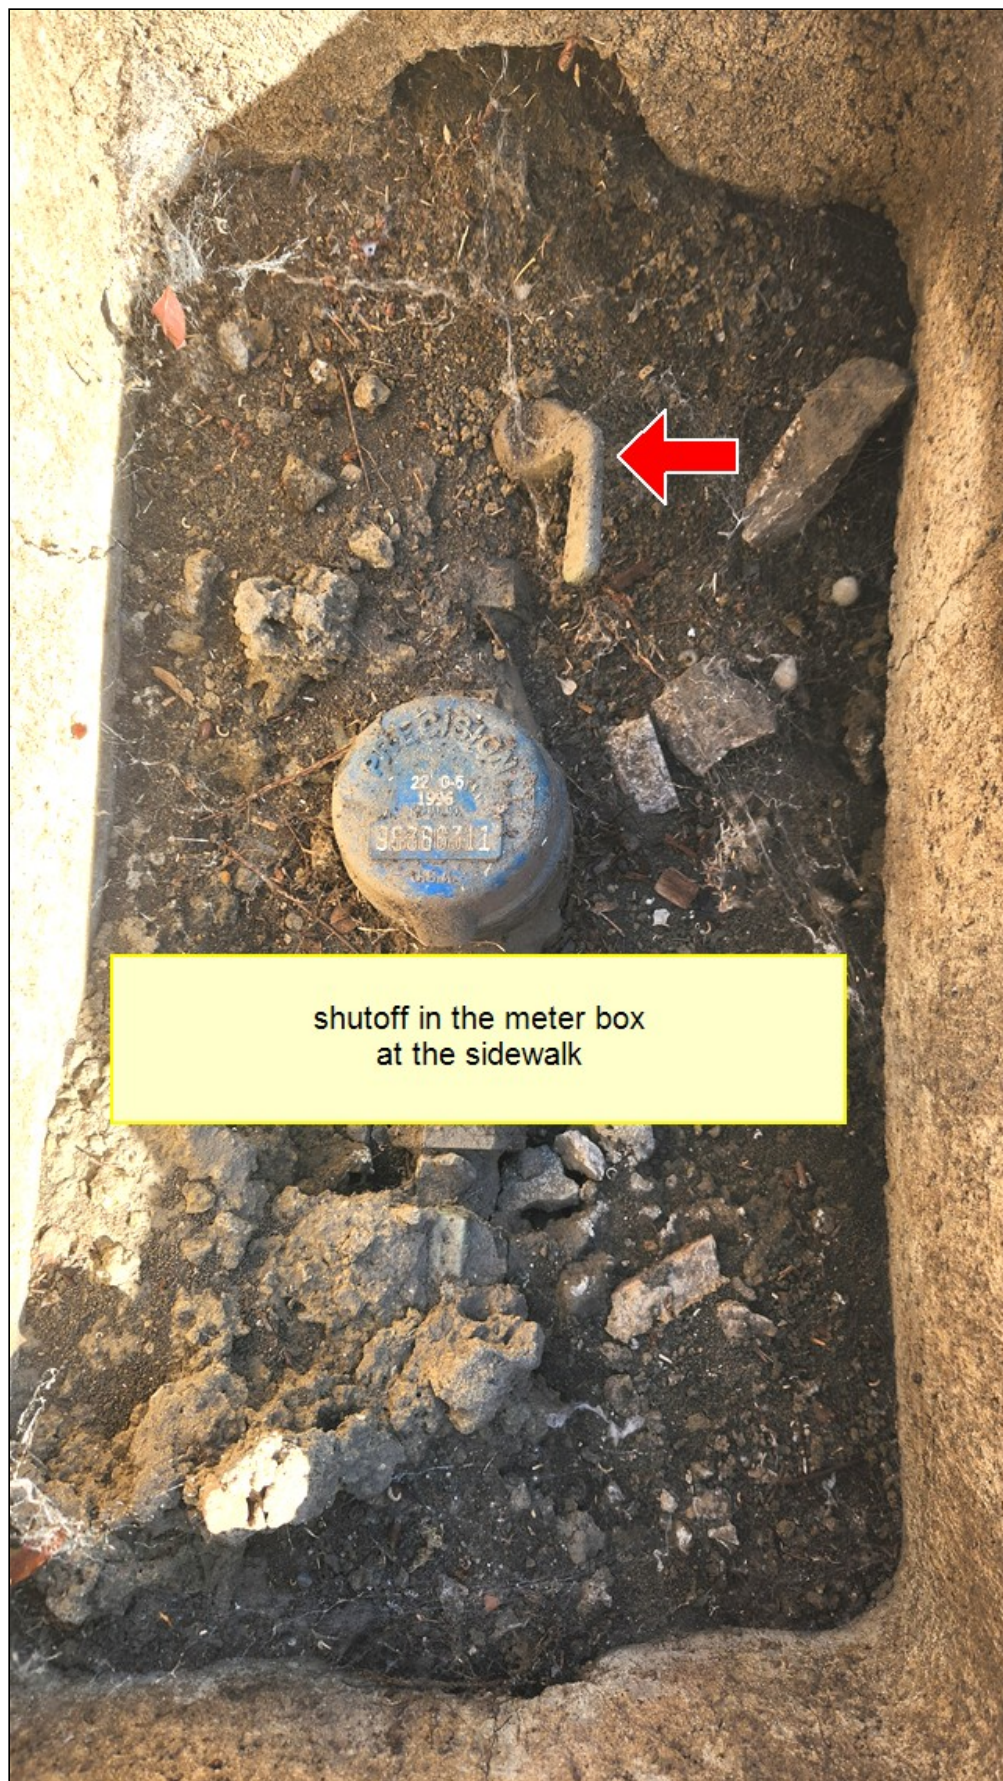
10.0 Item 2(Picture)

shutoff in the meter box  
at the sidewalk

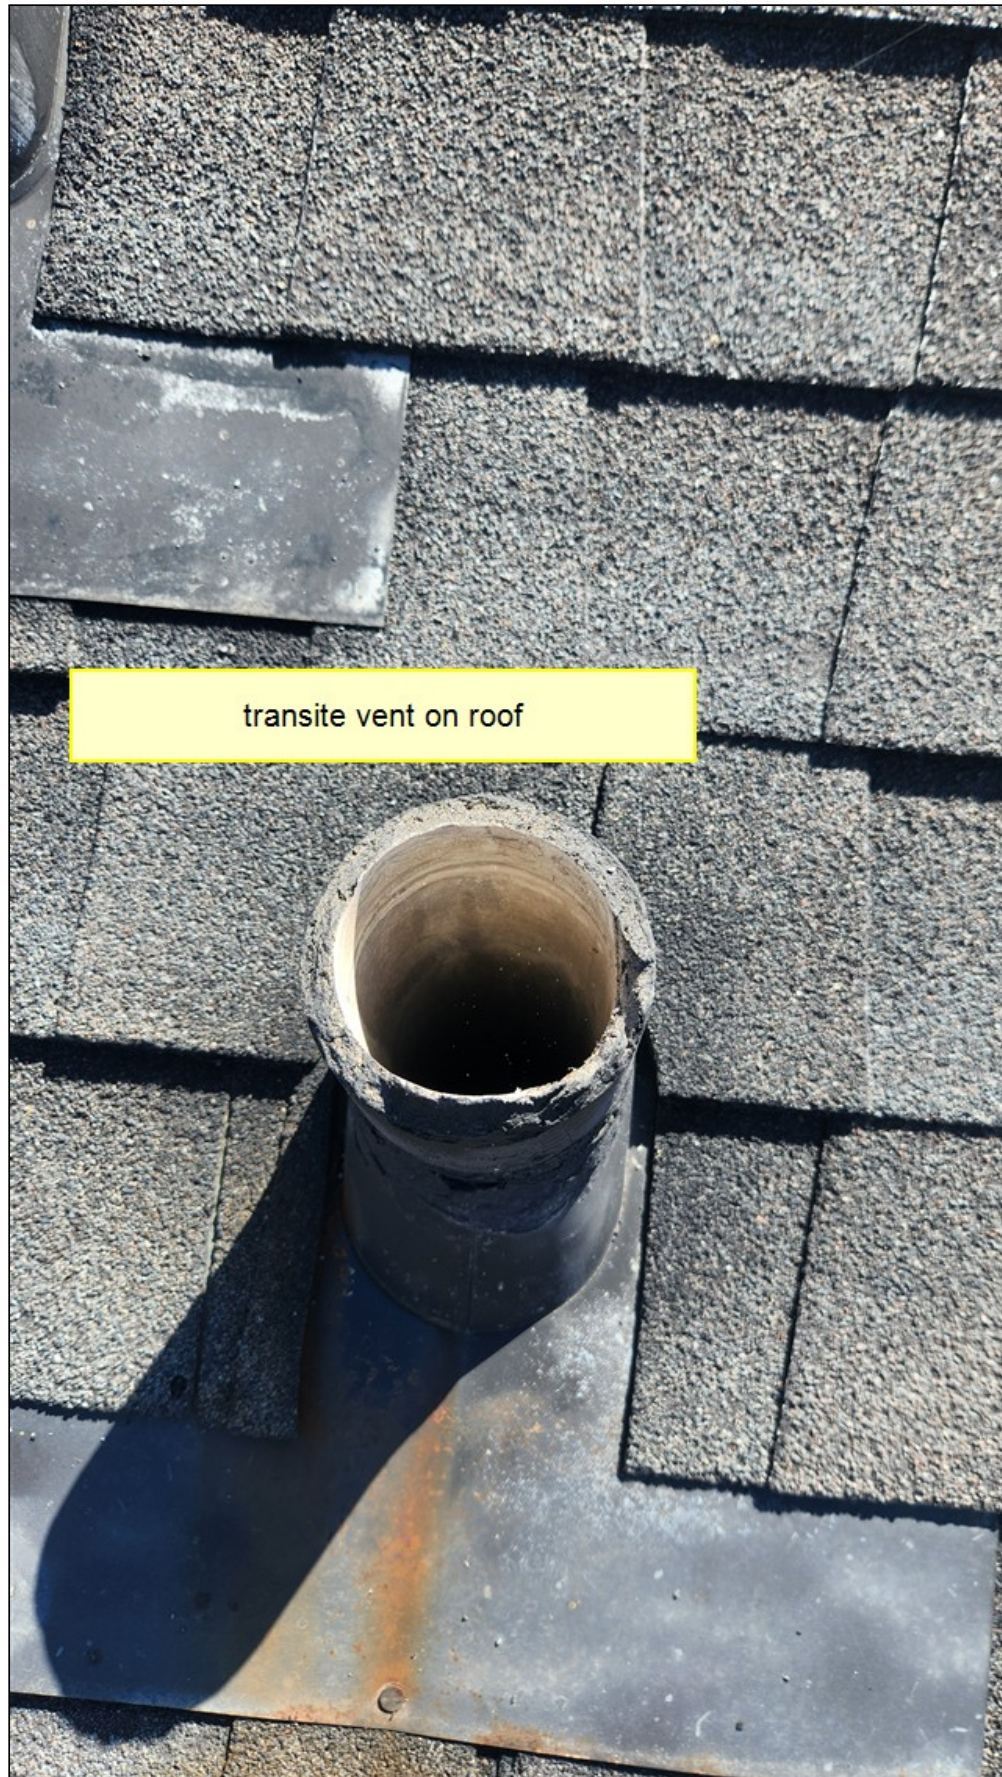
10.3 Item 1(Picture)

(1) **Metal/Transite:** The water heaters vent pipe is a combination of steel & "Transite" pipe which are jointed together. This combination of these dissimilar materials can cause unwanted condensation of flue gases inside the vent which can drip back into the gas appliance and hasten deterioration of the vent and appliance. It is recommended that the vent be replaced with similar materials the entire distance of the pipe to prevent any unwanted condensation and potential damage. **Recommend repairs by a licensed plumbing contractor.**

**NOTE: Transite Vent Pipe.** It was noted that the water heater provided for this home appears to have a Transite vent pipe. Transite has a high probability of containing asbestos, a material that if damaged or disturbed can cause serious health risks. For more information about this material please read the provided links found in **Section 1.13.** of this report.
