Inspection Report

Property Address:
10280 Caminito Rio Branco
San Diego CA 92131

Date: 8/5/2025	Time: 09:00 AM	Report ID: 20250805-10280-Caminito-Rio-Branco
Property: 10280 Caminito Rio Branco San Diego CA 92131	Customer: Keenan Kribs	Real Estate Professional: Ted Kavich Ready Homes

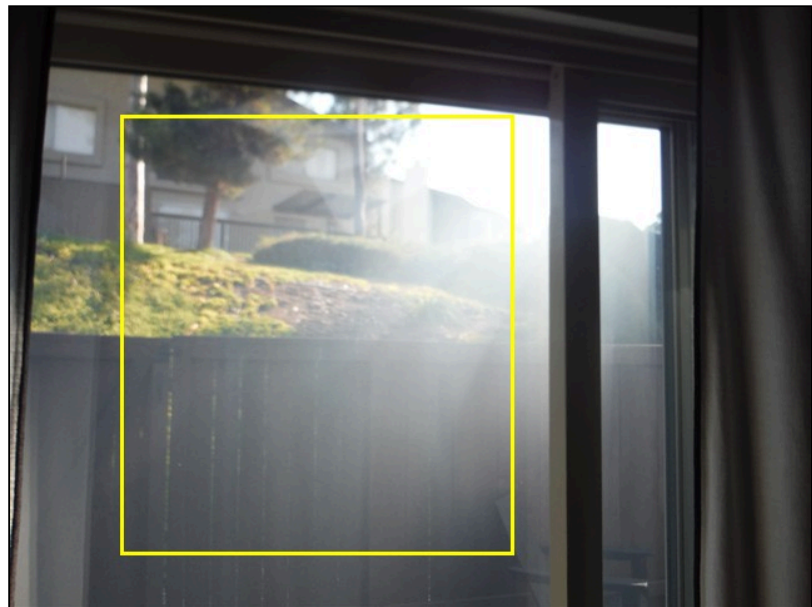
2.2 Item 1(Picture)

(1) Condensation was observed between the panes of glass at one or more window(s). This occurs when the seal has failed between the panes of glass, and ambient air has entered the assembly. Replacement of the glass is required. Since some failed windows may not be easily found due to changing ambient conditions (heat, humidity, etc). We recommend having all of the windows reviewed by a licensed window contractor to determine how many windows require repair/replacement. We recommend repairing or replacing all windows that have failed window seals by a qualified licensed window

contractor.

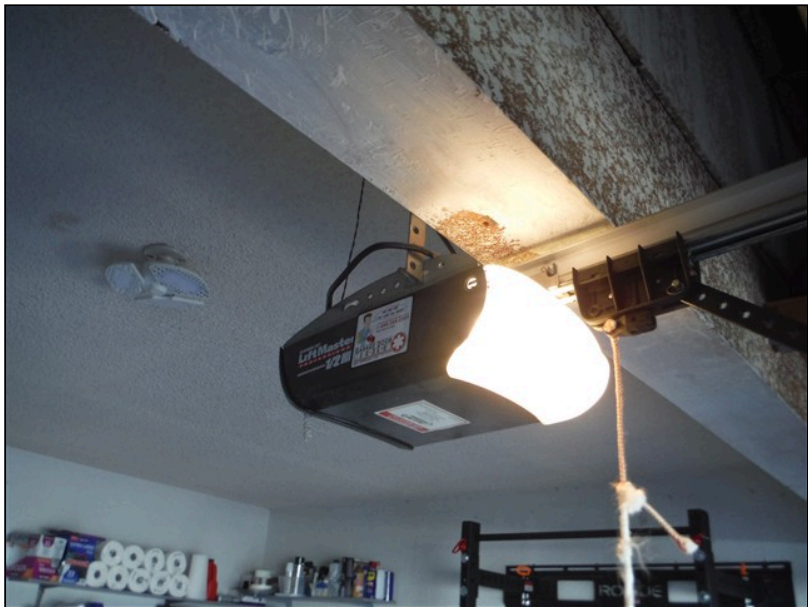
3.1 Item 1(Picture)

(1) The garage door opener did not reverse when met with resistance. The force sensor prevents the garage door from becoming damaged, or from causing injury if the door is prevented from closing. We recommend having a qualified licensed garage door contractor service the garage door opener prior to the end of your contingency period so the door will reverse easily when met with resistance.

Note: Photo eye sensors are in place and will reverse the garage door.

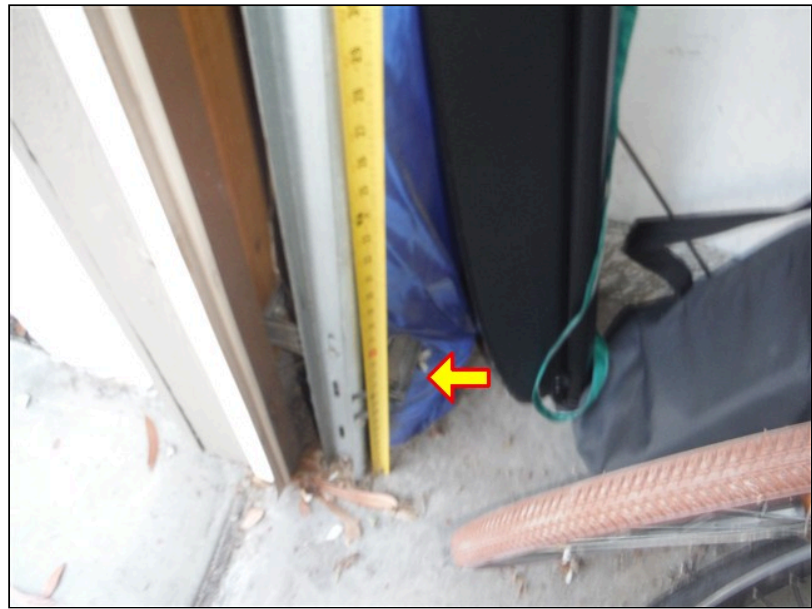
3.1 Item 2(Picture)

(2) The safety reverse photo-eye is mounted at an incorrect height from the ground. Most manufacturers recommend mounting these devices at about 4"-6" from the ground

for safety. We recommend necessary corrections by a qualified licensed garage door contractor.

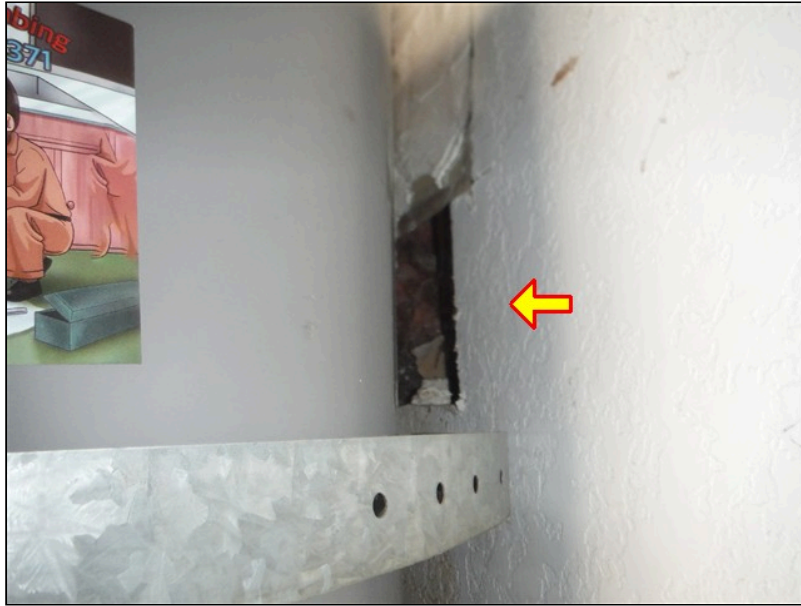
3.3 Item 1(Picture)

(1) There are one or more holes observed in the fire wall in the garage. Wherever the garage shares a wall with adjacent living space, the fire-rated sheetrock must be installed and intact for fire resistive performance. We recommend having the holes patched with fire-rated drywall or necessary corrections by a qualified licensed contractor.

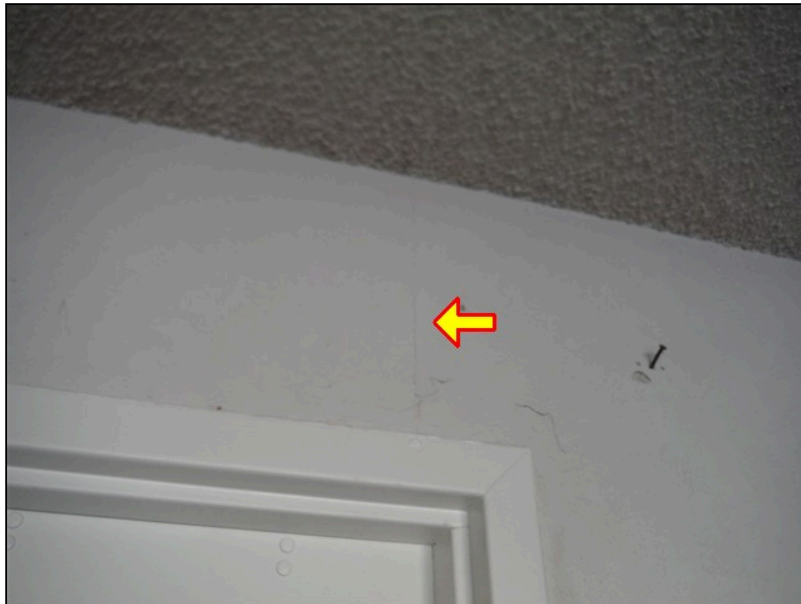
3.3 Item 2(Picture)

(2) Hairline cracking was observed at the garage walls in areas. These hairline cracks are likely due to material shrinkage or settlement of the structure. We recommend prep and paint by a qualified licensed painter.

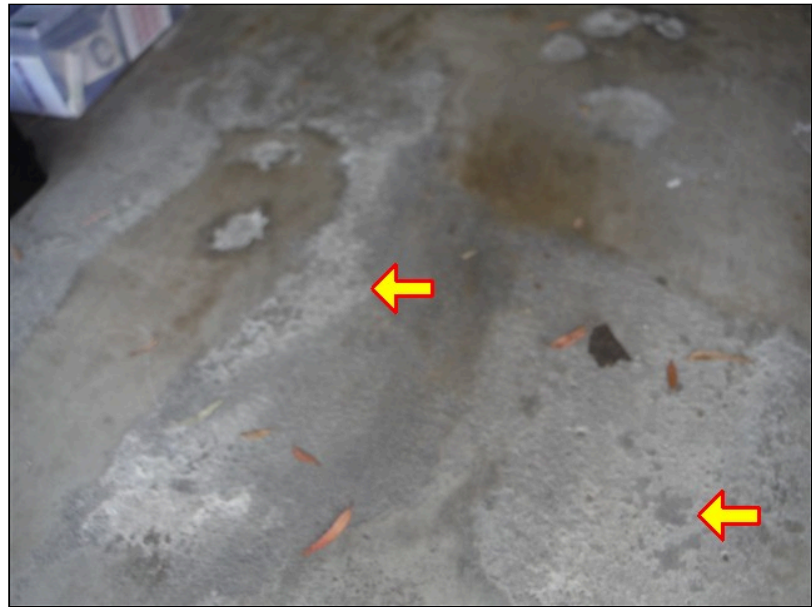
3.4 Item 1(Picture)

(1) Spalling/ flaking noted at the garage floor in areas. We recommend corrections as needed by a licensed concrete contractor.

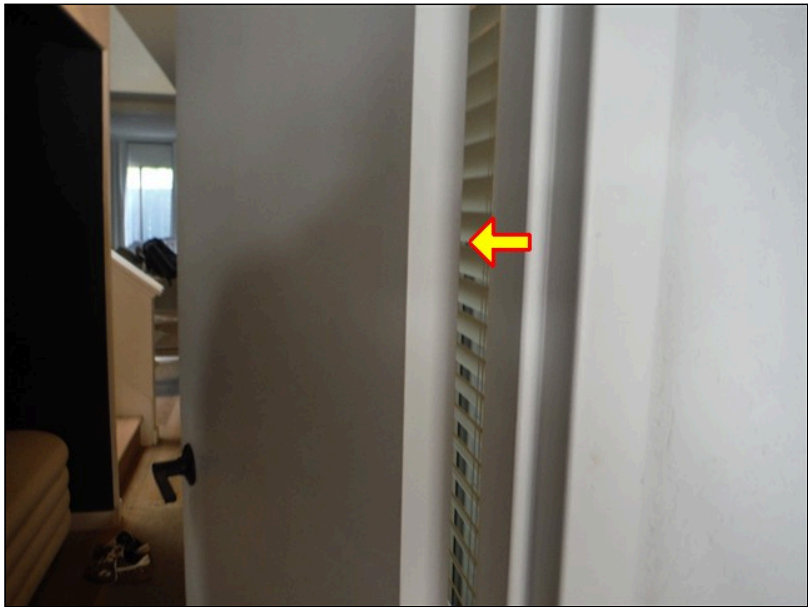
3.5 Item 1(Picture)

The door between the house and garage did not have a Fire Rating Certificate or Plate. Without a plate, I could not confirm whether the door meets fire code safety requirements. We recommend further evaluation by a licensed door contractor. The "fire door" is required to meet one of the following characteristics:1-3/8 inch thick solid wood, 1-3/8 inch thick steel shell door with Honeycomb core, Fire-rated (with certificate plate). If the door is not rated as a fire door we recommend replacing by a qualified licensed door contractor for safety.

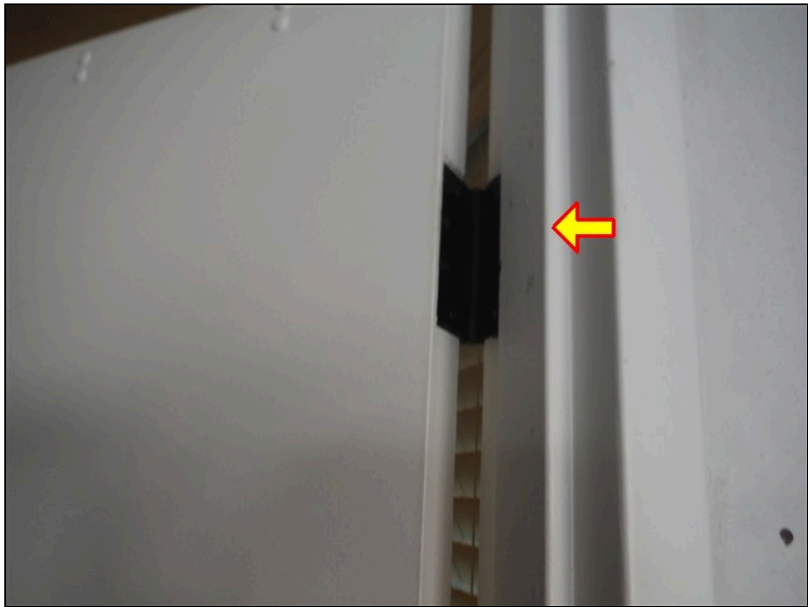
3.6 Item 1(Picture)

The self closing device at the fire door did not adequately close the door. The auto closer must close the door within 3 seconds with enough force to latch the door. We recommend adjusting or replacing the device or hardware by a qualified licensed door contractor.

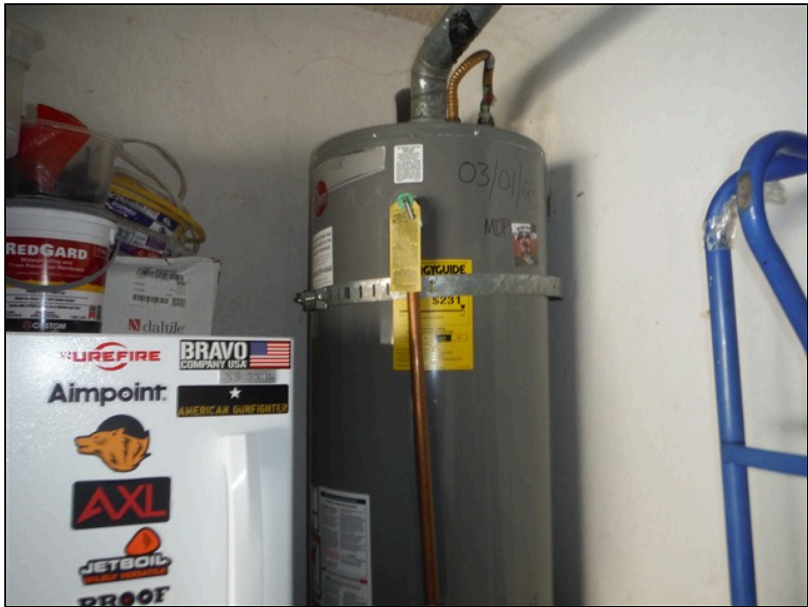
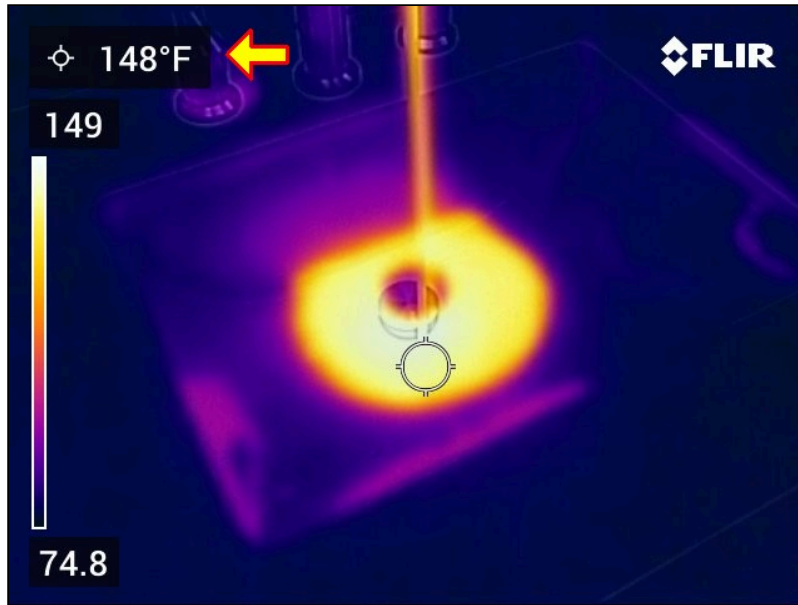
Findings
(1) The temperature of the water was tested using a thermal camera at the time of the inspection and found to be above 125 degrees. Water temperatures above 125 degrees can cause scalding or burns. We recommend setting the water heater controls at 120 degrees for optimum efficiency.

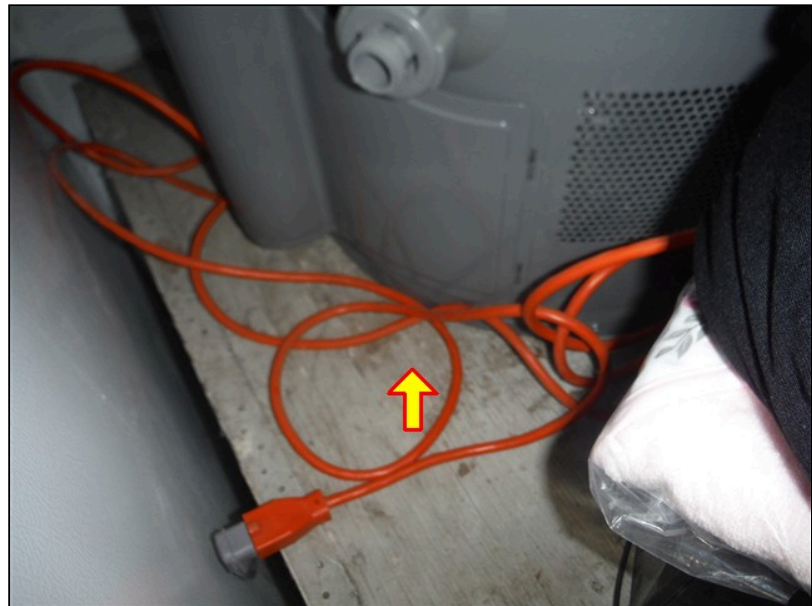
4.0 Item 4(Picture)

(3) A leak pan is not installed under the water heater. We recommend installing a leak pan under the water heater by a qualified licensed plumber.

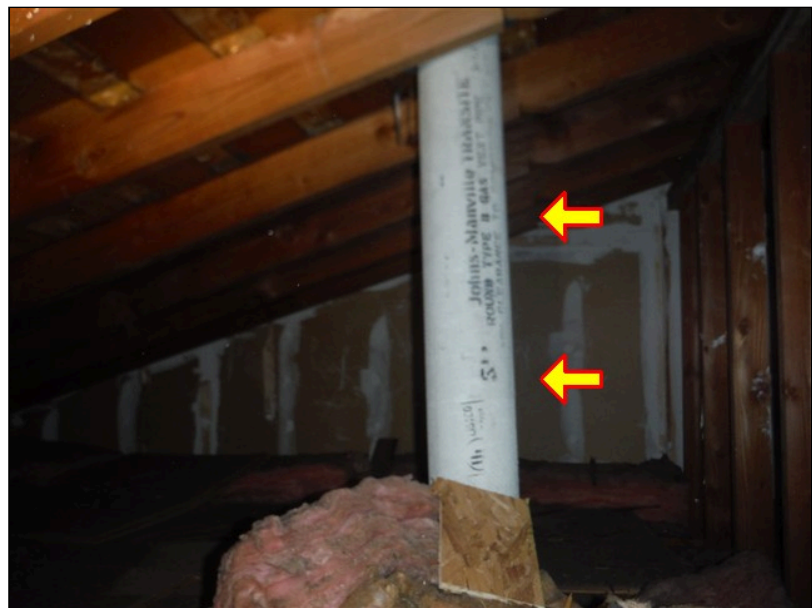
4.1 Item 1(Picture)

A section of the water heater flue is a cemetitious-type flue. Cemetitious-type flues may contain asbestos and other hazards. The only way to confirm the presence or absence of asbestos is through lab testing. It is beyond the scope of a home inspection to test for the presence or absence of asbestos. We recommend replacing this section of the water heater flue by a qualified licensed plumber.

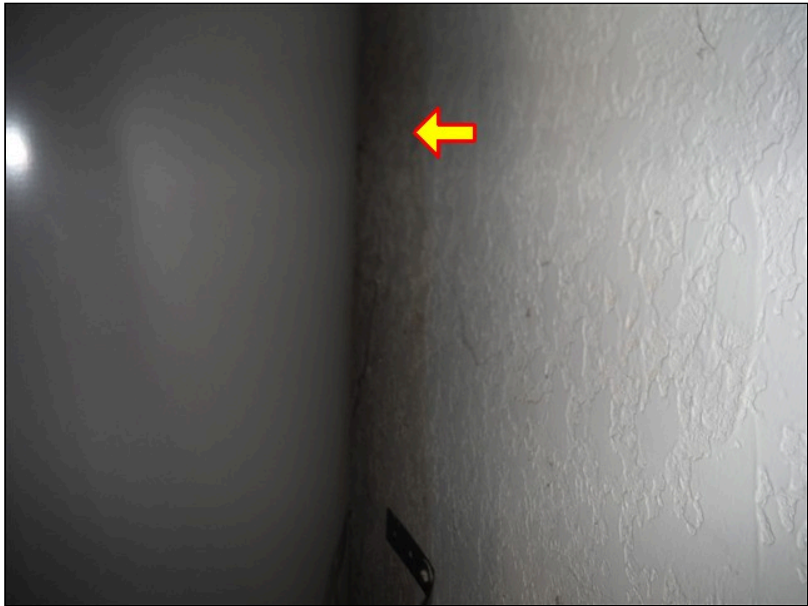
4.2 Item 1(Picture)

The water heater is properly strapped as required. However, there is a large gap behind the water heater and we recommend installing blocking in this gap by a qualified person to prevent the water heater from moving.

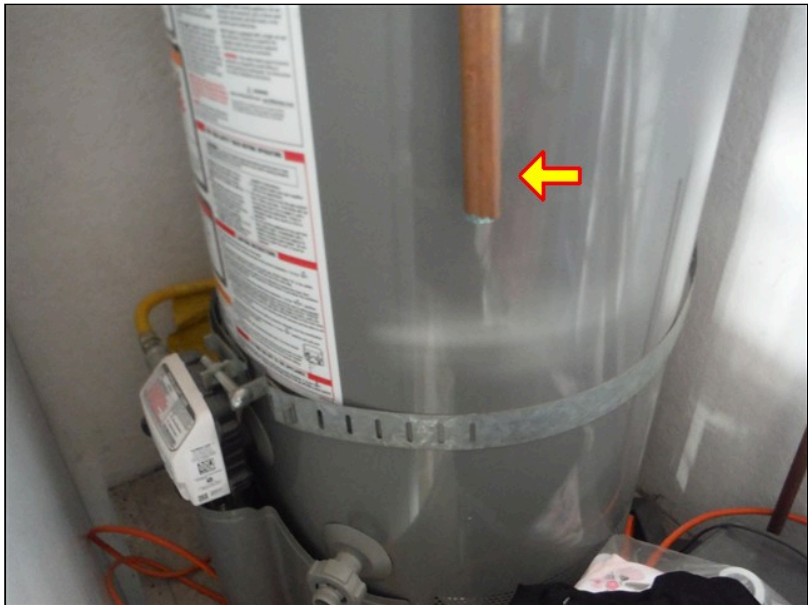
4.3 Item 1(Picture)

The water heater Temperature and Pressure (T&P) relief valve pipe short. The T&P pipe should extend within 6 inches of the floor. We recommend necessary corrections by a qualified licensed plumber.

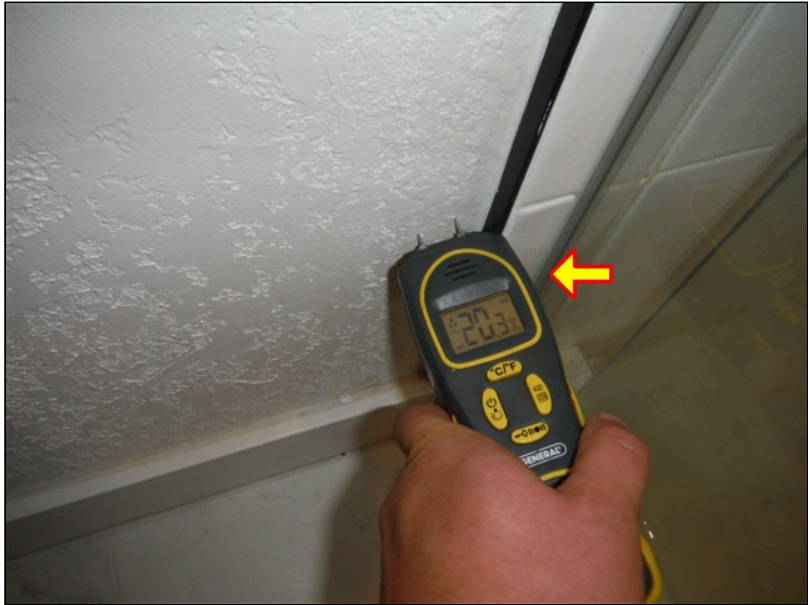
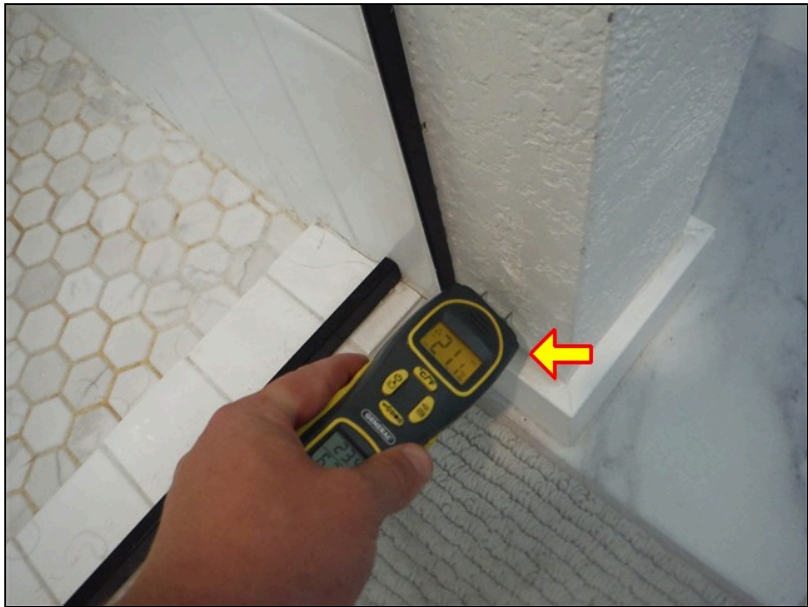
(1) An elevated level of moisture was detected at the wall adjacent to the shower in the bathroom. This can be caused by plumbing leaks or water leaking through grout or the enclosure. There may be moisture damage behind the wall which is concealed, and cannot be identified within the scope of a home inspection. To determine if moisture damage exists inside the walls, a more invasive inspection is required. We recommend further evaluation by a leak detection company, remediation contractor, or a licensed general contractor and necessary repairs made as needed.

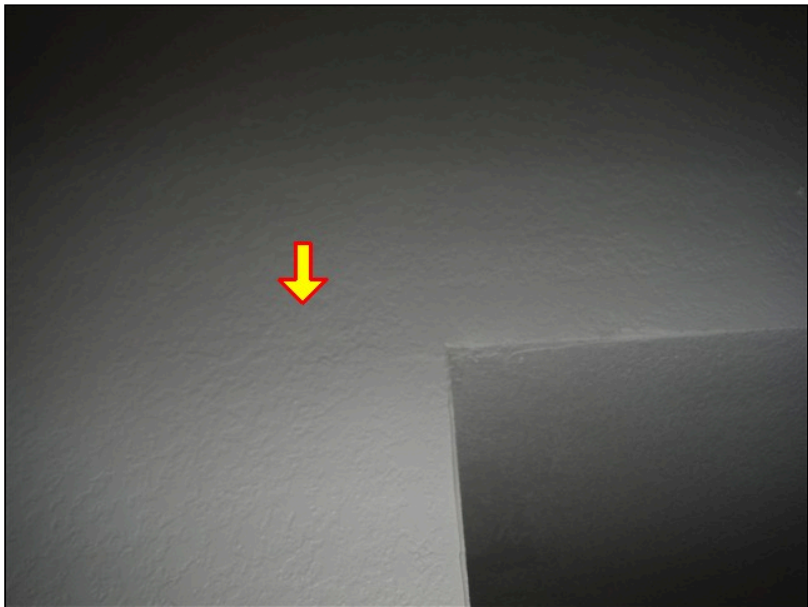
5.2 Item 3(Picture)

(2) Hairline cracking was observed at one or more locations throughout the house. These hairline cracks are likely due to material shrinkage or settlement of the structure. We recommend prep and paint by a qualified licensed painter.

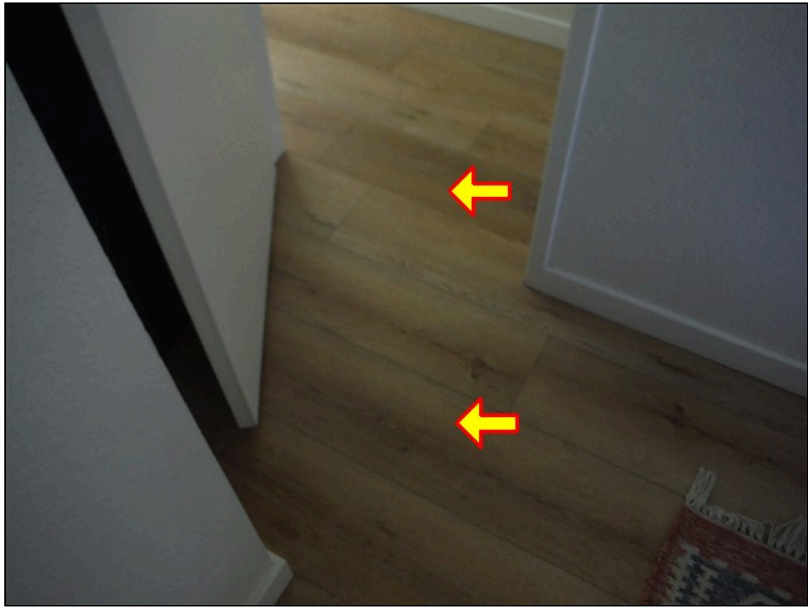
5.3 Item 1(Picture)

(1) The flooring is uneven in one or more areas . We recommend repairs or replacement by a qualified licensed flooring contractor.

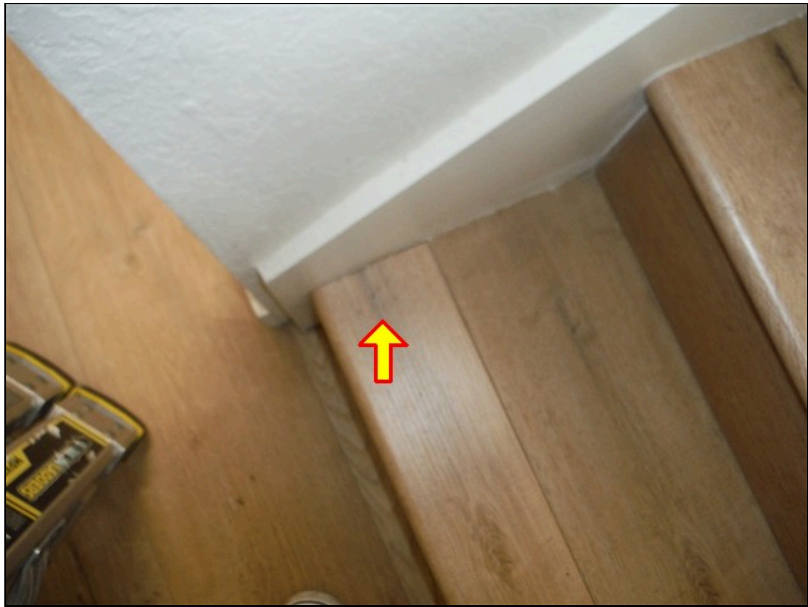
5.3 Item 3(Picture)

(3) Gaps noted in the flooring in one or more areas. Unworkmanlike finish in these areas. We recommend repairs or replacement by a qualified licensed flooring contractor.

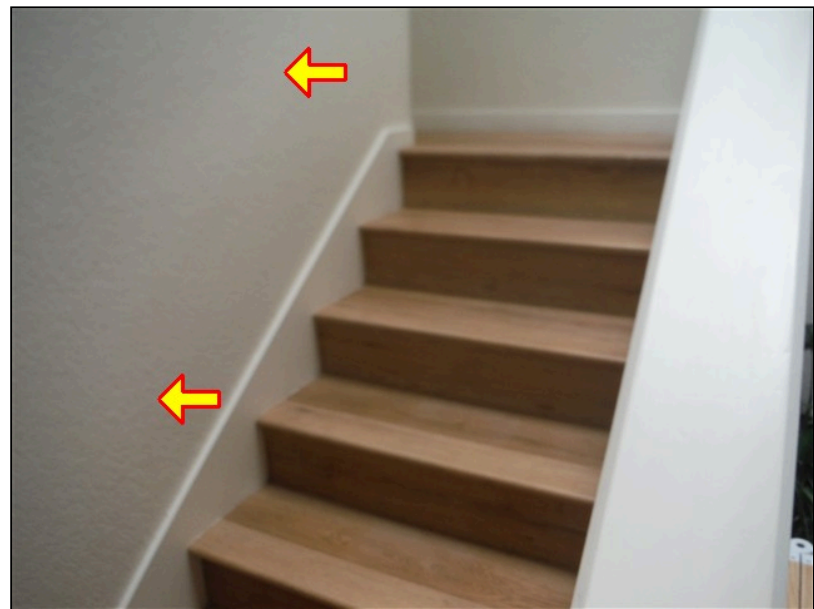
5.4 Item 3(Picture)

(2) No handrail was present at the interior stairs as required for safety. A handrail is required at at least one side of the stairs when four or more steps. We recommend installing a handrail for safety by a qualified licensed contractor.

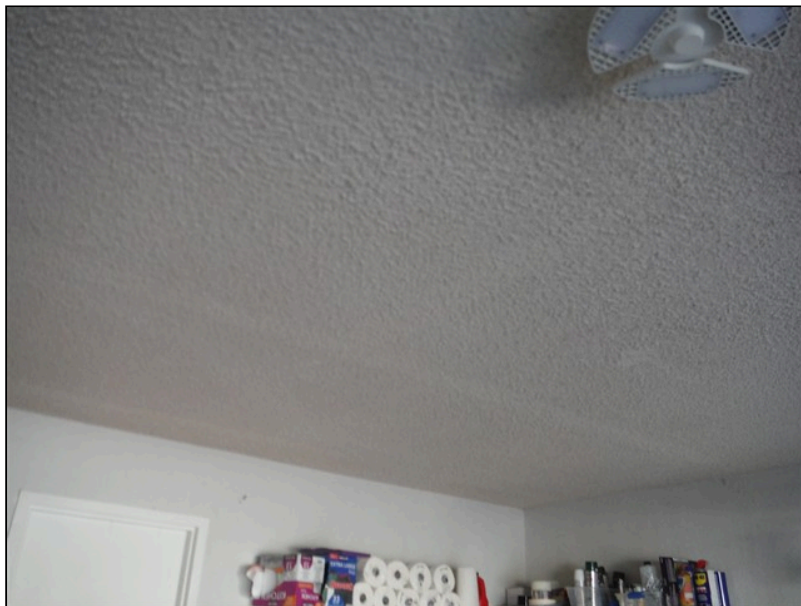
5.9 Item 1(Picture)

(1) There is acoustic texture present at the ceiling. Some of this acoustic texture installed before the 1980's has been known to contain asbestos. It is beyond the scope of this general home inspection for us to test for asbestos. The only way to confirm the presence or absence of asbestos is by having it tested by a qualified person. We recommend having the acoustic texture tested by a qualified person if concerned.

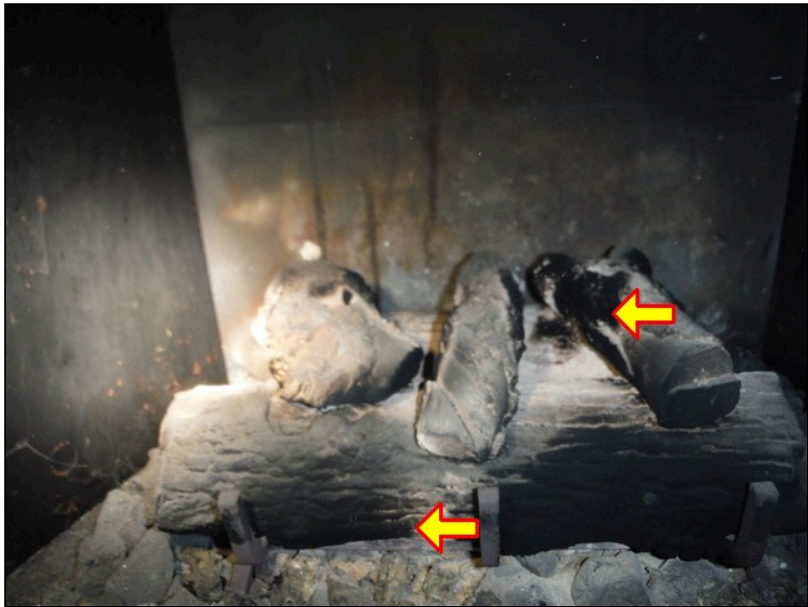
6.0 Item 1(Picture)

Black soot buildup is observed on the family room gas fireplace logs. Black soot buildup may indicates that gas fire logs are not arranged or positioned according to manufacturer's installation specifications. If the gas logs are not positioned correctly, carbon monoxide could be produced. We recommend referring to the manufacturer's installation specifications or a qualified person for corrections.

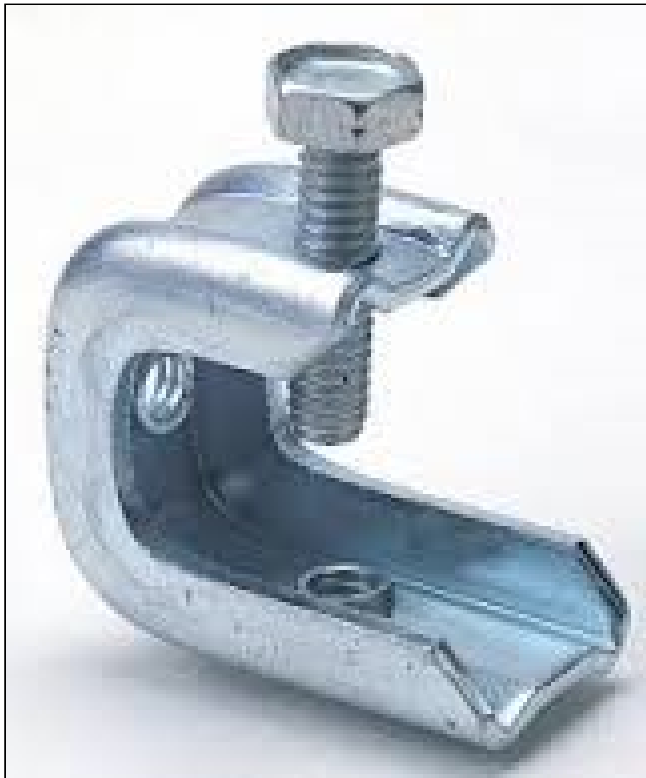
6.1 Item 1(Picture)

A damper clamp is not installed at the family room fireplace damper door. A damper clamp is required to be installed at a damper door when there is a gas supply to the fireplace(s). This damper clamp help prevents the damper from closing all the way as a safety precaution. If the damper is closed, Carbon Monoxide gas could enter the living space easier which is undetectable. SDG&E now requires damper clamps at all fireplaces damper doors. We recommend installation of a damper clamp by a qualified person.

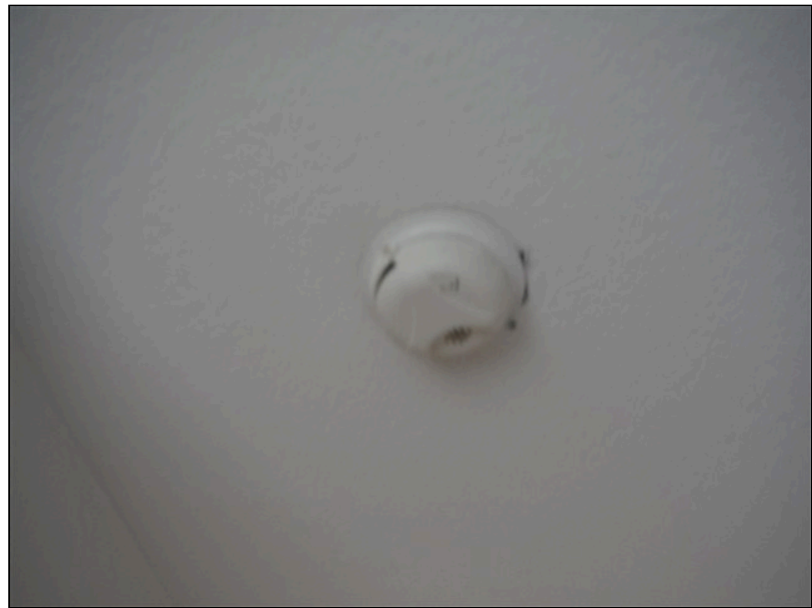
7.0 Item 1(Picture)

There are several smoke detectors missing where required. We recommend installing additional smoke detectors where needed to comply with current fire and safety standards and regulations.

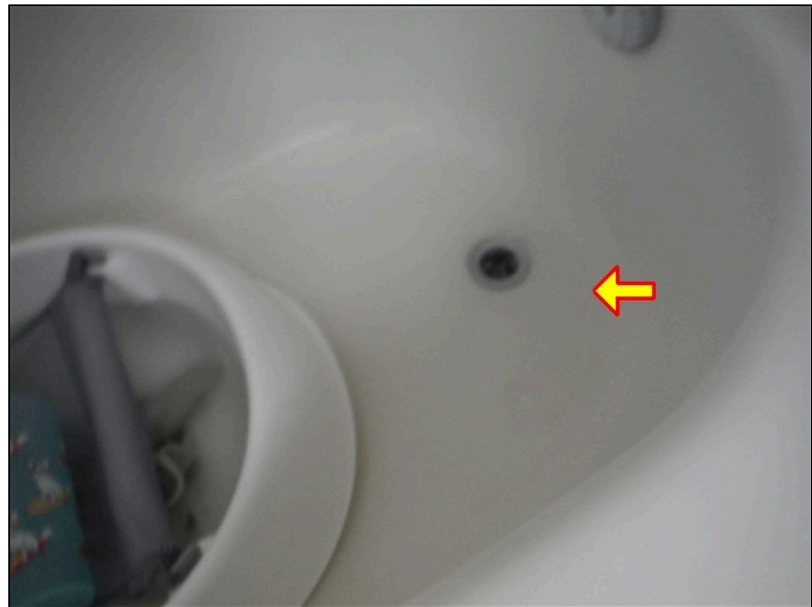
8.0 Item 1(Picture)

(1) The tub drain in the hall bathroom was slow draining at the time of the inspection. This may indicate a blockage in the drain line. We recommend further evaluation by a qualified licensed plumber and repairs as needed.

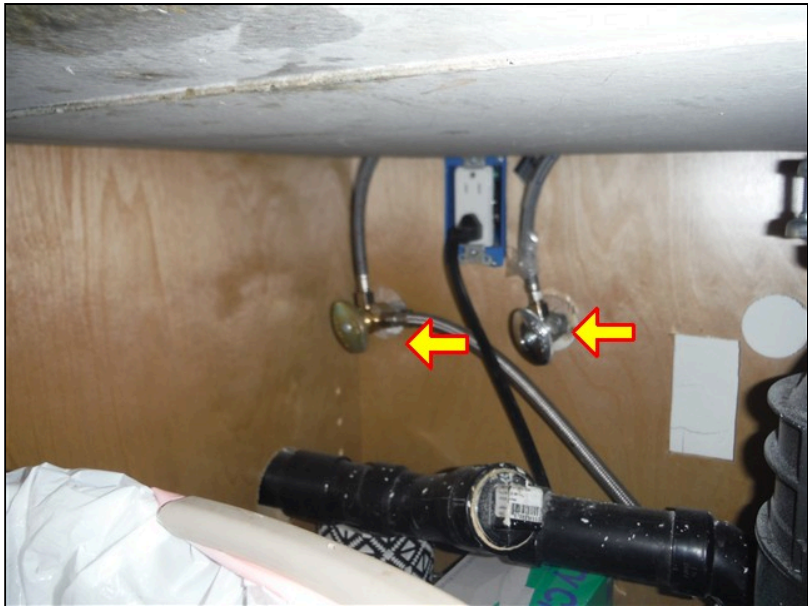
8.2 Item 1(Picture)

Some of the angle stop valves are an older style gate valve. These gate valves can become "seized" due to lack of regular use and/ or calcium build up. We recommend replacing these older style gate valves with ball type water shut off angle stop valves by a qualified licensed plumber.

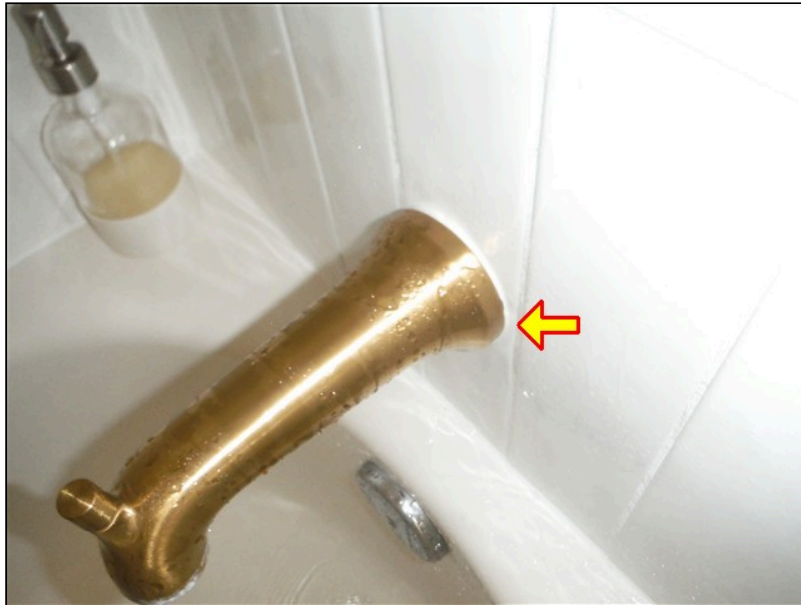
8.3 Item 1(Picture)

(1) The hall bathroom tub faucet spout is loose. This condition could allow water to enter behind the tub/shower wall and could put unwanted stress on the water supply pipes. We recommend necessary repairs by a qualified licensed plumber.

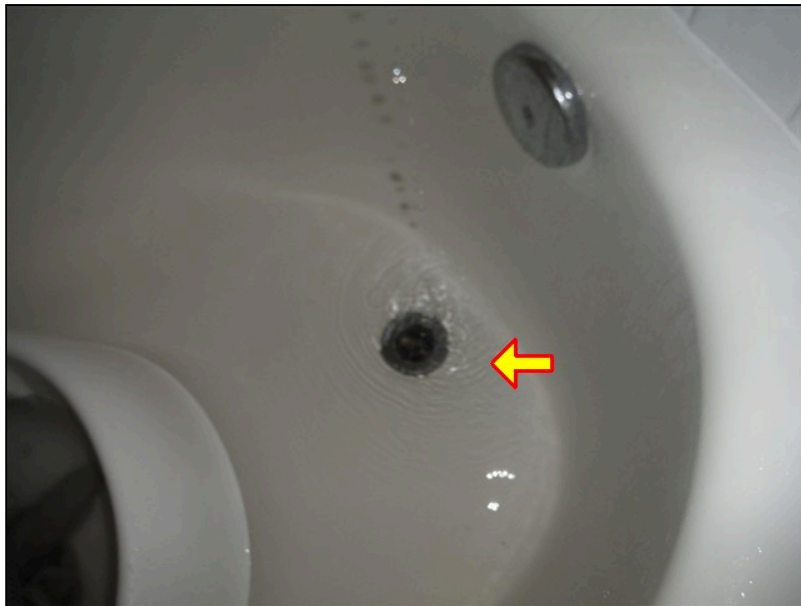
8.3 Item 2(Picture)

(2) The hall bathroom tub stopper is missing. We recommend replacement by a qualified person.

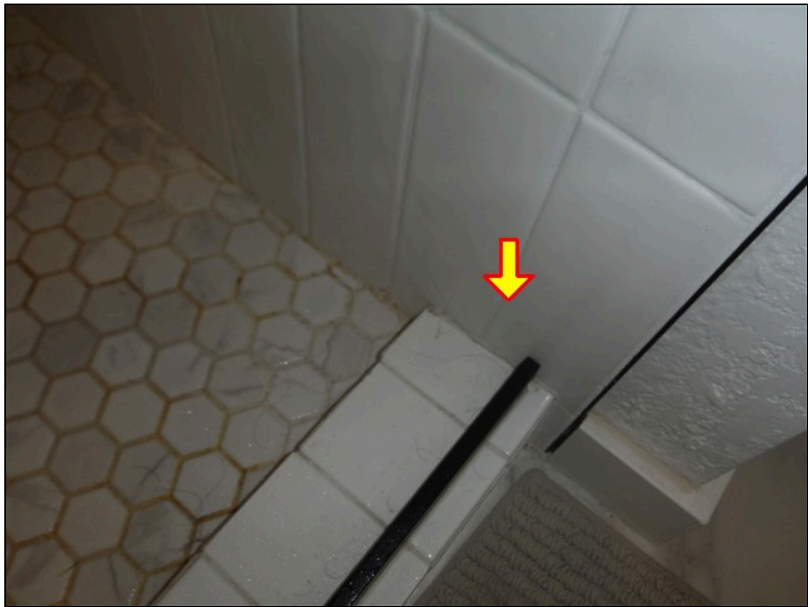
8.3 Item 3(Picture)

(3) The bathroom tile surround has cracked or missing grout between the tiles and needs repair or replace. There may be water damage to the wall behind the tiles which is not visible. Determining if water damage exists in the wall behind tiles is beyond the scope of our general home inspection. We recommend having the tiles repaired by a licensed tile contractor. Additional repairs may be required when tiles are removed. This area should be evaluated further by a qualified licensed tile contractor prior to the end of your contingency period.

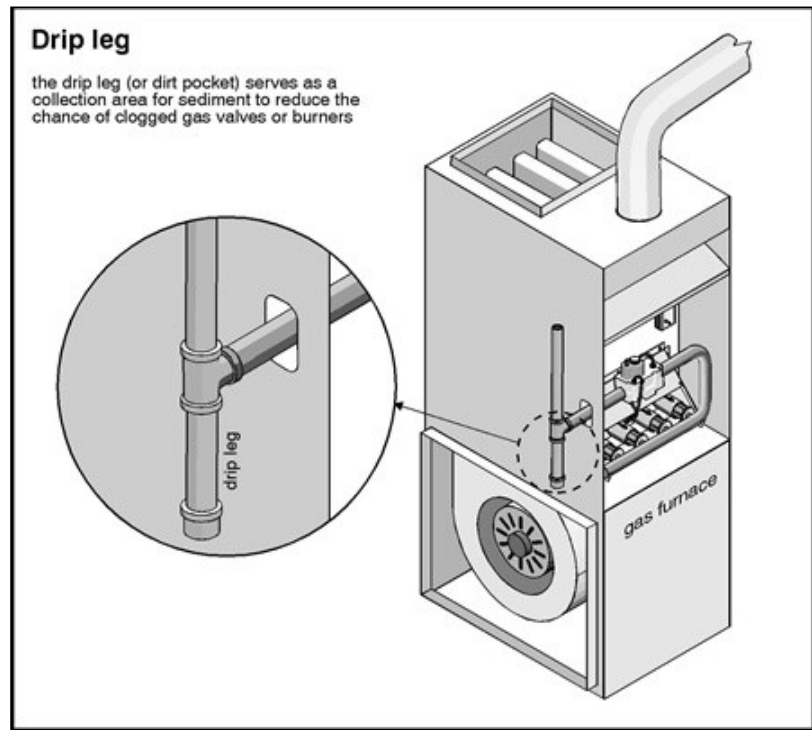
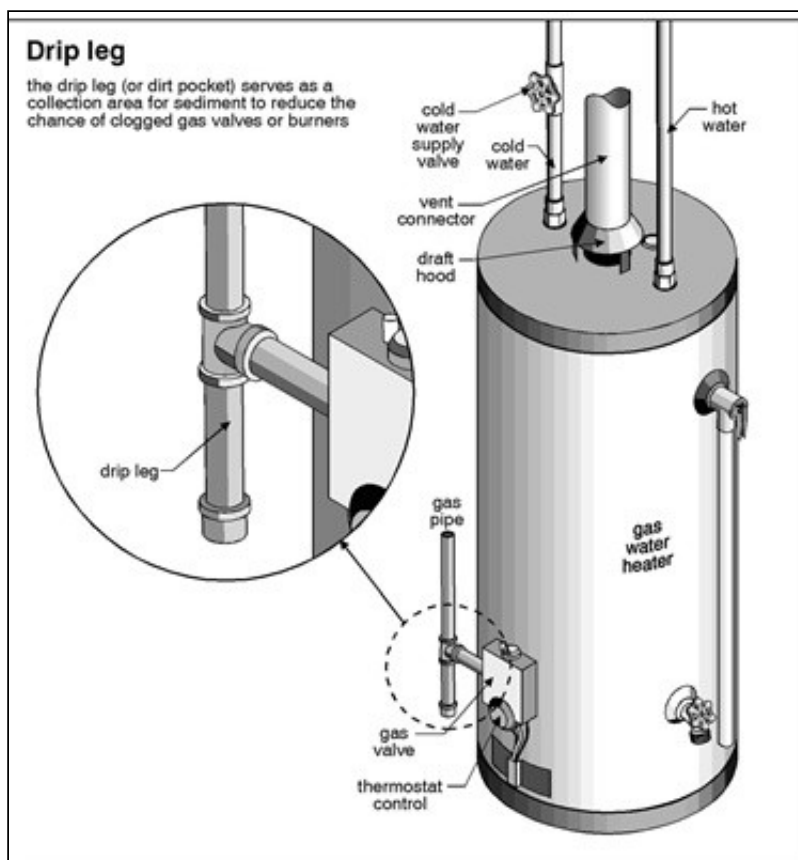
(1) The gas supply pipe at the water heater and furnace did not contained a drip leg/ sediment trap. This may have been standard at the time of installation but now is highly recommended. The purpose of a drip leg is to help prevent sediment/ debris from entering and clogging the gas appliance gas valve which could cause the gas appliance to shut down. We recommend having a drip leg installed at the water heater and furnace by a qualified licensed contractor.

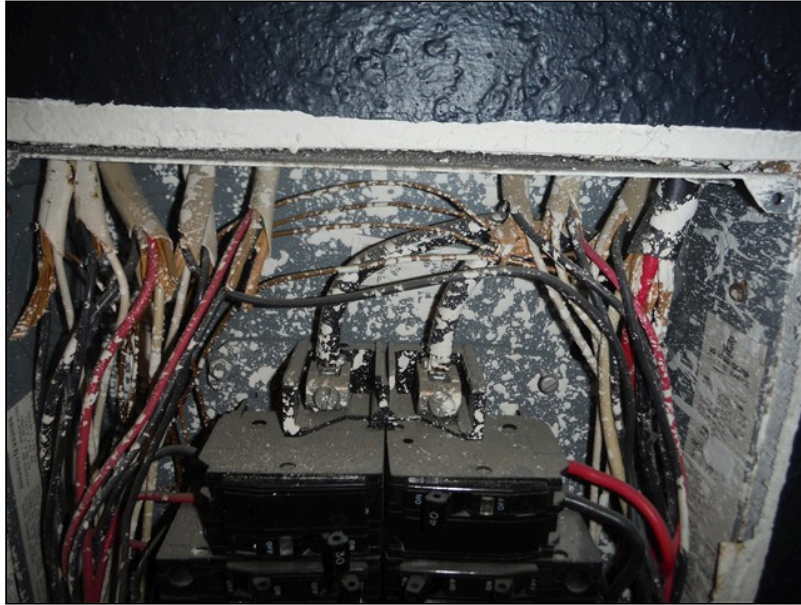
9.0 Item 1(Picture)

The sub electrical panel is observed with paint or wall texture material sprayed into it. This was common practice at the time of original construction as it was not required to have the sub panel cover installed during painting and texturing the walls. Current standards do not allow any foreign materials such as texture or paint in an electric panel. We recommend further evaluation by a qualified licensed electrician for repair or replacement options.

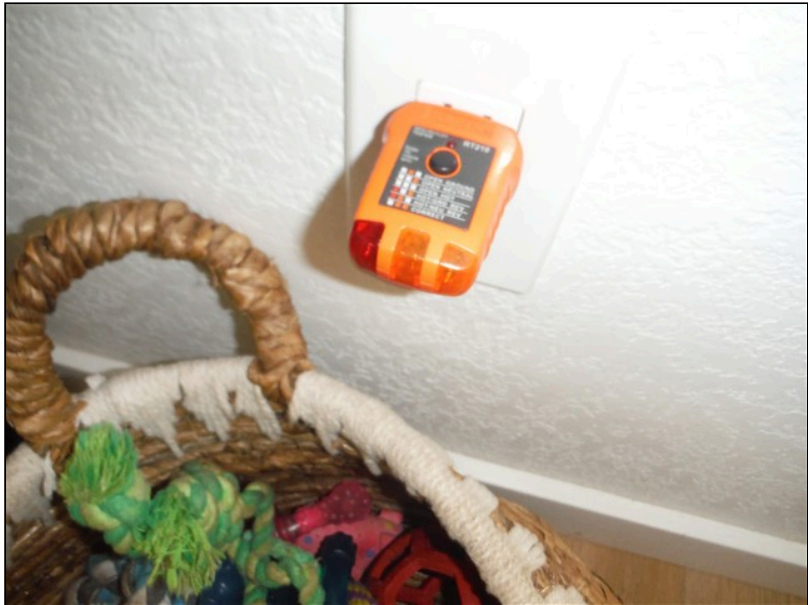
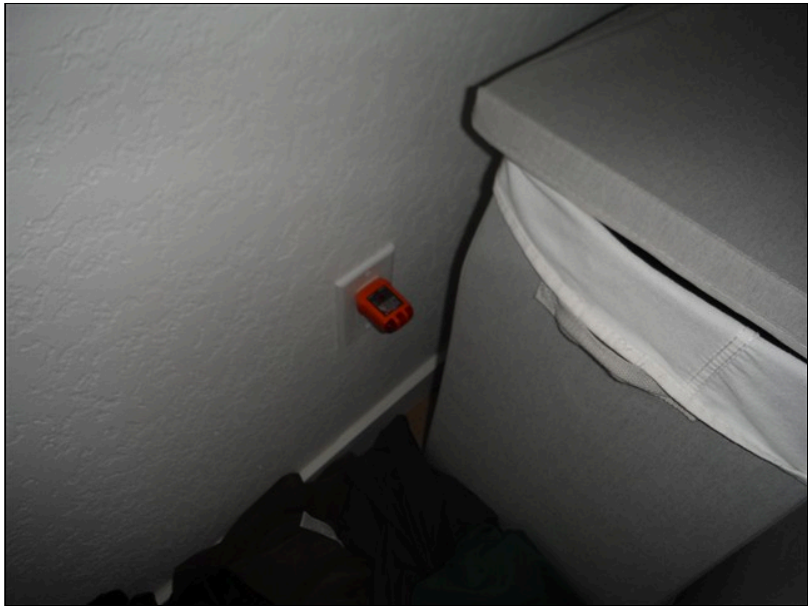
(1) Several receptacles in the garage were non operational when tested at the time of the inspection. We recommend further evaluation and necessary repairs by a qualified licensed electrician.

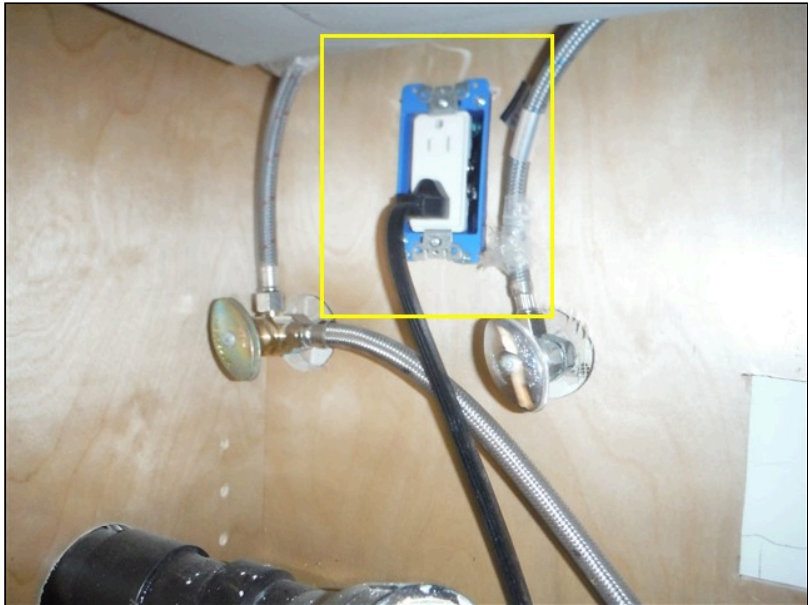
9.8 Item 1(Picture)

One or more junction boxes are loose in the wall. This condition could put stress on the conductors which can lead to loose connections. We recommend having these junction boxes secured by a qualified person.

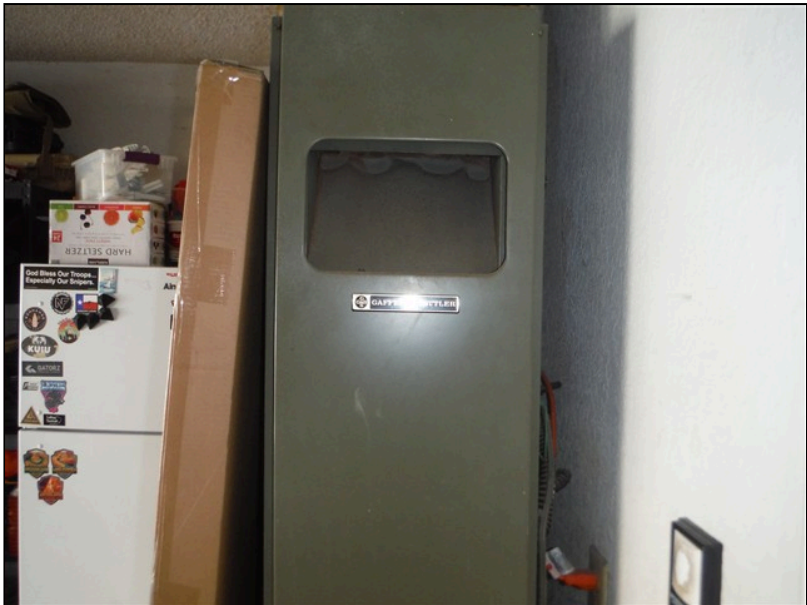
10.0 Item 1(Picture)

(1) The furnace appears to be older and I was unable to determine life remaining. Most HVAC contractors state that furnaces that are 20 years old or older are more likely be at the end of their useful life. We therefore recommend that you have this furnace inspected and serviced by a qualified licensed HVAC contractor to make sure that it is safe, and to obtain an estimate of life remaining, and a cost of replacement prior to the end of your contingency period.

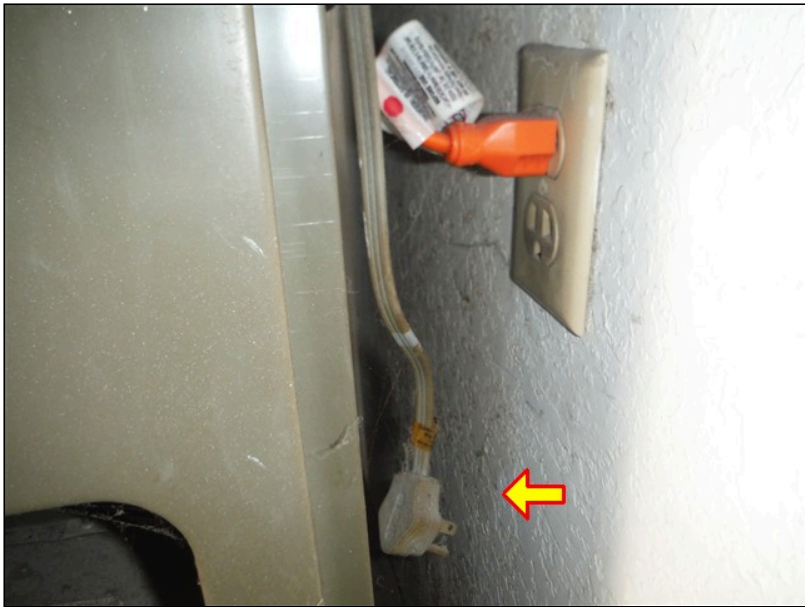
10.0 Item 2(Picture)

(2) The furnace was unplugged at the time of the inspection. We do not restore fuel or power to appliances that are shut off; therefore, our review is limited. We recommend that you obtain verification of this system's performance prior to the end of your contingency period.

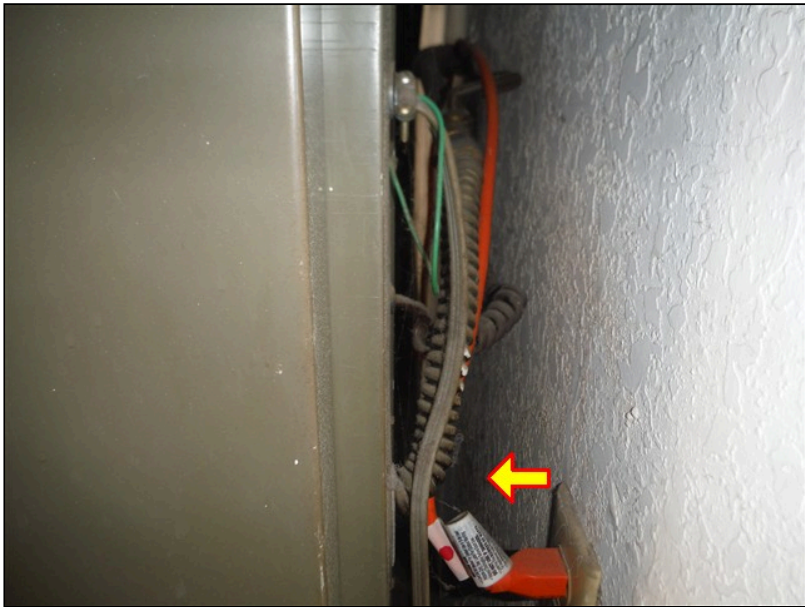
10.0 Item 3(Picture)

(3) The flexible gas supply pipe passes through furnace housing. Vibration from the furnace can wear through flexible gas pipe which could cause a gas leak. SDG&E is "Red Tagging" this condition as they considered it to be unsafe. Due to this condition we recommend a rigid cast pipe be installed from the gas regulator through furnace housing, to the exterior of furnace housing by a qualified licensed HVAC contractor.

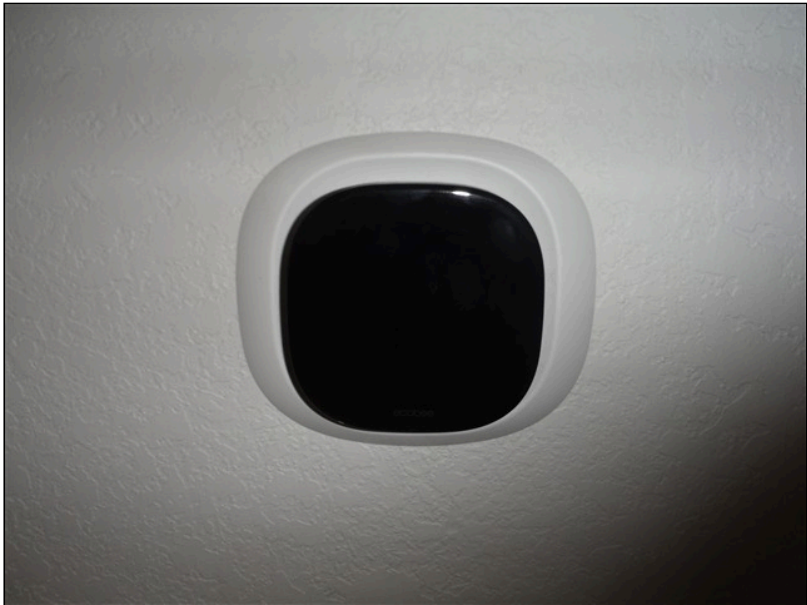
10.1 Item 1(Picture)

Findings
The thermostat did not work at the time of the inspection. Due to the condition the HVAC system could not be tested. We recommend repair or replacement of the thermostat and verifying that the HVAC system is operational prior to the end of your contingency period.
