Inspection Report

Property Address:
10280 Caminito Rio Branco
San Diego CA 92131

Date: 8/5/2025	Time: 09:00 AM	Report ID: 20250805-10280-Caminito-Rio-Branco
Property: 10280 Caminito Rio Branco San Diego CA 92131	Customer: Keenan Kribs	Real Estate Professional: Ted Kavich Ready Homes

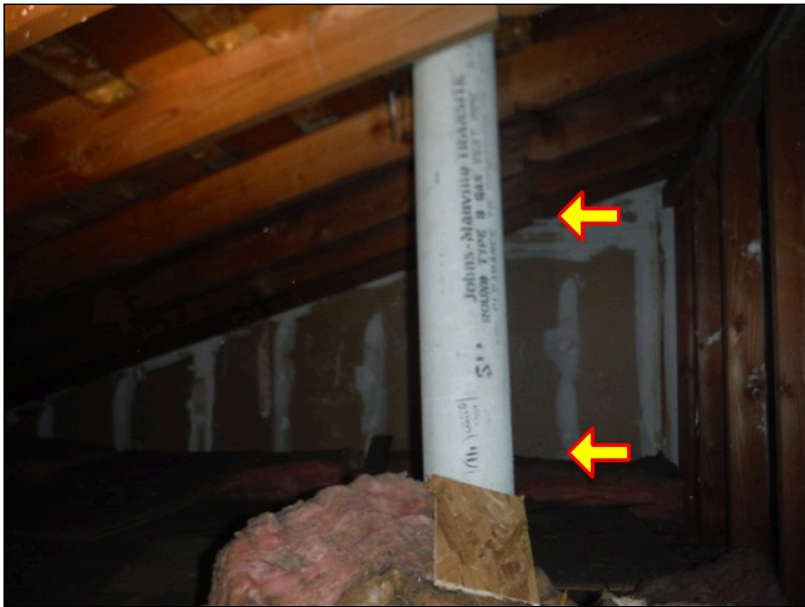
10.2 Item 1(Picture)

A section of the furnace flue may contain asbestos. It is beyond the scope of a home inspection to test for the presence or absence of asbestos. If the flue contains asbestos, there may be additional costs to remove the flue if you upgrade the Transite flue to metal. Inspecting the Transite flue should be part of an annual furnace servicing until it is replaced. We recommend replacement of the Transite flue upon replacement of the furnace, replacement of the roof, or if you are concerned about asbestos by a qualified licensed HVAC contractor.

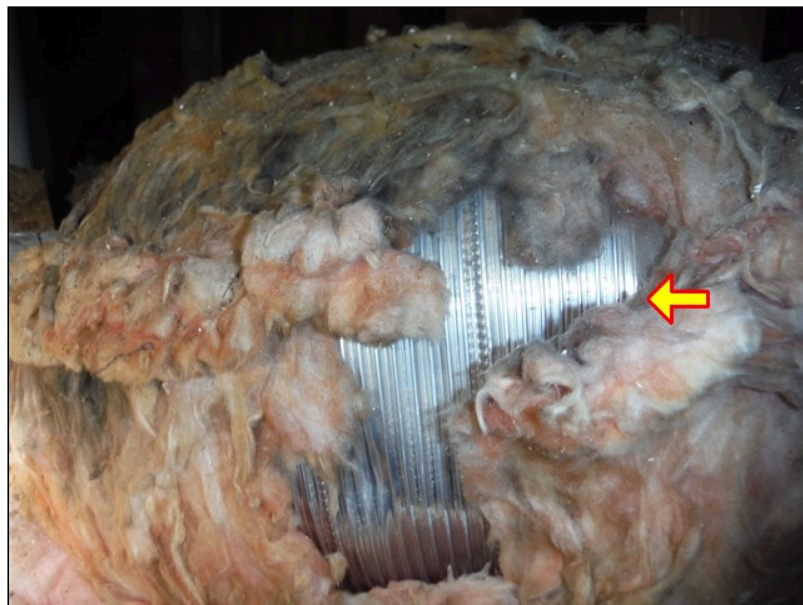
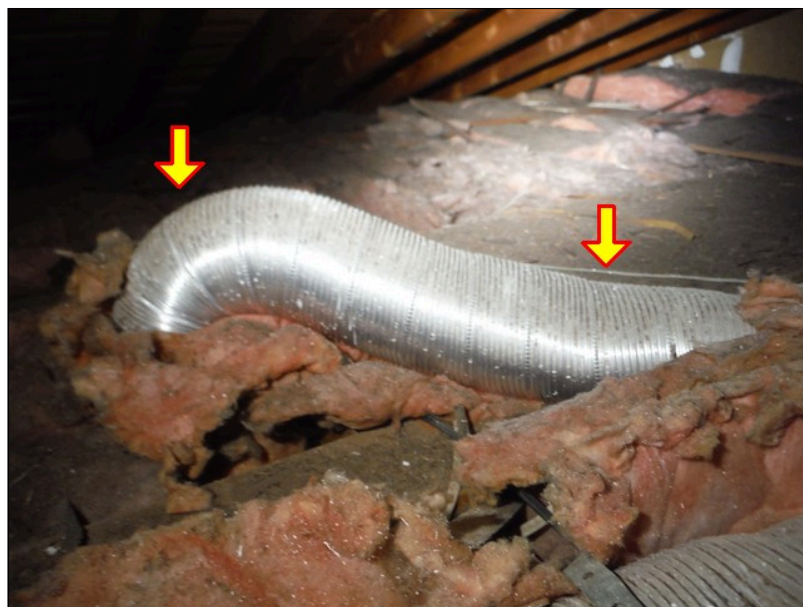
(1) The outer insulation covering on several of the air ducts in the attic space missing/damaged. We recommend repairs or replacing as needed by a qualified licensed HVAC contractor.

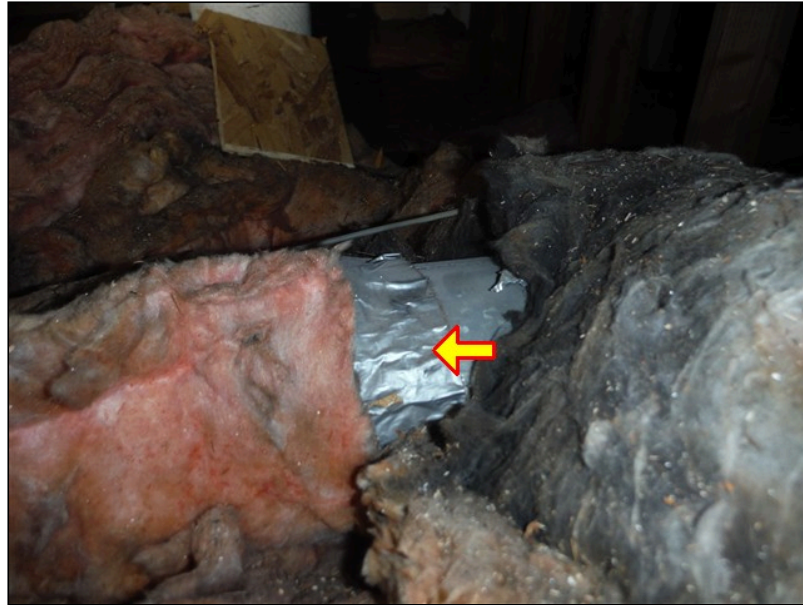
10.3 Item 3(Picture)

(2) Some of the ducts were sealed with duct tape. This was a poor practice as duct tape dries out and fails resulting in leaks in the system. Leaks reduce efficiency as the heated air which you pay for escapes into the attic. We recommend having a licensed HVAC contractor inspect and seal the ducts as needed.

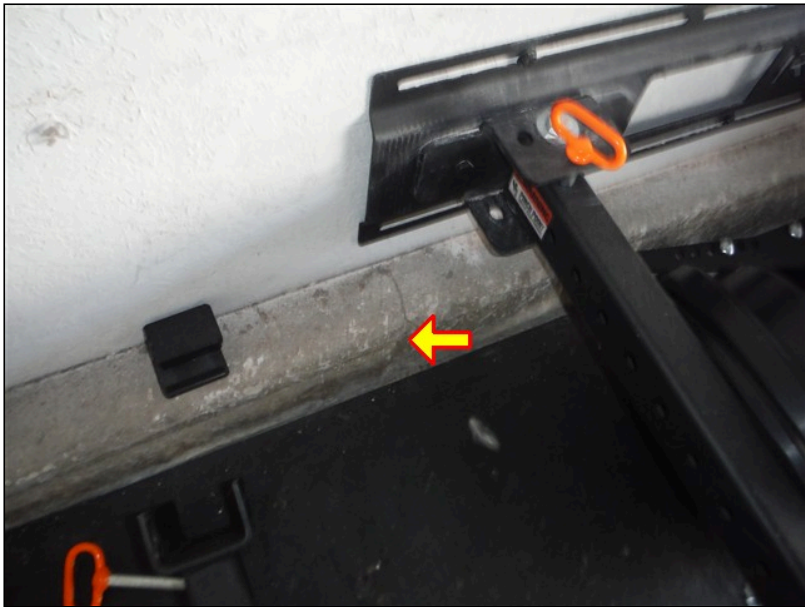
12.1 Item 1(Picture)

Hairline crack was observed in the garage stemwall (right side wall of the garage). Cracks like these are usually repaired with epoxy. However, the exact evaluation of the crack is beyond the scope of a general home inspection. We recommend inquiring with the HOA about any necessary repairs needed at this time.

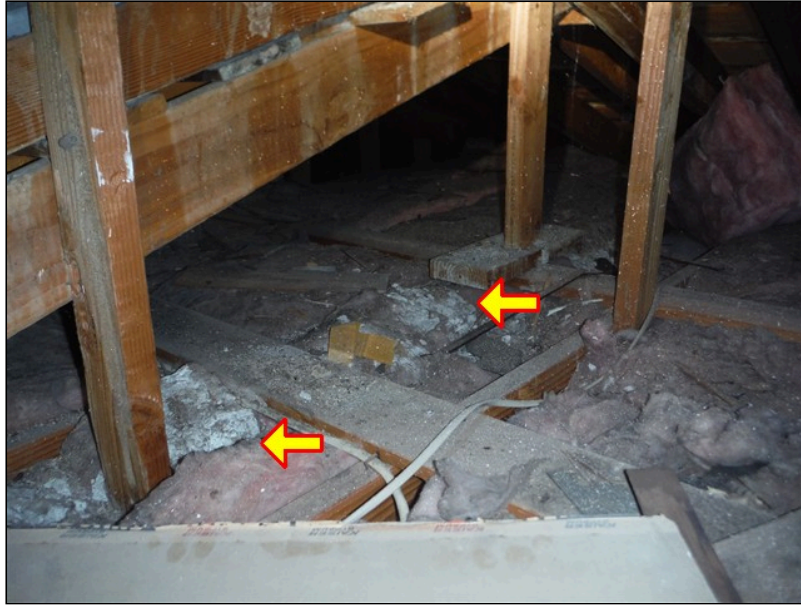
13.0 Item 1(Picture)

contingency period if the buyer is concerned. We recommend that the insulation in this area be removed and replaced by a qualified contractor.

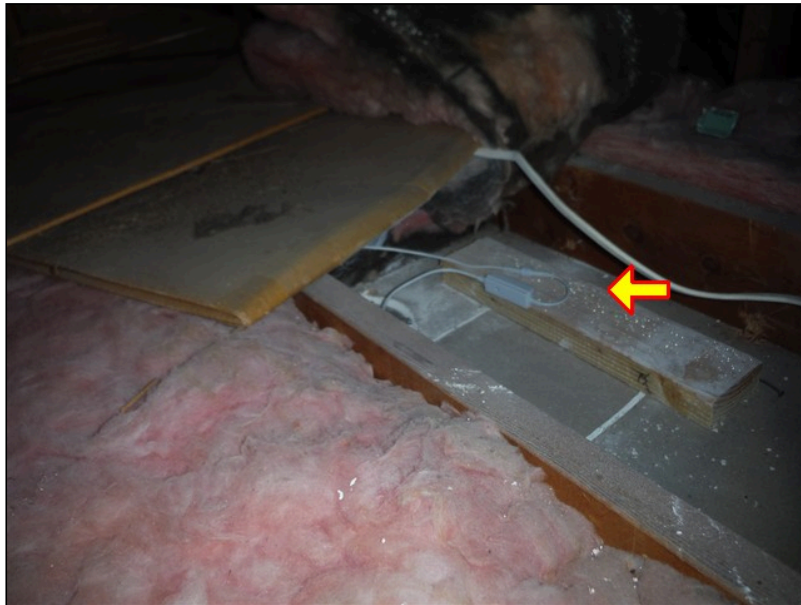
13.0 Item 2(Picture)

(2) Some of the batt insulation has been moved in the attic space for installation of recessed lights or other reasons. This insulation was not put back into position where needed. We recommend having the insulation distributed properly/ put back into place to improve the thermal efficiency of the house by a qualified person.

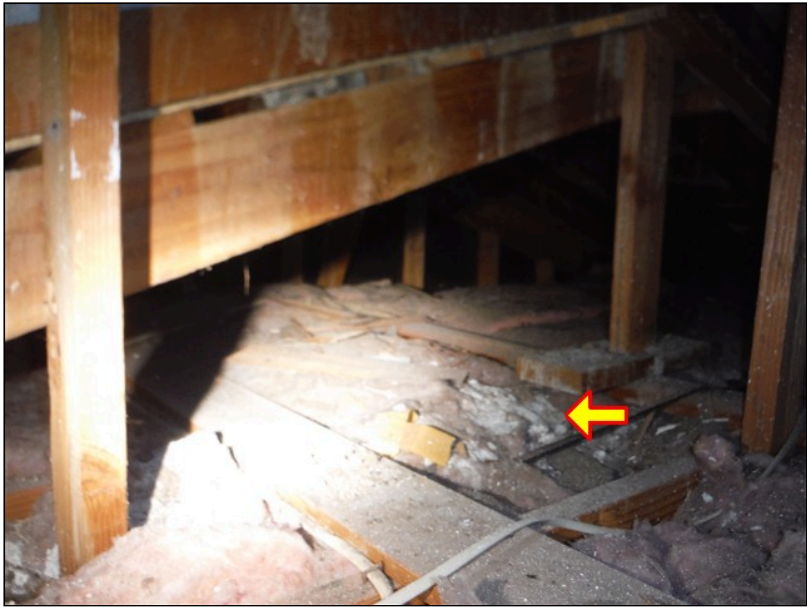
13.0 Item 3(Picture)

(3) Excessive debris noted in the attic. This is non standard. We recommend removal of the debris by a qualified person.
