**W18908**

**WOOD DESTROYING PESTS AND ORGANISMS INSPECTION REPORT**

| Building Address:<br><b>1505 Wendy Way, Manhattan Beach, CA 90266</b> | | Date of Inspection<br><b>09/05/2025</b> | Number of Pages<br><b>7</b> |
| General Description:<br>One-story, single-family residence, composition roof, attached garage, raised foundation, vacant/unfurnished | | Inspection Tag Posted:    Attic | |

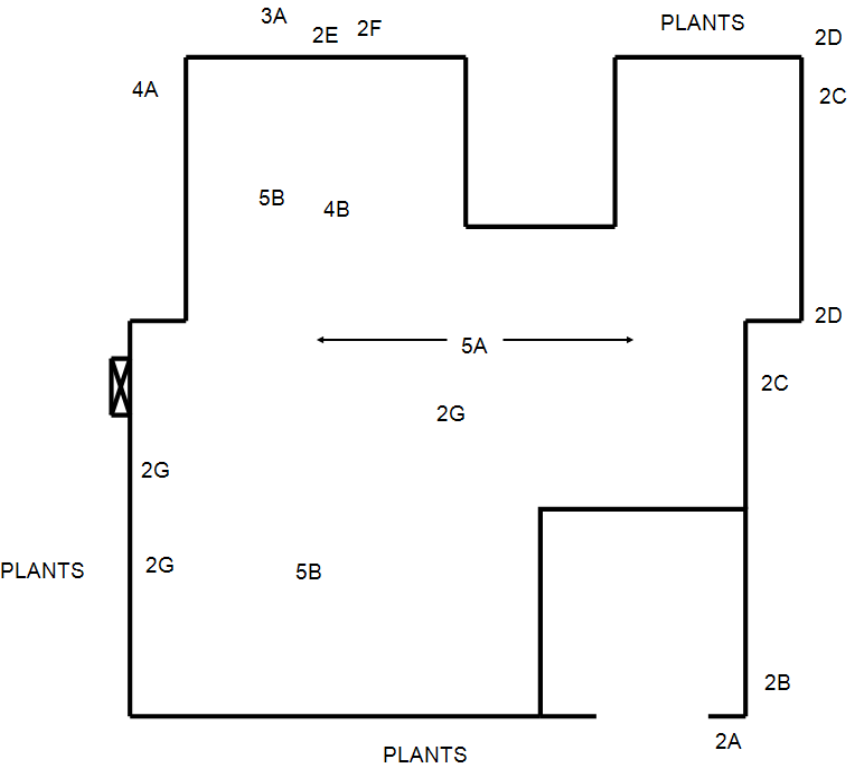
This Diagram is not to scale

- 2A (Section I)  
FINDINGS: Evidence of dry-wood termite infestations at garage front fascia, leading into inaccessible areas as indicated on the diagram.  
RECOMMENDATION: Vacate the premises and seal the structure(s) for fumigation with Vikane Gas. Remove or cover accessible evidence of infestation. Fumigation warranted for two years. Occupants Notice and Pesticides Disclosure form to be signed by owner/agent prior to fumigation. NOTE: Gas Company will shut off gas prior to fumigation, we will schedule turn off, if you need restore scheduled please notify us for explanation of restore procedures. IMPORTANT: If property has a tile roof, damage is likely, 2 Guys Termite Inc, is NOT responsible for damaged tiles. Any questions regarding liabilities and waivers please call office prior to scheduling. PLANTS ARE LIKELY TO BE DAMAGED DURING FUMIGATION PROCESS IF TOO CLOSE TO FOUNDATION OR EXTERIOR WALLS, OWNER TO MAKE SURE ALL PLANTS ARE TRIMMED AT LEAST 8" AWAY FROM STRUCTURE PRIOR TO FUMIGATION. SOIL WILL ALSO BE DISTURBED AS TARPS NEED TO BE SEALED AT GROUND LEVEL. GRASS, ROCKS, GRAVEL, MULCH OR SOIL MAY BE DISTURBED. 2 GUYS TERMITE INC. DOES NOT GUARANTEE EXACT CONDITION AFTER FUMIGATION. FUMIGATION DURING HIGH WINDS MAY CAUSE UNEXPECTED DAMAGE TO EXTERIOR LIGHTS, AWNINGS, ROOF OR ANY EXTERIOR FIXTURES, 2 GUYS TERMITE INC IS NOT RESPONSIBLE FOR WIND OR RAIN CAUSED DAMAGES. BY SIGNING THIS CONTRACT AND SCHEDULING THIS JOB, YOU UNDERSTAND THE LIABILITIES OF DAMAGE AND HOLD 2 GUYS TERMITE, INC HARMLESS FOR ANY DAMAGE TO AREAS DISCLOSED ABOVE.

- 2B (Section I)  
FINDINGS: Evidence of drywood termite damaged wood members noted at time of inspection at garage front fascia as indicated on the diagram.  
RECOMMENDATION: At the discretion of our company tradesman, Replace and/or repair termite damaged wood members as necessary. Paint with a primer coat if required. If additional adverse conditions are uncovered during repairs, further inspection will be recommended and a supplemental report will be issued indicating any infection, or additional repairs and/or fumigation if needed. This estimate does not include any permit fees or upgrades that may be required by local city codes.

- 2C (Section I)  
FINDINGS: Evidence of drywood termites noted at exterior right side fascia as indicated on diagram.  
RECOMMENDATION: See Recommendation 2A (fumigation)

- 2D (Section I)  
FINDINGS: Evidence of drywood termite damaged wood members noted at time of inspection at exterior right side fascia as indicated on the diagram.  
RECOMMENDATION: At the discretion of our company tradesman, Replace and/or repair termite damaged wood members as necessary. Paint with a primer coat if required. If additional adverse conditions are uncovered during repairs, further inspection will be recommended and a supplemental report will be issued indicating any infection, or additional repairs and/or fumigation if needed. This estimate does not include any permit fees or upgrades that may be required by local city codes.

- 2E (Section I)  
FINDINGS: Evidence of drywood termites noted at back fascia as indicated on diagram.  
RECOMMENDATION: See Recommendation 2A (fumigation)

- 2F (Section I)  
FINDINGS: Evidence of drywood termite damaged wood members noted at time of inspection at back fascia as indicated on the diagram.  
RECOMMENDATION: At the discretion of our company tradesman, Replace and/or repair termite damaged wood members as necessary. Paint with a primer coat if required. If additional adverse conditions are uncovered during repairs, further inspection will be recommended and a supplemental report will be issued indicating any infection, or additional repairs and/or fumigation if needed. This estimate does not include any permit fees or upgrades that may be required by local city codes.
- 2G (Section I)  
FINDINGS: Evidence of drywood termites noted at attic wall studs as indicated on diagram.  
RECOMMENDATION: See Recommendation 2A (fumigation)

- 3A (Section I)  
FINDINGS: Dry-rot wood members found at time of inspection at back door framing as indicated on the diagram. This is due to cracked paint allowing moisture intrusion.  
RECOMMENDATION: At the discretion of our company tradesman, repair and/or replace damaged wood as necessary. If additional adverse conditions are uncovered during repairs, further inspection will be recommended and a supplemental report will be issued indicating any infection, or additional repairs required. This estimate does not include any permit fees or upgrades that may be required by local city codes. 1 year warranty on repaired areas only.
