REAL ESTATE INSPECTION REPORT

5182 Vista Miguel Dr La Cañada Flintridge CA 91011

DATE OF INSPECTION:1/24/2023INSPECTION TIME:9:00 AM

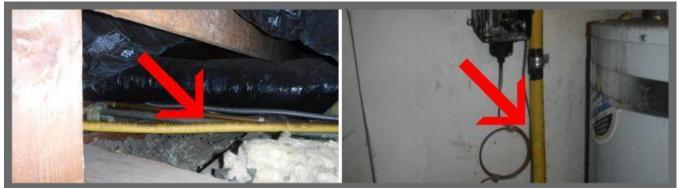
GAS PIPING CONDITION

SAFETY ALERT. CSST Gas Piping. CSST gas tubing was noted during my inspection. This is a corrugated stainless steel gas line tubing with a coating around it. There is a specific bonding requirement for this tubing for safety reasons.

It is recommended that a licensed electrical contractor be consulted to determine whether or not this CSST gas tubing is properly bonded per current National Fuel Gas Code and as required by the manufacturer's instructions.

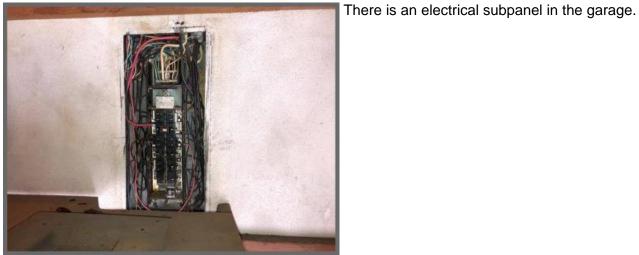
SUB PANEL

NOT ACCEPTABLE. This is a Bulldog Pushmatic brand system. This brand of breakers appears to have significant flaws that increases the risk of failure. The breakers tend to malfunction at the panels either not tripping off or tripping off and not resetting, and the 'on - off' indicator tends to display incorrectly.

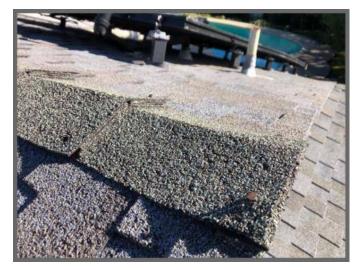
ROOF COVERING STATUS

NEEDS ATTENTION. There is a tree very close to the house and roof. The branches may rub the shingles and cause premature failure and leaking. Leaves can also block gutters etc. It is recommended to trim the tree/branhes away from the house and roof, as needed.

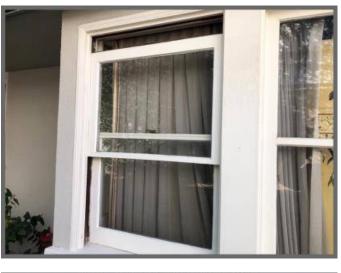
CONDITION

NOT ACCEPTABLE. Windows are painted shut and the paint is sticking or holding the windows from operating properly, in areas such as at the powder room.
