Confidential Inspection Report

LOCATED AT:
68 Via Marisma
Camarillo, CA 93012

INSPECTED ON:
Friday, June 28, 2024

Gary Schwarz, Inspector
Soft Landings Home Inspection
(805) 807-7334

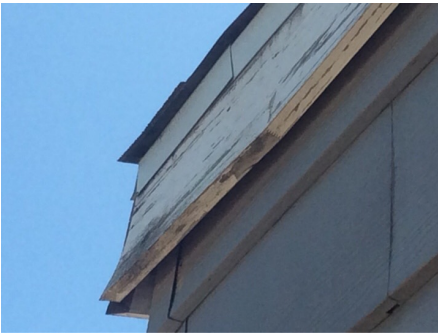
EXTERIOR PAINT/STAIN

MANT **s-14:** The exterior woodwork exhibits worn and missing caulk and paint which protects against the environment. Recommend preventive maintenance as required.

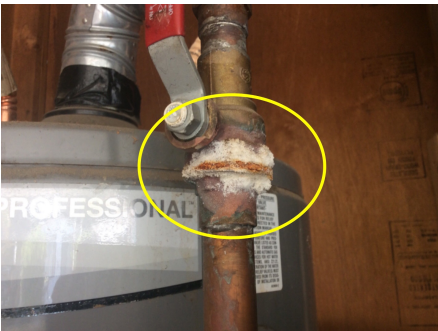
PLUMBING INTERIOR SUPPLY

WRKG **s-27:** There is corrosion which is indicative of a water leak at the water heater. Recommend this be corrected.

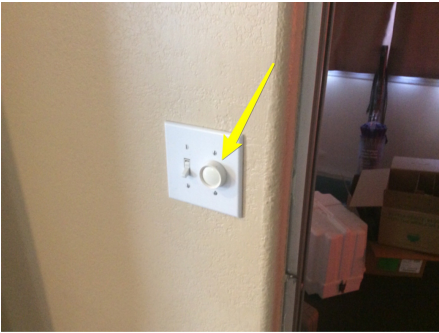
ELECTRICAL SYSTEM CEILING FANS

SFTY s-44: The dining room fan is powered by a dimmer switch. This is a fire hazard. Recommend this be corrected.

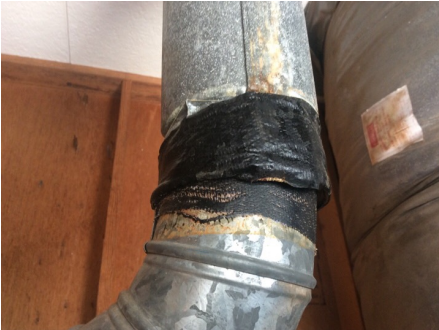
WATER HEATER VENTING

WRKG s-60: Duct tape, not rated for high temperatures, has been used to seal the vent pipe and should be removed. Recommend the vent be resealed with approved tape.

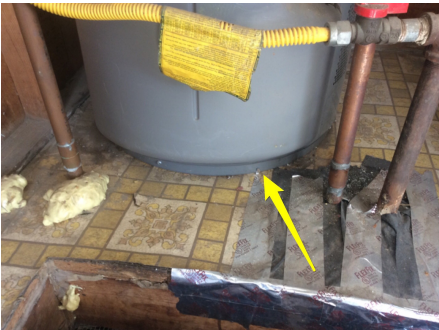
WATER HEATER ELEVATION/LOCATION/DRAIN PAN

MANT s-66: There is no metal pan under the water heater to catch and divert any dripping water to the exterior. Otherwise, damage to the wood base may result. We suggest installation of such a pan be considered.

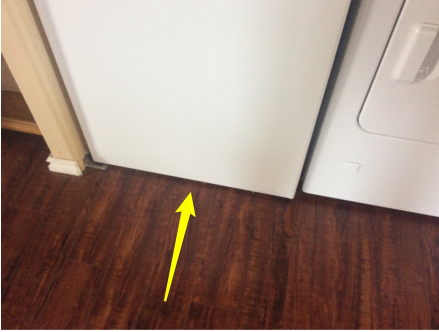
LAUNDRY AREA WASHER/DRYER

MANT s-69: Recommend installing a drip pan under the washing machine.

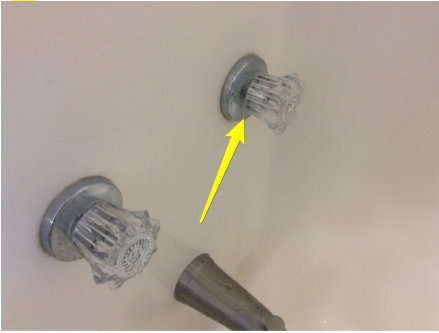
PRIMARY BATHROOM BATHTUB

WRKG s-105: The cold water valve at the tub is leaky. Recommend it be replaced.

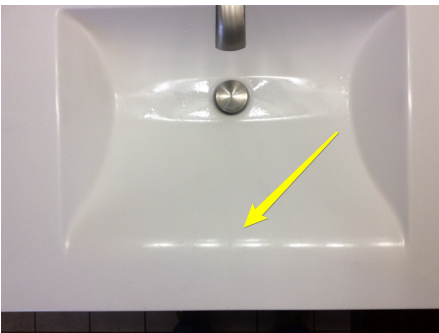
PRIMARY BATHROOM WATER BASIN

SFTY s-109: There is no overflow drain. Without an overflow drain, extensive water damage to the home is possible. Recommend this sink be replaced with one that features overflow protection.

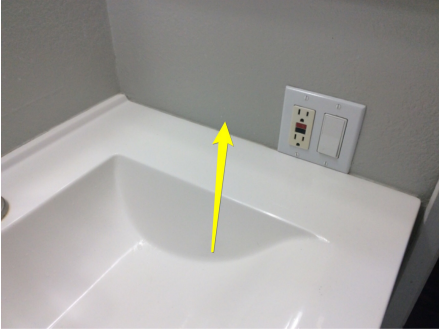
PRIMARY BATHROOM COUNTERTOPS

WRKG s-118: The countertop lacks a backsplash. Recommend a backsplash be installed to prevent water damage to the wall.

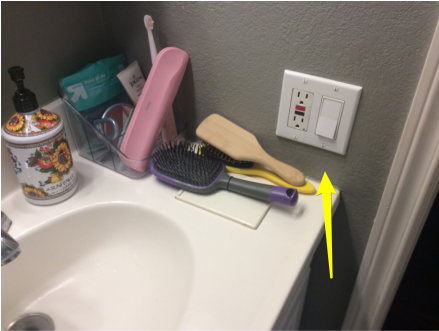
HALL BATHROOM COUNTERTOPS

WRKG s-136: The countertop lacks a backsplash. Recommend a backsplash be installed to prevent water damage to the wall.

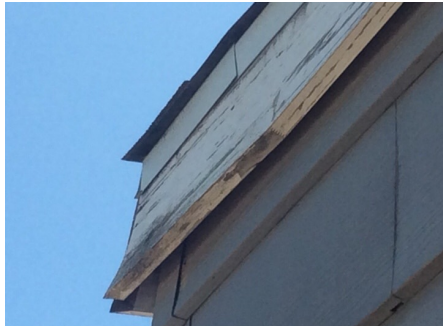
PAINT/STAIN

MANT 14: The exterior woodwork exhibits worn and missing caulk and paint which protects against the environment. Recommend preventive maintenance as required.

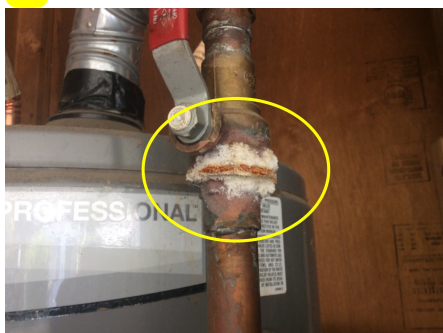
INTERIOR SUPPLY

WRKG 27: There is corrosion which is indicative of a water leak at the water heater. Recommend this be corrected.

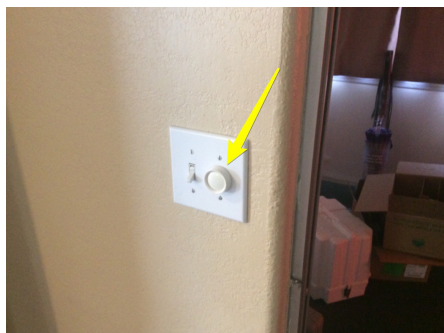
CEILING FANS

SFTY 44: The dining room fan is powered by a dimmer switch. This is a fire hazard. Recommend this be corrected.

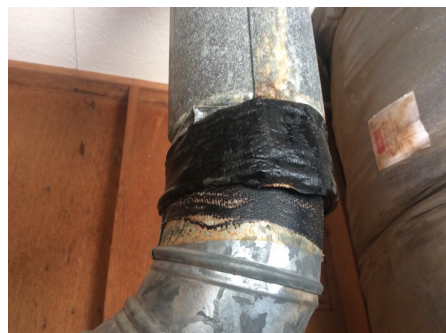
VENTING

WRKG 60: Duct tape, not rated for high temperatures, has been used to seal the vent pipe and should be removed. Recommend the vent be resealed with approved tape.

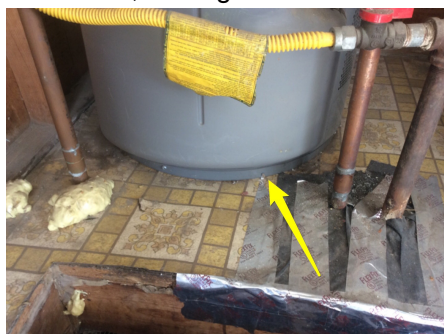
ELEVATION/LOCATION/DRAIN PAN

MANT 66: There is no metal pan under the water heater to catch and divert any dripping water to the exterior. Otherwise, damage to the wood base may result. We suggest installation of such a pan be considered.

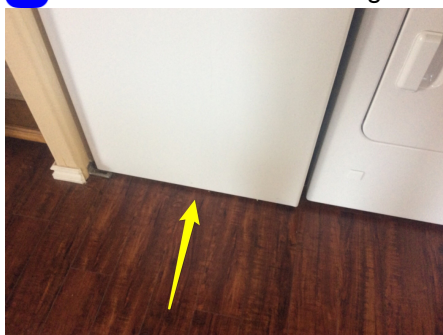
MANT 69: Recommend installing a drip pan under the washing machine.

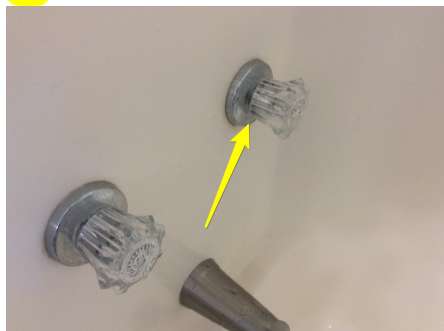
BATHTUB

WRKG **105:** The cold water valve at the tub is leaky. Recommend it be replaced.

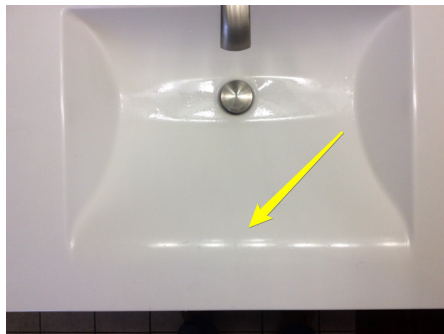
SFTY **109:** There is no overflow drain. Without an overflow drain, extensive water damage to the home is possible. Recommend this sink be replaced with one that features overflow protection.

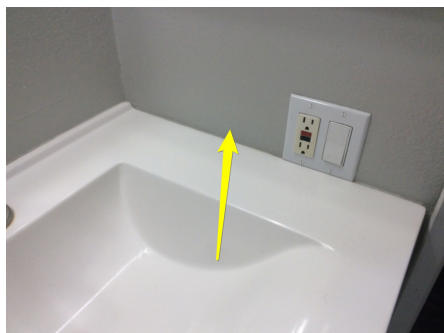
WRKG 118: The countertop lacks a backsplash. Recommend a backsplash be installed to prevent water damage to the wall.

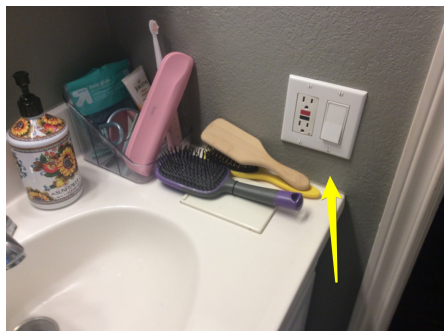
WRKG 136: The countertop lacks a backsplash. Recommend a backsplash be installed to prevent water damage to the wall.
