Jun 8th, 2026

26284 Trails End, Long Barn, CA, 95335

Home Inspection Report

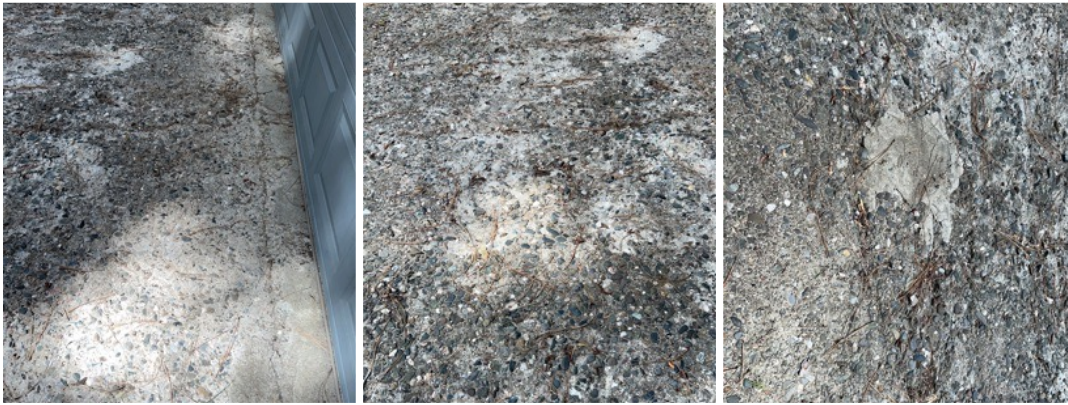
Concrete is cracked, pitted, and chipped.

Cosmetic Only

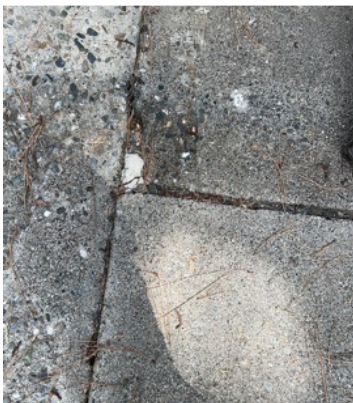
Concrete is cracked, pitted and, chipped.

Cosmetic Only

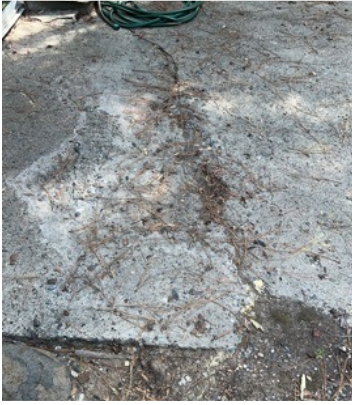
Heavily cracked and unevenly settled causing trip hazard

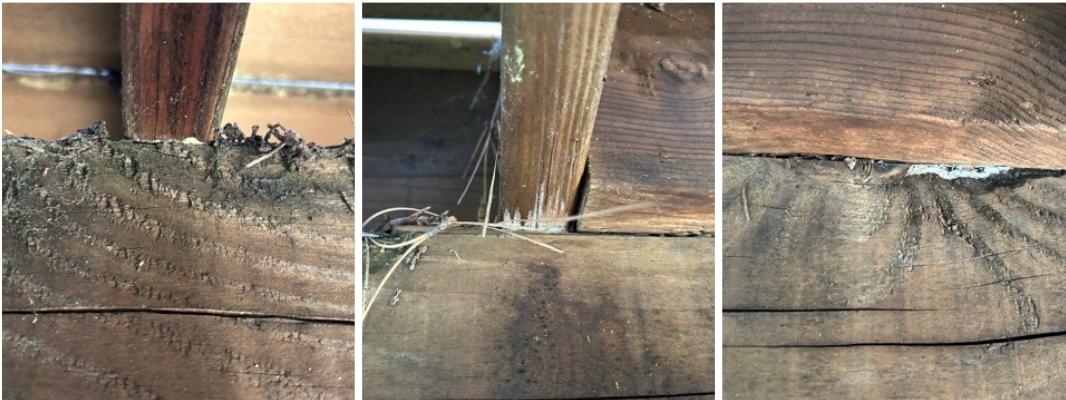
Surface fungus noted at underside of deck

See Structural Pest Report

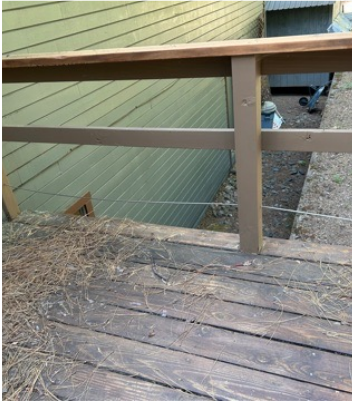
Large gaps are present at the baluster openings; this can be a fall hazard for small children.

Health and Safety Item

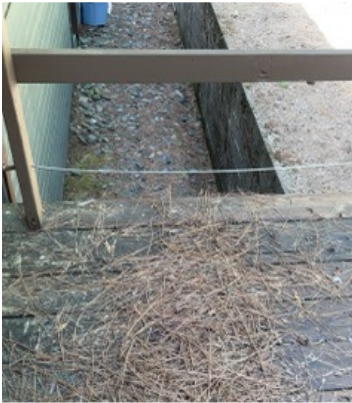
Cable railing was noted to be loose.

Marginal

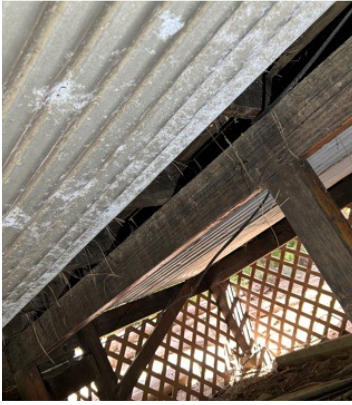
Gapping noted at deck wood members; this can allow moisture at adjacent wood members.

Marginal

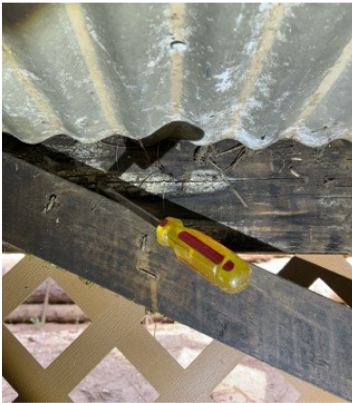
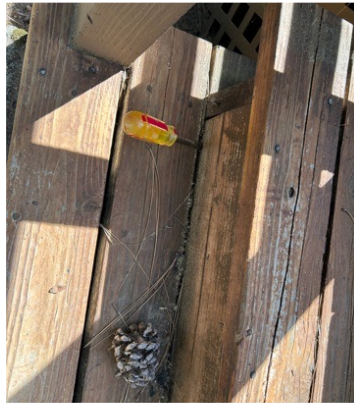
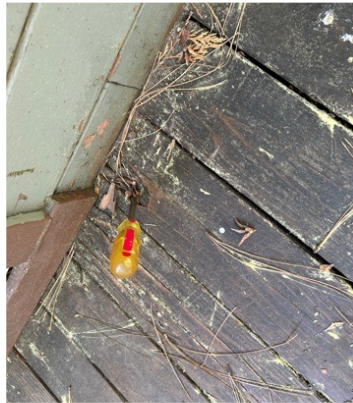
Wood deterioration is present

[See Structural Pest Report](#)

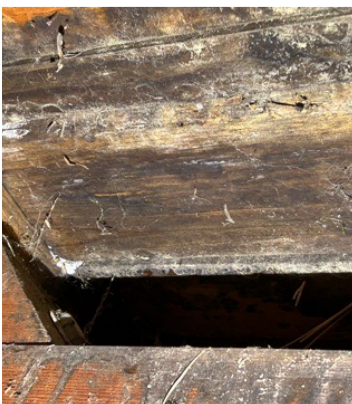
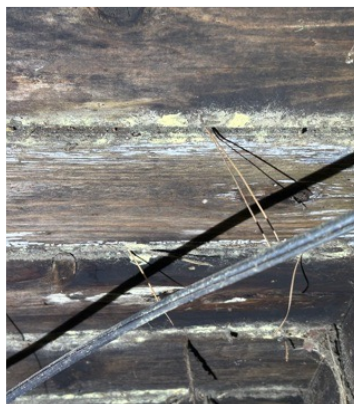
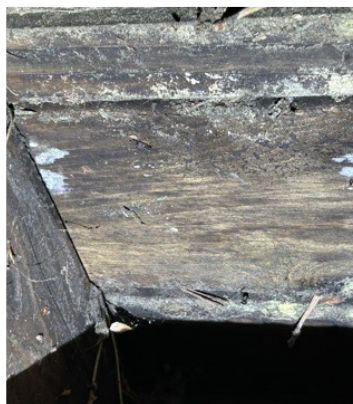
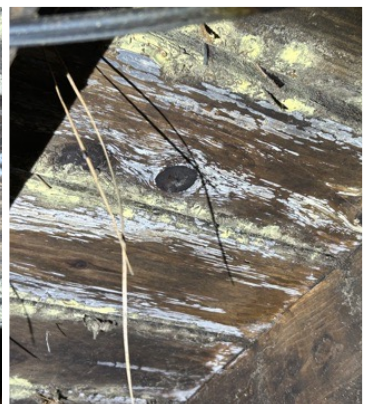
Surface fungus noted at underside of deck

[See Structural Pest Report](#)

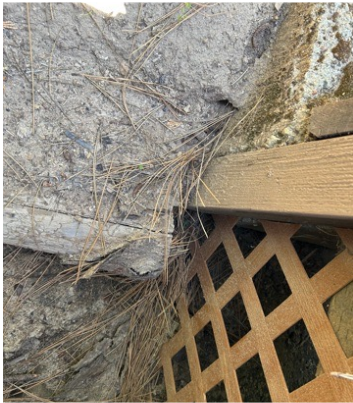
Drifting soil has caused earth to wood contacts.

[See Structural Pest Report](#)

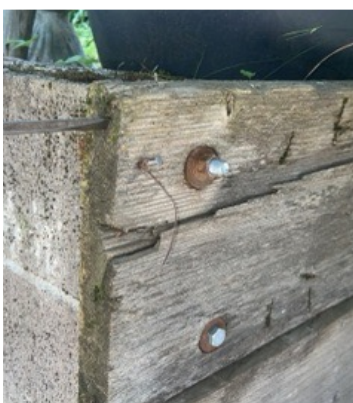
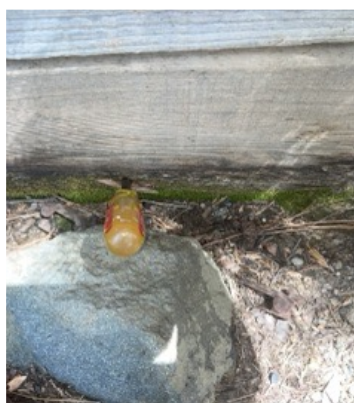
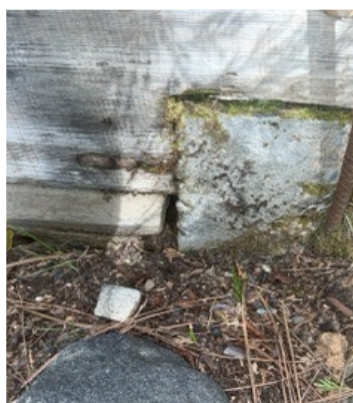
Wood deterioration noted at multiple portions of the retaining walls. Wood portion of retaining wall is not directly attached to the structure and will not be listed on Structural Pest Report.

[Defective](#)

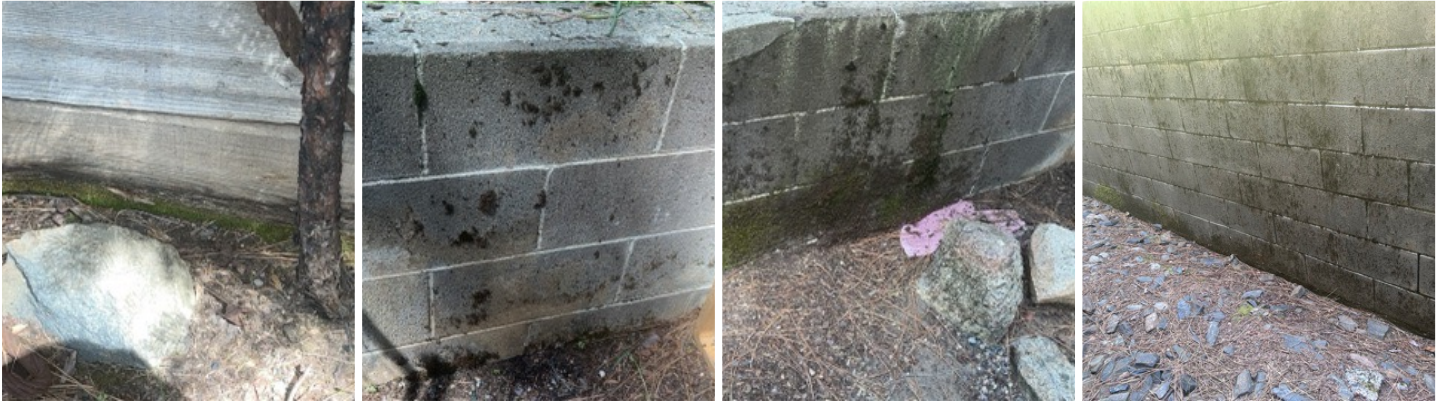
Moss was noted at the retaining wall.

Cosmetic Only

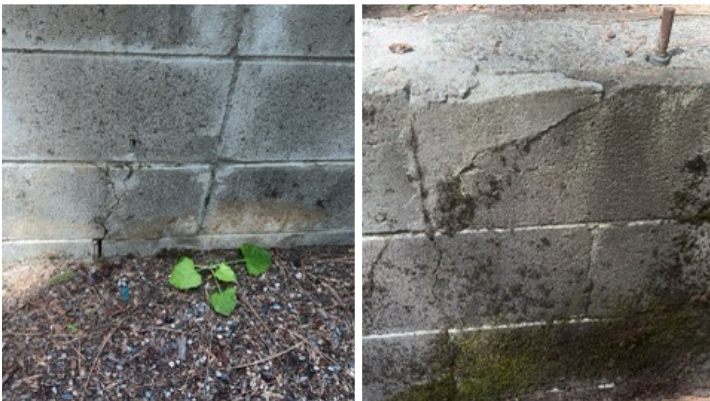
Cracks noted in cinder block retaining wall.

Cosmetic Only

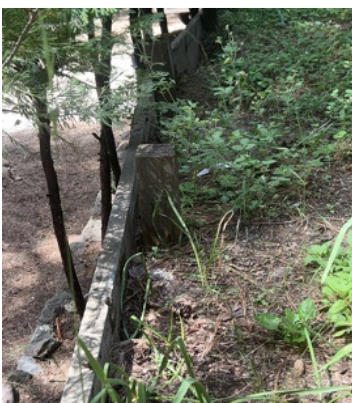
Portion failing

Wall is unsound and leaning.

Defective

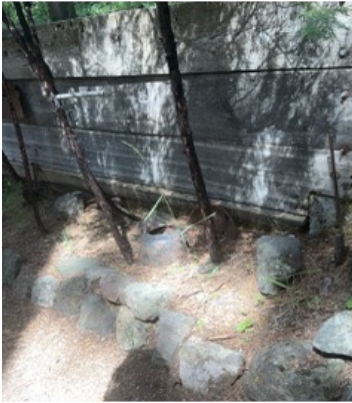
Earth to wood contacts are present. Wood portion of retaining wall is not directly attached to the structure and will not be listed on Structural Pest Report.

Defective

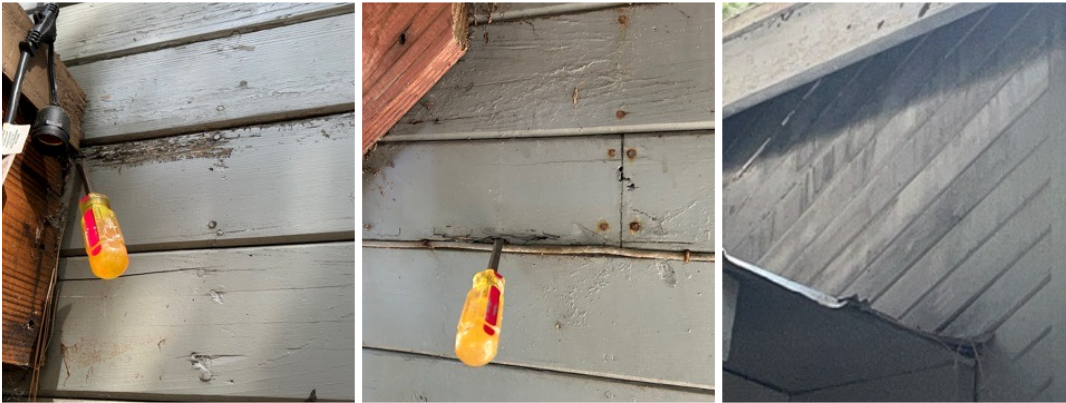
Wood deterioration is present at wood members.

[See Structural Pest Report](#)

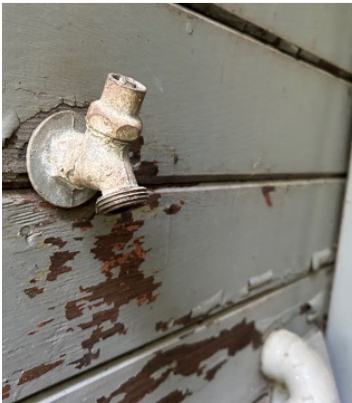
A continuous leak was noted at exterior hose bib spicket.

[See Structural Pest Report](#)

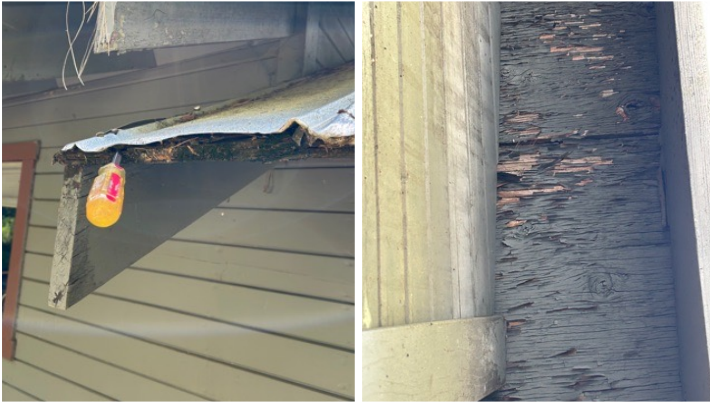
Wood deterioration was noted at roof sheathing in multiple locations.

[See Structural Pest Report](#)

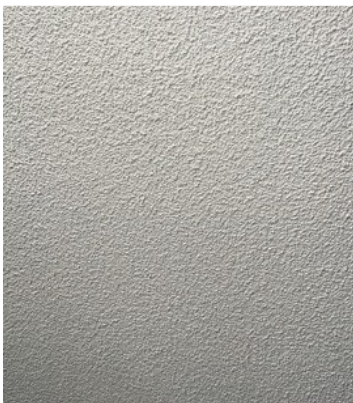
Popcorn ceiling can contain asbestos and should be tested prior to removal.

Informational Item

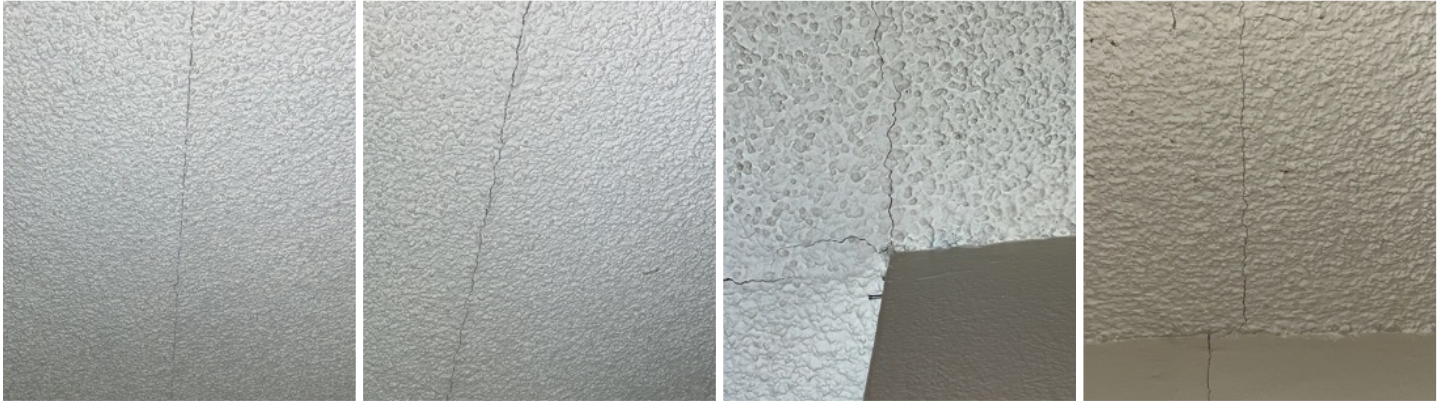
Cracks present at ceiling

Cosmetic Only

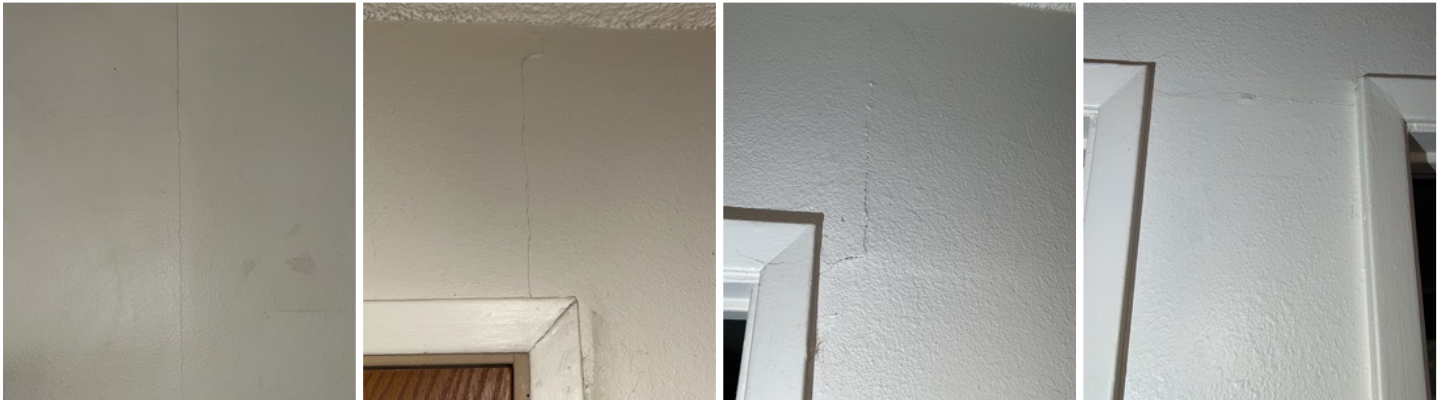
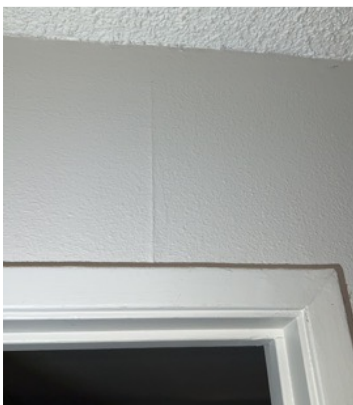
Cracks present at sheetrock.

Cosmetic Only

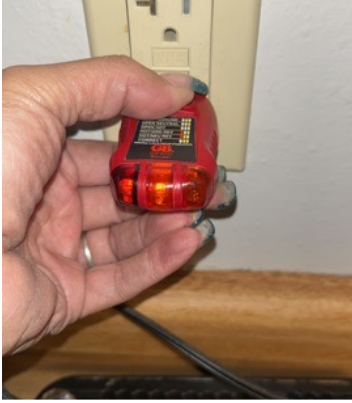
The GFI outlet was not tripping when tested.

Review by Tradesperson Recommended

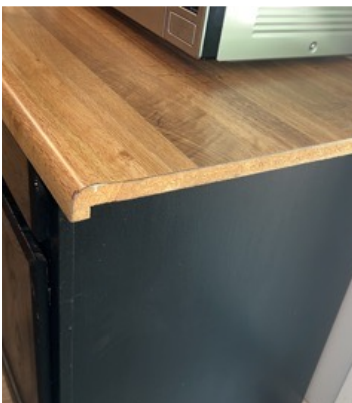
Surface laminate loose or missing.

Cosmetic Only

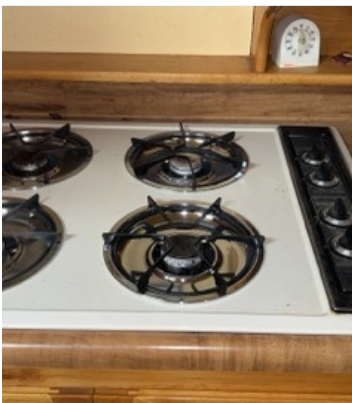
Appliance burners did not light automatically; may need to be match lit to test. Unable to inspect for functionality.

Not Inspected

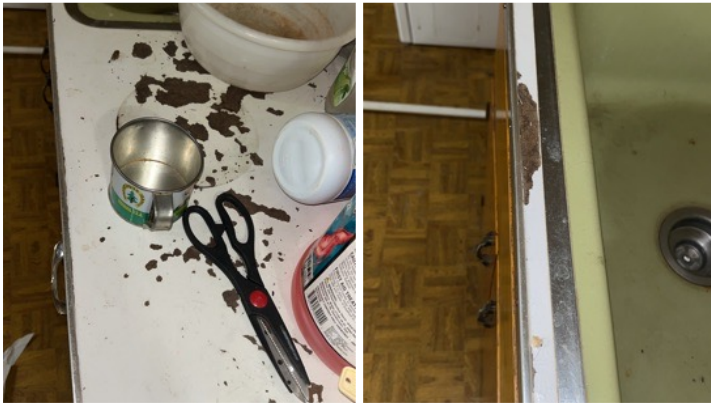
Cosmetic damage noted at countertop.

Cosmetic Only

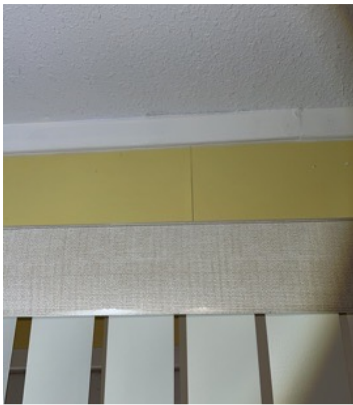
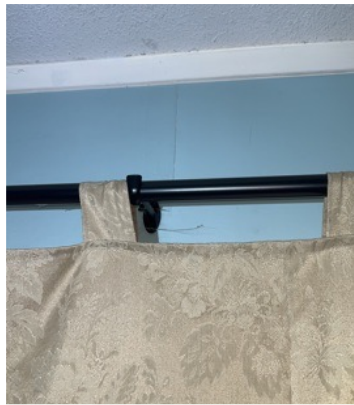
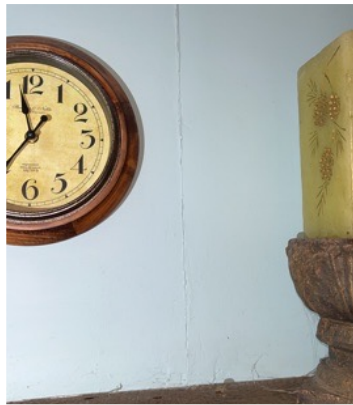
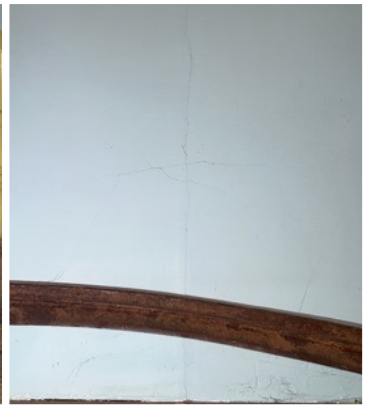
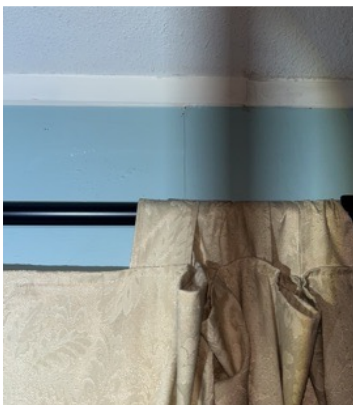
Cracks present

Cosmetic Only

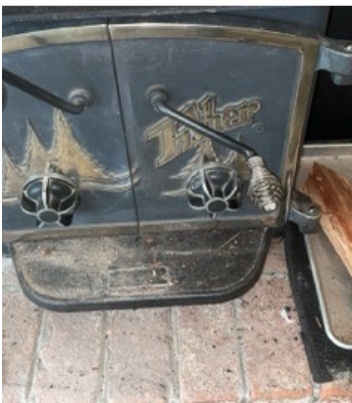
The handle does not operate as designed; appears to have been installed wrong.

Marginal

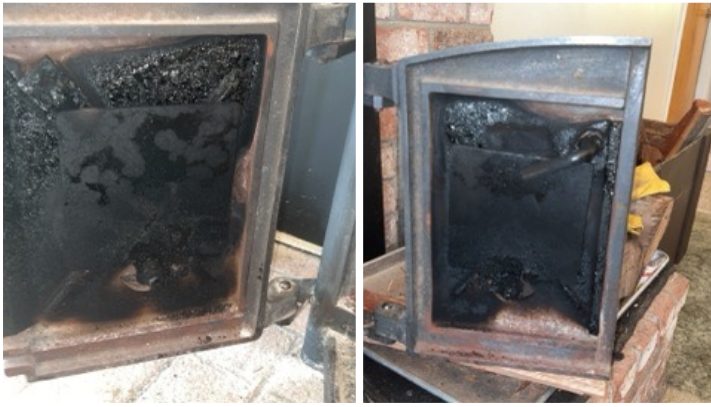
Missing corded rope seal.

Defective

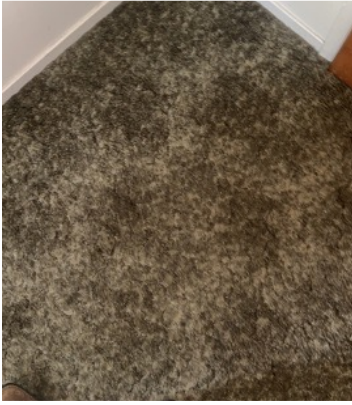
Floor squeaks noted, this is an indication that the subfloor fasteners are loose.

Marginal

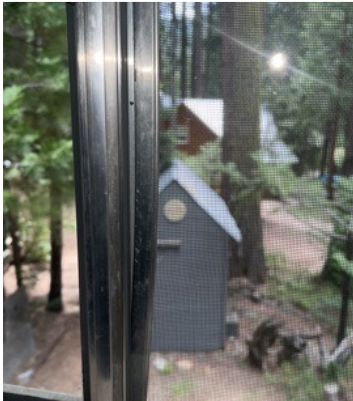
The aluminum screen frame was noted to be bent.

Cosmetic Only

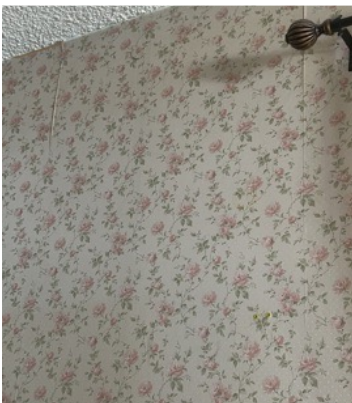
The wallpaper was noted to be loose and curling at seams.

Cosmetic Only

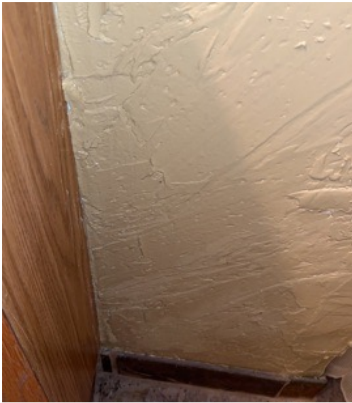
Cracks present at sheetrock.

Cosmetic Only

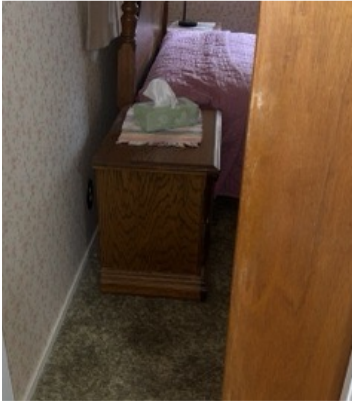
Missing hardware

Marginal

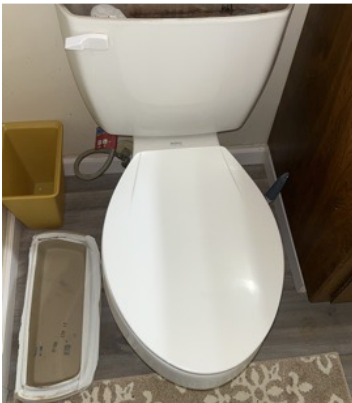
The toilet is loose at the floor and may require replacement of the wax seal

[See Structural Pest Report](#)

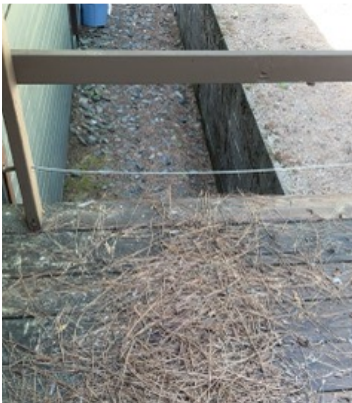
Cable railing was noted to be loose.

Marginal

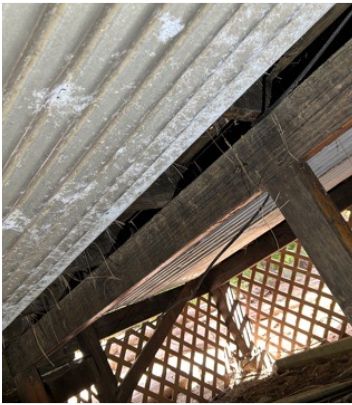
A portion of the back deck was inaccessible for full inspection due to corrugated metal installed at underside. Partial visual inspection performed.

[See Structural Pest Report](#)

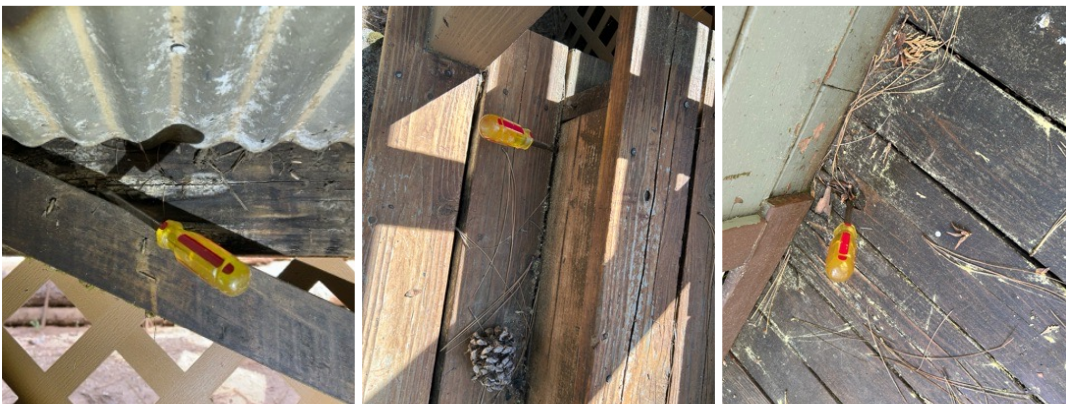
Wood deterioration is present

[See Structural Pest Report](#)

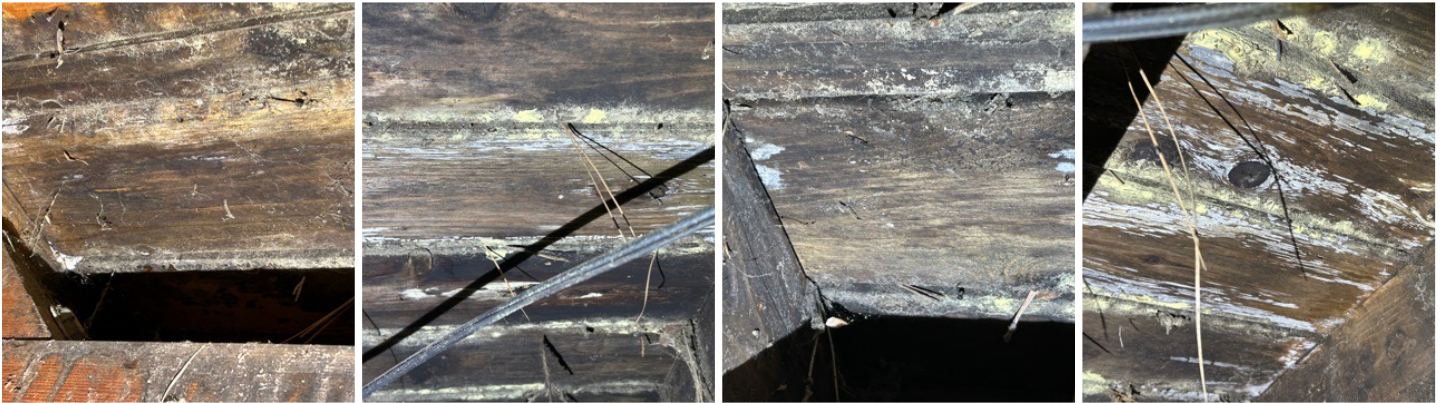
Surface fungus noted at underside of deck

See Structural Pest Report

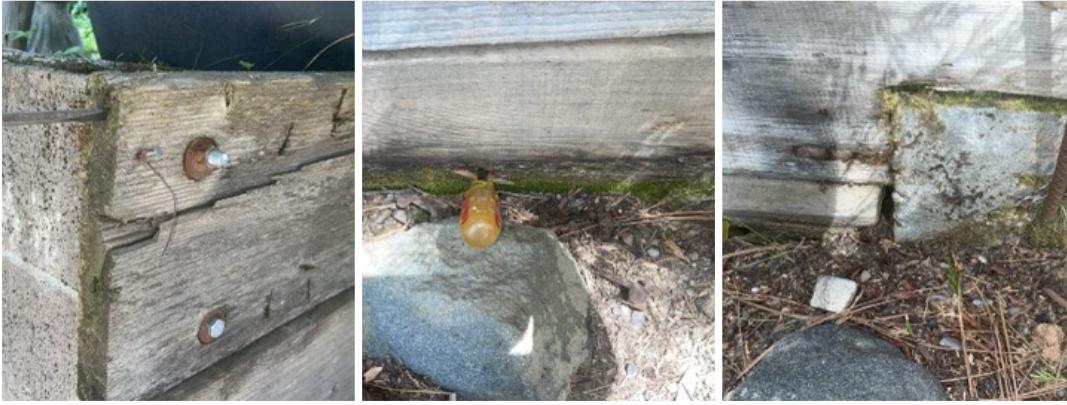
Wood deterioration noted at multiple portions of the retaining walls. Wood portion of retaining wall is not directly attached to the structure and will not be listed on Structural Pest Report.

Defective

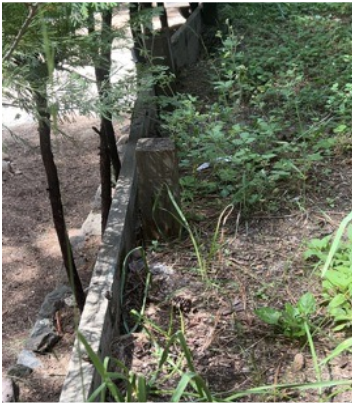
Portion failing

Wall is unsound and leaning.

Defective

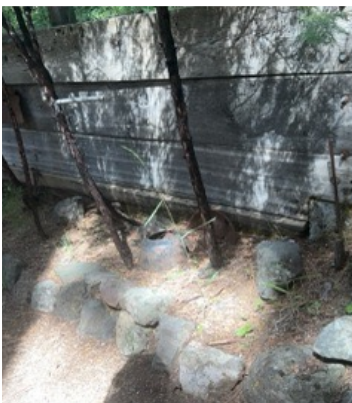
Earth to wood contacts are present. Wood portion of retaining wall is not directly attached to the structure and will not be listed on Structural Pest Report.

Defective

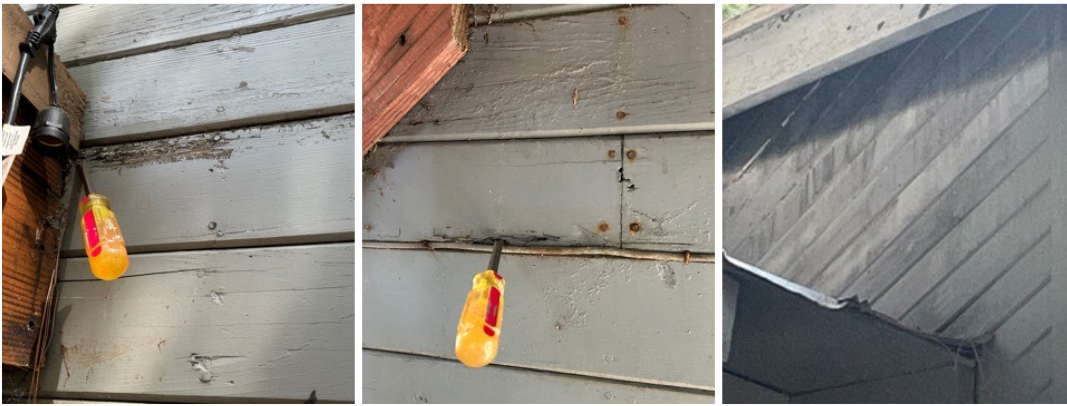
Wood deterioration is present at wood members.

[See Structural Pest Report](#)

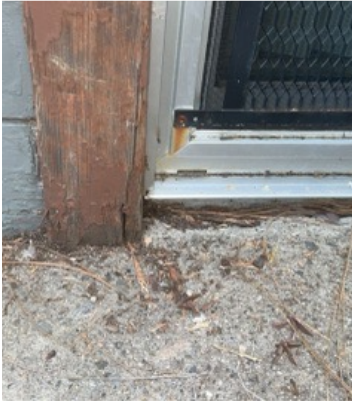
Cracks were noted at trim.

[Marginal](#)

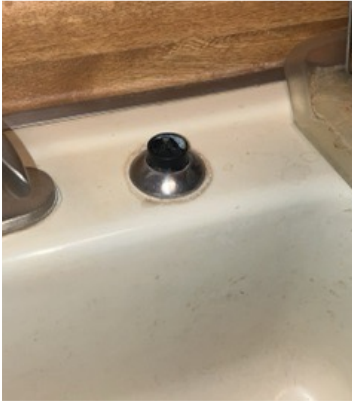
The sink spray nozzle was missing/not installed at time of inspection.

Defective

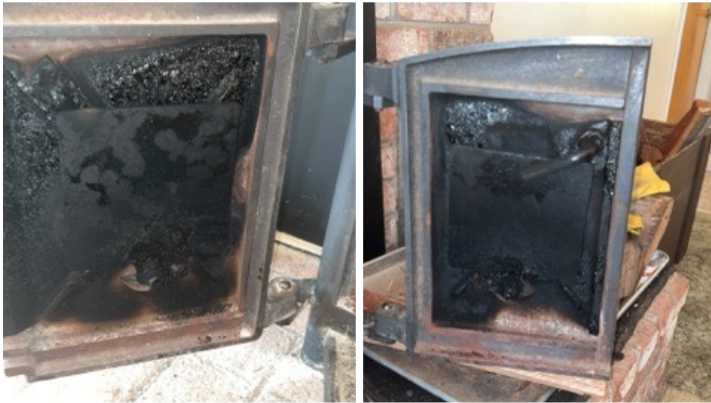
Missing corded rope seal.

Defective

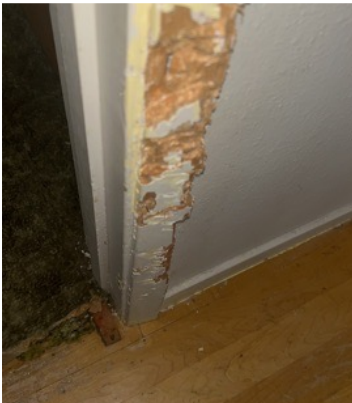
Damage noted.

Defective

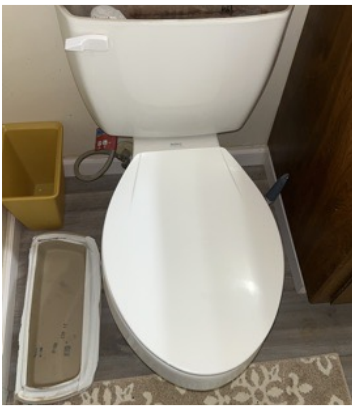
The toilet is loose at the floor and may require replacement of the wax seal

[See Structural Pest Report](#)
