## HOME INSPECTION REPORT

**2901 Webster Avenue  
San Diego, Ca 92113**

Client: Stephen Michea  
July 8, 2024  
File #240708AC

Prepared by: Chad Fisher, B.S.S.E., Certified CREIA Inspector

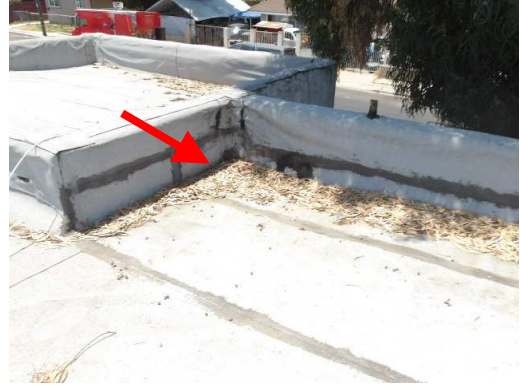
- There is debris present on the surface of the roof. The roof should be cleared of debris and kept clear.

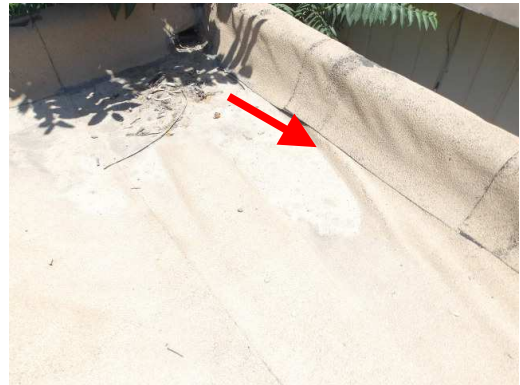
- There are wrinkles in the roofing in places. This condition is caused by incomplete bonding of the roofing plys.

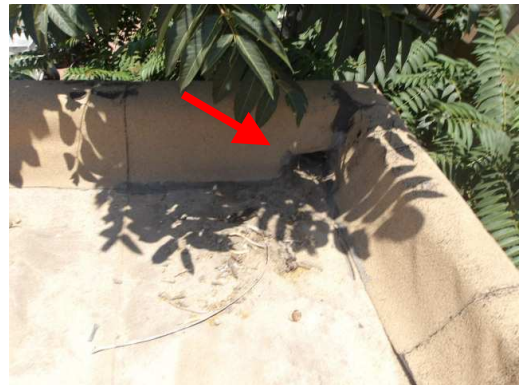
- There are no secondary roof drains present. Current local building codes require secondary roof drains. This may not have been required at the time of construction.

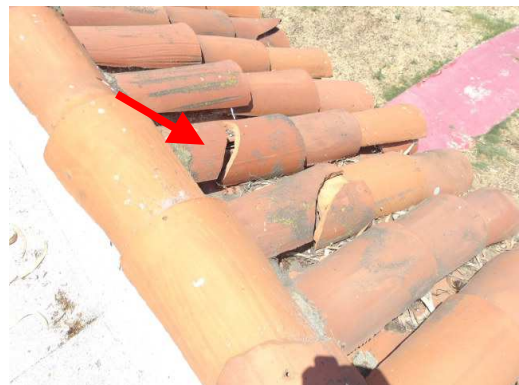
- There are several broken tiles visible on the roof surface. Any cracked or broken tiles should be properly repaired or replaced.

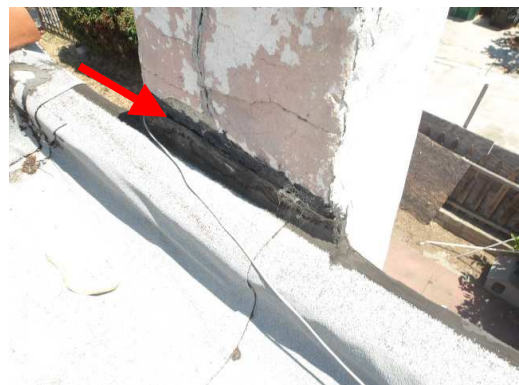
- The roof is in need of resealing at the junction with the chimney.

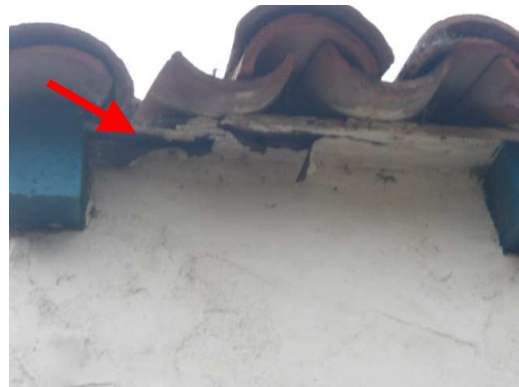
- The eaves at deteriorated at the northeast portion of the house. It is recommended that a licensed structural pest control company be contacted for further inspection and repair recommendations.

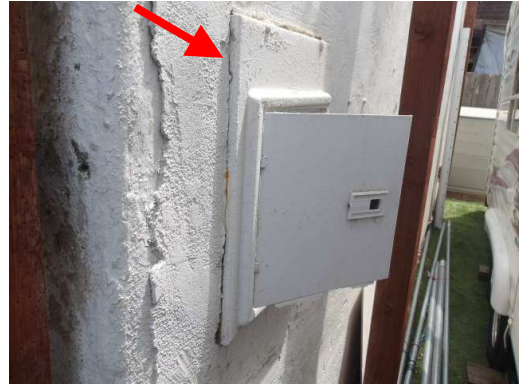
- The panel is not rated for an exterior location and the panel should be replaced or properly provided with weather protection.

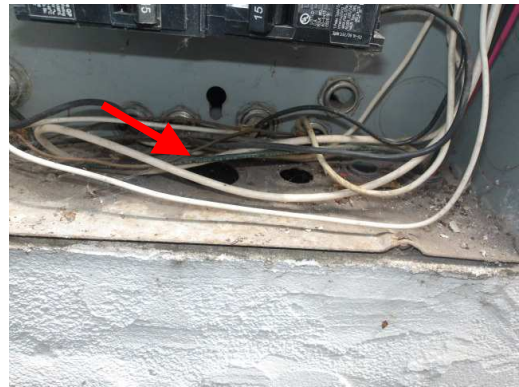
- There are uncapped knockout openings present in the bottom of the sub-panel. These openings should be properly capped as required by local building codes.

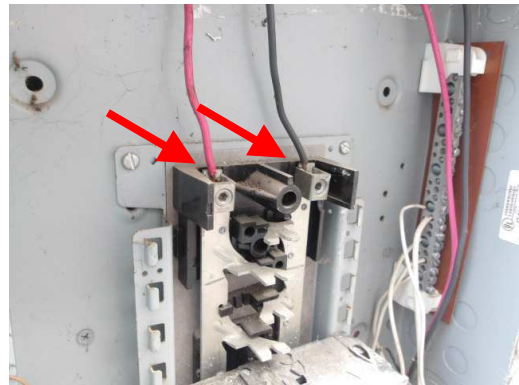
- The capacity of the wires feeding the panel are only 30 amps, however, the breaker feeding the panel appears to be 40 amps. This condition should be corrected.

- It is recommended that a licensed electrical contractor be contacted for further inspection of the electrical panels and for recommendations.

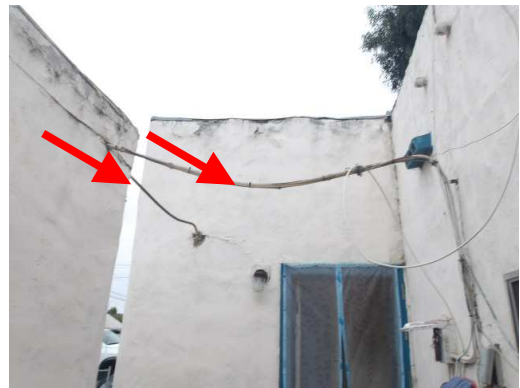
- The electrical conduit between the garage and house is damaged and this wiring is in need of repair.

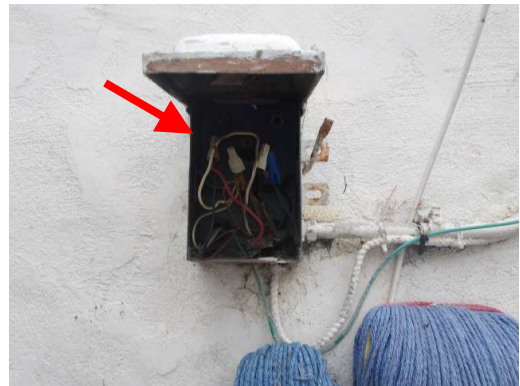
- There is a disconnect outside at the rear of the house which is being used as a junction box. This box should be sealed shut.

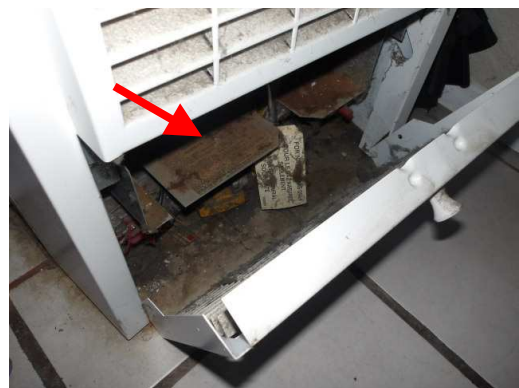
- There is an accumulation of dust and debris inside the furnace and the furnace should be cleaned prior to use.

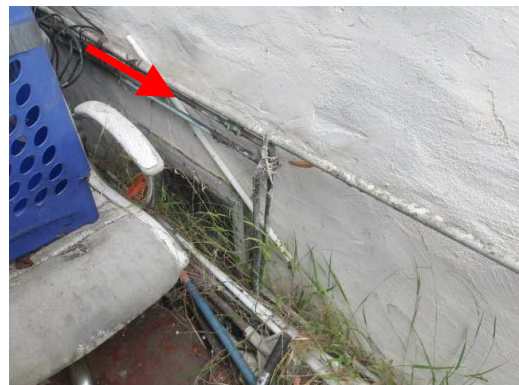
- The water lines outside at the east side of the house are loose and should be properly secured in place.

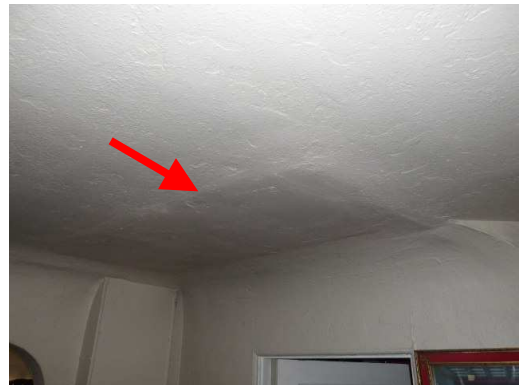
- The ceilings are patched in places, especially in the dining room. The causes for these conditions were not determined.

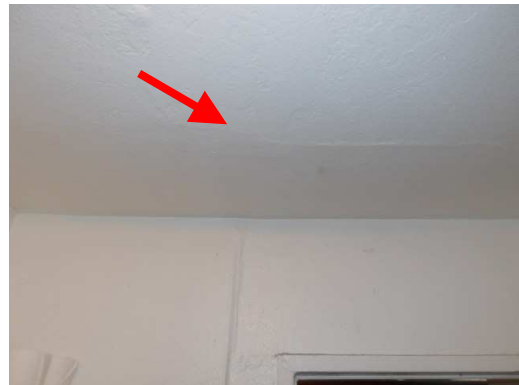
- The ceiling in the bathroom is sagging. This condition is possibly the result of roof leakage. It could not be determined by visual inspection if this condition is caused by on-going leakage or if the leakage has been repaired.

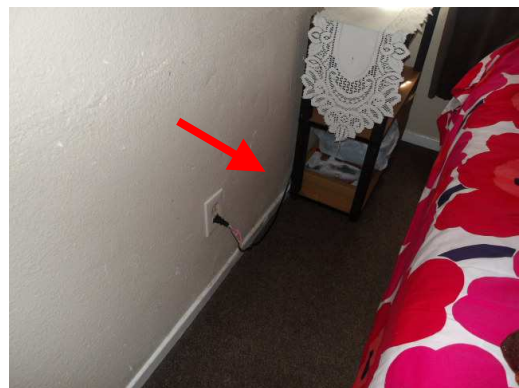
- There is some water damage to the lower wall in the north side of the southeast bedroom. This condition is apparently caused by plumbing leakage. Because of this condition this area was tested for the presence of elevated moisture with a Protimeter Surveymaster electronic moisture meter and was found to contain excessive moisture at the time of the inspection. The cause for this condition

should be determined and corrected.

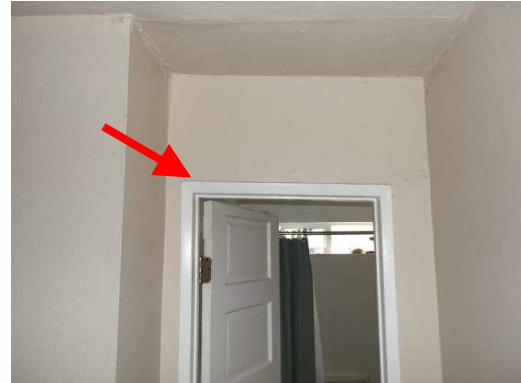
- Several of the door frames are out of square. This condition is apparently caused by some movement of the structure.

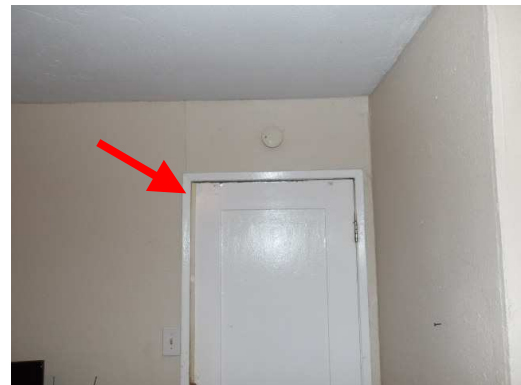
- The southeast bedroom closet door is loose on its hinges, rubs on the side of the door frame, and is in need of repair.
- The southeast bedroom door closes by itself. This condition is apparently caused by some movement of the structure.

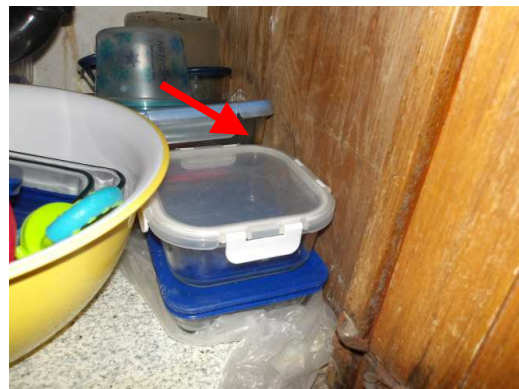
- There is some water damage to the interior of the cabinet underneath the sink. The cause for this condition could not be determined by visual inspection, however, because of this condition this area was tested for the presence of elevated moisture with a Protimeter Surveymaster electronic moisture meter and was found to be dry at the time of the inspection. The Client is advised that the absence of moisture at this time does not necessarily indicate that any previous leakage has been successfully repaired or that future leakage will not occur. It is recommended that a qualified indoor air quality specialist be contacted for comprehensive investigation and for recommendations for the reasons stated above.

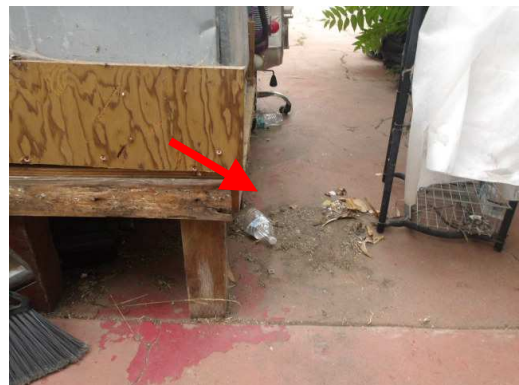
- There is evidence of water ponding on the patio at the east side of the house. The drainage should be improved in this area and water should not be allowed to pond in areas adjacent to the foundation.

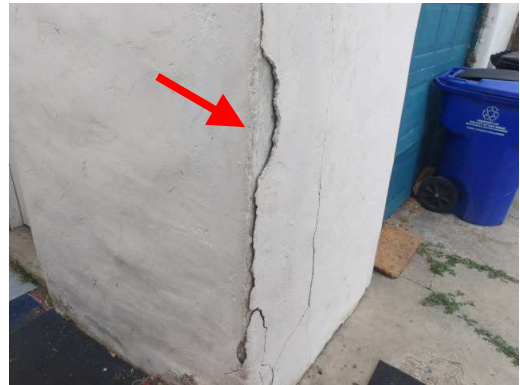
- The stucco is flaking off at the front of the garage and is in need of repair or replacement.

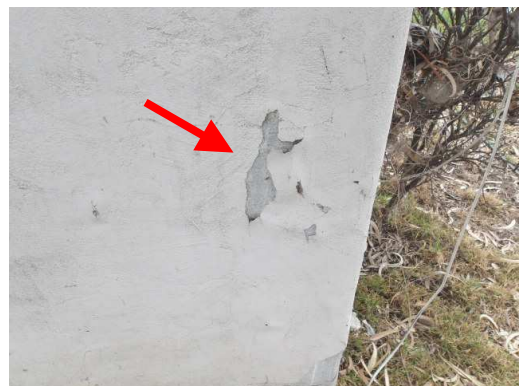
- The paint is flaking off the stucco in several places. This condition is cosmetic in nature.

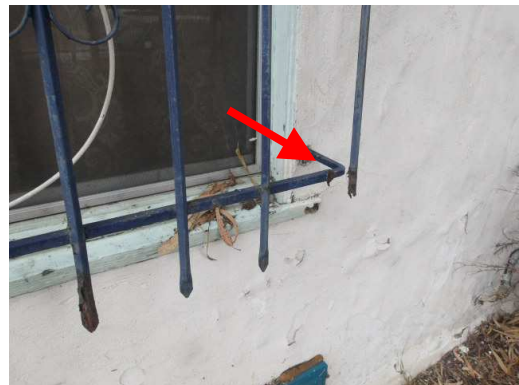
- The security bars at the west side of the living room are damaged.

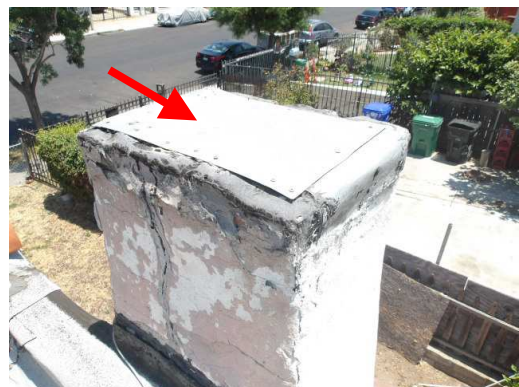
- The top of the chimney has been capped off. The cause for this condition was not determined.

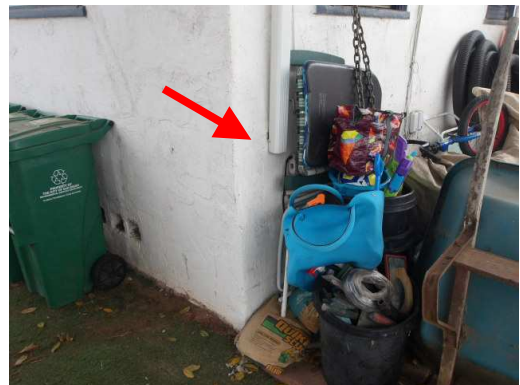
- The roof drain downspouts discharge adjacent to the foundation and should be reconfigured to drain away from the foundation.

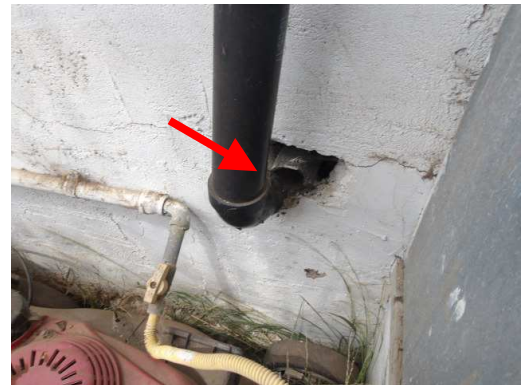
- The plumbing vent outside at the rear of the building left of the water heaters is disconnected and is in need of repair.

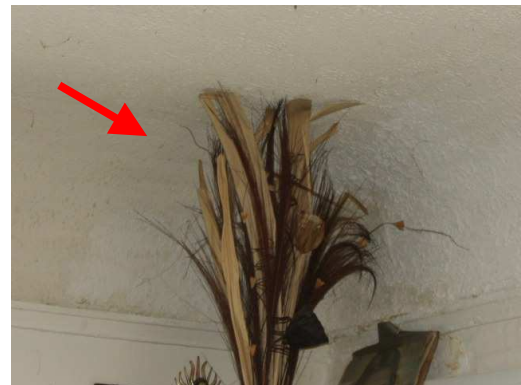
- The ceilings and upper walls in the northwest and southwest corners of the building have been patched.

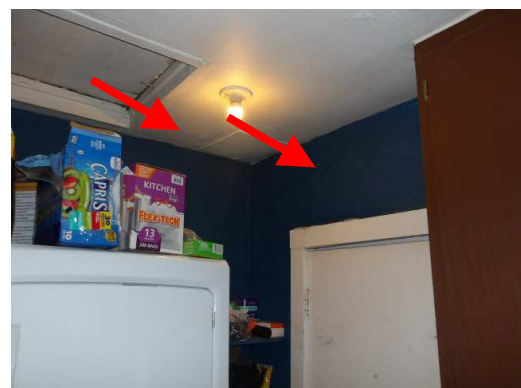
- The ceiling and upper walls in the kitchen in 221 South 29<sup>th</sup> Street are damaged.

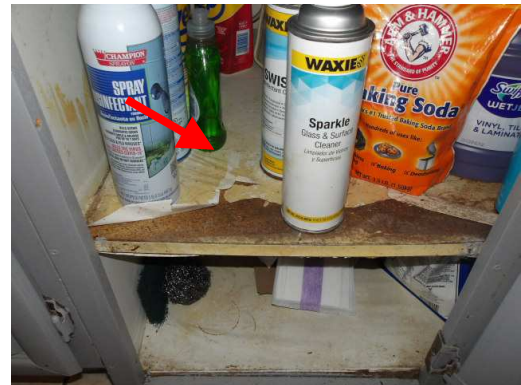
- There is some water damage to the interior of the cabinet underneath the sink. Because of this condition this area was tested for the presence of elevated moisture with a Protimeter Surveymaster electronic moisture meter and was found to contain excessive moisture at the time of the inspection. The cause for this condition should be determined and corrected. It is recommended that a qualified indoor air quality specialist be contacted for comprehensive investigation and for recommendations for the reasons stated above.

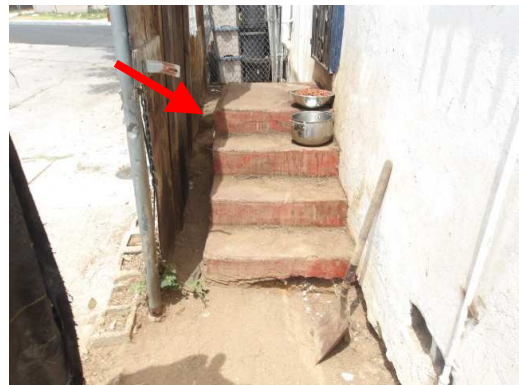
- The exterior stairways at the north and south sides of the building should be provided with handrails as required by local building codes.

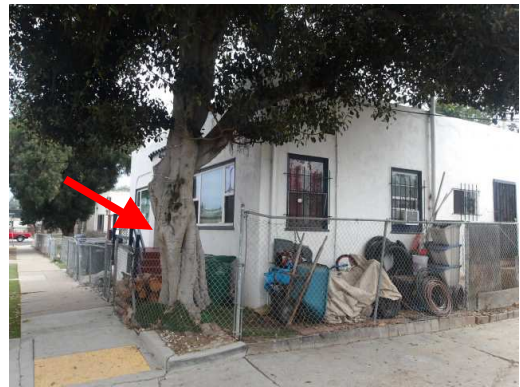
- There is a tree growing close to the foundation at the southwest corner of the house. Tree roots can cause movement of the foundation and it is recommended that the tree be removed.

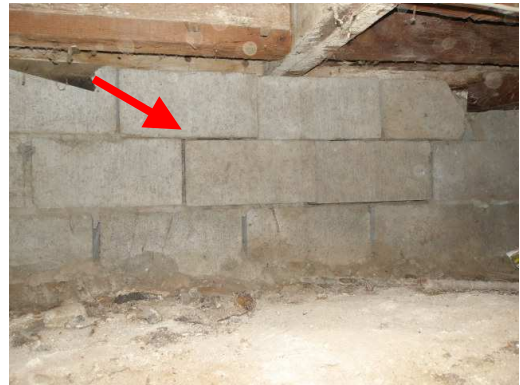
- The west foundation wall has gaps between the blocks in places. This condition is apparently caused by some movement of the foundation.

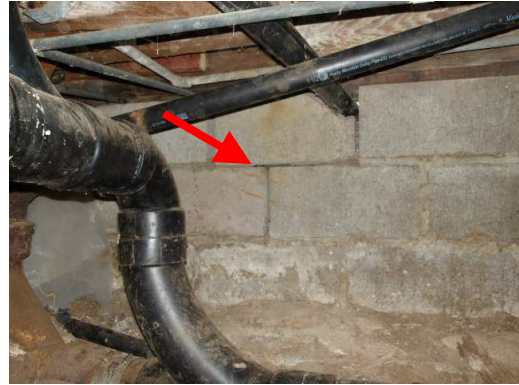
- The east foundation wall has gaps between the blocks in places. This condition is also apparently caused by some movement of the foundation.

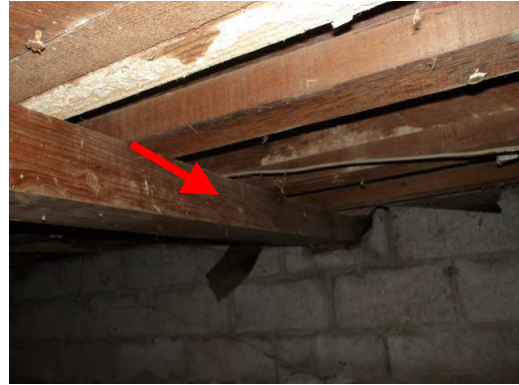
- The girders are only 4 inches deep and are sagging in places. Current standards require girders at least 6 inches deep.

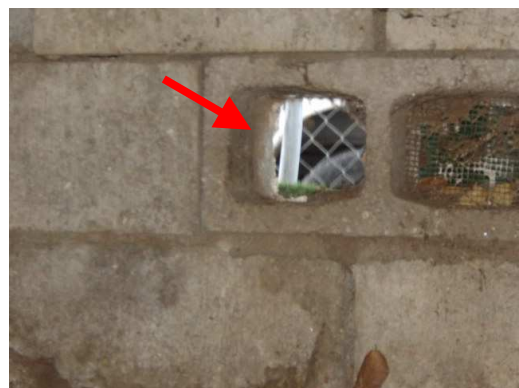
- There are openings in some of the vent screens and these vents should be properly screened.
