# *Home Inspections San Diego*

## Property Inspection Report

122 Elder Avenue , Chula Vista, CA 91910  
Inspection prepared for: Shannon Medina  
Real Estate Agent: Patrick Adams -

Date of Inspection: 7/17/2026 Time: 12:00 p.m.

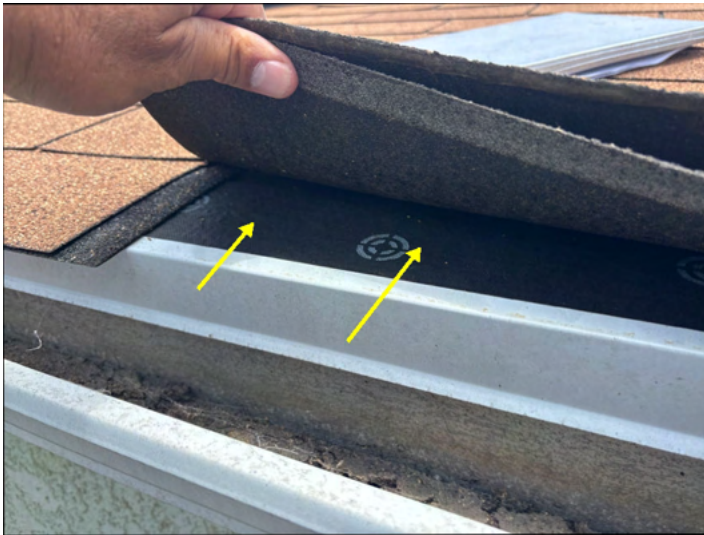
The roofing material was not installed with a starter strip and not tightly secured at the eaves.

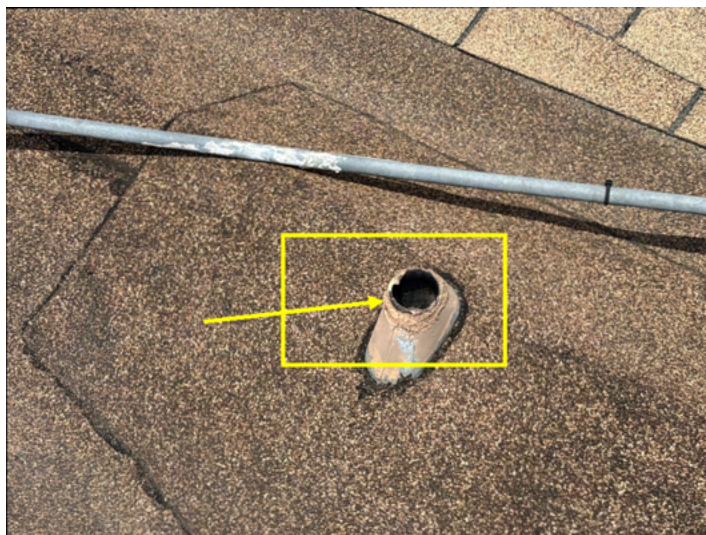
A venting pipe and or pipes located on the top of the roof does not extend 6 inches from the roof's surface. We recommend you have this condition further evaluated by a licensed roofing contractor to ensure it complies to the current standards. Location: Center of the roof at th cricket intersection.

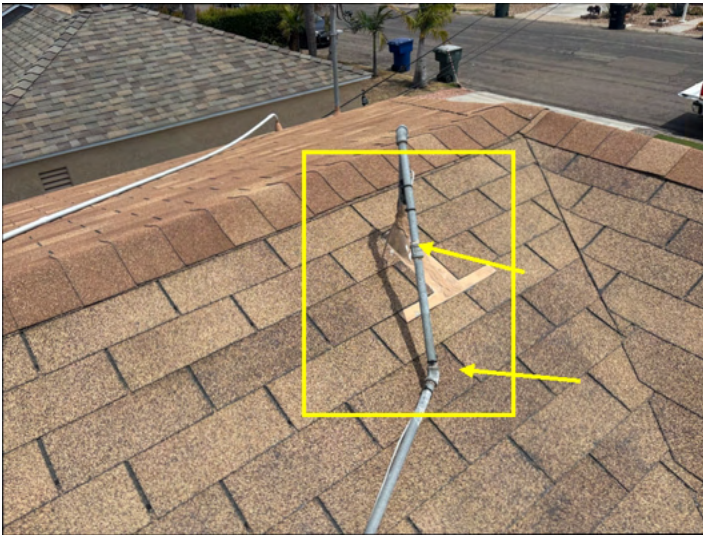
A gas and electrical pipe is installed on the roof top which needs to be sealed and or secured at the roof intersection. We recommend service for this condition by a licensed contractor.

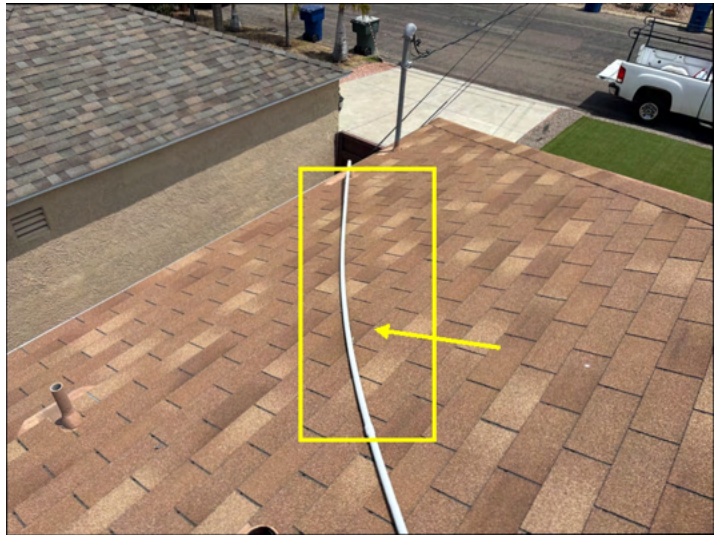
A gas and electrical pipe is installed on the roof top which needs to be sealed and or secured at the roof intersection. We recommend service for this condition by a licensed contractor.

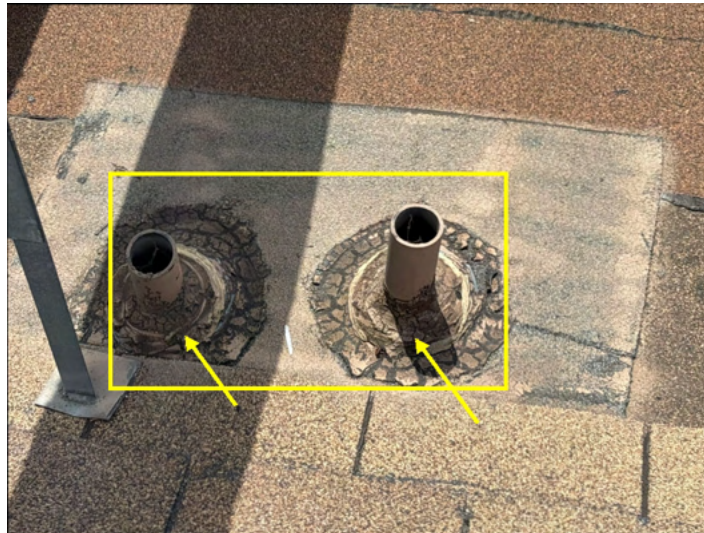
A vent pipe and or pipes has been heavily sealed with mastic and there are no visible flashing, a condition that could lead to future leakage. We recommend that the vent pipe further evaluated by a licensed roofing contractor and flashing added in this area. Location: Flat roof.

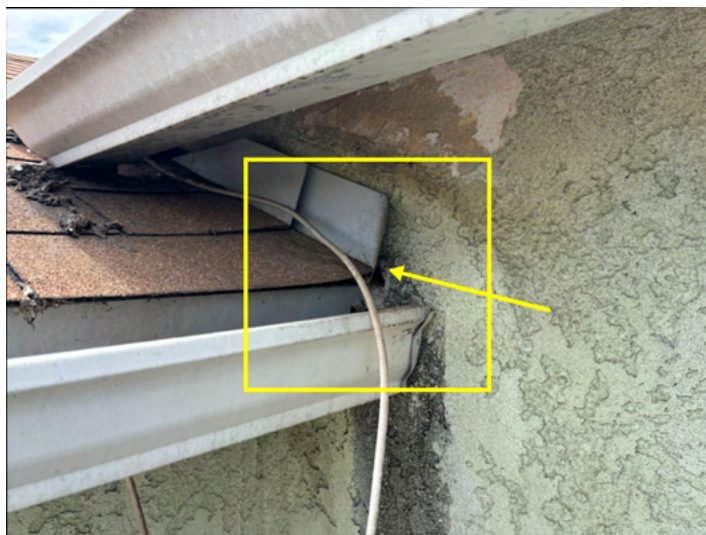
The roof to wall flashing is in need of additional sealant and or flashing. We recommend that you have a licensed roofing contractor evaluate this condition as it may cause water intrusion into the living structure. Location: Front of the roof at the garage intersection.

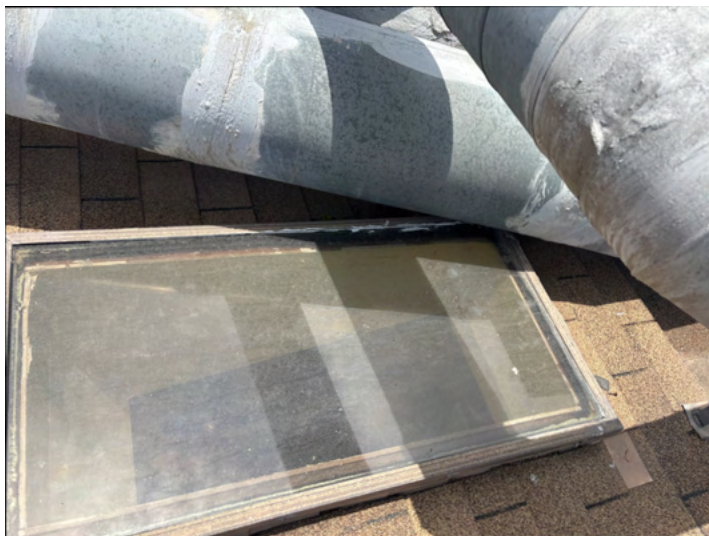
The inner seal of a skylight and or skylights shows signs of deterioration. We recommend you have a licensed roofing contractor further evaluate this condition to ensure they are watertight. Due to the overall condition of the skylights', service and or replacement may be necessary. Location: Throughout the roof. Note: The dome skylight at the center of the roof appears be in good condition.

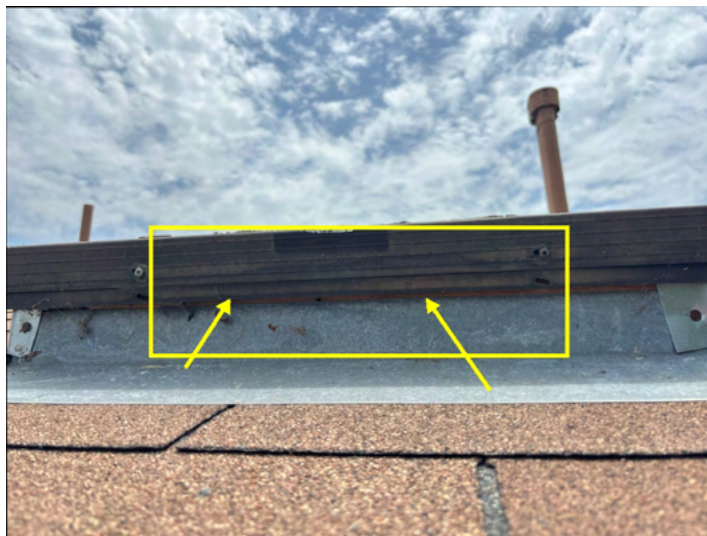
There is exposed wood at the base of the skylight at the right side of the home which may require future service and or flashing.

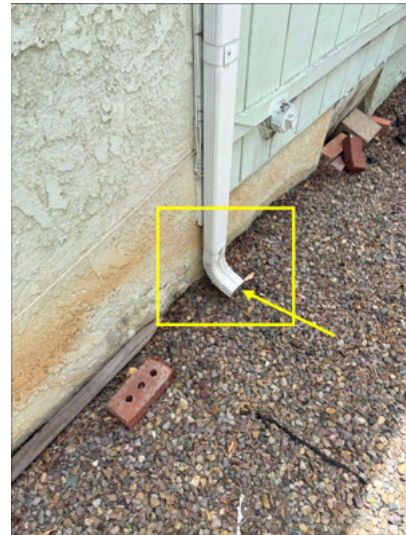
As a preventive measure we recommend that you have a water diverter and or splash blocks installed at the bottom of the downspouts in order to help divert water away from the house foundation.

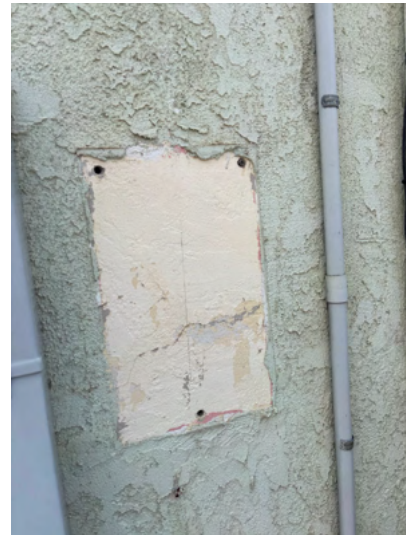
The section and or sections of color coat (top layer of the stucco finish) is missing and or shows signs of wear. Repair to the color coat in this area would be necessary. We recommend you have this condition evaluated by a licensed stucco contractor. Location: Right side of the home.

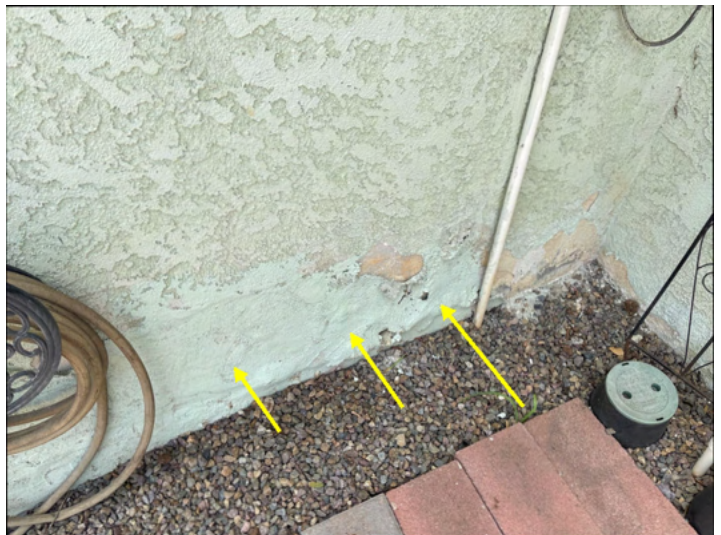
The current condition of the stucco color shows signs of flaking. This condition may have been caused by an improper application of paint and or moisture behind the stucco surface. This condition should be noted as it may require scraping of the stucco, installation of texture and color coat or painting to match. We recommend the overall condition of the stucco in this area evaluated by a licensed stucco contractor. Location: Front of the home (right side of the garage).

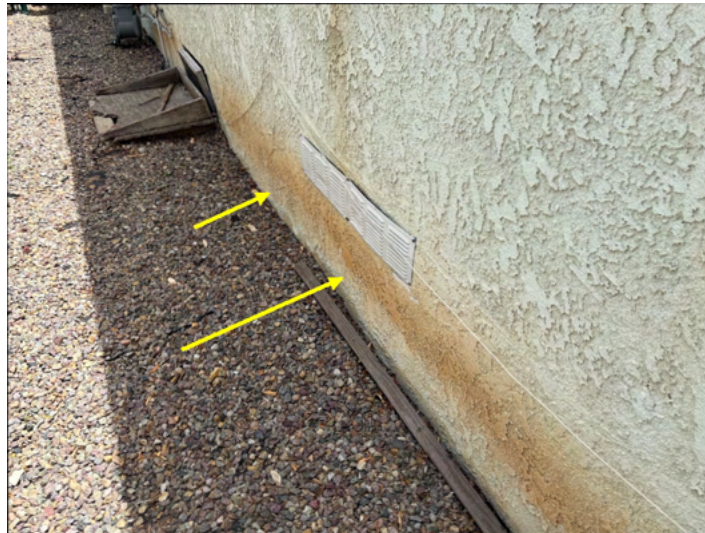
There are stains present at the base of the home on the stucco. This condition appears to have been caused by not having rain gutters installed and or damaged rain gutters. We recommend the addition and or the repair of the rain gutters to prolong the life expectancy of the stucco. Location: Right side of the home.

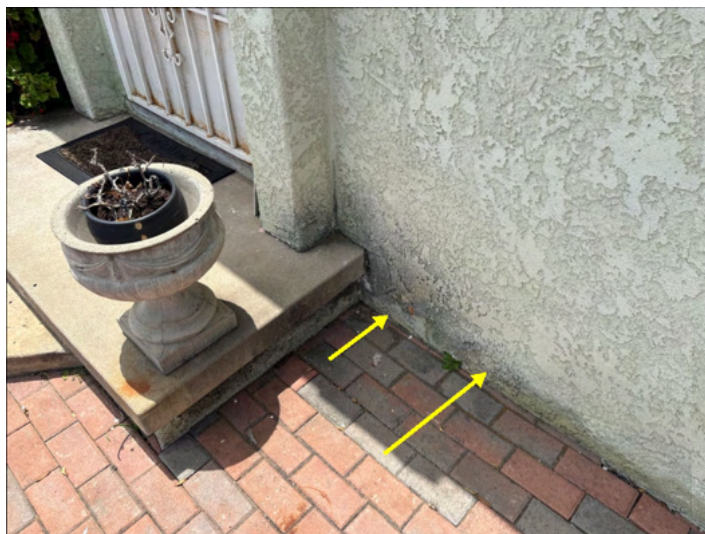
The current stucco has been installed without a stucco/weep screed. The stucco extends down to the soil without the benefit of a weep-screed. Weep screed is a horizontal strip of metal that isolates the stucco house walls from the foundation and allows them to move independent of the foundation. This not only prevents horizontal cosmetic cracks that are commonly seen at the base of many stucco walls but, also isolates the stucco from the soil and inhibits the wicking effect of moisture being drawn up into the stucco which in turn creates the flaking and peeling that is common on such surfaces. This condition was common in older homes and should be noted.

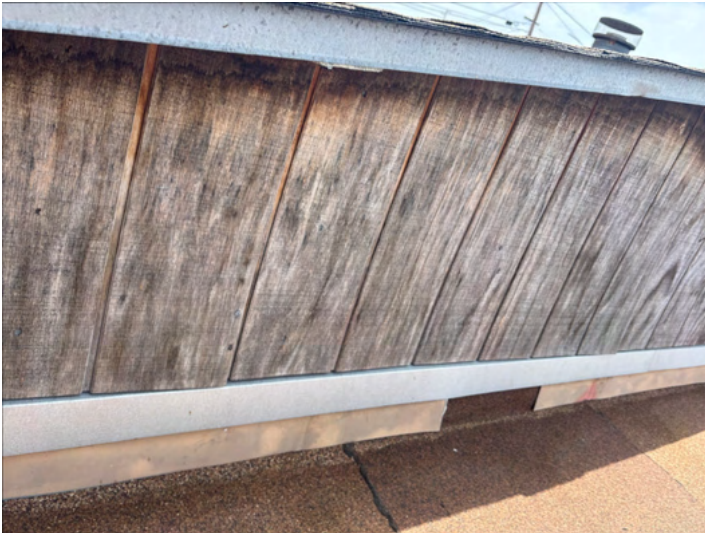
The overall condition of the wood siding's paint is fair as sections may require additional paint, paint touch up and or service. Location: Rear of the home at the gable end.

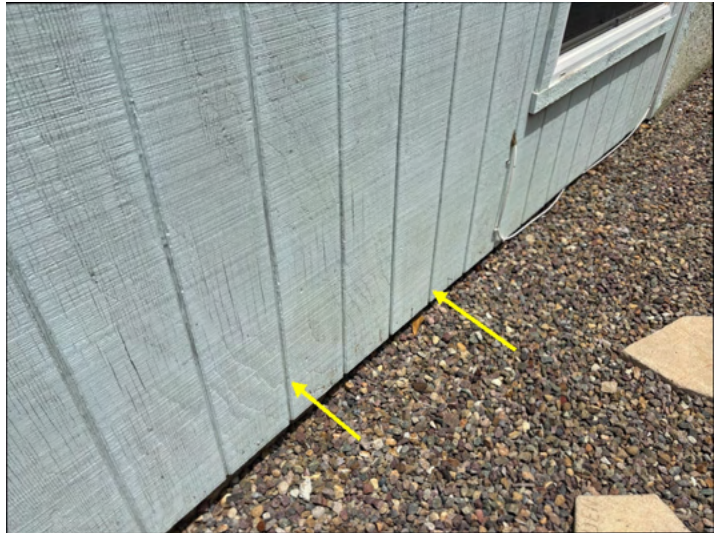
The siding located on the left side of the home is in need of nailing.

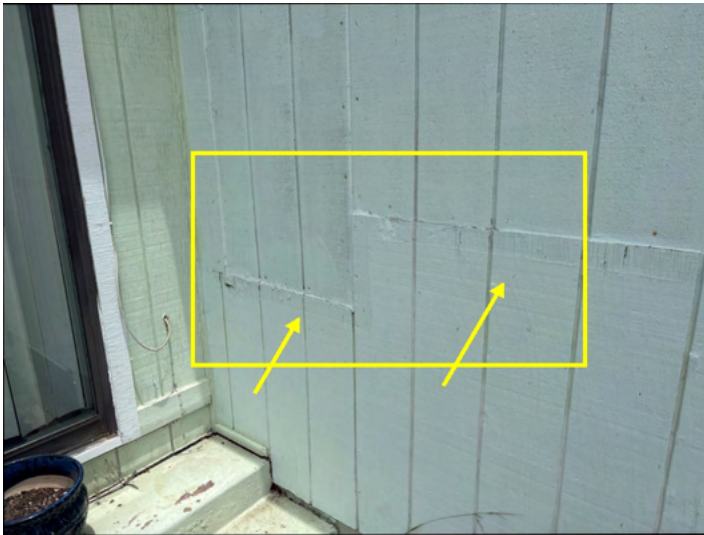
A repair was made to the wood siding at the rear of the home and the texture does not match exactly.

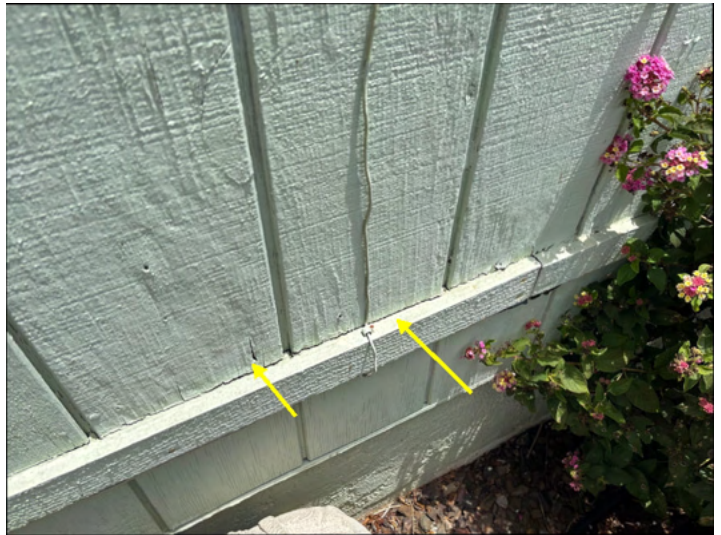
There is wood siding on the right side of the home. This siding shows signs of insect and or water damage. This condition should be noted and may require future maintenance. Please review the termite report regarding this condition as Home Inspections San Diego doesn't perform any insect and or water damage inspections.

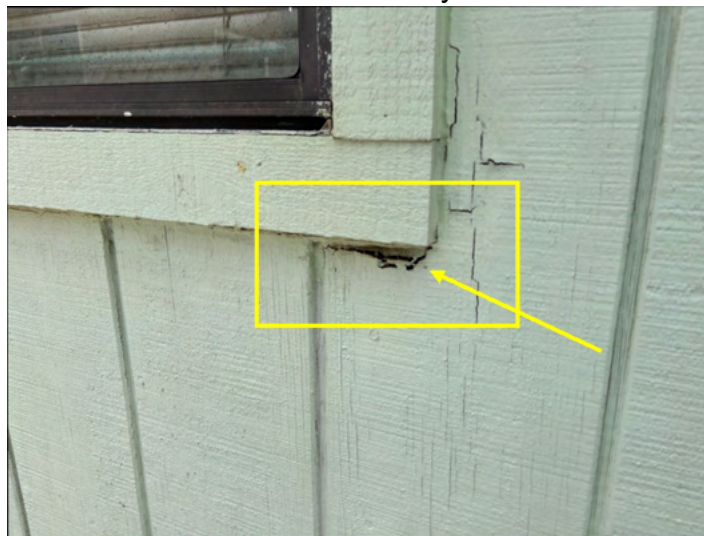
There is wood siding on the right side of the home. This siding shows signs of insect and or water damage. This condition should be noted and may require future maintenance. Please review the termite report regarding this condition as Home Inspections San Diego doesn't perform any insect and or water damage inspections.

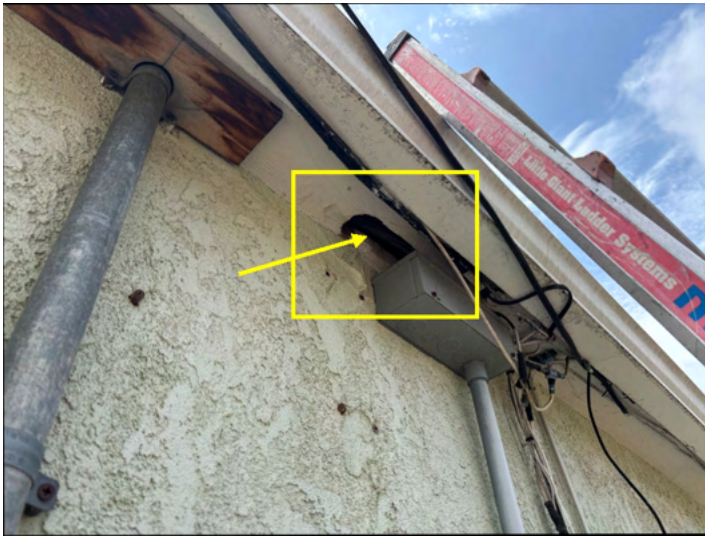
A screen and or screens for the eaves venting is damaged. Replacement or repair is recommended as it could promote insect and or pest intrusion into the attic area. Location: Right side of the home and at the electrical to junction box intersection at the right side of the home.

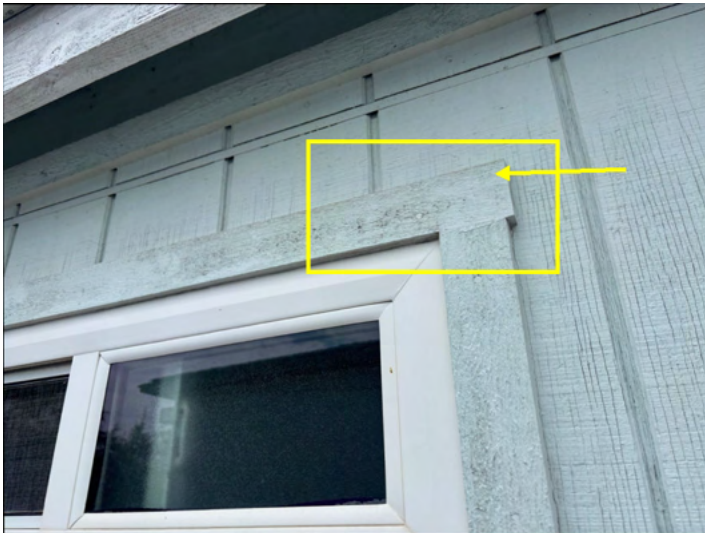
The header flashing is missing at the wood window frame intersection. We recommend you have this condition corrected by a licensed contractor to prevent water intrusion inside the wall cavity. Location: Throughout.

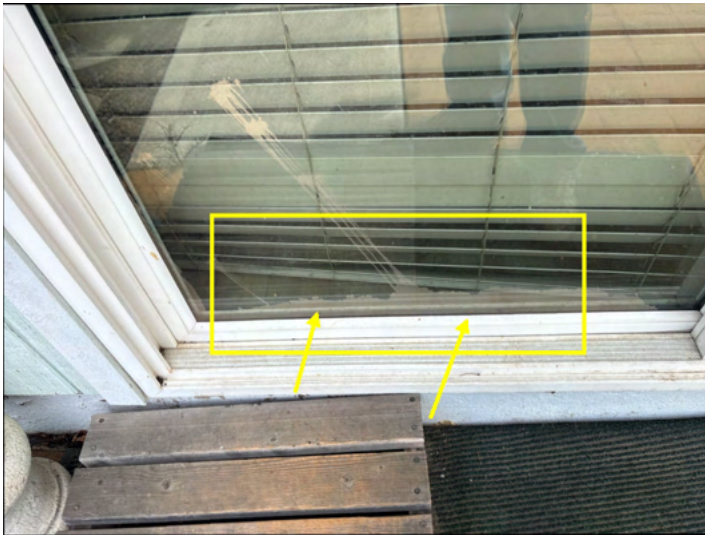
The dual glazed sliding glass door has a broken hermetic seal. This is evident from fogging, or condensation forming between the panes of glass, that confirms that the seal has failed. The condition should be noted as it may require future repair and or replacement. We recommend you have a licensed door contractor evaluate the overall condition of this door. Location: Bedroom 4.

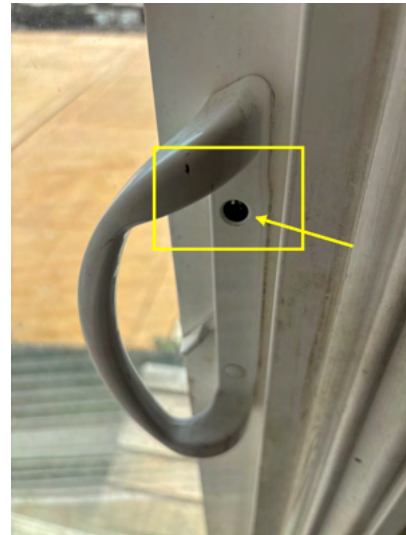
Missing item: Plastic door lock cap. Location: Bedroom 3 sliding door.

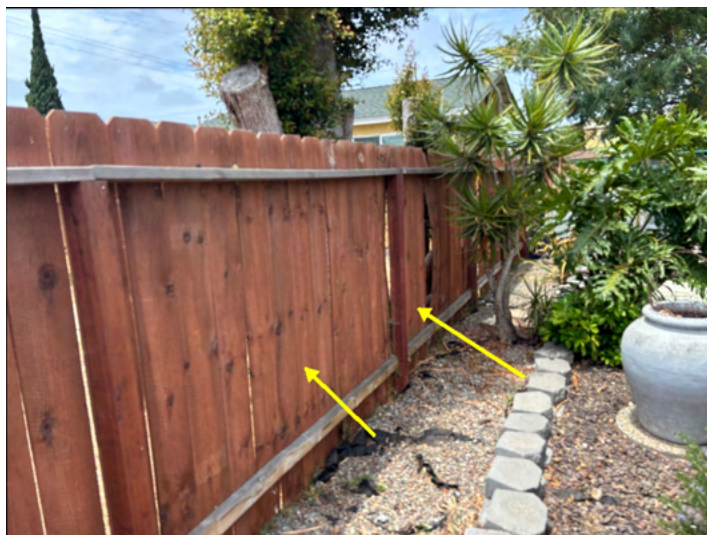
Original/older wood fencing remains on the property. Due to the current condition of the fencing, replacement may be necessary as sections/pieces of the fencing are damaged and their posts show signs of wear. Due to the overall condition of the fencing, we recommend it evaluated by a licensed fencing contractor. Location: Left side and rear of the property.

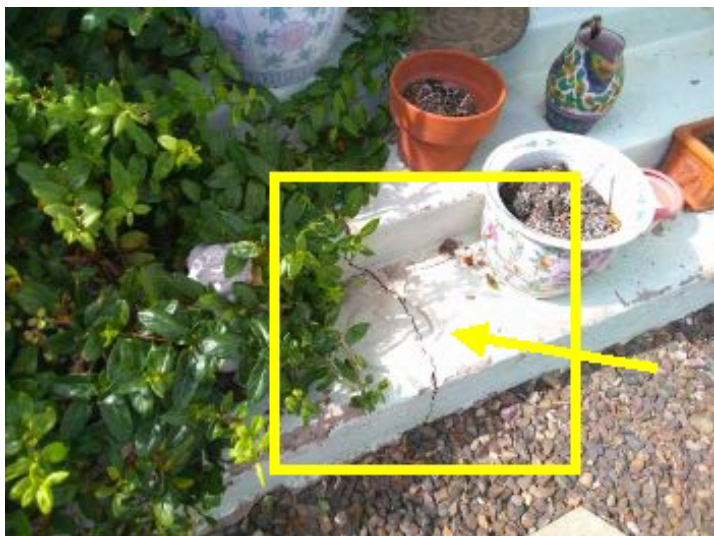
The overall condition of the concrete steps is fair as they: are settling away from the home, shows signs of settling and may not have the correct flashing installed at the house intersection. We recommend a licensed contractor evaluate the overall condition of these concrete steps.

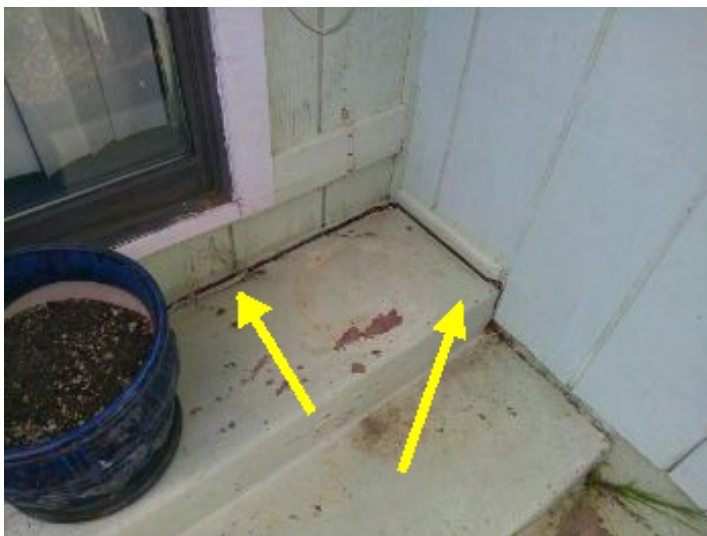
The overall condition of the concrete steps is fair as they: are settling away from the home, shows signs of settling and may not have the correct flashing installed at the house intersection. We recommend a licensed contractor evaluate the overall condition of these concrete steps.

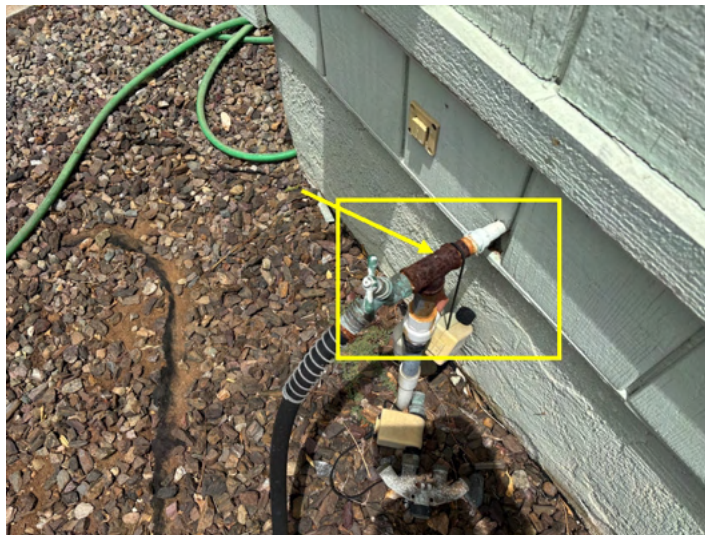
A hose bib has been installed with galvanized pipe t-fitting that is rusted. This condition should be noted and replacement to the galvanized pipe may be necessary in the near future. Location: Rear of the home.

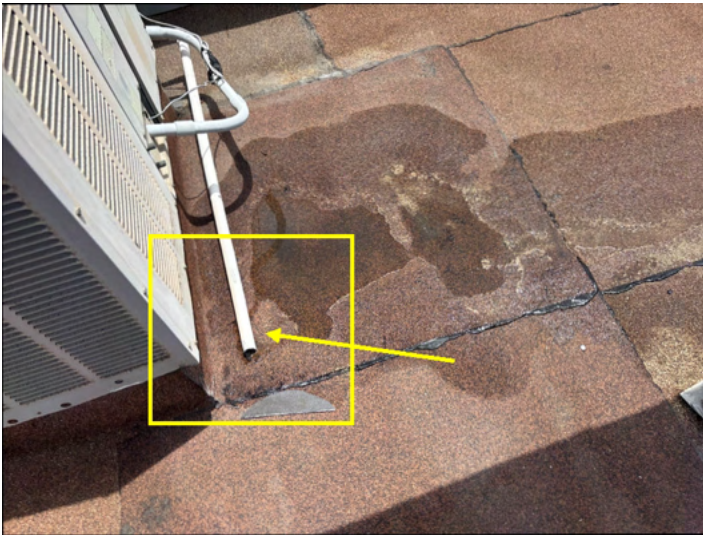
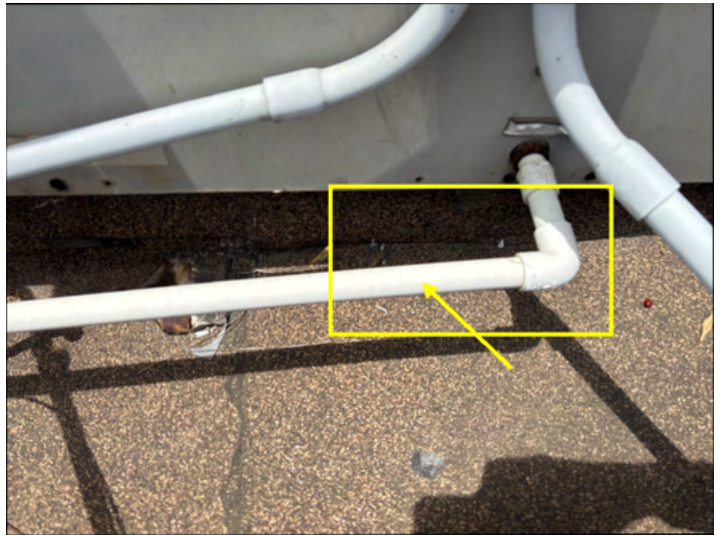
The primary drain line drains onto the roof top. We recommend a licensed H.V.A.C. contractor evaluate this condition to prevent water puddling next to the unit. The possible extension into a rain gutter and then diverted away from the foundation may be necessary.

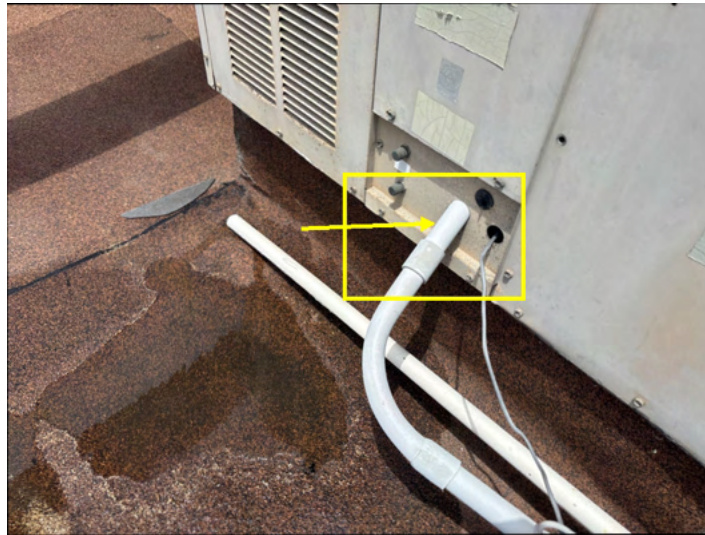
The electrical conduit for the heating and cooling unit located on the roof is not tightly secured to the unit (missing the correct attachment nut at the conduit to unit intersection) which we recommend you have corrected as it could pose a safety concern.

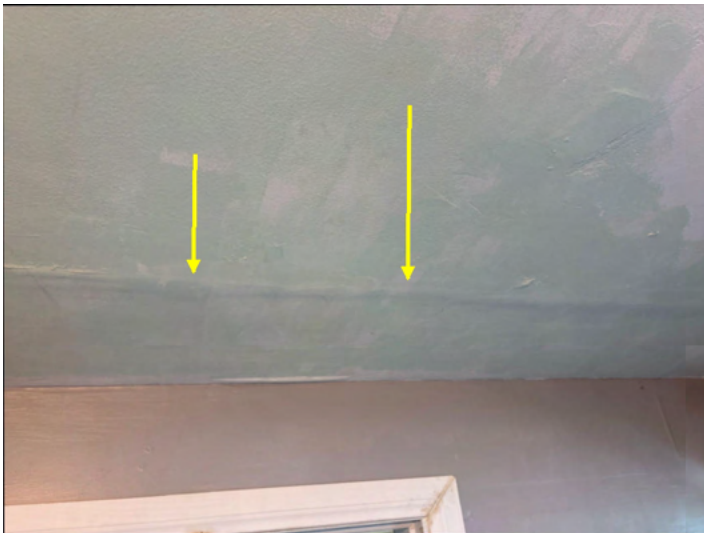
Repair was made to the drywall ceiling and or walls and the texture does not match exactly. We recommend the ceiling texture repaired to match and painted. Location: Bathroom 3.

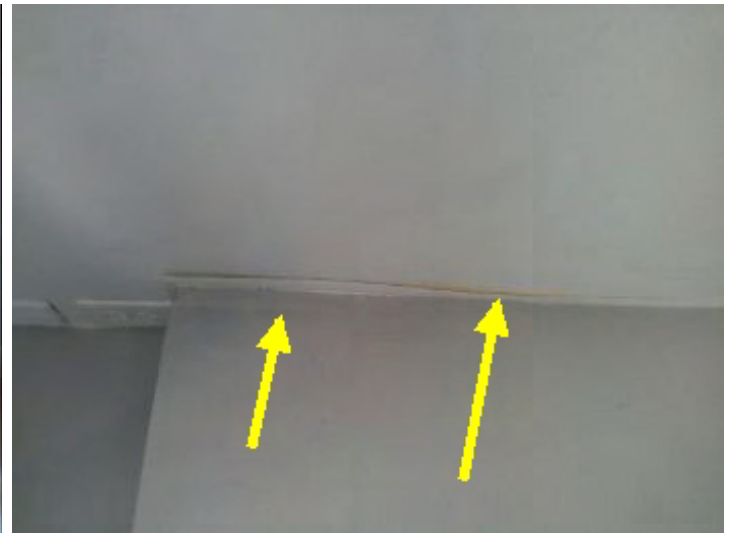
Repair was made to the drywall ceiling and or walls and the texture does not match exactly. We recommend the ceiling texture repaired to match and painted. Location: Bathroom 3.

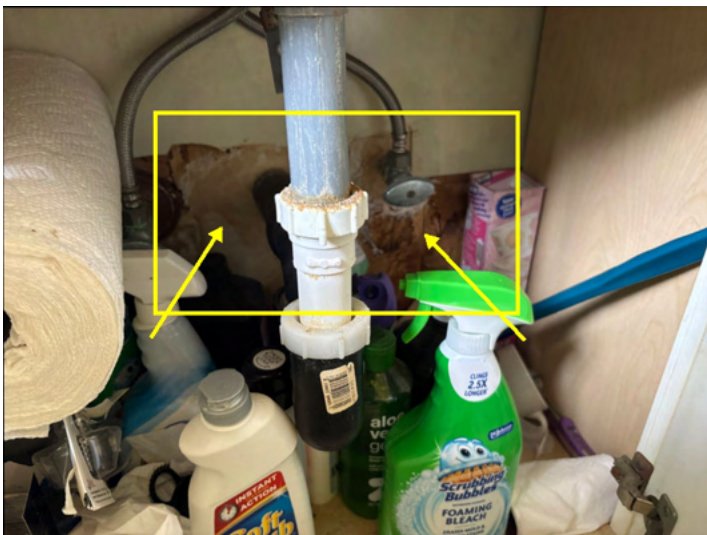
There has been drywall repair made under the vanity sink. This area remains unpainted and the texture does not match exactly. Location: Bathroom 2.

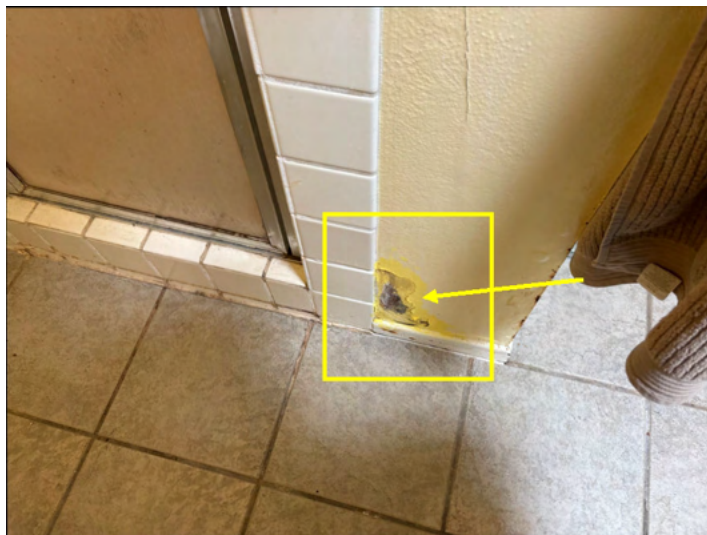
The drywall located at the right side of the shower opening shows signs of drywall damage. Due to the current condition of the drywall in this area; repair to the drywall texture and painting is necessary. Location: Masterbathroom.

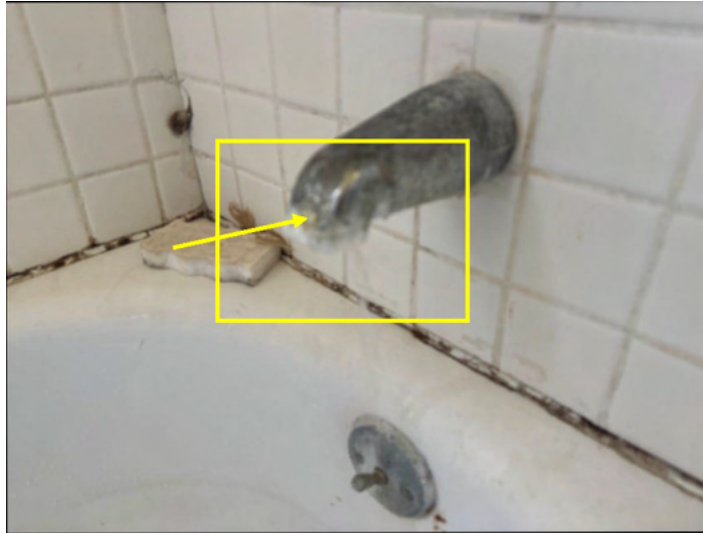
The center handle water diverter for the shower in the bathroom tub-shower does not function properly. It is allowing a small quantity of water to continue flowing through the bath spout, after the water has been diverted to the shower head. This condition should be noted as the internal components may require repair and or replacement. Location: Bathroom 2.

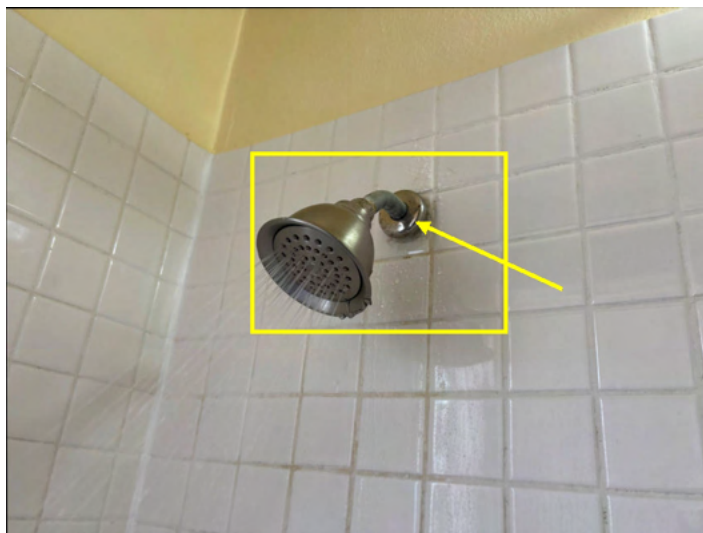
The shower head wall spout is loose at the wall connection. The repair of this condition would be to fasten the shower copper water supply line to a solid framing member in the wall cavity. Location: Bathroom 2.

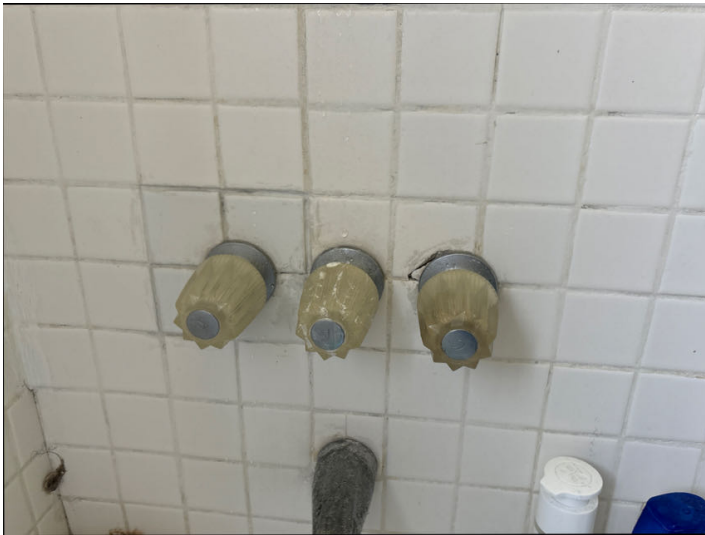
The shower wall is in need of additional grout and or sealant at the bathtub intersection as the current seal is worn. Location: Bathroom 2.

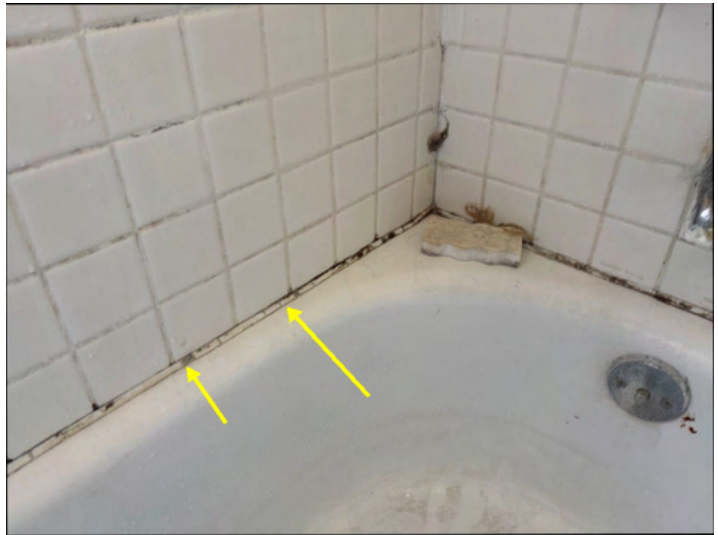
The shower wall is in need of additional grout and or sealant at the bathtub intersection as the current seal is worn. Location: Bathroom 2.

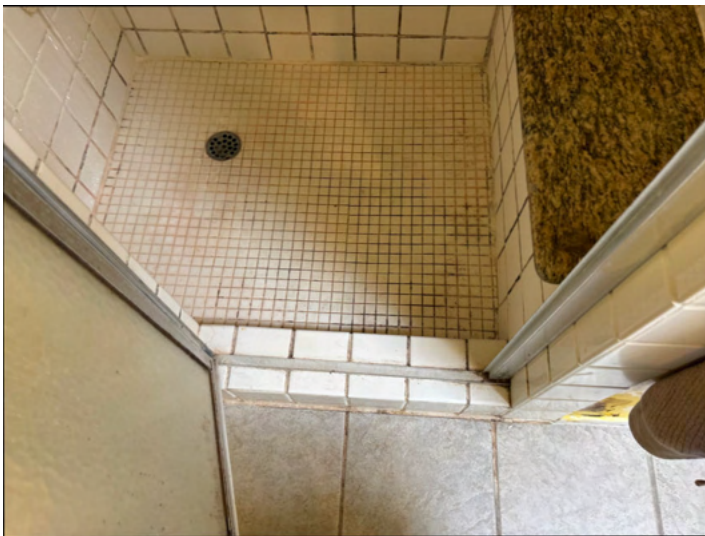
The shower wall grout, tile and shower base are in need of cleaning. Location: Masterbathroom.

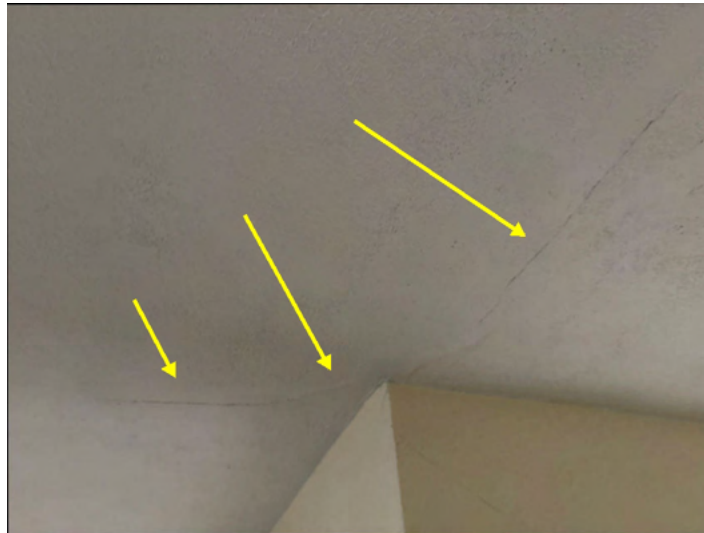
The property is an older home with hairline cracks in the ceiling and or walls. We are unable to determine the cause of this condition as many older homes contain these types of settling cracks. This condition should be noted as we cannot guarantee if these settling lines are repaired they will not reappear. We recommend a licensed drywall evaluate and repair this area. Location: Living room.

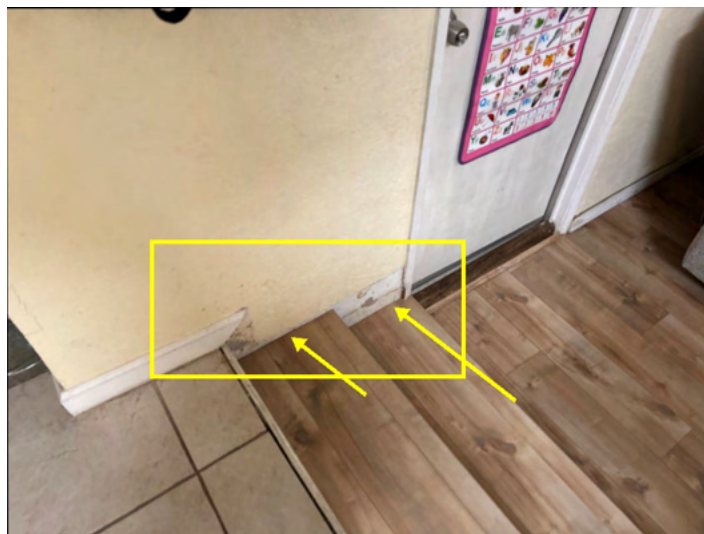
There is a section and or sections of baseboard missing in a interior room and or rooms. Replacement to the baseboard is necessary. Location: Family room stairway.

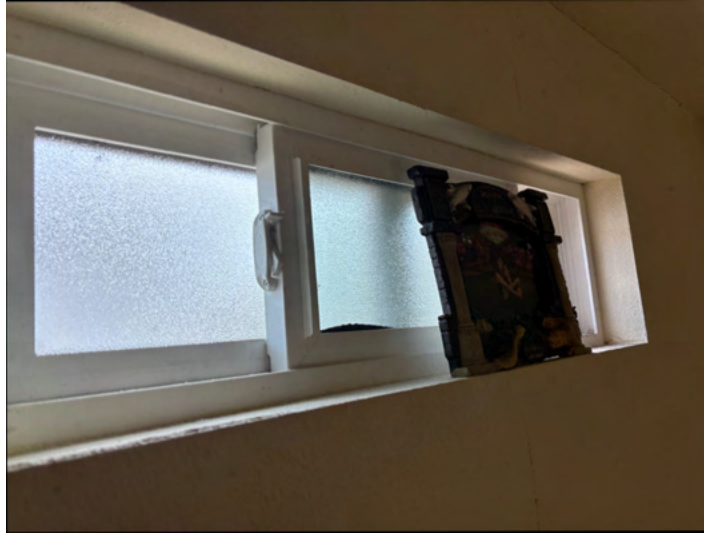
The inner seal of the window shows signs of deterioration. This condition has not affected the functionality of the windows, but should be noted and may require future service. Location: Bedroom 4.

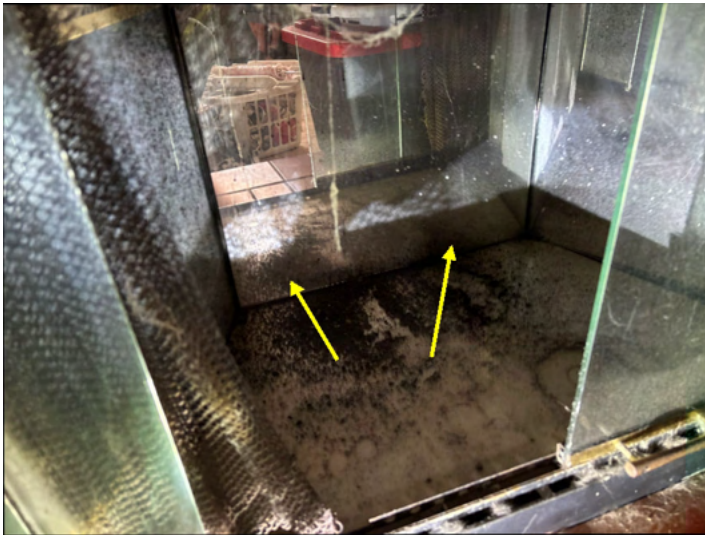
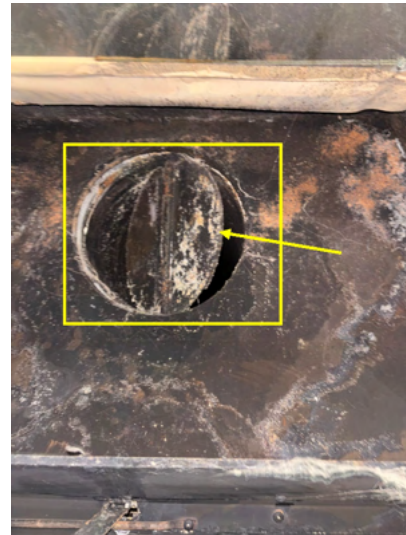
There was soot or creosote buildup was observed within the chimney flue. We recommend you have a licensed chimney specialist further evaluate this condition as the chimney flue may require cleaning. Note: Glass was added at the inside of the fireplace which we recommend you have removed and the the fireplace box inspected to enure it is safe for use.

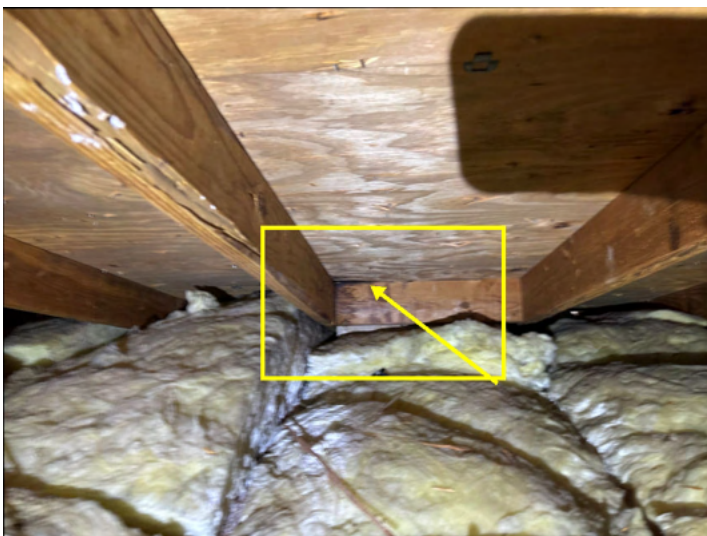
There are stains on the plywood in the attic area. This appears as though it may have been caused by a roof leak (at the vent flashings, skylights and or roofing material). We recommend you have the roofing material; including, the vent flashings', skylights' and roofing material evaluated by a licensed roofing contractor. Location: Masterbedroom closet.

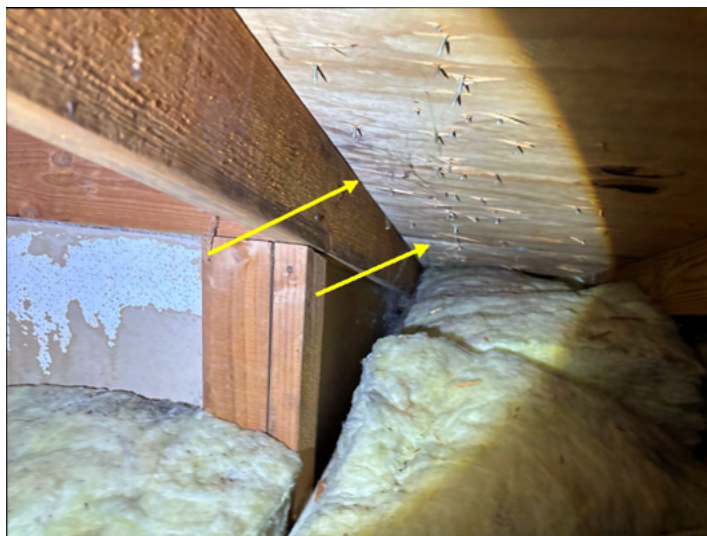
There are stains on the plywood in the attic area. This appears as though it may have been caused by a roof leak (at the vent flashings, skylights and or roofing material). We recommend you have the roofing material; including, the vent flashings', skylights' and roofing material evaluated by a licensed roofing contractor. Location: Masterbedroom closet.

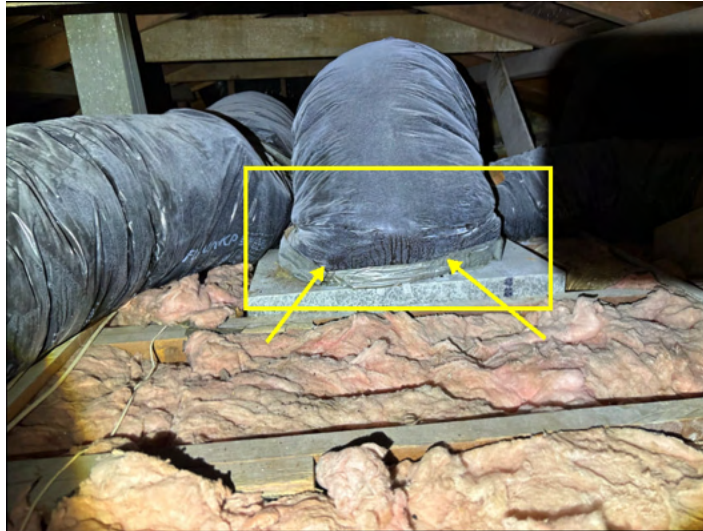
The connections for this ducting has duct tape applied which deteriorates over time and should be replaced with an aluminum tape.

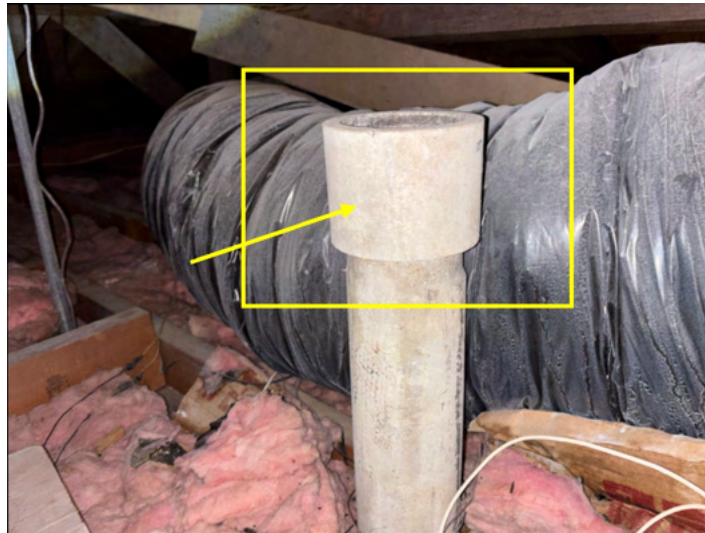
A discarded and or non functional heat vent remains in the attic. This type of piping is comprised of Transite, which contains asbestos. If this pipe is to be removed, we recommend it removed and discarded by a licensed specialist. Location: Main hallway attic access.

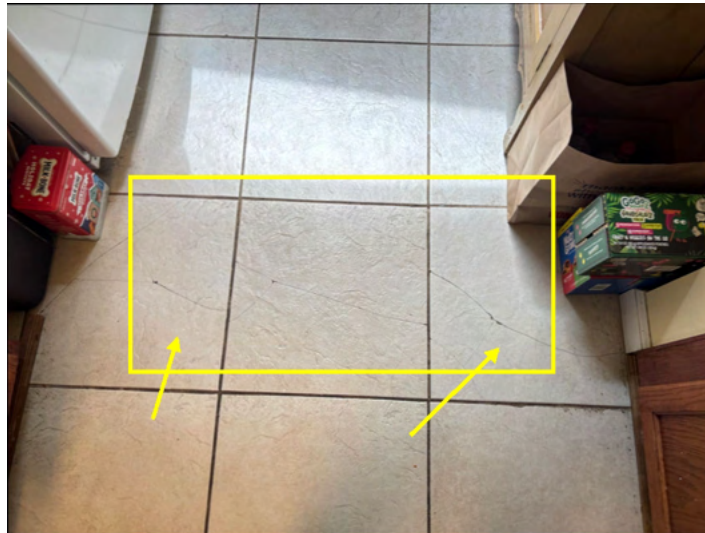
A hairline crack and or cracks is present in the tile flooring. This condition should be noted as repair to the tile(s) and additional grout to the surrounding tiles is necessary. Location: Kitchen. Amount more than 6. We recommend you consult with a licensed contractor regarding this condition.

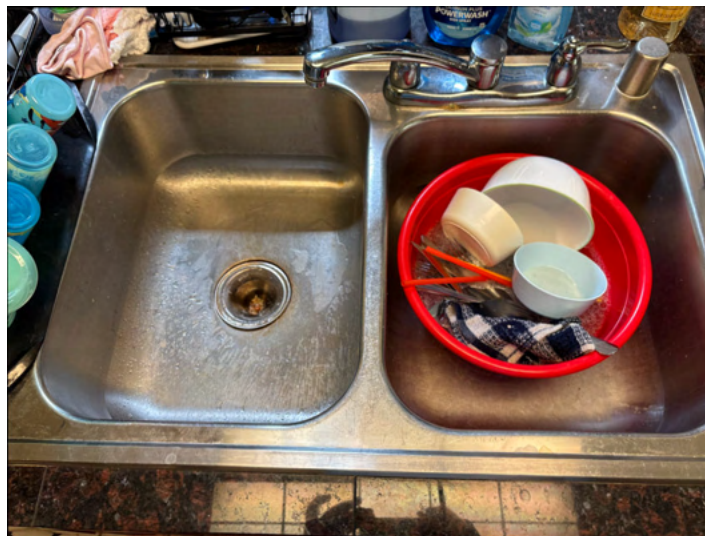
A stainless steel sink is present in the kitchen. The base of the sink shows signs of wear to its surface.

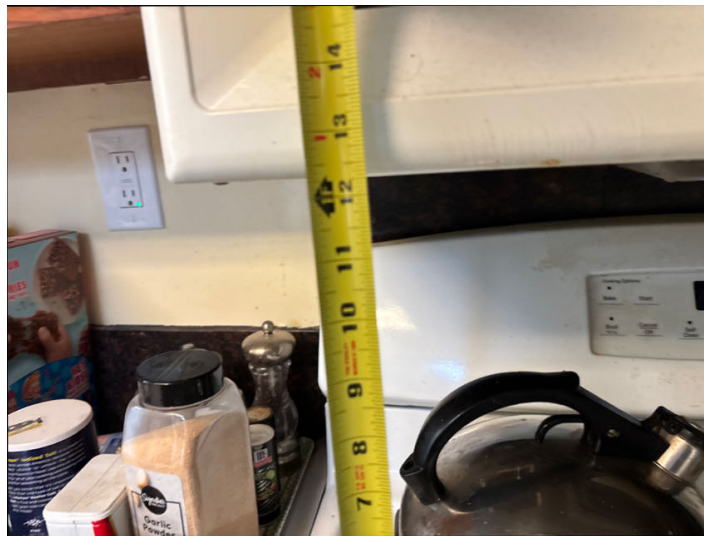
A newer microwave has been installed above the stove/cooktop and the height from the stove to the base of the cabinet is lower than standard. The current standards recommend that a microwave is to be installed between 16-18 inches above the cooktop unless listed on the unit. Therefore, we recommend you consult with the existing homeowner regarding the manufactures specifications to ensure this microwave has not been installed too close to the stove/cooktop surface.

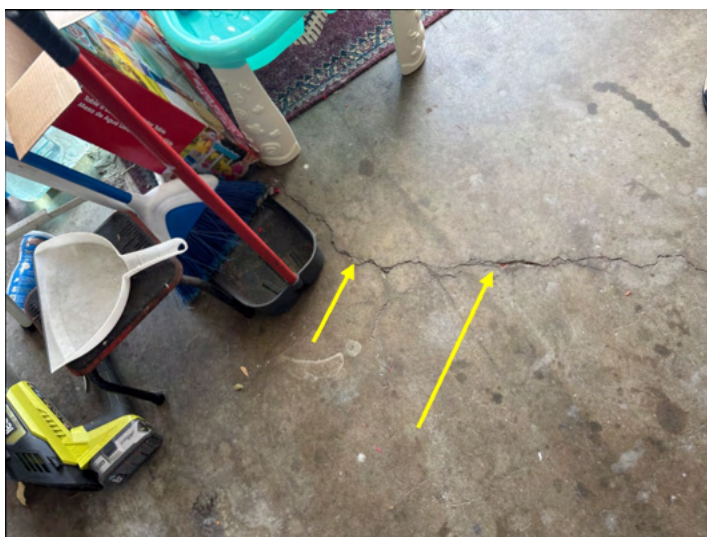
The concrete flooring located in the garage shows signs of settling. The garage flooring is not typically considered part of the house foundation, but this condition should be noted. Due to the size of the settling line, we recommend you have a licensed foundation contractor evaluate its overall condition.

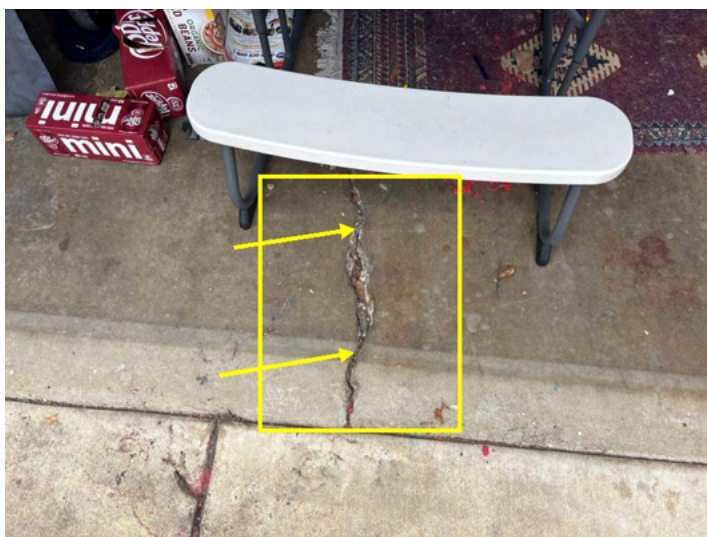
The concrete flooring located in the garage shows signs of settling. The garage flooring is not typically considered part of the house foundation, but this condition should be noted. Due to the size of the settling line, we recommend you have a licensed foundation contractor evaluate its overall condition.
