# *Home Inspections San Diego*

## Property Inspection Report

122 Elder Avenue , Chula Vista, CA 91910  
Inspection prepared for: Shannon Medina  
Real Estate Agent: Patrick Adams -

Date of Inspection: 7/17/2026 Time: 12:00 p.m.

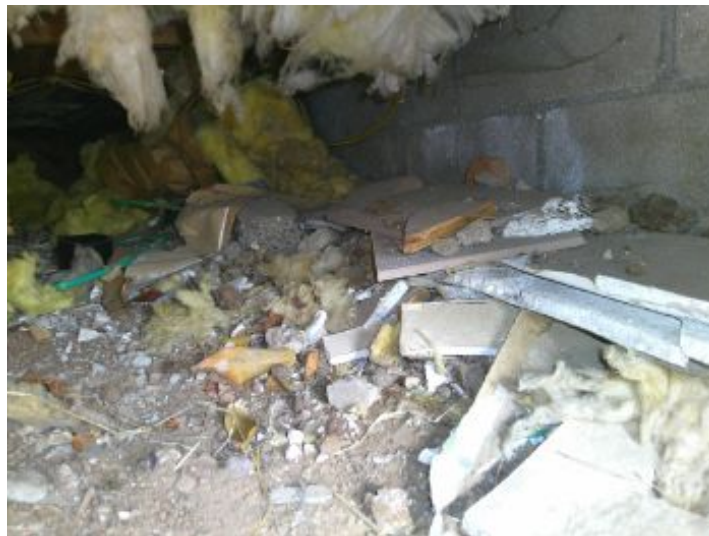
Construction debris are present under the raised foundation. We recommend these items cleaned, the insulation returned to its original state and re-inspected. Location: Bathroom 3.

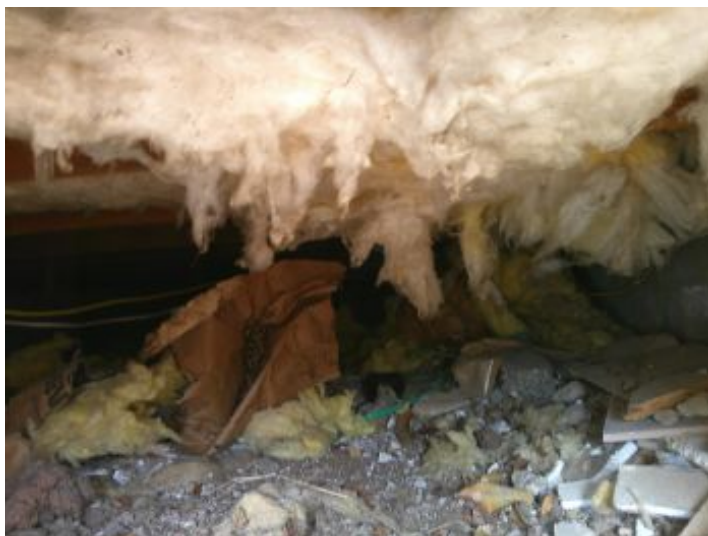
Insulation: The home has insulation installed under the raised foundation. This insulation has fallen from the floor joist. We recommend the correction of this condition for proper insulation of the home. Location: Under the bathroom 3 and masterbedroom addition.
