## WOOD DESTROYING PESTS AND ORGANISM INSPECTION REPORT

Building No. <b>1177</b>	Street <b>Muirlands Vista Way</b>	City <b>La Jolla</b>	ZIP <b>92037</b>	Date of Inspection <b>10/8/2025</b>	Number of Pages <b>Page 1 of 10</b>

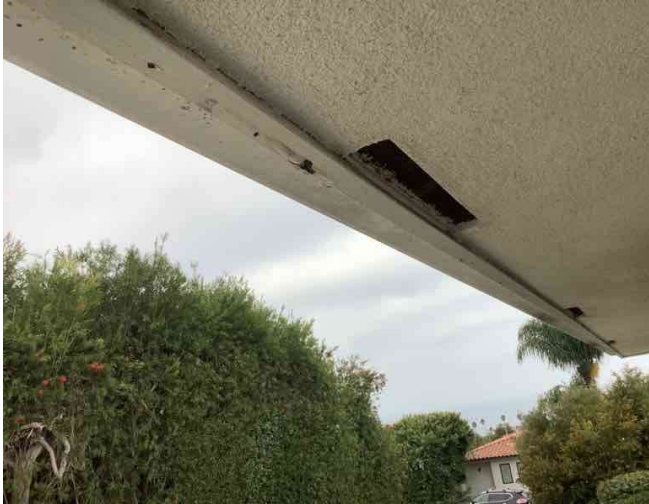
*Photo 01*

- 1A.** FINDING: The fascia has been damaged by drywood termites and fungus where indicated on the diagram. The contributing moisture source appears to have been caused by a failure of the roof covering and/or exposure to weather. (See Photo 1) (See Photo 2) (See Photo 3)

- 1F.** FINDING: Infestation by Drywood Termites was noted at the fascia throughout the exterior and attic. (See Photo 1) (See Photo 4) (See Photo 11)

- 1G.** FINDING: Drywood termite pellets were evident as noted in the above recommendation. (See Photo 1) (See Photo 4) (See Photo 11)

RECOMMENDATION: Remove and replace the damaged fascia to correct this condition. This bid *Estimated Cost* includes repair of the roof covering if disturbed by our repairs. If existing gutters need to be removed to perform the repairs then our bid also includes reinstallation of original gutters. If it becomes necessary or desirable to install new gutters this will be done only if authorized and at an additional cost. The guarantees on the roof covering are limited to the areas where the repairs were performed.

RECOMMENDATION: Due to the nature of these infestations, it will be necessary to seal the entire  
*Estimated Cost* structure and fumigate it with Vikane (sulfuryl fluoride), using Chloropicrin as a warning agent. The entire structure must be vacant for this process. It is the owners responsibility to make any preparations required by the fumigators or to have someone to do so at a separate expense and to have the gas turned back on when the fumigation is complete. "NOTICE: The charge for service that this company subcontracts to another registered company may include the company's charges for arranging and administering such services that are in addition to the direct costs associated with paying the subcontractor. You may accept HomeGuard Incorporated's bid or you may contract directly with another registered company licensed to perform the work. If you choose to contract directly with another registered company, HomeGuard Incorporated will not in any way be responsible for any act or omission in the performance of work that you directly contract with another to perform." HomeGuard Incorporated guarantees all fumigations for a period of three years from the date of completion.

RECOMMENDATION: Remove and/or mask over all accessible termite pellets. It is possible for the  
*Estimated Cost* drywood termite pellets to sift down or reappear in these areas where they have been masked over.

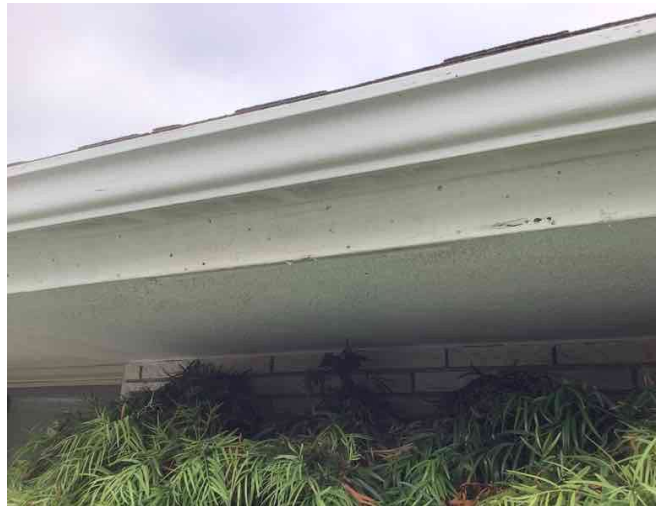
*Photo 04*

- 1B.** FINDING: The fascia and post has been damaged by drywood termites and fungus at the rear of the structure and carport. This damage appears to be minor. The contributing moisture source appears to be exposure to the weather. (See Photo 4) (See Photo 9)

RECOMMENDATION: Hollow out this area and fill the void with an appropriate wood filler.

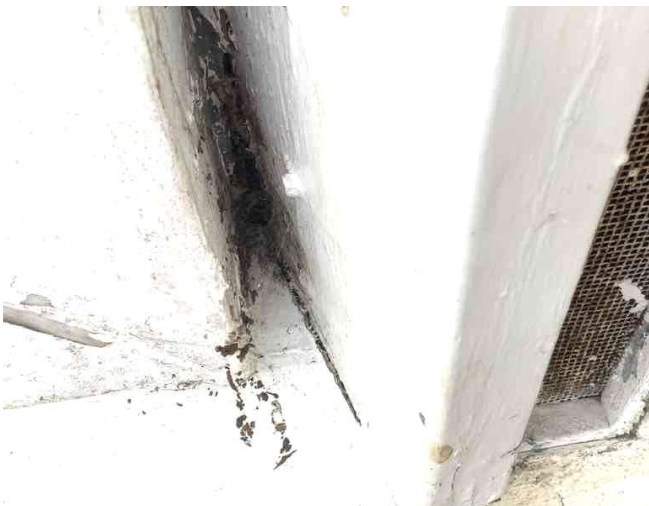
*Photo 05*

- 1C.** FINDING: The roof sheathing has been damaged by fungus at the rear of the structure. The contributing moisture source appears to have been caused by a failure of the roof covering. (See Photo 5)

RECOMMENDATION: Remove and replace the damaged sheathing to correct this condition. This bid *Estimated Cost* includes repair of the roof covering if disturbed by our repairs. If existing gutters need to be removed to perform the repairs then our bid also includes reinstallation of original gutters. If it becomes necessary or desirable to install new gutters this will be done only if authorized and at an additional expense. The guarantees on the roof covering are limited to the areas where the repairs were performed.

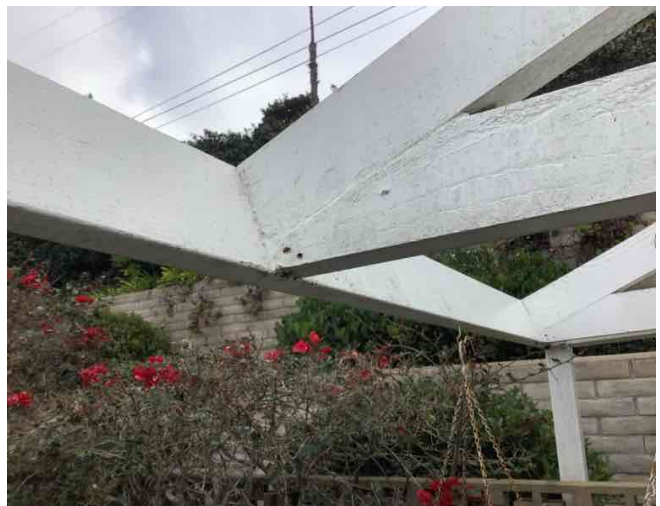
*Photo 06*

- 1D.** FINDING: The beams and fascia have been damaged by fungus at the rear overhang adjacent to the carport. The contributing moisture source appears to be exposure to the weather. (See Photo 6) (See Photo 7) (See Photo 8)

RECOMMENDATION: Remove and replace the damaged wood members. If damage is found to extend *Estimated Cost* into inaccessible areas, a supplemental report will be issued with any findings, recommendations, and/or bids.

NOTE: This bid includes any necessary stucco repair to the area adjacent to the beams if disturbed during the course of our repairs to the wood members.

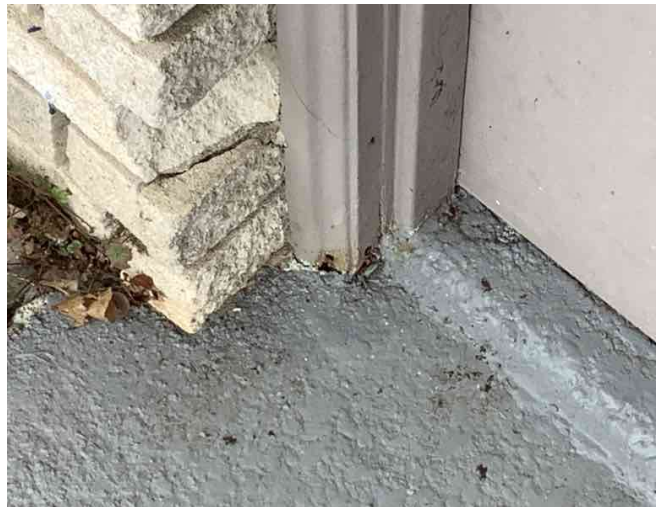
Photo 10

- 1E.** FINDING: The brick molding has been damaged by fungus at the garage man door and shower room door. The contributing moisture source appears to be exposure to the weather. (See Photo 10)

RECOMMENDATION: Remove and replace all the damaged wood members. If any damage is found to  
*Estimated Cost* extend into any enclosed areas a supplemental report and bid will be issued.

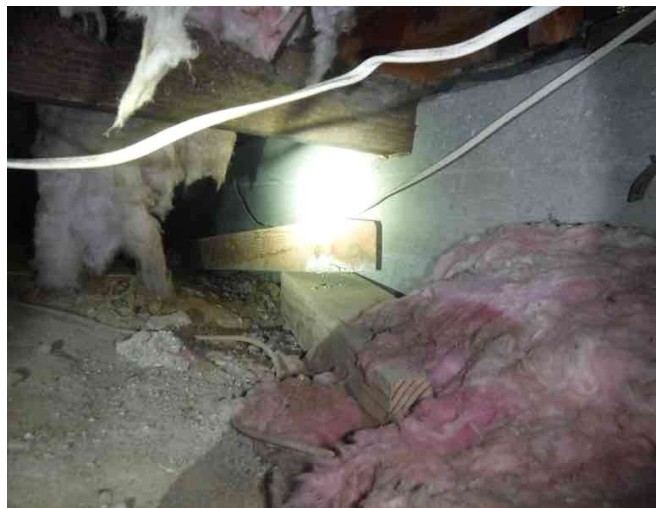
Photo 12

**2D.** FINDING: There is cellulose debris in earth contact in the substructure area. (See Photo 12)  
(See Photo 13) (See Photo 14)

RECOMMENDATION: Remove cellulose debris of a size that can be raked from the substructure area.

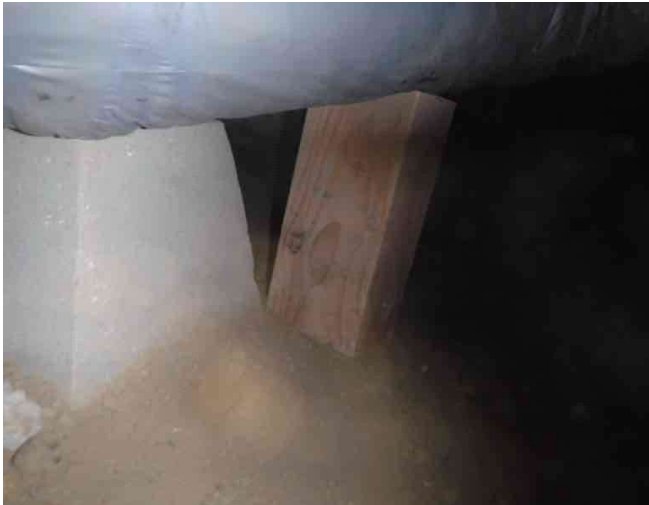
Photo 15

**2E.** FINDING: There is earth contact in the substructure area at the wood blocking under the ducting. (See Photo 15)

RECOMMENDATION: Remove the wood blocking and strap the ducting in place as needed.

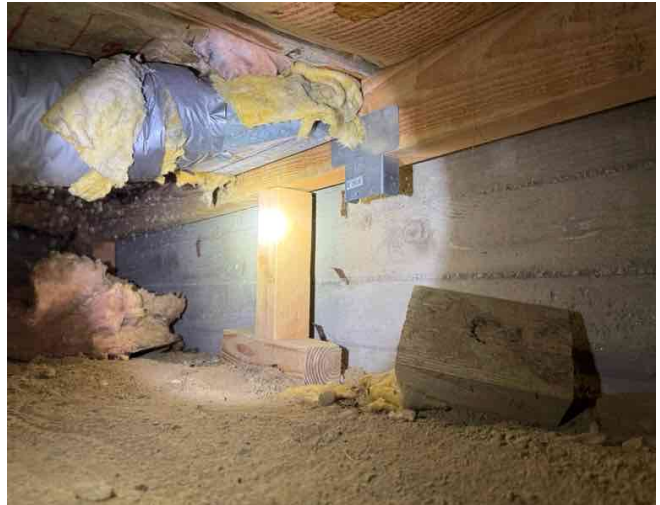
Photo 16

**2F.** FINDING: There is one wooden support post under the structure in contact with the earth.  
(See Photo 16)

RECOMMENDATION: Cut off the bottom of the post and install a raised concrete base under it.

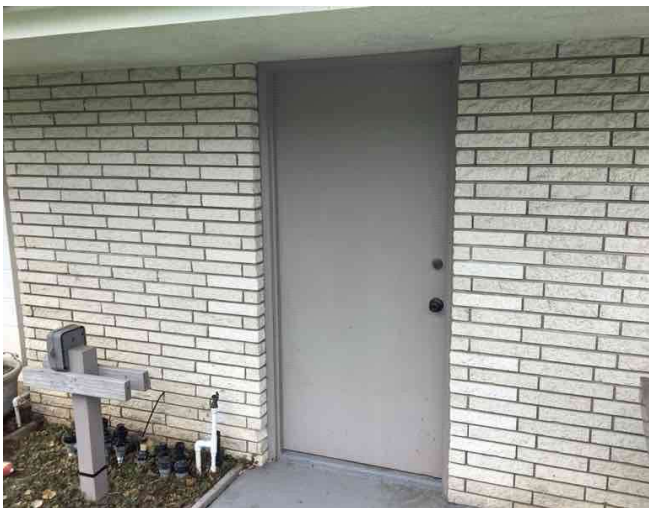
Photo 17

**3A.** FINDING: The storage room was locked and inaccessible for inspection. (See Photo 17)

RECOMMENDATION: The owner is to provide access to the storage room for further inspection. Upon further inspection, a supplemental report will be issued listing all findings, recommendations and bids.
