HOME INSPECTION

6224 Rose Lake Ave
San Diego, CA 92119

08/01/2025

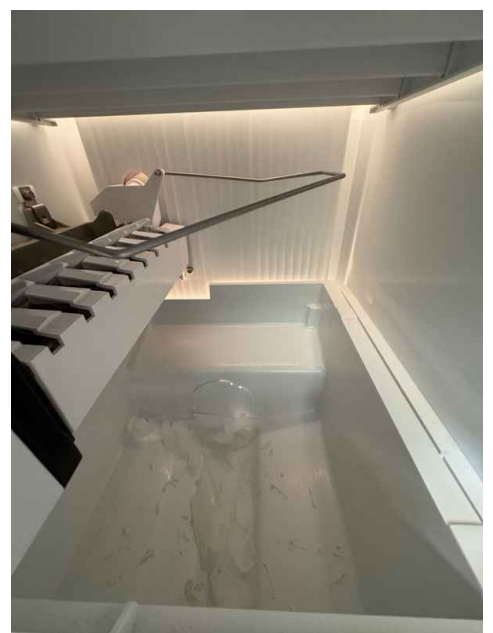
2.8.1 REFRIGERATOR

NO ICE IN FREEZER

No ice was observed in the ice maker in the freezer. The absence of ice may indicate that there is no water supplied, the ice maker was off, or there is a problem with the ice maker. We advise further review with the seller to demonstrate function, or further review with qualified appliance technician.

Contact a qualified appliance repair professional.

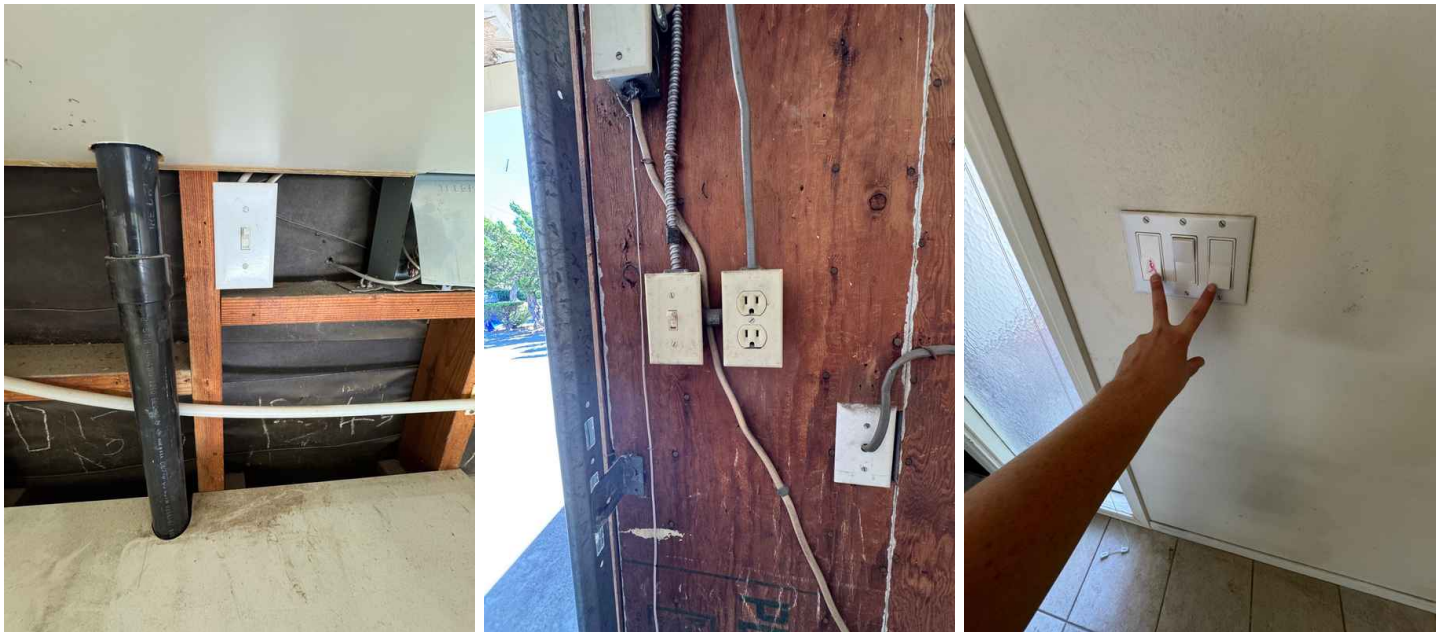
4.8.2 CONNECTED DEVICES AND FIXTURES (Representative number, excluding low-voltage items)

Unable to determine the function of the wall switch; possible mis-wired switched receptacle(s) or receptacles located behind personal property. We advise inquiry with seller or licensed electrician.

Recommendation
Contact the seller for more info

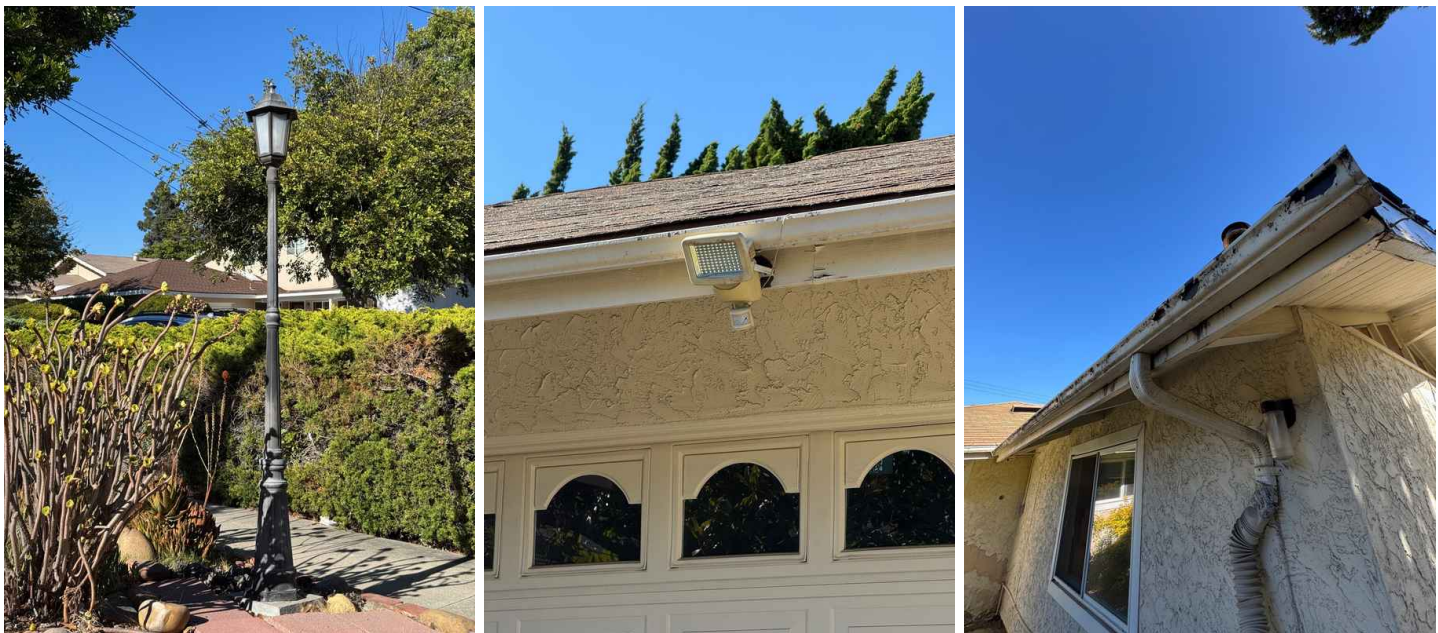
4.9.1 EXTERIOR LIGHTING

EXTERIOR LIGHTS - COULD NOT CONFIRM

The inspector could not confirm the functionality of the majority of exterior lights. This may be due to a bad bulb, dusk sensors and or possibly an electrical problems. Advise changing the bulb and testing. If light fails to work, further repairs may be required by an electrician.

Recommendation
Contact a qualified professional.

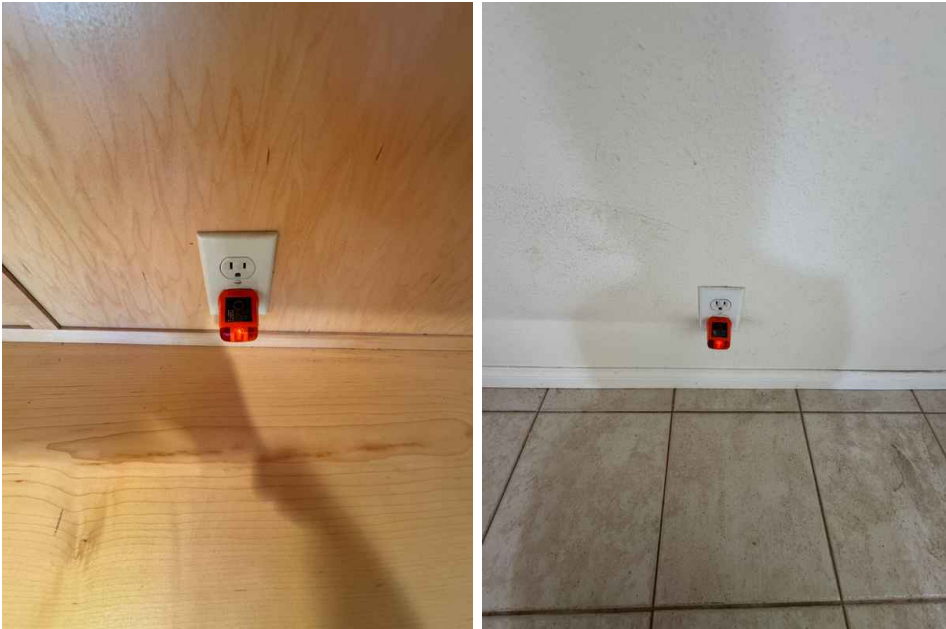
4.10.1 POLARITY AND GROUNDING OF RECEPTACLES

RECEPTACLE - NOT GROUNDED

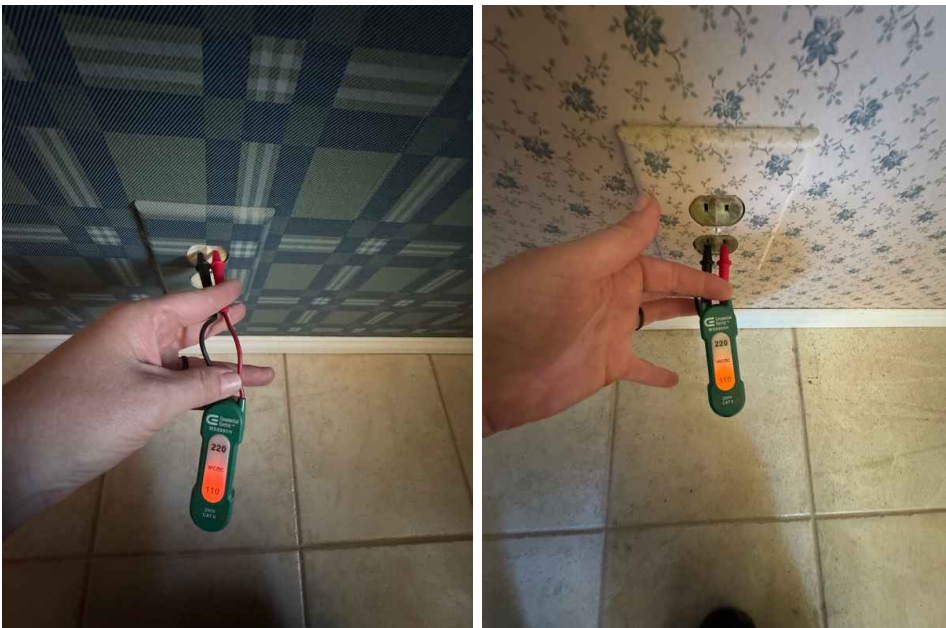
4.10.2 POLARITY AND GROUNDING OF RECEPTACLES

RECEPTACLES - 2-PRONG AND 3-PRONG - MIXED

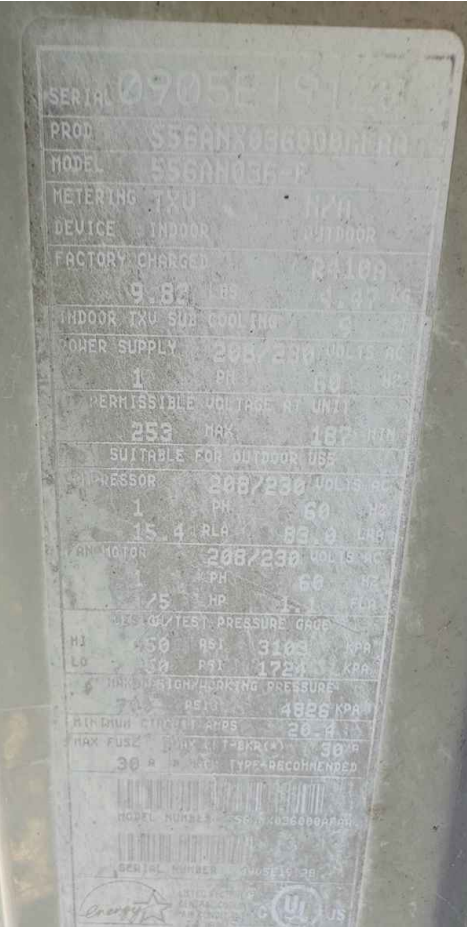
The condenser outside (AC unit) is an older unit, and the life remaining may be limited. ([Table of Life Expectancy](#)) We recommend that you keep a good home warranty covering the AC system. Consider consulting a licensed HVAC contractor before the close of your contingency period if information such as the potential cost to replace is needed.

Recommendation
Contact a qualified heating and cooling contractor

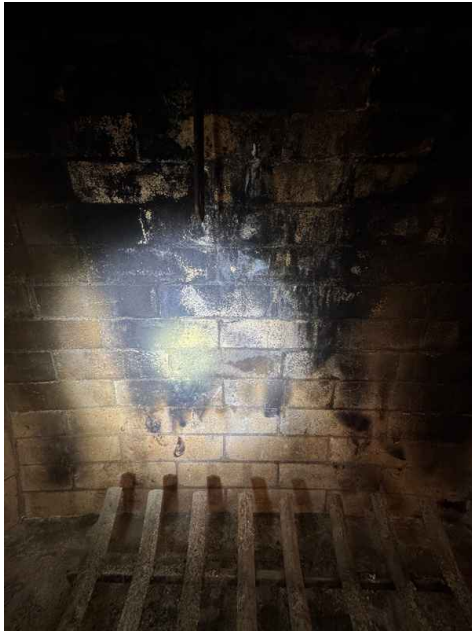
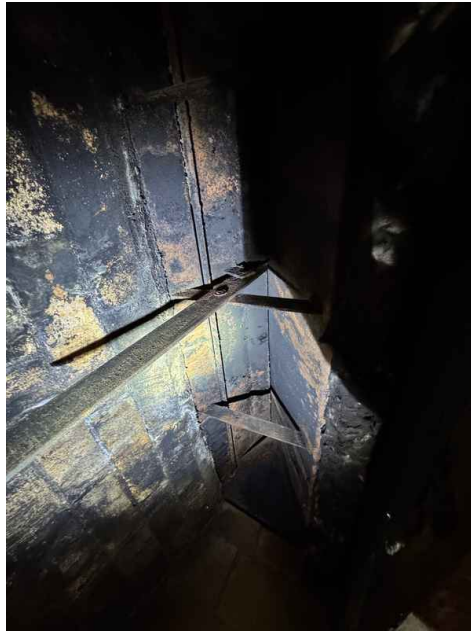
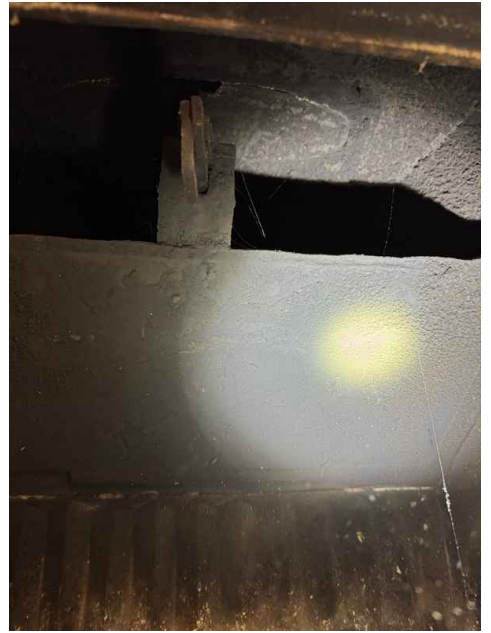
7.2.3 FIREPLACES (including Gas/LP firelogs) AND CHIMNEYS

CHIMNEY SWEEP - EXCESSIVE CREOSOTE

Contact a qualified chimney sweep.

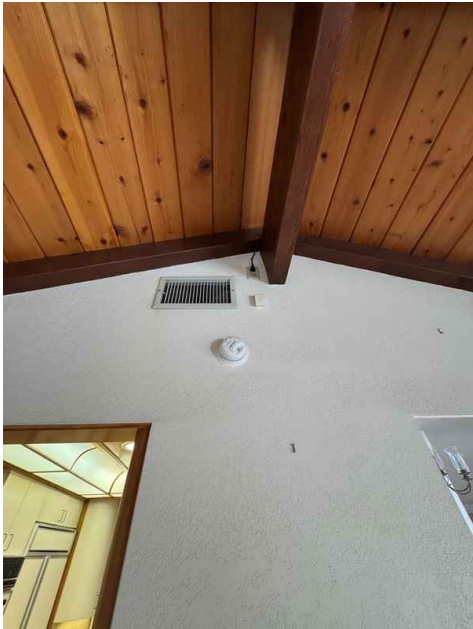
8.6.1 SMOKE DETECTORS

SMOKE DETECTOR - MISSING - LOCATION

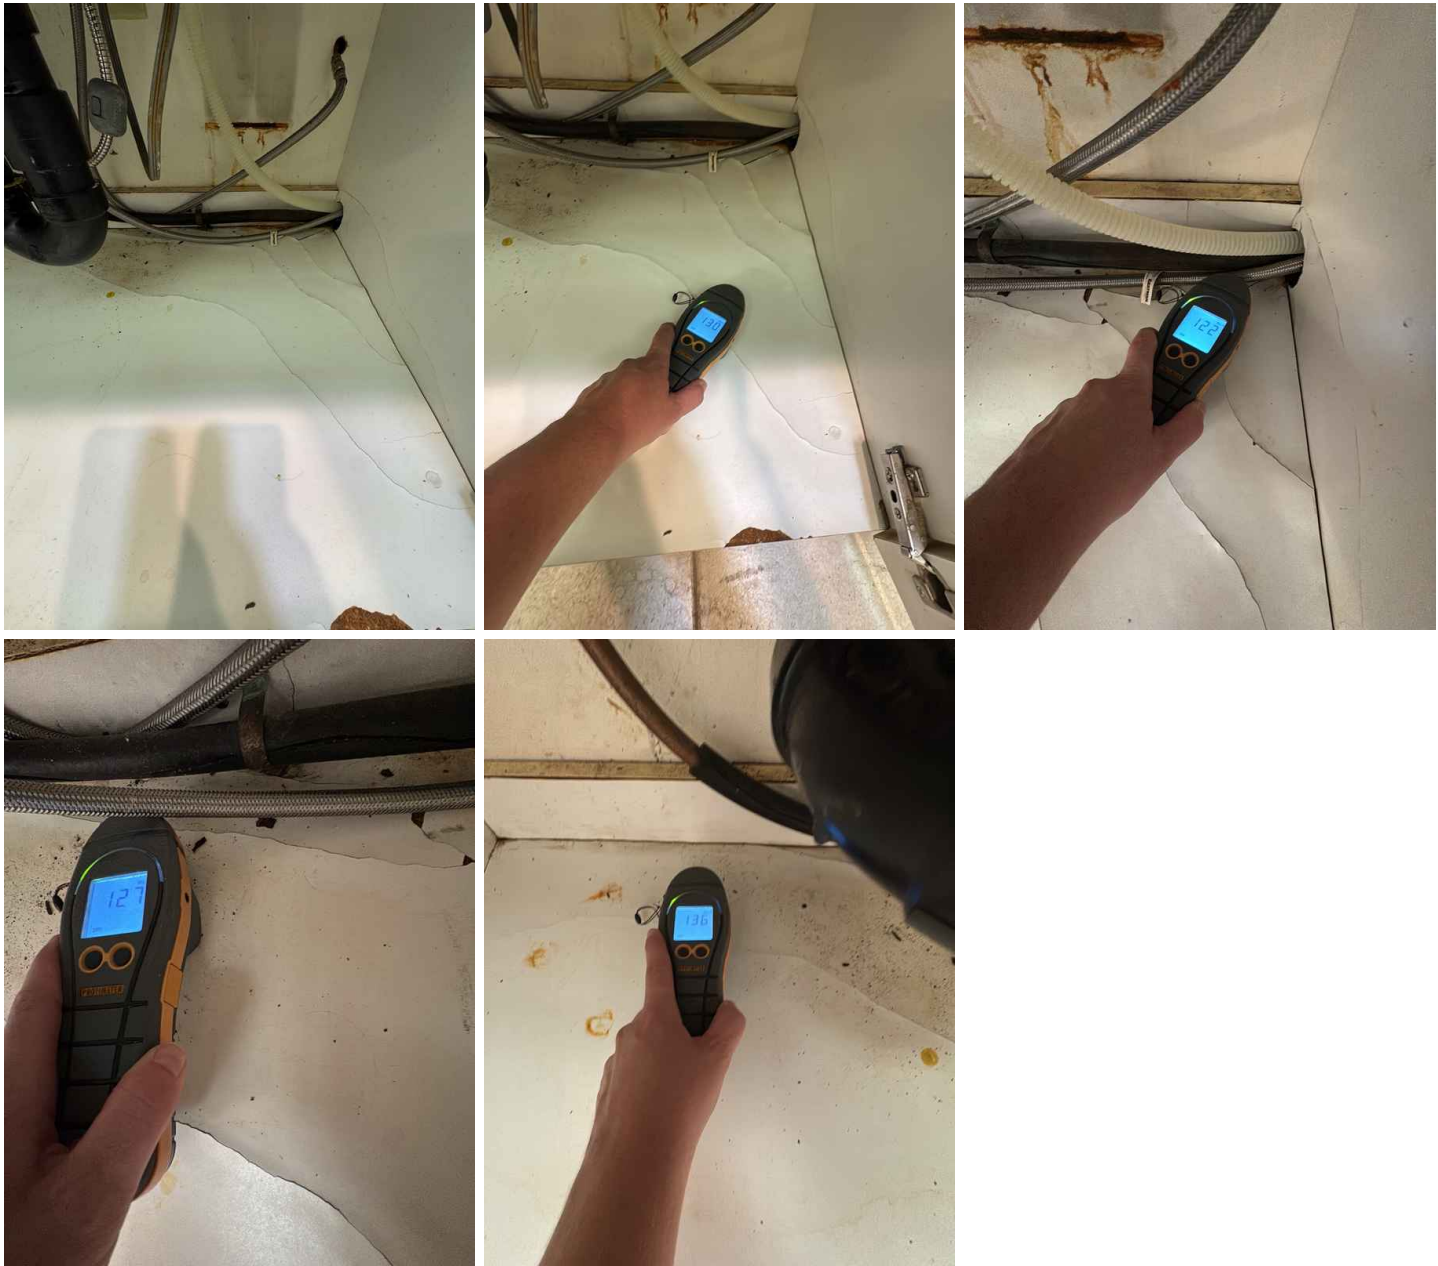
Staining was noted in the cabinet below the sink. The staining was tested for moisture and found to be dry at the time of the inspection. Appears to be caused by a past leak. Under certain conditions or regular use, the leak may become active. We advise reviewing with the seller for repair history.

Recommendation
Contact the seller for more info

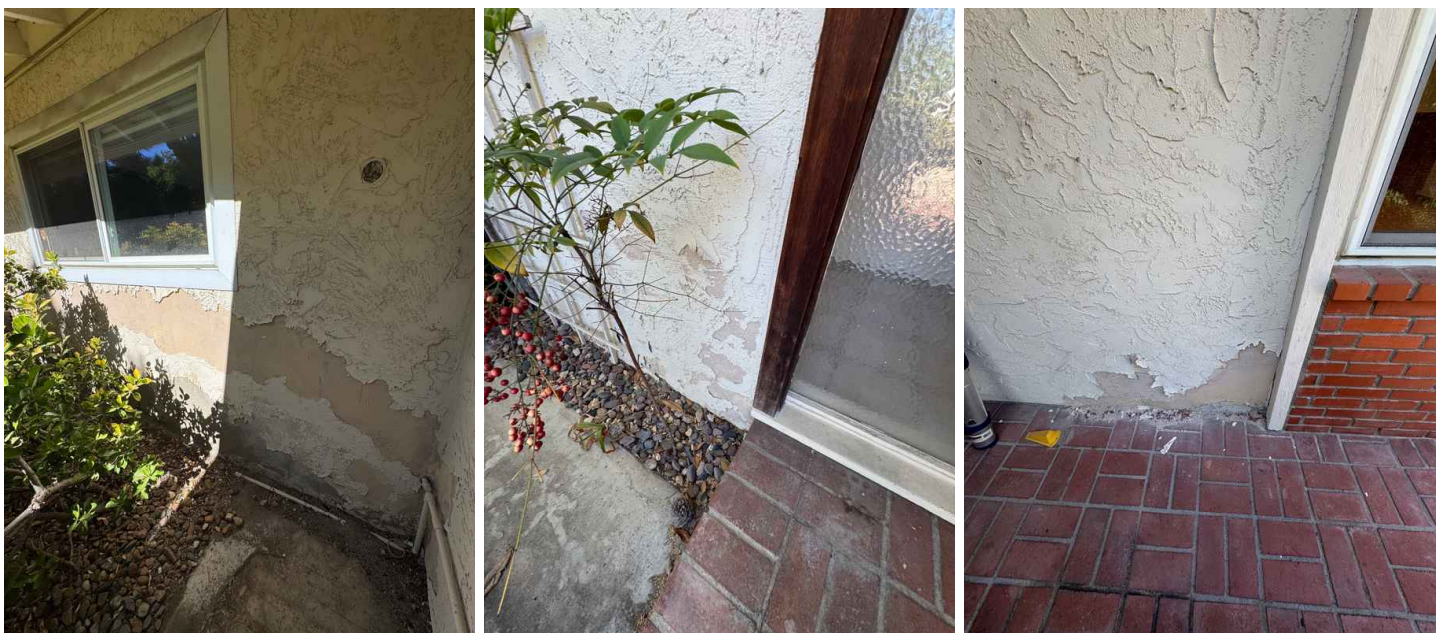
10.5.1 WALL SIDING FLASHING AND TRIM

STUCCO - DAMAGED

Contact a stucco repair contractor

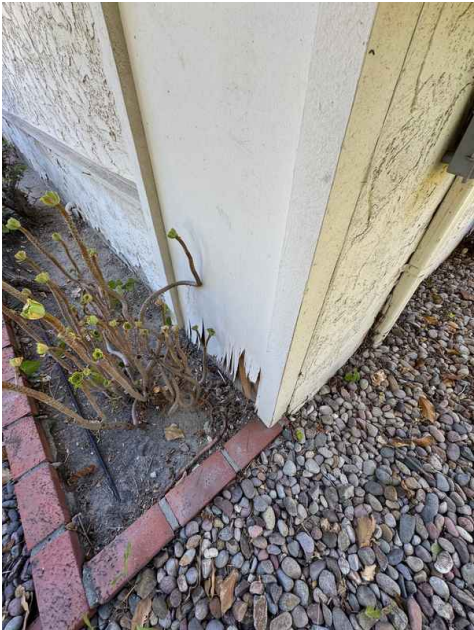
10.5.2 WALL SIDING FLASHING
AND TRIM

Siding is failing at nail heads and end cuts. Water absorption is present and blisters and deterioration are observed. We recommend repair or replacement as necessary.

Recommendation
Contact a qualified siding specialist.

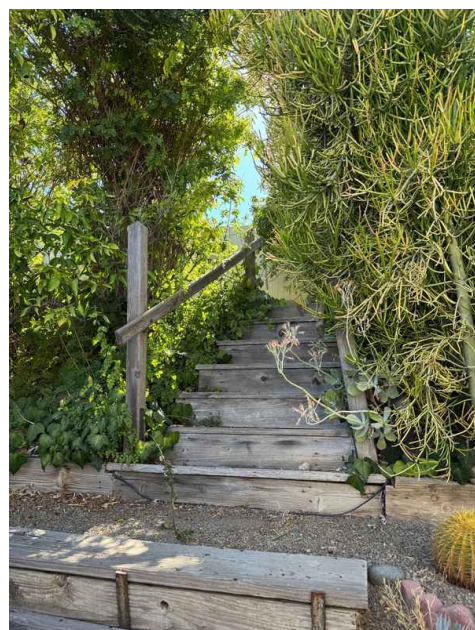
10.9.1 STOOPS, STEPS,
PORCHES AND RAILINGS**LOOSE POST**

Loose, deteriorated post noted. This is a safety hazard. We recommend repair by a qualified contractor.

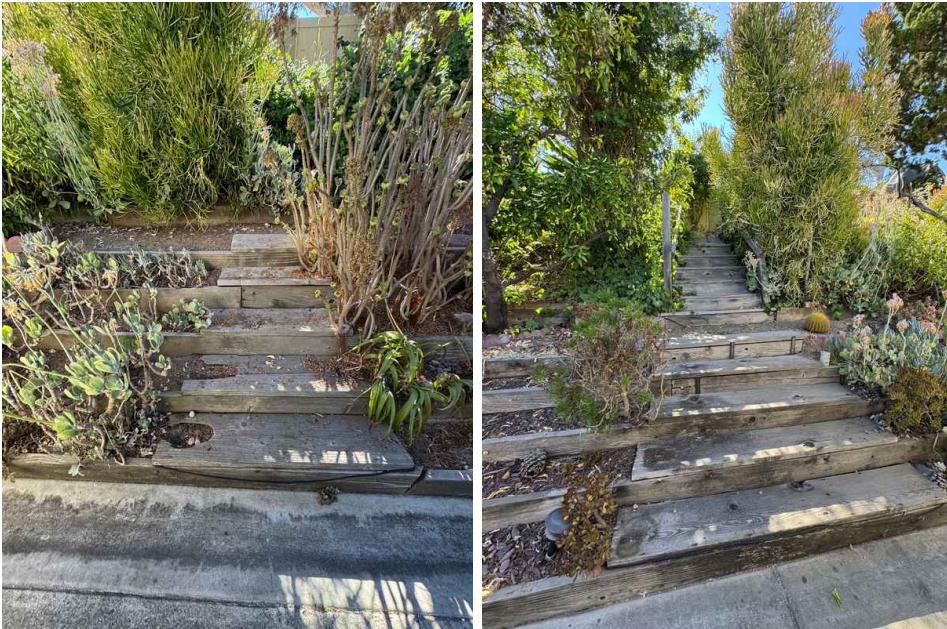
10.9.2 STOOPS, STEPS, PORCHES AND RAILINGS

HANDRAIL - NONE

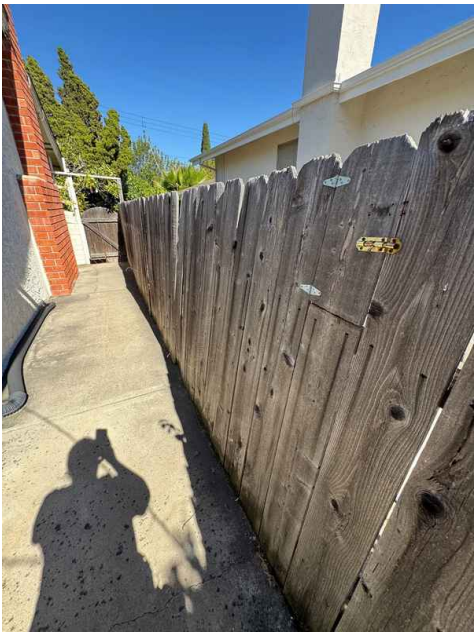
10.12.1 FENCE, LANDSCAPE
WALLS, BOUNDARY WALLS

FENCE LEANING

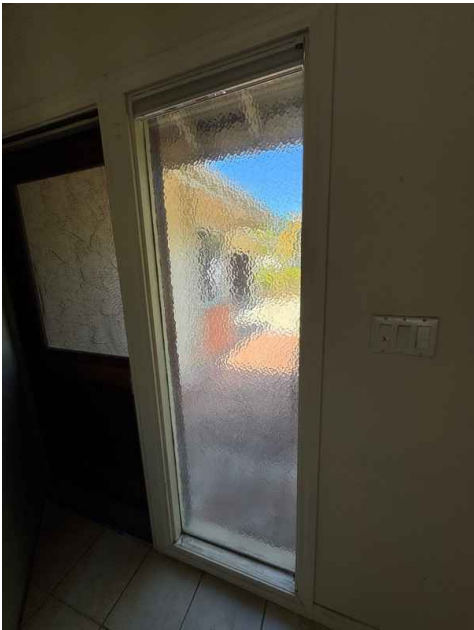
10.13.1 SAFETY GLASS

TEMPERED - MISSING

The glass door does not appear to be tempered glass. I could not find any markings on the glass which would confirm the presence of tempered. Having standard plate glass could cause serious injury if someone breaks the glass. We recommend having the glass or whole door replaced for safety.

Recommendation
Contact a qualified window repair/installation contractor.

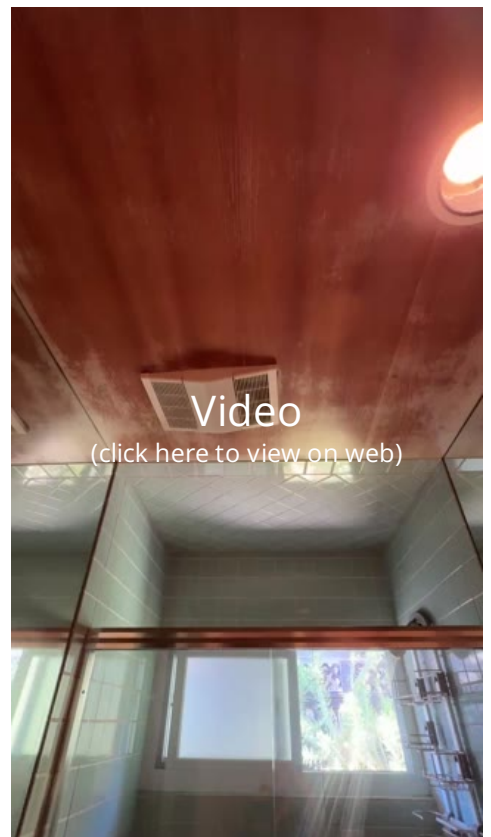
13.5.1 BATHROOM VENTING

BATH VENT - EXCESSIVE NOISE

Contact a qualified professional.
