WOOD DESTROYING PESTS AND ORGANISMS INSPECTION REPORT

BUILDING NO. 450	STREET, CITY, STATE, ZIP E Bradley Ave #46, El Cajon CA 92021	Date of Inspection 7/23/2024	No. of Pages 8
----------------------------	---	--	--------------------------

COMPLETE REPORT <input checked="" type="checkbox"/>	LIMITED REPORT <input type="checkbox"/>	SUPPLEMENTAL REPORT <input type="checkbox"/>	REINSPECTION REPORT <input type="checkbox"/>
General Description: One Story, mobile home, carport, occupied & furnished		Inspection Tag Posted: Subarea	
		Other Tags Posted: None	
An inspection has been made to the structure(s) shown on the diagram in accordance with the Structural Pest Control Act. Detached porches, detached steps, detached decks and any other structures not on the diagram were not inspected.			
Subterranean Termites <input type="checkbox"/> Drywood Termites <input checked="" type="checkbox"/> Fungus/Dryrot <input checked="" type="checkbox"/> Other Findings <input checked="" type="checkbox"/> Further Inspection <input checked="" type="checkbox"/>			
If any of above boxes are checked, it indicates that there were visible problems in accessible areas. Read the report for details on checked item

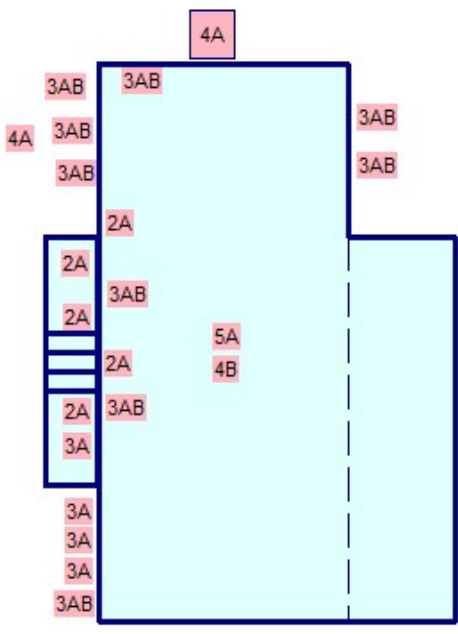
DIAGRAM NOT TO SCALE

ITEM **2A** FINDING Evidence of Drywood termites was noted at/in the SUB-AREA, EXTERIOR. The infestation(s) appear to extend into inaccessible areas.

ITEM 3A FINDING Wood destroying fungus dry rot and damage was noted at/in SIDING. Condition appears to be caused by exposure to moisture.

ITEM 3B FINDING Wood destroying fungus dry rot and damage was noted at/in 1X4 TRIMS. Condition appears to be caused by exposure to moisture.

ITEM 4A FINDING Earth to wood contact was noted at/in SIDING.

ITEM **4B** FINDING Excessive moisture in the subarea soil apparently due to ground water seepage.

ITEM **5A** FINDING SUB-FLOOR was inaccessible for inspection due to MOISTURE BARRIER WRAP.

RECOMMENDATION Vacate the structure for 2-3 nights (3-4 days). Fumigate the entire structure with an approved fumigant (Vikane*- Sulfuryl Fluoride) in accordance with the manufacturers label for the eradication of the Drywood termites. Note: Owner/agent is responsible for preparing the structure according to the terms and conditions outlined in the terms, conditions and agreements, to be furnished by Nix Termite, Inc. Nixtermite, Inc. is not responsible for delays due to inclement weather or delays from the gas company.

RECOMMENDATION Replace the fungus infected and damaged component(s) noted in the SIDING with new material, in currently available widths and sizes. Fungicide may be used in conjunction with this replacement.

RECOMMENDATION Replace the fungus infected and damaged component(s) noted in the TRIMS with new material, in currently available widths and sizes. Fungicide may be used in conjunction with this replacement.

RECOMMENDATION Correct the earth to wood contact by LOWERING SOIL.

RECOMMENDATION In this inspectors opinion, the ground water seepage is not a commonly controllable moisture condition. It is recommended that the owner employ the services of an appropriate trades-person to determine what control measures are required.
