REAL ESTATE INSPECTION SUMMARY

LOCATED AT:
403 S Paseo Laredo
Cathedral City, CA 92234

INSPECTED ON:
Monday, September 12, 2022 at 1:00 PM

Report# 11761

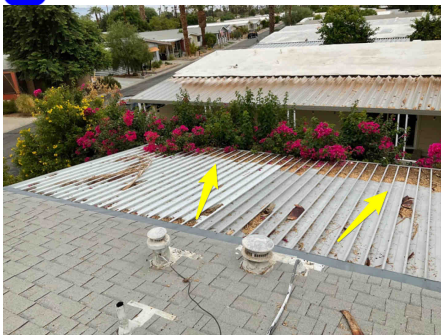
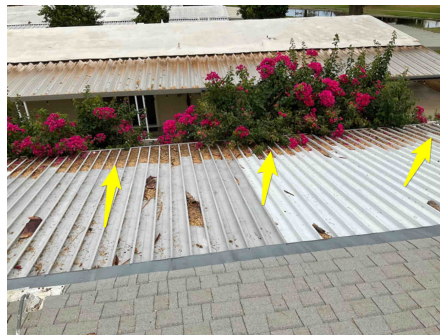
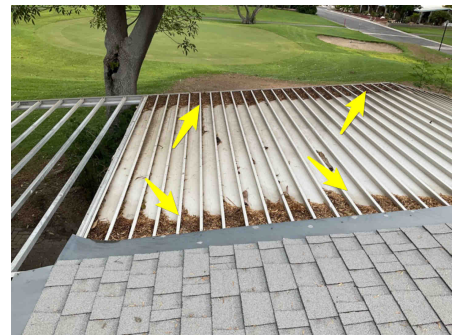
NR 1: Debris should be removed from patio roof.

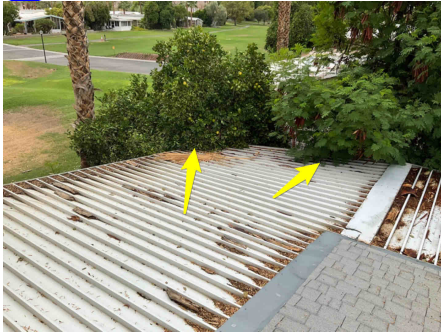
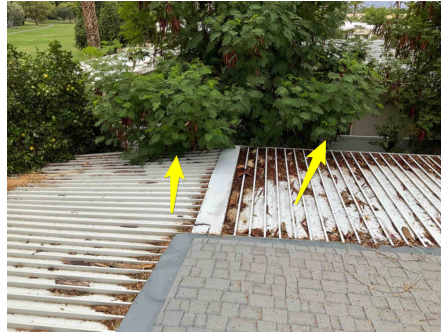
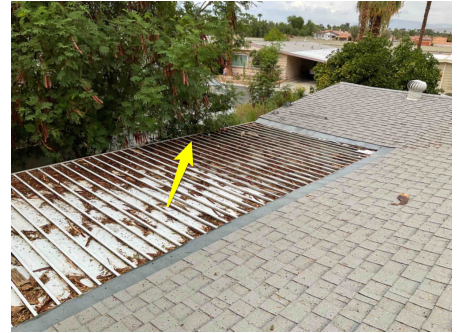
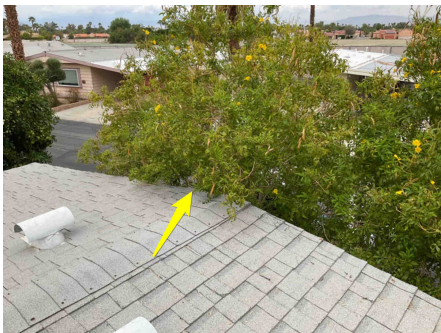
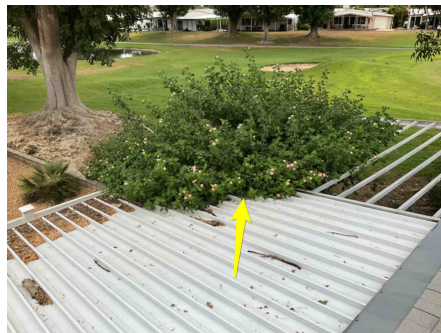
NR 2: Trimming is needed to the tree(s) to prevent rodents from getting on roof and then into the attic.

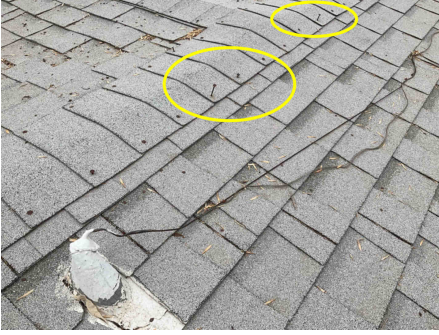
NR 3: Wear is noted to composition roof.

NR 4: Nails/Fasteners are protruding from the roof surface. Recommend the entire roof be evaluated and repaired by a qualified Roofing Contractor

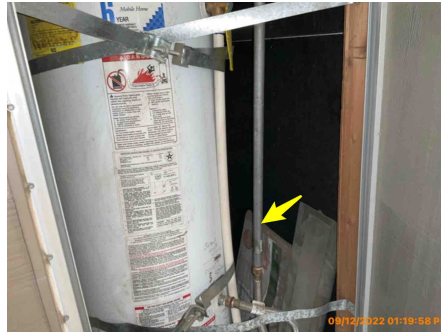
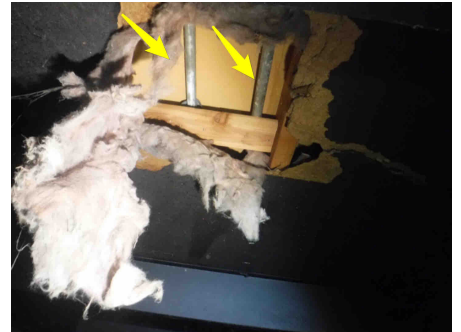
NR 6: The home contained galvanized steel water distribution pipes. These pipes are outdated and subject to corrosion which will eventually result in restricted flow and leakage. We recommend the advice and services of a qualified Plumbing Contractor

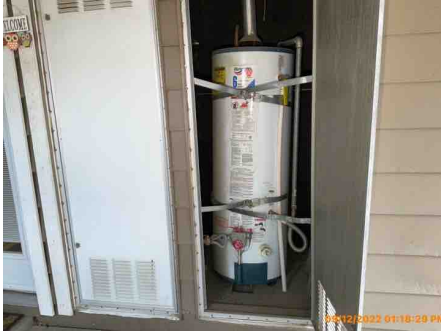
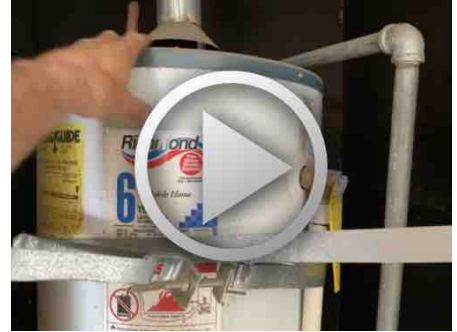
NR 7: Water heater appears to be leaning and not securely installed.

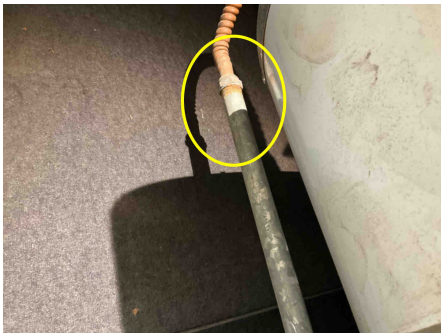
NR 8: No shutoff valve at water heater. A valve is required. Recommend the advice and services of a qualified Plumbing Contractor

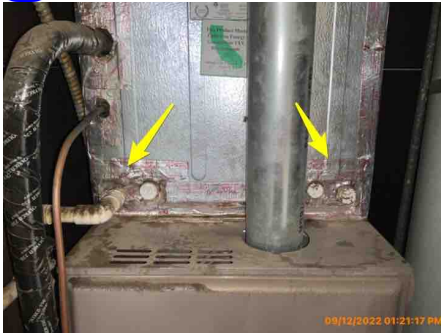
NR 9: Air was leaking from coil, it is recommended that this area be sealed to prevent leaking of cool air.

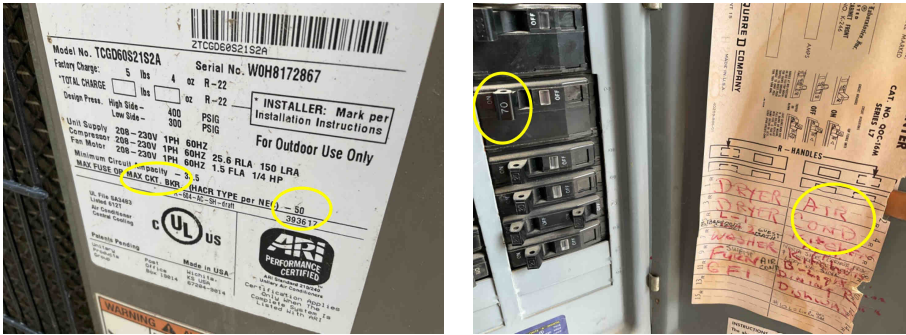
NR 10: Air conditioners manufacture max fuse or circuit breaker per the National Electrical Code that should be installed for air conditioner is **50 amps**. **70 amp** breaker is too large for unit. Proper sized breaker or fused disconnect should be installed. Recommend further review and repair by qualified Electrical Contractor.

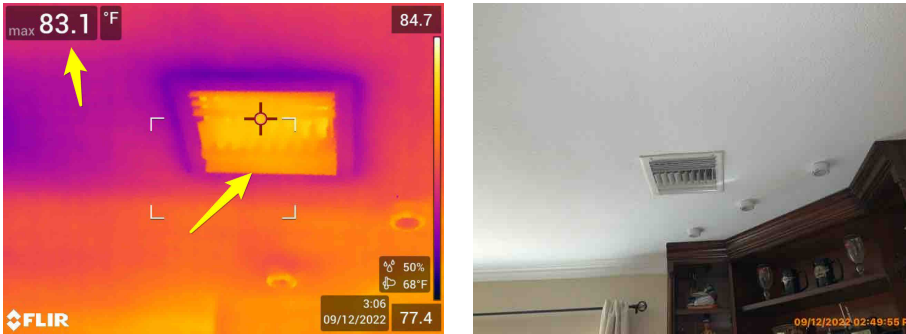
NR 11: Thermal image shows register above bar did not work. We recommend further review and repairs of ducting system by a qualified Licensed HVAC Contractor

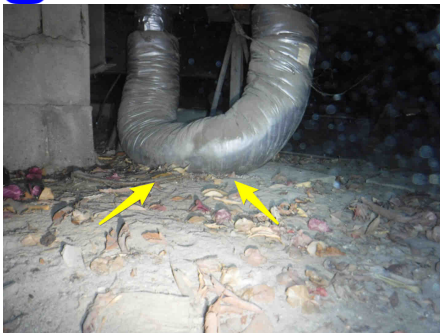
NR 12: Duct clearance to dirt should be minimum 4" under house.

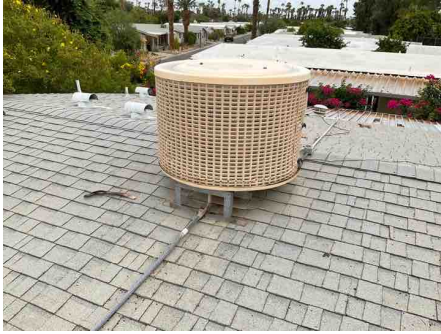
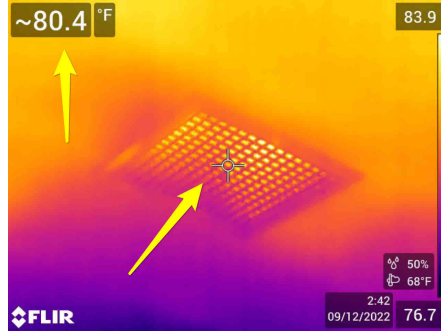
NR 13: Unit did not cool properly

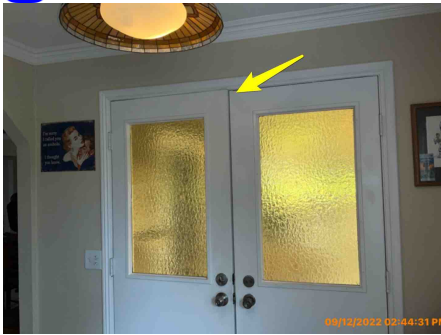
NR 14: Front door rubbing on frame.

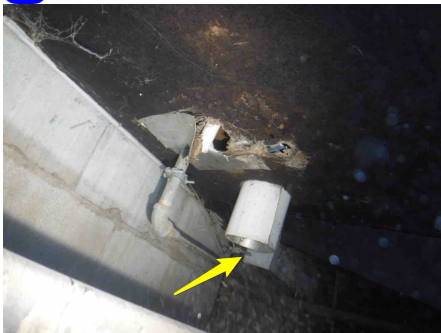
NR 15: Dryer vent appears to be venting into the crawlspace and not to exterior of house.

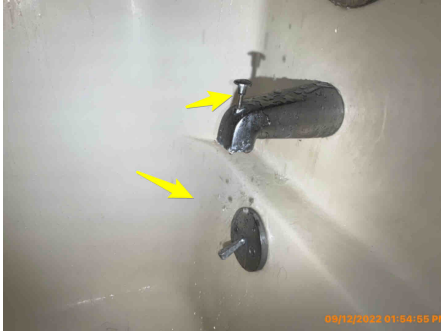
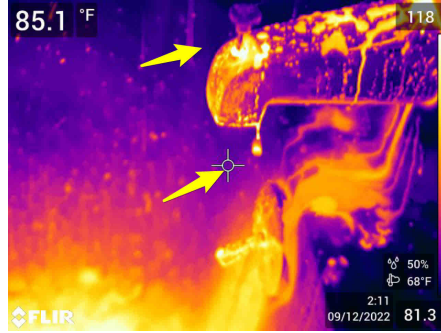
NR 16: Shower diverter does not work properly, We recommend the advice and services of a qualified Plumbing Contractor

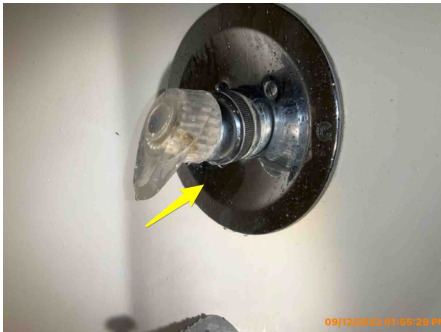
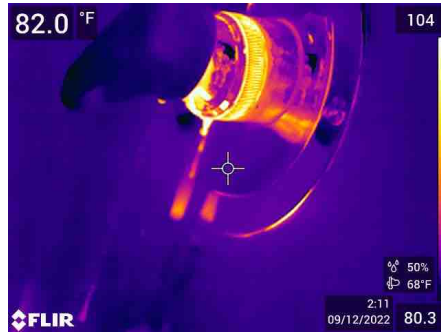
NR 17: Leakage is noted at faucet handle. We recommend further review and repairs by a qualified specialist in the appropriate trade.

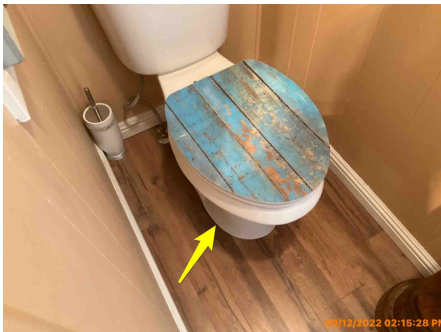
NR 18: Toilet is loose at floor, correction is advised to prevent leaking. This involves removal of the toilet, inspecting for water damage, replacing the wax seal and re-installing the toilet. We recommend further review and repairs by a qualified specialist in the appropriate trade.

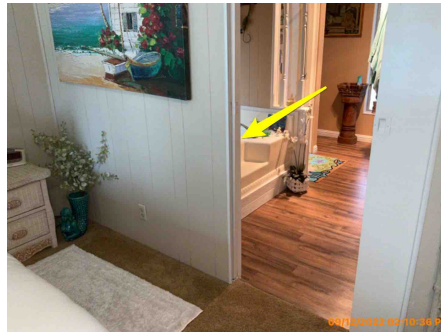
NR 20: Pocket door pull handle is damaged and door is stuck in pocket

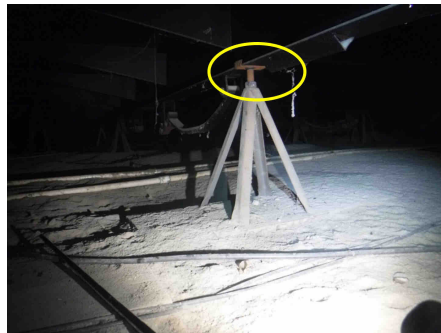
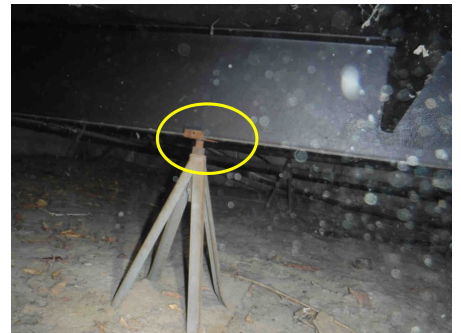
NR 21: No, steel jacks are not secured to frame

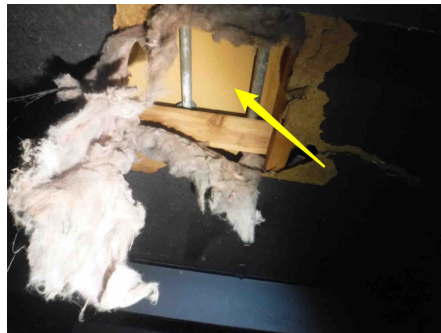
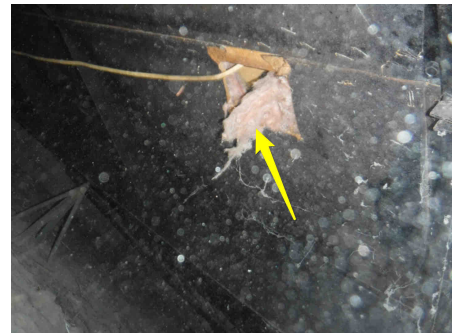
NR 22: Openings to the bladder under the home should be repaired.

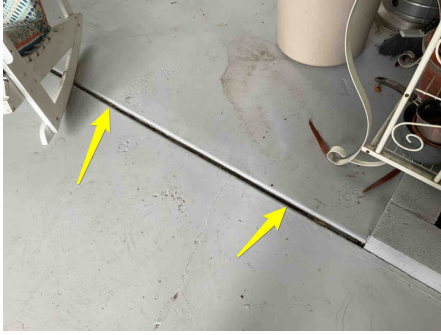
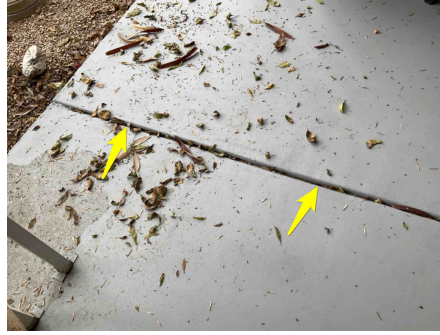
SC 23: Patio surface raised/settled, this has created a TRIP - HAZARD at rear. We recommend further review and repairs by a qualified specialist in the appropriate trade.

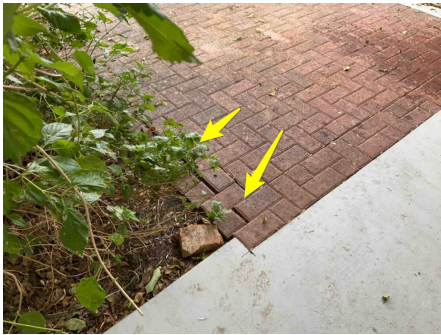
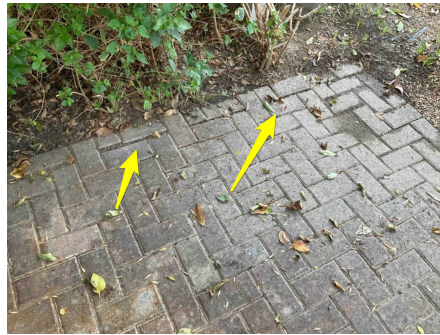
SC 24: Brick/Pavers are uneven. We recommend further review and repairs by a qualified specialist in the appropriate trade.

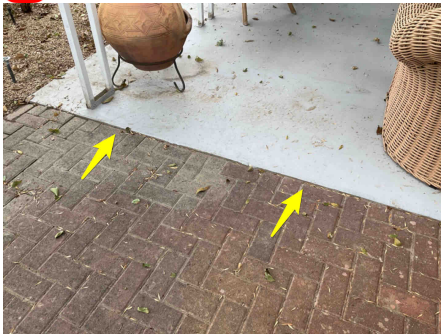
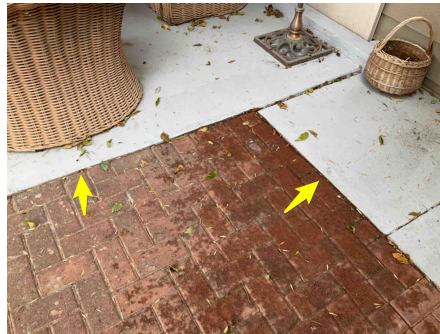
SC 25: Tripping hazard note at rear

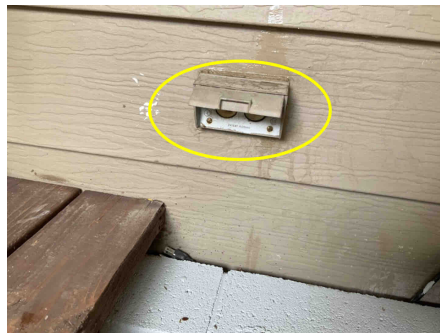
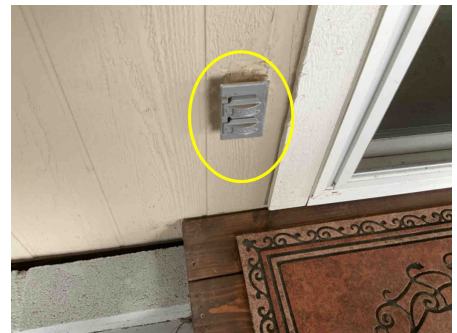
SC 26: Ground Fault Circuit Interrupter (GFCI) receptacles are required at all exterior receptacles. Recommend further review and repair by qualified Electrical Contractor.

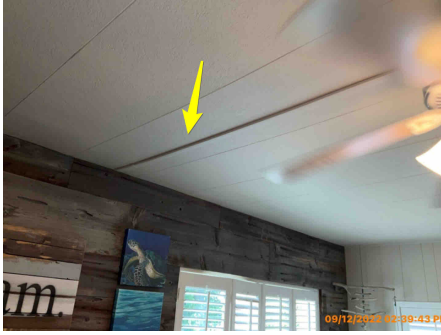
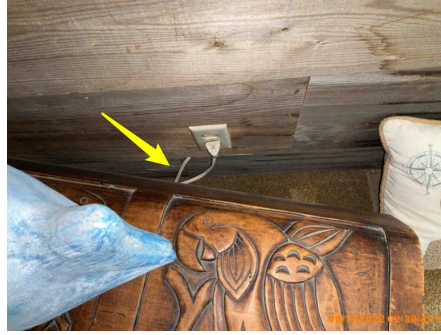
SC 27: Lamp cord used to power ceiling fans, recommend fans be wired with romex type wiring with a ground, We recommend further review and repairs by a qualified specialist in the appropriate trade.

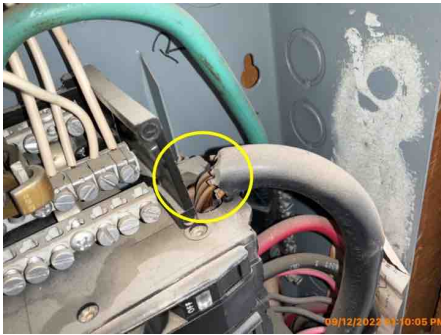
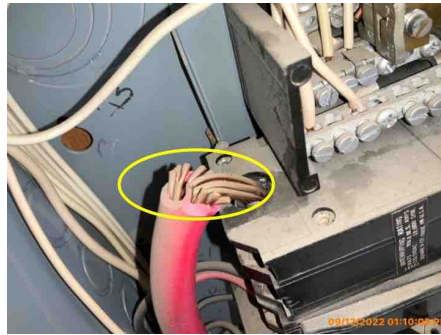
SC 28: Main power supply wires were cut down to fit terminals. Recommend further review and repair by qualified Electrical Contractor.

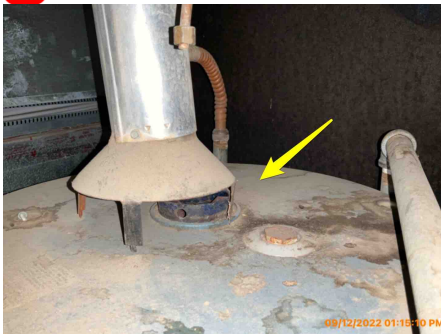
SC 29: Water heater vent not lined up with draft hood.

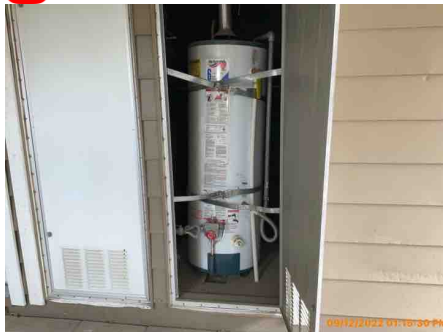
SC 30: Straps are loose, tightening is needed.

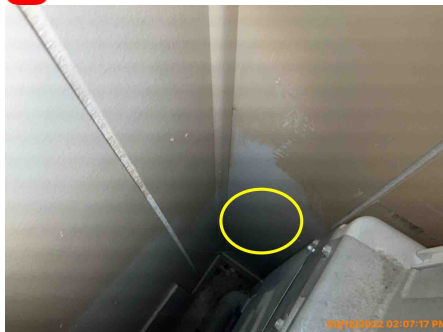
SC 31: Dryer vent should terminate to exterior.

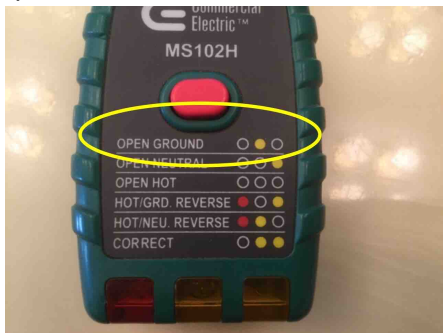
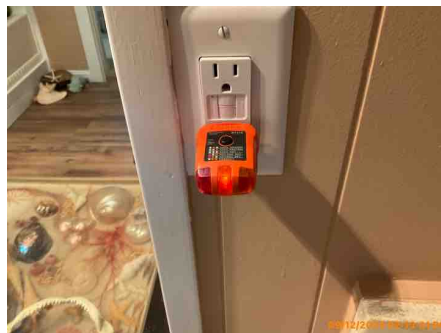
SC 32: Bathroom GFCI receptacle(s) is not properly grounded. Recommend further review and repair by qualified Electrical Contractor.

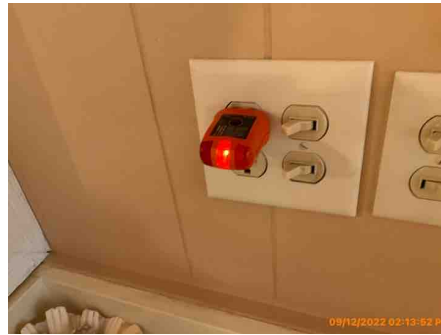
SC 33: Receptacle in bathroom is not grounded and protected by a GFCI receptacle, GFCI protected receptacles are required in all bathrooms, Recommend further review and repairs as needed by a Qualified, State Licensed Electrical Contractor.

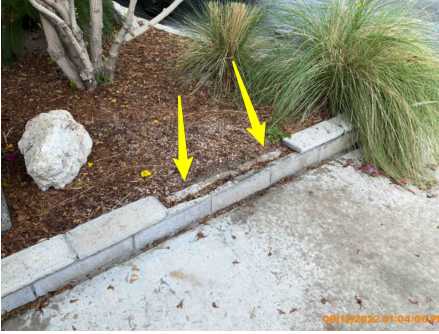
RM 36: Bricks missing at top of retaining wall at front

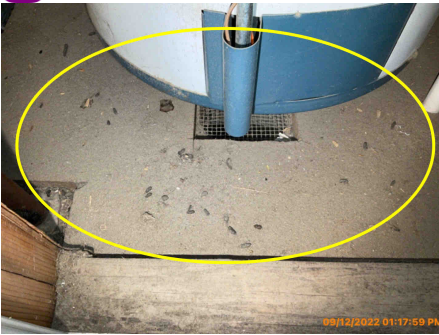
RM 37: Rodent droppings noted at water heater closet floor

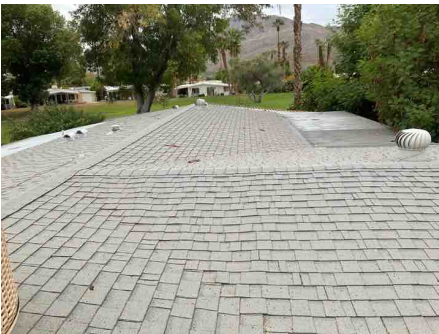
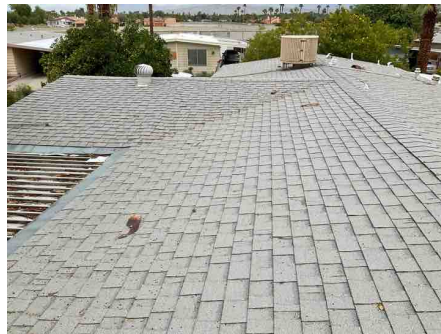
RM 38: The only way to determine whether a roof is absolutely water tight is to observe it during a prolonged rainfall. Many times, this situation is not present during the inspection. Recommend asking the seller for further information on the roof and if they have had any leaks or modifications. Recommend roof be evaluated and certified by a qualified Roofing Contractor.

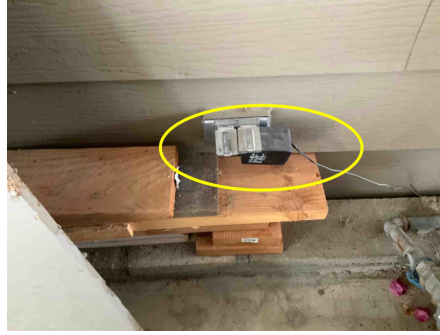
Example

RM 39: Recommend installation of listed outdoor cover for unattended cords to protected receptacles from moisture damage at exterior of house.

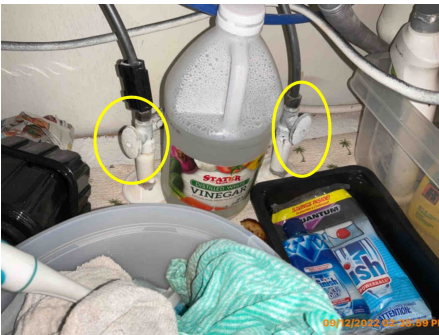
RM 40: Recommend all original shut off valves under sinks and at toilets throughout the house that have not been replaced, be replaced due to age. Recommend the advice and services of a qualified Plumbing Contractor

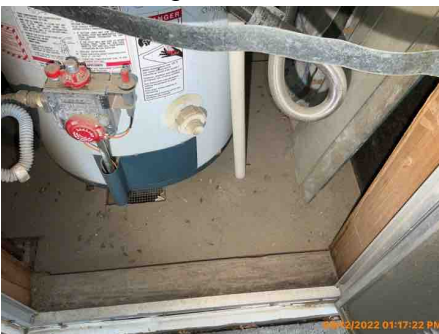
RM 42: End water heater Temperature pressure relief valve drain pipe is required to be visible, so you can see the line leaking. We recommend the advice and services of a qualified Plumbing Contractor

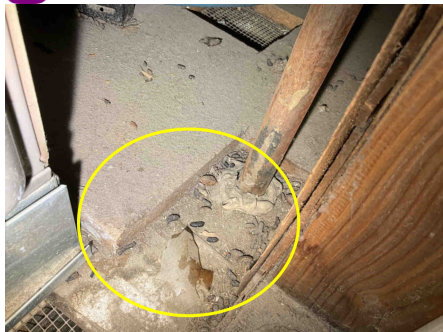
RM 43: Evidence rodents are entering furnace closet

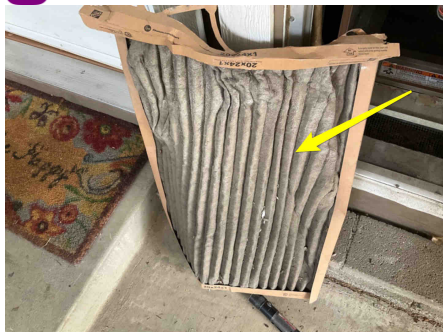
RM 44: Heater filter is dirty, new filter is needed, suggest cleaning/changing filter regularly

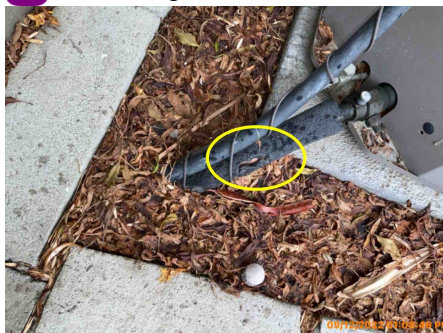
RM 45: Refrigerant line insulation is deteriorated, recommend new insulation be installed.

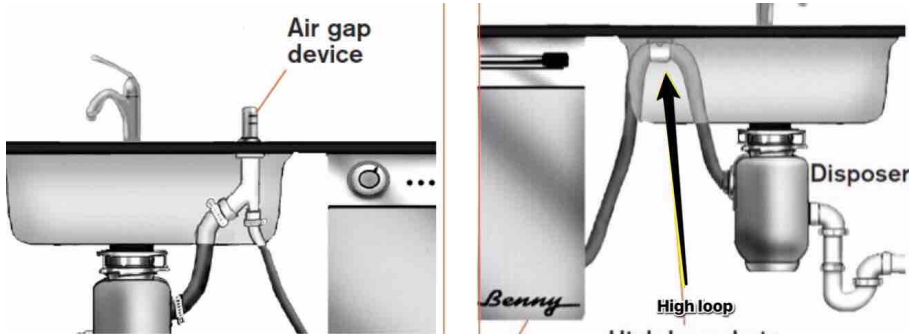
RM 46: A proper air gap is not installed at the dishwasher drain line, an air-gap device is required on all dishwasher drain lines. We recommend the installation or at least high looping the drain line under the sink. We recommend further review and repairs by a qualified handyman

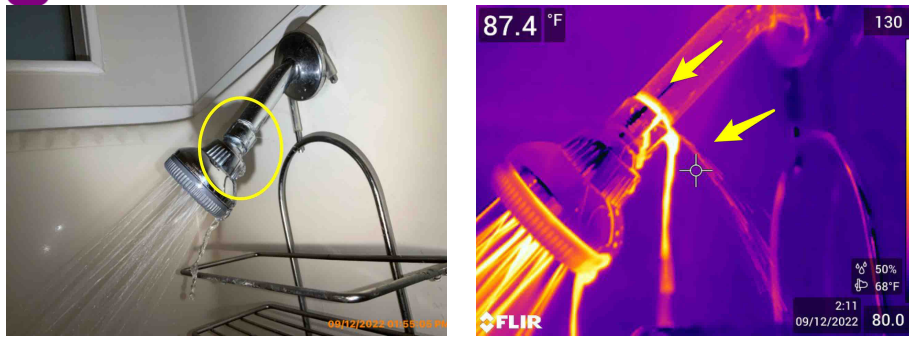
RM 47: Leaking is noted at shower head connection

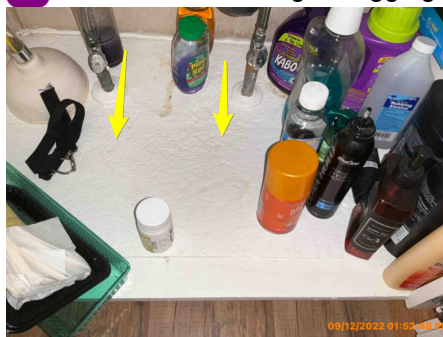
RM 48: Cabinet decking is sagging under sink

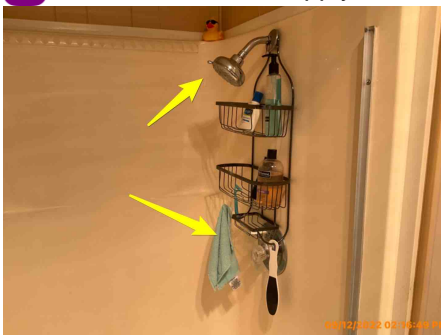
RM 51: Shower head supply line and mixer valve loose inside wall

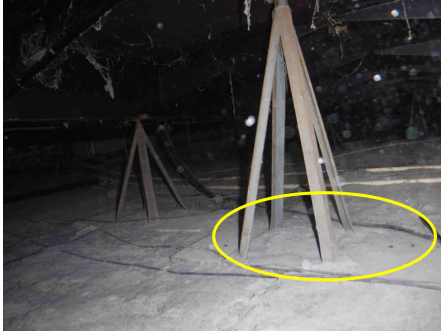
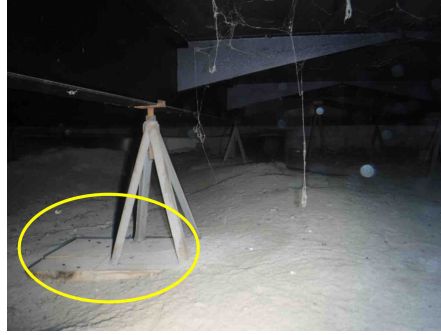
RM 52: Rodent droppings noted, We recommend further review and repairs by a qualified specialist in the appropriate trade.

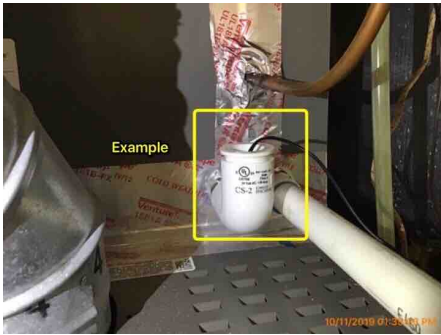
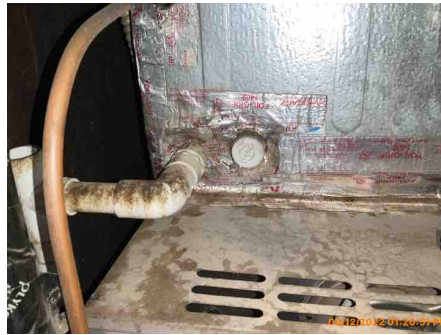
UG 53: Recommend Micro switch be installed on secondary condensation line to prevent moisture damage if primary condensation line becomes blocked.

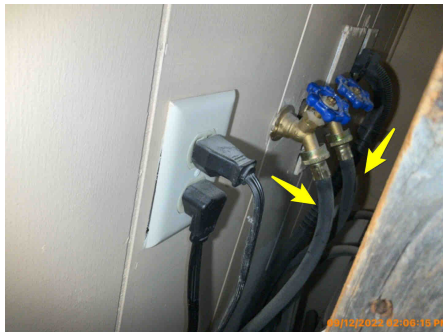
UG 55: It is recommended that you use braided steel flexible water supply lines for washer hook up. The cheaper rubber lines are more prone to rupturing and flooding of the home.
