## **Confidential Inspection Report**

**475-169 MIDWAY DRIVE**

**Escondido, CA 92027**

**December 10, 2025**

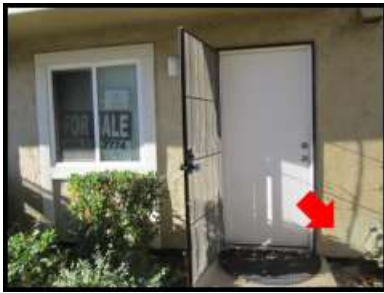
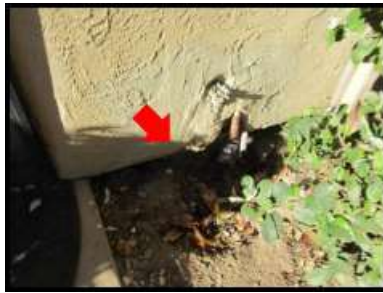
Weathering Noted.

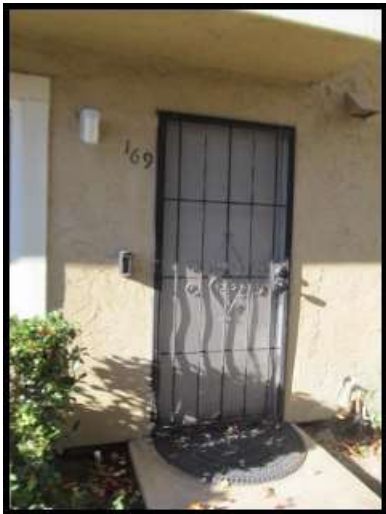
Rear Entry Door(s):                      ☐ OK    ☒ MM    ☐ RR    **Observations-**

The threshold is severely deteriorated and needs replacement.  
Screen door needs to be installed.

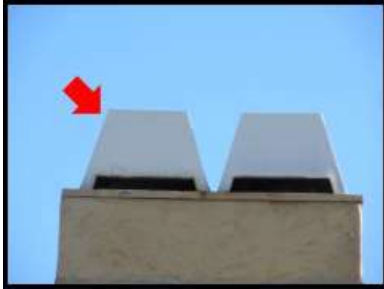
*Flue:*

☐ ☒ ☐ CREOSOTE noted, interior areas of fire place and flue. Cleaning and re-evaluation needed, by a qualified chimney expert. Inspection is incomplete due to surfaces being covered.

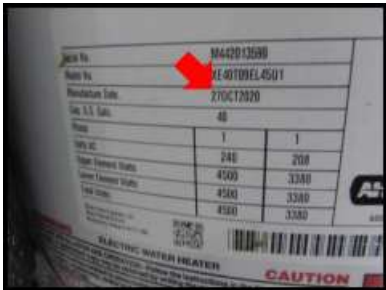
Condition:                      ☐   ☒   ☐   Unit(s) located in the closet.

- Drain pan piping is incorrect size
- Expansion tank is hanging loose
- Seismic straps are the wrong size.
- PVC pressure Relief is not connected to exterior of unit.
- PVC Pressure Relief pipe is not allowed to be installed
- PVC pipe is not glued together.
- There is no emergency disconnect means at the unit.
- Further evaluation and Corrections Recommended, to current standards.
- Most of these problems can cause water damage to the home.

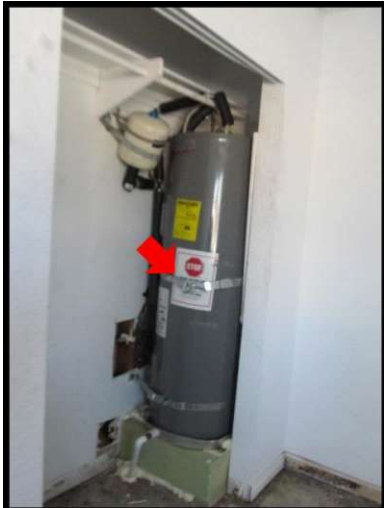
**Improper Strapping noted.**

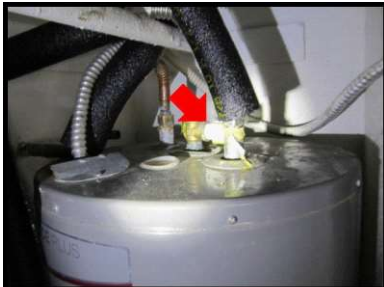
**PVC Pipe**

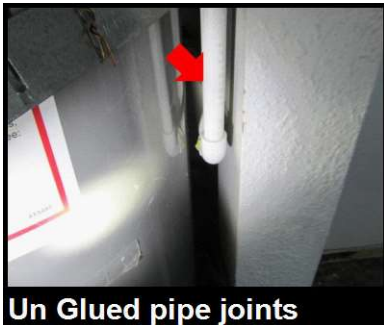
**Un Glued pipe joints**

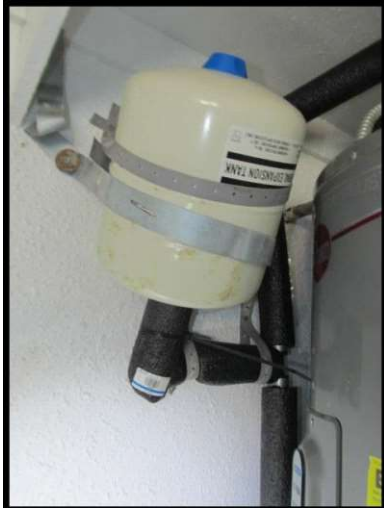
**Improperly Mounted Expansion Tank noted**

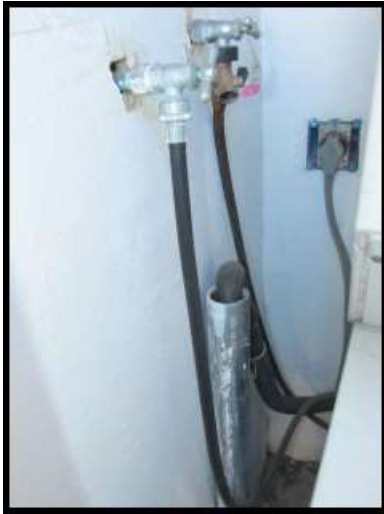
Rubber hoses noted.  
Replacement recommended with steel braided hoses.

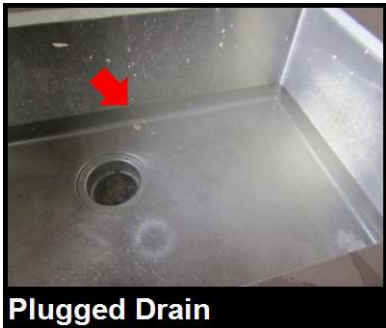
**Plugged Drain**

The drain is Clogged drain noted.  
Repair as needed.

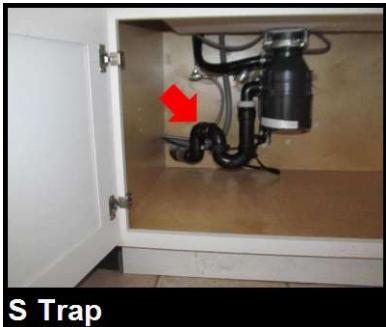
An 'S' trap is installed. 'S' traps are prone to siphoning the water out of the trap which could let sewer gases into the house.

**S Trap**

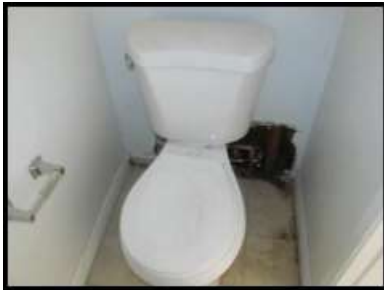
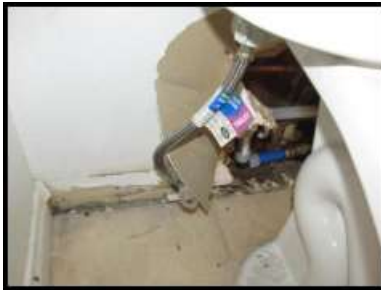
Defects Noted  
Improper base bolts noted.  
Further Evaluation and Repairs as needed are recommended.

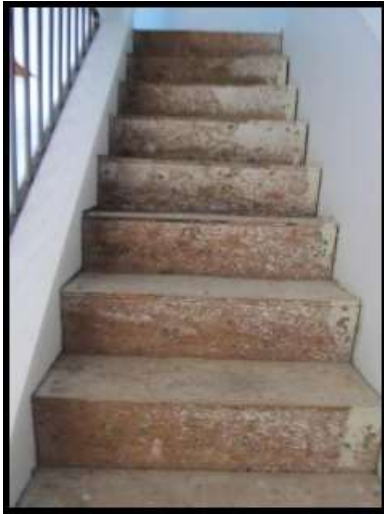
Wet Drywall on stair case surfaces.

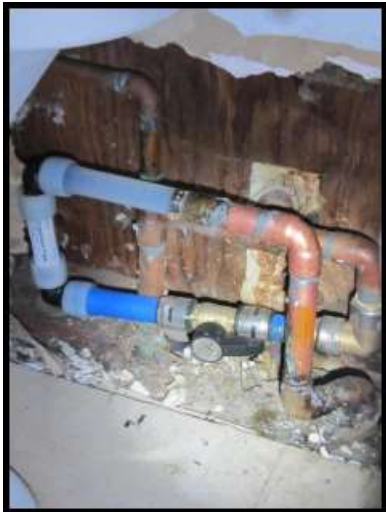
Pipe repairs noted  
Wall repairs needed.

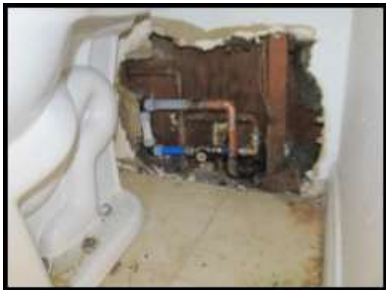
Further Evaluation and Repairs as needed are Recommended.  
Open wall holes noted.

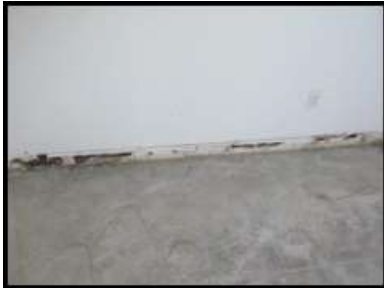
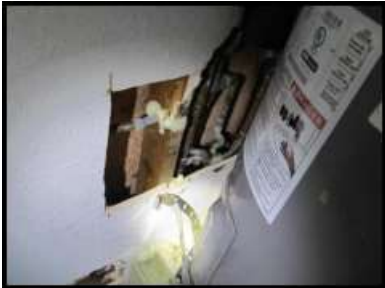
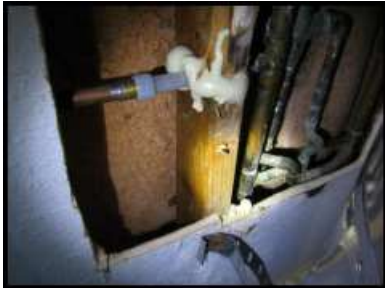
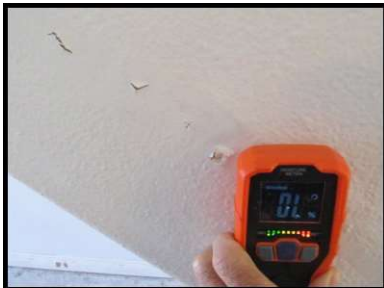
Open holes on both floors need to be repaired

Further Evaluation and Repairs as needed.

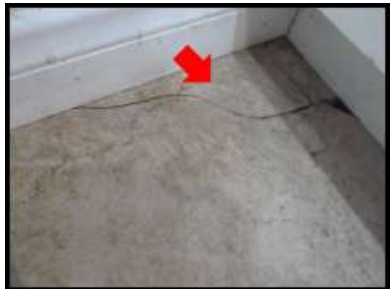
The floor coverings are; Tiles  
Random cracks are noted in the grout/tile area of the floor  
Monitoring is recommended.  
If cracks become longer or wider a foundation or installation problem is developing.

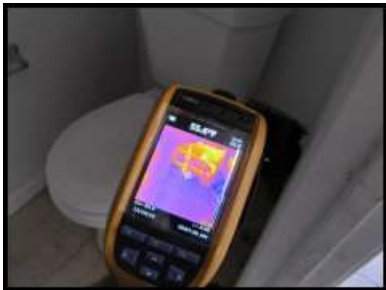
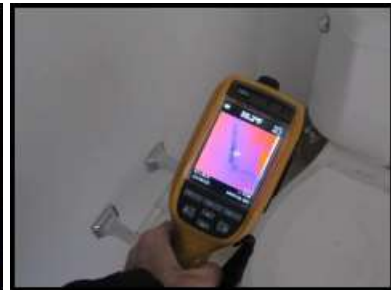
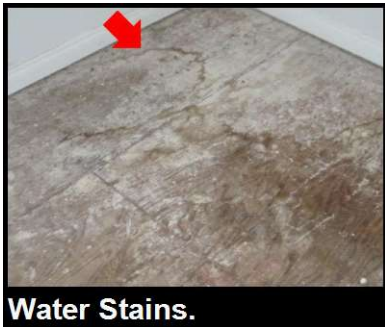
Water stains noted on sub flooring.  
Both bedrooms  
Hall  
Stairs.

Water Stains.

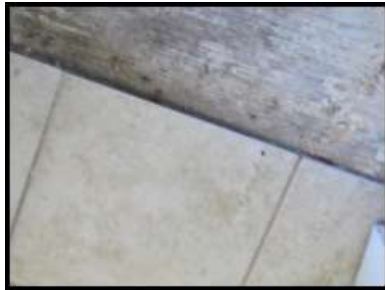
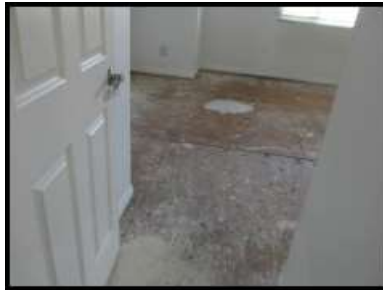
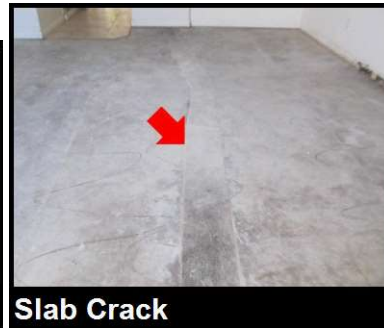
Slab Crack

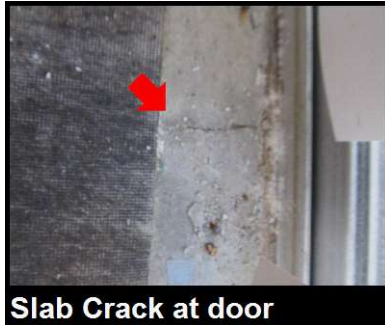
Slab Crack at door
