WOOD DESTROYING PESTS AND ORGANISMS INSPECTION REPORT

Building No. 21532	Street Crystal Falls Dr.	City Sonora	ZIP 95370	Date of Inspection 04/20/2026	Number of Pages 6
-----------------------	-----------------------------	----------------	--------------	----------------------------------	----------------------

Report # : 12576
Registration # : PR8529
Escrow # :
 CORRECTED REPORT

GENERAL DESCRIPTION: Single story, single family residence, wood frame and siding, composition roof, raised foundation, carpeted, and furnished.	Inspection Tag Posted: Subarea
	Other Tags Posted:

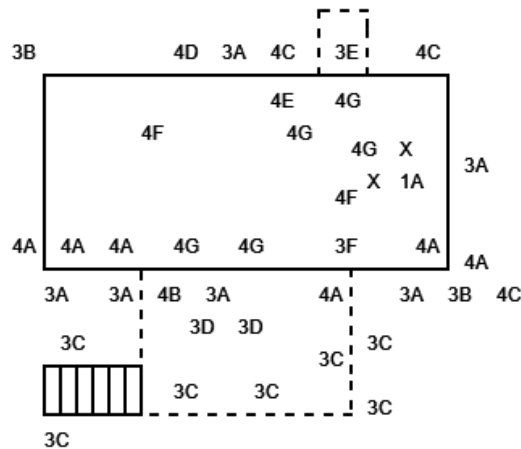
Diagram Not To Scale

FINDING: Subterranean Termite activity was noted at the cellulose debris.

FINDING: Wood decay fungus was noted on the siding and trim at the base of the wall.

FINDING: Wood decay fungus was noted on the barge rafter and fascia.

FINDING: Wood decay fungus was noted on large portions of the decking, joists, girders, posts, and stingers.

FINDING: Wood decay fungus was noted on the rafter ends at the entry cover.

FINDING: Wood decay fungus was noted on the landing.

FINDING: Surface fungus was noted on the subarea siding.

RECOMMENDATION: To prevent subterranean termites from constructing mud tubes between the foundations and the wood members, apply Taurus to the soil in accordance with the label adjacent to the area of infestation (see X on diagram). Post a completion tag listing the materials used. Treatment to be applied by Lawson Home services licensed applicator per current label instructions. Local Treatment is not intended to be an entire structure treatment method. If infestations of wood-destroying pests extend or exist beyond the area(s) of local treatment, they may not be exterminated.
