## Inspection Report

1245 Saxony Rd  
Encinitas CA 92024

| <b>Date:</b> 4/4/2026 | <b>Time:</b> 09:00 AM | <b>Report ID:</b><br>20260404-1245-Saxony-Rd |

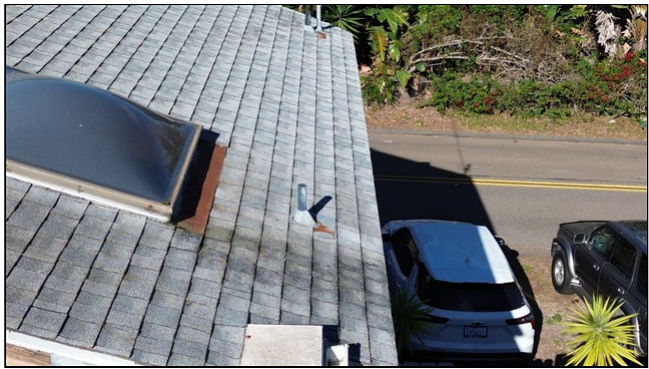
1.0 Item 1(Picture)

(1) There are several metal roof flashings that are rusted. We recommend they be cleaned, painted and/ or replaced as needed by a qualified licensed roof contractor.

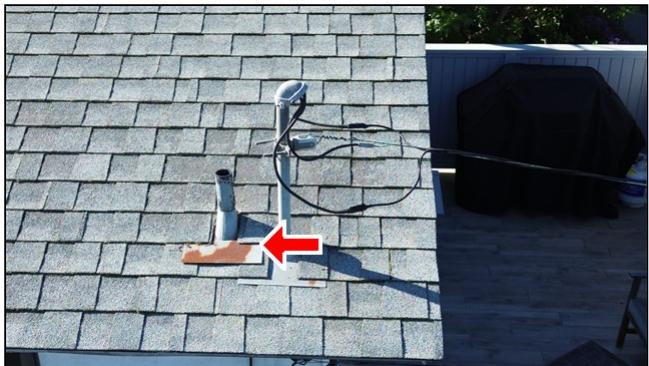
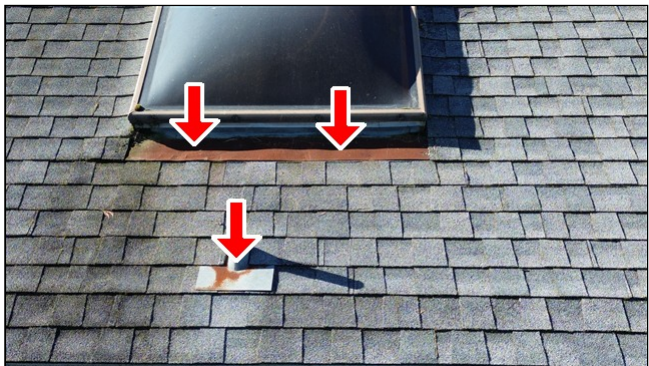
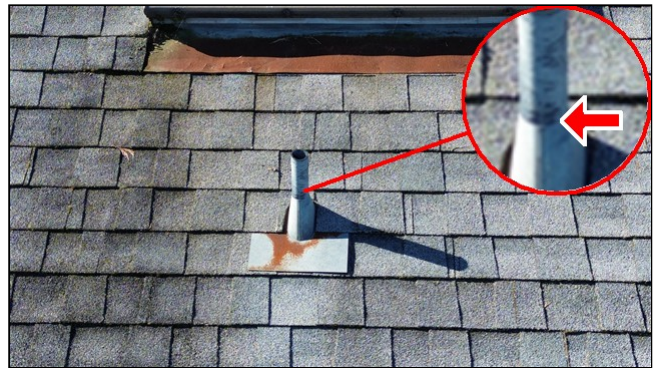
(2) Sealant around the roof flashings/ penetrations is cracked. We recommend further evaluation and/or necessary corrections by a qualified licensed roofer.

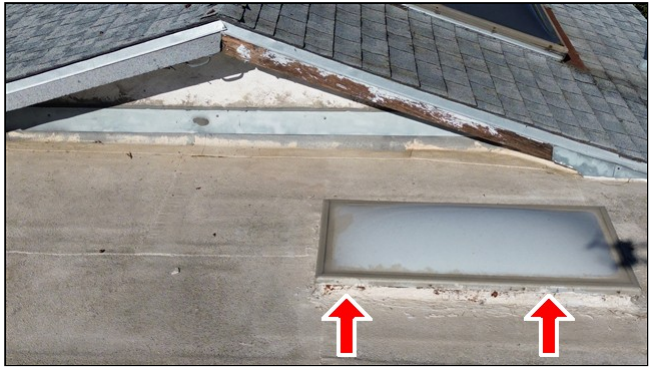
1.5 Item 1(Picture)

The skylight on the flat roof has excessive sealant applied around it. This condition may indicate previous leak repairs and can be a sign of ongoing or recurring water intrusion issues. We recommend necessary repairs and further evaluation by a licensed certified contractor to ensure the skylight is properly sealed and functioning as intended.

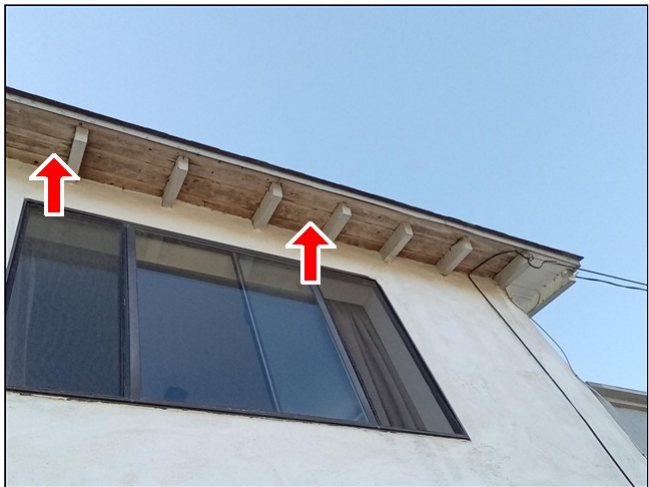
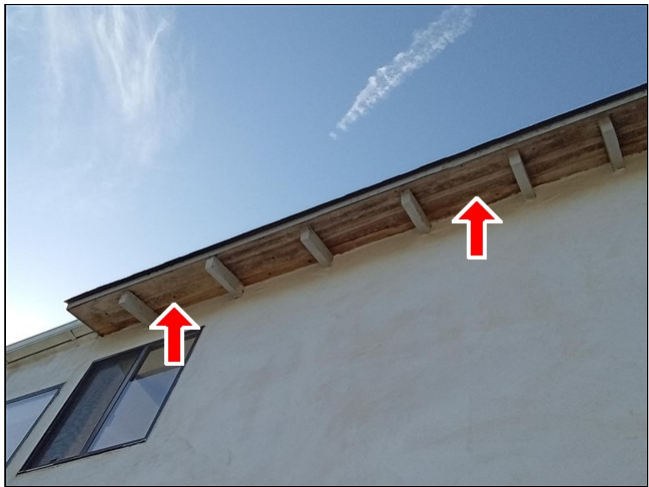
(1) Bare wood needs primer and paint at several areas. Maintaining paint is essential to preventing the wood from damage. We recommend prep and paint where needed by a licensed painter.

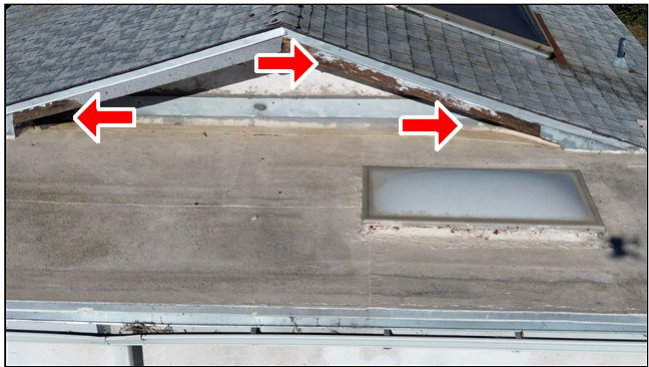
2.3 Item 3(Picture)

(2) Paint is failing at the eaves at several areas and needs prep and paint. We recommend prep and paint where needed by a licensed paint contractor.

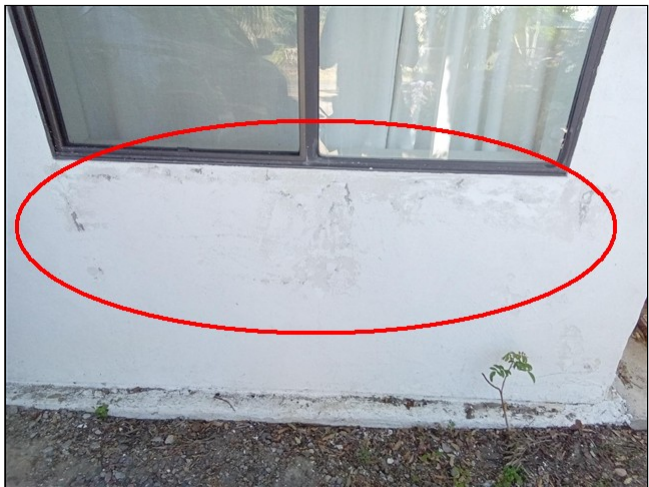
2.4 Item 1(Picture)

(1) There is damaged/ deteriorated stucco observed at several areas. We recommend necessary repairs where needed by a licensed stucco contractor.

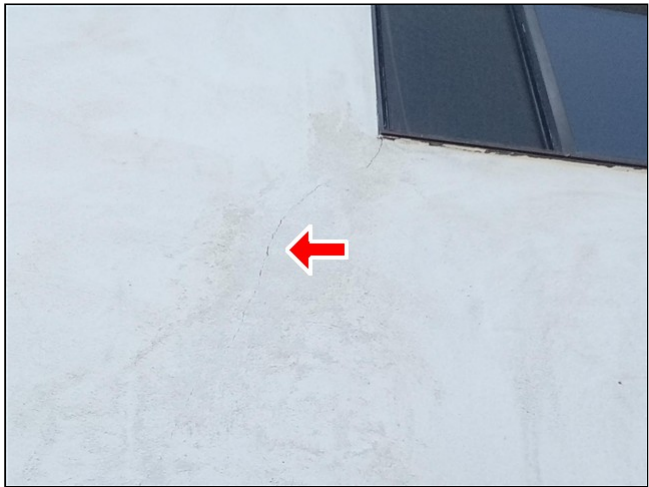
2.4 Item 3(Picture)

(2) Hairline cracking was observed at the stucco at several areas. The cracks are less than 1/8 inch in width, and generally considered common in this material. These cracks should be caulked and painted where possible. If cracks increase in width, it may indicate that structural movement is occurring. Determining this is beyond the scope of a home inspection.

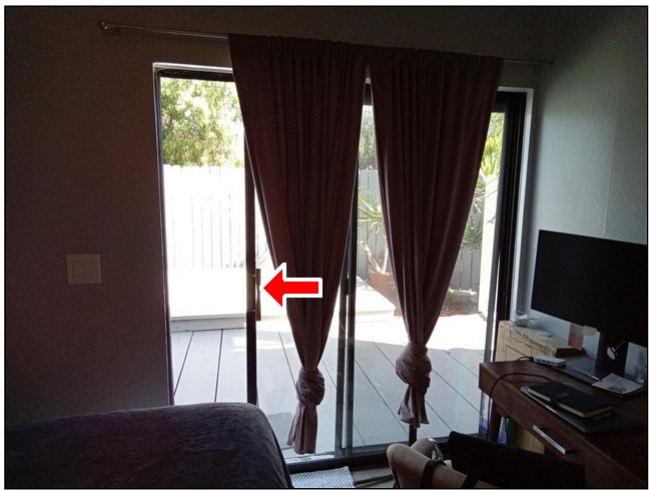
2.5 Item 1(Picture)

The latch is inoperable at the sliding glass door in the downstairs bedrooms. We recommend necessary repairs or replacement by a qualified person.

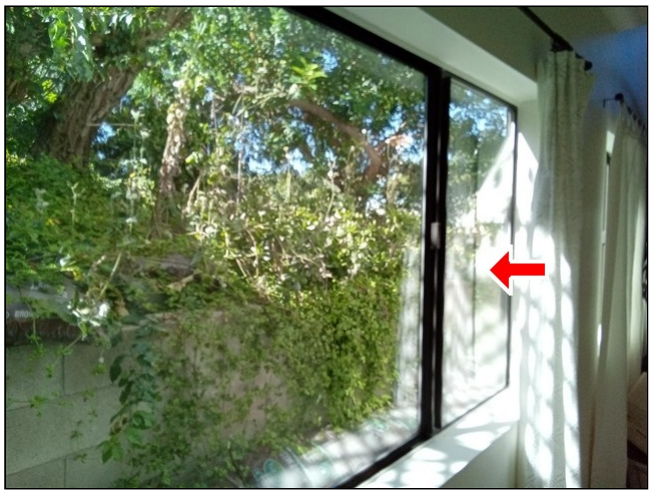
2.6 Item 1(Picture)

(1) A window screen is missing in the downstairs hallway. We recommend replacing by a qualified person.

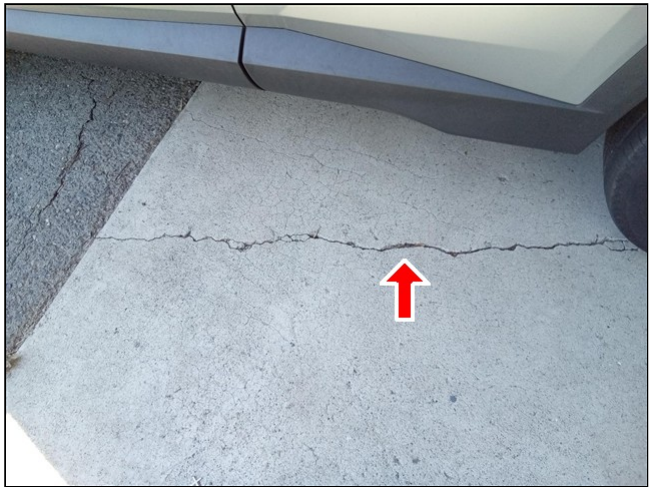
2.8 Item 1(Picture)

There are several stress and/ or settling cracks observed in the concrete driveway. This may indicate that soil movement is occurring, there may be root encroachment, or the concrete was installed without re-enforcement. This driveway may deteriorate further. We recommend obtaining a quote for necessary repairs or replacement by a licensed concrete contractor prior to the end of your contingency period.

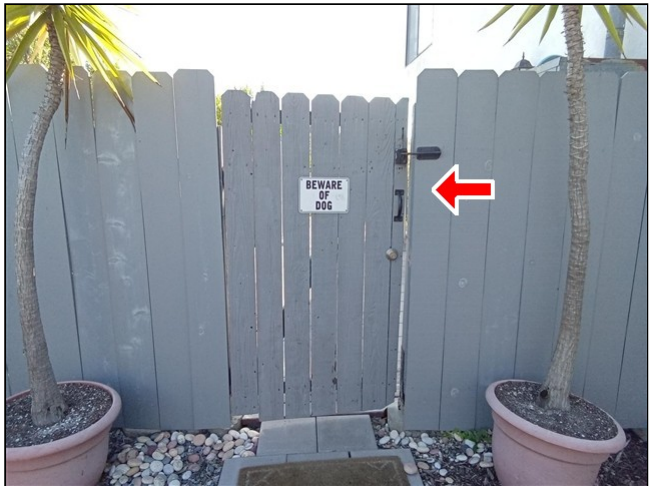
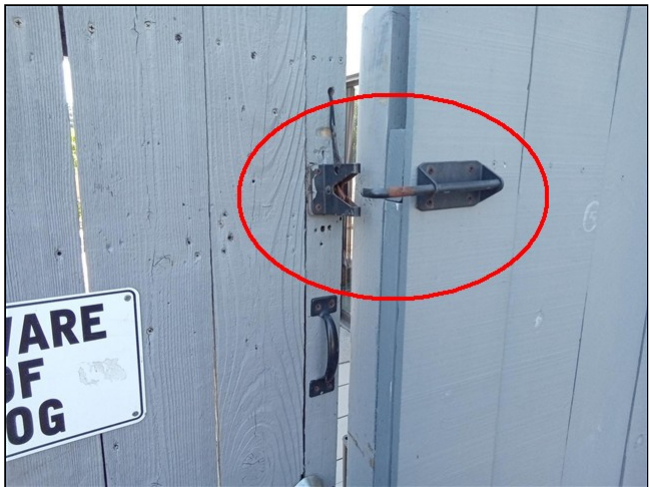
(1) The gate hardware is in poor condition and requires adjustment for the gate to operate (latch) properly. We recommend necessary repairs by a qualified licensed fence contractor.

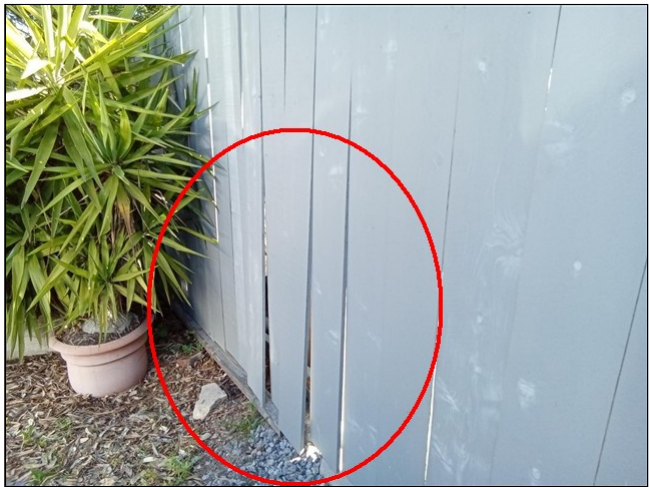
2.9 Item 3(Picture)

(2) The fence is loose, and damaged in several areas. We recommend necessary repairs or replacing as needed by a licensed fence contractor.

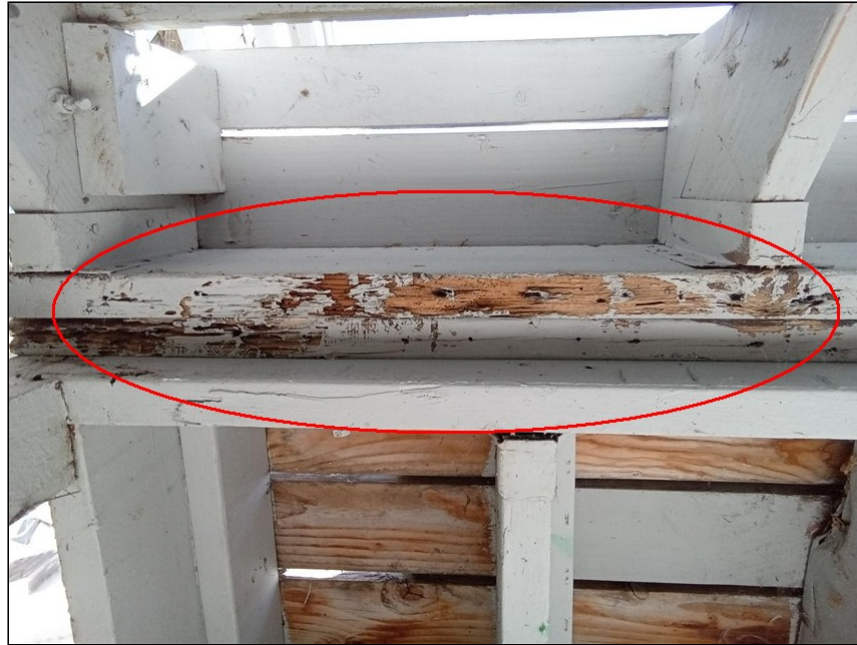
2.11 Item 1(Picture)

(1) Some damaged wood is observed at the entry stairs at several areas. We recommend referring to the pest inspection report for a detailed evaluation of the wood. We also recommend necessary repairs or replacing the damaged wood as needed by a qualified licensed contractor.

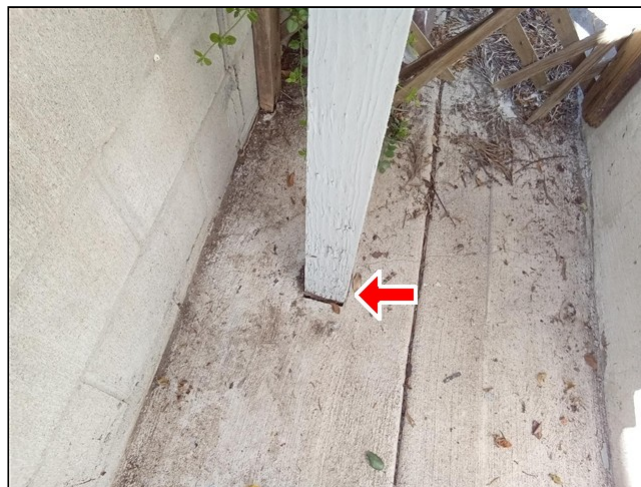
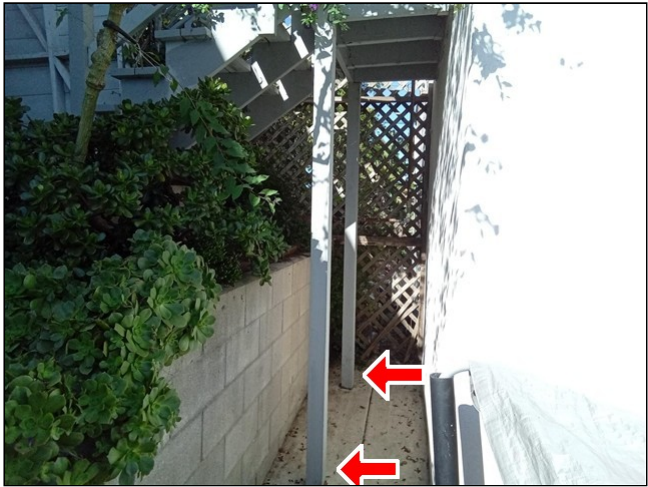
(2) Wood posts at the stairs are observed in direct contact with the concrete, and lose. This may have been acceptable years ago. Currently post are required to be elevated 1" off concrete pier unless pressure treated or naturally decay resistant (red wood/cedar) post is used. We recommend necessary corrections by a licensed deck contractor.

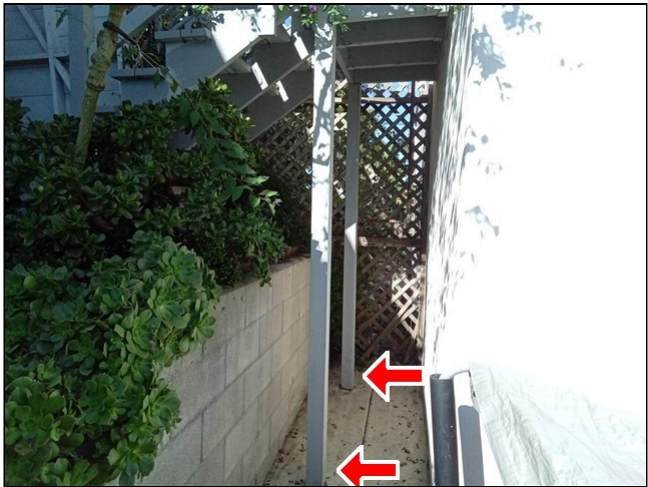
2.11 Item 4(Picture)

(3) The deck was constructed using 4" x 4" post. This deck is greater than 8 feet in height, current standards require 6" x 6" post(s) when greater than 8 feet in height. This installation may have been acceptable years ago but does not meet today's building standards. We recommend necessary repairs by a licensed deck contractor for safety.

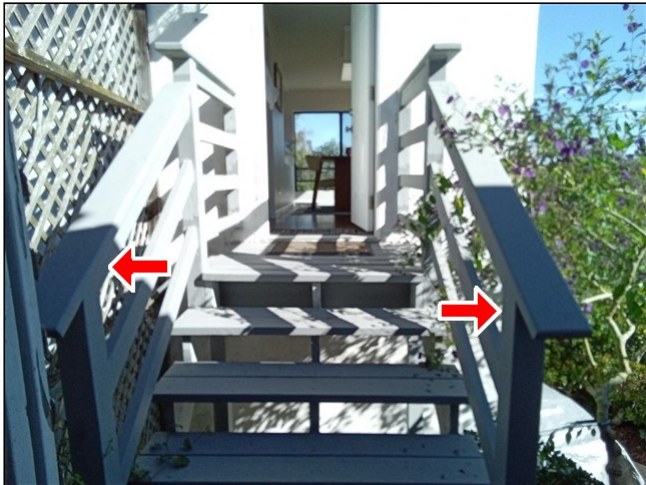
2.11 Item 5(Picture)

(4) The handrail at the deck is too thick and not easily grasped. This is a fall hazard. The handrail must be easily grasped and measure between 1-1/2" to 2" in width. We recommend having the handrail modified by a qualified licensed contractor.

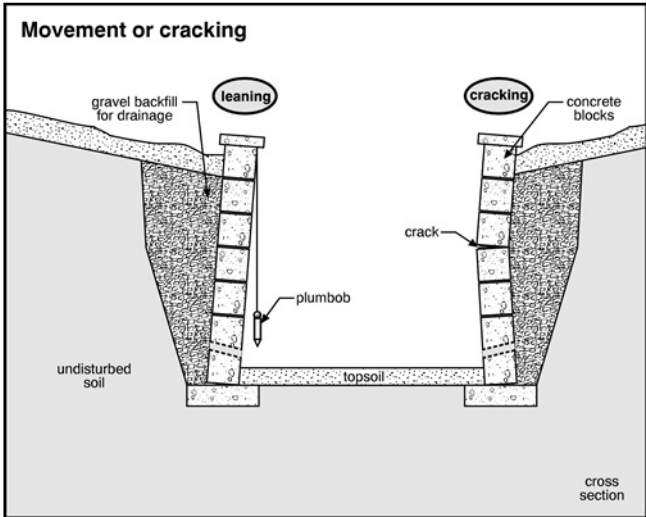
2.12 Item 1(Picture) 1936

The retaining wall is leaning and erosion signs are present. This problem will continue to become worse and needs correcting. We recommend further evaluation and repair by a licensed contractor.

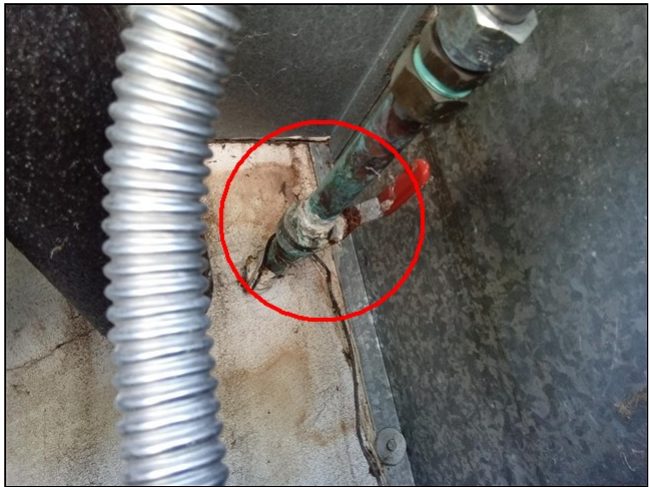
3.0 Item 1(Picture)

(1) The water heater cold water shut-off valve is rusted/corroded. We recommend replacing this shut-off valve by a licensed plumber.

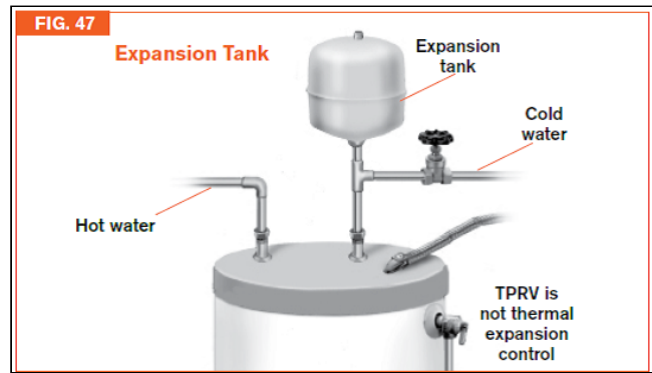
3.0 Item 5(Picture)

(4) The water heater does not have a "Thermal Expansion Tank" installed to prevent a possible leak at the T&P or "pop-off" valve. Recent changes in code require one when a new water heater is installed. This change is not retroactive on older previously installed Gas/LP water heaters. In addition, this requirement is subject to your local municipal code. There were no leaks or drips at the T&P valve during inspection. If your water heater does begin to drip or leak, then a thermal expansion tank may be needed. We recommend installing a thermal tank by a qualified licensed plumber as an upgrade.

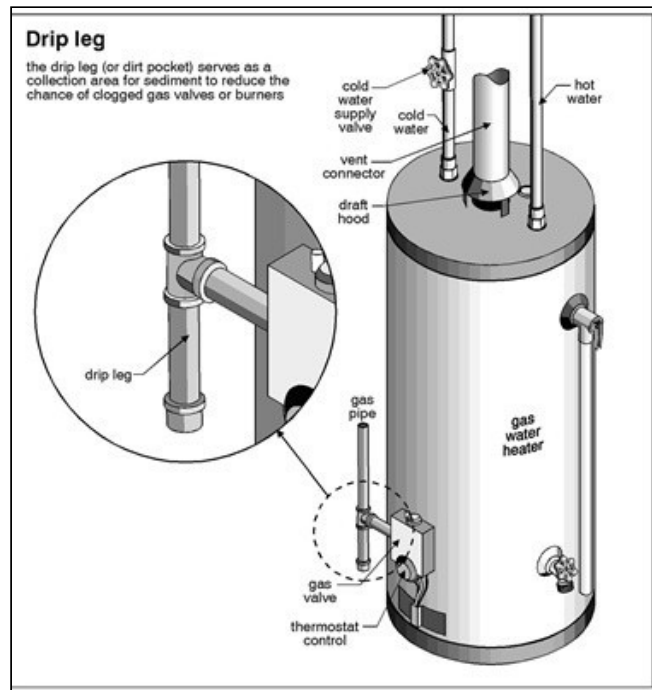
3.0 Item 6(Picture)

(5) The gas supply pipe at the water heater did not contained a drip leg/ sediment trap. This may have been standard at the time of installation but now is highly recommended. The purpose of a drip leg is to prevent sediment/ debris from entering and clogging the water heater gas valve which could cause the water heater to shut down. We recommend having a drip leg installed by a qualified licensed plumber.

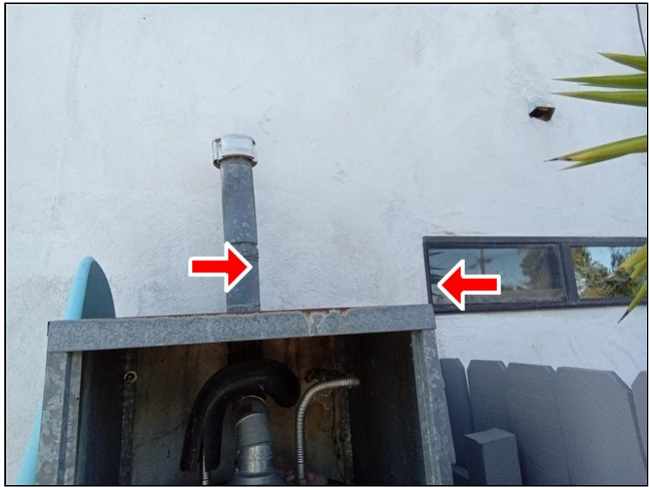
3.1 Item 1(Picture)

The water heater flue termination was installed too close to an opening at the exterior of the home. The flue should terminate a minimum of 4 feet to the side or below any building opening, and 1 foot above any opening. The current installation does not meet this requirement and can allow carbon monoxide gasses to enter the home. This is a safety hazard and indicates the water heater was not have been professionally installed. We recommend further evaluation by a qualified licensed plumber for repair options.

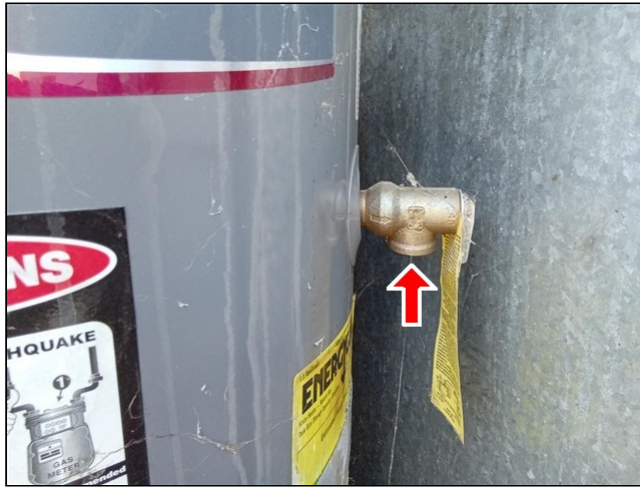
3.3 Item 1(Picture)

There is no discharge pipe connected to the water heater Temperature and Pressure (T&P) relief valve. This is non standard and a potential scalding hazard. A metal discharge pipe must be installed which drains water to within 6 inches of the ground in the event of an over-heat/ pressure scenario. We recommend that a metal discharge pipe be installed at the water heater temperature pressure relief valve by a qualified licensed plumber for safety.

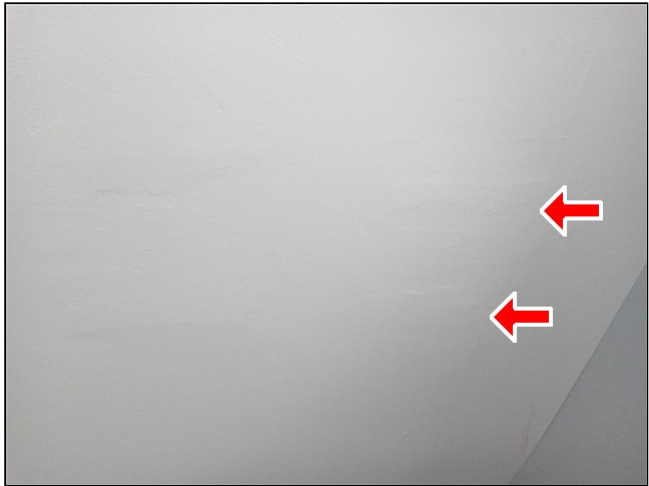
4.1 Item 1(Picture)

(1) Patching was noted at the ceiling in the master bedroom. We recommend asking the seller if they have knowledge of the repair or cause.

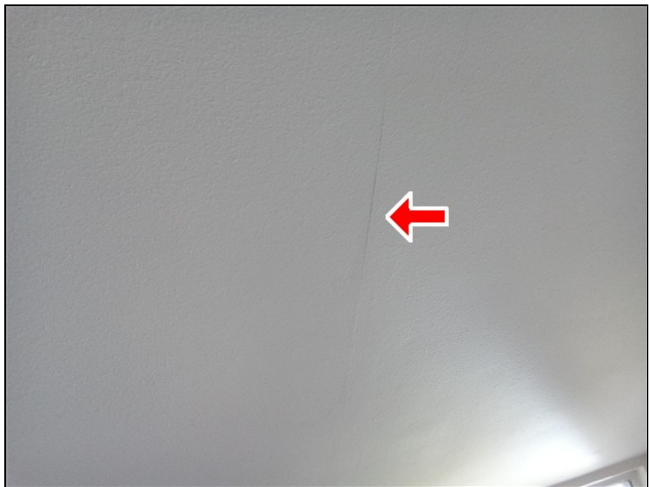
4.1 Item 3(Picture)

(2) Hairline cracking was observed at the ceiling at several locations in the house. These hairline cracks are likely due to material shrinkage or settlement of the structure. We recommend prep and paint by a qualified licensed contractor.

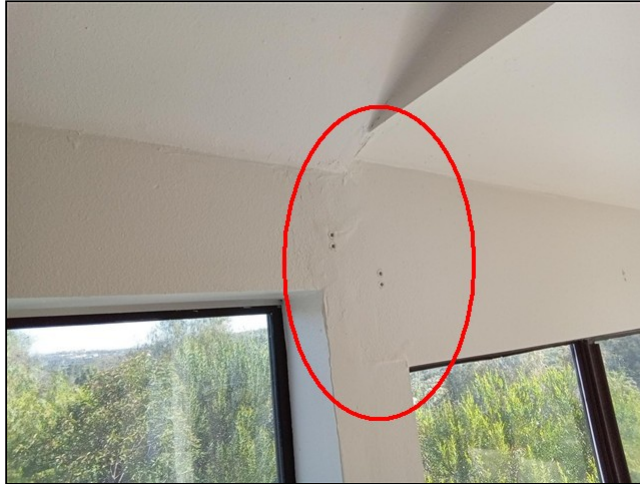
4.2 Item 1(Picture)

(1) The walls have cosmetic damage in one or more locations. We recommend prep and paint and/or repairs as needed by a qualified licensed drywall contractor.

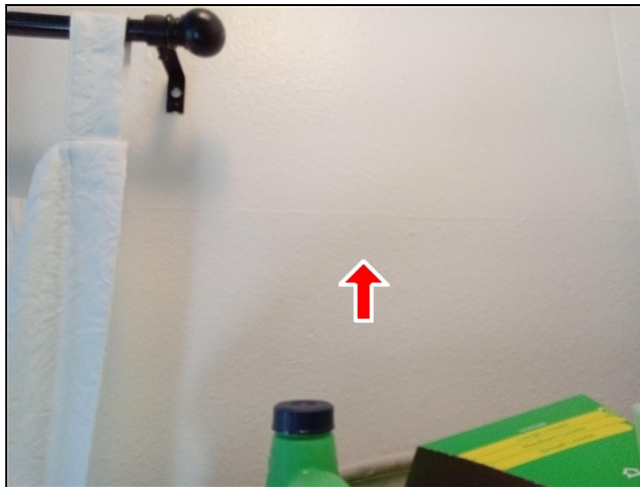
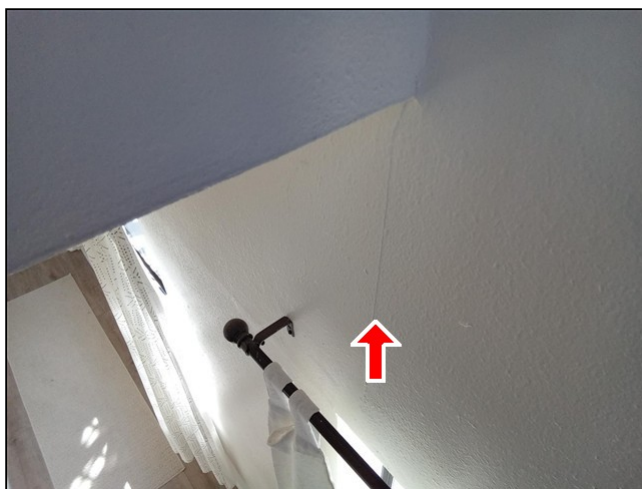
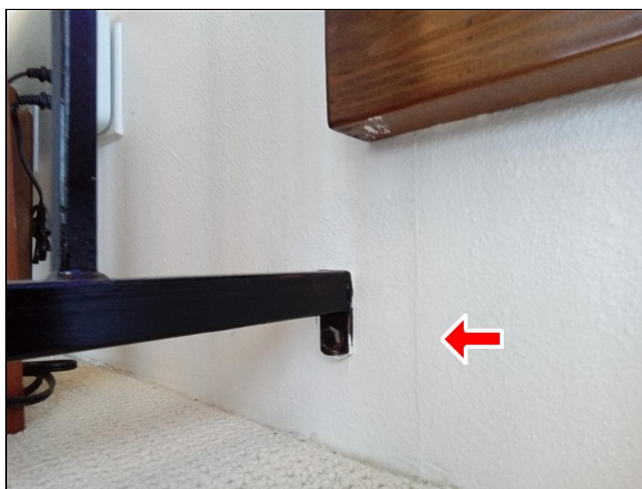
(2) Hairline cracking was observed at several locations throughout the house. These hairline cracks are likely due to material shrinkage or settlement of the structure. We recommend prep and paint by a qualified licensed painter.

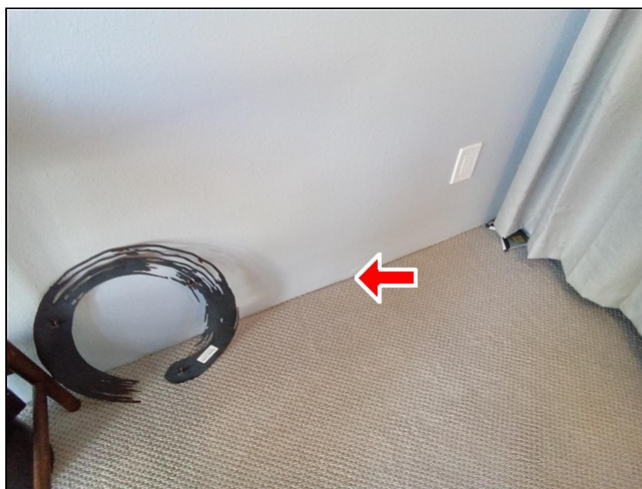
4.2 Item 5(Picture)

(3) Base boards are missing at several areas throughout the house. We recommend replacing where needed by a qualified person.

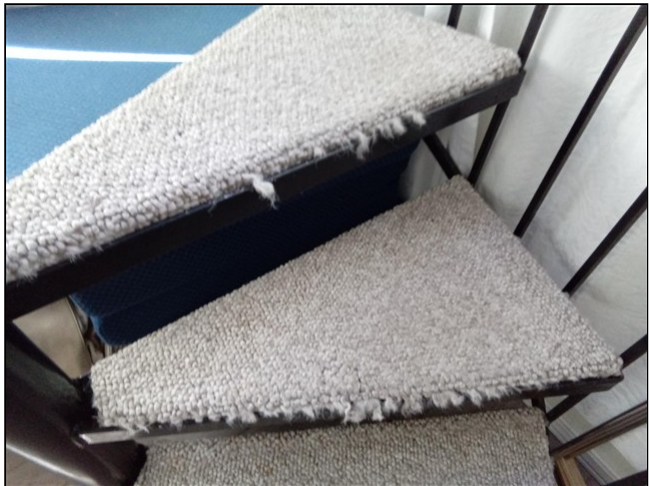
4.3 Item 1(Picture)

There is damaged carpet on the stairs. We recommend replacing where needed by a qualified licensed flooring contractor.

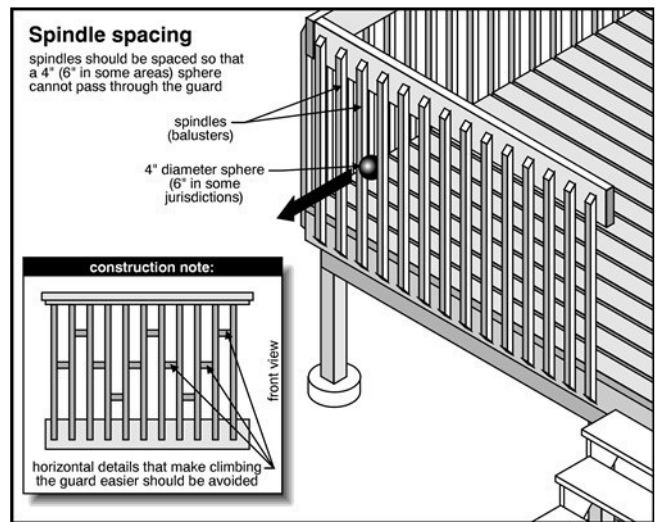
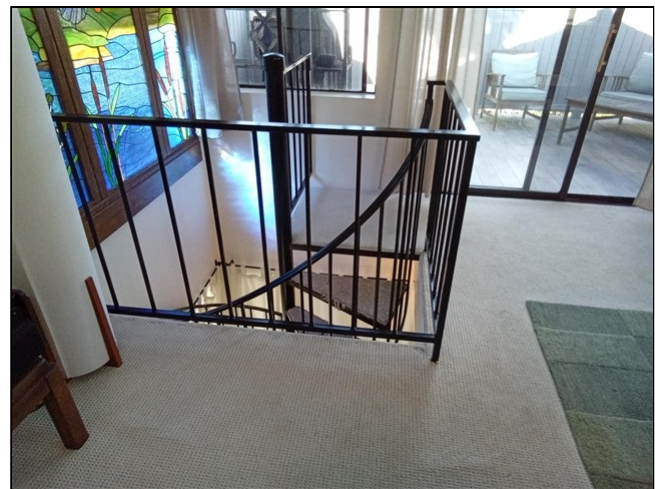
While the railing/baluster spacing may have been standard at time of construction, it does not comply with current safety standards. The large openings can allow pets or children to fall through. We recommend installing additional pickets, or other form of barrier to prevent injuries by a qualified licensed contractor.

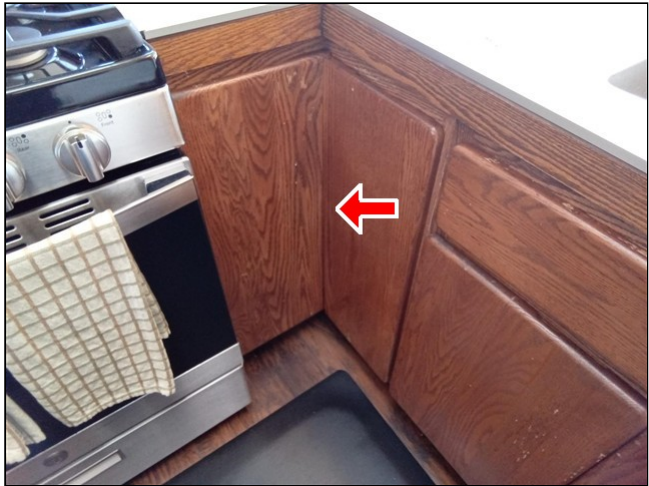
4.5 Item 1(Picture)

Cabinet door hardware is noted to be loose at several kitchen cabinet doors. We recommend necessary corrections where needed by a qualified person.

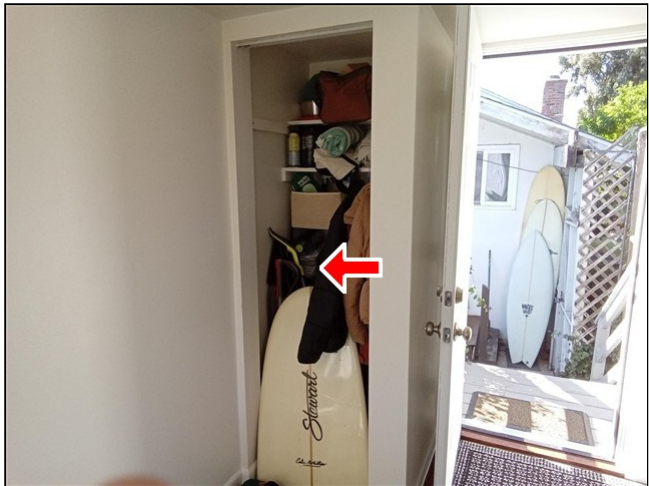
4.6 Item 1(Picture)

**Findings**  
(1) The closet doors are missing in the entry closet. We recommend replacing the doors as needed by a qualified person.

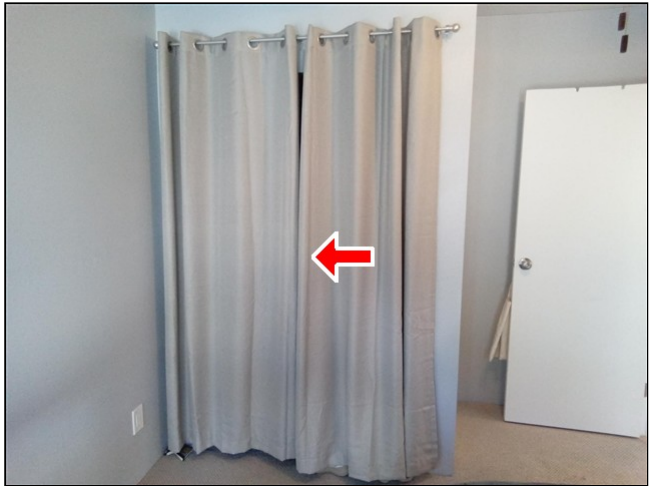
4.6 Item 2(Picture)

(2) The closet doors are missing in both bedrooms. We recommend replacing the doors as needed by a qualified person.

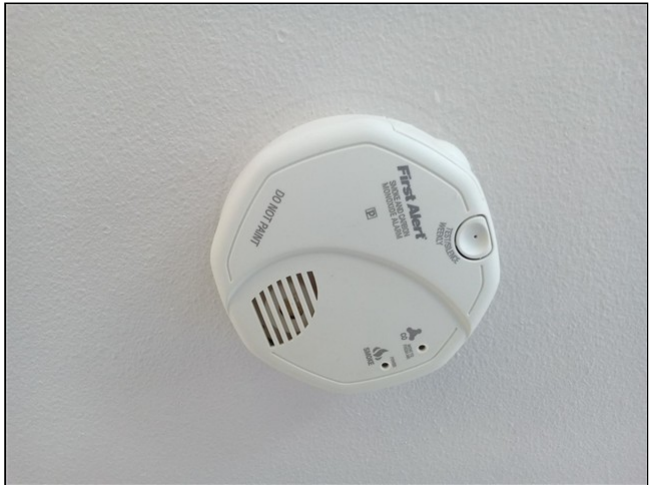
5.1 Item 1(Picture)

**Findings**  
This house has only one Carbon Monoxide detector. The quantity of Carbon Monoxide detectors that are required to be installed varies with each house. Larger houses, or those with multiple levels are required to have more CO detectors. A Carbon Monoxide detector is required on each level of a multi-level house and adjacent to each cluster of bedrooms. We recommend installing additional Carbon Monoxide detectors where needed.

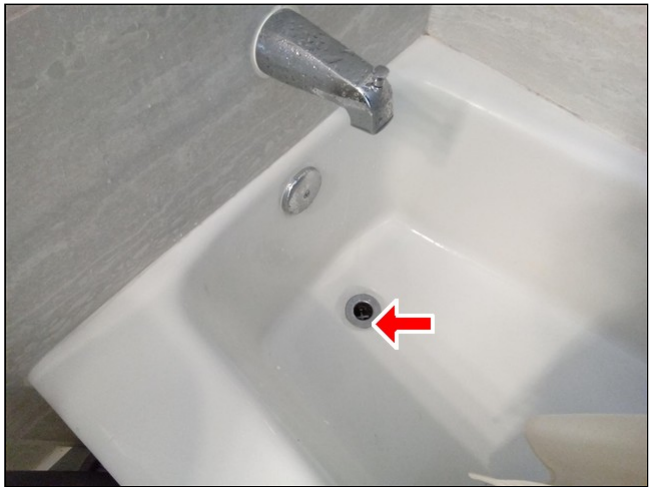
6.3 Item 1(Picture)

The hall bathroom tub stopper is missing. We recommend replacement by a qualified person.

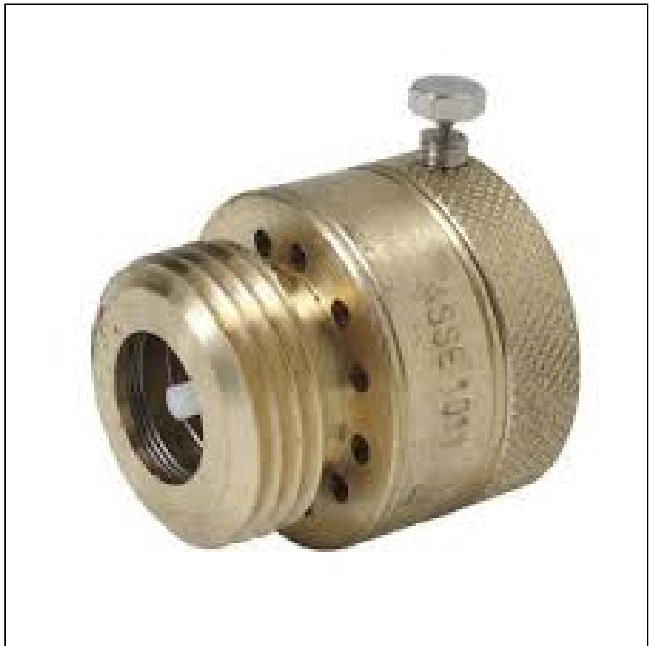
6.6 Item 1(Picture)

(1) The exterior hose spigots do not have anti-siphon or anti-backflow devices installed on them. Theses anti-siphon or anti-backflow devices help prevent contaminated water from flowing back into the the house water supply system. We recommend installing anti-siphon or anti-backflow devices at the every exterior hose spigots by a qualified person.

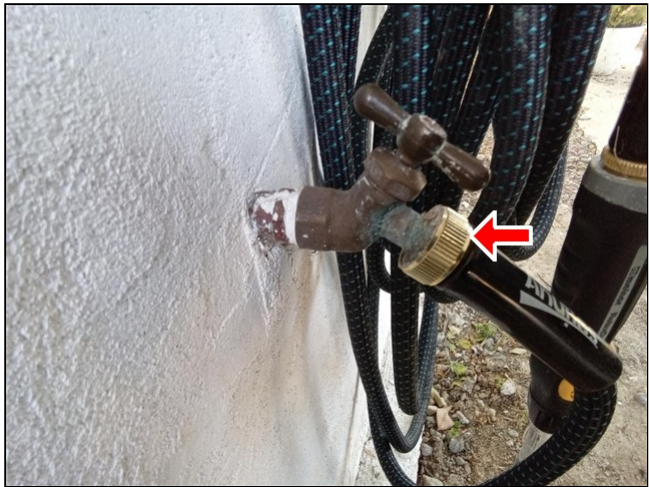
6.6 Item 2(Picture)

(2) The front hose is fused/ tight to the hose bib. I was unable to remove the hose at the time of the inspection. We recommend having the sellers remove the hose and/or repairs by a qualified licensed plumber as needed.

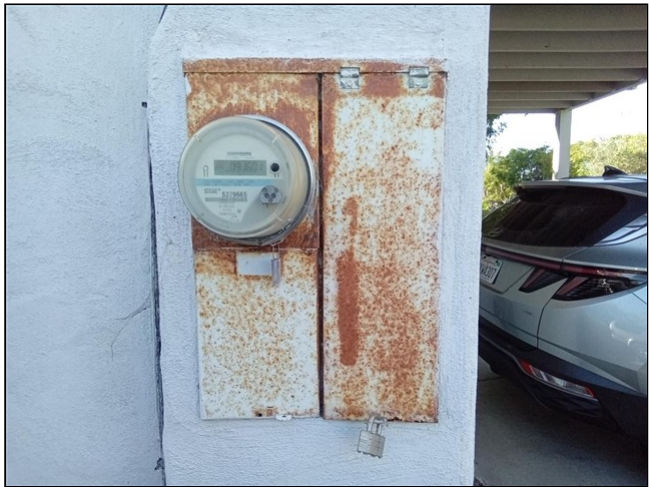
7.0 Item 1(Picture)

The main panel access cover was locked at the time of the inspection preventing access to the breakers, wiring, and related components. The main panel and related components could not be inspected at this time. We recommend that the lock be removed and that the main electrical panel and it's related components be inspected by this company or a qualified person prior to the end of your contingency period.

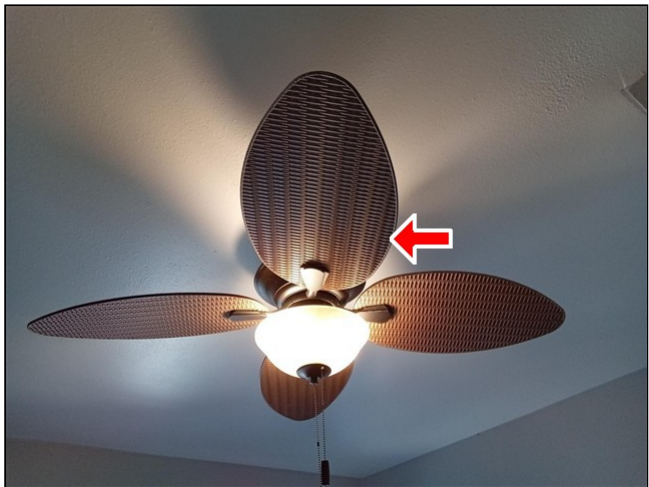
7.4 Item 1(Picture)

The ceiling fan in the downstairs bedroom did not work when tested at the time of the inspection. We recommend further evaluation by a qualified person and repairs or replacement made as necessary.

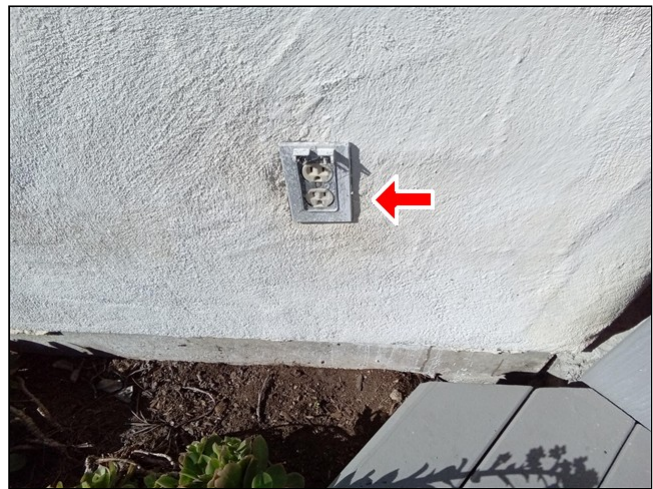
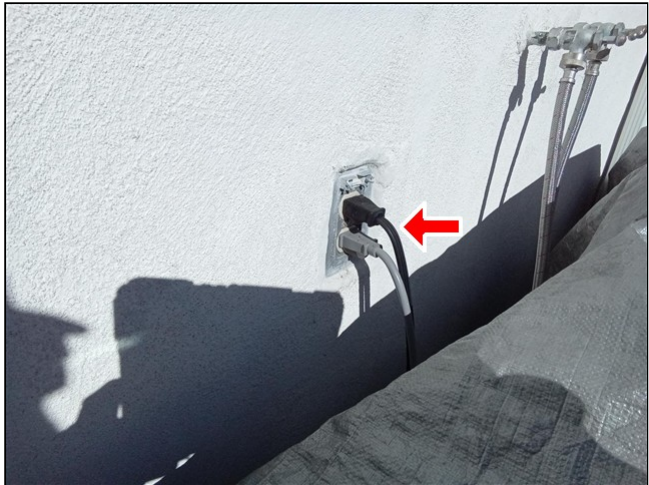
**Findings**  
(1) Several exterior receptacles do not have weather proof covers installed. A weather proof cover is required at all exterior receptacles. If an accessory will be plugged in for long periods of time than a weatherproof enclosure is required. We recommend installing a weather proof cover or weather proof enclosure by a qualified person where needed.

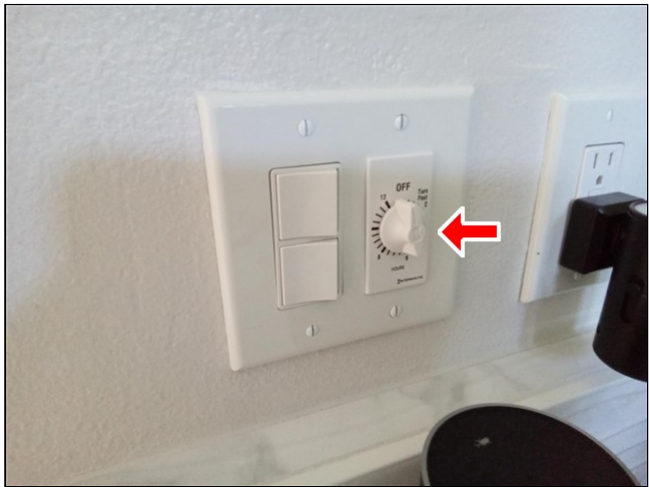
7.7 Item 3(Picture)

(2) The timer switch in the bathroom just makes a loud noise. This is non standard and a potential shock hazard. We recommend installing a cover plate by a qualified person.

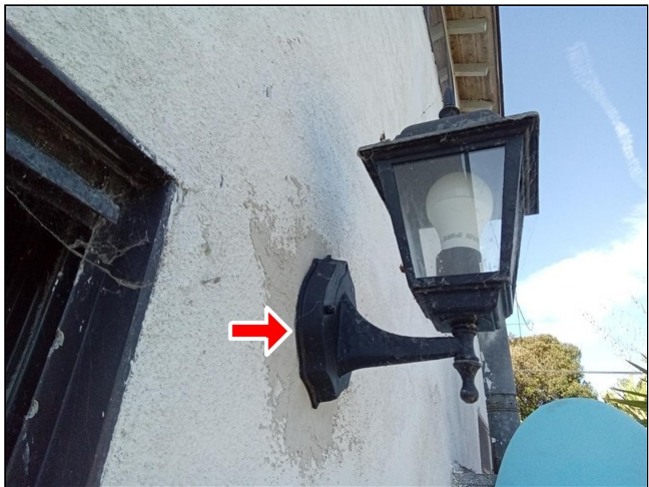
7.8 Item 1(Picture)

(1) The exterior light fixtures were not sealed where the fixture meets the wall. This condition could allow moisture intrusion in this area. We recommend sealing exterior light fixtures where they meet the wall by a qualified person.

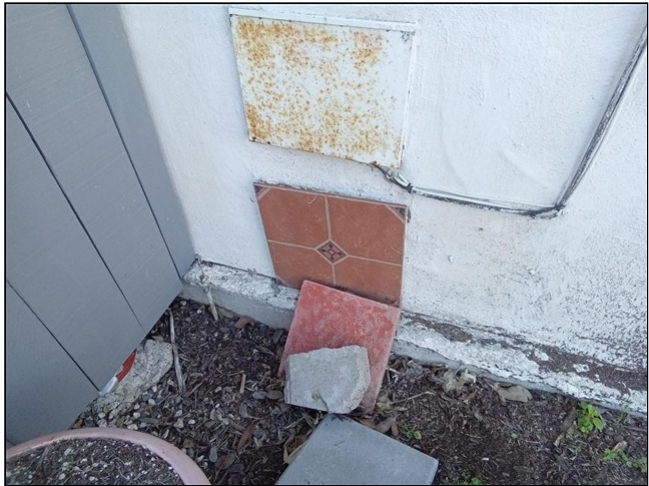
7.9 Item 1(Picture)

The cover for the cable service entrance is missing. We recommend replacement by a qualified person.
