HOME INSPECTION REPORT

On Friday, May 7, 2021 The HomeTeam Inspection Service made a visual inspection of 4704 Rim Rock Rd, Oceanside, CA 92056. Enclosed please find a written, narrative report of our findings in accordance with the terms of our Inspection Agreement.

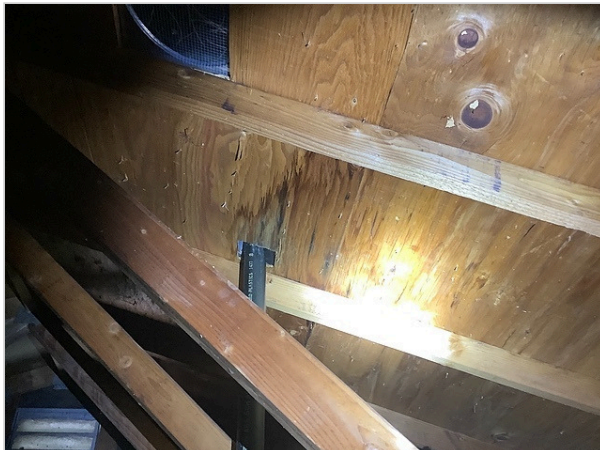
Photo 1

> Attic show signs of previous moisture intrusion. The areas were dry at the time of the inspection. Suggest review of SPDS and/ or discussion with seller to determine if areas of moisture intrusion have been previously repaired. If repairs have not been done, a qualified roofing specialist should evaluate and repair.

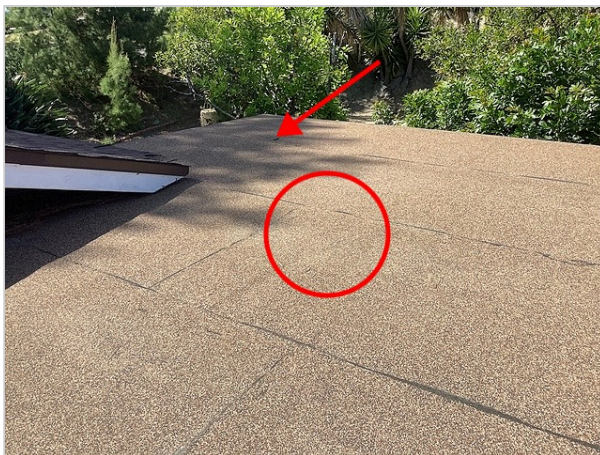
Photo 2

> **Bubbling observed on the rolled roofing.** Bubbling occurs when the roofing material loses its adhesion to the structure below. The inspector did not observe any cracking associated with the bubbling. Suggest that issue be monitored by a licensed roofing specialist.

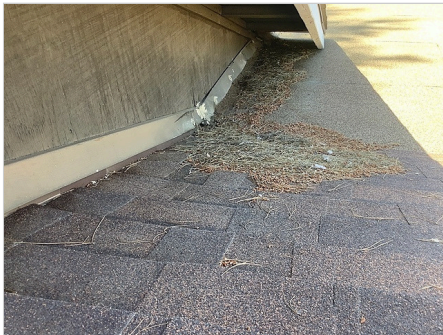
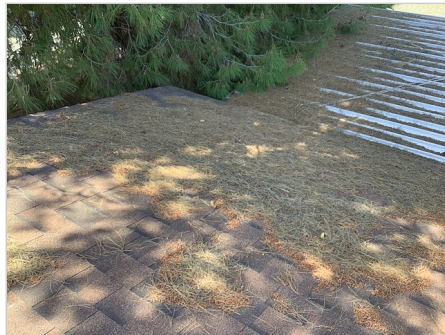
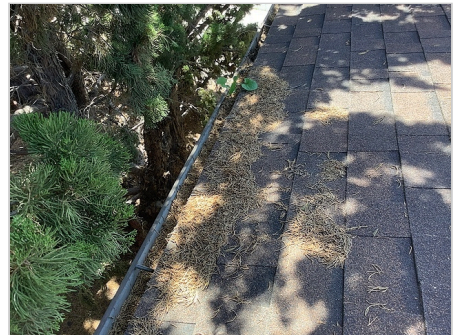
> **Excessive leaves and/ or other debris observed on roof.** This debris can trap moisture on roof and cause deterioration of the roofing material. Suggest that this debris be removed by a qualified party and that this issue be monitored in the future.

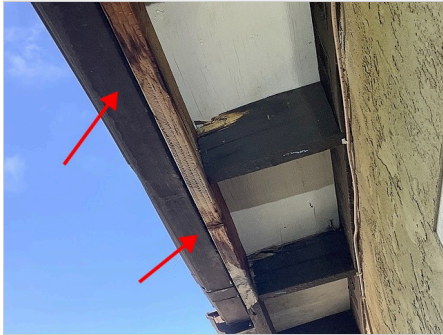
Back

> Fascia board showing significant deterioration (splitting, staining, warping or surface degradation) due to prior moisture intrusion. Suggest evaluation by a qualified party to determine where moisture is/was being introduced. Once the moisture intrusion has been eliminated, the fascia boards should be repaired or replaced as necessary.

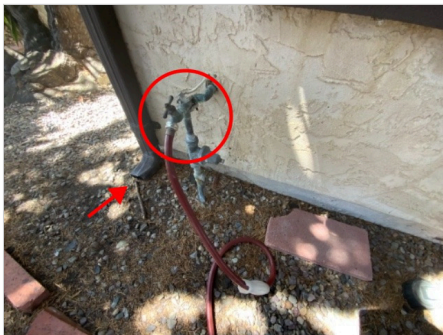
Front left

>Several downspout(s) did not have proper termination to direct runoff away from foundation of home. Suggest that downspouts with proper terminations be installed by a qualified party.

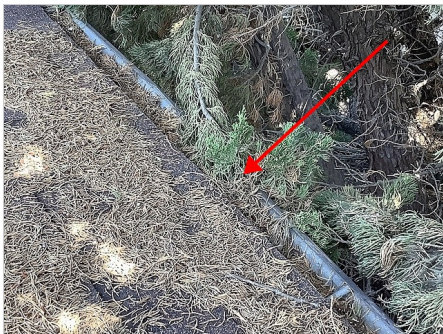
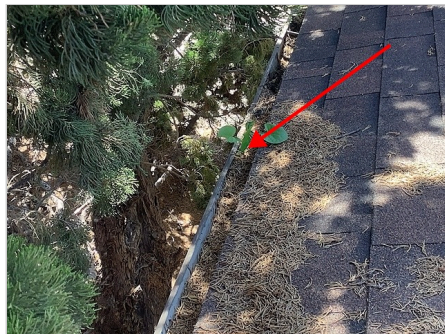
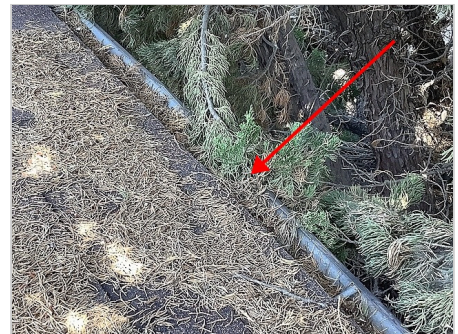
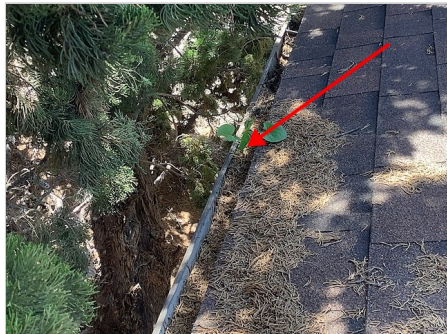
> Roof gutter(s) observed with excessive debris. Suggest periodic cleaning to insure that runoff is properly directed rather than held.

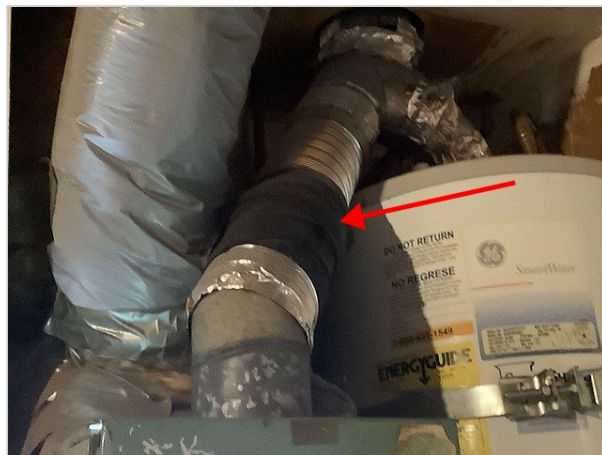
Photo 17

> **At least one section of the B-vent (exhaust) is in contact with combustible material.** Generally, B-vents should have at least one inch of clearance from insulation or combustible materials. Suggest repair by a qualified party to ensure adequate clearance from combustibles.

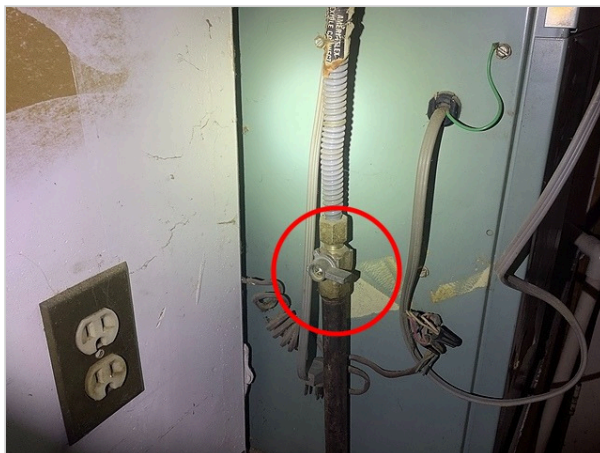
Furnace

> **HVAC unit was inoperable at time of inspection.** Because of this, the inspector was unable to test the unit in either heating or cooling mode. Suggest repair by a qualified HVAC professional

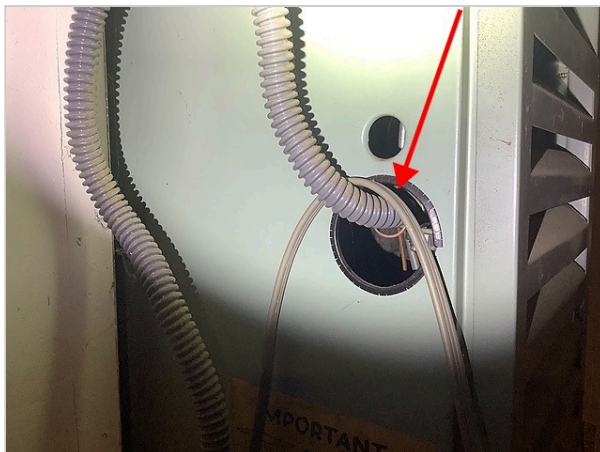
Photo 19

A flexible gas supply connector line transited the interior of the furnace cabinet. To improve safety of the unit, the flexible connector should be replaced with rigid gas pipe.

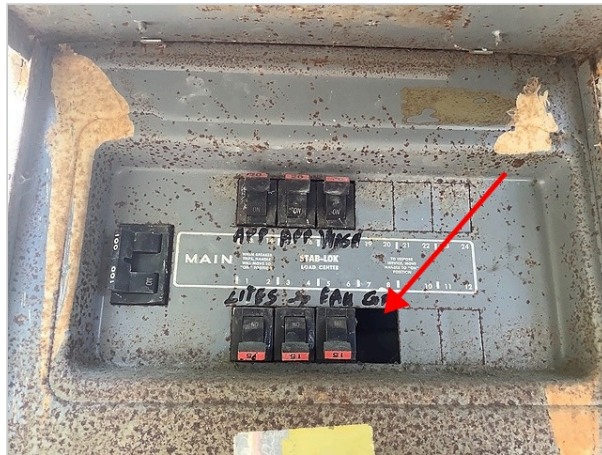
Photo 21

> An open knockout observed in electric service panel. All service panel openings should be covered to prevent access to high voltage and risk of electrical shock. Electrical related repairs should be performed by a qualified electrician.

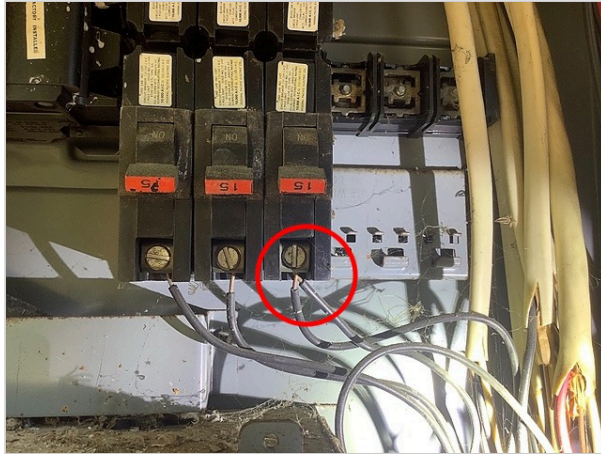
Photo 22

> One circuit breaker(s) in the electric panel had two attached circuits (wires). This situation is commonly referred to as a "double-tap". This practice is allowed if the breaker is clearly marked to accept 2 wires (which it was not). Circuits that are incorrectly double-tapped can be subject to nuisance tripping and overheating at the wire attachment to the breaker. An electrician should repair this condition and further assess the panel for any additional required repairs.

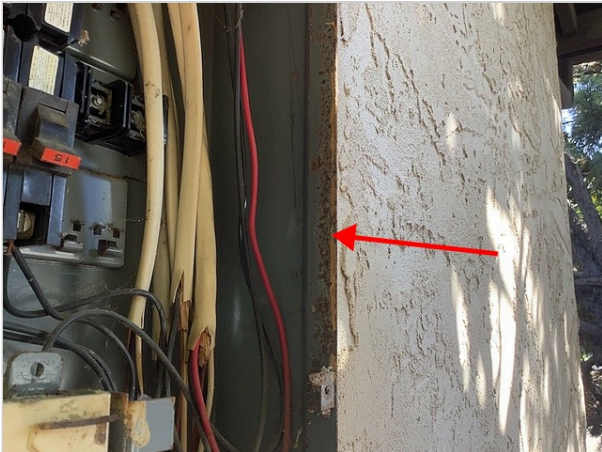
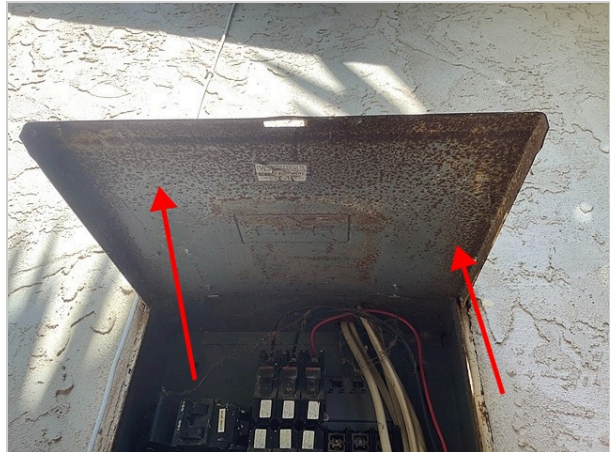
> Corrosion/ rust was observed on components in the electric panel. Corrosion on terminal screws can progress to a point that can result in overheating of terminals and possible arcing problems in the panel. HomeTeam recommends that a licensed electrician repair and further evaluate the condition of the electrical panel.

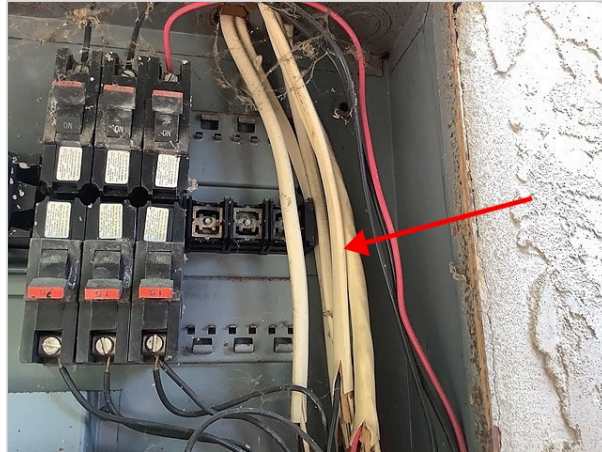
Photo 25

> Wire sheathing found in panel projecting more than an inch into panel. Sheathing is removed to allow heat dissipation and to remove a fuel source in the event of a panel fire. Suggest repair by a qualified electrician.

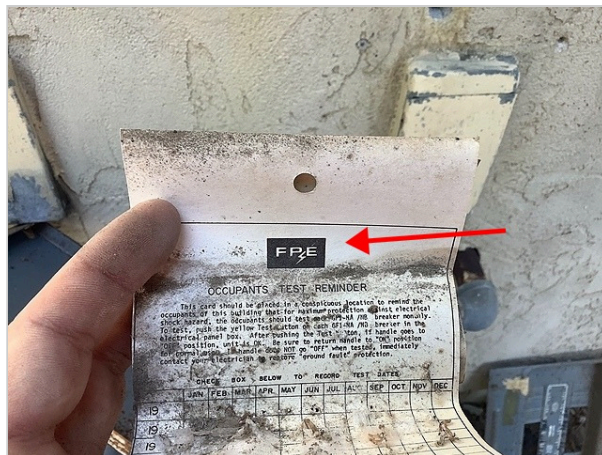
Photo 26

Note- The main electrical panel in the structure is manufactured by Federal Pacific -- also known as Federal Pacific Electric (FPE). FPE panels and breakers were very popular from the 1950's until the early 1980's, and some communities have FPE panels in almost every structure. Numerous claims have been made, and articles written questioning the safety and reliability of FPE panels and breakers. Specifically, claims were made that breakers failed to trip when an overload or short condition occurred. The Consumer Product Safety Commission conducted an investigation. The following excerpts were taken from the CPSC's press release dated March 3, 1983: "the data currently available to the Commission does not establish that the circuit breakers pose serious risk of injury to consumers. The Commission staff believes that it currently has insufficient data to accept or refute Reliance's (the owner of FPE) position". Regardless of the investigation results, the debate over the safety of FPE panels and breakers continues. While providing information on product defects is beyond the scope of the inspection, HomeTeam wants to make its clients aware of this particular issue. The insurance industry is aware of the debate over FPE panels, and at least one major insurance carrier is refusing to insure structures with FPE electric panels. HomeTeam recommends consulting with your insurance provider.

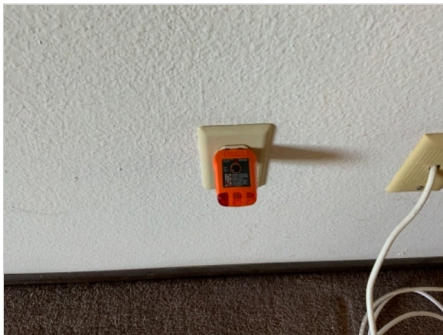
Left living room wall

> **Multiple outlets were not functional and this issue did not appear to be related to another issue called out by the inspector.** Consult with a qualified electrician for evaluation and repair.

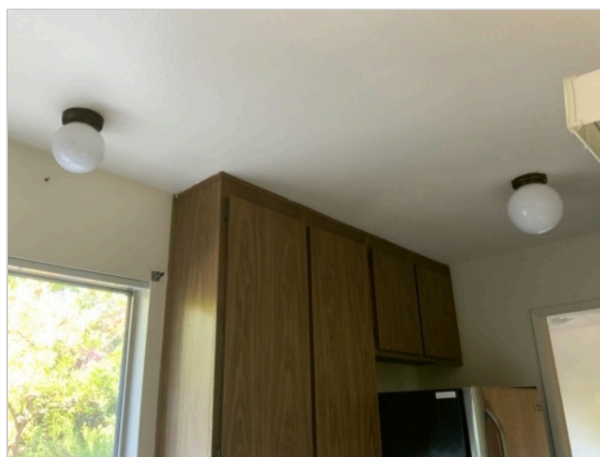
Kitchen lights

> **Inspector noted two lights where the light did not turn on when switched.** The issue may be with the bulb rather than with the fixture but further investigation may be warranted.

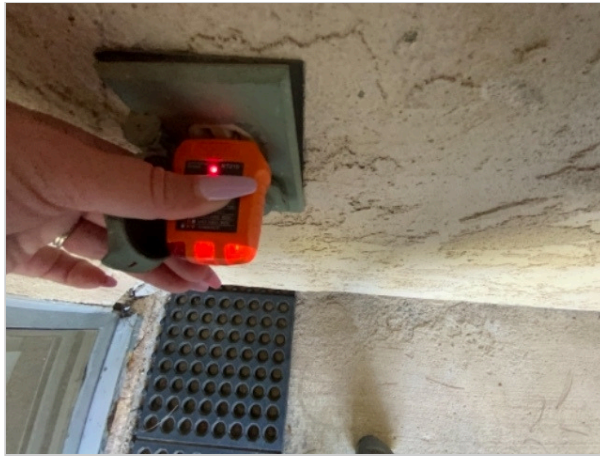
Rear of home

> **The home lacks GFCI protection for all outlet(s).** Suggest addition of GFCI to provide protection against shock in kitchens, laundry, garages and exterior by a qualified electrician.

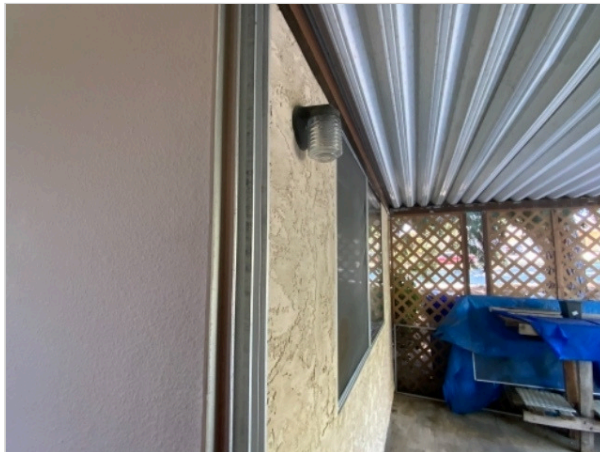
Patio light

> **Inspector was unable to get one of the exterior lights to come on during the inspection.** In many cases, this is due to a sensor that turns the lights on automatically at dusk and off at dawn. Suggest a discussion with seller to verify that this is the case for this home.

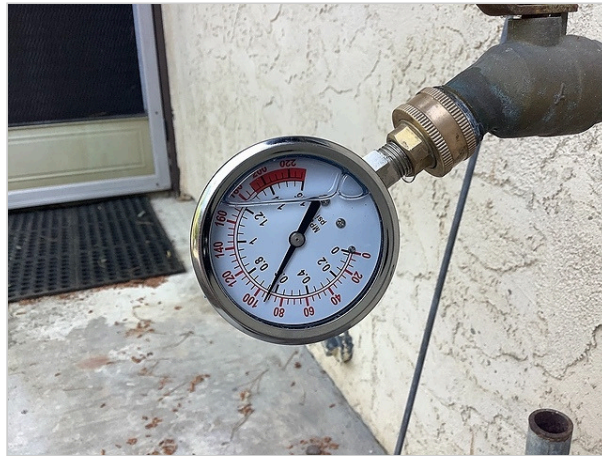
Photo 38

> Water pressure tested high(in excess of 80 psi). Consult with a professional plumber to determine an appropriate course of action, which may include adding a pressure regulator.

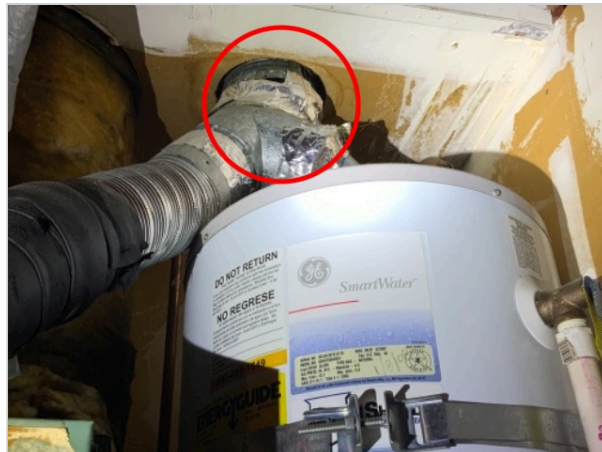
Photo 40

The water heater flue pipe is not sealed where it enters the chimney. To prevent noxious fumes from entering the structure, the flue/chimney connection should be properly sealed. Consult with a qualified plumber for repair.

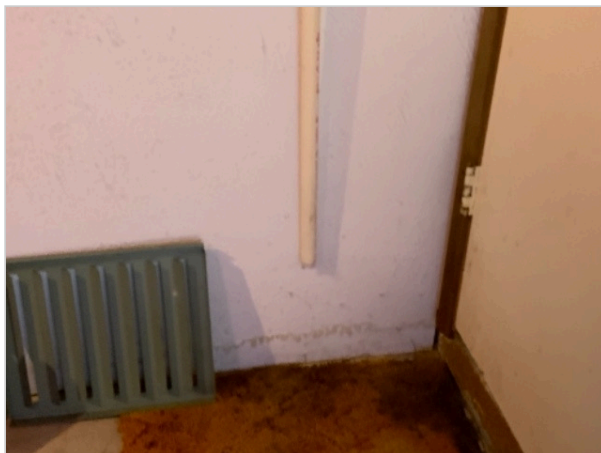
Photo 41

> TPR valve appears to terminate incorrectly (too high). Termination for the TPR valve discharge piping should be downward and within 6 inches of the ground to minimize chances of anyone getting sprayed with scalding hot water. Suggest evaluation and repair by a qualified party.

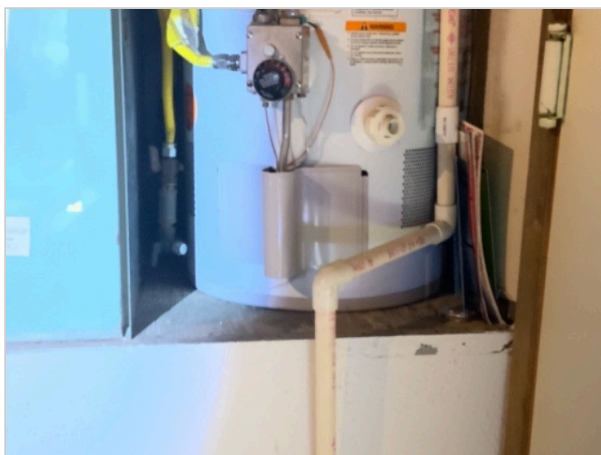
Photo 42

Note- Water heater does not have drain pan to catch and direct possible leakage. As leakage is typically the first sign that a water heater has reached EOL (end of life), a water heater without a drain pan can cause moisture damage to drywall, trim, and flooring. Suggest that water heater be closely monitored for leakage and, when replaced, that a drain pan be installed with an appropriate drain pipe by a qualified plumbing technician.

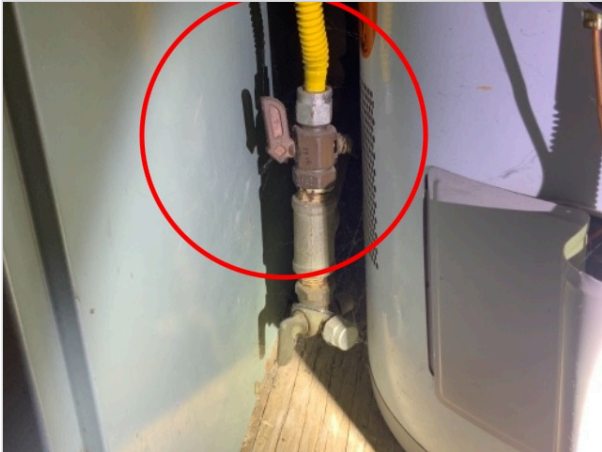
Water heater

Note: Sediment trap was not present on the gas line supplying the furnace or water heater. A sediment trap allows impurities to be filtered prior to combustion, prolonging the life of the unit (upgrade recommendation).

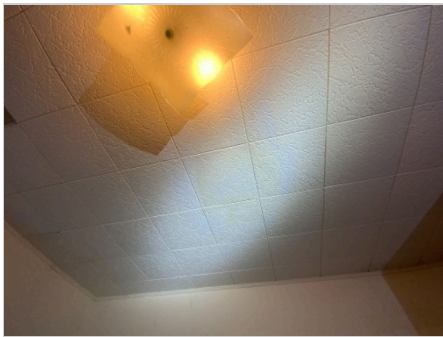
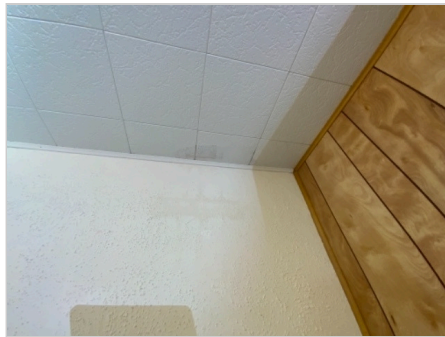
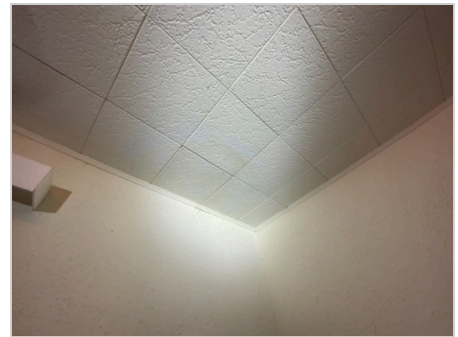
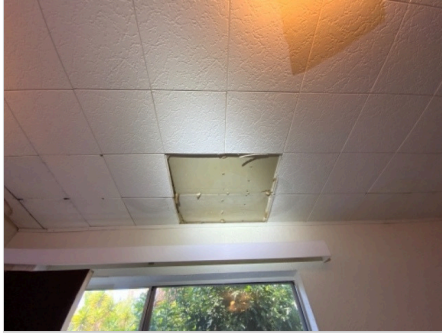
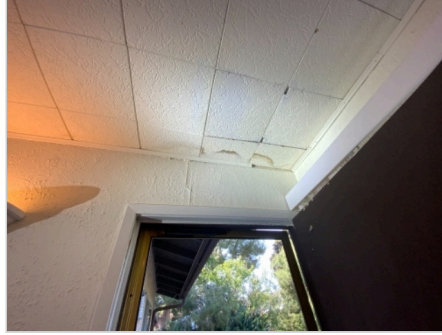
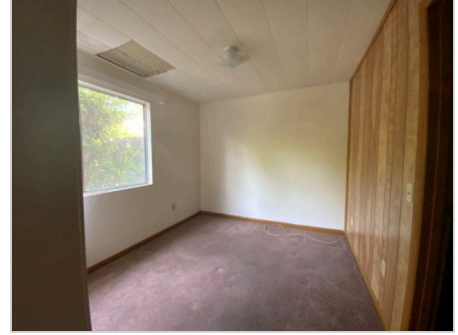
> **Ceiling displays evidence of prior moisture intrusion.** Examination of the attic above showed no telltale signs of moisture intrusion so it is beyond the scope of this inspection to determine cause and whether the issue has been previously resolved. Suggest discussion with seller and, if no repairs have been done, further evaluation by a qualified roofing specialist to determine cause of moisture intrusion and extent of repair required.

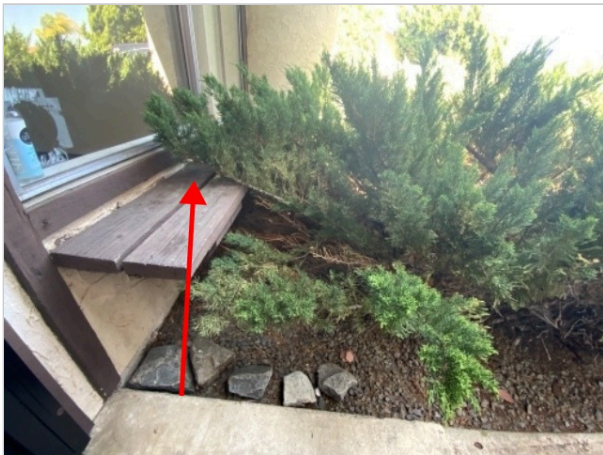
Front of home

> **Vegetation observed in contact with the cladding, roof, or fascia that could have a detrimental effect on the surface.** Suggest that this vegetation be trimmed to allow at least 12 inches of space between plant and structure.

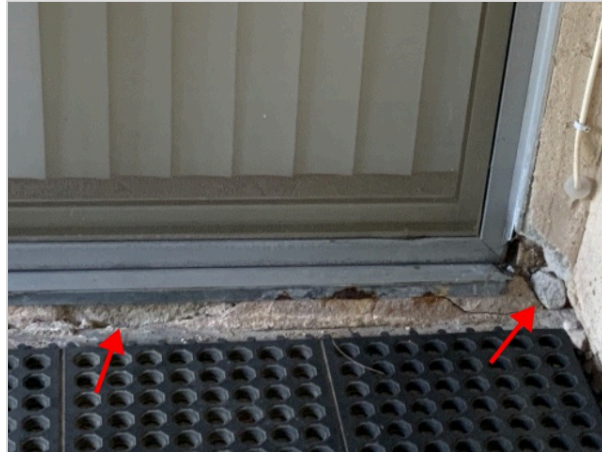
Rear patio

> **Missing or damaged cladding on the back of the structure's exterior.** This condition does not have any effect on the structural integrity of the building. The areas should be repaired to prevent water or pest intrusion.

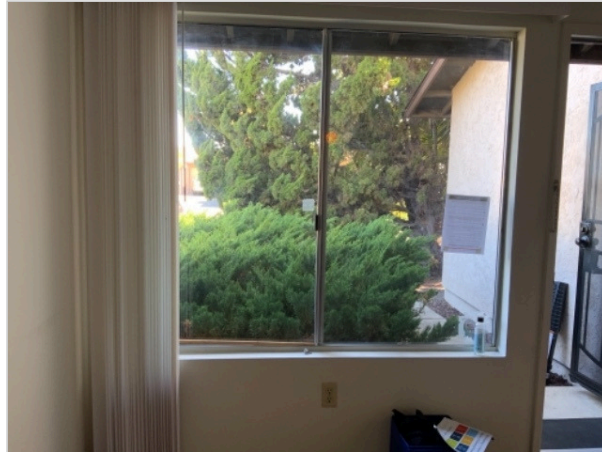
Living room window

> **Window locking hardware was in need of repair on one window(s).** Hardware should be repaired or replaced by a qualified party to allow for proper locking of the windows to secure structure.

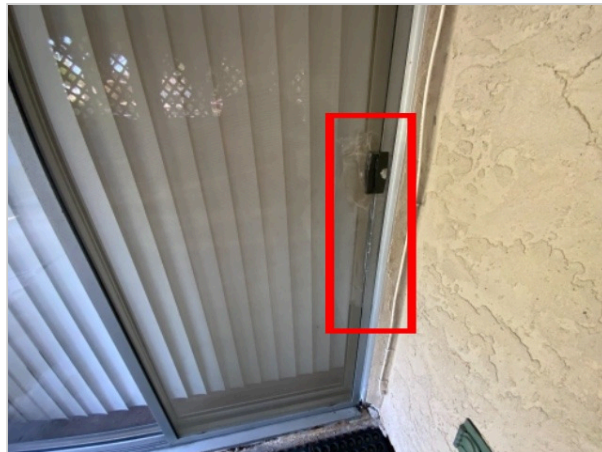
Rear patio

>One patio screen door(s) observed to be damaged. Although missing or damaged window screens are beyond the scope of this inspection, patio door screens are noted.
