**BPG Inspection, LLC**

**9806 Old Ridge Road  
Spring Valley CA 91977**

Client(s): McDonald  
Inspection Date: 2/5/2025  
Inspector: Brian Chatfield ,

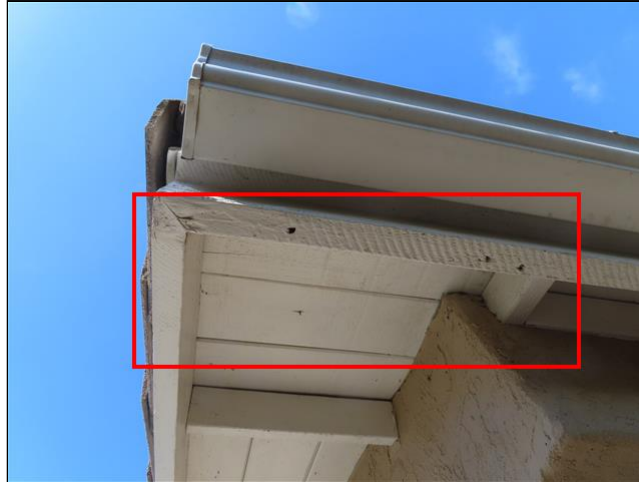
- ✘ 1. The fascia boards and other wood members at the exterior are damaged. Refer to the full termite report. A qualified technician should make any needed repairs or modifications.

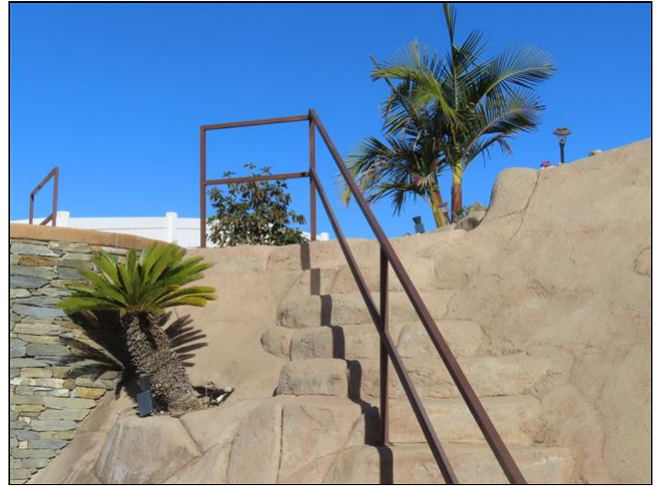
- ✘ 2. 1. The rear exterior railing has wide spaces between the spindles. For safety, railing spindles should be spaced close enough to prevent the passage of a 4-inch sphere through any part of the railing.

- Consider modifications to reduce the width of the openings. A qualified technician can perform the work.
2. The rear exterior railing is too low for modern safety standards. Railings should be at least 42" inches above the level of the walking surface to minimize the chance of someone falling over them.

- Have a qualified technician provide repair specifications and costs, and perform the work.
3. A proper handrail is needed on the exterior steps on the left side rear exterior of the building. No rail is installed.

- Handrailings should be installed, to reduce the potential for personal injury at this location.
4. The rear exterior area's steps are uneven in height. This could pose a trip hazard. A technician should repair the steps as needed.

5. There is an elevated surface at the rear hillside exterior of the home that needs a railing. Railing protection should be present where the floor of the elevated surface, deck or porch is more than 30 inches above the ground.

- A qualified technician should install a proper railing, for safety and liability purposes.

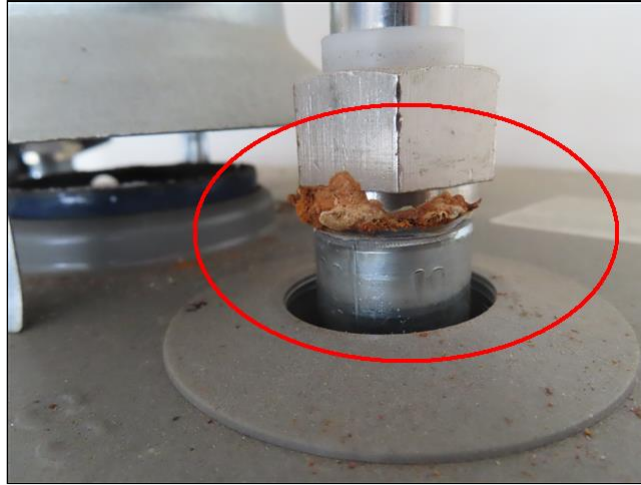
- ❌ 3. The water heater water connection is corroded. A qualified plumber should replace or repair the corroded connection.

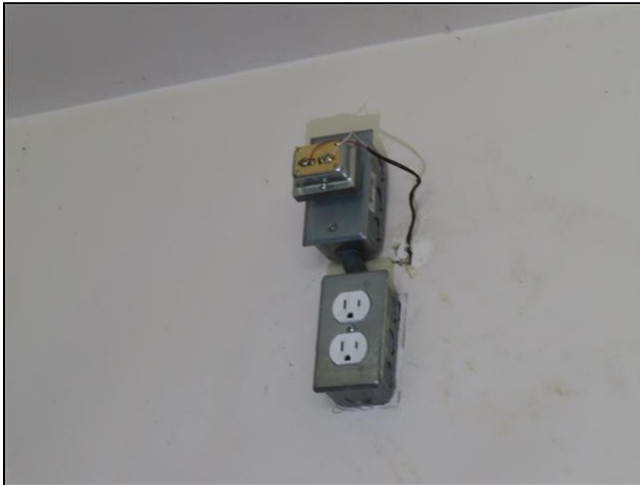
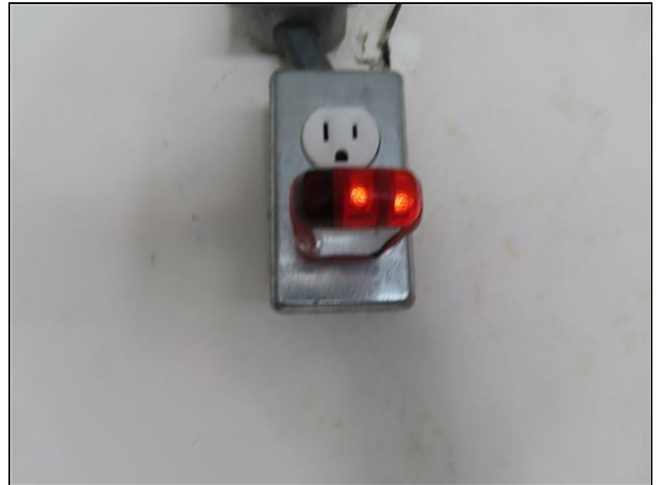
- ❌ 4. Ground Fault Circuit Interrupter (GFCI) protection is installed for some, but not all, of the receptacles where this type of protection is presently required. This includes locations in the garage.
- Consider upgrading unprotected receptacles in areas where GFCI protection is presently required.

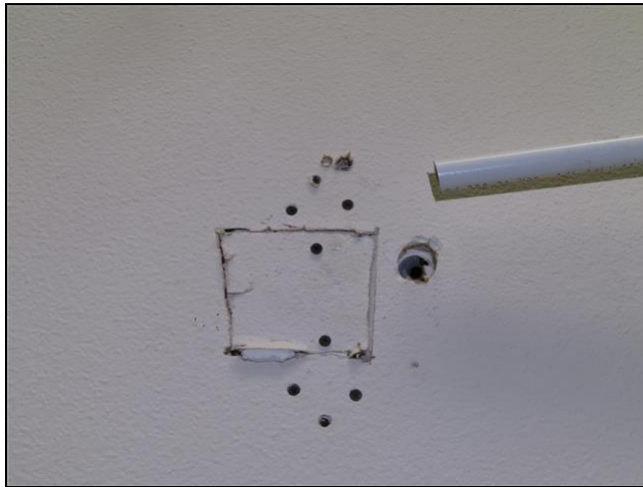
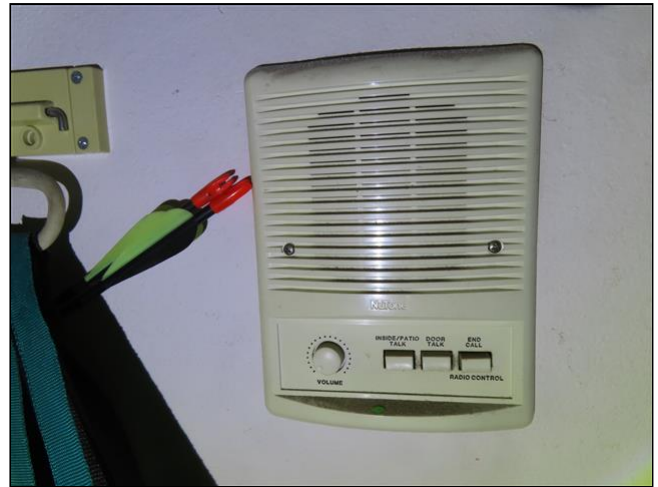
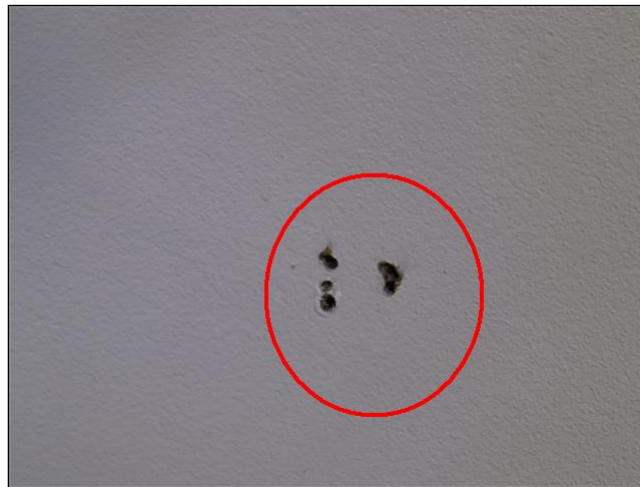
- ❌ 5. 1. There are holes/damage in the fire-resistive barrier between the garage and interior. This condition can allow more rapid spread of smoke and flames in the event of a fire.
- All voids should be repaired.
2. Plastic passes through the fire separation wall. Plastic can disintegrate in a fire, allowing the fire to enter the penetration. Fire caulking was not visible in these areas.
- A qualified plumber should replace the plastic piping with approved material or add fire caulking as needed.

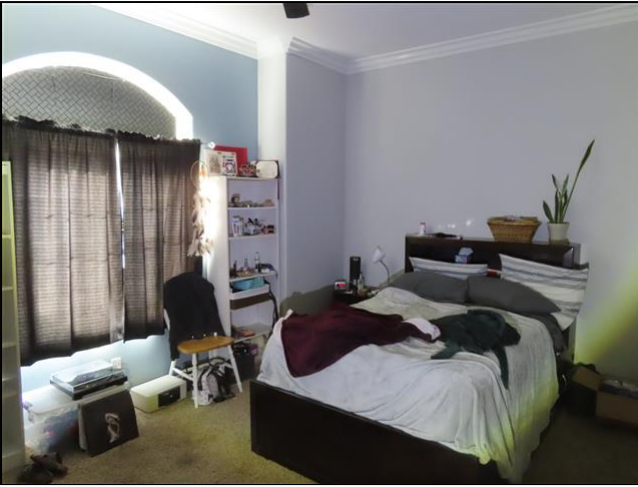
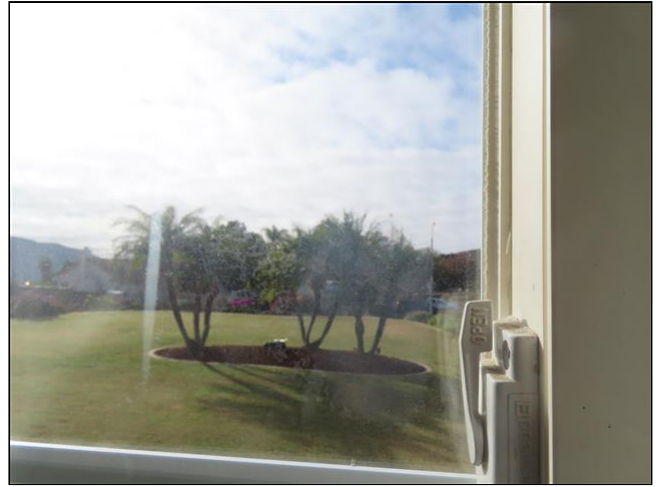
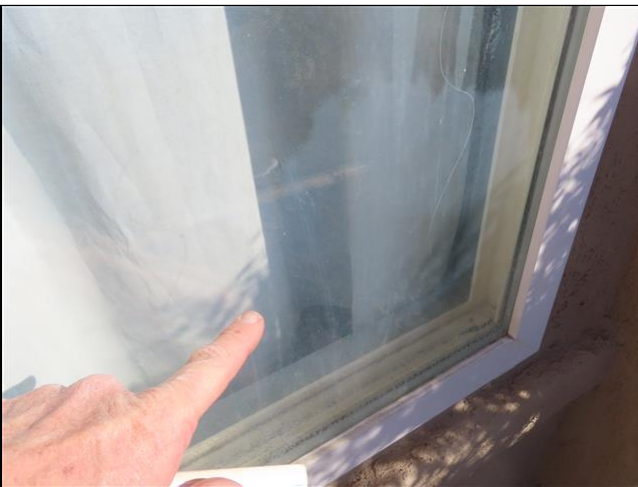
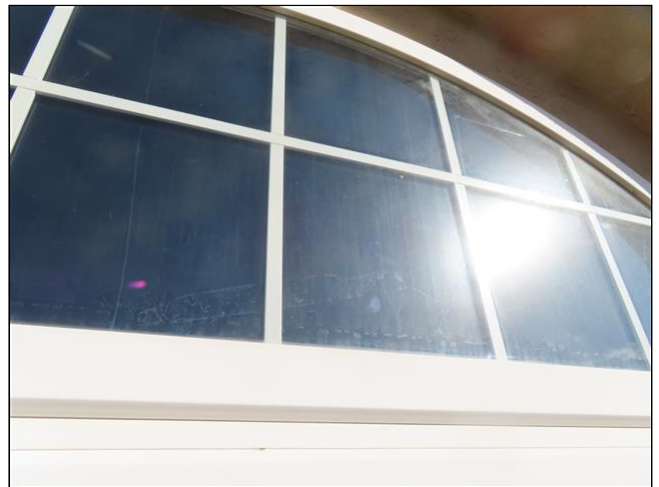
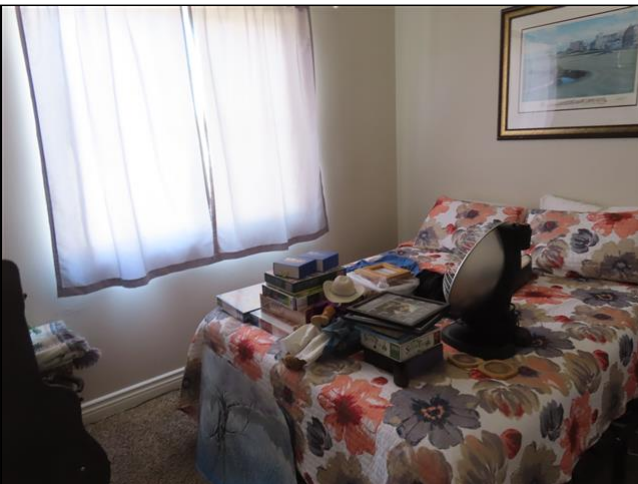
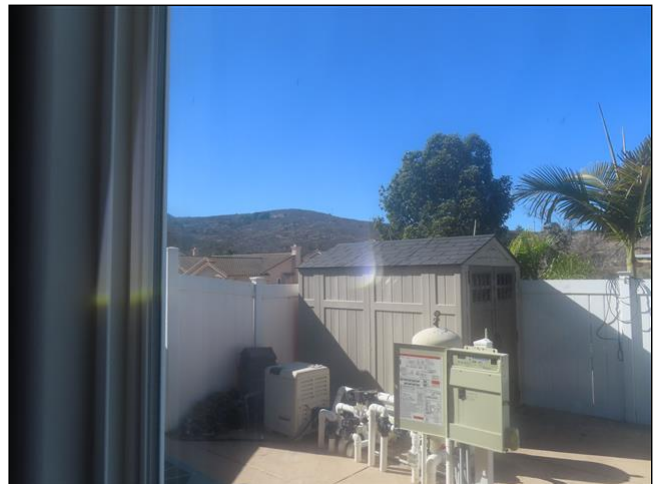
- ❌ 7. Condensation, staining or droplets, is present between the panes of insulated glass windows in three or more rooms at this house. This suggests a failure of the factory seal between the twin pieces of glass. Unfortunately, there is no simple, permanent, "fix" for this condition short of replacing the glazing unit. "Fogged" windows can still perform their function for ventilation and light admittance, but can become so opaque that visibility is impaired. We did not attempt to list every fogged window. Have a qualified glass contractor check all windows before closing escrow. Any insulated glass units which display symptoms of breached seals should be replaced as desired

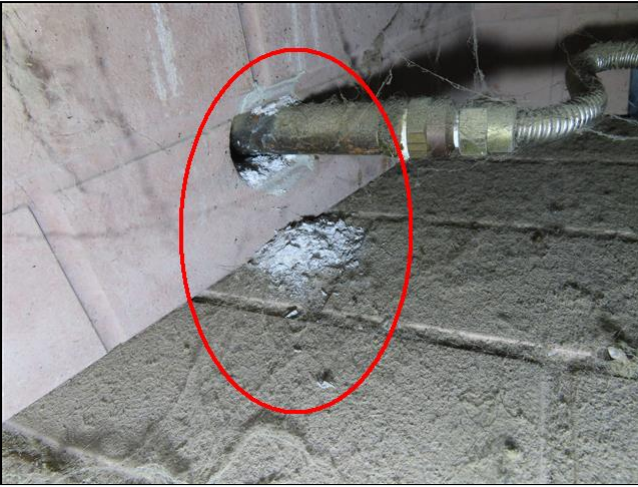
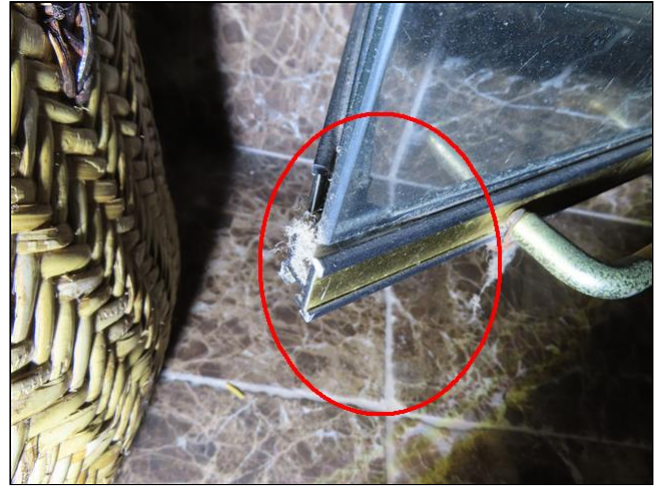
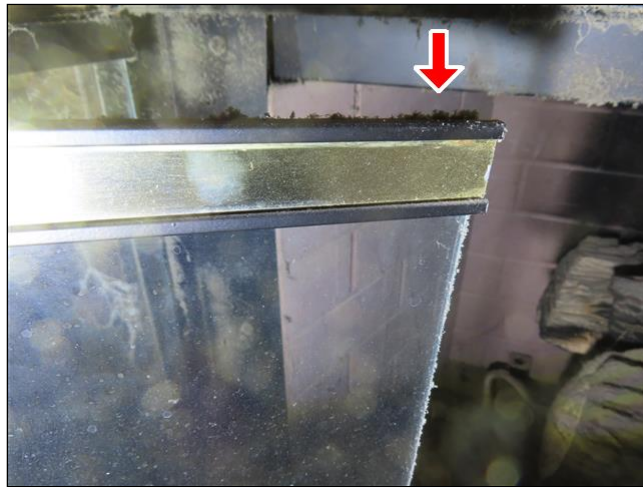
- ❌ 8. 1. There is a gap around the gas supply pipe where it enters the living room fireplace firebox. Heat can be drawn into the wall cavity around the gas line and reach combustible materials. This is a potential fire hazard. Any gap between the firebox, wall, hearth or gas supply piping should be filled with proper mortar or noncombustible packing.

2. The glass enclosure at fireplace in the living room does not stay in their tracks "Missing top door guides" and could fall out when used "Left door". We recommend repair as needed.

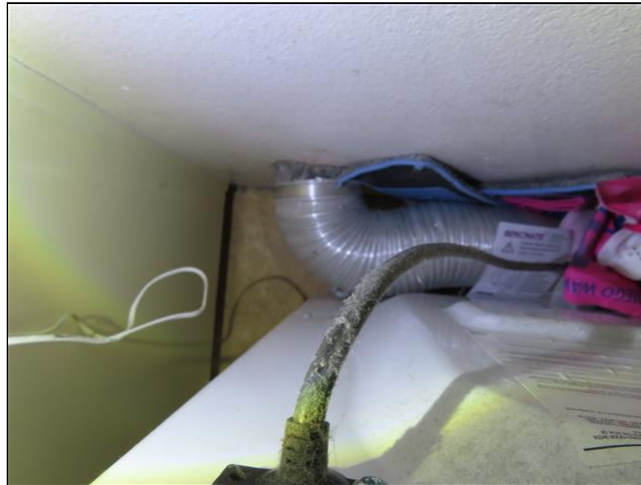
- ❌ 10. The clothes dryer vent lint is noted at the closet and is a fire hazard. A qualified technician should make any needed repairs or modifications

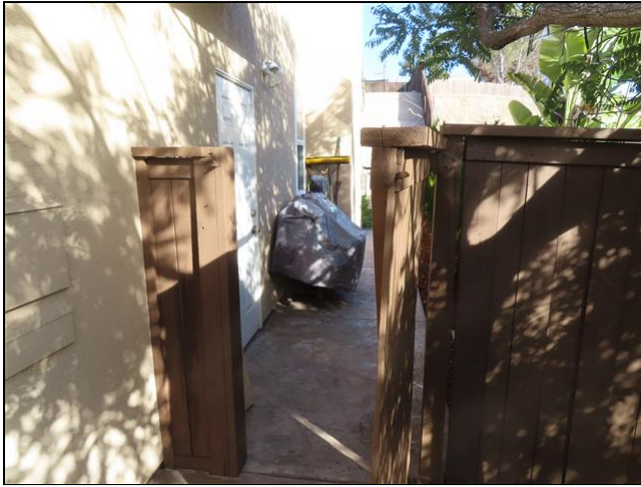
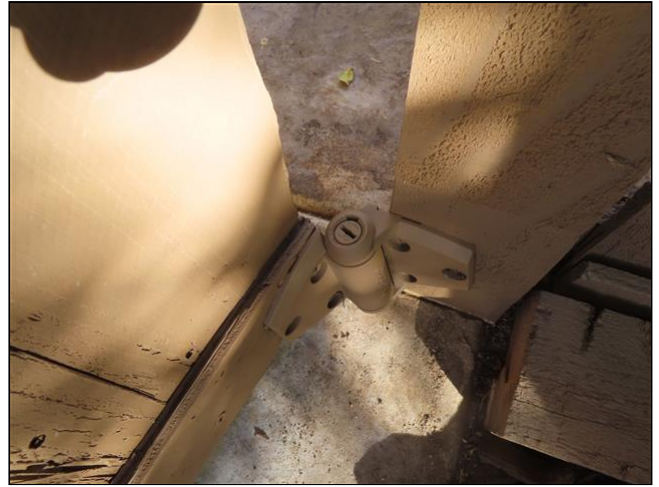
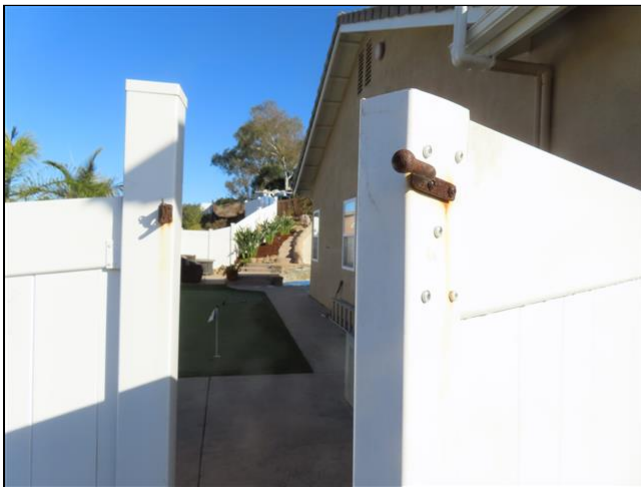
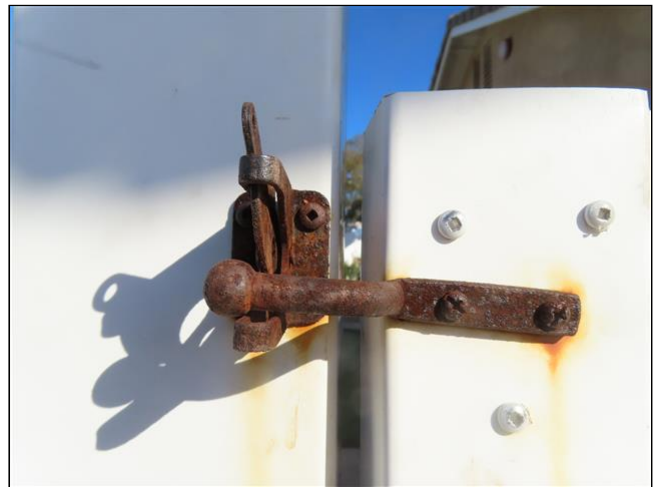
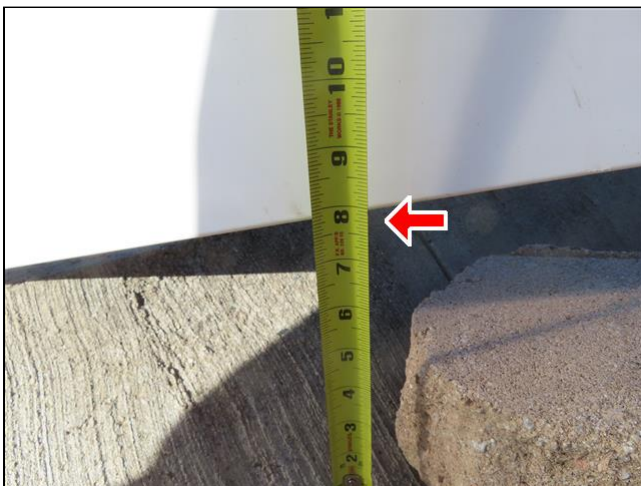
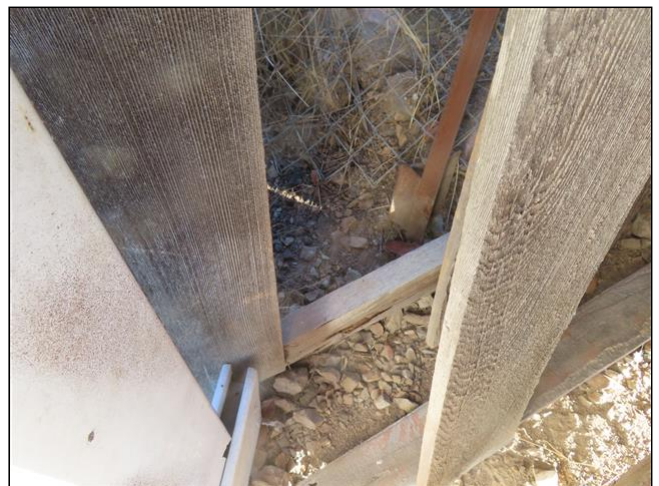
- ❌ 13. 1. The gates having direct access to the pool/spa area do not self close and latch as required. The purpose of this important safety feature is to keep children out of the pool or spa area. The gates should be repaired or replaced as needed by a qualified technician.
2. The protective barrier at the pool area is hazardous, in that it is too low or small children might be able to climb or pass through it. This is not safe. The barrier should be modified or replaced to meet safety standards. A qualified technician should do the work.

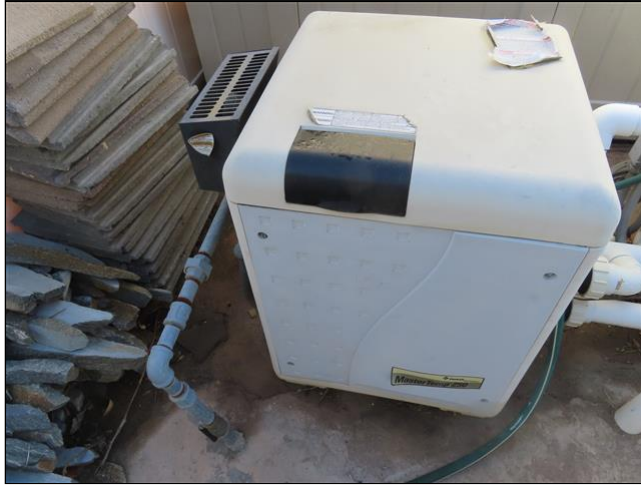
- ❌ 15. The gas pool/spa heater did not respond to the controls. A qualified pool contractor should further evaluate the heater and make repairs or replace the heater as needed.

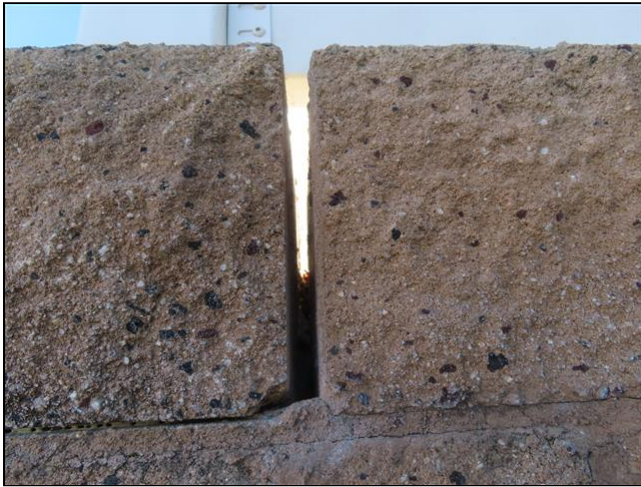
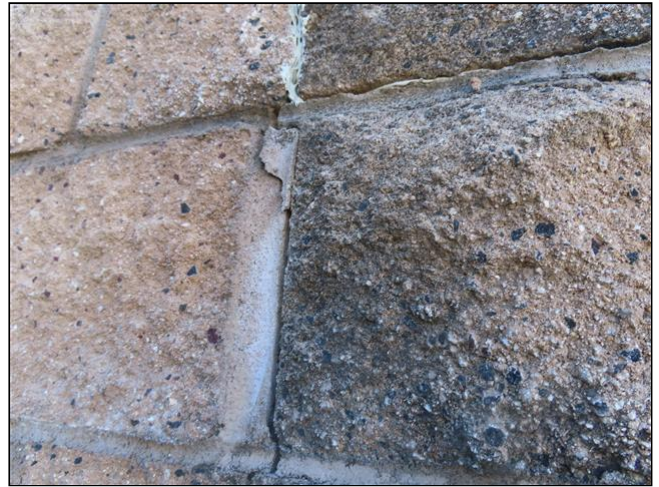
20. The left rear retaining wall shows some settlement cracks and some mortar joint missing, but appears stable. Repairs needed.

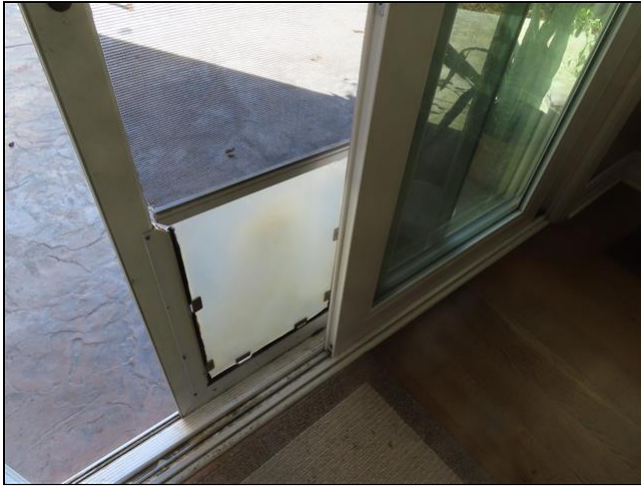
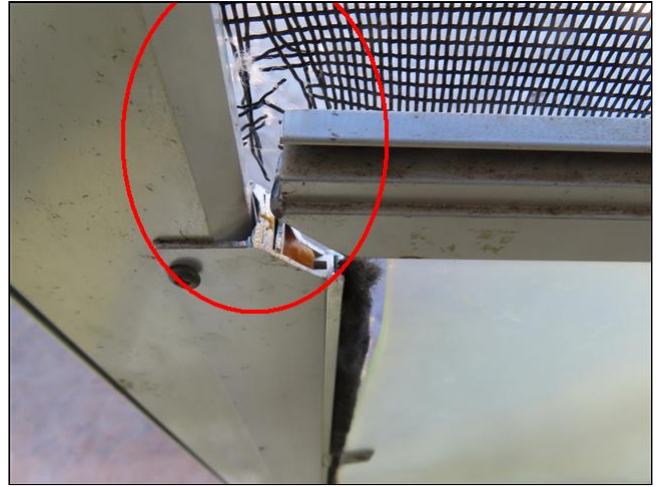
22. The screen door at the rear exterior has a torn screen and the pet door is damaged and rubbing the door. A qualified technician should make any repairs or modifications as needed.

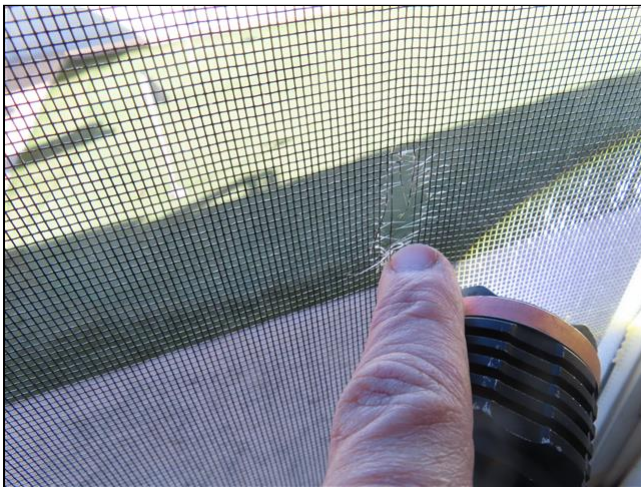
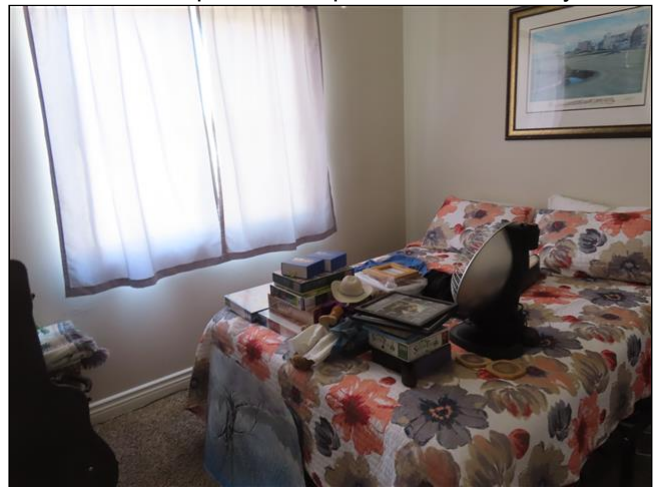
- ☒ 23. One or more window screen is torn/bent. All window screens should be repaired or replaced as necessary.

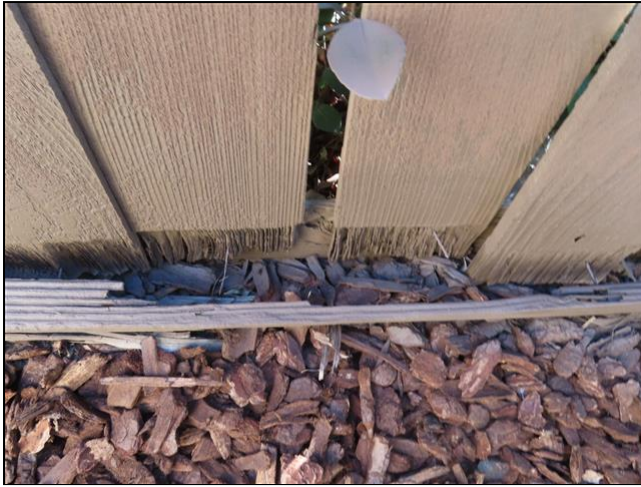
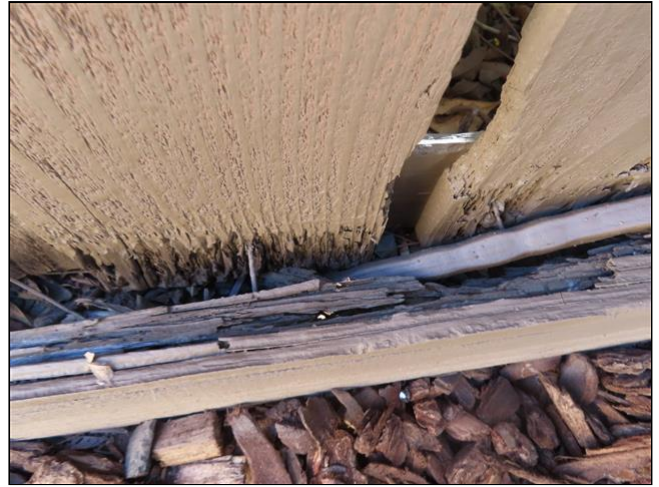
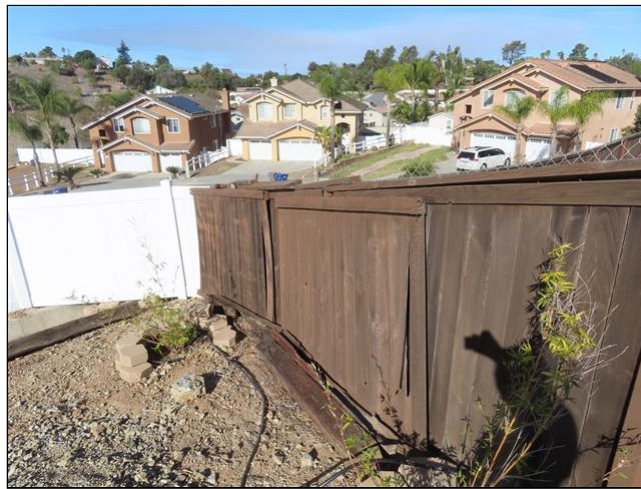
- ☒ 24. The wood fencing at the exterior area's of the property are damaged / loose. - Damaged fence elements should be repaired if possible, or replaced as necessary.

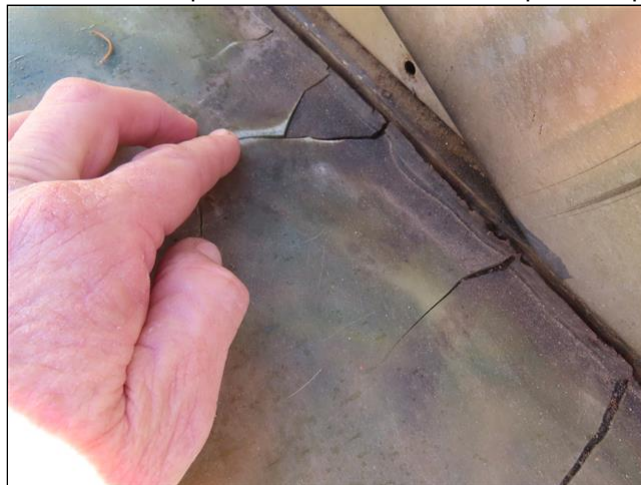
- 25. The exterior BB-Q countertop is cracked. A qualified technician should repair or replace as needed.

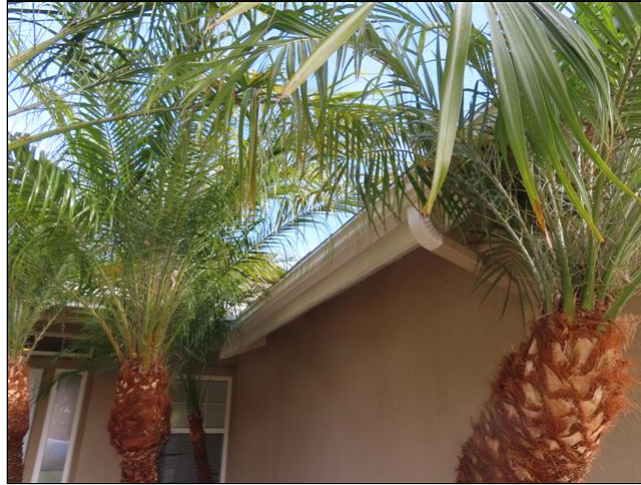
26. Branches from the surrounding trees are overhanging the roof, or are in contact with the roof surface. This can provide a route onto the roof and into the attic for pests. Nearby trees should be kept pruned.

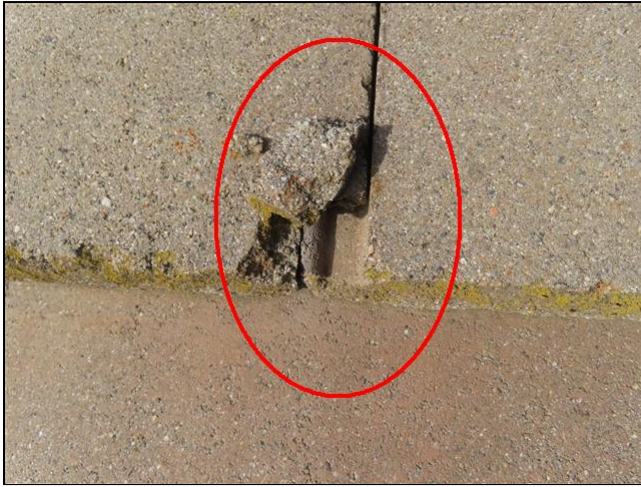
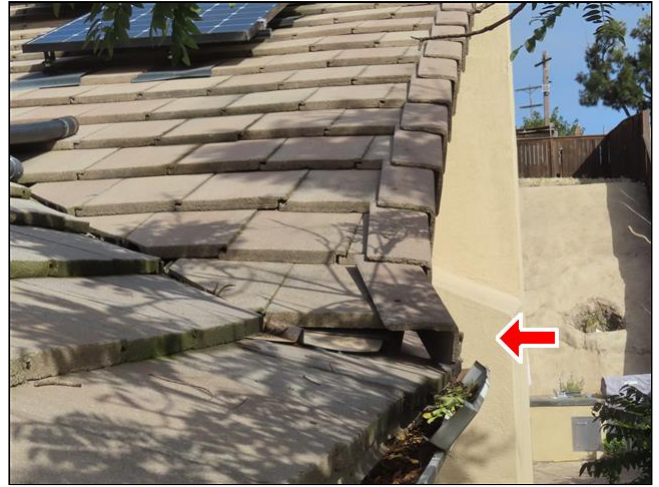
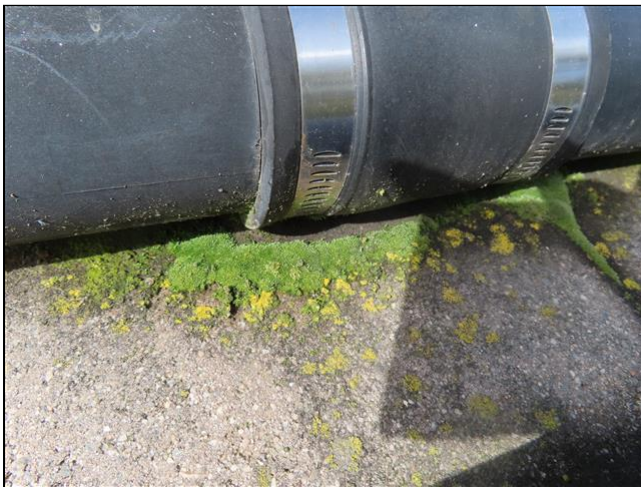
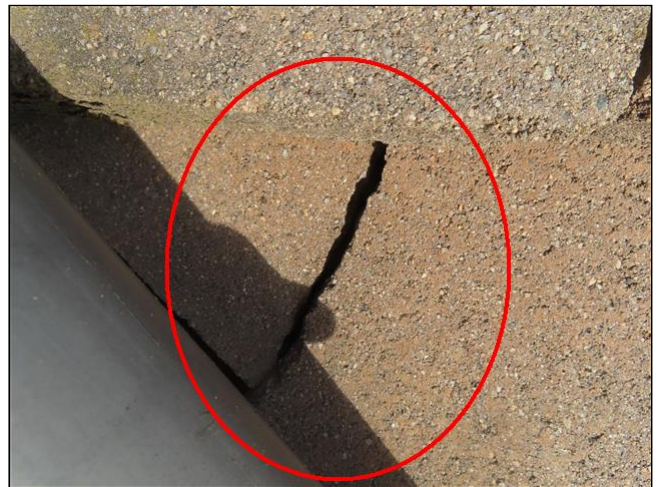
27. 1. There are several loose or slipped tiles on more than one side of the building. Algae is also noted at the right exterior.
- A qualified roofer should repair as needed.
2. There are tiles with cracks and chips on more than one side of the building.
- A qualified roofer should repair as needed.

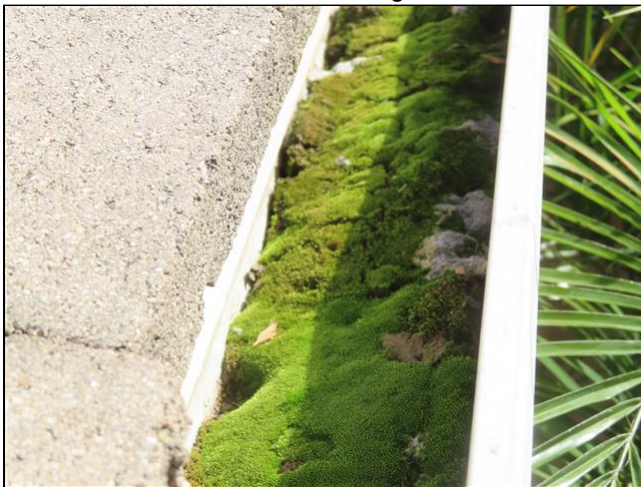
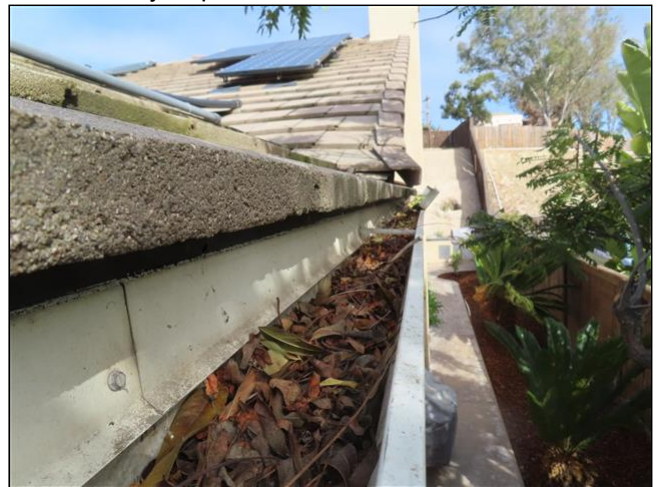
28. The gutters have debris noted in areas. Debris in gutters can conceal rust, deterioration or leaks that are not visible until cleaned. We recommend the gutters be cleaned and evaluated by a qualified technician.

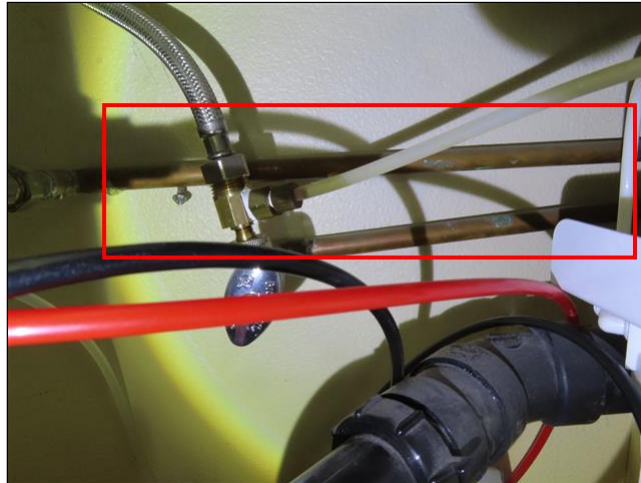
- ☒ 30. Water supply lines are exposed on the interior walls of the home. A technician should evaluate the installation and re-install or insulate the lines as needed.

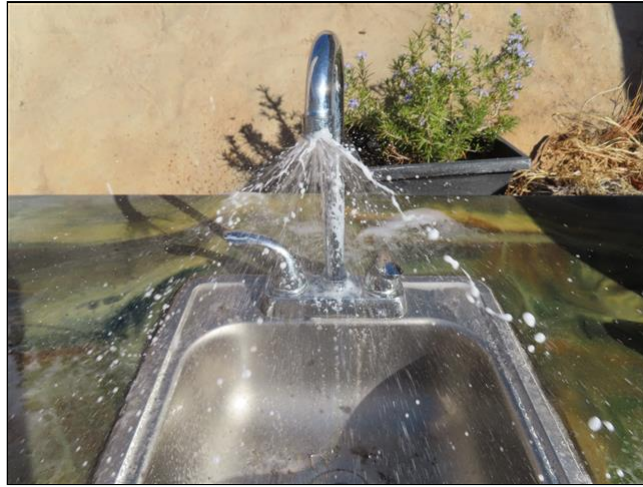
- 32. The faucet aerator is clogged in the rear exterior.  
- All aerators should be cleaned periodically.

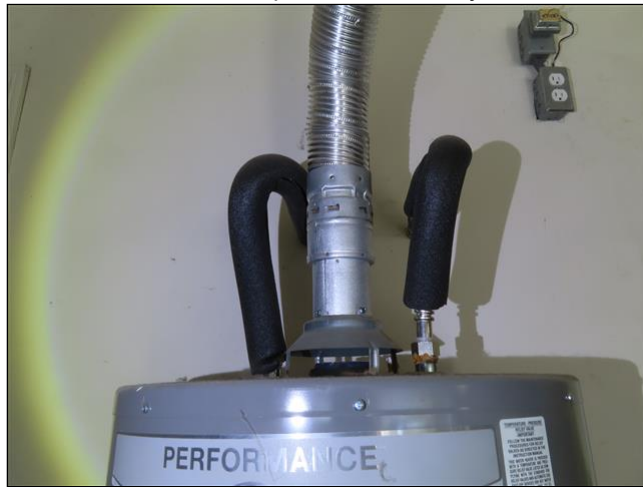
33. This water heater does not have a "Thermal Expansion tank" installed to prevent a possible leak at the T&P or "Pop-off" valve. Changes in the building standards may require one when a new water heater is installed. This change is not retroactive on older previously installed Gas/LP water heaters. Check with your local building department as to their requirements. There were no leaks or drips at the T&P valve during inspection. If your water heater does begin to drip or leak, then a Thermal Expansion tank may be needed.

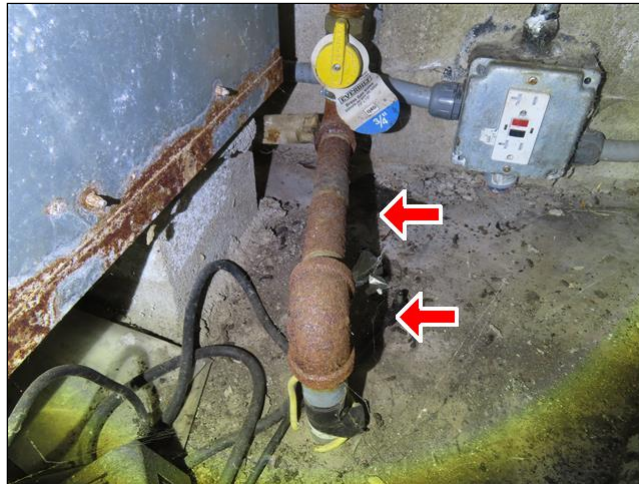
- ☒ 35. There is surface corrosion in some areas of the visible gas piping at the exterior.  
 - This piping should be evaluated for leaks by the local gas service provider and repaired if necessary .

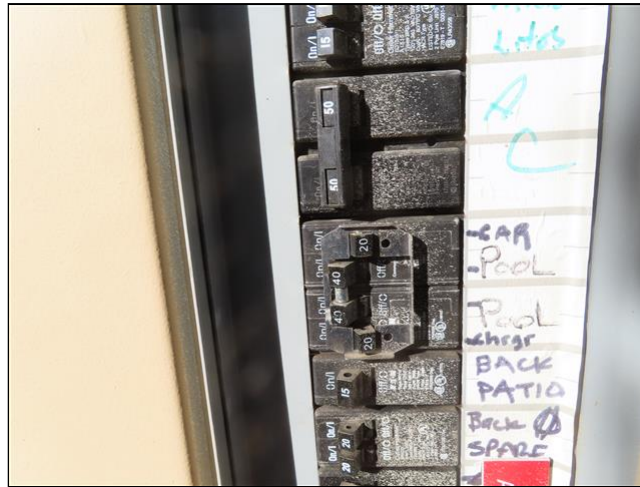
- ☒ 36. One or more breaker in the panel was in the off position at the time of this inspection. We did not activate the breaker, or energize the circuit because doing so could create a hazard.  
 - The owner may have information as to why the breaker is in the OFF position. If it is not functional, a licensed electrician should make appropriate repairs before closing escrow.

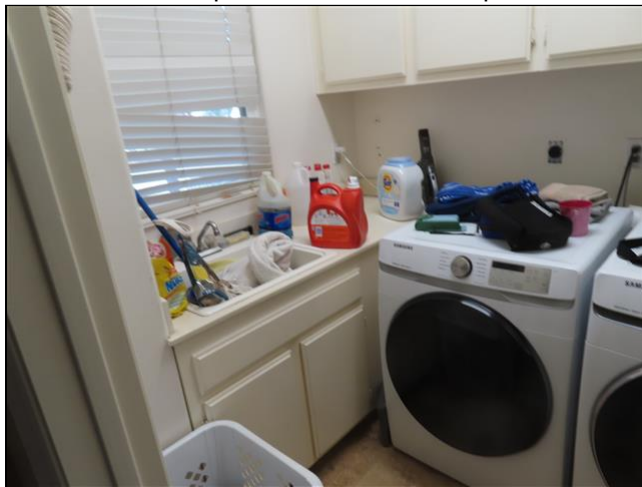
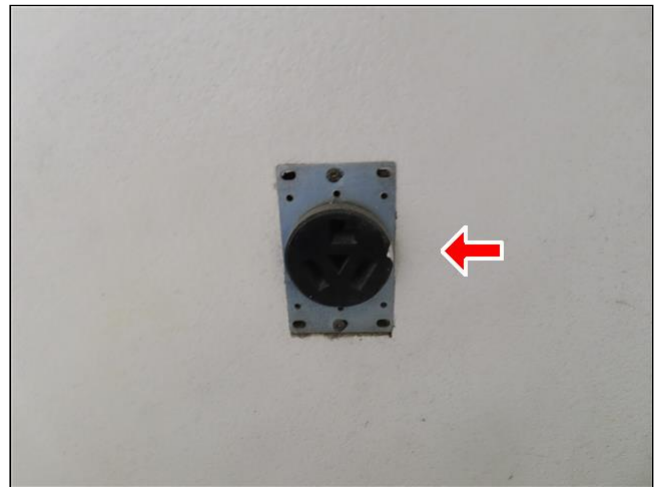
- ☒ 37. There is no weather cover on a receptacle on the rear exterior / BB-Q cabinet. This condition could pose a shock hazard.
- An exterior rated, water-resistant cover should be installed on every outdoor receptacle.

- ☒ 38. One or more cover plate for the "220" receptacle is missing at the laundry room. All missing or damaged cover plates should be replaced with new cover plates.

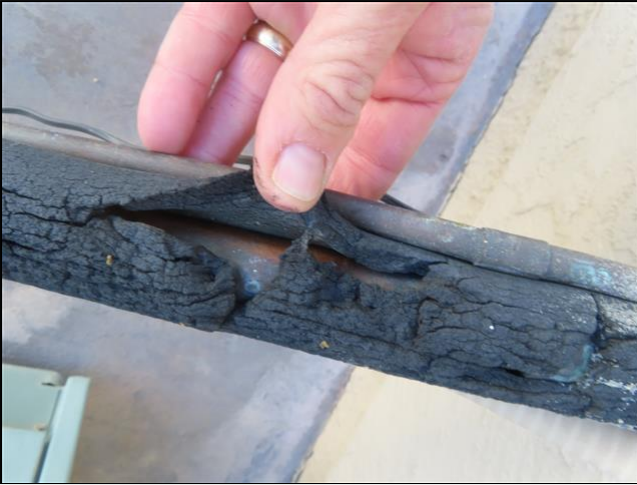
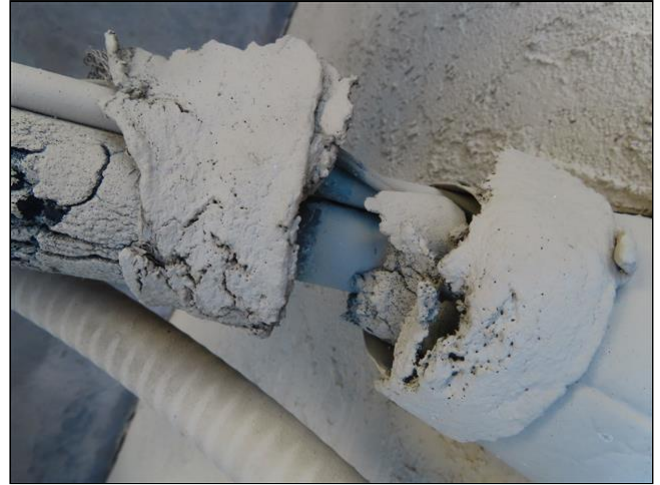
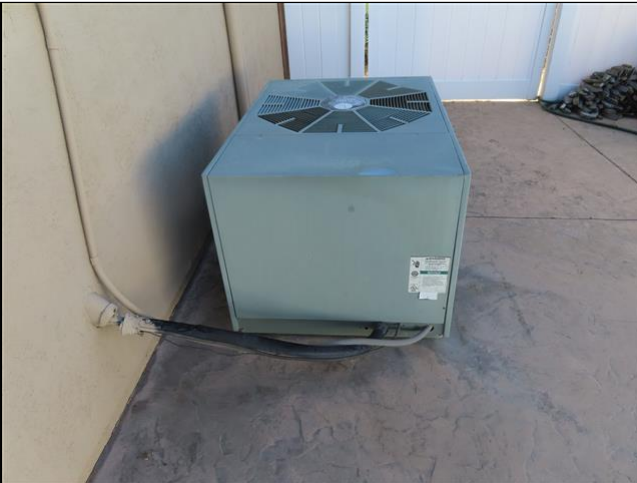
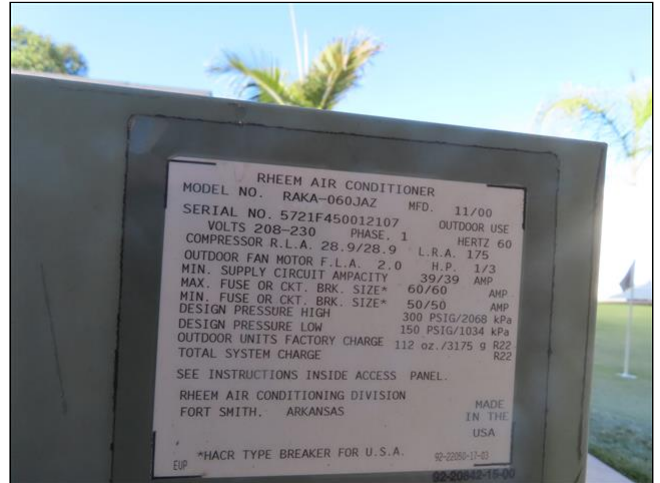
- ☒ 39. 1. The insulation on the suction line is missing at the exterior. Missing insulation on a suction line can cause energy loss and condensation. We recommend replacing missing insulation.
2. The cooling equipment is old (24+ years). However, it responded to the user operating controls and is functional. You should budget to replace the equipment in the not too distant future.
3. The air conditioning system in this building is at or approaching the end of its service life. Effective Jan. 23, 2006, the Department of Energy mandates that all manufactured air conditioner condensing units meet new SEER 13 regulations. These new systems are more efficient, but often physically larger and invariably more costly.

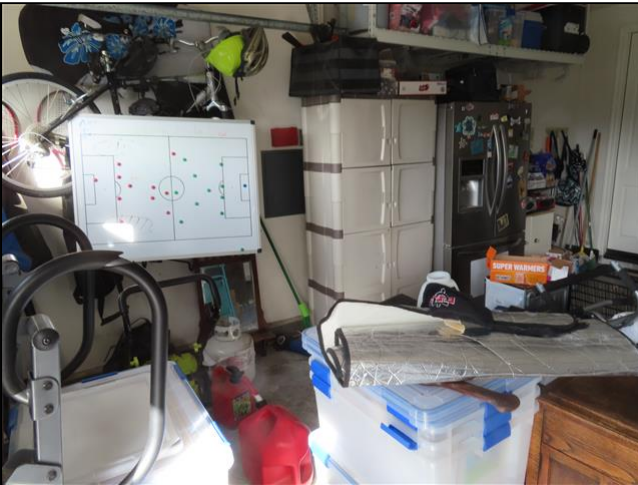
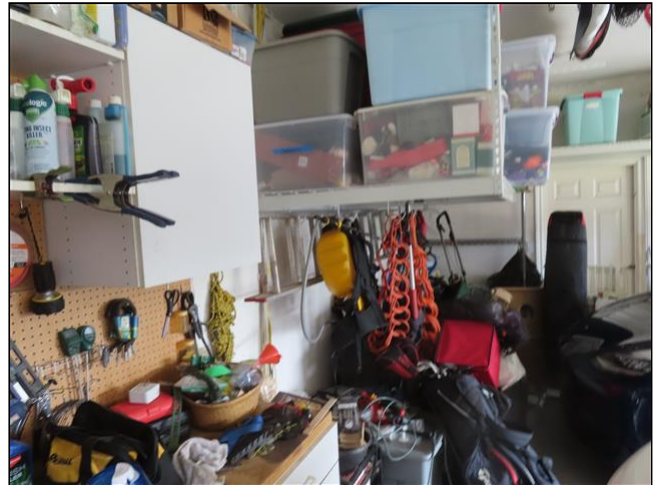
41. The presence of personal items limited access to the garage at the time of this inspection.  
 - A "walk through" is recommended when the areas is cleared and accessible, prior to the close of escrow.

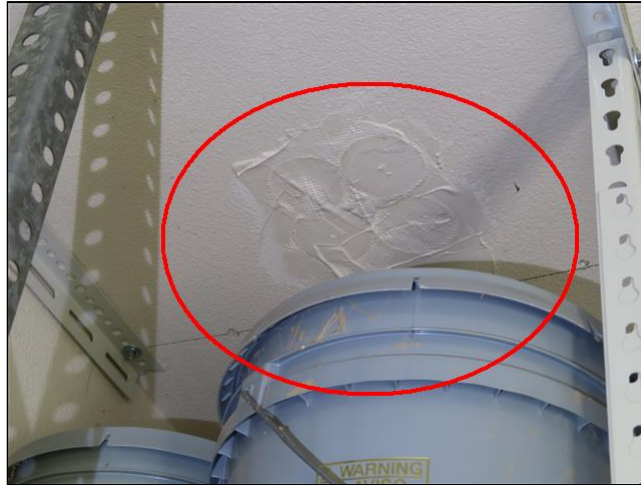
42. There is evidence of previous patching and/or repairs to the ceiling and may not meet firewall standards..  
 - The owner may know about the cause of any damage and/or what repairs were done. If necessary, have a qualified technician repair the finished surfaces.

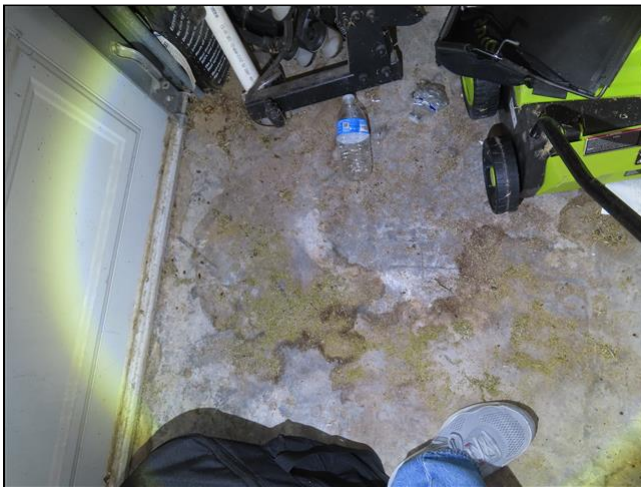
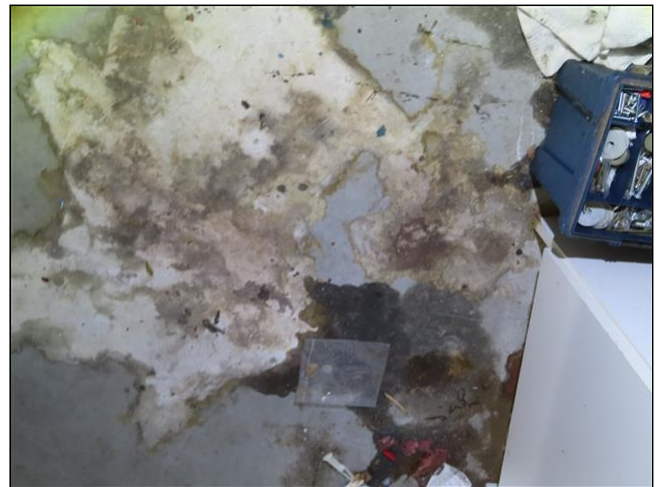
43. 1. A condition known as "efflorescence" is present on portions of the garage concrete floor. This whitish, fuzzy material is a mineral deposit left when moisture in the slab evaporates. The presence of efflorescence indicates an occasional surplus of moisture on the surface of the slab.
- Steps should be taken to improve the exterior drainage, but no other action is indicated at this time.
2. Staining is noted at the garage flooring. Clear as needed.

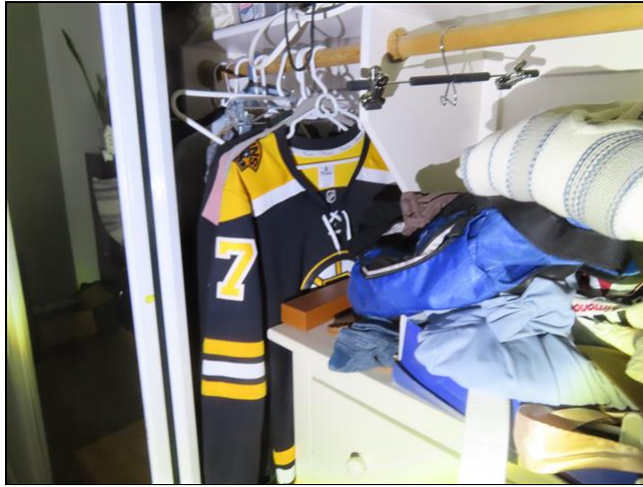
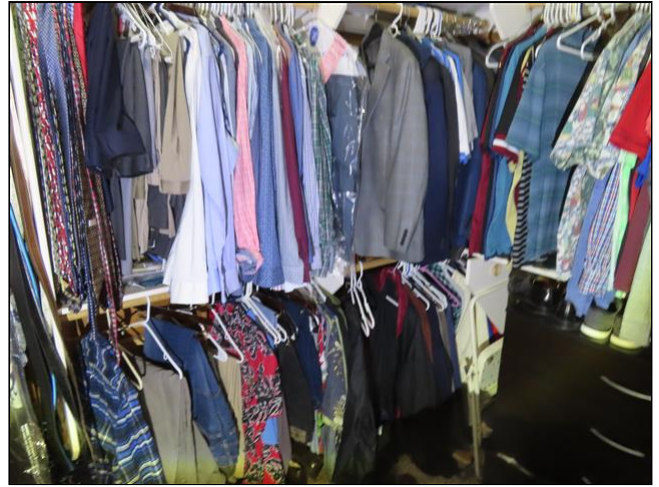
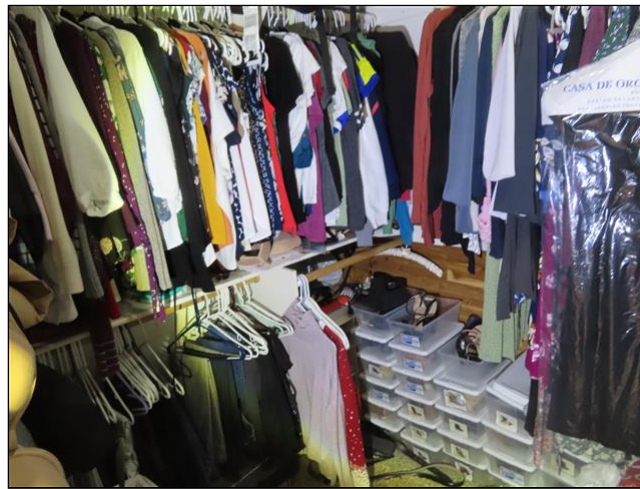
46. The presence of many personal items limited access to the house at the time of this inspection.  
- A "walk through" is recommended when the areas is cleared and accessible, prior to the close of escrow.

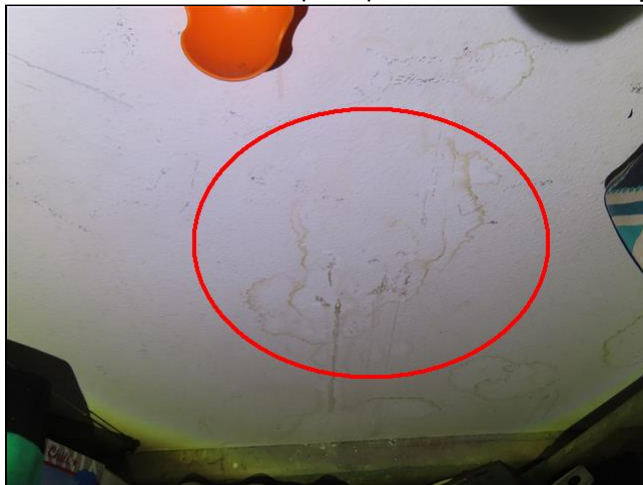
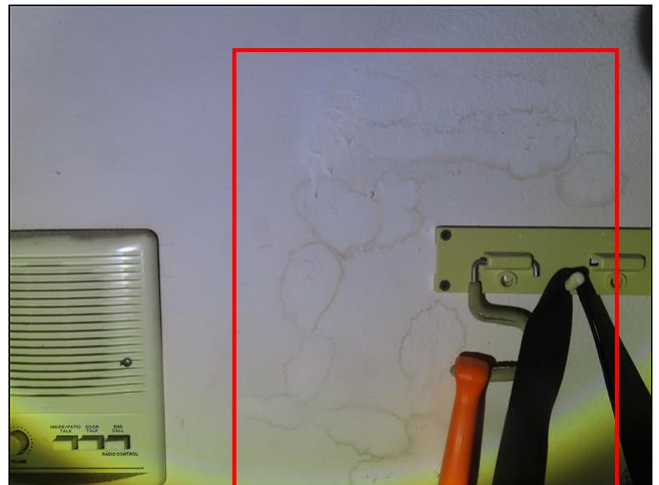
- 47. There are water stains on the garage walls. However, we found no sign of active leaks. The source of the leak(s) should be identified and repairs performed as necessary.
