**BPG Inspection, LLC**

**9806 Old Ridge Road  
Spring Valley CA 91977**

Client(s): McDonald  
Inspection Date: 2/5/2025  
Inspector: Brian Chatfield ,

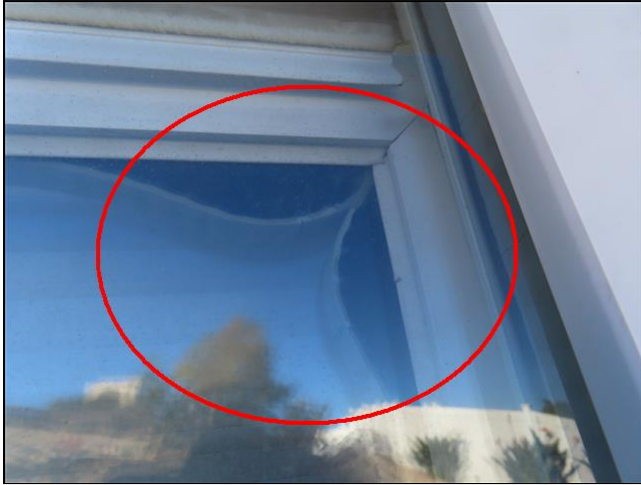
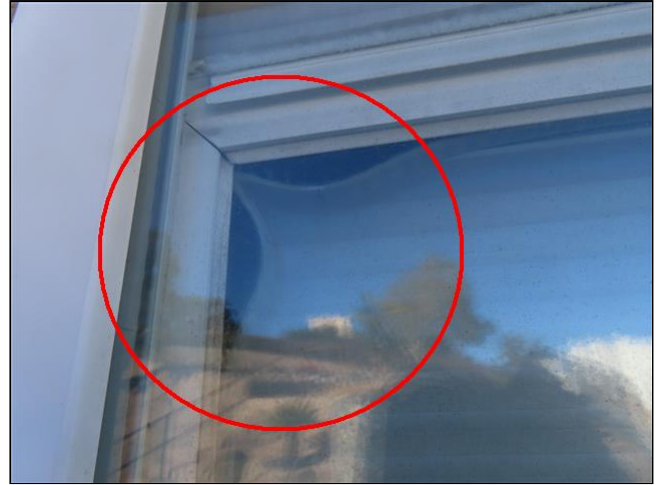
48. Several windows in the home has internal loose or cracked seals noted. A qualified technician should make any needed repairs.

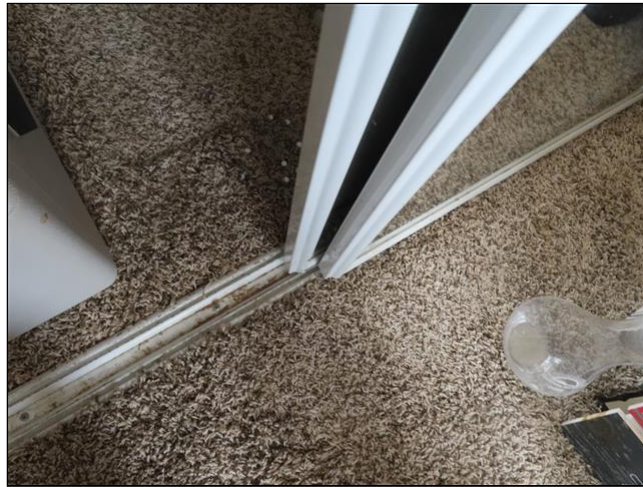
49. One or more closet doors are off their tracks and not operating properly. A qualified technician should make repairs or modifications as necessary.

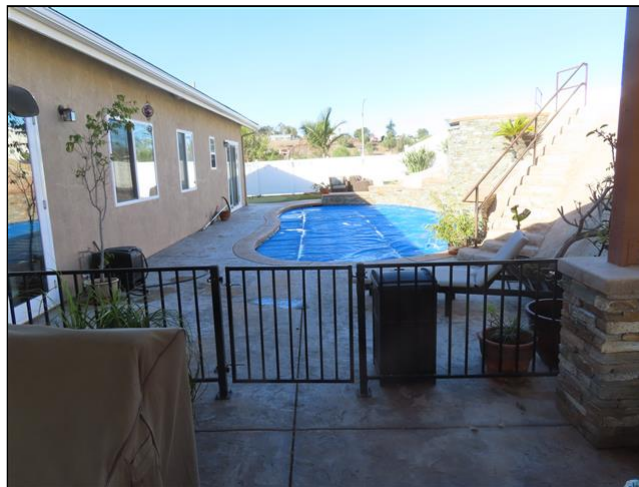
55. **As of January 1, 2018**, California law requires homes with a pool or spa to be equipped with **at least 2 of the 7** specified drowning prevention safety features according to **Senate Bill 442**. Conformance of several of the items cannot be determined by a visual inspection. We recommend that the current owner or their representative provide any and all documentation to ensure compliance or have a qualified pool contractor further evaluate and perform any needed repairs.
