# WOOD DESTROYING PESTS AND ORGANISMS INSPECTION REPORT

BUILDING NO. <b>1045</b>	STREET, CITY, STATE, ZIP <b>Crestview Road, Vista CA 92081</b>	Date of Inspection <b>3/22/2023</b>	No. of Pages <b>6</b>
-----------------------------	---	--	--------------------------

General Description: Two story, single family home, wood frame, stucco siding, composition roof and vacant.	Inspection Tag Posted: Garage
	Other Tags Posted: None Noted

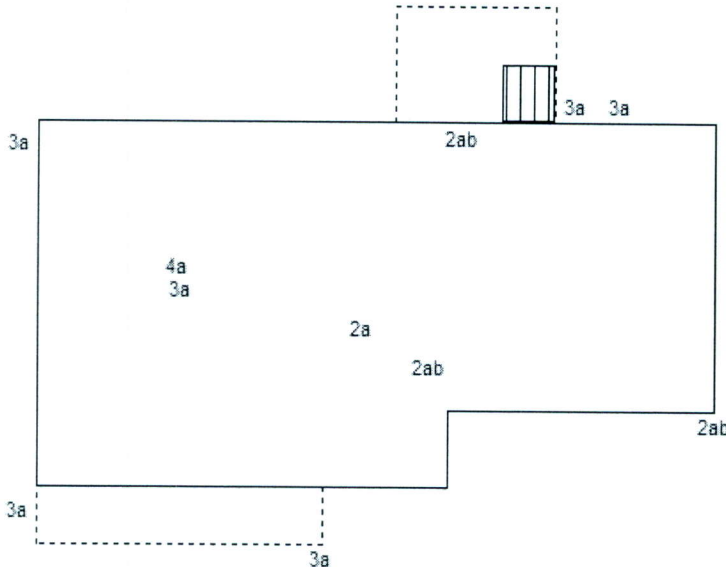
DIAGRAM  
NOT TO  
SCALE

ITEM 2B FINDING: Drywood termite damage was noted at trim, pedestrian garage door jamb, pedestrian garage door and rafter as indicated on the diagram.

ITEM 3A FINDING: Fungus damage was noted at siding, trellis framing, post and plywood flooring from sub-area as indicated on the diagram.

RECOMMENDATION: Remove termite damaged wood. Where removal appears impractical, adequate reinforcement will be done. Minor damage may be filled. If upon performance of work the damage extends into inaccessible areas, a new report and estimate will be issued.

RECOMMENDATION: Remove fungus damaged members. Replace with new material. If upon performance of work the damage extends into inaccessible areas, a new report and estimate will be issued.
