Covenant Home Inspection

Home Inspection Report

209 Wright Ct

Inspected on Tue, Apr 30 2024 at 10:00AM

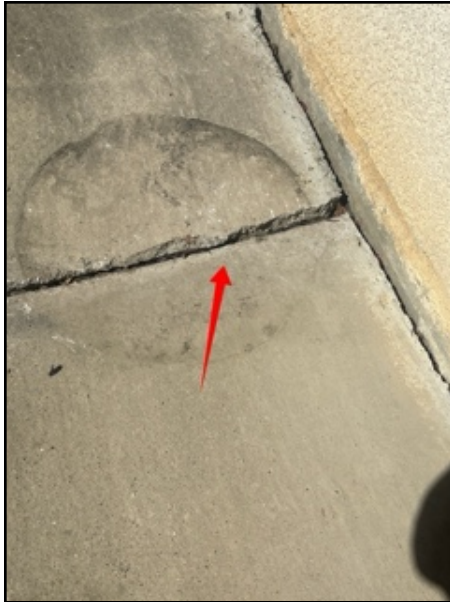
Figure 1-1

Comment 1:
Concrete patio is uneven and could be potential tripping hazard. Recommend repair as needed.

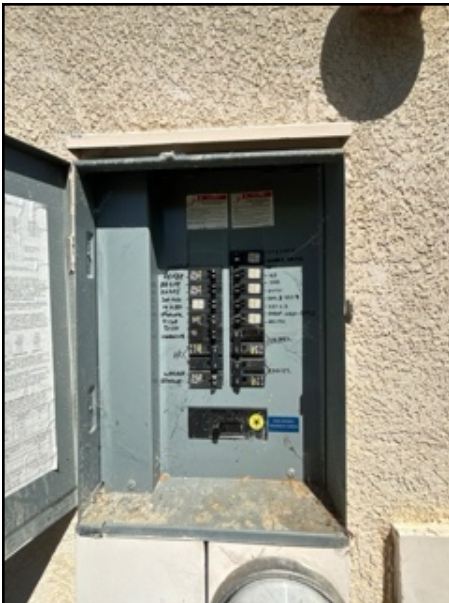
Figure 2-1

Comment 2:
Main Service Panel.

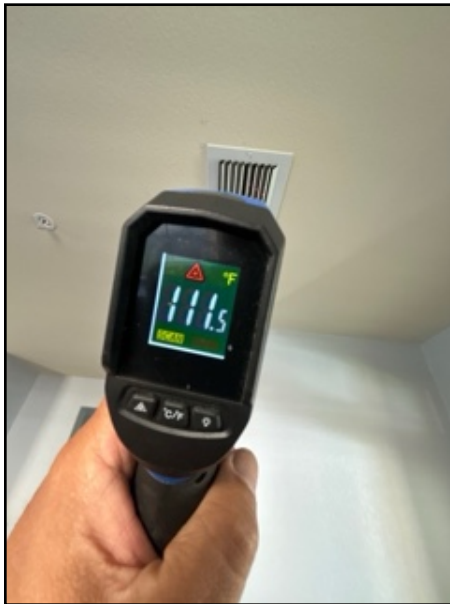
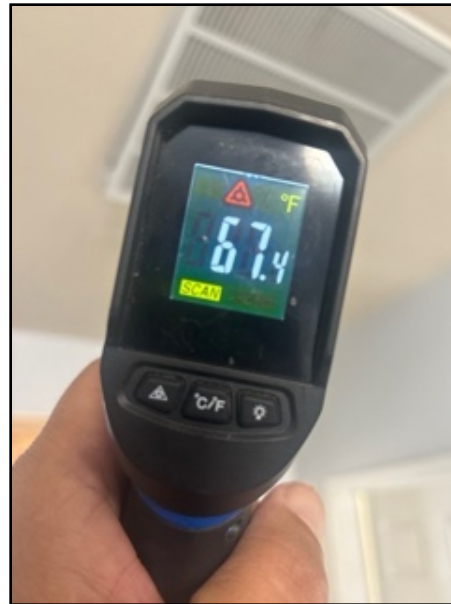
Output heating temperature shows that the unit is working at time of inspection.

Furnaces over 10 years old should be checked, cleaned and serviced yearly by a licensed contractor.

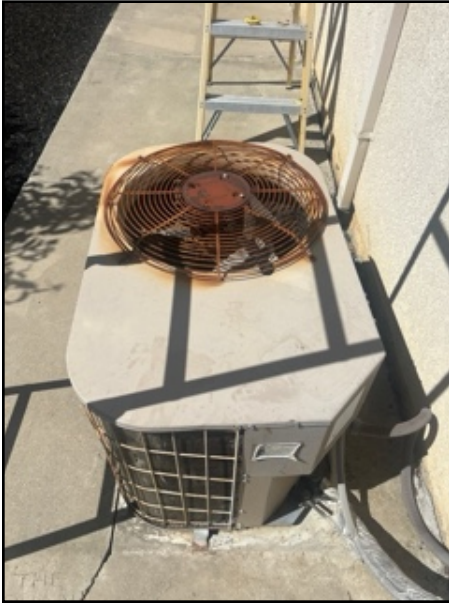
Figure 4-1

Comment 4:
Cooling unit.

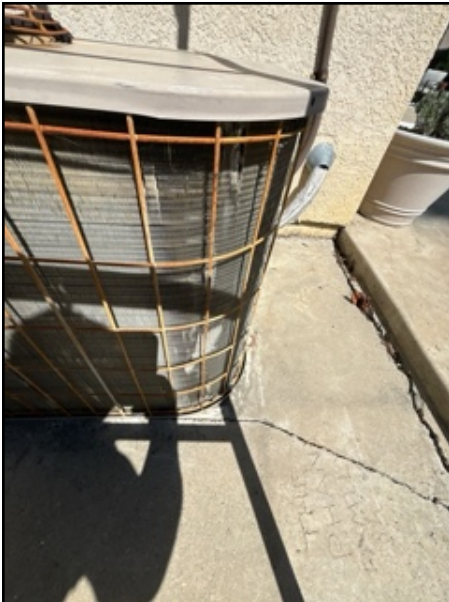
Figure 5-1

Comment 5:
The cooling fins on the unit are damaged or deteriorated which cause loss of air flow. Recommended repairing as needed to prevent energy loss.

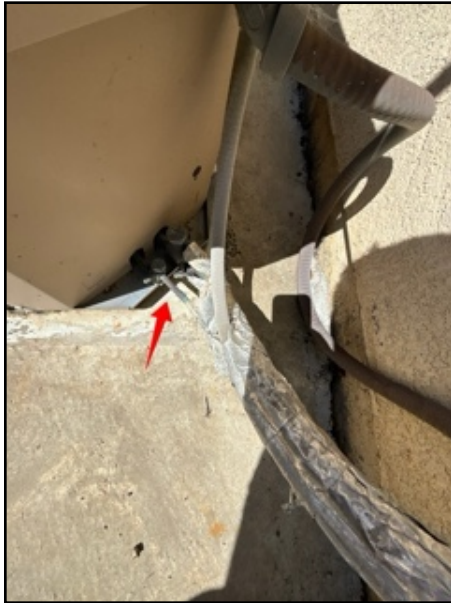
Figure 6-1

The foam sleeve is deteriorating on the suction line at outside unit. Missing foam sleeve can cause condensation and energy loss. I recommended replace as needed.

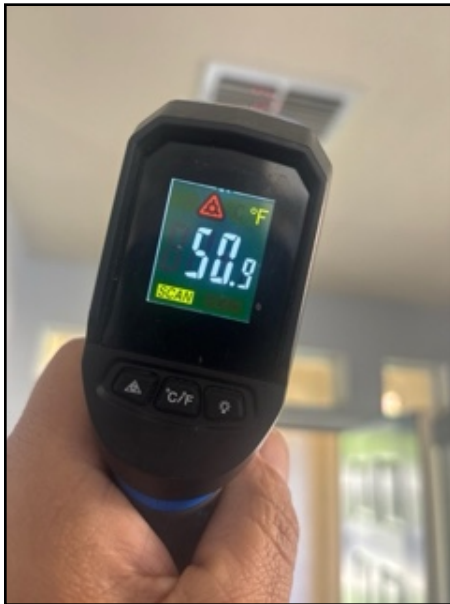
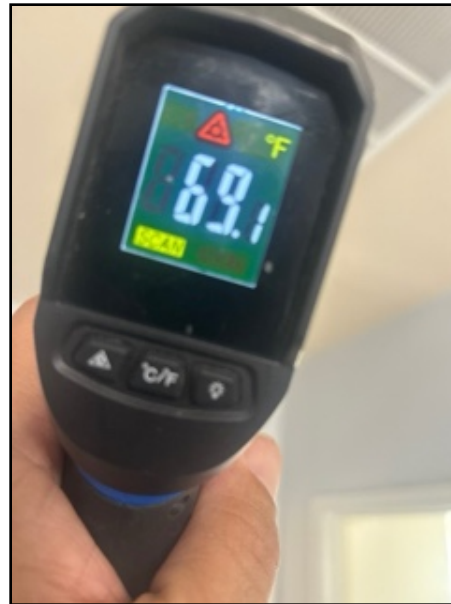
The temperature drop at the supply vent and return vent shows the unit is working properly at time of inspection.

Air conditioners over 10 years old and heat pumps over 5 years old should be checked, cleaned and serviced yearly by a licensed contractor.

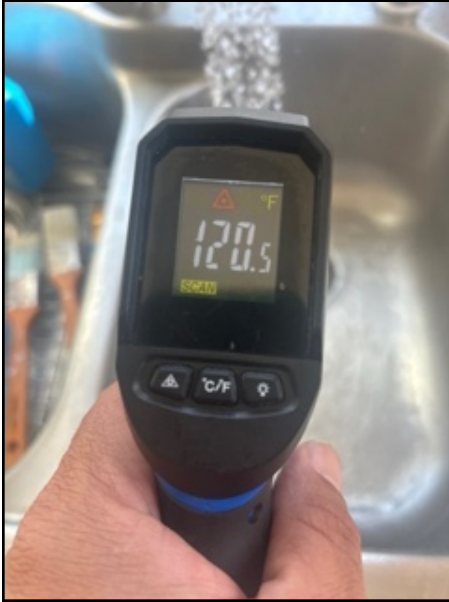
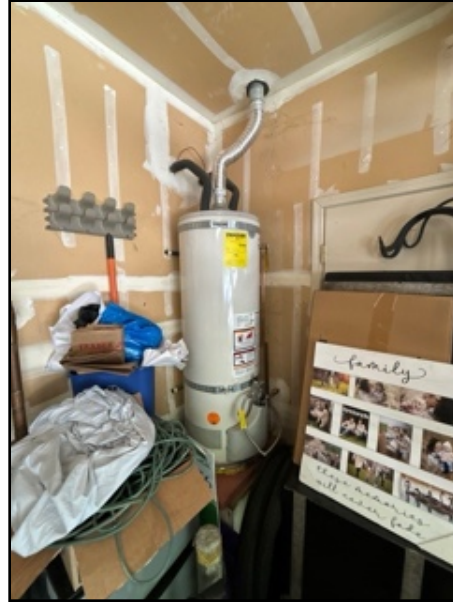
**Comment 8:**
Water temperatures show the water heater was working properly at time of inspection.

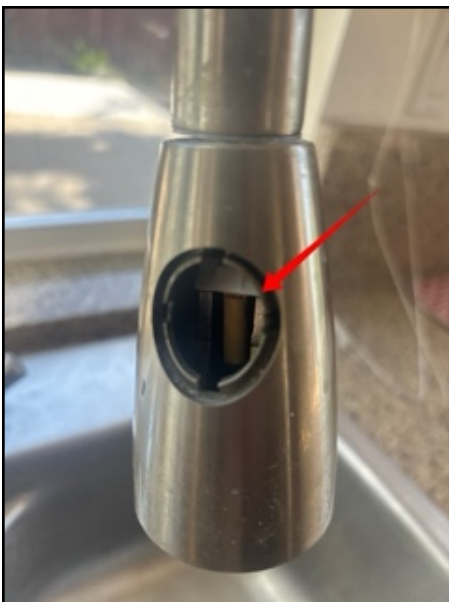
Figure 9-1

**Comment 9:**
Button at the kitchen faucet spray nozzle is missing. Recommend installing for proper use.

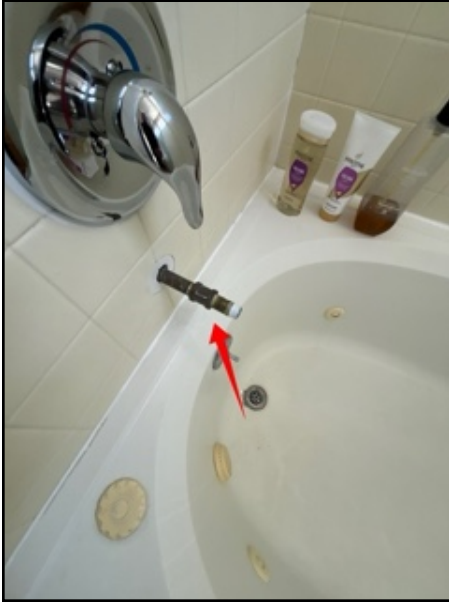
Figure 10-1

Tub spout was missing at time of inspection. Recommend installing for proper water distribution.

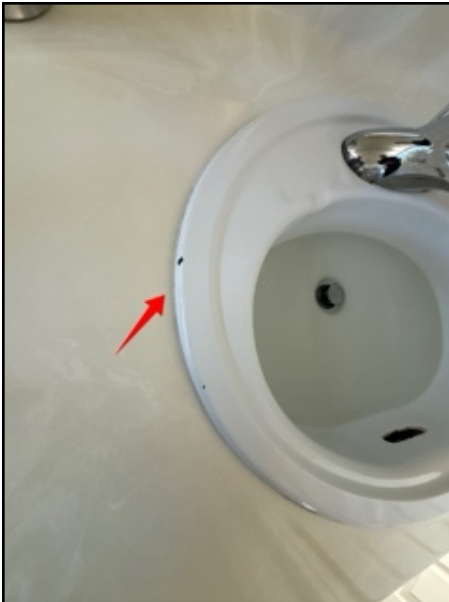
Figure 11-1

Sink is chipped. This is cosmetic but recommend repair as needed to prevent leak.

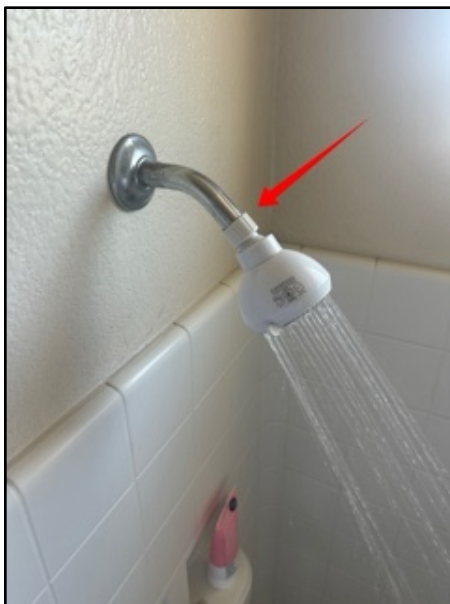
Figure 12-1

Active leak was noted at the shower head. Recommend repair as needed to prevent water damage/water waste.

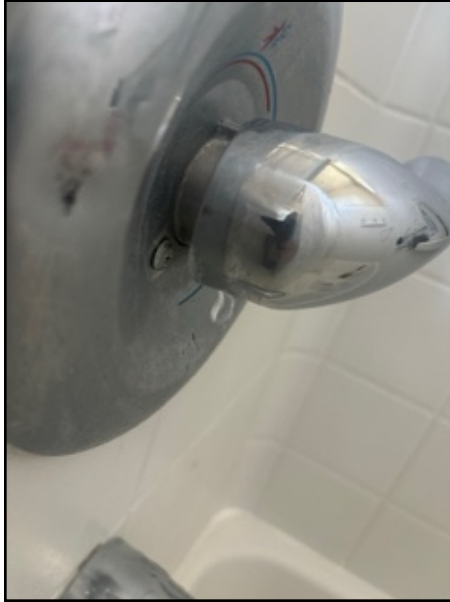
Figure 13-1

Active leak at shower control valve. Recommend repair to prevent damage and water waste.

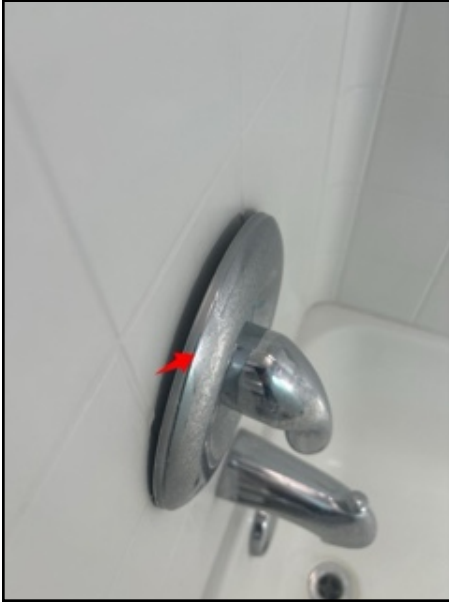
Figure 14-1

**Comment 14:**
Caulking was missing on plumbing fixtures at shower/tub wall. Recommend sealing to prevent water intrusion.

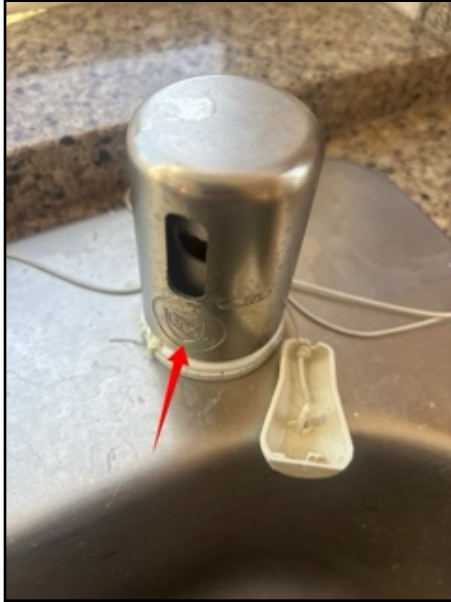
Figure 15-1

Comment 15:
Plumbing leak coming from air gap at the dishwasher. Recommend repair for proper function and drainage.

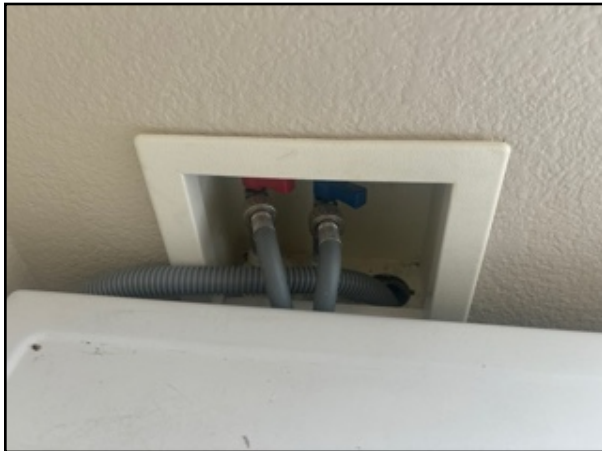
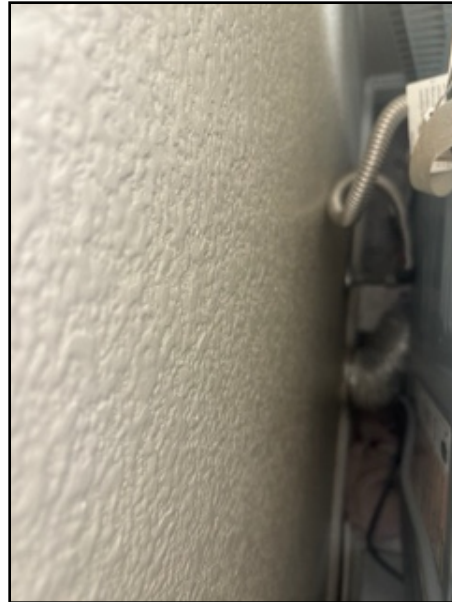
Laundry hooks ups appear to be sufficient at time of inspection. 220v electric connection present.

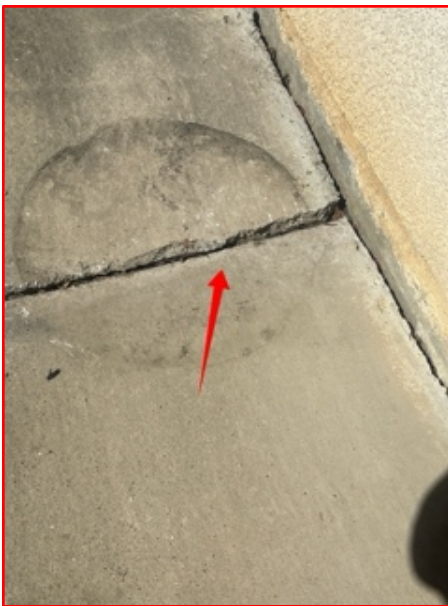
Figure 1-1

1) Concrete patio is uneven and could be potential tripping hazard. Recommend repair as needed.

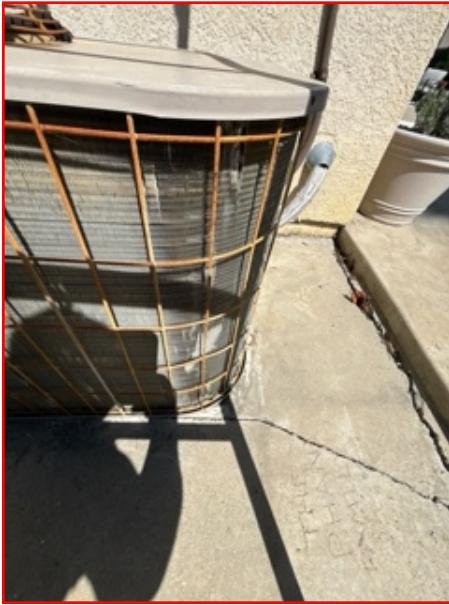
Figure 5-1

2) The cooling fins on the unit are damaged or deteriorated which cause loss of air flow. Recommended repairing as needed to prevent energy loss.

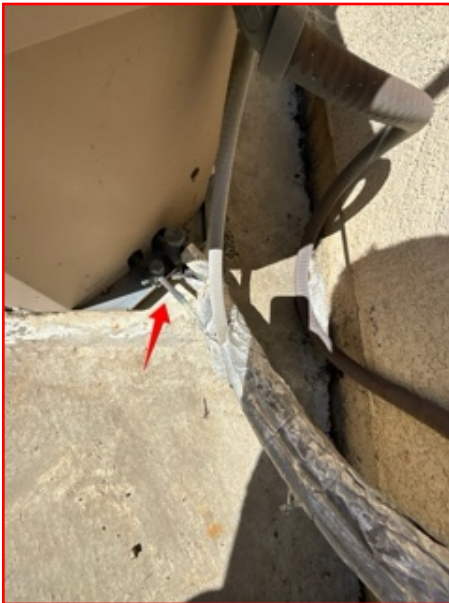
Figure 6-1

3) The foam sleeve is deteriorating on the suction line at outside unit. Missing foam sleeve can cause condensation and energy loss. I recommended replace as needed.

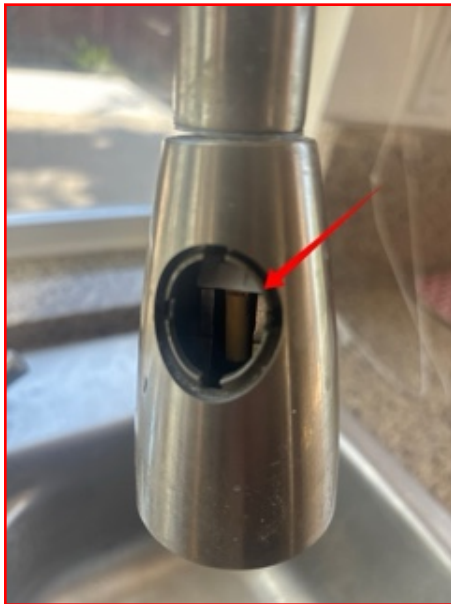
Figure 9-1

4) Button at the kitchen faucet spray nozzle is missing. Recommend installing for proper use.

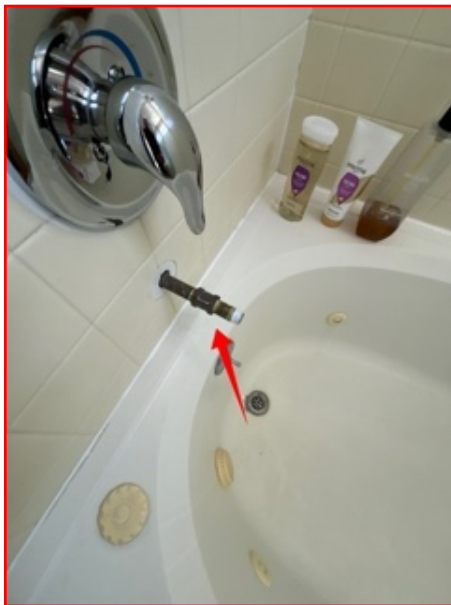
Figure 10-1

5) Tub spout was missing at time of inspection. Recommend installing for proper water distribution.

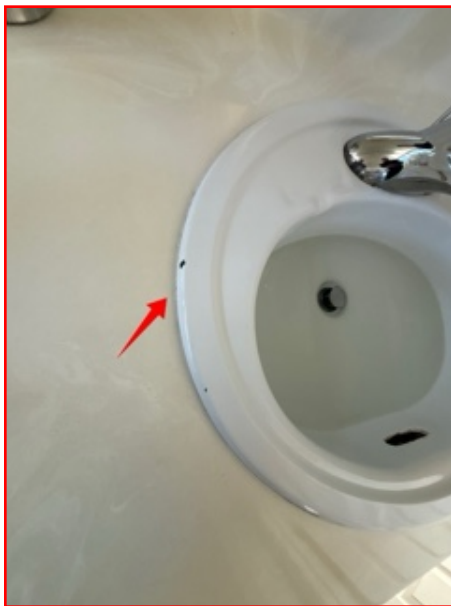
Figure 11-1

6) Sink is chipped. This is cosmetic but recommend repair as needed to prevent leak.

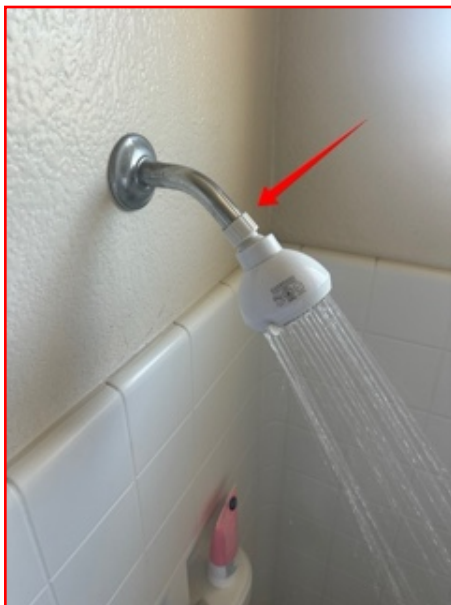
Figure 12-1

7) Active leak was noted at the shower head. Recommend repair as needed to prevent water damage/water waste.

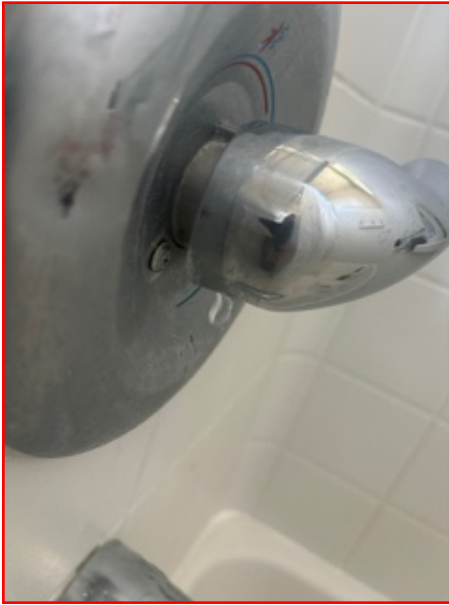
Figure 13-1

8) Active leak at shower control valve. Recommend repair to prevent damage and water waste.

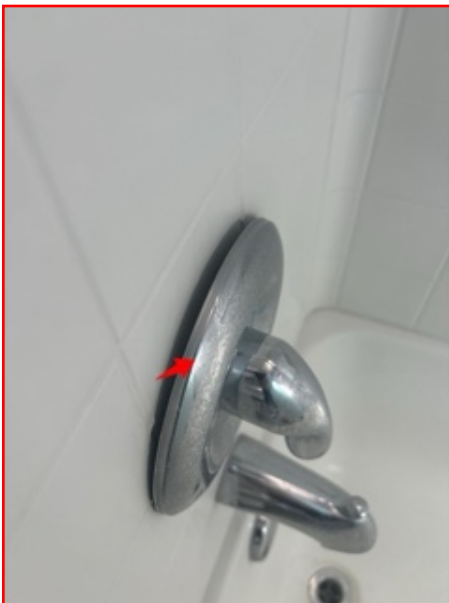
Figure 14-1

9) Caulking was missing on plumbing fixtures at shower/tub wall. Recommend sealing to prevent water intrusion.

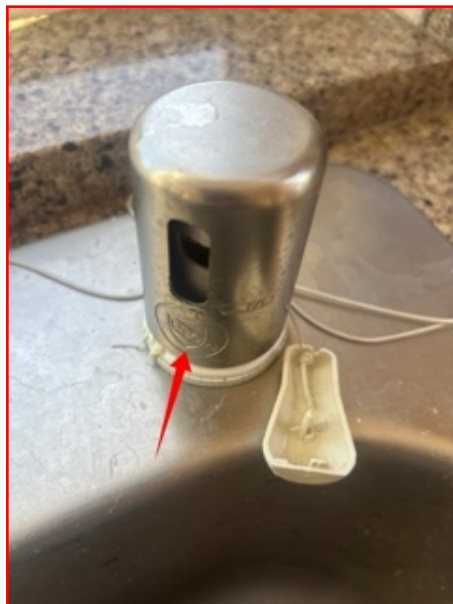
Figure 15-1

10) Plumbing leak coming from air gap at the dishwasher. Recommend repair for proper function and drainage.
