WOOD DESTROYING PESTS AND ORGANISMS INSPECTION REPORT

Building No. 20029	Street Upper Skyridge Dr.	City Groveland	Zip 95321	Date of Inspection 05/28/25	Number of Pages 1 of 12
------------------------------	-------------------------------------	--------------------------	---------------------	---------------------------------------	-----------------------------------

Report # 7152

General Description: Multi level, single family residence, wood frame construction, stucco siding, tile roof.	Inspection Tag Posted: Subarea
Other Tags Posted:

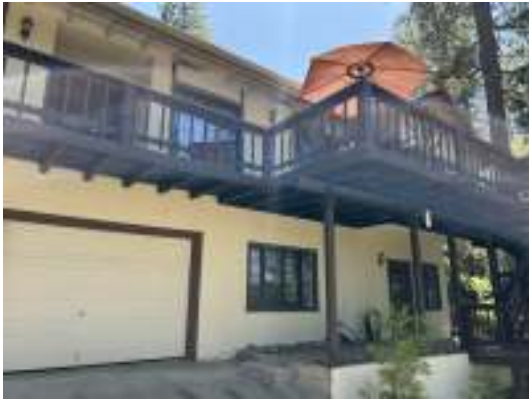
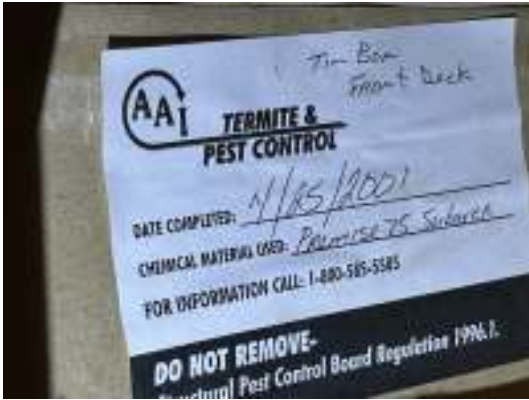
0:

NOTE: Evidence of previous subterranean termites is present in the subarea. chemical tag indicates termiticide applied on 04/25/2007. No evidence of current activity was noted.

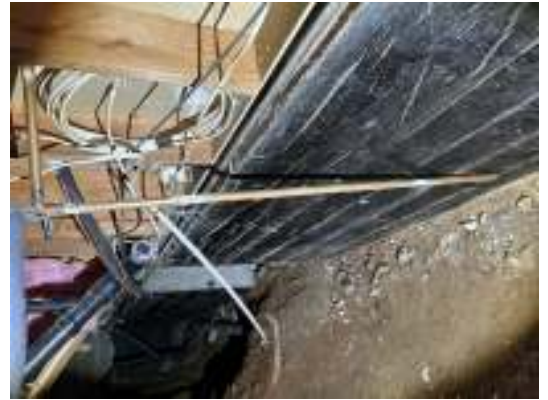
1B:

The water heater pressure relief valve exits in the subarea; this can create excessive moisture conditions in the subarea.

RECOMMENDATION: Extend valve to the exterior as necessary.

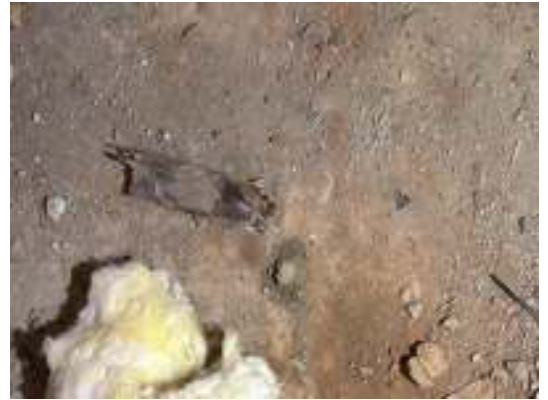
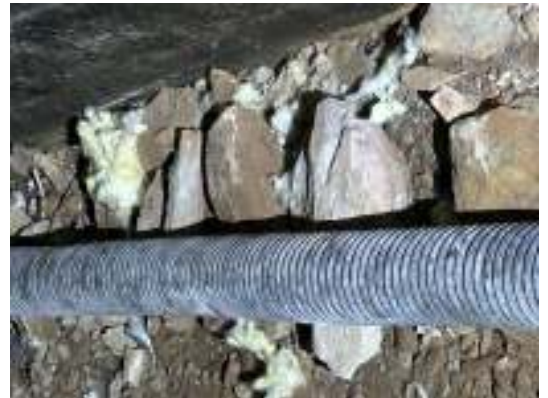
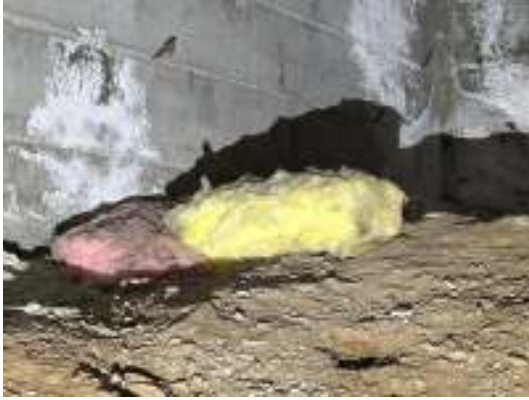
1C:

Cellulose debris was noted in subarea; this can attract subterranean termites to the structure.

RECOMMENDATION: Remove and dispose of cellulose debris as practical. (Note: Should any evidence of subterranean termites be uncovered upon removal of cellulose debris, recommendations and prices for treatment will be given in a supplemental report.)

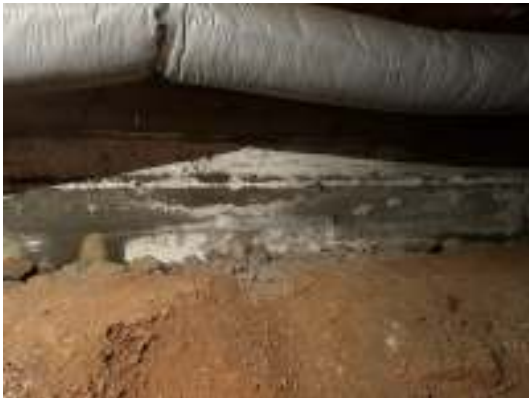
1A:

NOTE: Efflorescence is present at the foundation wall indicating excessive moisture at the exterior of foundation in this area.

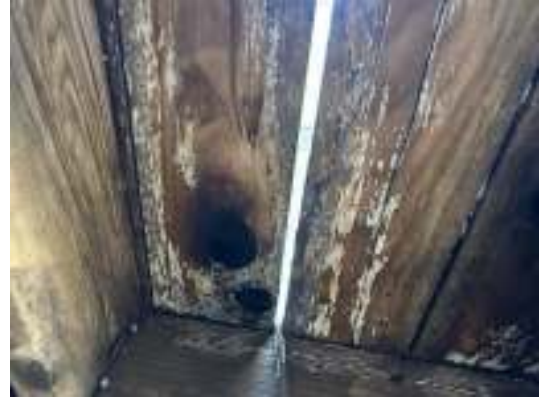
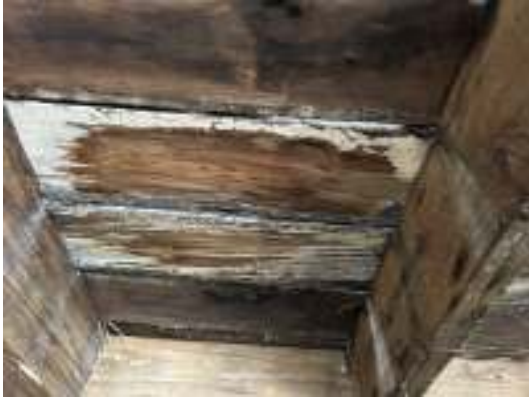
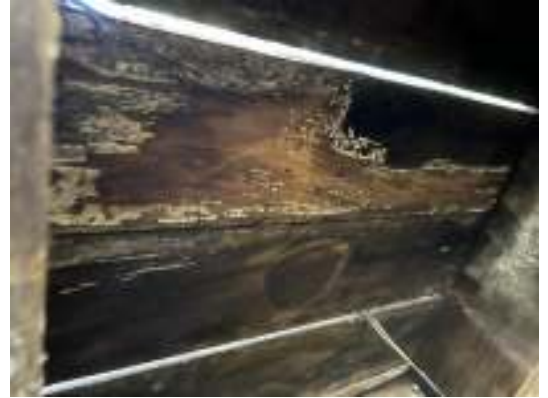
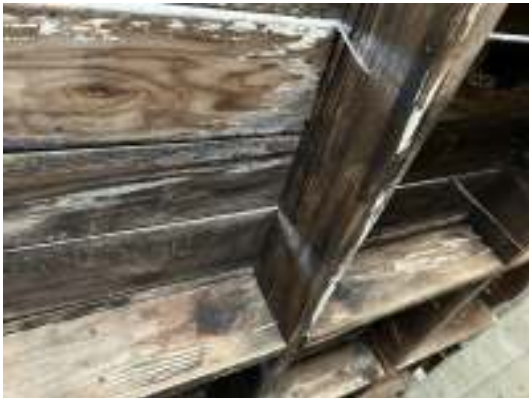
9A:

Wood decay fungus is infecting the surface of the underside of the front deck.

RECOMMENDATION: Scrape and treat infected wood with (Tim-bor) disodium octaborate tetrahydrate. All chemicals are to be applied by a state licensed applicator in accordance with manufacturer labels.

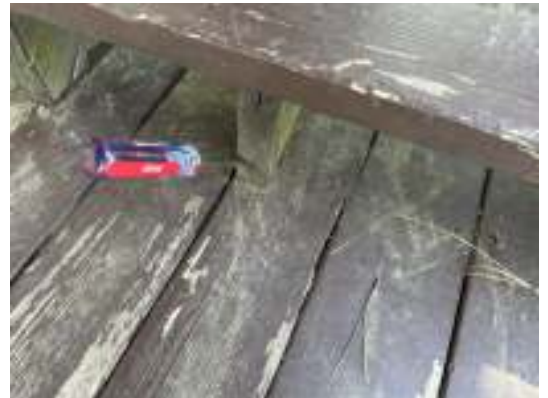
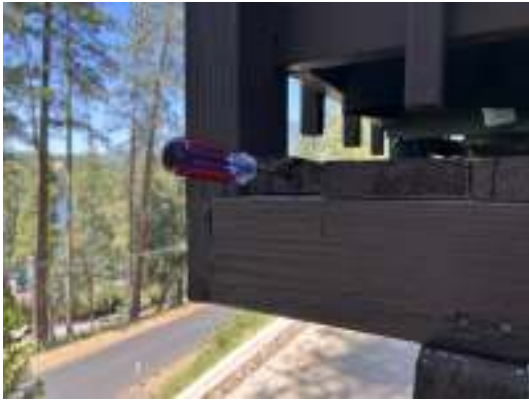
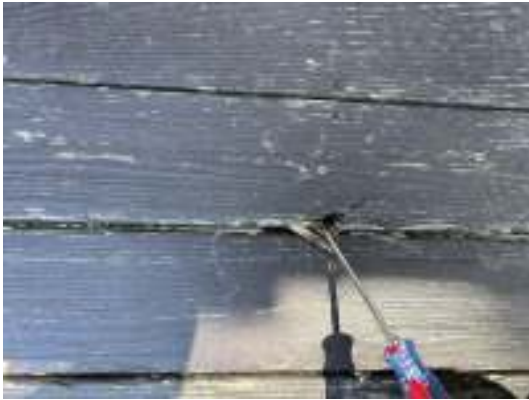
9B:

Wood decay fungus is infecting and damaging the front deck stair riser, and decking boards.

NOTE: While not anticipated, it is unknown if further damage exists in the inaccessible areas behind the visibly affected wood members stated above. Should additional damage be exposed during the course of repairs, new findings, recommendations, and prices for additional scope of work will be given in a supplemental report.

RECOMMENDATION: Remove and replace one 2x8 stair raise and up to 165 linear feet of damaged 2x6 decking boards; price for repairs does not include paint / stain. Treat all exposed wood members with (Tim-bor) disodium octaborate tetrahydrate to arrest the growth of wood decay fungi. All chemicals are to be applied by a state licensed applicator in accordance with manufacturer labels. *Upon request, prices can be given for others to perform repairs and Streamline Inspections to chemically treat only.

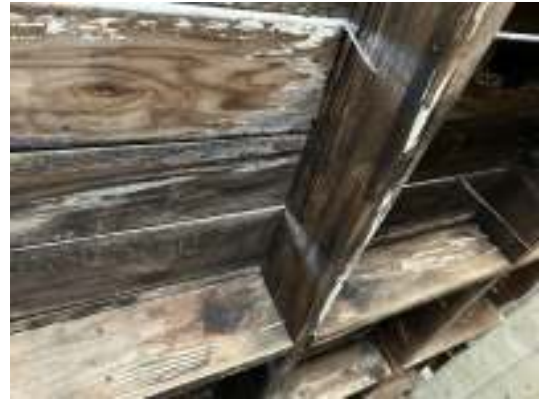
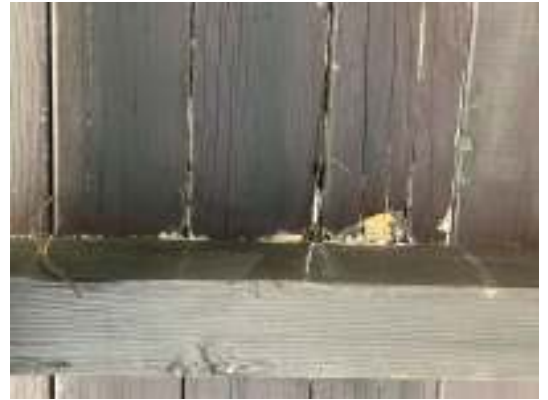
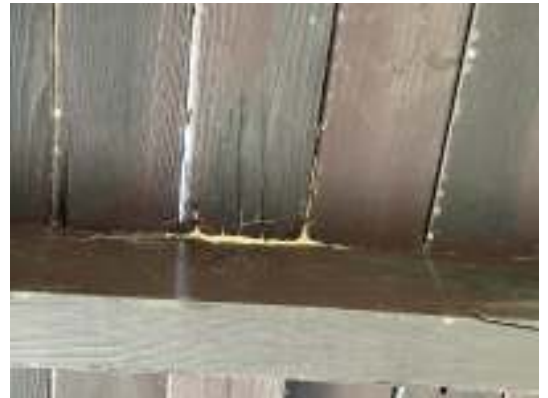
9D:

Wood decay fungus is infecting the surface of the underside of the back deck.

RECOMMENDATION: Scrape and treat infected wood with (Tim-bor) disodium octaborate tetrahydrate. All chemicals are to be applied by a state licensed applicator in accordance with manufacturer labels.

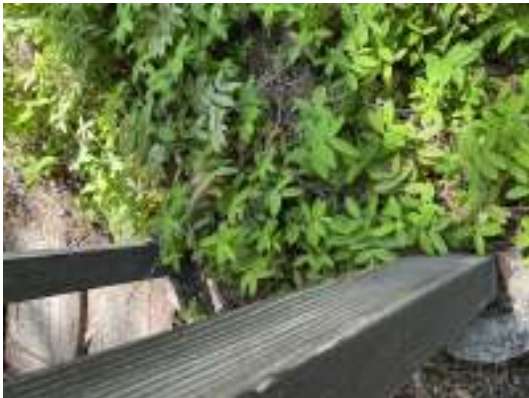
9C:

Earth to wood contacts are present at the front deck pier pads and the base of the support post; this can allow wood destroying

pests and organisms access to the wood members.

RECOMMENDATION: Regrade the soil to break the earth to wood contacts; owner is advised to maintain grade. *Note: If damage is exposed upon regrading, any/all findings, recommendations and prices for additional scope of work will be given in a supplemental report.

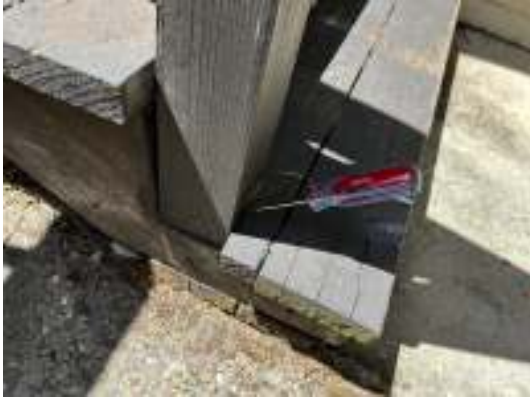
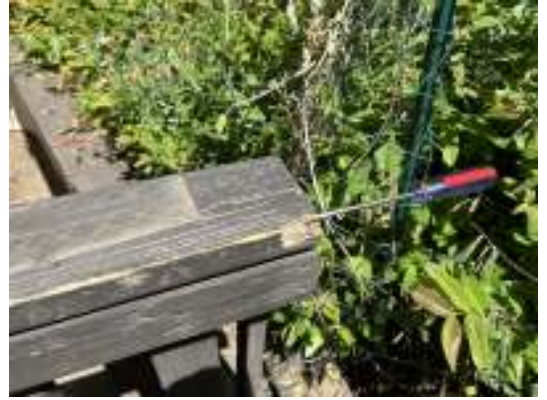
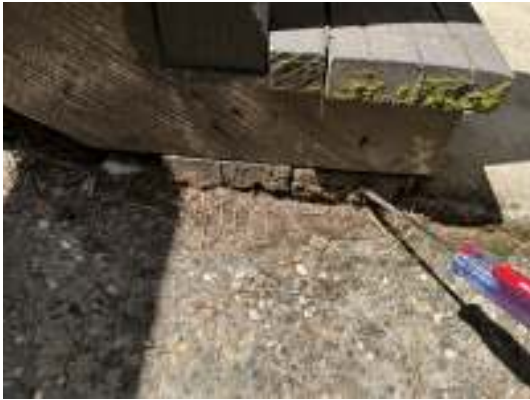
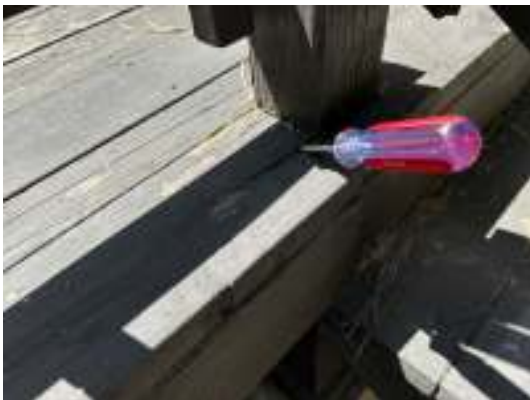
9E:

Wood decay fungus is infecting and damaging the back deck handrail post, stair pad, rail cap, and decking boards.

NOTE: While not anticipated, it is unknown if further damage exists in the inaccessible areas behind the visibly affected wood members stated above. Should additional damage be exposed during the course of repairs, new findings, recommendations, and prices for additional scope of work will be given in a supplemental report.

RECOMMENDATION: Remove and replace up to 4 linear feet of damaged 4x4 handrail post, up to 8 linear feet of damaged 2x6 stair pad, up to 4 linear feet of damaged rail cap, and up to 60 linear feet of 2x6 decking boards; price for repairs does not include paint / stain. Treat all exposed wood members with (Tim-bor) disodium octaborate tetrahydrate to arrest the growth of wood decay fungi. All chemicals are to be applied by a state licensed applicator in accordance with manufacturer labels. *Upon request, prices can be given for others to perform repairs and Streamline Inspections to chemically treat only.
