WOOD DESTROYING PESTS AND ORGANISMS INSPECTION REPORT

Building No. / Street 879 Date Avenue	City Chula Vista	Zip 91911	Date of Inspection 10/21/2024	Number of Pages 1 of 7

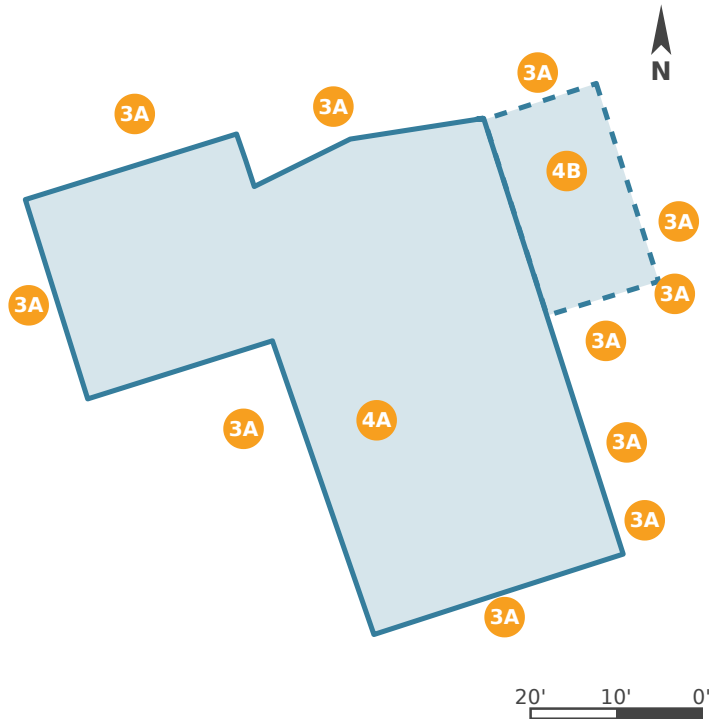
2A	Finding Evidence of drywood termites found in areas marked on Diagram.	Recommendation Cover entire structure(s) and fumigate with Sulfuryl Fluoride for the elimination of drywood termites. Chloropicrin will be used as a warning agent. Cover or remove accessible termite pellets. Lloyd Termite Control Company assumes no responsibility for damage to any plant life or roofing caused by fumigation operation.
		Price: \$1975.00

3A	Finding Termite and fungus damaged wood found in area marked on diagram. Stairs, trim, siding, eaves	Recommendation Remove and replace termite and fungus damaged wood as needed. Painting is included in this estimate. If damaged wood extends into concealed or inaccessible areas, cost of repair will be in addition to estimate given.
		Price: \$5850.00

4A	Finding Water damage found in areas marked on diagram.	Recommendation Owner to contact a licensed contractor to make necessary repairs.
-----------	--	--

Inaccessible area noted in substructure due to inadequate clearance, marked on diagram.

It is impractical to make this area accessible for inspection. There are no visible signs of infestation or infection at this time. No further recommendation. No future guarantee.
