Your Sewer Inspection Report

Inspected by: Josh Diven, (858) 257-2888

Date: 07/08/2025

5036 Litchfield Road, San Diego, CA 92116

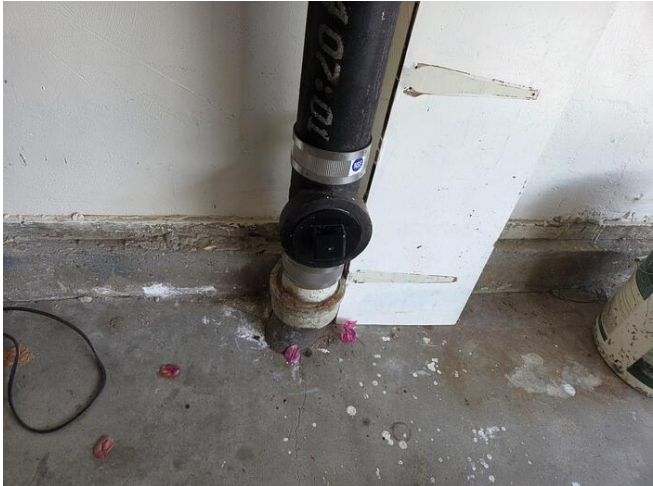
No title
Cleanout access in the garage for the right side of the house

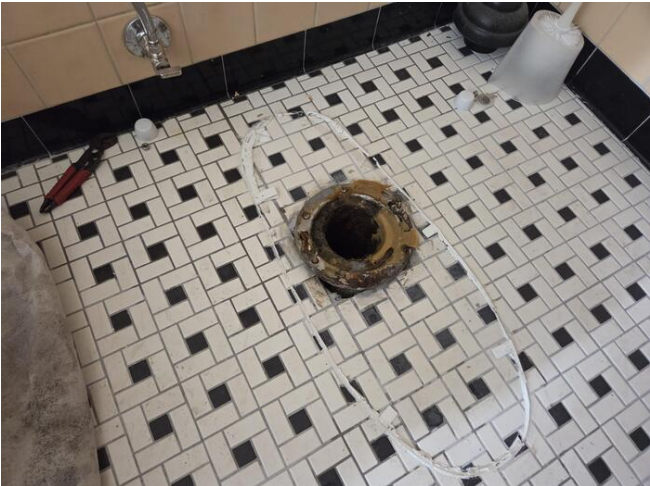
No title
Toilet sweep for the left side of the house

1) Recommend extending a full-size cleanout to the exterior of the house to allow proper access to the main sewer line as needed by a reputable plumbing contractor.

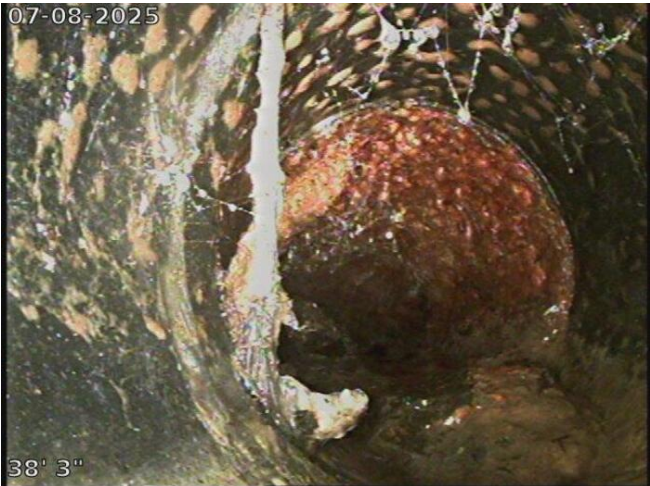
2025-07-08-09-54-53
ABS to Cast Iron connection

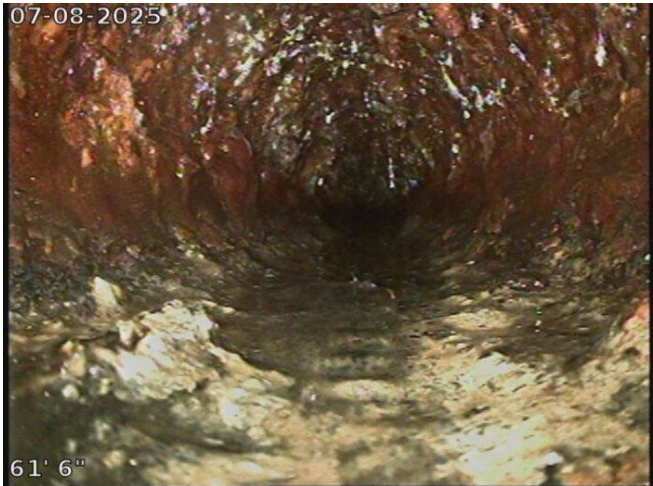
Right side of the house - Cast Iron under the garage is damaged throughout (about 2' deep). ABS under the house has roots which are restricting the visibility. Cast Iron outside of the house has buildup and debris which is restricting the visibility. PVC outside of the house to the city main is open and in serviceable condition.

2025-07-08-09-54-04
Scale buildup in the Cast Iron

2) Recommend hydro jetting by a reputable plumbing contractor prior to moving in to remove buildup in the Cast Iron (if any Cast Iron remains after the repairs) and roots in the ABS, after the full-size cleanout has been made accessible for the left side of the house.

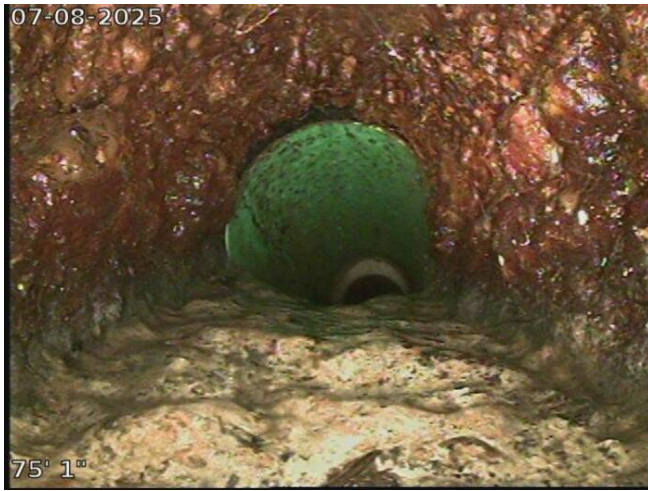
2025-07-08-09-53-32
Cast Iron to PVC connection

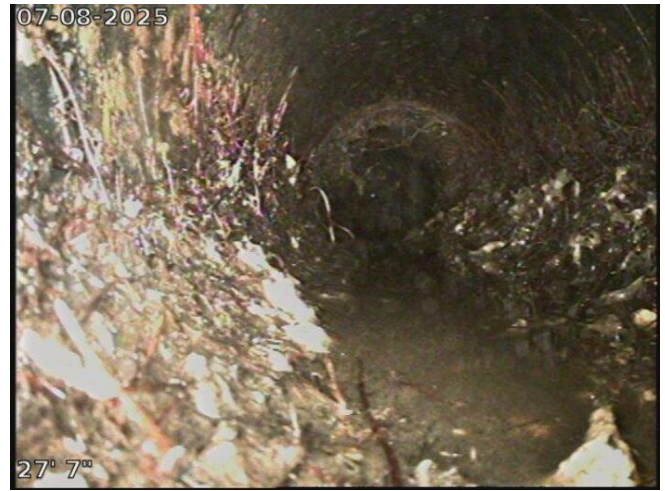
2025-07-08-09-55-14
Damaged Cast Iron

1) Recommend further evaluation and repair of all Cast Iron sewer lines as needed by a reputable plumbing contractor.

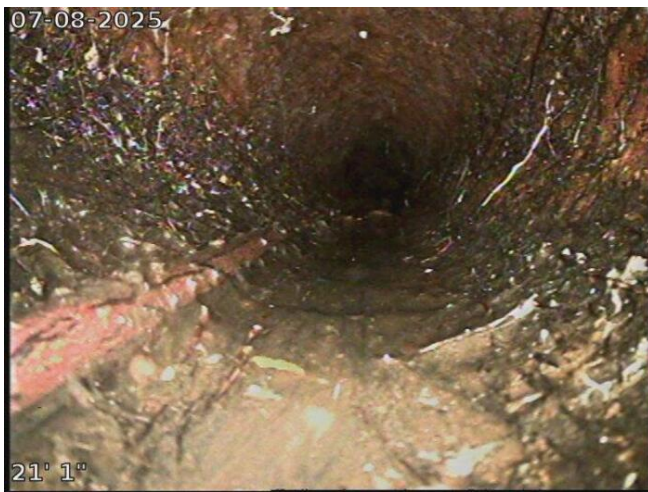
2025-07-08-09-55-32
Damaged Cast Iron

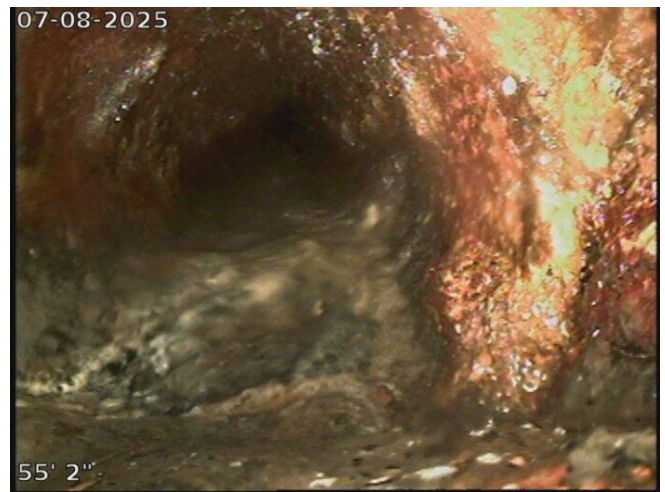
2025-07-08-10-18-18
Scale buildup in the Cast Iron

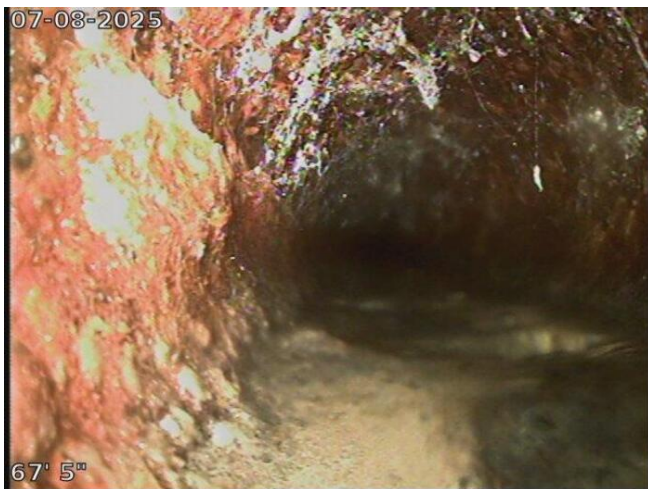
Left side of the house (Pulled the toilet on the left side of the house to gain access to that portion of the main sewer line) - Cast Iron under the house has buildup and which is restricting the visibility up to the furthest point the camera could go from the toilet sweep.

2025-07-08-10-17-30.mp4-thumb
Scale buildup in the Cast Iron / The furthest point the camera could go from the toilet sweep on the left side of the house

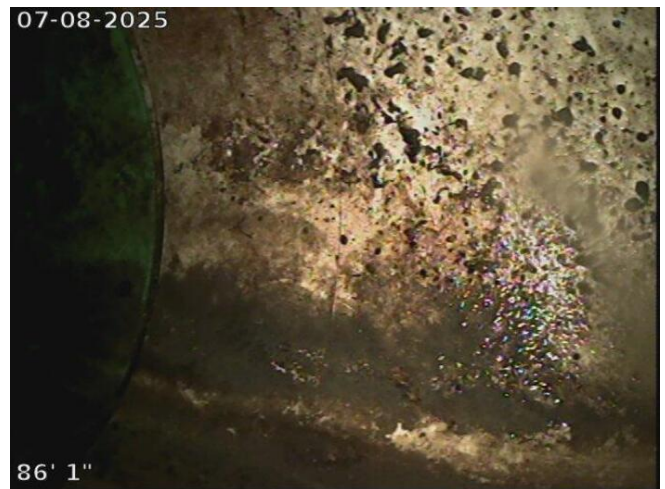
2025-07-08-09-52-19.mp4-thumb
Connection to the city main

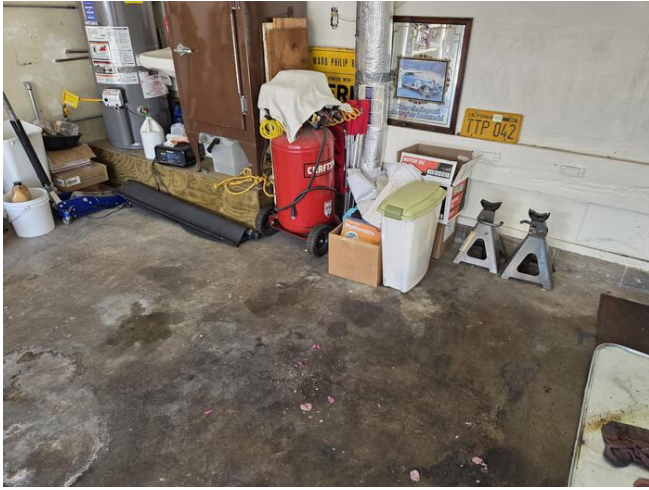
General area and direction of the damaged Cast Iron (about 2' deep)

Areas that have been located and marked are for reference only and may not be exact due to signal interference and/or depth of the sewer line. All damaged areas may not be marked and damage may extend beyond the marked areas (especially in Cast Iron). The Sewer Pros always recommend having the repair contractor re-locate prior to repair which will help insure accuracy.
