# PROPROPERTY INSPECTION AND SERVICES INC.

## PROPERTY INSPECTION REPORT

15718 Creek Hills Rd  
El Cajon, CA 92021

Hardev Shergill  
07/31/2025

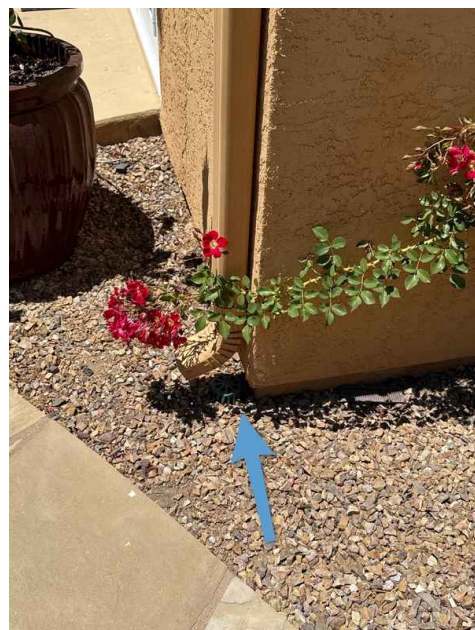
#### GROUND DRAINS

Contact a qualified professional.

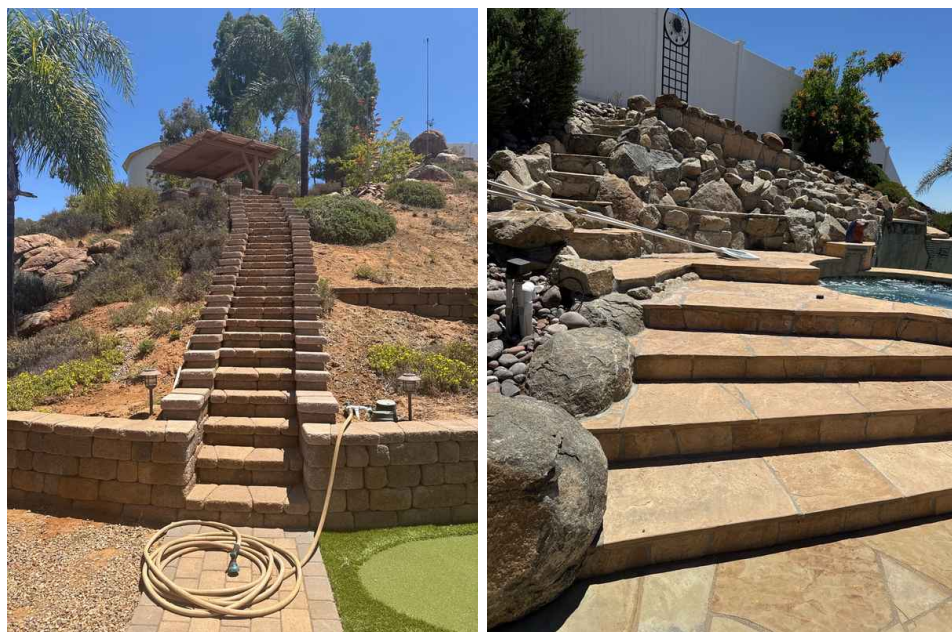
**HANDRAILS MISSING MORE THAN 3 STEPS**

Contact a qualified general contractor.

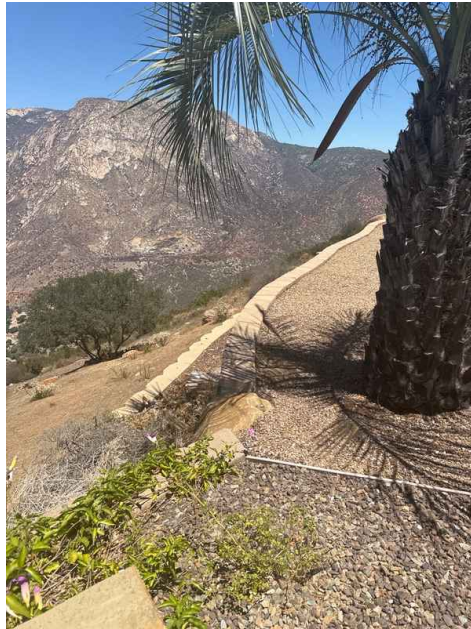
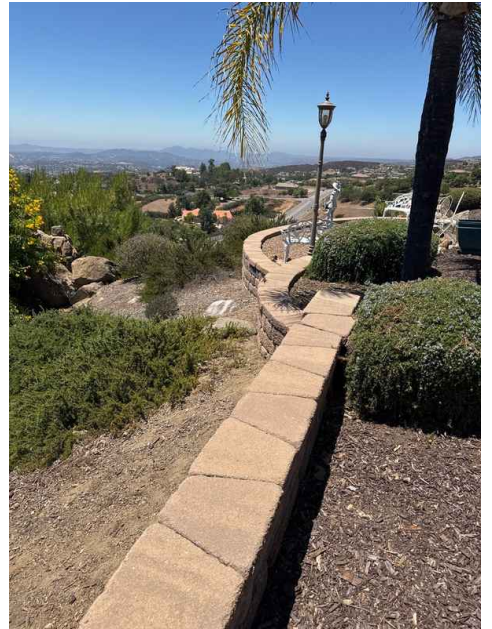
**WALKOFF HAZARD(S)**

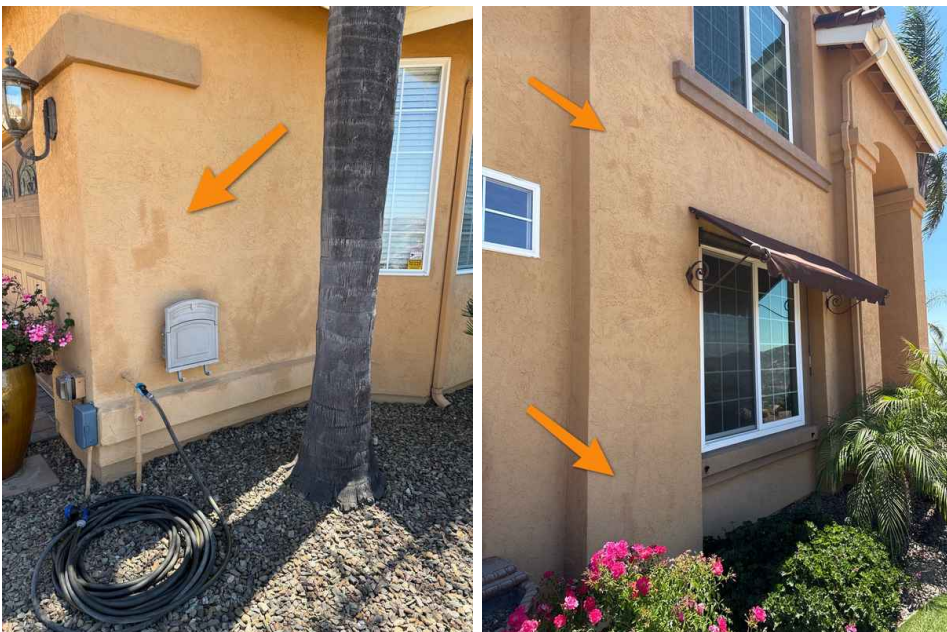
**STUCCO - STAINING**

Contact a stucco repair contractor

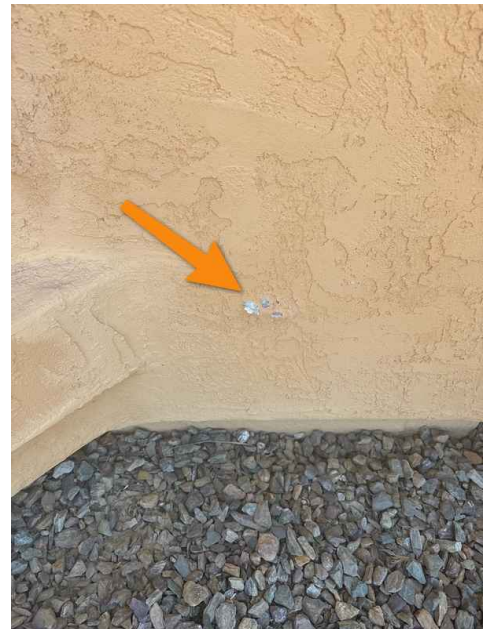
**STUCCO DAMAGE - MOISTURE**

Contact a stucco repair contractor

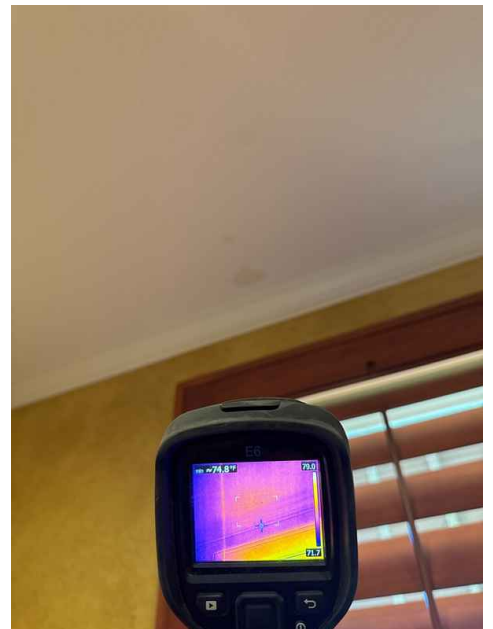
**WATER STAINS - DRY**

Contact a qualified professional.

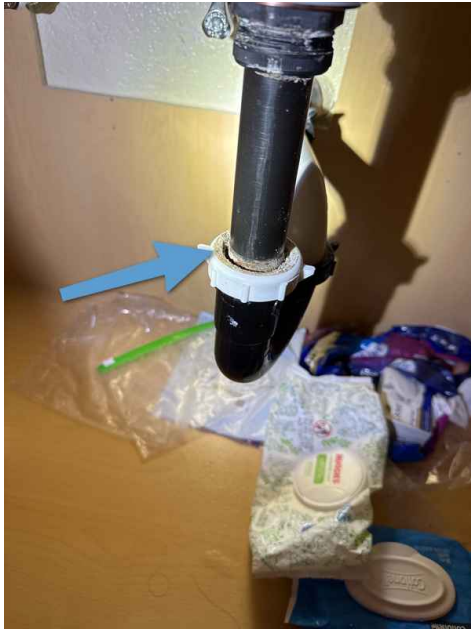
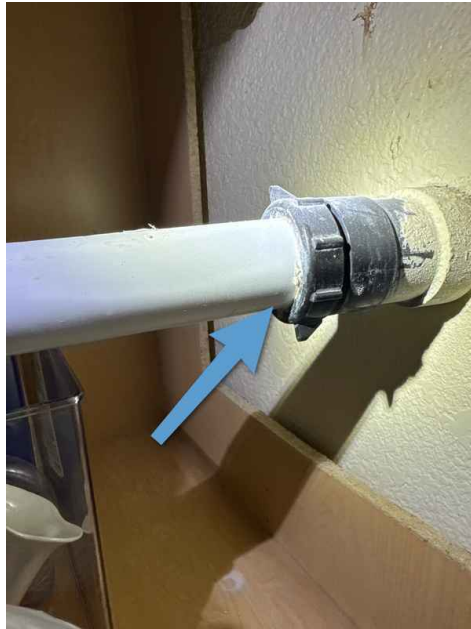
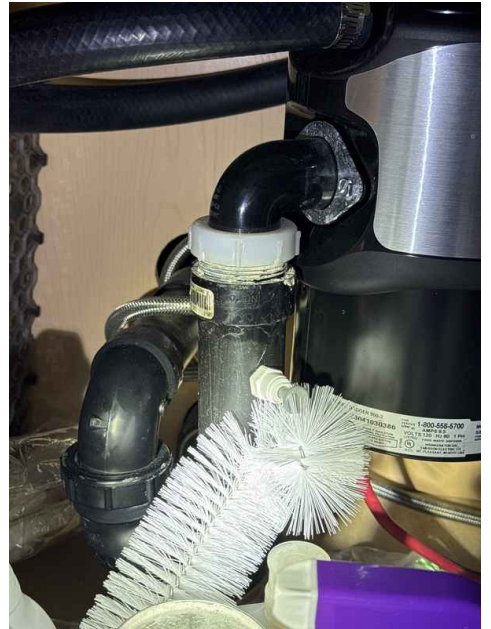
**PREVIOUS LEAK**

Contact a qualified professional.

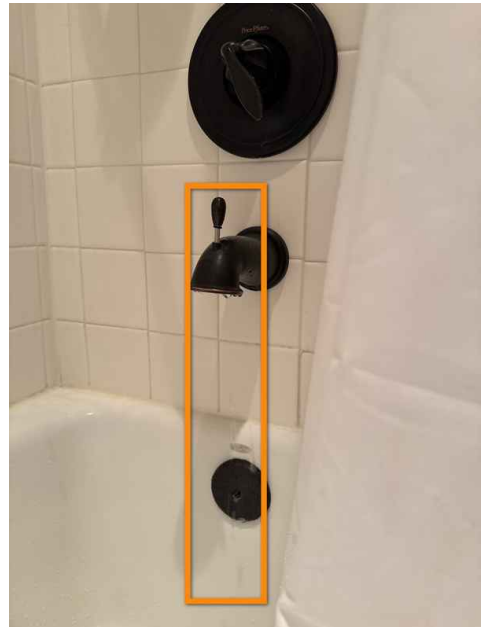
**DIVERTER - TUB SPOUT LEAKS WITH SHOWER ON**

Recommendation

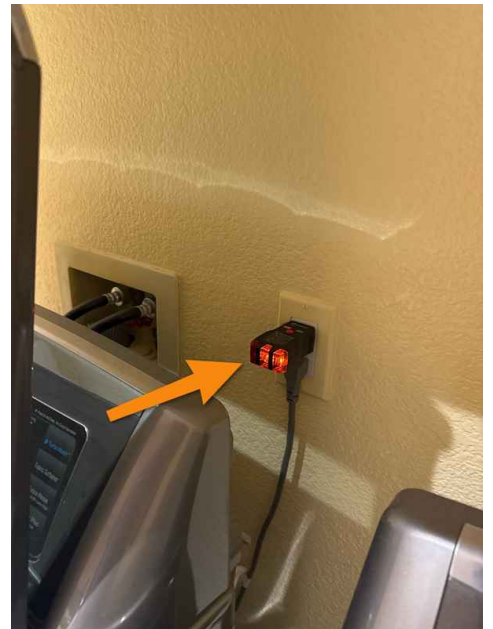
**RECOMMEND GFCI UPGRADE - LAUNDRY**

Contact a qualified electrical contractor.

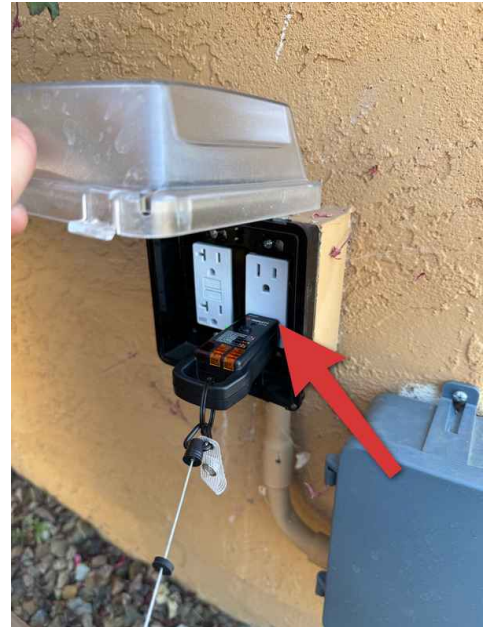
### MISSING GFCI PROTECTION - EXTERIOR

Contact a qualified electrical contractor.

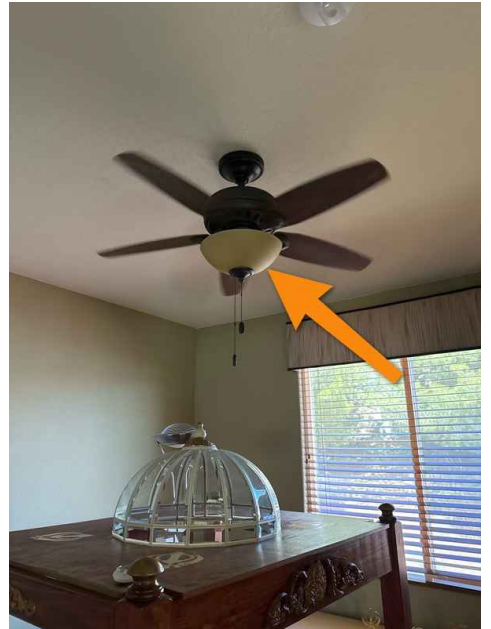
**LAMPS INOPERABLE**

Recommendation

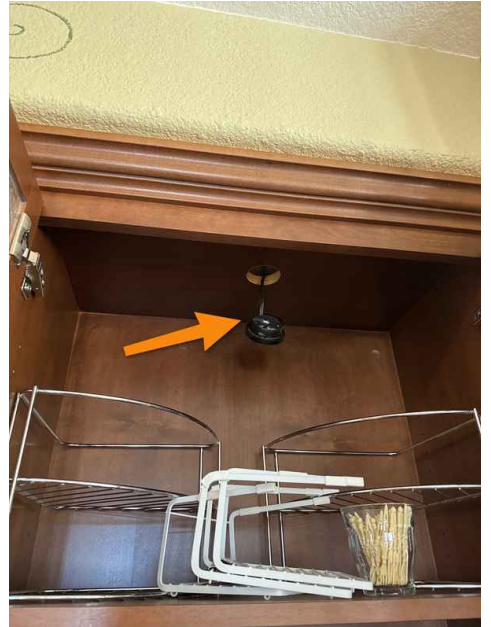
**LIGHTING LOOSE - INTERIOR**

Recommendation

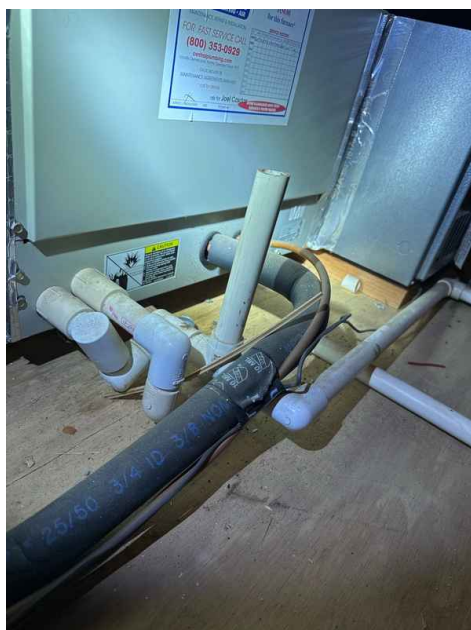
**NO CONDENSATION CATCH PAN INSTALLED**

Recommendation

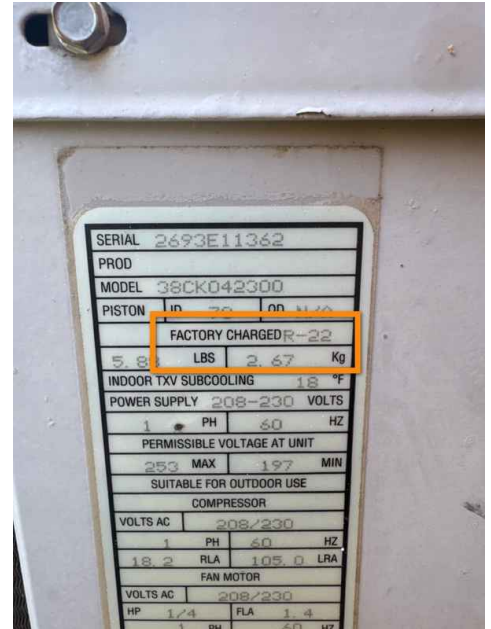
**LIFESPAN - AGED**

Recommendation

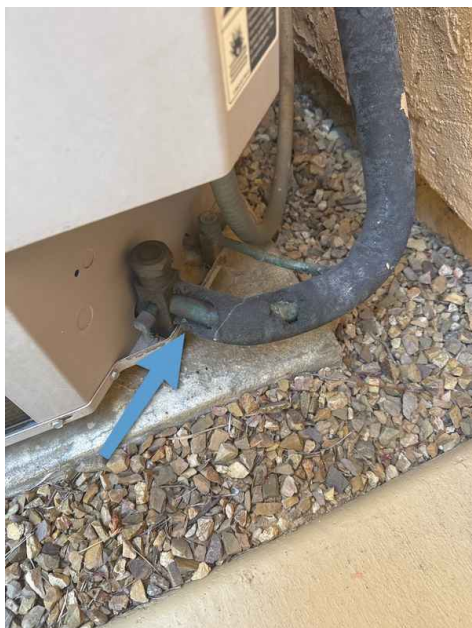
##### REFRIGERANT LINE INSULATION DETERIORATED

Maintenance Item

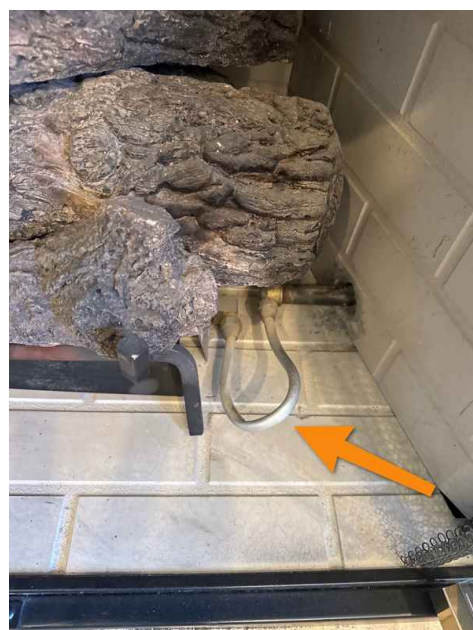
#### **ALUMINUM FLEX**

**Recommendation**

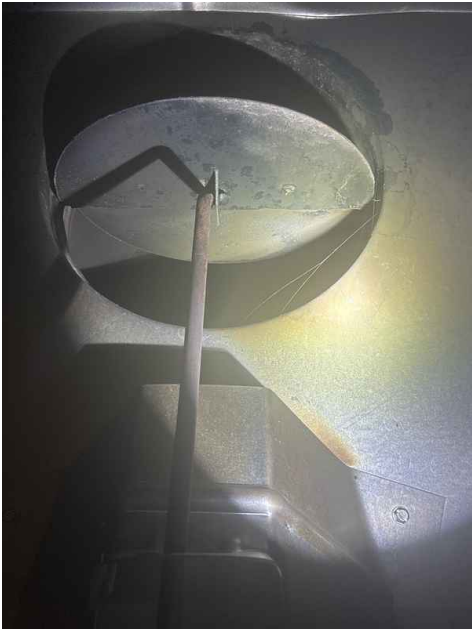
#### **CHIMNEY LINER DIRTY**

**Recommendation**
