## **Confidential Inspection Report**

**474 Via Juarez**  
**Newbury Park, CA 91320**

**Prepared for: D.W. Homes, INC**

**For D.W. Homes, INC**  
**474 Via Juarez**  
**Newbury Park, California 91320**  
**Date 09/08/2026.**

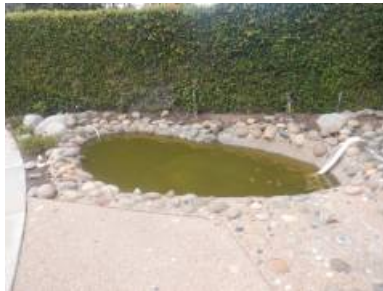
- 2.1 House faces: The front of the house faces Southwest.
- 2.2 Rear View The rear of the house faces Northeast.
- 2.3 Style of House: Two Story.
- 2.4 Estimated age of house: The house is 20 - 30 years old.
- 2.5 Approximate Lot Size: The lot appears to be of an average size for the area.
- 2.6 Site Drainage: **Attention Needed** - The lot needs some attention in areas to prevent water from standing in the yard. Standing/stagnant water at front yard noted at time of inspection. Attention is recommended. Health Concern.

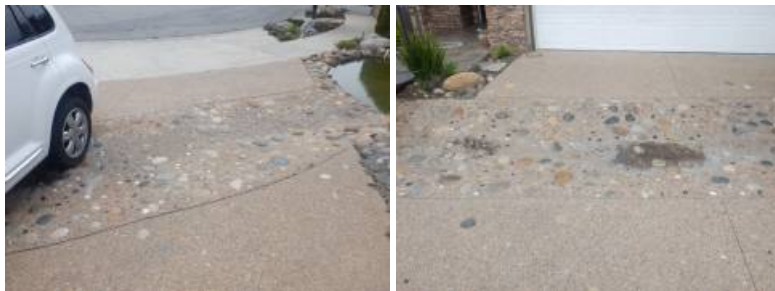
- 2.8 Driveway Paving Material: Concrete. Stone.
- 2.9 Driveway Condition: **Attention Needed** - The driveway needs attention. Unevenness noted - Trip Concern.

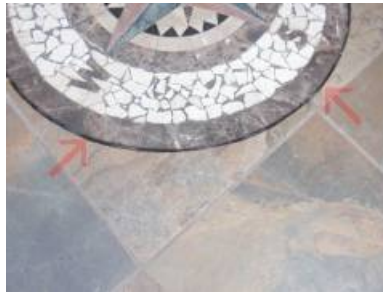
- 2.10 Walkways and Stoop Materials: Concrete. Tile.
- 2.11 Walkway Condition: Satisfactory - The walkway surface material is in satisfactory condition with only normal deterioration noted.
- 2.12 Entryway Stoop: **Attention Needed** - The entryway stoop needs some minor repair in order to defer deterioration. Deteriorated grout between tile inlay noted. Repair is recommended.

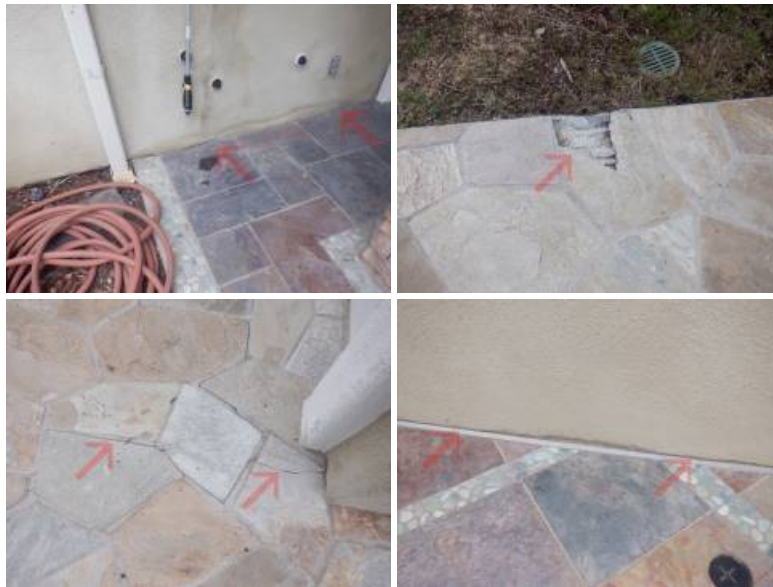
**Attention Needed** - The slab is in need of attention. Cracking and damaged materials at patio slab noted. Repairs are recommended to prevent any further damages. There are areas where the patio slab has sealed the weep screed within stucco siding. Potential for deterioration to siding due inability for the stucco to drain as intended. Monitor for any activity. Repair as needed.

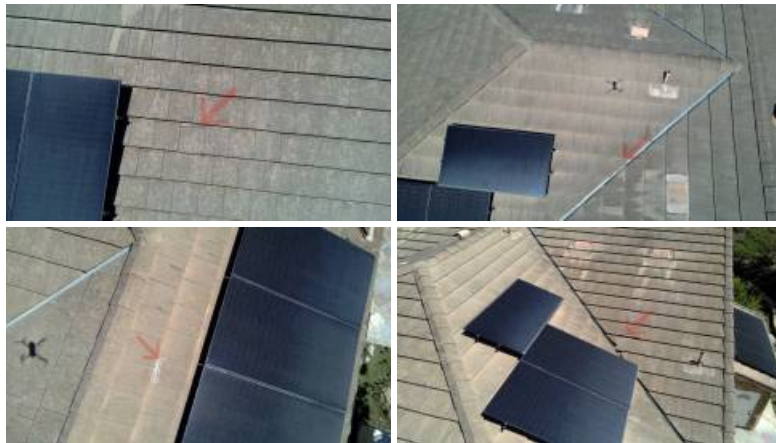
- 4.5 Condition of Roof Covering Material:** **Action Necessary** - The roof covering material shows evidence of deterioration or leakage to the degree that action is required to determine the extent of repairs needed. Estimates from licensed professionals are needed. Loose / Cracked tiles noted. Repair as needed.

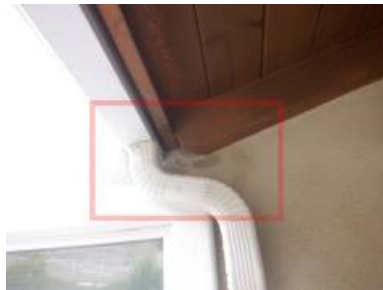
**Attention Needed** - The gutter system on the roof edge appears to be leaking or inadequately sloped to carry the water to the downspouts. Leakage at gutter system noted. Repairs are recommended.

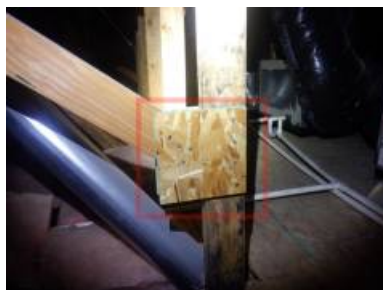
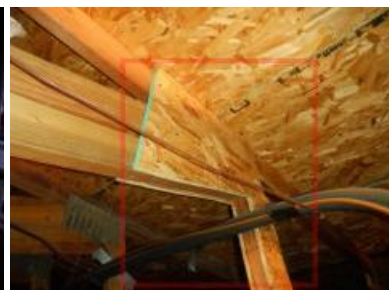
**Attention Needed** - A condition exists that needs attention. There are previous repairs to truss plates noted. Plywood materials installed over truss plates. Not typical installation. Recommend checking permits. Noted at truss above furnace unit.

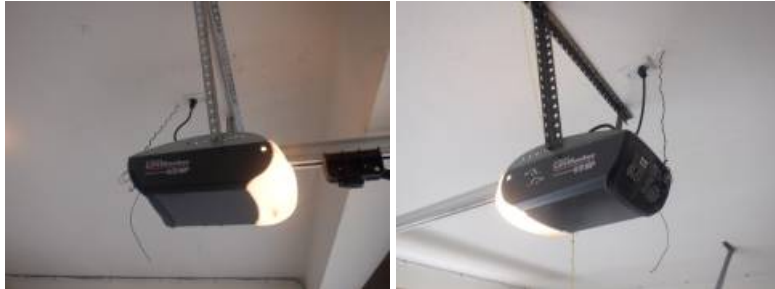
- 5.1 *Garage Type* The garage is attached.
- 5.2 *Size of Garage:* Five car garage.
- 5.3 *Number of Overhead Doors* There are two overhead doors.
- 5.4 *Overhead Door and Hardware Condition:* Satisfactory - The overhead door is in satisfactory condition, and it is functional.
- 5.5 *Automatic Overhead Door Opener:* **Attention Needed** - As of July 1, 2019 all new or replaced garage door openers are required to have battery system to allow the door to open in the event of a power outage. The current opener does not appear to have a backup installed .

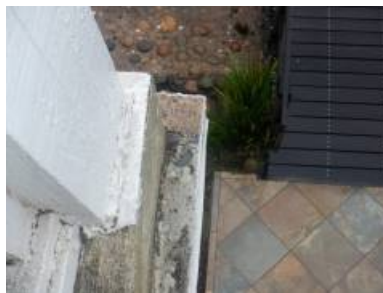
- 6.18 *There is a Wood Framed:* Suspended balcony.
- 6.19 *Deck/Porch/Balcony Materials:* The surface covering is a facade with a different material base.
- 6.20 *Framing of Deck/Porch/Trellis* Due to limited visibility under the deck, I was not able to verify the structural condition of the framing members, if there is correct drainage, or if framing is bolted to the structure.
- 6.21 *Deck, Porch, or Balcony Flooring Material:* **Action Necessary** - The decking material is either damaged or deteriorated to the degree that repairs are needed to maintain serviceability. There is deterioration to flooring membrane and exposed nails observed. Repair, if not replacement, is recommended. Contact appropriate professional to further evaluate.

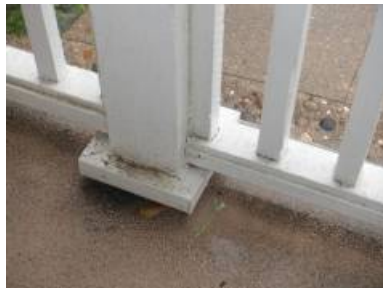
- 6.22 *Deck or Porch Railings:* Wood decay noted. Contact Pest Control Specialist for Full Details.

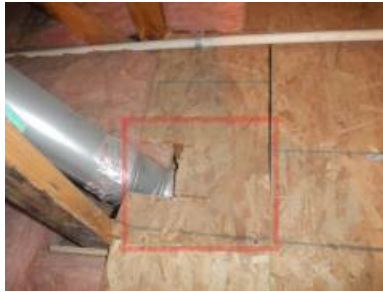
- 7.24 Heating System Location: Attic - Damaged service platform at furnace unit. Repair is recommended for safety.

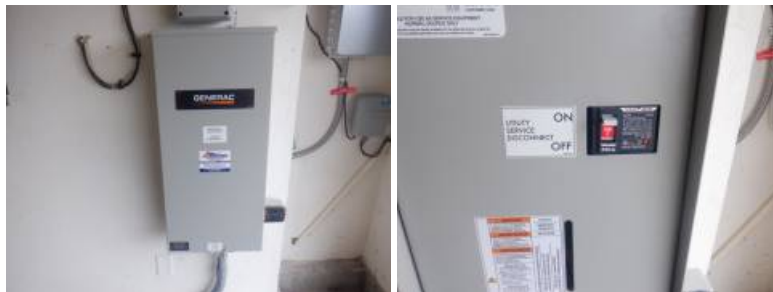
**Attention Needed** - 200 amp - The amperage of the main power panel appears to be more than adequate for the structure as presently used with room for expansion; However, the main disconnected has been relocated to the interior garage area. Not typical installation. Recommend checking permits.

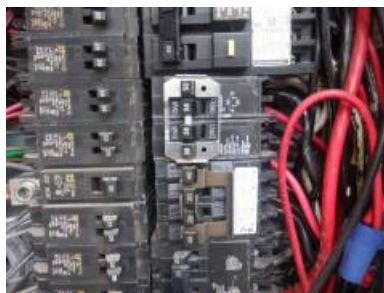
**Action Necessary** - The power panel, as a container for safely covering circuitry and components, requires immediate action to minimize the possibility of electrical shock. Mismatched breakers within main breaker panel observed. Not to building standards. Contact licensed electrician to further evaluate and repair as needed.

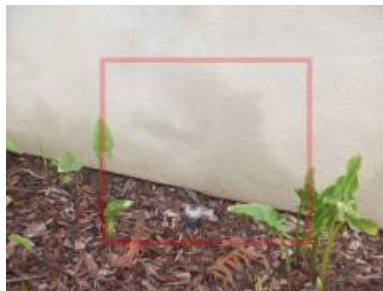
- 9.20 *Lawn Sprinkler System:* **Attention Needed** - Sprinklers are spraying against house. Recommend redirecting to prevent further damages.  
The inspection of the installed lawn sprinkler is beyond the scope of this inspection. Recommend further inspection by a licensed plumber or lawn sprinkler company.  
The inspection of the installed lawn sprinkler is beyond the scope of this inspection. Recommend further inspection by a licensed plumber or lawn sprinkler company.
