**BPG Inspection, LLC**

Client(s): Camberos  
Inspection Date: 4/22/2026  
Inspector: Mark Kirkland ,

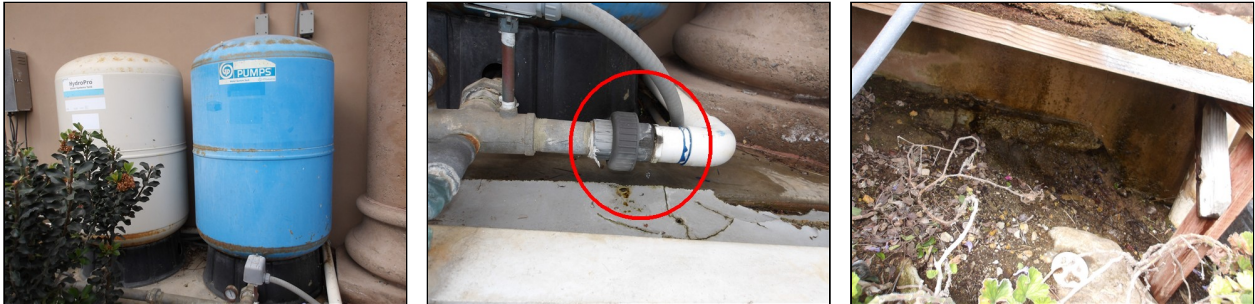
7. Inspection of the well water system is outside the scope of this inspection. However, we observed active leaking noted at the well pipes. We recommend a licensed plumber perform repairs.

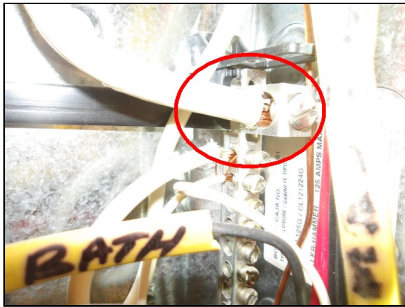
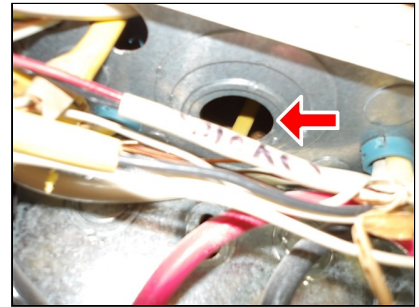
- ✖ 12. The problem(s) discovered in the master bedroom sub panel such as double lugged neutral wires at buss, frayed wires, knock out missing, and any other problems that an electrician may discover while performing repairs need correcting. We recommend a licensed electrician inspect further and correct as needed.

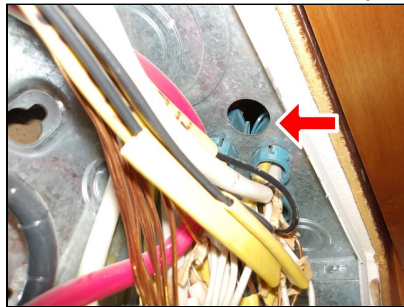
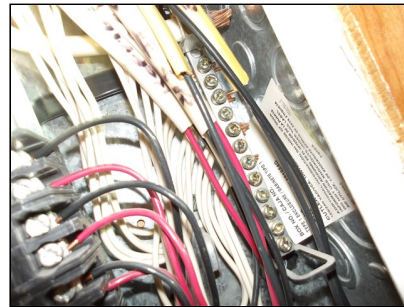
- ✖ 13. The problem(s) discovered in the kitchen pantry sub panel such as double lugged neutral wires at buss, knock outs missing in panel, and any other problems that an electrician may discover while performing repairs need correcting. We recommend a licensed electrician inspect further and correct as needed.

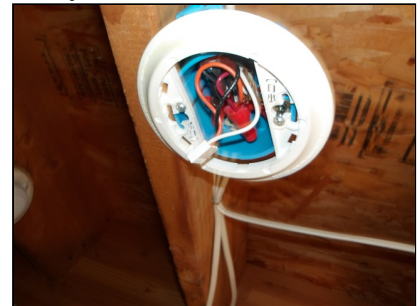
- ❌ 17. There are several open junction boxes at various locations in the attics. Lack of covers can create a shock or fire hazard.
- A qualified technician should check the system and install proper covers on all junction boxes.

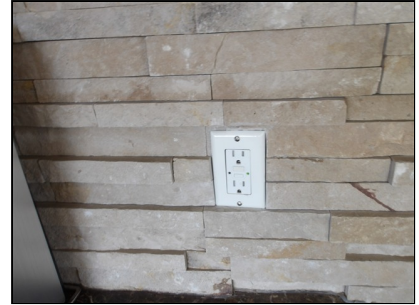
- ❌ 18. Several exterior outlet and switches at the front exterior, left side cabana, prayer house entryway, does not have an exterior rated cover installed. A qualified technician should install exterior rated covers at all exterior locations.

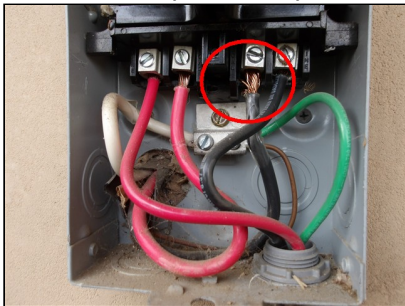
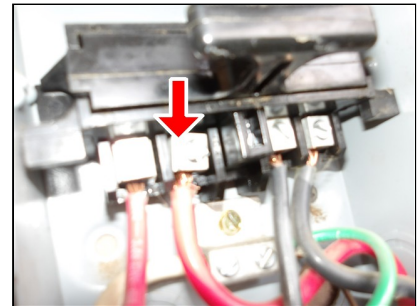
- ❌ 23. Two of the AC electric disconnects has frayed wire connections at the rear exterior of the home. A licensed electrician should perform repairs.

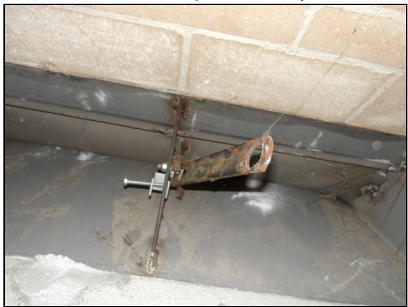
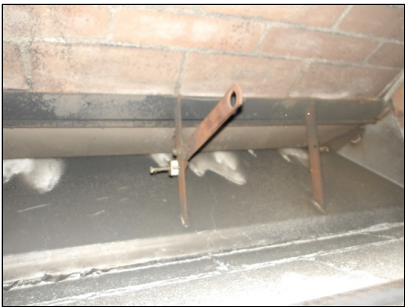
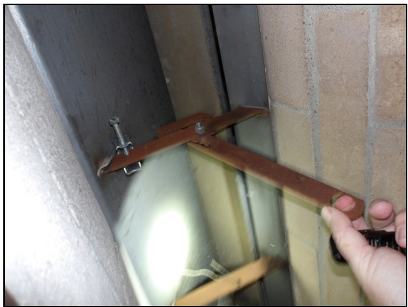
- ❌ 30. All of the gas log fireplaces have a damper clamp installed but they are incorrectly installed and fail to stop the damper from fully closing. This is an important safety feature that ensures toxic gases go up the chimney, instead of escaping to the interior. - An approved damper clamp should be installed. (This is a very small "C" clamp attached to the damper door.)

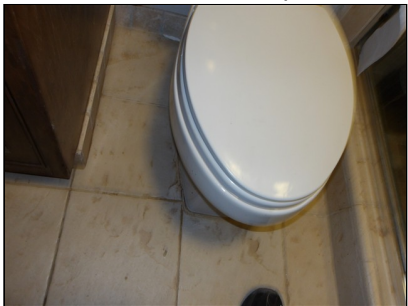
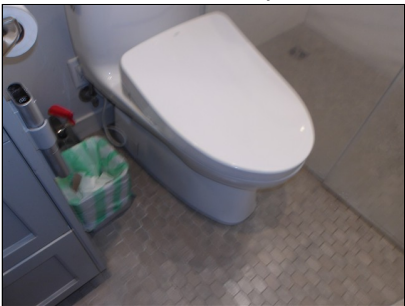
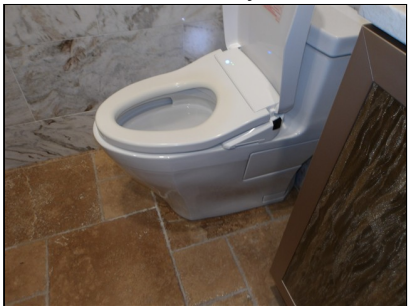
- ❌ 31. The garage, half bathroom and front right bedroom toilets are not securely attached at the floor. This could allow leaks at or into the floor. A qualified technician should make repairs or modifications as necessary.

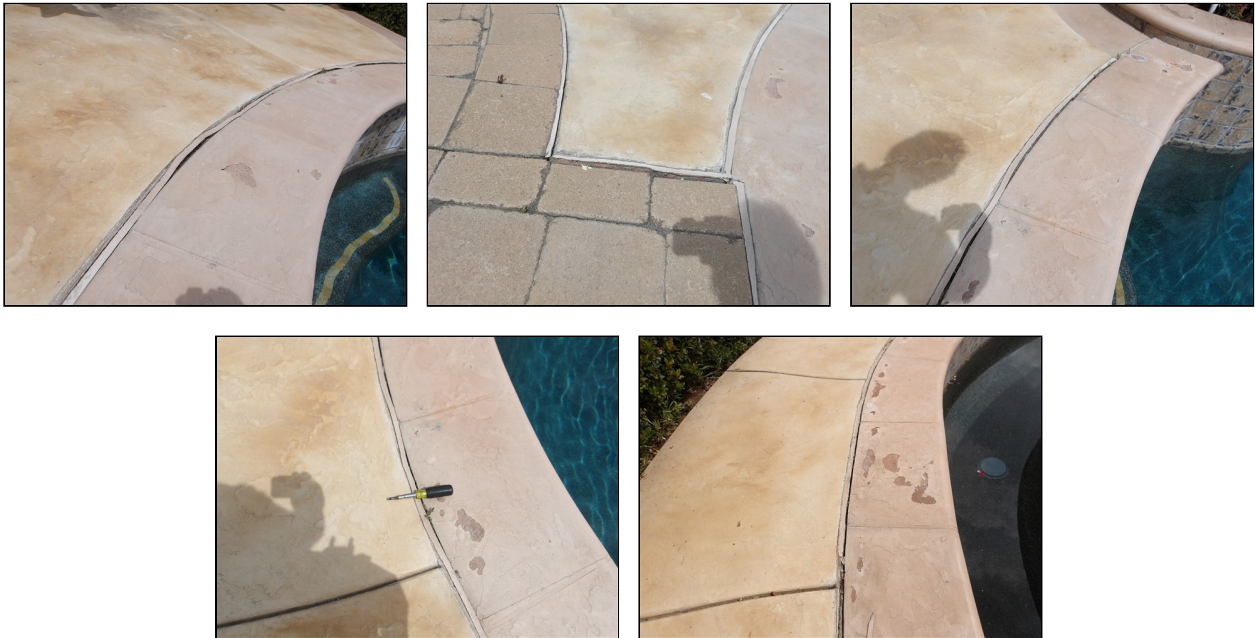
34. The flexible expansion joint separating the pool coping from the surrounding flatwork is deteriorated. This may lead to water penetration under the concrete. Over time, this could damage the concrete and pool. There is currently an uneven walking surface, signs of separation and possible movement. A qualified pool contractor should evaluate the area and perform repairs.

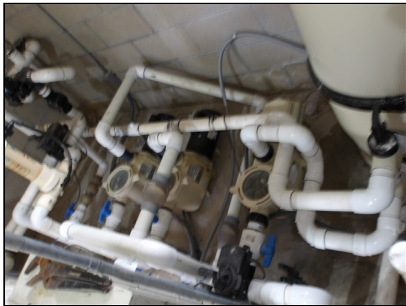
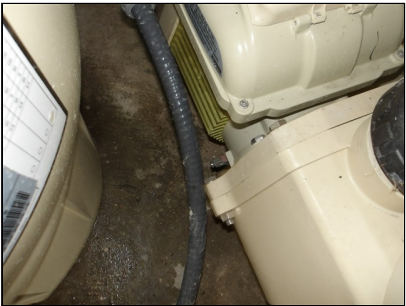
- ❌ 36. Two pool pumps lacks proper bonding to ground. Equipment that is not bonded can be a shock hazard. A qualified licensed electrician should make any needed modifications.

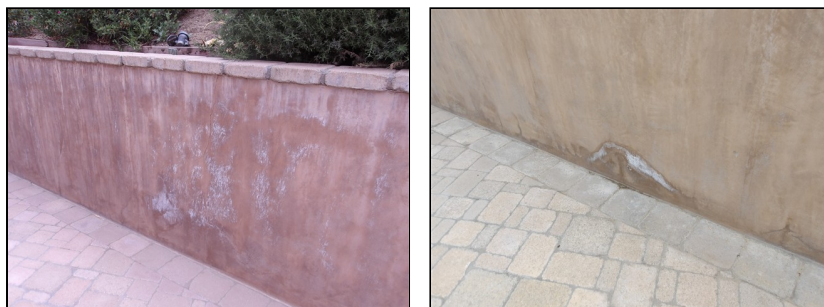
49. A condition known as efflorescence is evident on portions of the retaining walls. This whitish, fuzzy material is a mineral deposit left when moisture in the concrete evaporates. The presence of efflorescence and water marks often indicates an occasional surplus of moisture on the outside of the wall. The efflorescence was minor in the opinion of the inspector. The areas should be monitored for signs of excess moisture and repaired by a licensed technician if needed.

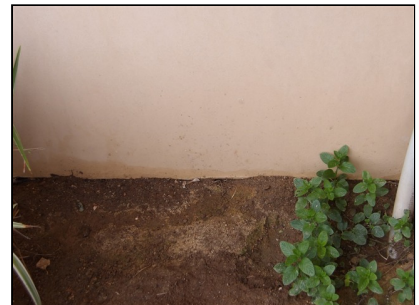
55. Soil is at or above the weep screed at several areas.  
- We recommend adequate clearances be provided in accordance with current standards.

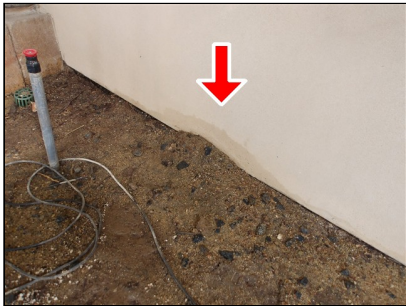
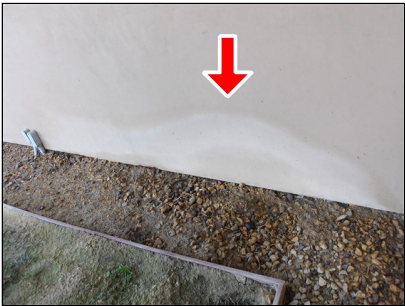
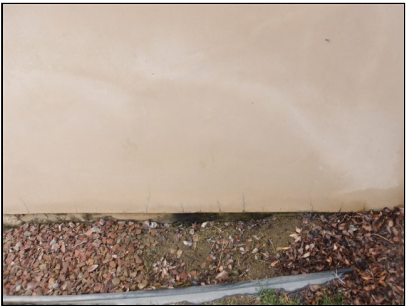
57. One or more of the sprinkler heads on several areas sprays the building. This can promote damage to the siding, trim or structure. The sprinkler heads should be adjusted to ensure that they do not spray the building.

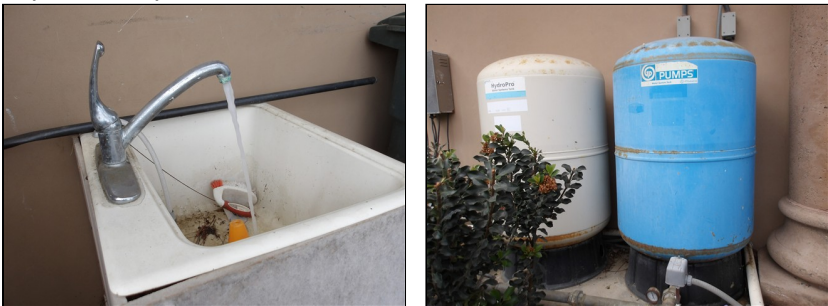
61. The sink at the exterior of the exterior storage building has cold water only. We are unable to verify the drain discharge location. There is no trap on the sink and it looks like it drains toward the yard drain. A licensed contractor and/or specialist should perform repairs.

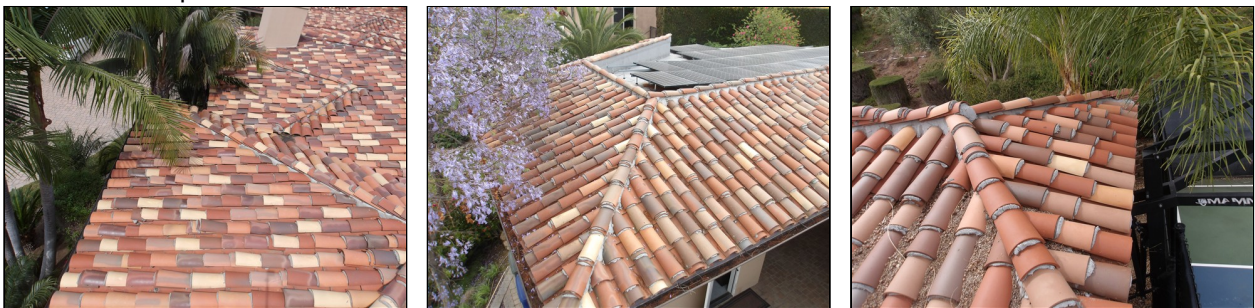
62. Trees near the building have overhanging branches resting on the roof. This could damage (abrade) the roof surfaces.  
- Trees should be pruned as needed.

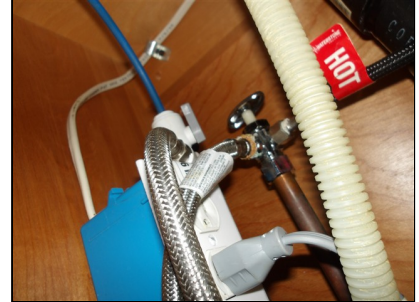
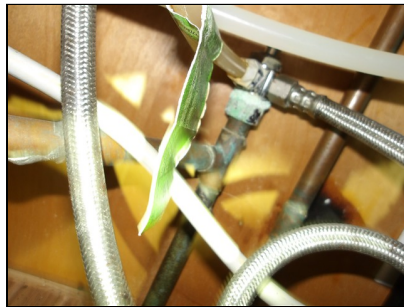
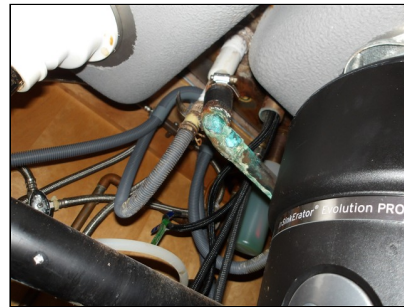
68. There is surface corrosion in the visible supply and/or waste piping at several valves, fixture and drains in the home. We observed no signs of active leaks at the time of the inspection but leaks can develop anytime without

- This piping should be evaluated for leaks on a regular basis and repaired by a qualified technician when necessary.

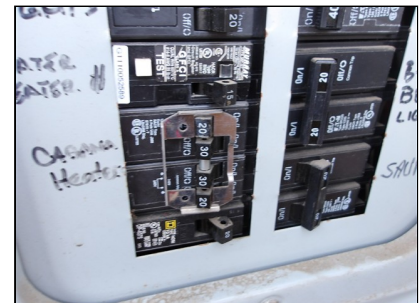
78. One or more breakers in the exterior cabana sub panel are in the off position at the time of this inspection. We did not activate the breakers, or energize the circuits because doing so could create a hazard.
- The owner may have information as to why the breakers are in the OFF position. If it is not functional, a licensed electrician should make appropriate repairs before closing escrow.

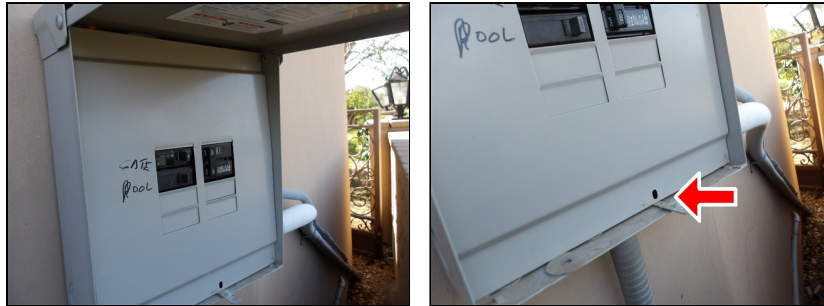
80. The exterior cabana electric panel is missing a cover screw and labels. A qualified technician should install a cover screw and label the circuits.

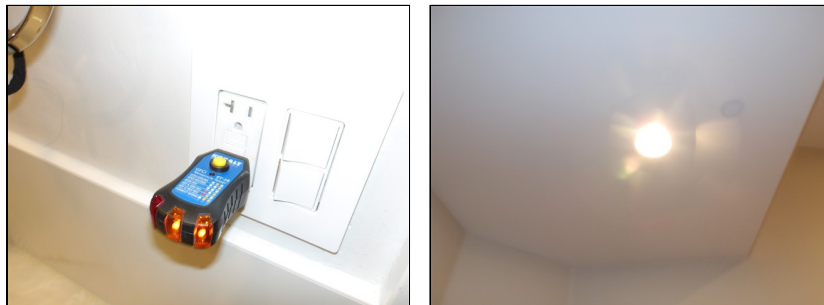
81. The middle bedroom bathroom GFCI outlet is wired to the bedroom entryway lights. If the GFCI trips then the lights will also go out, this could create a trip hazard if this happens in the dark. We recommend installing additional lights to assist you if the lights go out from tripping the GFCI. A licensed contractor and/or specialist can perform the work.

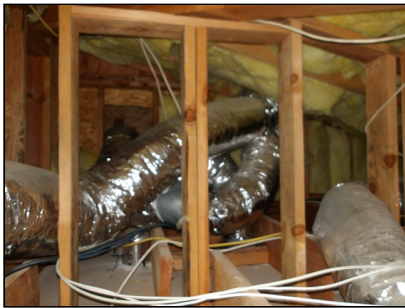
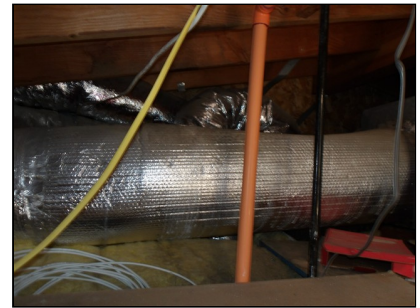
87. We could not access one or more attic areas due to one or all of: no access, low headroom, vaulted ceilings, insulation concealing the rafters, duct work, temperature, unsafe conditions, storage, etc. Further evaluation is advised if the client has concerns about these areas.

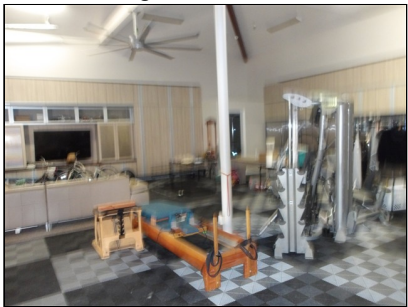
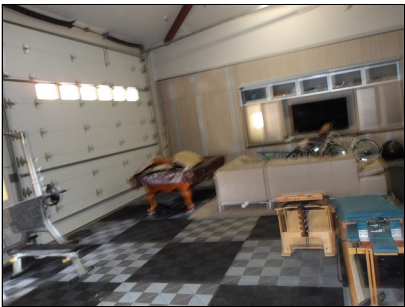
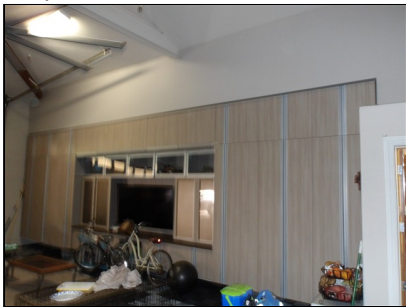
91. The presence of personal items limited access to the garage at the time of this inspection.
- A "walk through" is recommended when the areas is cleared and accessible, prior to the close of escrow.

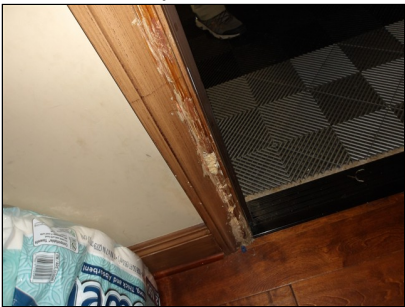
93. The door trim is damaged in the garage bedroom. A qualified technician should repair the damaged areas.

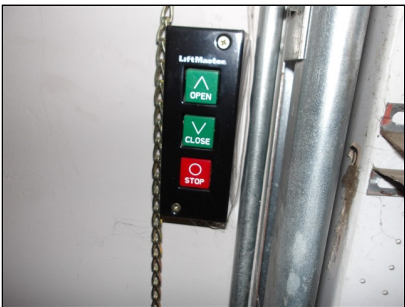
94. The garage door controls near the doors failed to stop when the buttons were pushed. The doors stopped when the wall controls near the garage pedestrian door was pushed but not when these buttons were pushed. A qualified technician should repair as needed.

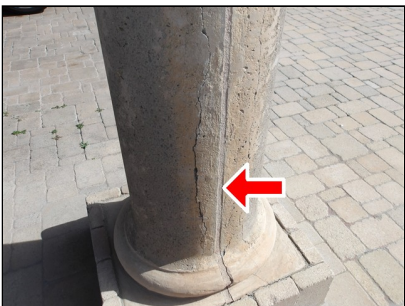
95. Several exterior front carport cover post are cracked. We observed no signs of structural movement. A qualified technician should repair the cracked areas

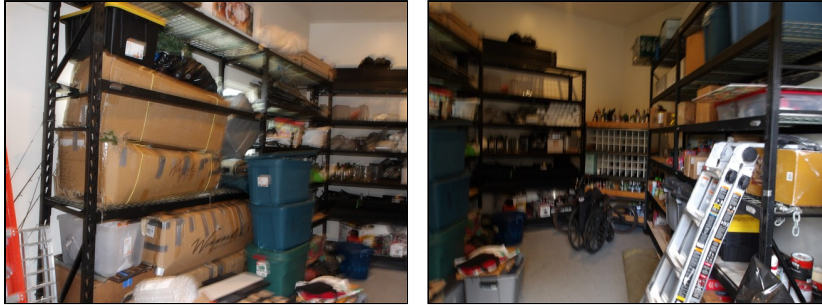
96. The presence of many personal items limited access to the detached storage room at the time of this inspection.  
- A "walk through" is recommended when the areas is cleared and accessible, prior to the close of escrow.

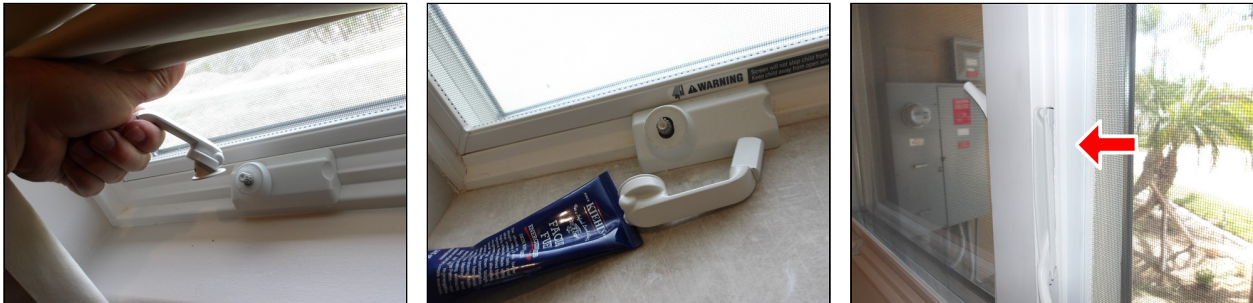
98. Several windows do not operate smoothly, are difficult to latch or are in need of adjustment. All poorly or non-operating windows and their associated hardware should be cleaned, lubricated, and adjusted for smoother operation. Where needed, essential hardware, such as operator cranks, sash balances and latches should be replaced with compatible components.

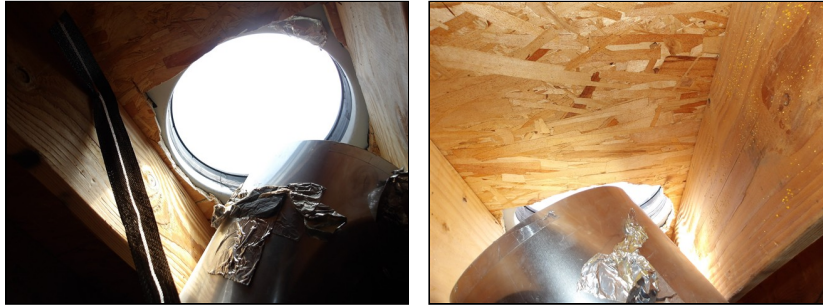
103. The solar tub is disconnected in the master bedroom attic. It does not divert the light down the tube and into the room. A qualified technician should repair as desired.

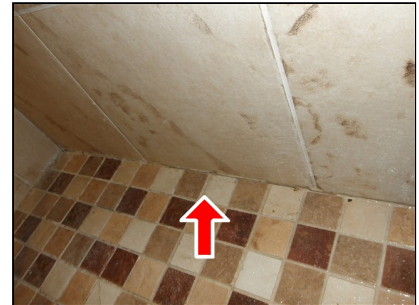
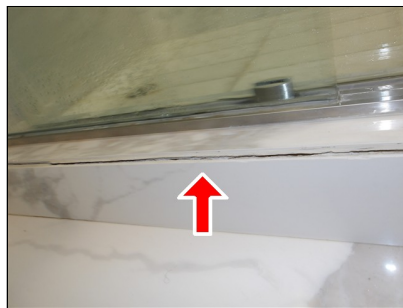
107. The grout is cracked, deteriorated and/or missing in several areas at the cabana, garage, far right side bathroom. Damaged or missing grout can cause leaks and moisture damage. A licensed contractor and/or specialist should perform repairs.

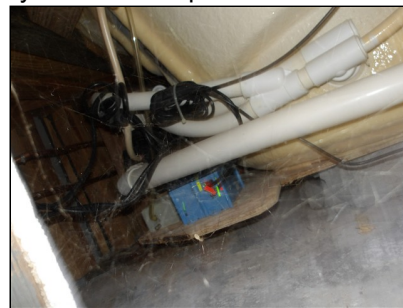
111. There is an access panel for the jet tub at the rear exterior of the home. There is limited access inside the panel to inspect the jet tub and its components. We were unable to verify if the jet tub is properly bonded. We saw no GFCI for the jet tub. We recommend having the seller identify the GFCI location for the jet tub. A licensed contractor and/or specialist should gain access and verify pump is properly bonded and perform additional repairs as needed.

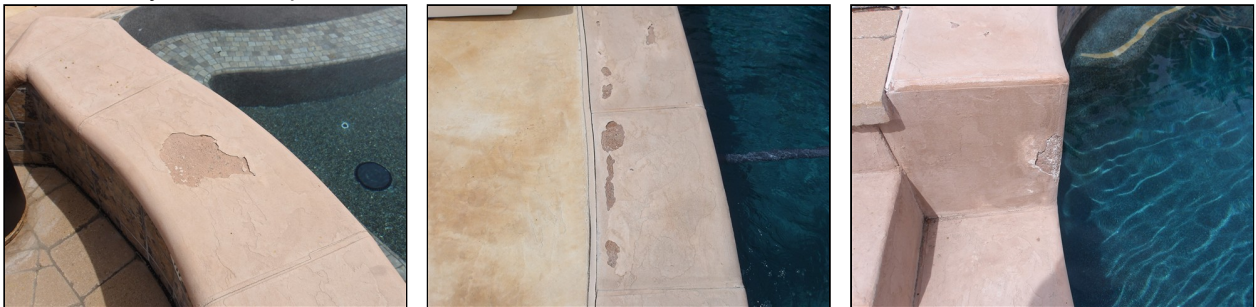
115. The pool and spa patio surface is damaged, deteriorated and peeling paint in several areas. A qualified contractor should make any needed repairs or modifications.

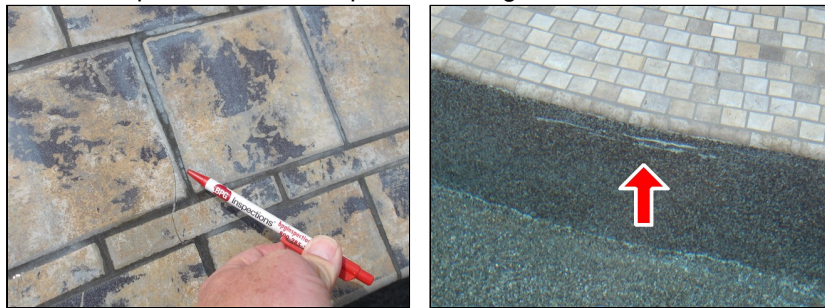
117. One or more cracked tiles were noted in the spa. We observed deterioration and possible cracks in the spa. A licensed pool contractor and/or specialist should repair all damaged areas.

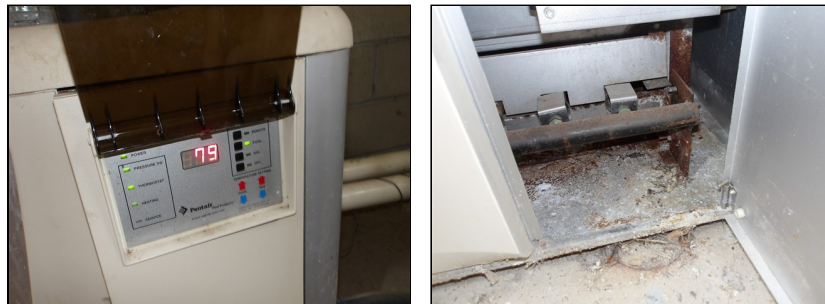
119. The heating system, which is an older system, responds to normal operating controls. The system is dirty and shows normal wear and tear for a system this age. We recommend review and servicing by a qualified pool contractor prior to close of escrow.
