USA Home Inspectors

Home Inspection Report

3254 S Bonita St

Inspected On: Wed, Jul 23 2025 at 8:00AM

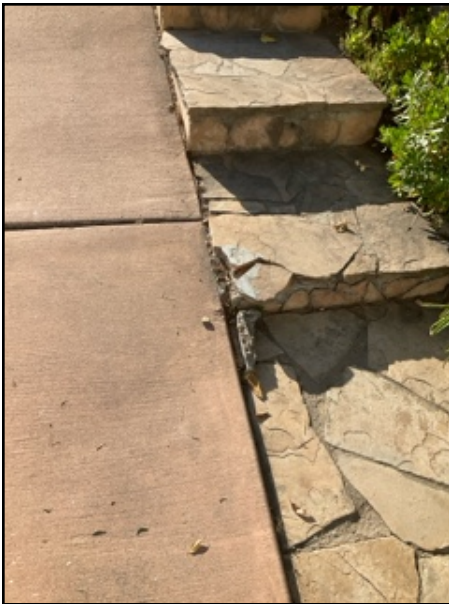
Figure 5-1

Cracks, stains and uneven surfaces noted at driveway, walkways and patio.

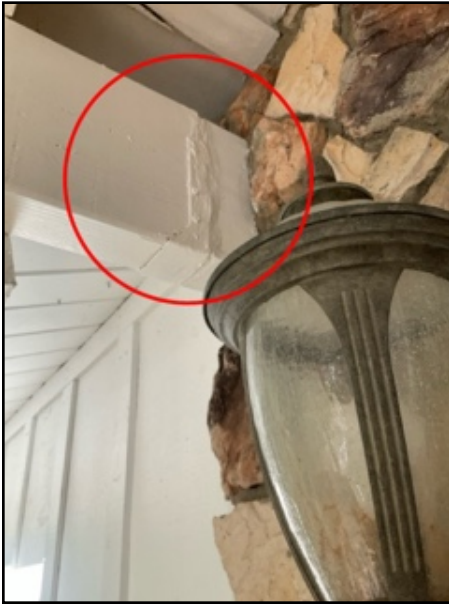
Figure 7-1

FURTHER EVALUATION REQUIRED: Evidence of possible wood destroying organisms noted on front porch. Beam at front porch noted as recently installed with joist hanger. Have a more qualified professional to evaluate.

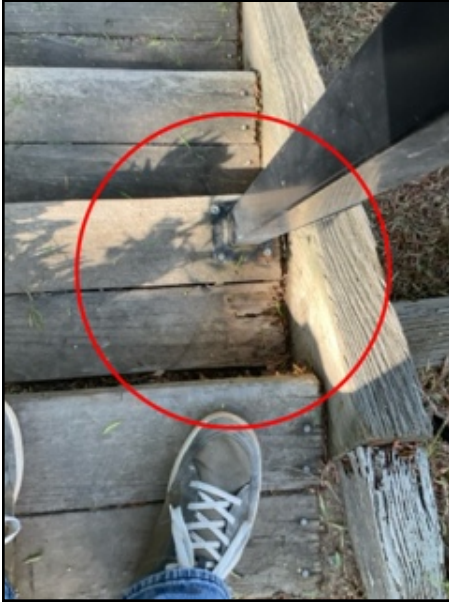
Figure 8-1

REPAIR OR REPLACE: Evidence of dry rot and disintegrating wood steps off side yard. Handrail noted as loose.

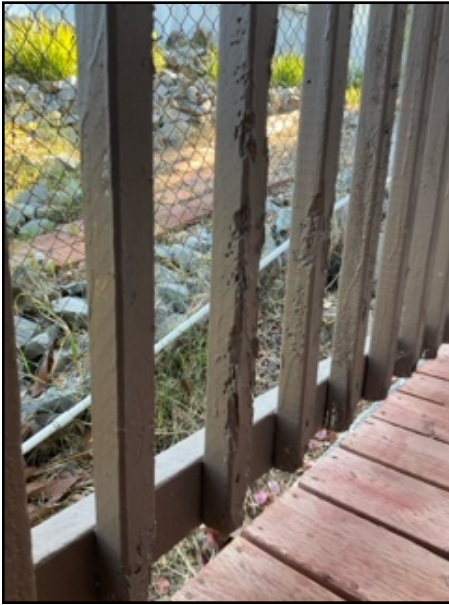
Figure 9-1

FURTHER EVALUATION REQUIRED: Evidence of possible wood destroying organisms/dry rot noted on wood railing on deck in backyard. Boards noted as not flush with deck.

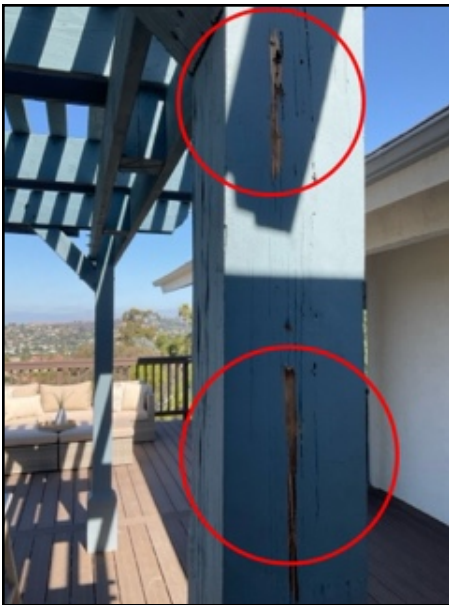
Figure 10-1

FURTHER EVALUATION REQUIRED: Evidence of possible wood, destroying organisms/dry rot noted on wood pergola off top deck.

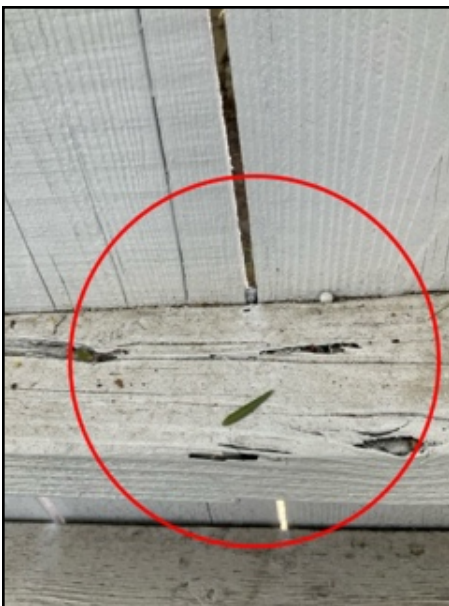
Figure 11-1

REPAIR OR REPLACE: Sunburn, peeling paint, damaged wood, wood-to-soil contact, and evidence of possible wood destroying organisms noted at various locations throughout fence.

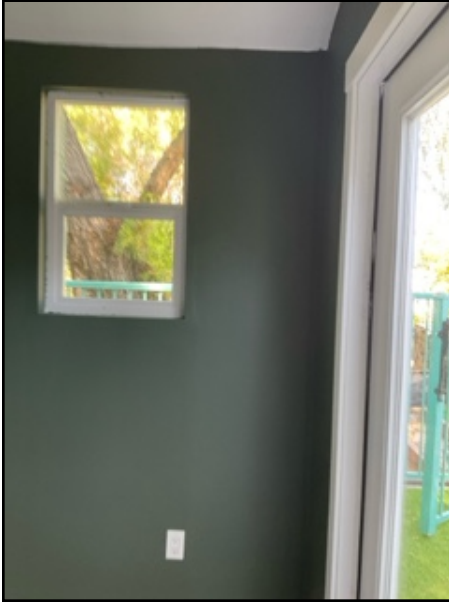
Figure 12-1

REPAIR OR REPLACE: Electrical outlet on right side in shed noted as open ground and covers are loose.

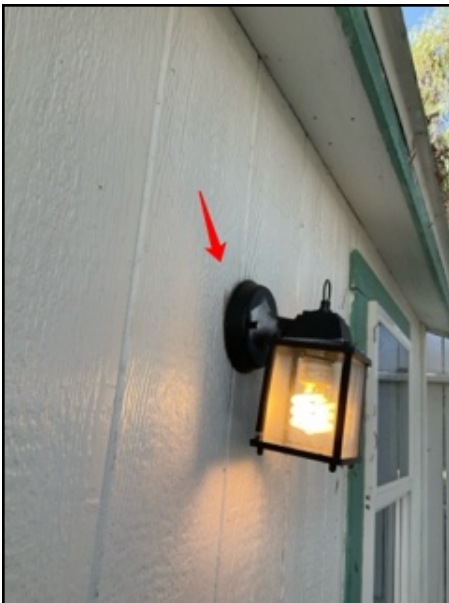
Figure 13-1

REPAIR OR REPLACE: Outside electrical lights noted as loose and not sealed off shed.

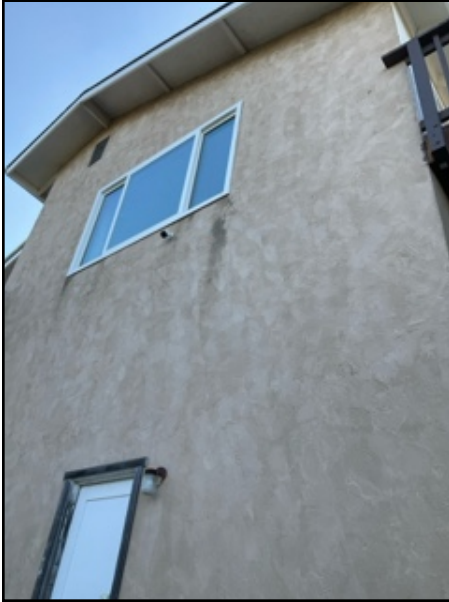
Figure 14-1

**Comment 14:**
Defects such as peeling, holes, cracks, and patches noted at various places throughout exterior.

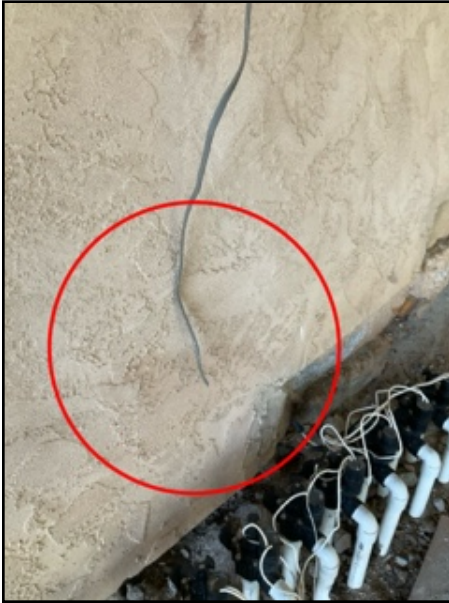
Figure 15-1

REPAIR OR REPLACE: Exposed non-hot wires noted on exterior.

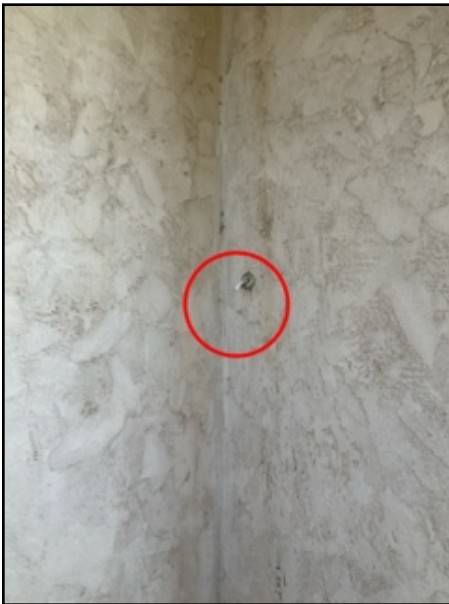
Figure 16-1

REPAIR OR REPLACE: Exposed cable wire noted on exterior.

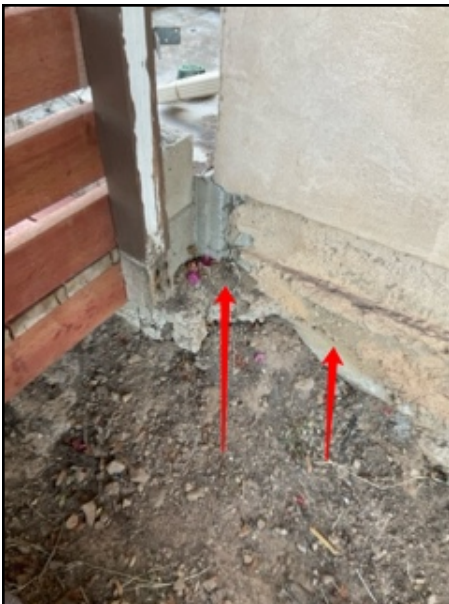
Figure 17-1

FURTHER EVALUATION REQUIRED: Exposed foundation noted in rear and side of home. So erosion noted.

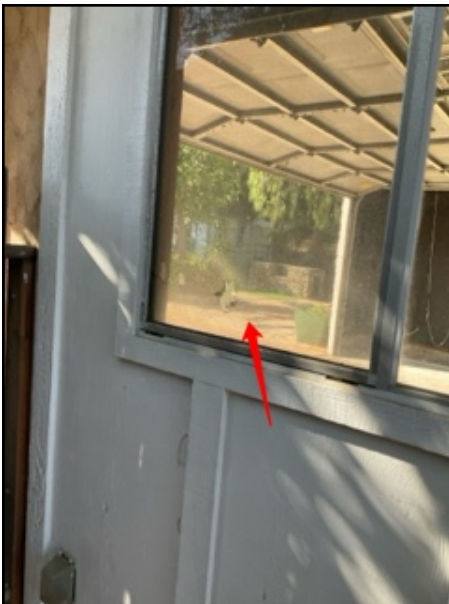
Figure 18-1

REPAIR OR REPLACE: Window screen off garage noted as torn.

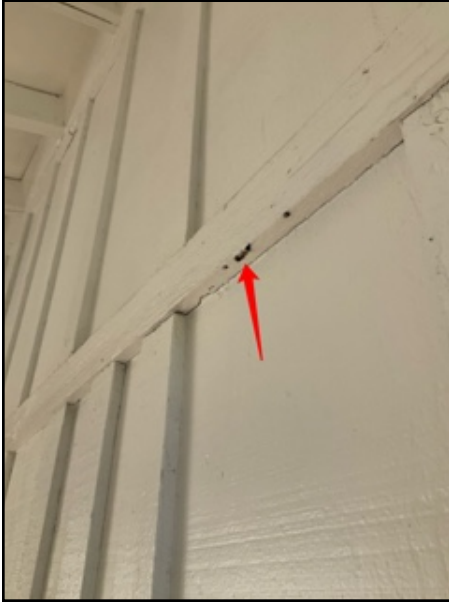
Figure 19-1

**Comment 19:**
FURTHER EVALUATION REQUIRED: Evidence of possible wood, destroying organisms/dry rot noted on wood siding near front door.

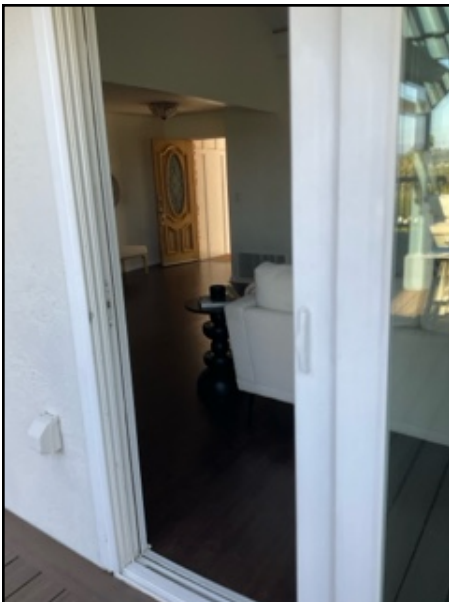
Figure 20-1

**Comment 20:**
REPAIR OR REPLACE: Patio screen doors turned as not installed.

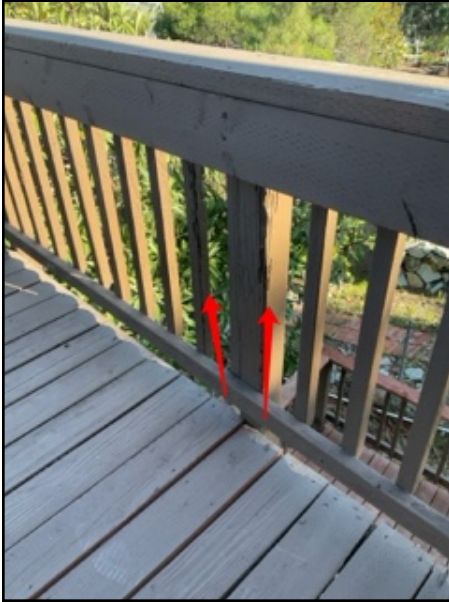
Figure 21-1

**Comment 21:**
FURTHER EVALUATION REQUIRED: Evidence of possible wooddestroying organisms/dry rot noted on wood balcony off master bedroom.

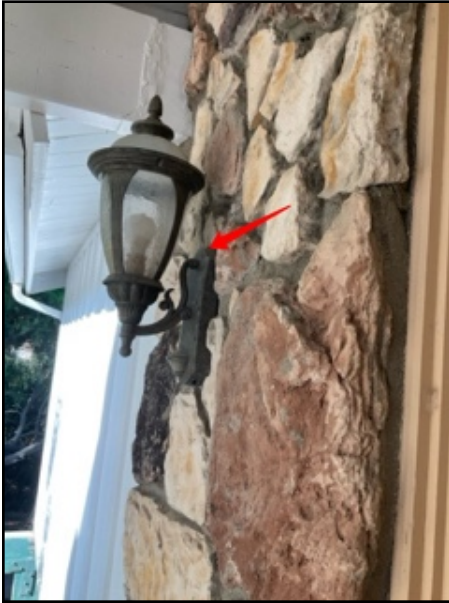
Figure 22-1

**Comment 22:**
REPAIR OR REPLACE: Exterior lights noted as loose and not sealed.

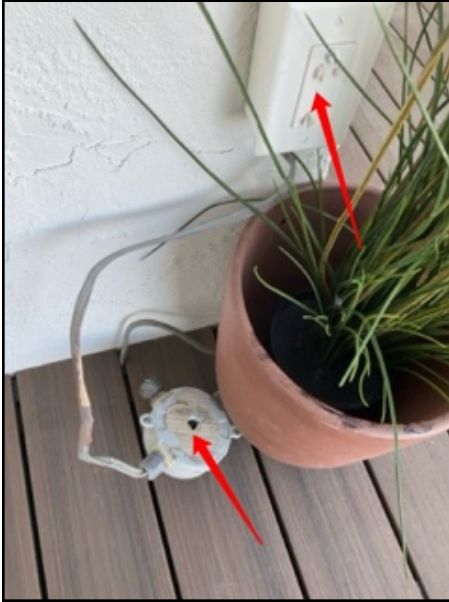
Figure 23-1

REPAIR OR REPLACE: Exterior outlet noted as missing cover, tape noted in holes and junction box not connected.

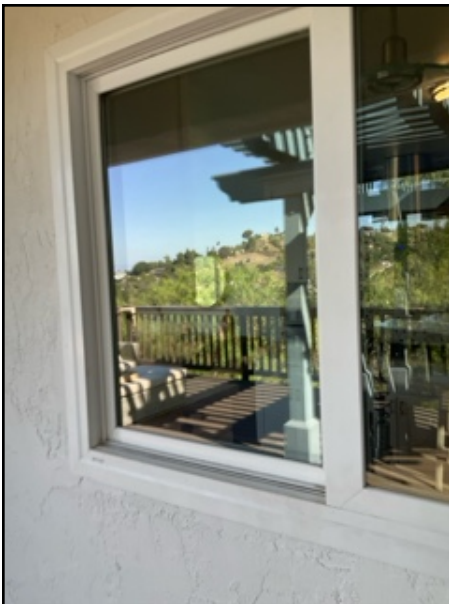
Figure 24-1

REPAIR OR REPLACE: Window screens noted as not installed on any windows.

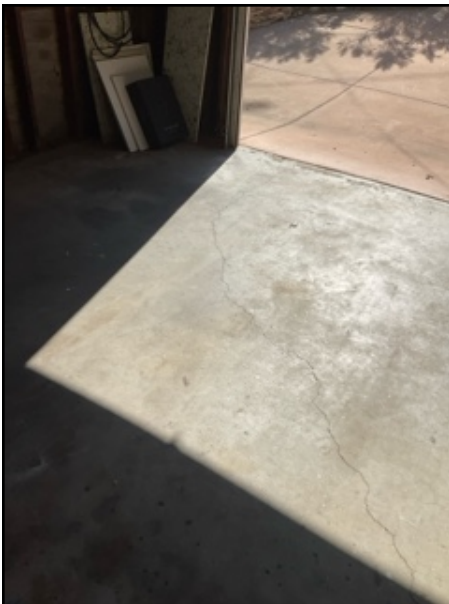
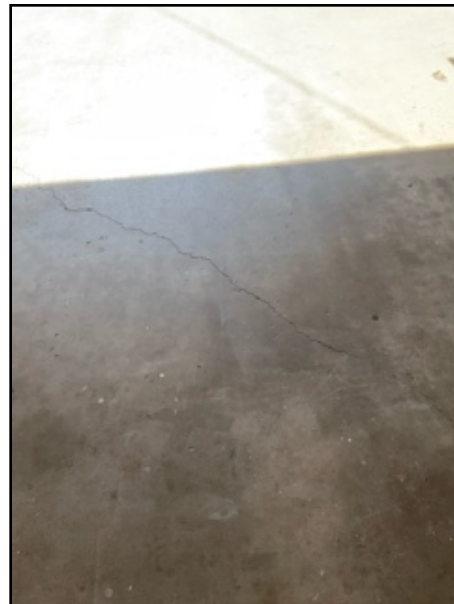
Comment 26:
Cracks and stains noted at garage floor.

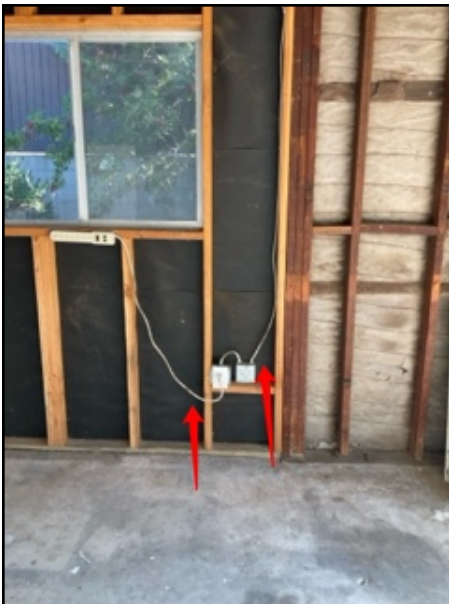
Figure 27-1

REPAIR OR REPLACE: Exposed electrical wires under 7 feet in garage.

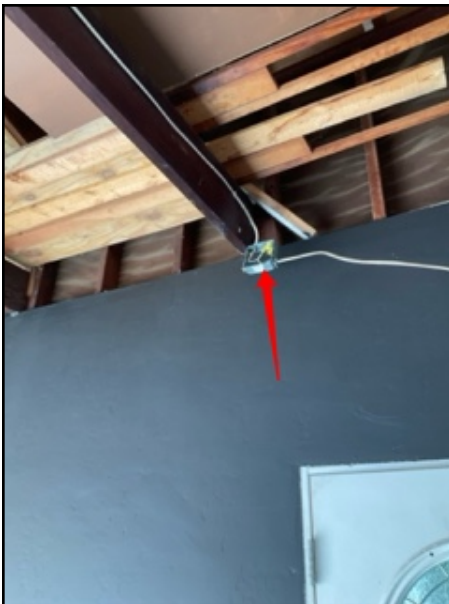
Figure 28-1

REPAIR OR REPLACE: Junction box noted as missing cover.

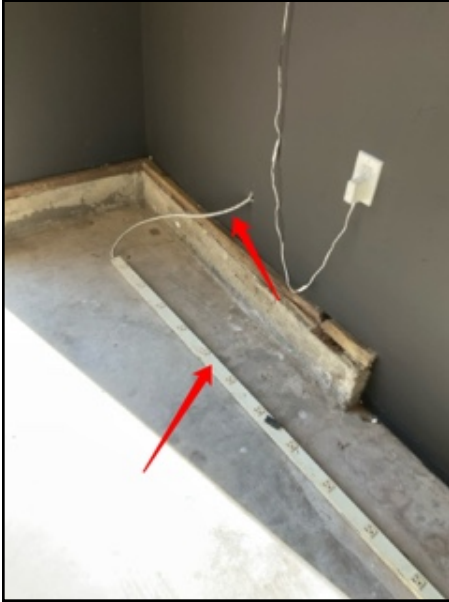
Figure 29-1

REPAIR OR REPLACE: Electrical strip noted as hardwired in wall and loose on ground.

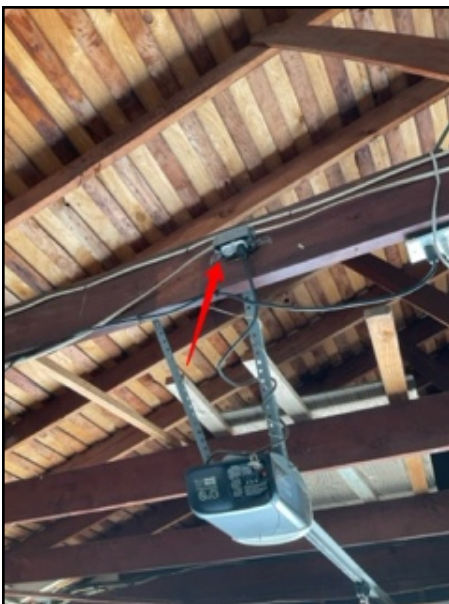
Figure 30-1

REPAIR OR REPLACE: Electrical outlet for garage vehicle door motor noted as missing cover.

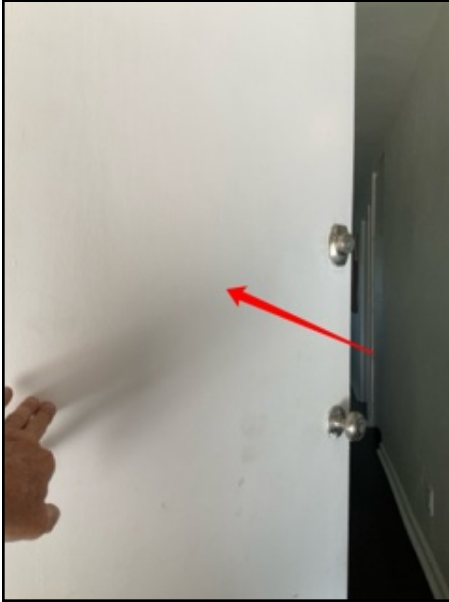
Figure 31-1

REPAIR OR REPLACE: Garage entry doors are required to have at least a 20-minute fire rating or be solid wood of at least 1-3/8 inches thick with a self-closing hinge.

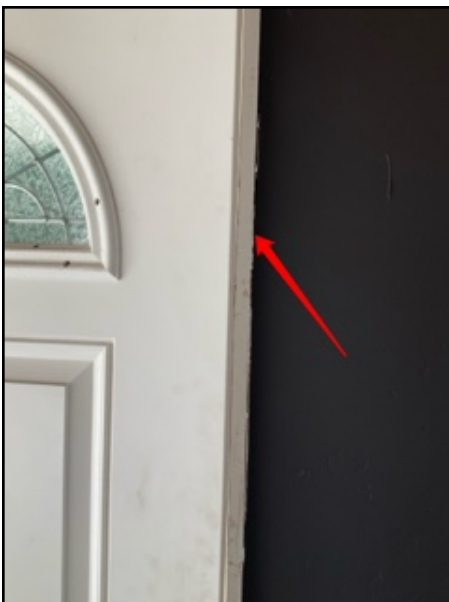
Figure 32-1

REPAIR OR REPLACE: Garage side door noted as hitting door jam and will not close without force.

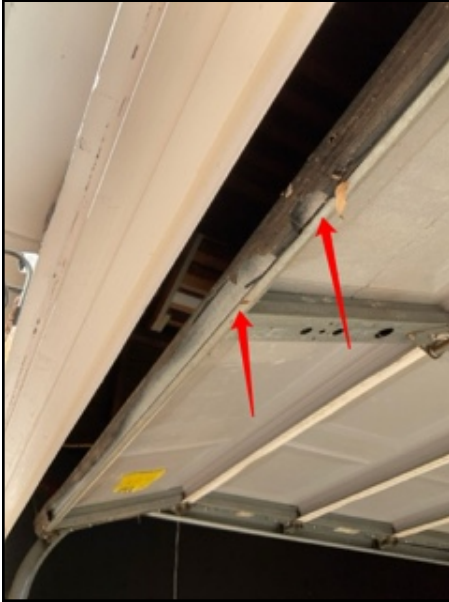
Figure 33-1

REPAIR OR REPLACE: Weatherstripping on bottom of garage vehicle door noted as torn and deteriorated.

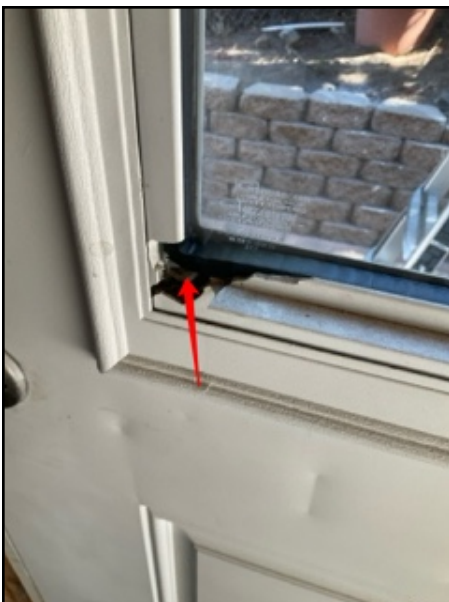
Figure 34-1

REPAIR OR REPLACE: Trim around garage window off side door noted as broken and seal is moving.

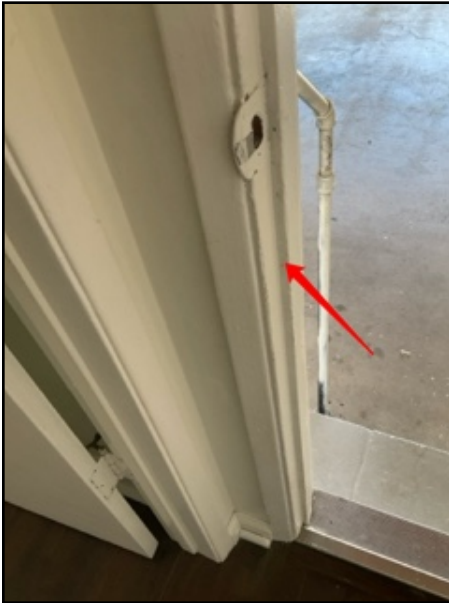
Figure 35-1

REPAIR OR REPLACE: No weatherstripping noted as installed around garage entry door. Daylight noted as coming through bottom of door. This is a possible rodent entry point.

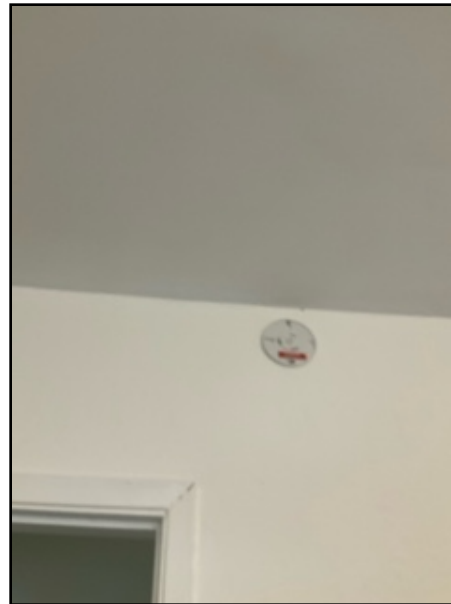
Figure 41-2

**Comment 41:**
REPAIR OR REPLACE: Smoke detectors noted as not installed in two small bedrooms.

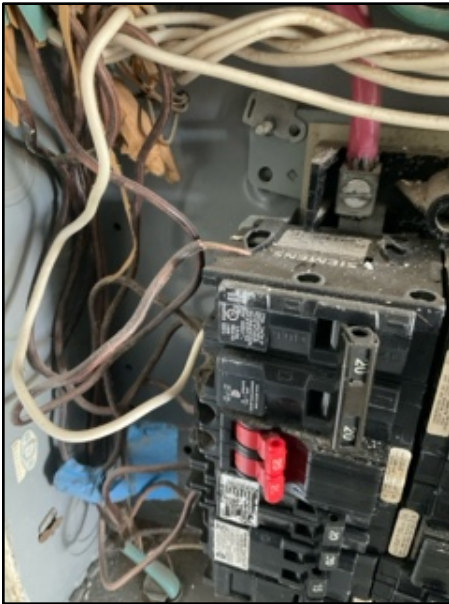
Figure 42-1

REPAIR OR REPLACE: Copper wire noted as not connected to 20 amp 220 breaker top left.

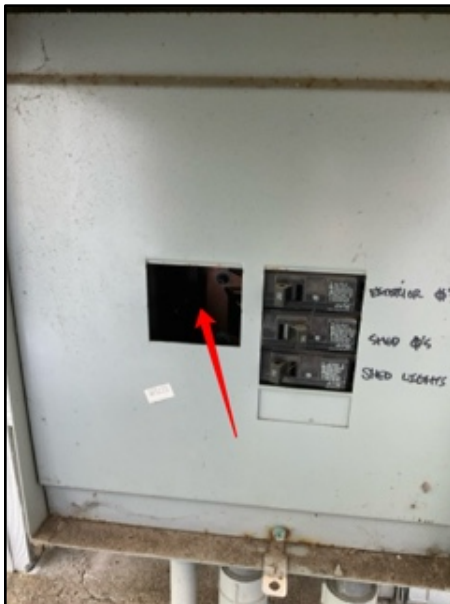
Figure 43-1

REPAIR OR REPLACE: Missing block off plates noted at empty breaker spots inside service sub panel.

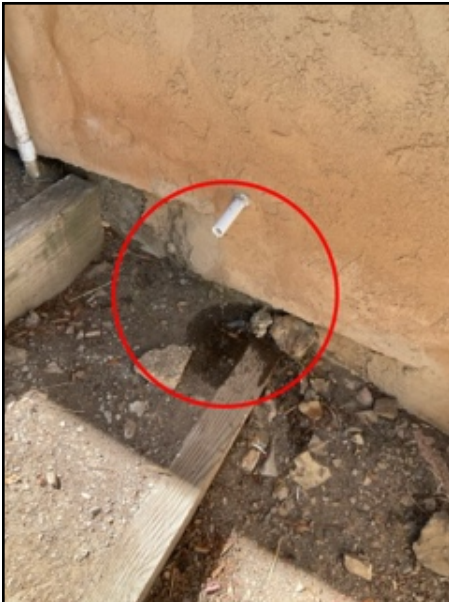
Figure 52-1

FURTHER EVALUATION REQUIRED: Condensation drain line for AC noted as draining on exterior dirt. Should be draining into gravel pit or drain.

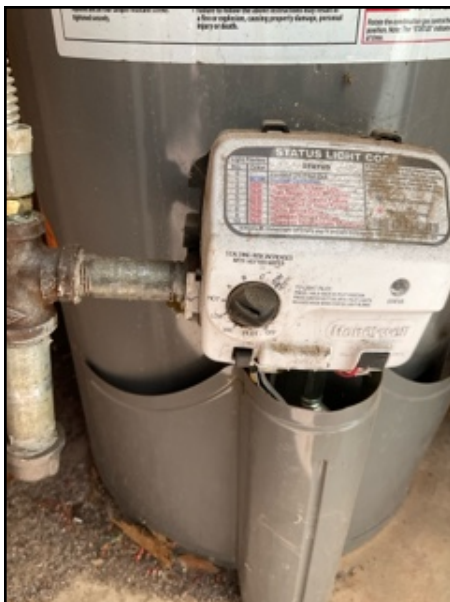
Figure 60-1

Comment 60:
FURTHER EVALUATION REQUIRED: Thermostat on water heater noted as set to the A position. Water temperature reach 132°F. Inspector recommends turning down thermostat to recommended manufactured setting.

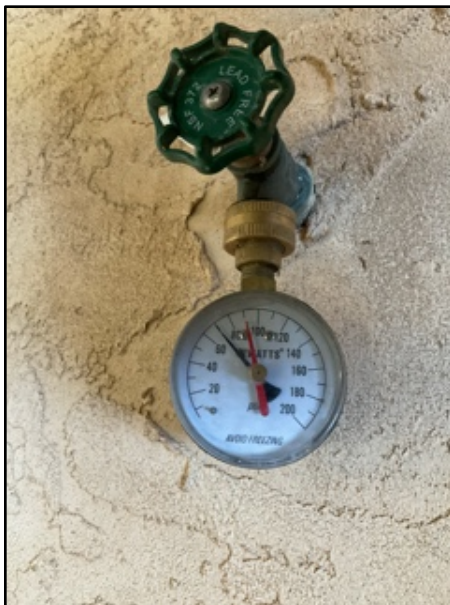
Figure 61-1

Water pressure is 70 psi. Most appliance manufacturers recommend pressure to be set between 50 and 80 psi.

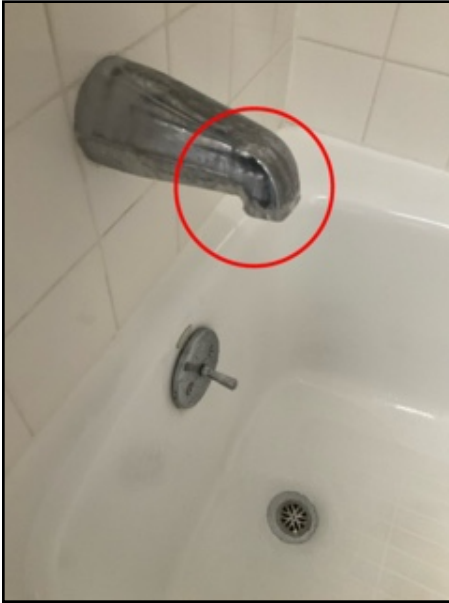
Figure 62-1

REPAIR OR REPLACE: Shower diverter allows water to leak by and is corroded.

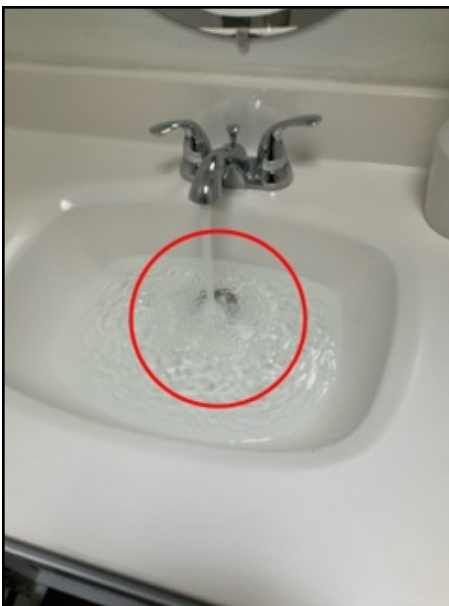
Figure 63-1

REPAIR OR REPLACE: Sink drains slowly.

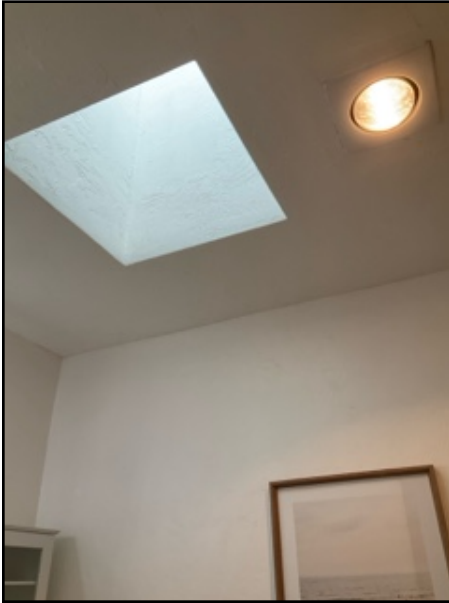
Figure 64-1

REPAIR OR REPLACE: no ventilation noted as installed in hallway bathroom.

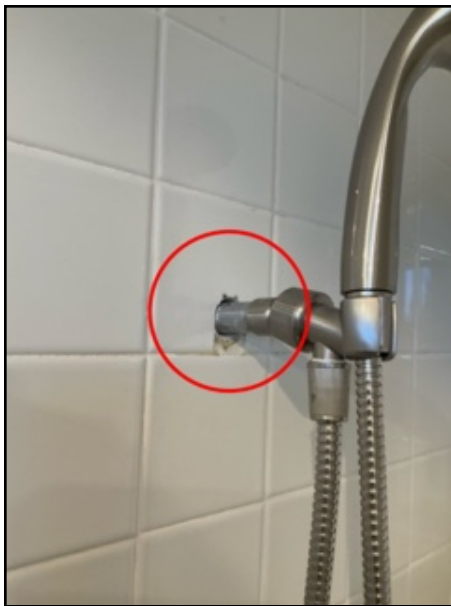
Figure 65-1

REPAIR OR REPLACE: Shower extension cover plate noted as not installed. The plumbing noted is not sealed.

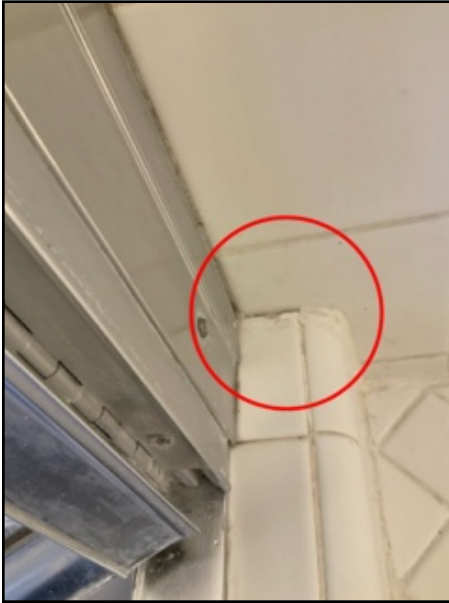
Figure 66-1

**Comment 66:**
REPAIR OR REPLACE: Grout around shower wall tiles noted as cracked.

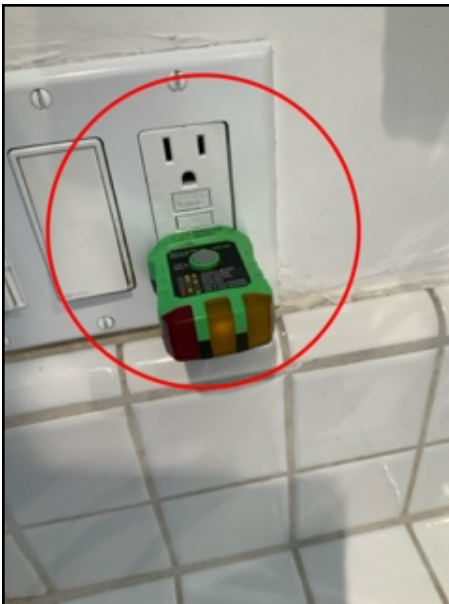
Figure 67-1

**Comment 67:**
REPAIR OR REPLACE: GFCI electrical outlet in primary bathroom noted as failed test and is open ground.

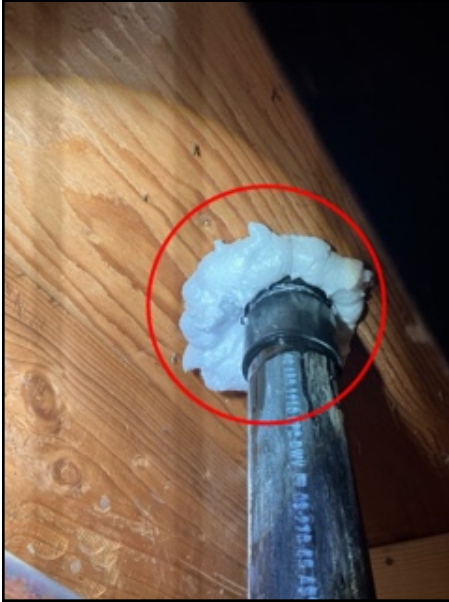
Figure 68-1

REPAIR OR REPLACE: Two leaks on drainage lines underneath primary bathroom. Have a more qualified professional to evaluate and repair.

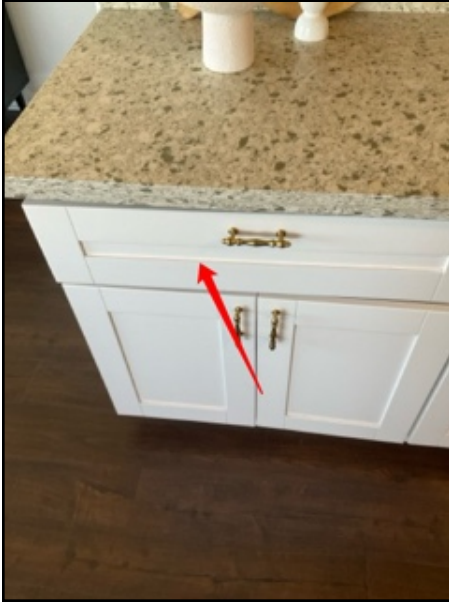
Figure 69-1

REPAIR OR REPLACE: Kitchen cabinet drawers noted as misaligned and not closing flush. Scratches noted on outside of cabinets.

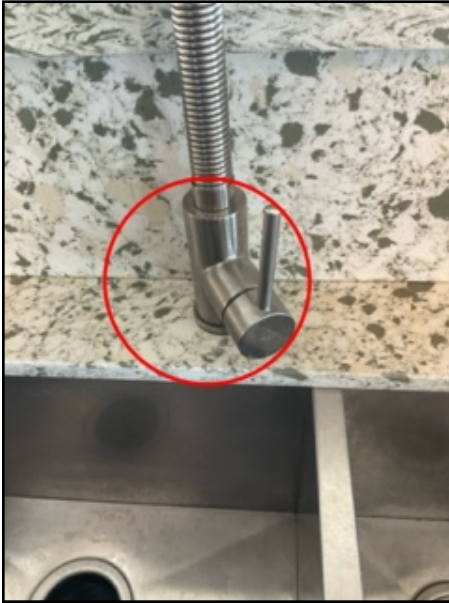
Figure 70-1

REPAIR OR REPLACE: Kitchen faucet noted as loose.

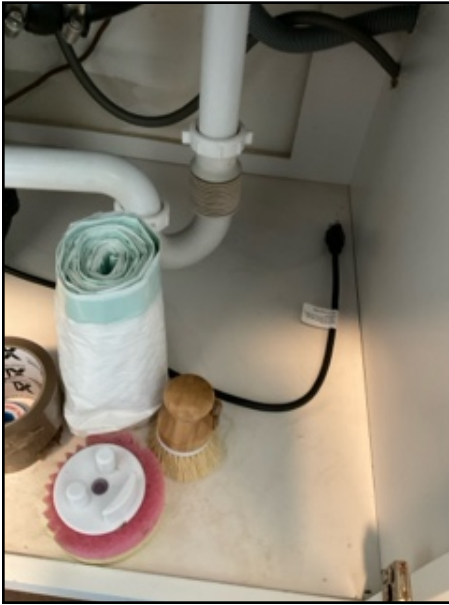
Figure 73-1

Comment 73:
REPAIR OR REPLACE: Garbage disposal noted as not plugged in at time of inspection. Inspector plugged in unit to both top and bottom outlet and it would continuously run. The outlet is not connected to the switch on right side of sink. Have a more qualified professional to evaluate and repair.

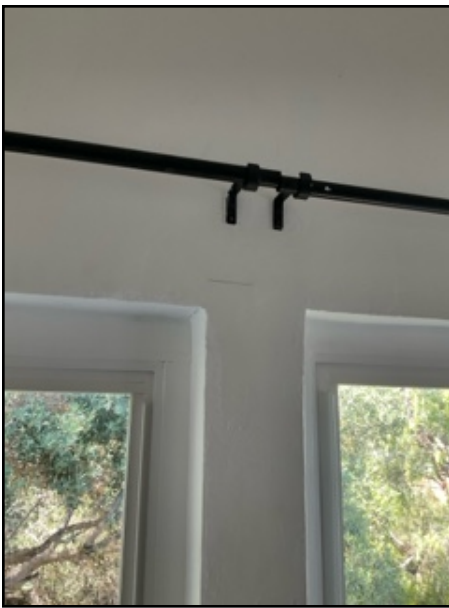
Figure 78-1

Minor paint, drywall damage, burned out bulbs, broken/missing covers and other minor cosmetic defects noted at various locations throughout the home.

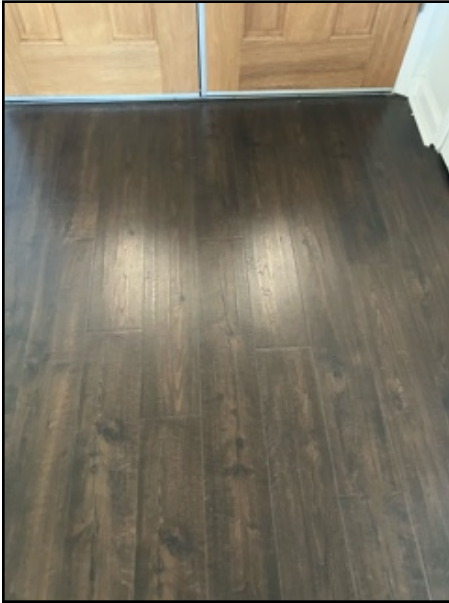
Figure 79-1

**Comment 79:**
REPAIR OR REPLACE: Entry floor noted as squeaking when stepped on.

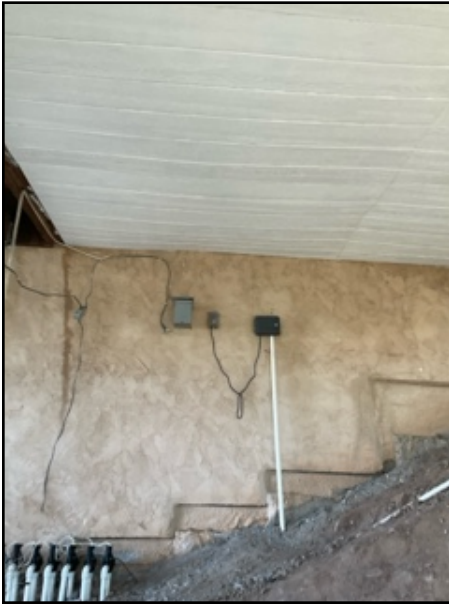
Figure 80-1

FURTHER EVALUATION REQUIRED: Water noted as turned off to sprinkler system at time of inspection. Some drip head sprinklers were not connected.
