December 28, 2015
GS15-050X

SUBJECT: Preliminary Visual Geologic Evaluation,
Lot 3, Tract 12000, 1805 Nichols Canyon Road, Los Angeles, California.

January 27, 2012

Project No. 5325

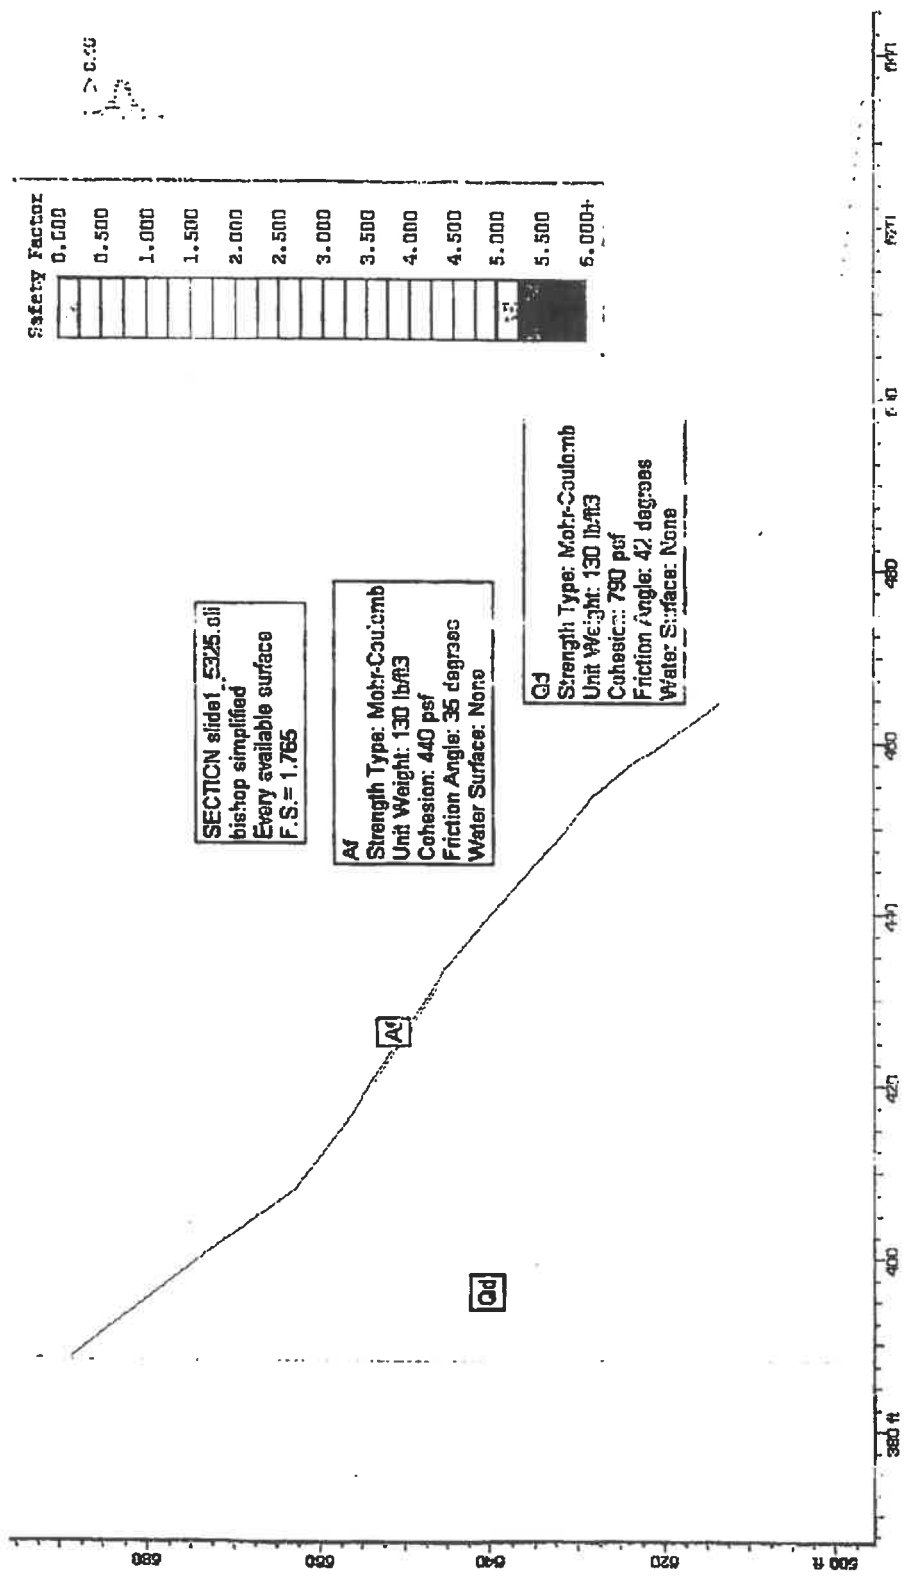
SECTION slide1_5325.dbl
 bishop simplified
 Every available surface
 F.S. = 1.765

A1
 Strength Type: Mohr-Coulomb
 Unit Weight: 130 lb/ft³
 Cohesion: 440 psf
 Friction Angle: 35 degrees
 Water Surface: None
