# INSPECTION REPORT

**75720 MCLACHLIN CIR**

**PALM DESERT, CA 92211**

Inspection Date: **Friday, May 8, 2026**

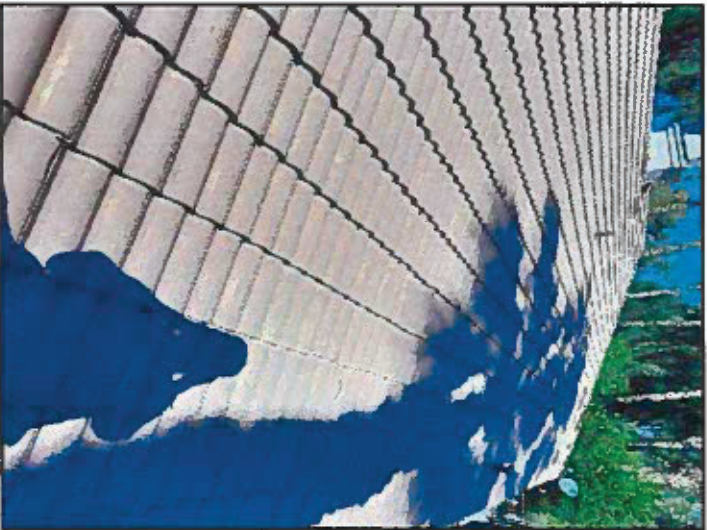
roof tiles look good

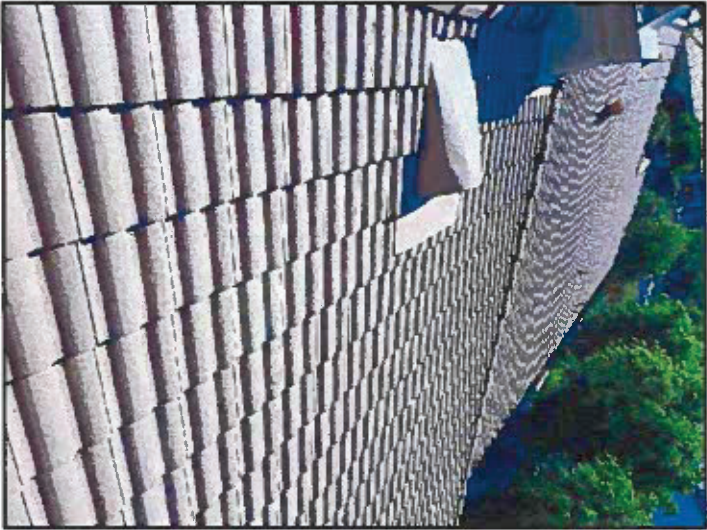
Roof tiles look good

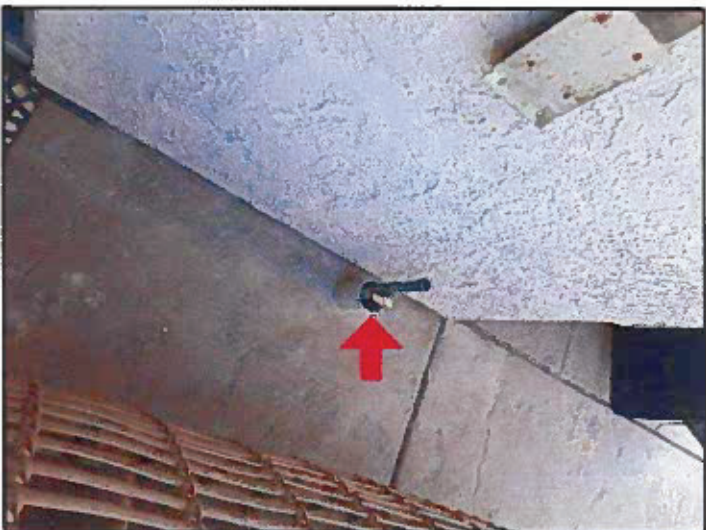
There is a gas line for the barbeque in the patio area.

Gas for barbeque

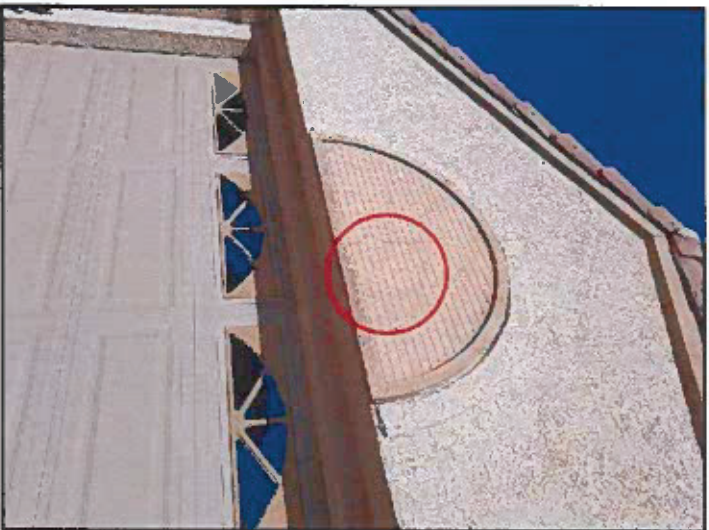
*Weathered wood in areas*

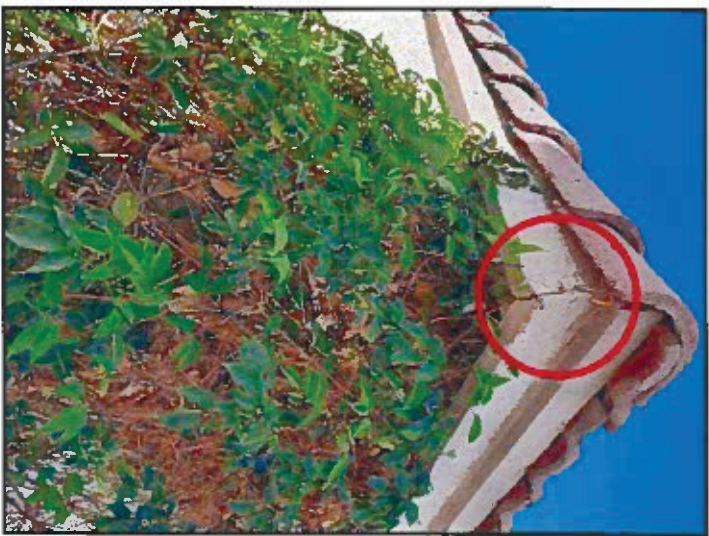
*Weathered fascia board*

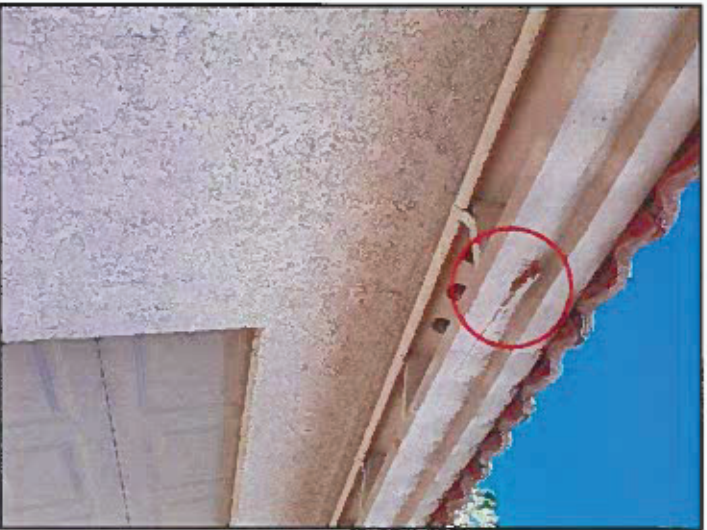
*weathered fascia boards*

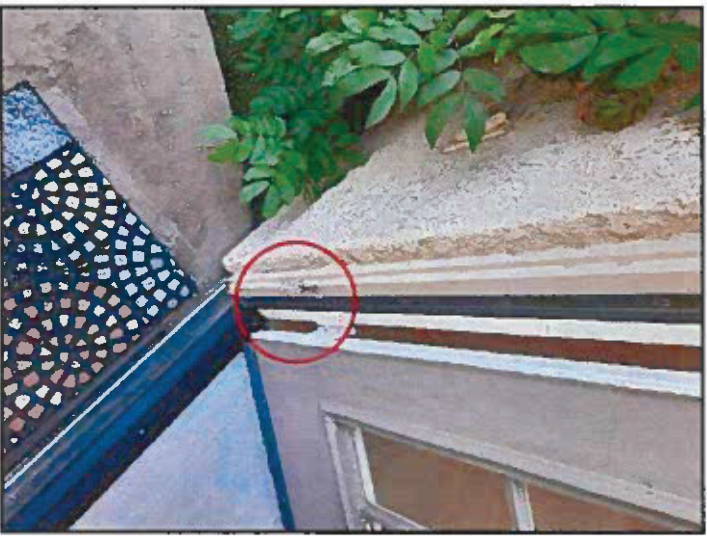
*Weathered wood trim*

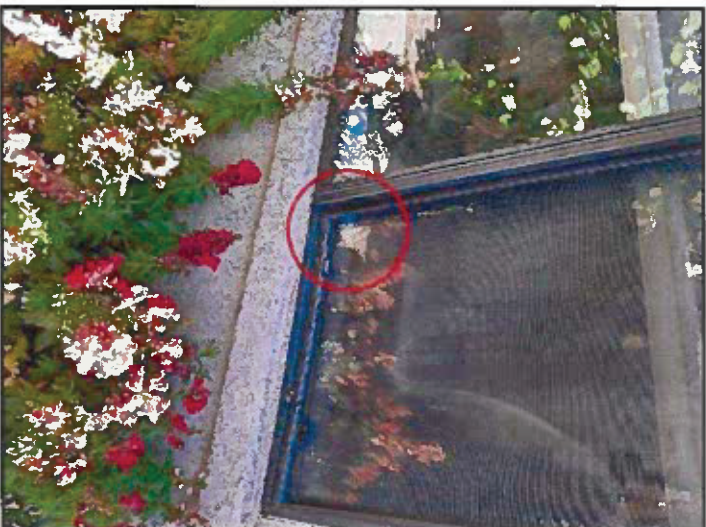
One damaged screen

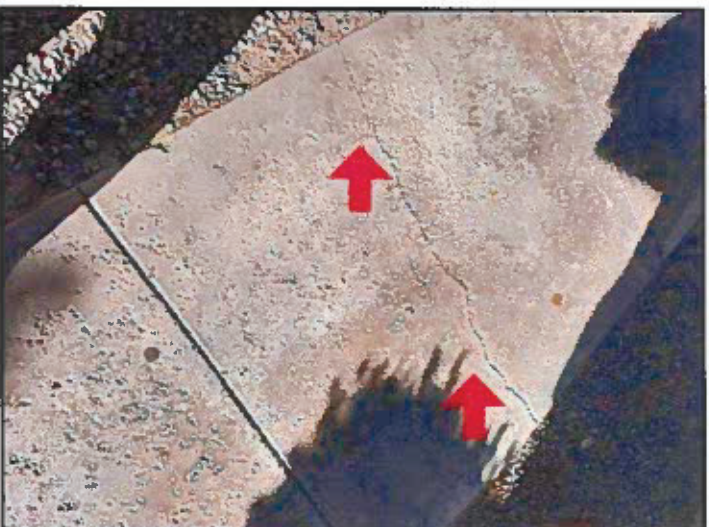
**5. Condition:** • Cracked or damaged surfaces

Cracked concrete walkway

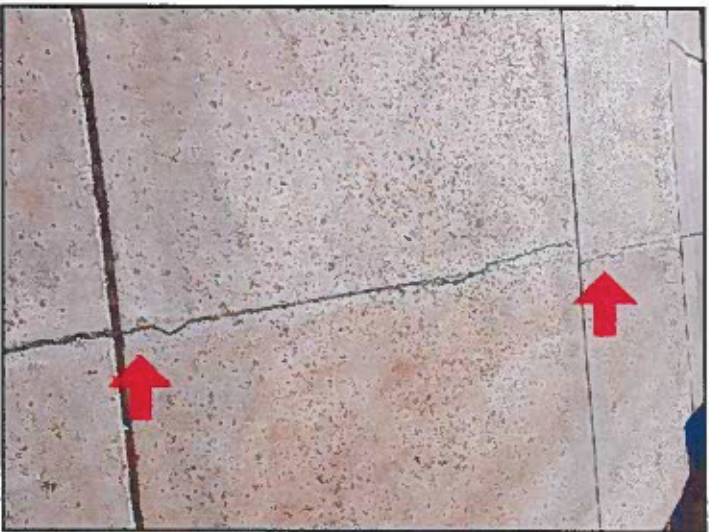
6. Condition: • Cracked or damaged surfaces

*Cracked concrete driveway*

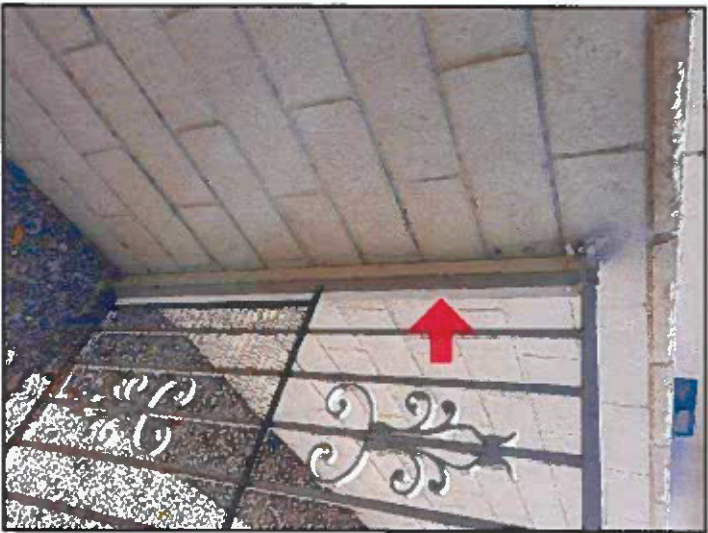
**7. Condition:** • Gate - adjustment needed

*frame loose from wall*

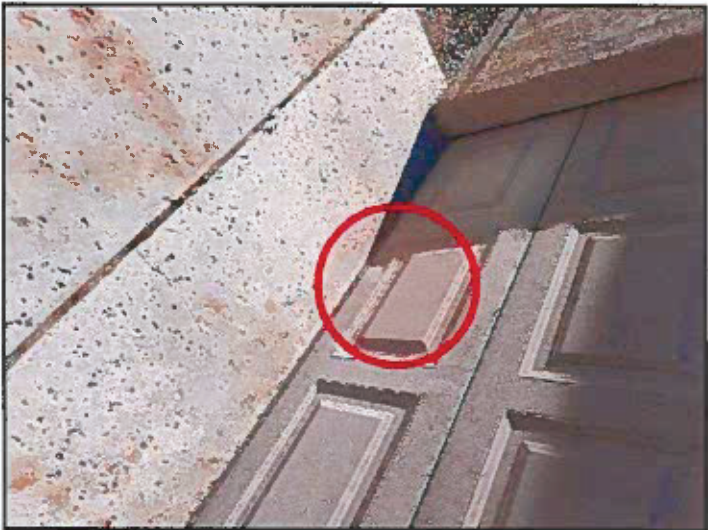
**8. Condition:** • Dented

*Dent in garage door*

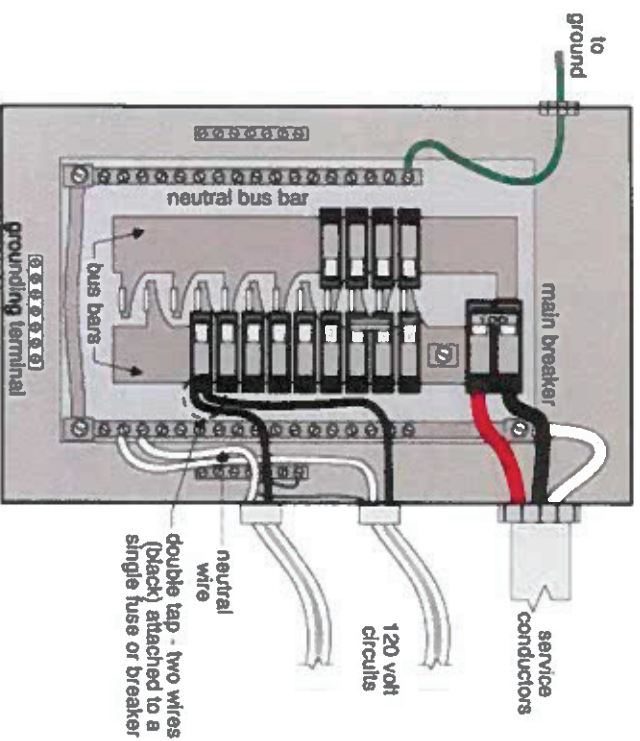
### **11. Condition:** • Double taps

There is three breakers that have more than one line going into the breaker this is called double taps , two lines to one breaker can cause over heating , recommend a electrician to repair.

3 double taps

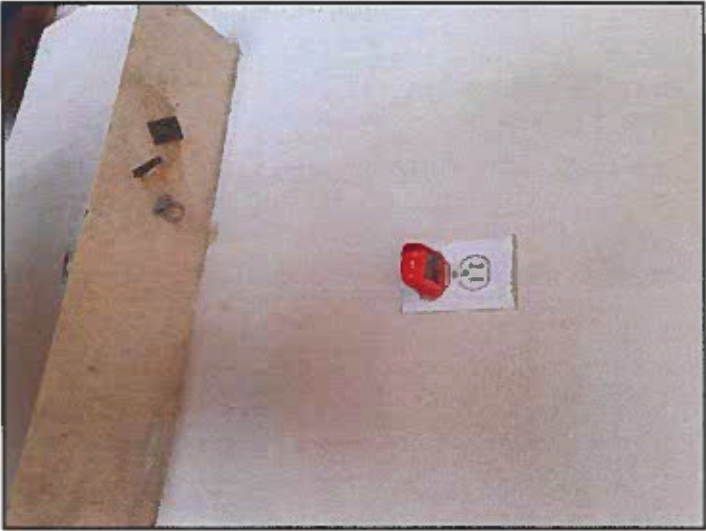
Missing GFCI garage area

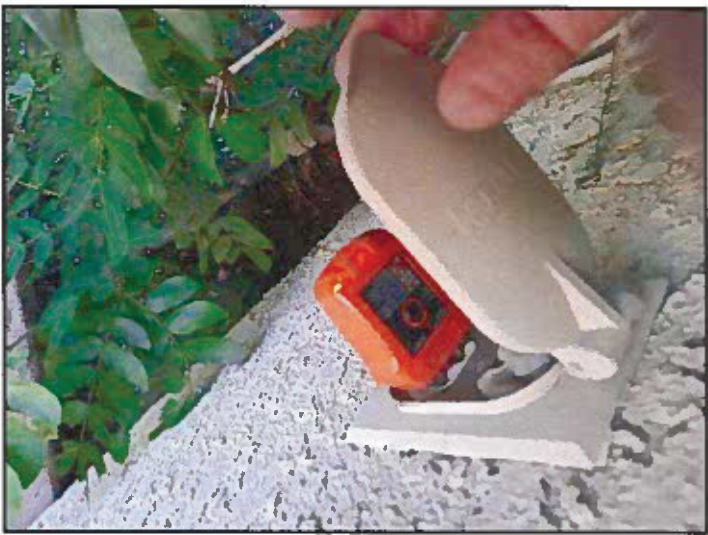
Missing GFCI exterior plug

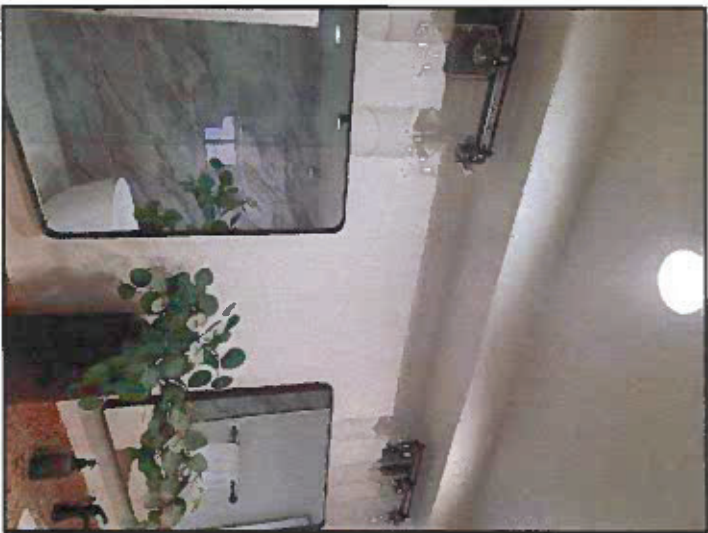
Although the light is known to burn out it is recommend to confirm this is the reason for the light not working. Recommend replacing the light to confirm.

Missing light bulbs

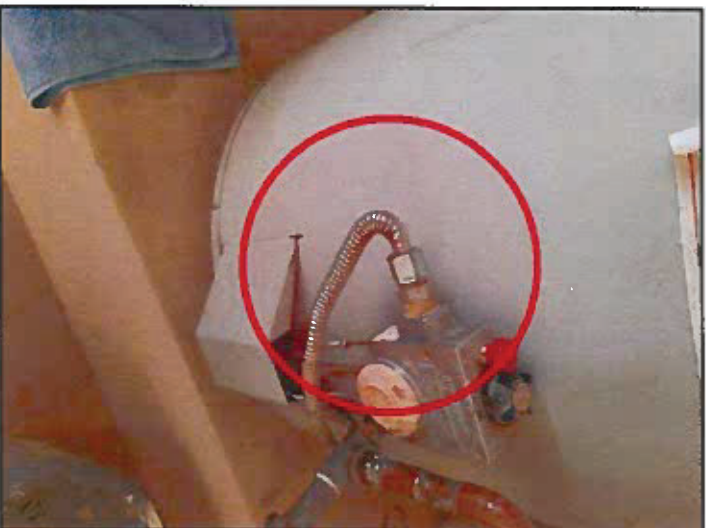
**15. Condition:** • No drip leg (sediment trap, dirt pocket)  
The heater and hot water tank are missing a drip leg , this is to stop any particles from reaching the burner area.  
Recommend a plumber to repair.

*Missing drip leg hot water tank*

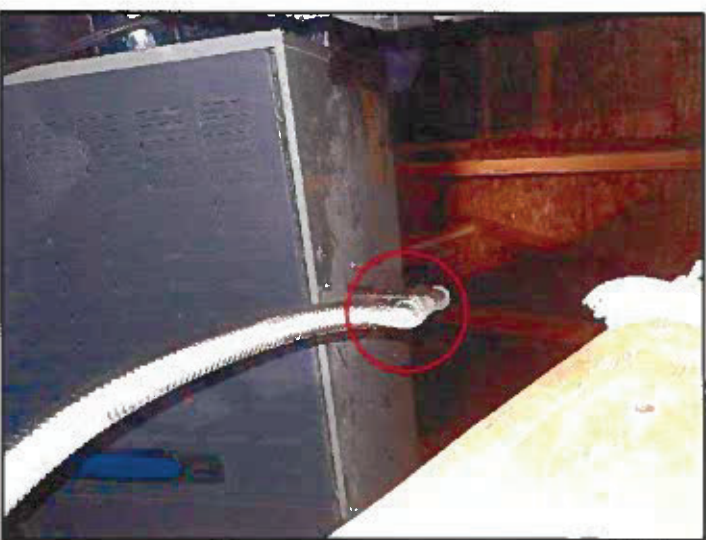
*Missing drip leg heater***FIREPLACE \ Gas fireplace or gas logs****16. Condition:** • **Damper in existing fireplace not fixed open**

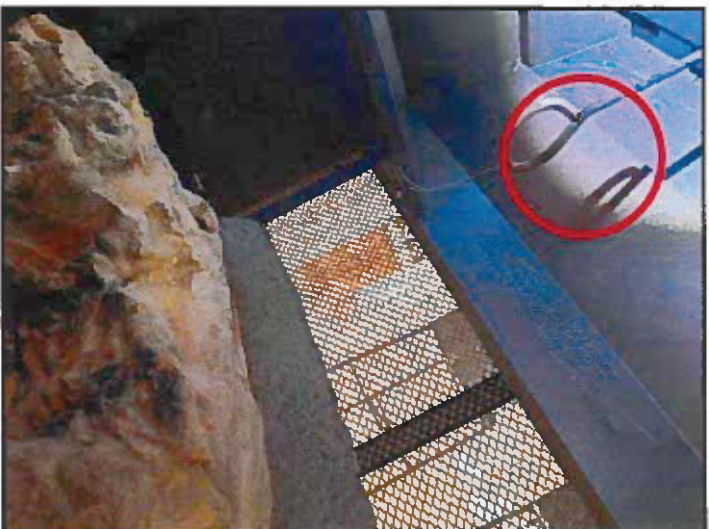
The Damper clamp is to stop the ability for someone lighting a fire and forgetting to open the damper. If damper is left closed gases could enter the house , recommend a handyman to repair.

Missing damper clamp

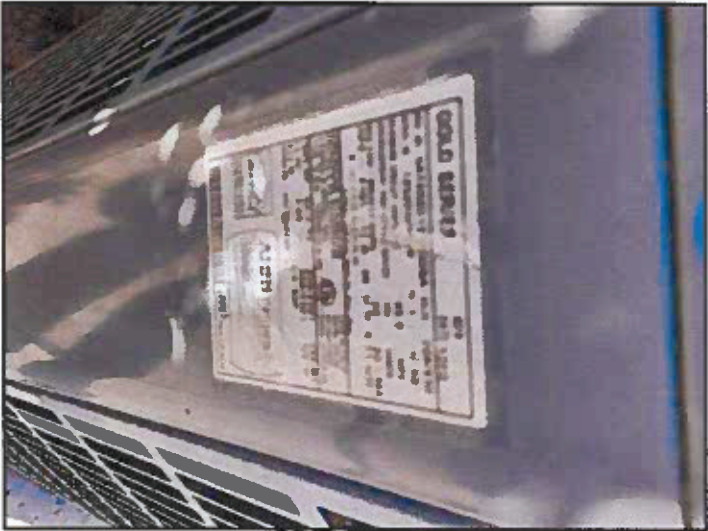
Although the AC is working accordingly , it would be considered to be near the end of its life in the desert, Recommend annually service by a professional and a home warranty. Unit is 14 years old.

14 years old

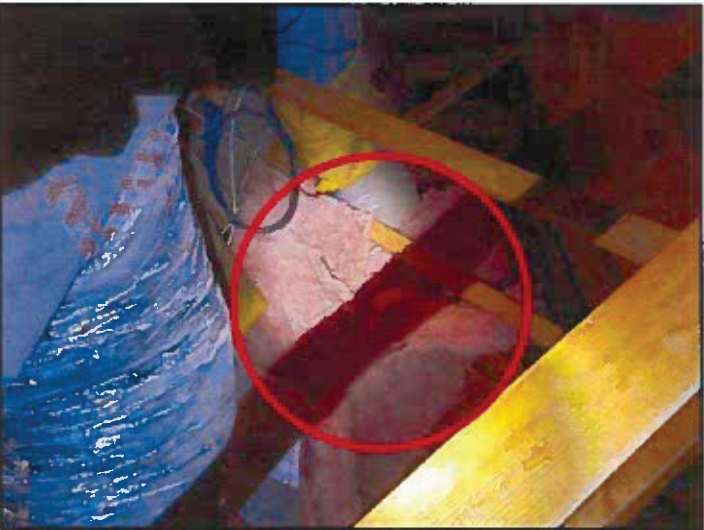
There is some areas in the attic where the insulation has been moved around . recommend a handyman, It appears that there was work done and the insulation was never replaced correctly.

Insulation has been moved

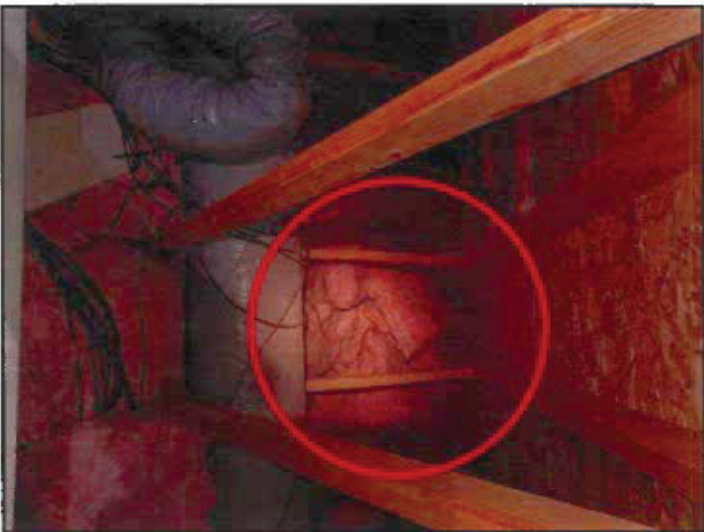
gaps or voids in attic

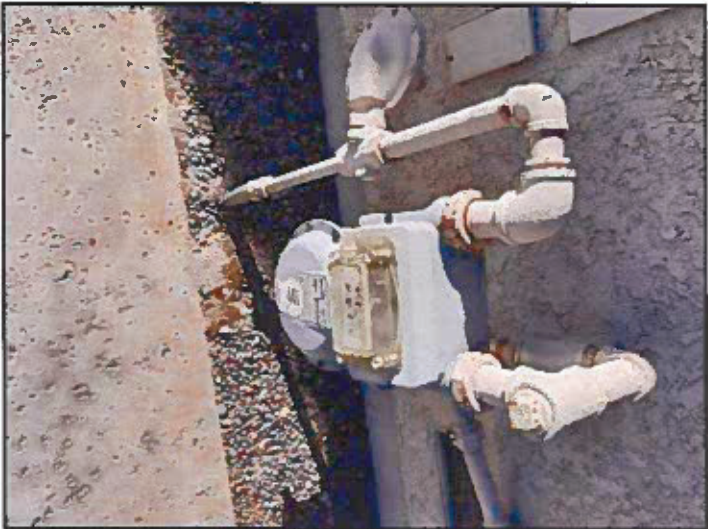
20. Condition: • Recommend a earthquake wrench for the gas meter you can purchase one at home depot and strap it to the meter.

Missing earthquake wrench

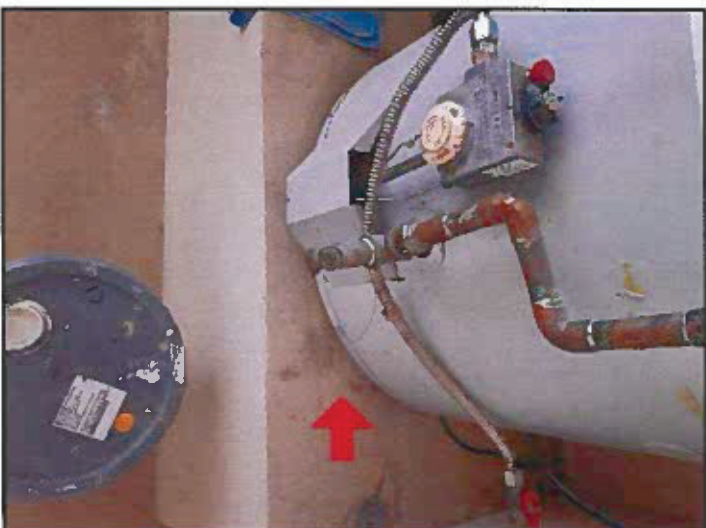
Although the hot water was working accordingly at the time of inspection the hot water tank is 25 years old, recommend a home warranty and saving for a new one . Also tank is missing a safety pan.

Missing safety pan

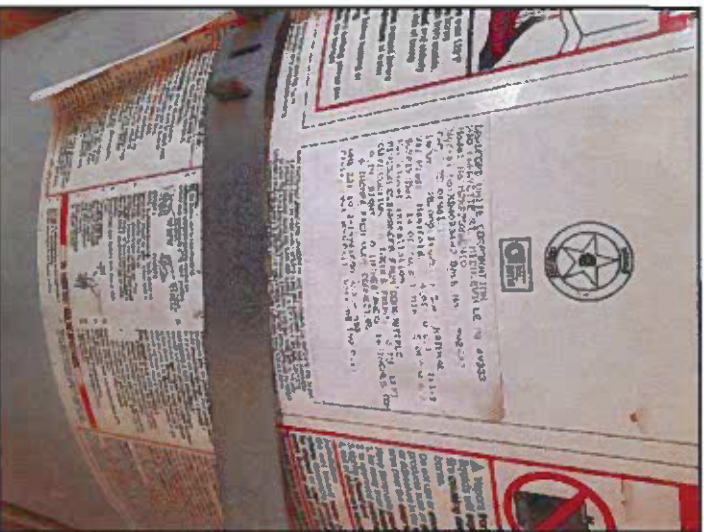
Past its life

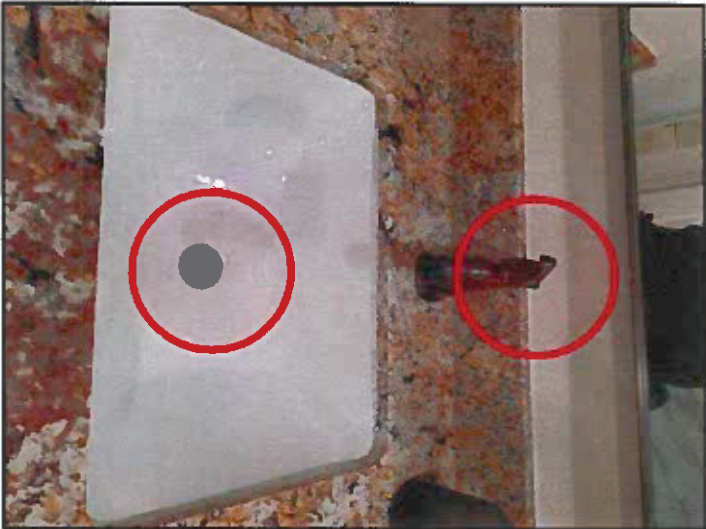
The drain stop in the bathroom is disconnected from the control , recommend a handyman to improve.

Inoperative drain stop

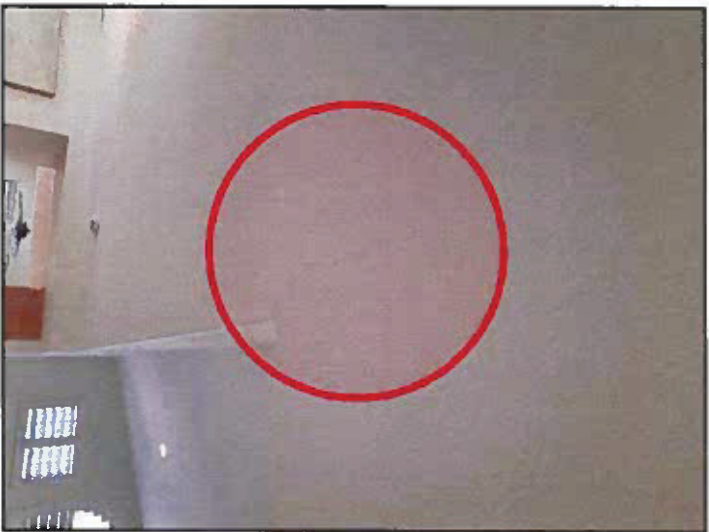
*common drywall cracking*

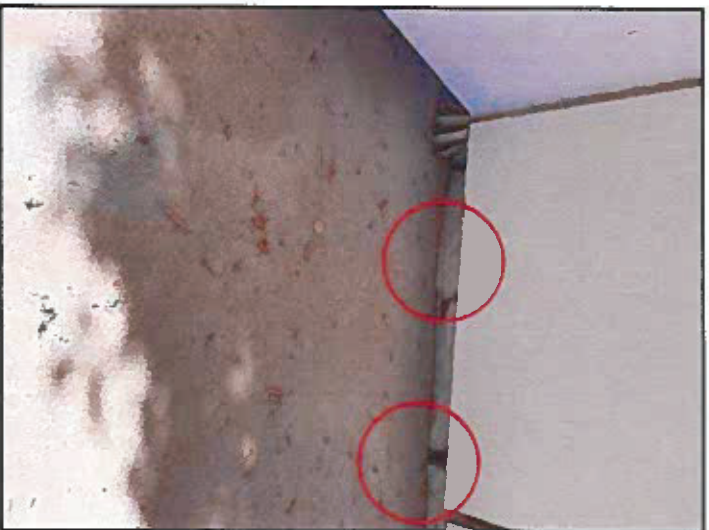
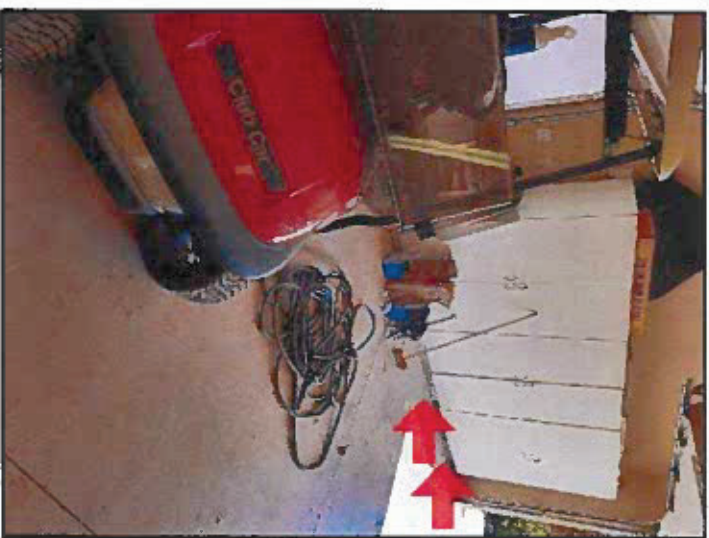
The storage cabinets in the garage have water damage , it is unknown what has caused this or how long area was wet.

Storage cabinets garage water damaged

Water damaged storage cabinets

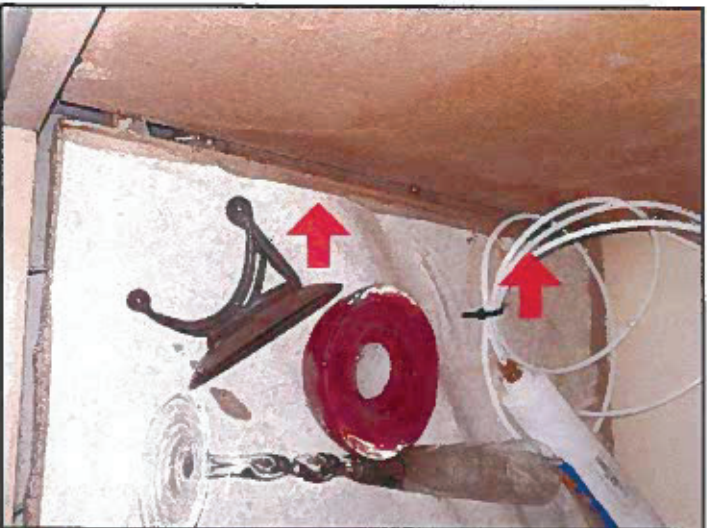
The bar cabinet has water damage , there is no leak at the time of inspection , the bottom and side of the cabinet is damaged . It is unknown what was leaking or how long area was wet. It only takes 48 hours of moisture to create fungi growth.

*Water damaged cabinet bar area*

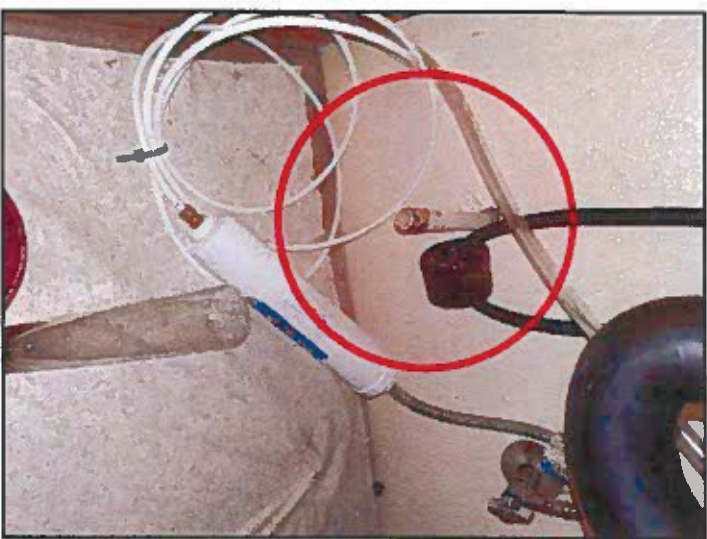
*Abandoned pipe bar area***28. Condition:** • **Stained, worn, damaged****Implication(s):** Material deterioration**Location:** Bathroom**Task:** Repair or replace Provide Improve**Time:** Discretionary

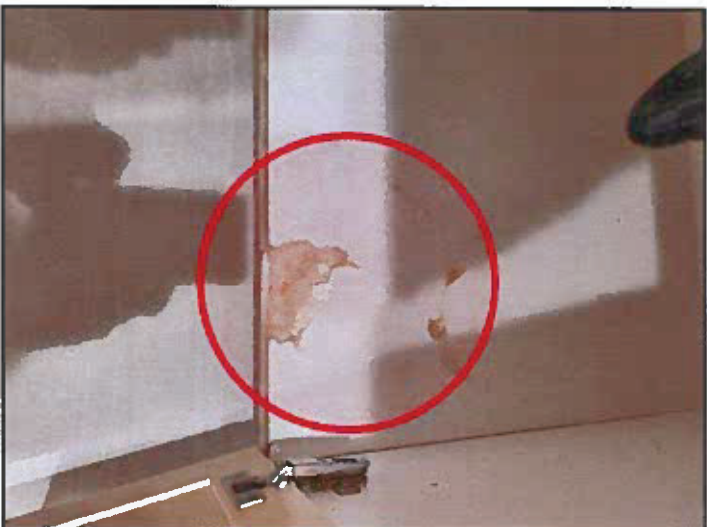
*Damaged cabinet bathroom*

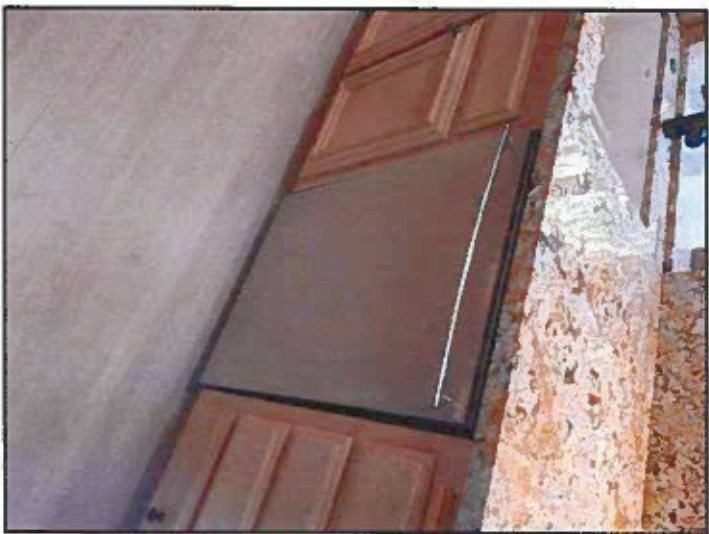
The drain pump for the dishwasher was stuck on , recommend a appliance company to evaluate and repair.

*Drain pump is stuck on*

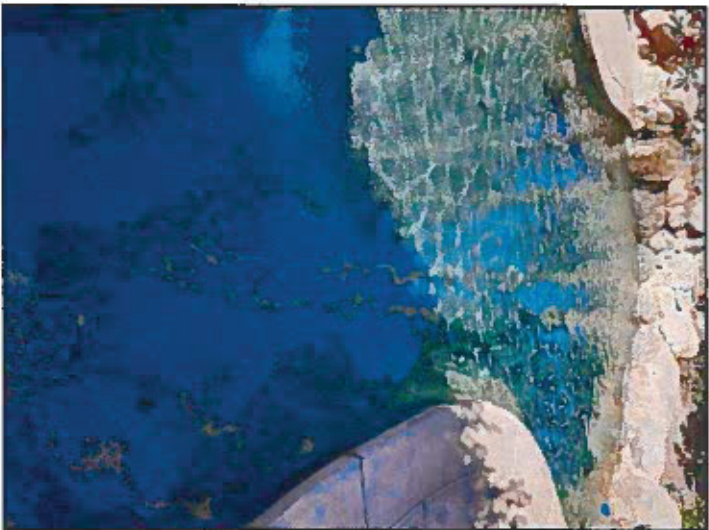
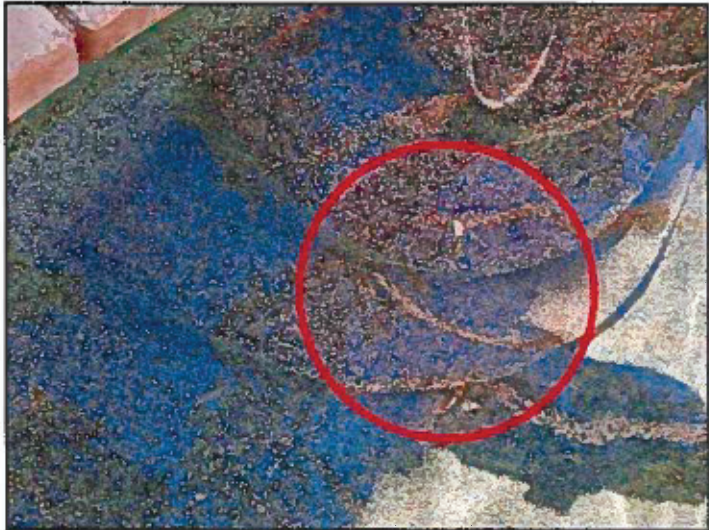
The surface of the pool shows some defects, discoloration , Recommend a pool specialist to evaluate the pool surface and repair if needed. It is unknown how old surface is or how many years are left.

Unknown age of pebble surface

Surface defects

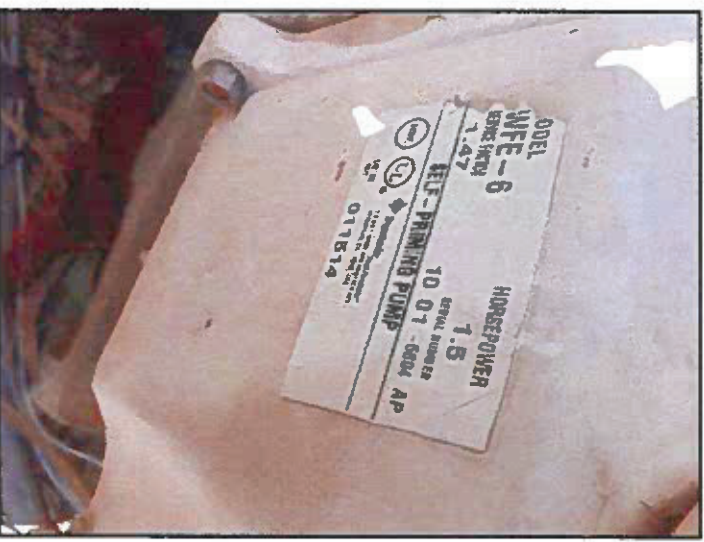
## Pump is aging

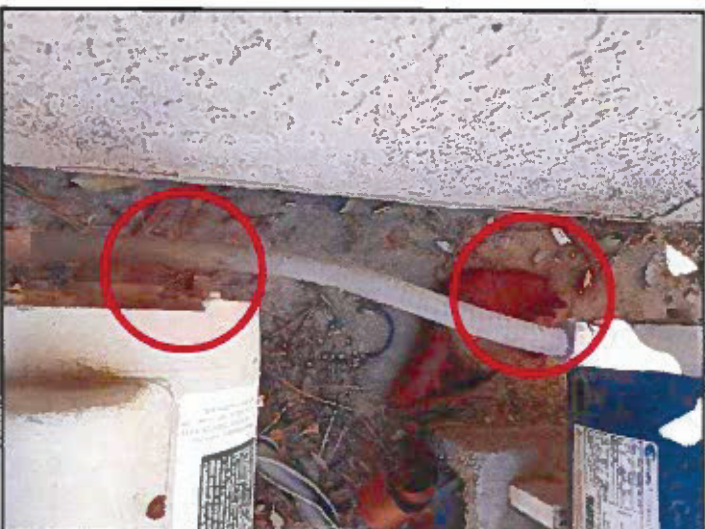
The pumps and heater are missing a ground wire , recommend a electrician to repair.

*Missing body bond/ground*

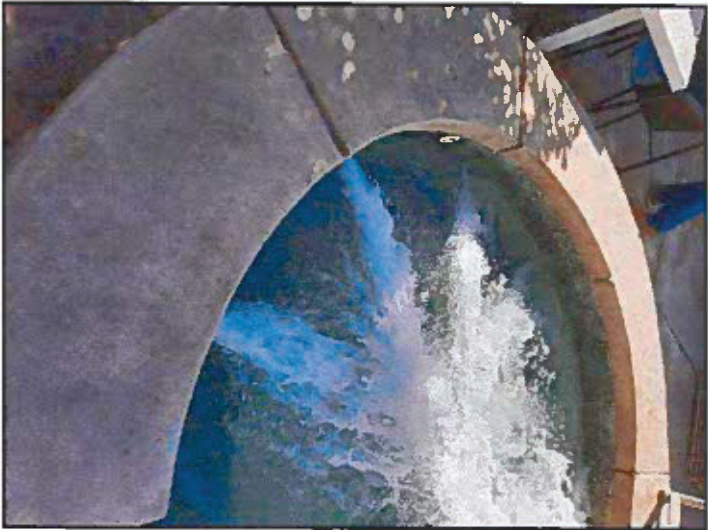
Condition: • The water in the spa was to low for the jets to work properly, recommend a pool company to evaluate the situation and repair.

*water to low for jets*

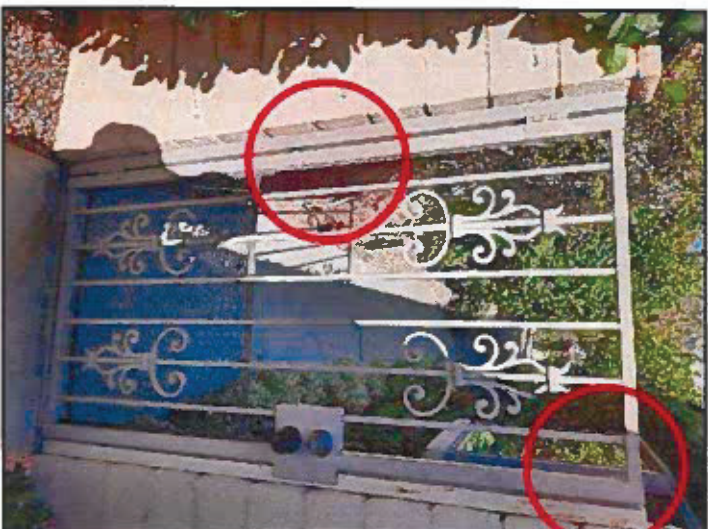
All gates to the entrance of the pool to the outside of the property need to be self closing , It also needs a latch 54 inches high to keep the children out . Side gates need to swing outwards to make it harder for a child to get in. Recommend a contractor to repair. barriers and regulation can be found at [www.pool-safety.gov/parents/safety-tips/](http://www.pool-safety.gov/parents/safety-tips/)

*Missing high latch/ self closing spring*

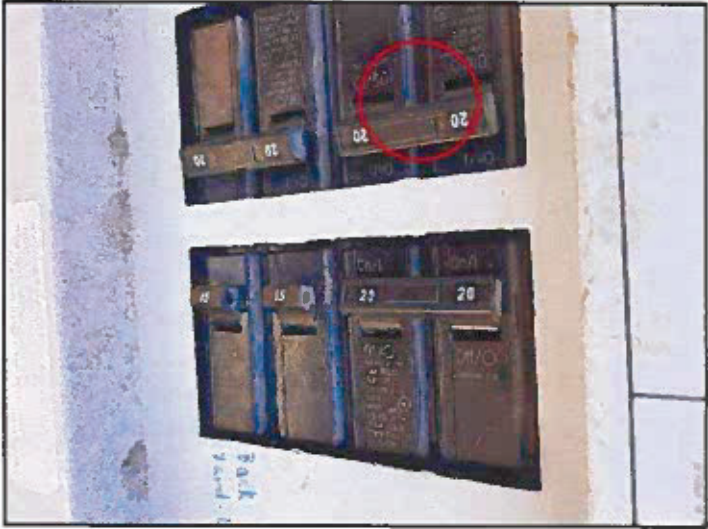
Condition: • Due to new codes there should be a GFCI breaker for the pool pump , recommend a electrician to repair.

Missing GFCI pool pumps

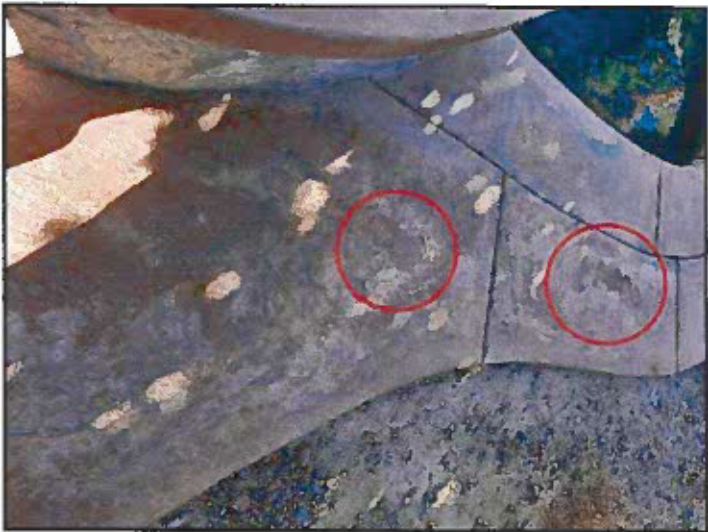
*Surface damage pool area*

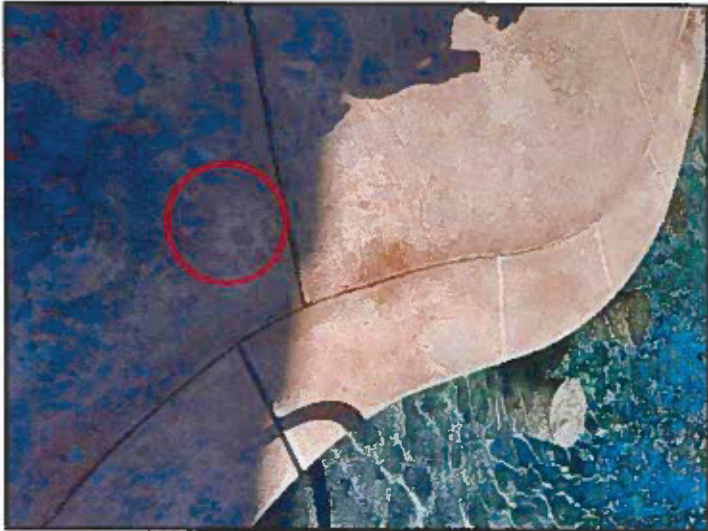
*Common cracking pool area*

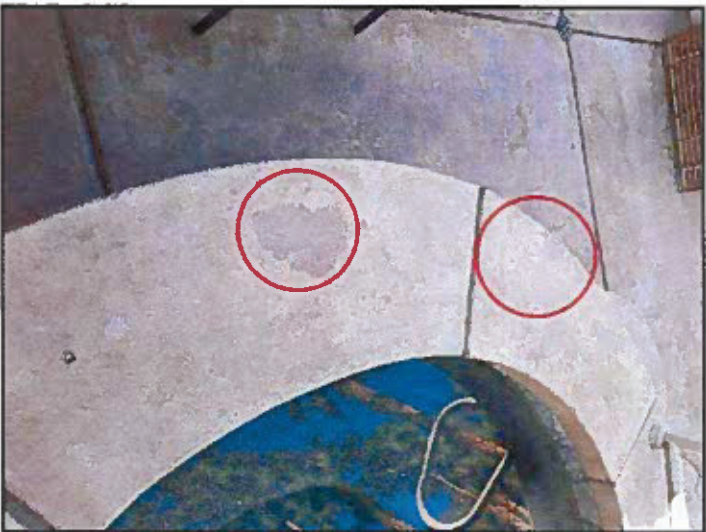
*surface damaged pool area*

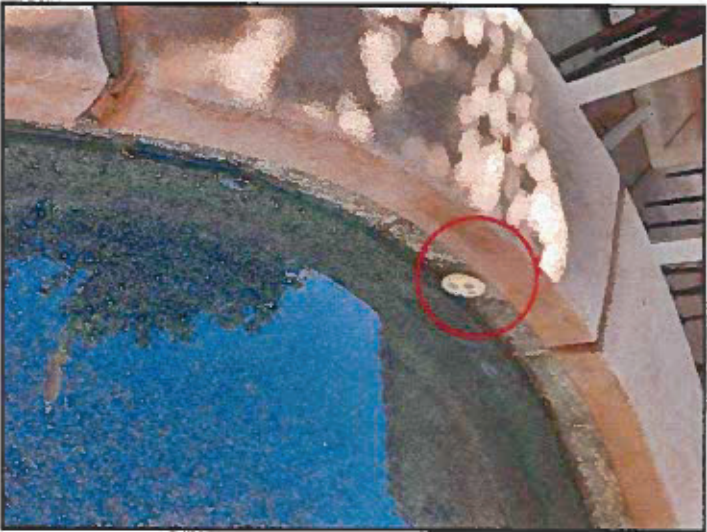
**Condition:** • The controls at the spa are inoperative, recommend a pool company to repair or replace the controls.

*Inoperative controls at spa*
