## SUMMARY

332 Bandini Pl, Vista, CA 92083

Martin Keith  
08/28/2026

Mark Taibo  
A Better Home Inspection By Forsters,  
Inc.  
(800) 720-2844  
[Info@ForsterHomeInspections.com](mailto:Info@ForsterHomeInspections.com)

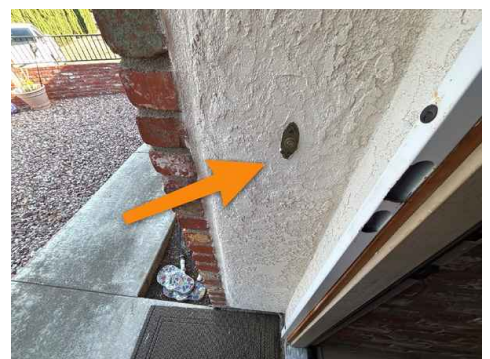
Front of Property

The doorbell failed to respond during testing, indicating a possible malfunction or failure within the system. This condition can lead to:

Recommend further evaluation and repair or replacement of the doorbell as needed by a licensed electrician or qualified professional to restore proper functionality.

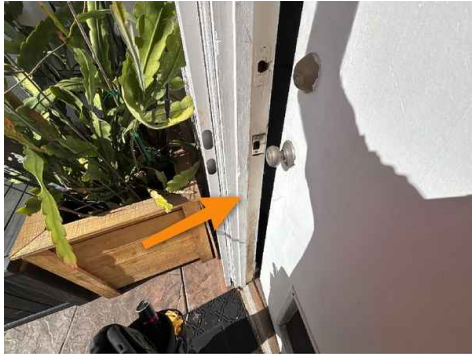
Rear of Property

Weather-stripping was found to be damaged, degraded, or missing in one or more areas at the time of inspection. Proper weather-stripping is essential for:

We recommend correcting or replacing the weather-stripping as needed to restore its effectiveness and ensure the comfort and protection of the home.

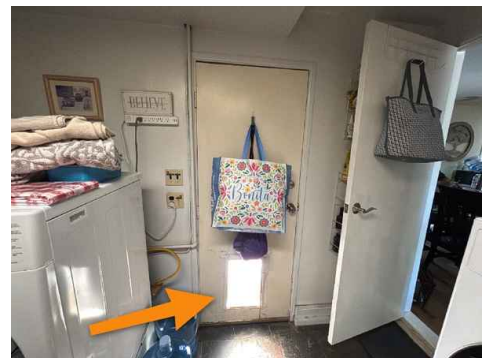
Rear of Property

A pet door was observed to be installed in one or more exterior doors. While convenient for pet access, this installation can potentially lead to:

Reduced security, as pet doors can be a point of entry for intruders. Increased risk of drafts, moisture intrusion, and energy loss if the pet door is not properly sealed.

We recommend assessing the pet door's installation to ensure it is secure and adequately sealed. If necessary, consult with a professional to address any concerns related to security or energy efficiency.

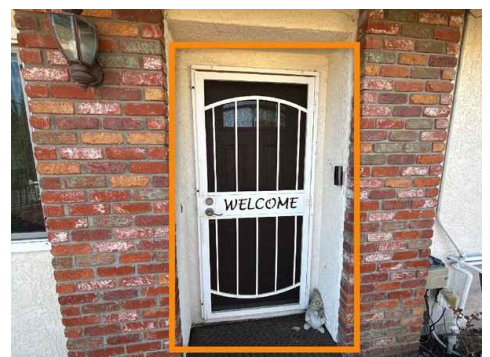
Front of Property

Surface rust was observed on the security screen door. This condition can lead to:

We recommend correcting the surface rust as needed, which may include cleaning, treating, and repainting the affected areas to prevent further corrosion and maintain the door's integrity.

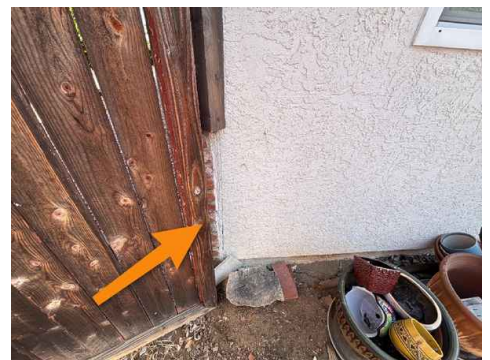
Right of Property

Minor stucco cracks were observed in the exterior at one or more points, and it is important to note that not all areas may have been reported. Common stucco cracks often result from the natural curing process or settling of the structure over time.

- Consulting with a licensed stucco professional: A thorough assessment of the cracks should be conducted to determine their cause and whether any repairs are necessary.
- Monitoring for further movement: In some cases, cracks may widen or increase over time, potentially indicating more significant structural concerns.

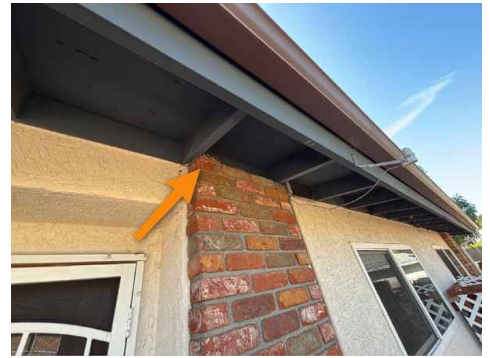
Front of Property

Bird nesting or evidence of previous nesting was noted at the eaves in one or more areas. This condition can lead to:

We recommend correction as needed by a qualified professional to remove the nests and prevent future nesting.

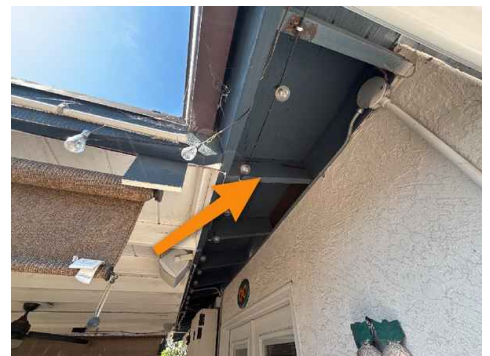
Rear of Property

Moisture stains were noted on the eaves and fascia in one or more areas around the home. This condition may indicate:

We recommend further evaluation and correction by a licensed professional to address the moisture stains and ensure the affected areas are properly protected.

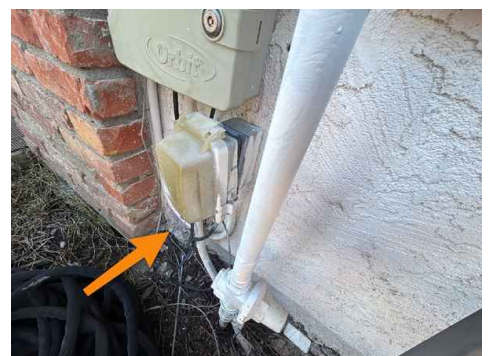
Front of Property

The exterior outlet(s) and/or switch(es) were noted to be loose in one or more areas at the time of inspection. This condition can lead to:

We recommend further evaluation and correction by a licensed professional to ensure proper installation and safety.

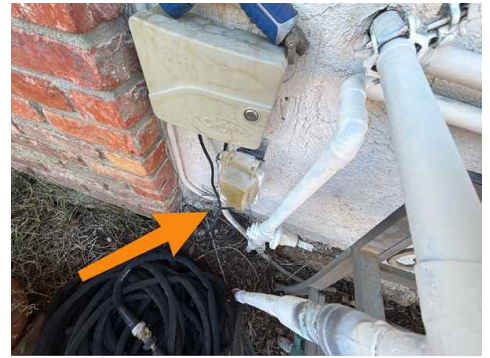
Front of Property

One or more exterior outlets and/or switches were observed to be missing or have damaged weatherproof covers. This condition can lead to:

It is recommended to address these issues by replacing, repairing, or adding weatherproof covers as needed to protect the outlets and switches from the elements.

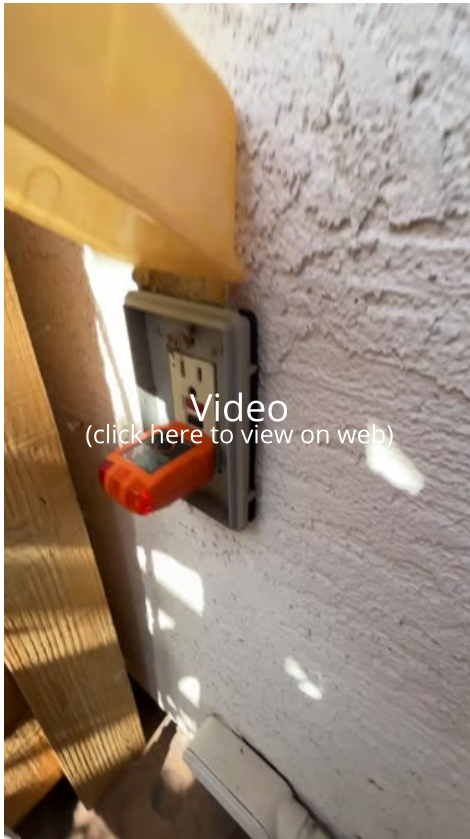
One or more outlets appear to have GFCI reset outlets installed with power, however, the GFCI did not trip off when tested. This condition can lead to:

We recommend further evaluation and correction as needed by a licensed professional to ensure proper functionality and compliance with safety standards.

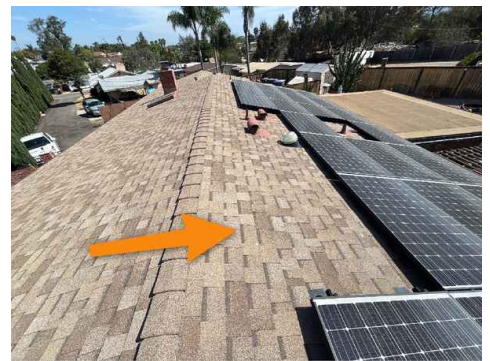
Roof Middle

- Reduced load capacity: Soft or thin sheathing may not adequately support the roof structure, especially under weight or weather stress.
- Increased risk of leaks: Compromised sheathing can allow moisture to penetrate, leading to further damage.

Recommend further evaluation and correction as needed by a licensed roofing contractor to assess and reinforce the sheathing where necessary.

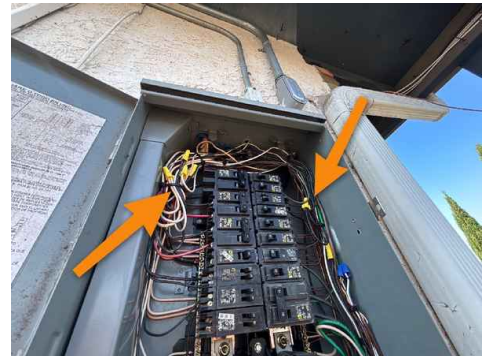
- Safety concerns: Unsecured wire nuts may come loose over time, increasing the risk of electrical faults or arcing.
- Improved durability: Taping wire nuts provides additional security, reducing the likelihood of loose connections.

Recommend further evaluation and correction as needed by a licensed professional to ensure all spliced connections are properly secured.

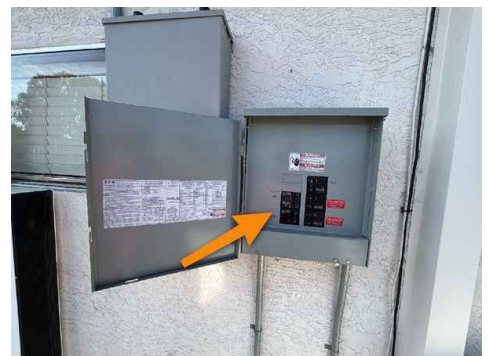
- Without proper labeling, it may be difficult to identify circuits, increasing the risk of accidental shutoffs or unsafe maintenance practices.
- Inefficient troubleshooting: Missing labels can cause confusion when locating specific circuits, making it more time-consuming to diagnose and resolve electrical issues.

Recommend further evaluation and correction as needed by a licensed professional to label the panel accurately and ensure safe and efficient operation.

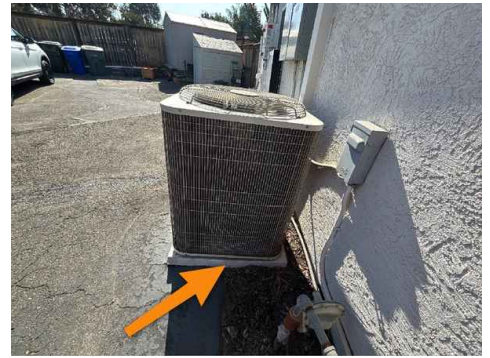
- Insect or rodent entry into the structure, potentially causing damage or infestation.
- Moisture intrusion that may lead to deterioration of building materials over time.

Recommend sealing or caulking the exterior refrigerant line entry points at the wall and having the area further evaluated and corrected as needed by a licensed HVAC contractor or qualified professional.

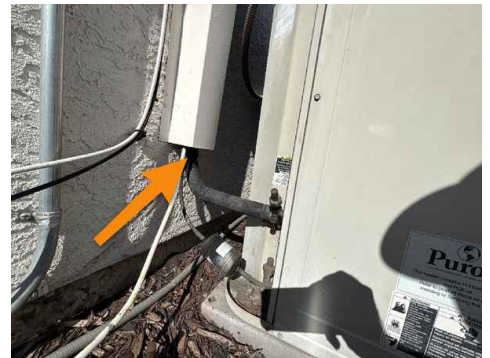
- Water damage to surrounding materials, including walls, ceilings, or flooring.

Recommend further evaluation and correction as needed by a licensed HVAC contractor to properly secure and route the condensation line to the exterior of the building in accordance with current code requirements.

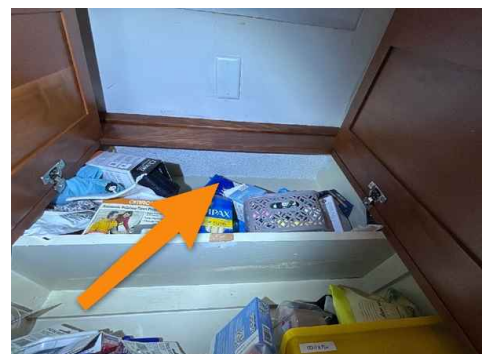
Hall Closet

Acoustic (popcorn) ceilings were observed in the home. If installed prior to the mid-1980s, the material may contain asbestos. Although asbestos was outlawed in 1978, existing supplies continued to be used in construction. This condition can lead to:

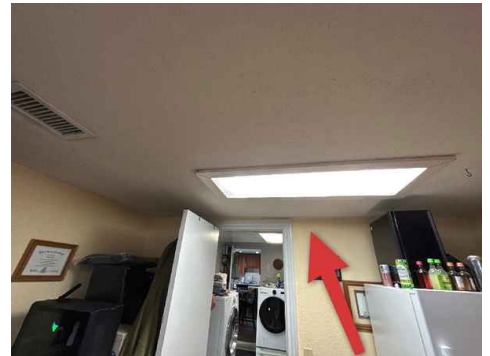
Left Room

No smoke detectors were observed in the home, recommend installing for safety.

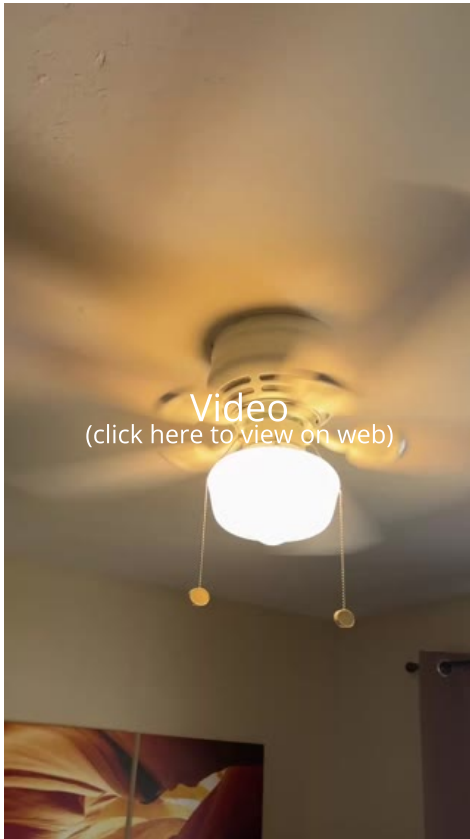
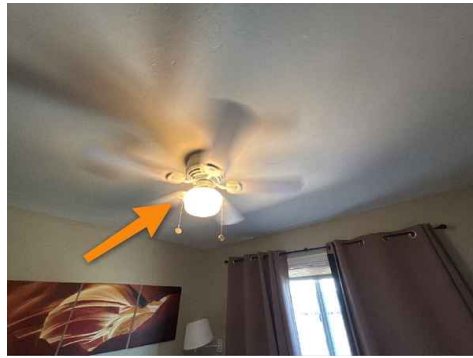
Right Bedroom

The fan unit makes an irregular noise when operating, recommend repair/replace as needed.

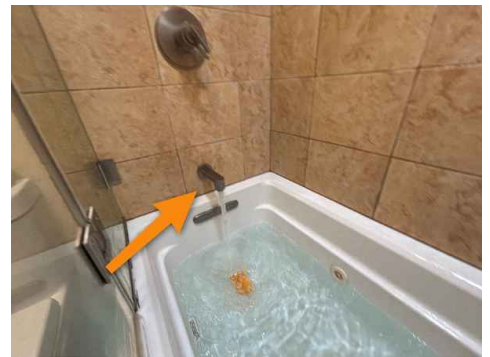
Hall Bathroom

Plumbing fixtures appeared to be loose when operated. Recommend further evaluation and correction as needed by licensed professional.
