## HOME INSPECTION REPORT

**4667 Lotus Street  
San Diego, Ca 92107**

Client: Leanne Tibiatowski  
August 20, 2026  
File #260820BC

Prepared by: Chad Fisher, B.S.S.E., Certified CREIA Inspector

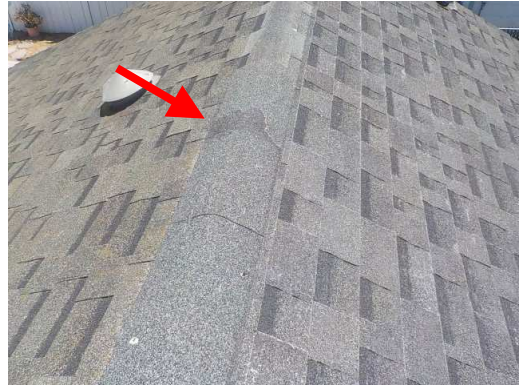
- Some of the shingles are deteriorated or damaged and are in need of repair or replacement, especially at the ridges.

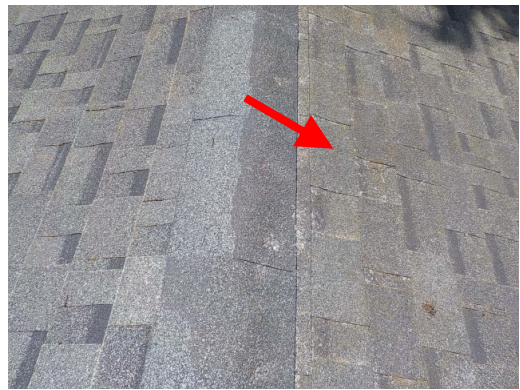
- The shingles are cupped and brittle and are showing signs of aging. The roof is deteriorating in places and appears to be at or past its expected lifespan.

- It is recommended that a licensed roofing contractor be contacted for a complete roofing inspection and for repair or replacement recommendations.

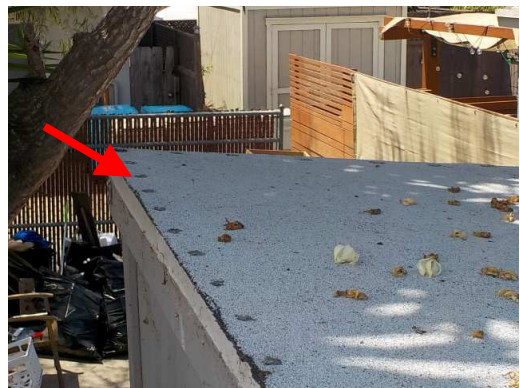
- There are exposed fasteners on the roof surface at the seams and edges. This condition can cause leakage of the roof.

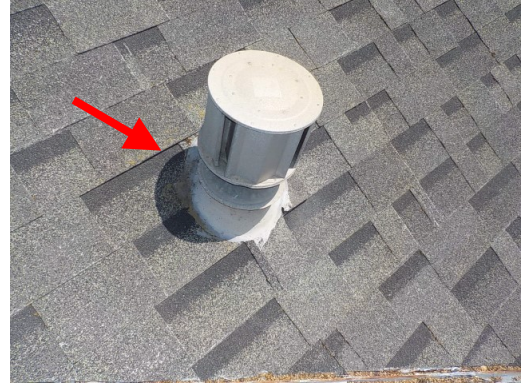
- The lower portions of the flashings for many of the roof penetrations terminate underneath the shingles rather than extending onto the surface of the shingles. This condition can cause leakage of the roof.

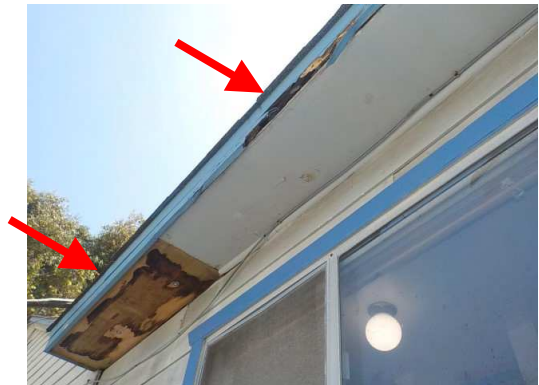
- Some water staining and deterioration was noted to the eaves, especially at the southwest corner of the house. It is recommended that a licensed structural pest control company be contacted for further inspection and repair recommendations.

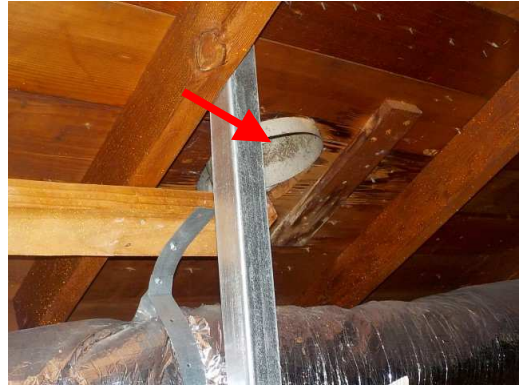
- The kitchen vent duct has been removed and should be properly replaced.

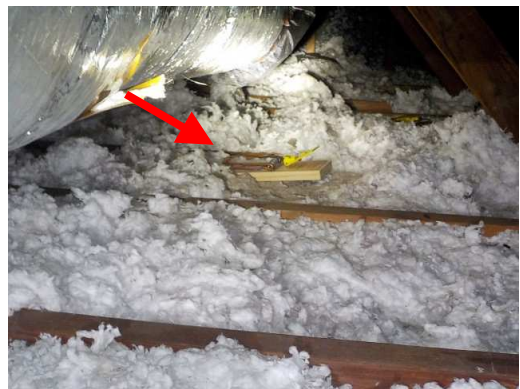
- It is beyond the scope of this inspection to determine the presence of rodents, however, evidence of rodent activity was noted in the attic space. It is recommended that a licensed pest control company specializing in rodent remediation be contacted for further inspection and recommendations.

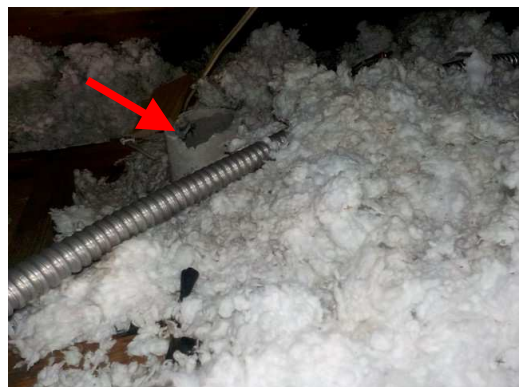
- It is beyond the scope of this inspection to determine the presence of asbestos, however, there is an unused gas vent visible in the southeast portion of the attic space which is constructed of a fibrous cement type material which may contain asbestos. The presence of asbestos can pose a health hazard. It is recommended that a qualified asbestos specialist be contacted for further inspection and for recommendations.

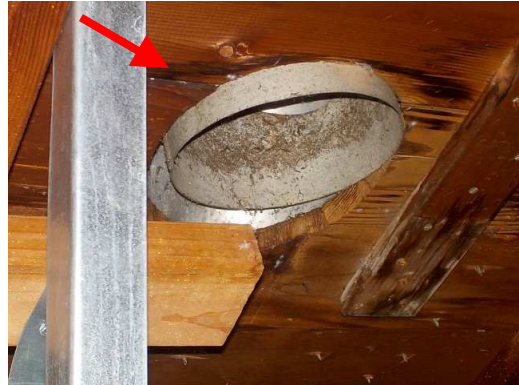
- There are some water stains in the attic roof framing and sheathing. These conditions are apparently caused by leakage of the roof. It could not be determined by visual inspection if these conditions are caused by on-going leakage or if the leakage has been repaired.

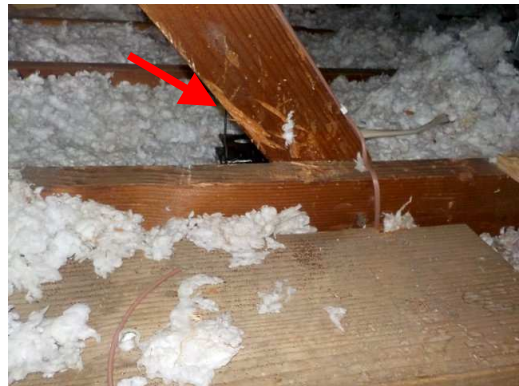
- The wood framing is deteriorated in places. It is recommended that a licensed structural pest control company be contacted for further inspection and repair recommendations.

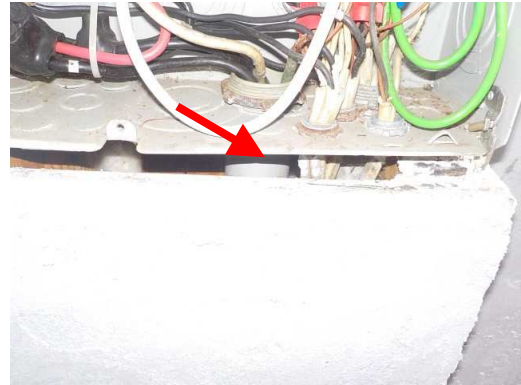
- The panel coverplate does not stay shut by itself. This condition should be corrected.
- There are exposed wires under the main panel. This condition should be properly corrected.

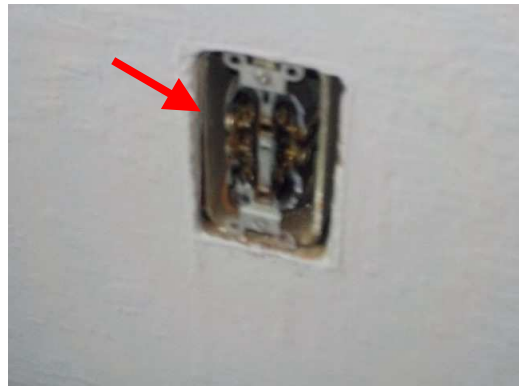
- The outlet in the north side of the front bedroom is broken, is a shocking hazard, and should be replaced.

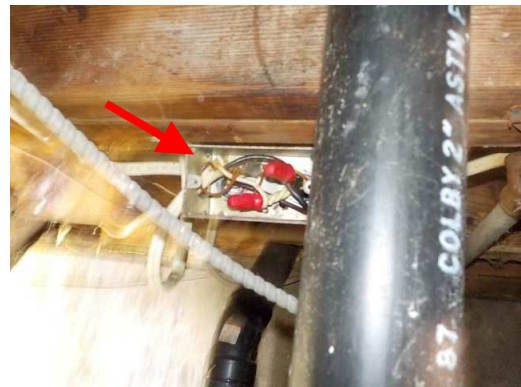
- There are uncovered junction boxes in the foundation crawl space. All junction boxes should be properly covered as required by local building codes.

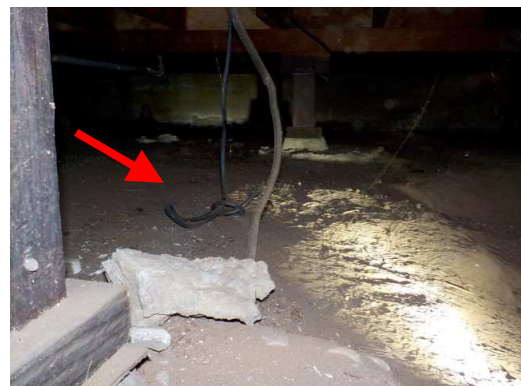
- There are wires terminated improperly in the foundation crawl space. All wires should be properly capped and terminated inside of approved junction boxes as required by local building codes.

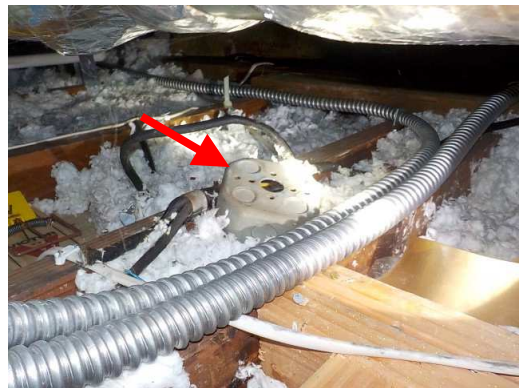
- There is a loose junction box in the attic space which is loose and should be secured in place.
- There is an uncapped knockout opening present in the loose junction in the attic space. This opening should be properly capped as required by local building codes.

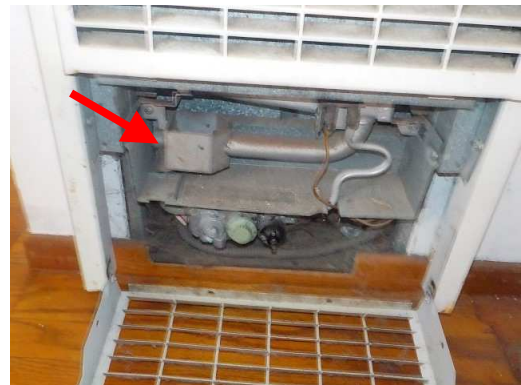
- There is an accumulation of dust and debris inside the furnace and the furnace should be cleaned prior to use.
- The furnace operated when activated by the control valve, however, the furnace appears to be near or beyond the expected service life. It is recommended that a licensed heating contractor be contacted for further inspection of the furnace and for recommendations.

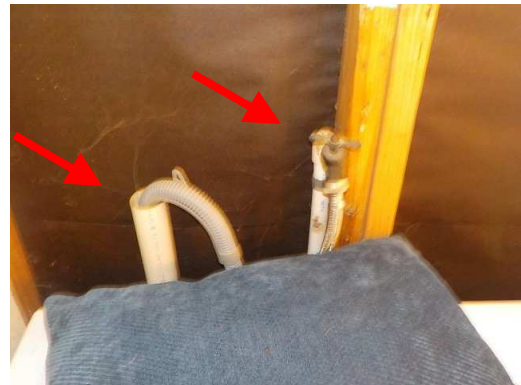
- There is only cold water supplied to the laundry room.
- There is no visible trap or vent for the washer drain. Local building codes require that each drain be provided with a properly vented trap. It was also not determined where the laundry drain connects. It is recommended that a licensed plumbing contractor be contacted for further inspection of the laundry drain and for repairs.

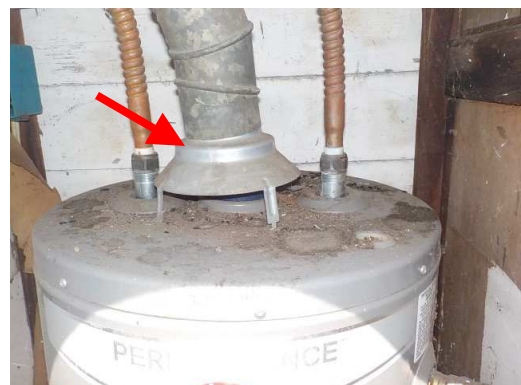
- The gas vent is offset and loose from the top of the water heater and should be properly repaired.

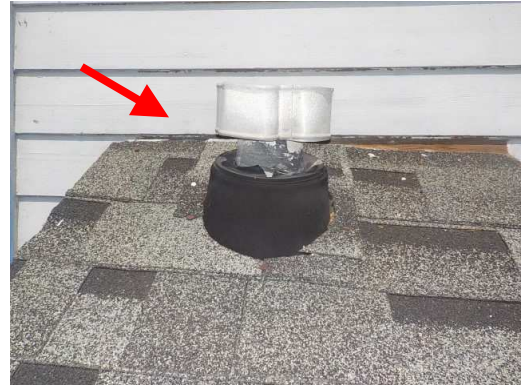
- The water heater gas vent terminates too close to the water heater closet roof and should be properly extended a minimum of one foot above the roof surface to prevent damage to the roofing and rubber flashing.

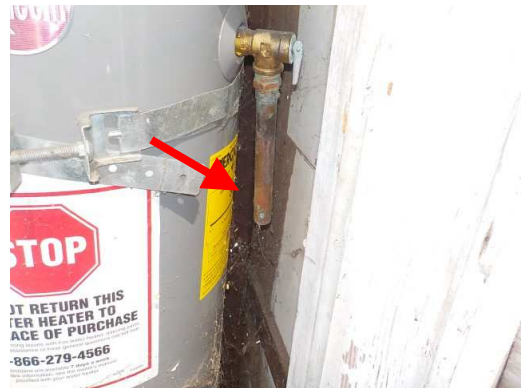
- There is no sediment trap present in the gas supply line. The absence of a sediment trap can cause the water heater to malfunction and manufacturers of gas fired water heaters generally require the presence of a sediment trap. It is recommended that the Client consider installing a sediment trap.
- The pressure-temperature relief valve discharge is not vented to an approved location and the discharge should be properly extended to within 6 to 24 inches of the ground or to a drain.

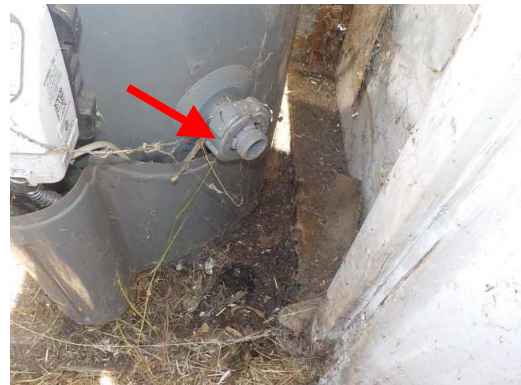
- The drain valve drips and is in need of repair or replacement.

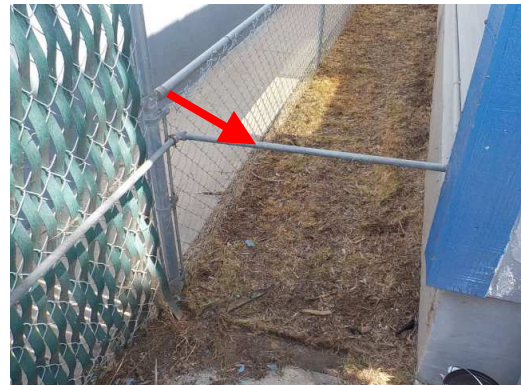
- The gas line for the laundry room passes through a walk able area and is exposed to physical damage. The gas line should be properly rerouted.

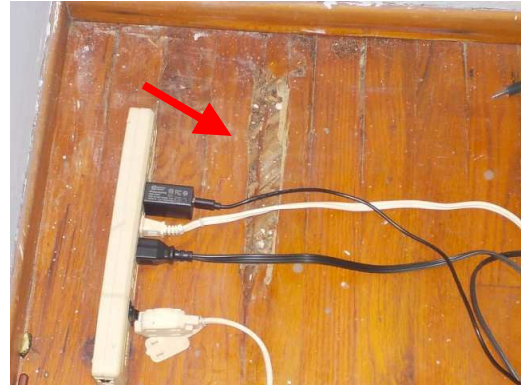
- The wood flooring is deteriorated in places, especially in the front bedroom. It is recommended that a licensed structural pest control company be contacted for further inspection and repair recommendations.

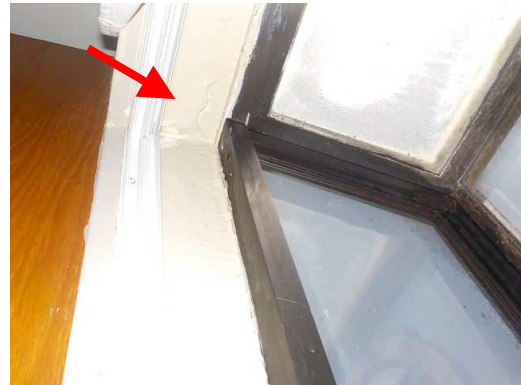
- The back bedroom closet window does not lock and is in need of adjustment or repair.
- There is some water damage to the drywall around the kitchen window. This condition is apparently caused by leakage of the window or of the window flashing. Determining the cause for this condition requires intrusive investigation and is beyond the scope of this inspection. It is recommended that a qualified moisture intrusion specialist be contacted for further investigation and for repair recommendations.

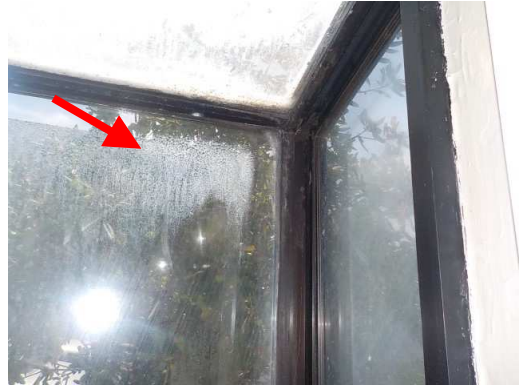
- The dual glazed type windows were examined for evidence of condensation between the panes. There is evidence of previous condensation between the panes of the dual glazed windows in the kitchen. This condition is typical of dual glazed windows which have lost their seal and the defective windows are in need of replacement. Detection of condensation between the panes of dual glazed windows which have lost their seals is weather dependent and defective windows may not be detectable at the time of the inspection. It is recommended that a licensed glazing contractor be contacted for further inspection of all of the windows and for repairs.

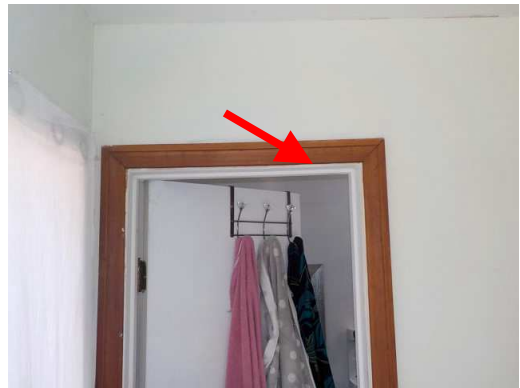
- The back bedroom door is delaminating at the bottom.
- The bathroom door rubs and is in need of adjustment or repair.
- The back bedroom and back bedroom closet doors leave a gap at the top when closed. These conditions are caused by the door frames being out of square and are apparently caused by some movement of the structure.

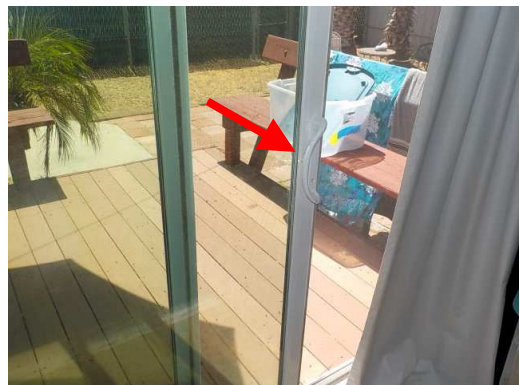
- The front bedroom closet doors have been removed.
- The sliding glass door to the outside from the back bedroom does not lock and is in need of adjustment or repair. This condition is possibly caused by some movement of the structure.

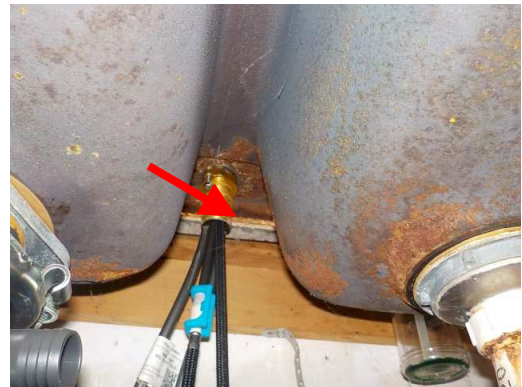
- There is a gap between the rear of the sink and the countertop. This condition can cause water damage to the cabinets and should be corrected.

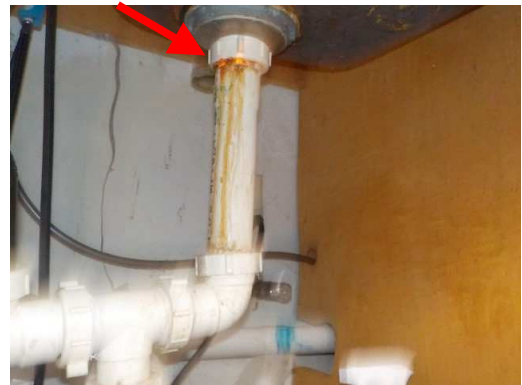
- The drain leaks underneath the sink and is in need of repair.

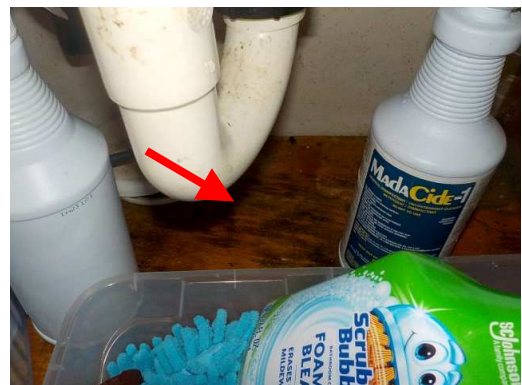
- There is some water damage to the interior of the cabinet underneath the sink. The cause for this condition could not be determined by visual inspection, however, because of this condition this area was tested for the presence of elevated moisture with a Protimeter Surveymaster electronic moisture meter and was found to be dry at the time of

the inspection. The Client is advised that the absence of moisture at this time does not necessarily indicate that any previous leakage has been successfully repaired or that future leakage will not occur. Water intrusion can cause damage to the structure, as well as promote the growth of mold and mildew. It is beyond the scope of this inspection to determine the presence of potentially harmful mold and mildew. It is recommended that a qualified indoor air quality specialist be contacted for comprehensive investigation and for recommendations.

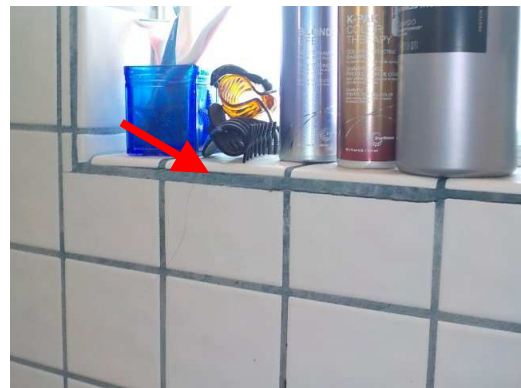
- Some of the enclosure tiles are not completely bonded to the wall at the window sill. This condition is possibly an indication of water damage to the walls behind the tiles. The loose tiles should be removed and any water damaged wall areas should be repaired. The tiles should then be properly replaced and sealed. It is recommended that a qualified indoor air quality specialist be contacted for comprehensive investigation and for recommendations for the reasons stated above.

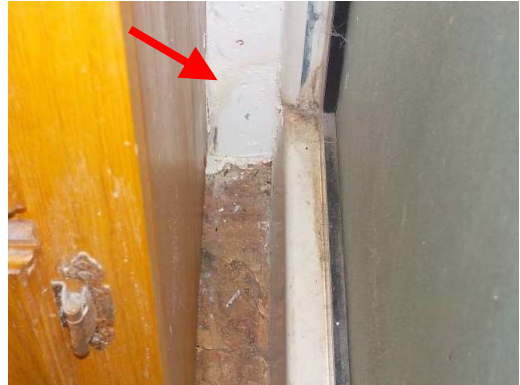
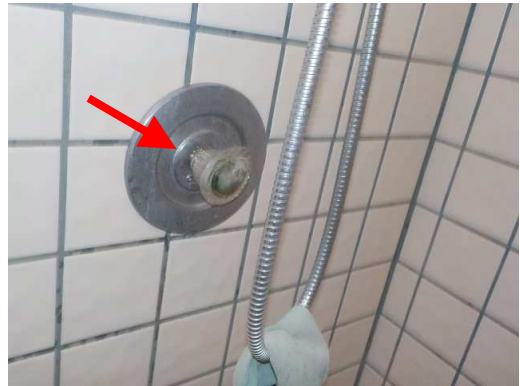
- There is some water damage to the wall next to the shower. This condition is possibly caused by shower overspray or by leakage around the shower doors. Because of this condition this area was tested for the presence of elevated moisture with a Protimeter Surveymaster electronic moisture meter and was found to be dry at the time of the inspection. The Client is advised that the absence of moisture at this time does not necessarily indicate that any previous leakage has been successfully repaired or that future leakage will not occur. It is recommended that a qualified indoor air quality specialist be contacted for comprehensive investigation and for recommendations for the reasons stated above.
- The faucet handle is hard to operate and is in need of adjustment or repair.

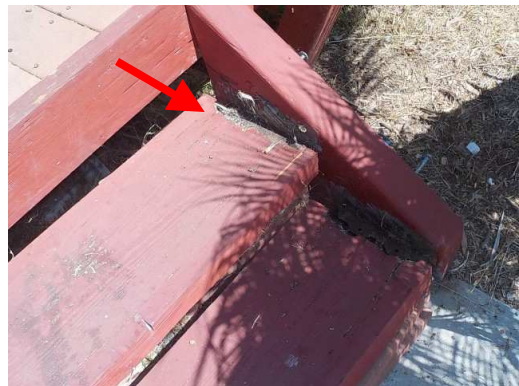
- The deck steps are damaged, are a safety hazard, and the deck is in need of repair.

- It is recommended that a licensed contractor specializing in decks be contacted for further inspection and for repairs.

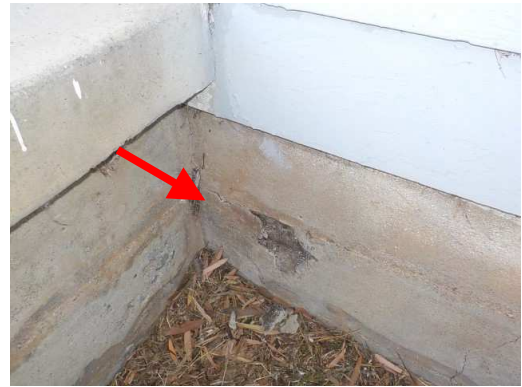
- The concrete has spalled away from the edge of the foundation at the front of the house west of the entry. This condition is apparently caused by one of the anchor bolts being placed too close to the edge of the foundation wall during construction. When the foundation walls become wet, moisture penetrates the concrete to the steel anchor bolt. The moist steel then rusts and expands producing the spalled area. Only one bolt appears to be affected and there is no evidence that this condition is structurally significant.

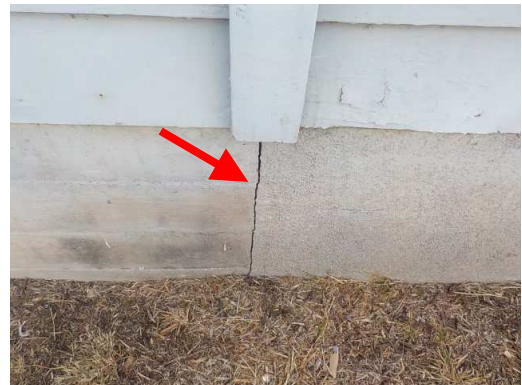
- There is a joint in the foundation wall at the main house/addition junction. This condition is not unusual for this type of junction.

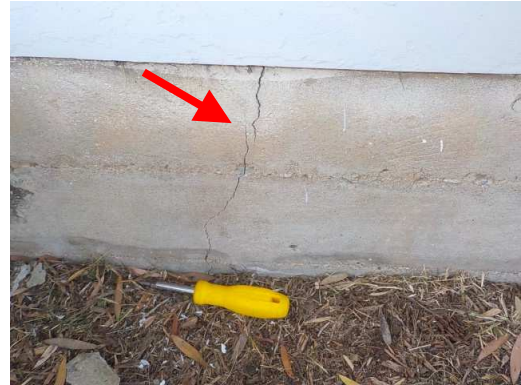
- There is a slightly offset crack in the foundation wall at the front of the living room west of the entry. This condition is apparently caused by some movement of the foundation.

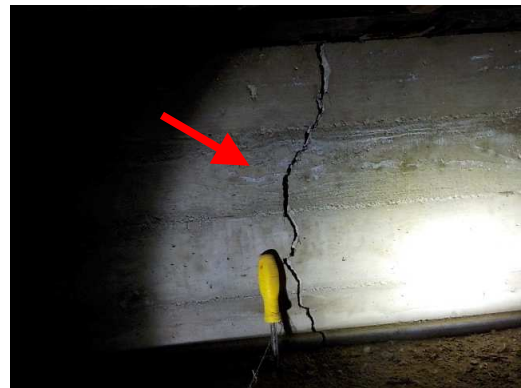
- There is a large crack visible in the foundation wall under the south side of the original portion of the house. This condition is also apparently caused by some movement of the foundation.

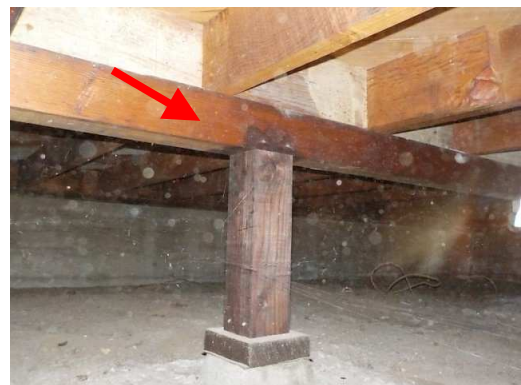
- The house appears to have possibly experienced some distress as evidenced by the out of square condition of some of the door frames and cracks in the foundation walls. It is recommended a registered professional engineer well versed in the evaluation of residential foundations be retained for further inspection and recommendations.
- There are no brackets at the beam/post connections and the beams are only 4x4. Current standards require brackets and 4x6 beams, however, these conditions were not require at the time of the inspection.

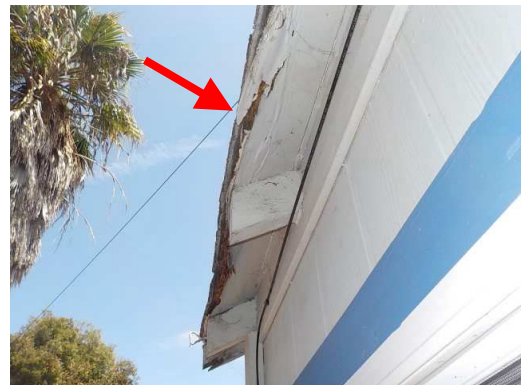
- Some deterioration was noted to the eaves in many places. It is recommended that a licensed structural pest control company be contacted for further inspection and repair recommendations.

- It is recommended that a licensed roofing contractor be contacted for a complete roofing inspection and for repair or replacement recommendations.

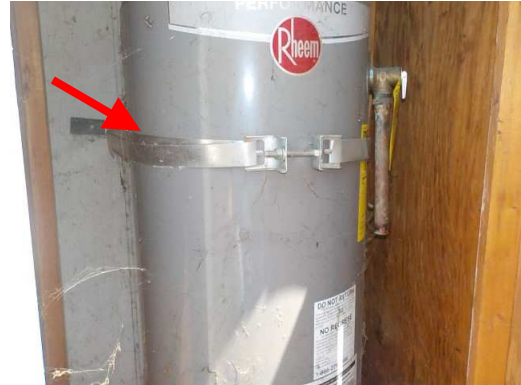
- The water heater is not adequately secured by seismic restraints because there is only one strap. The water heater should be properly restrained as required by California state law.

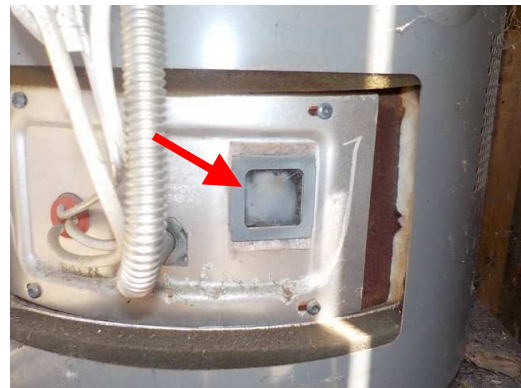
- The glass window for the water heater flame is obstructed and is in need of repair or replacement.

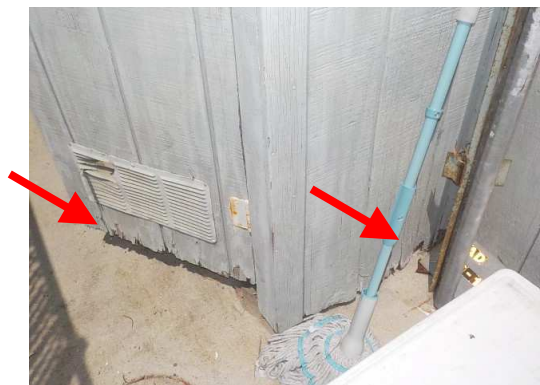
- The water heater was off at the time of the inspection and did not light when tested. The cause for this condition should be determined and corrected.
- It could not be determined if the hot/cold water orientation is correct at the fixtures. Local building codes require that the hot water supply be on the left. It is recommended that the fixtures be tested for proper hot/cold orientation after the water heater has been placed in service.
- It is recommended that a licensed plumbing contractor be contacted for further inspection of the water heater and for repairs.
- The water heater closet is deteriorated in places. It is recommended that a licensed structural pest control company be contacted for further inspection and repair recommendations.

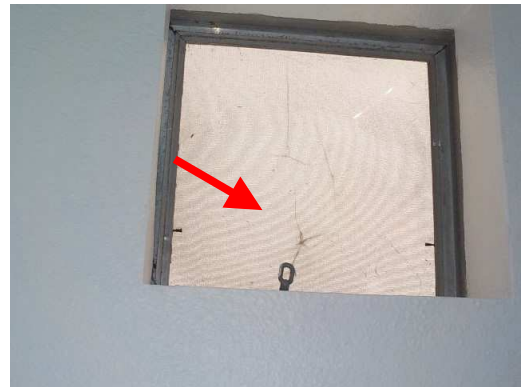
- The bathroom skylight is cracked and is in need of repair or replacement.

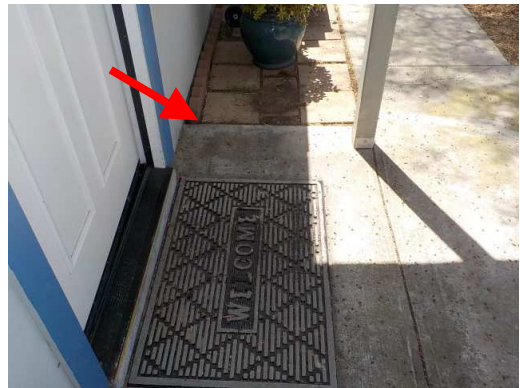
- There is evidence of water ponding on the walkway at the west side of the house. The drainage should be improved in this area and water should not be allowed to pond in areas adjacent to the foundation.
